Attachment J

Subject: Biological assessment for 26307 Isabella Avenue in Carmel

Project No. M11382
18 December 2017

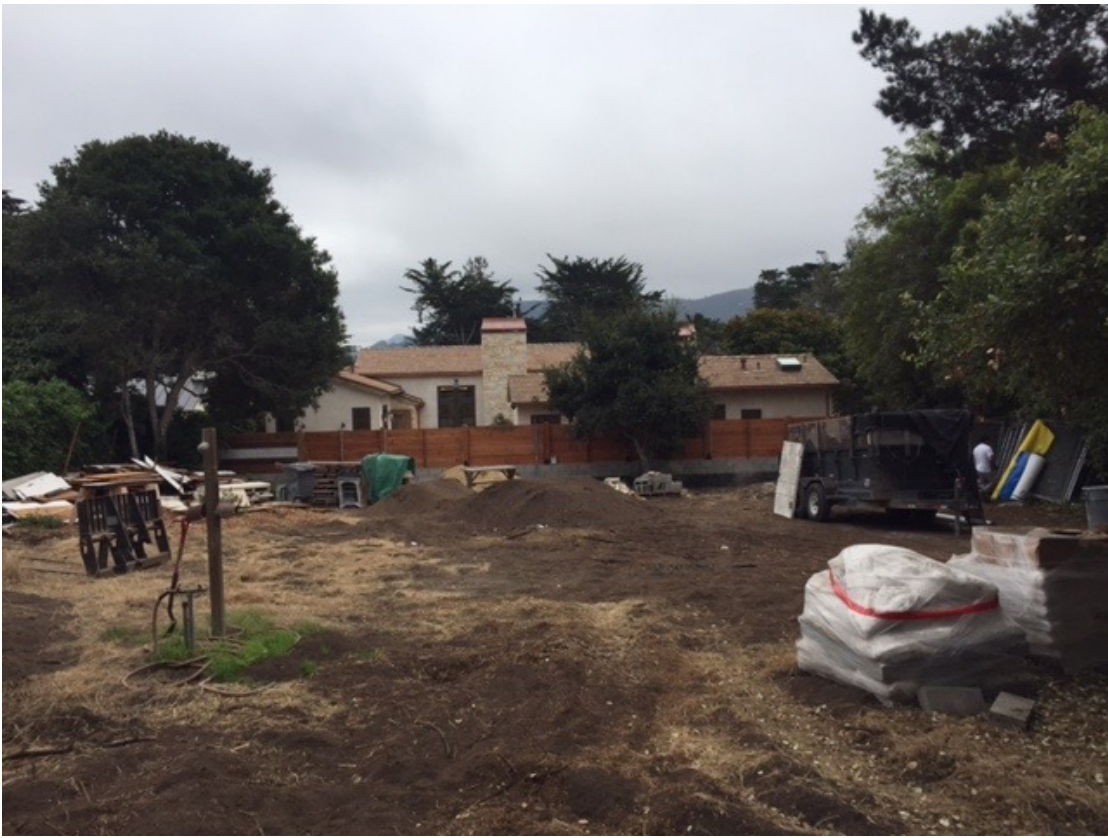
2). This undeveloped and ruderal property has been previously impacted and disturbed. Homes in this community are located in relatively close proximity to one another and natural open space is generally absent in this particular area.

Based on a thorough assessment and evaluation of this previously disturbed and impacted property it is clearly evident that the subject parcel does not support protected special status species and/or sensitive habitat. There are no known occurrences of special status species, sensitive habitat or other protected resources on the subject property and none were observed during the field assessment.

Figure 1. Sensitive and protected biological resources are not occurring on previously disturbed and impacted property located at 26307 Isabella Ave in Carmel. Resources are limited to a few native tree and plant species, as well as some non-native introduced plant species.

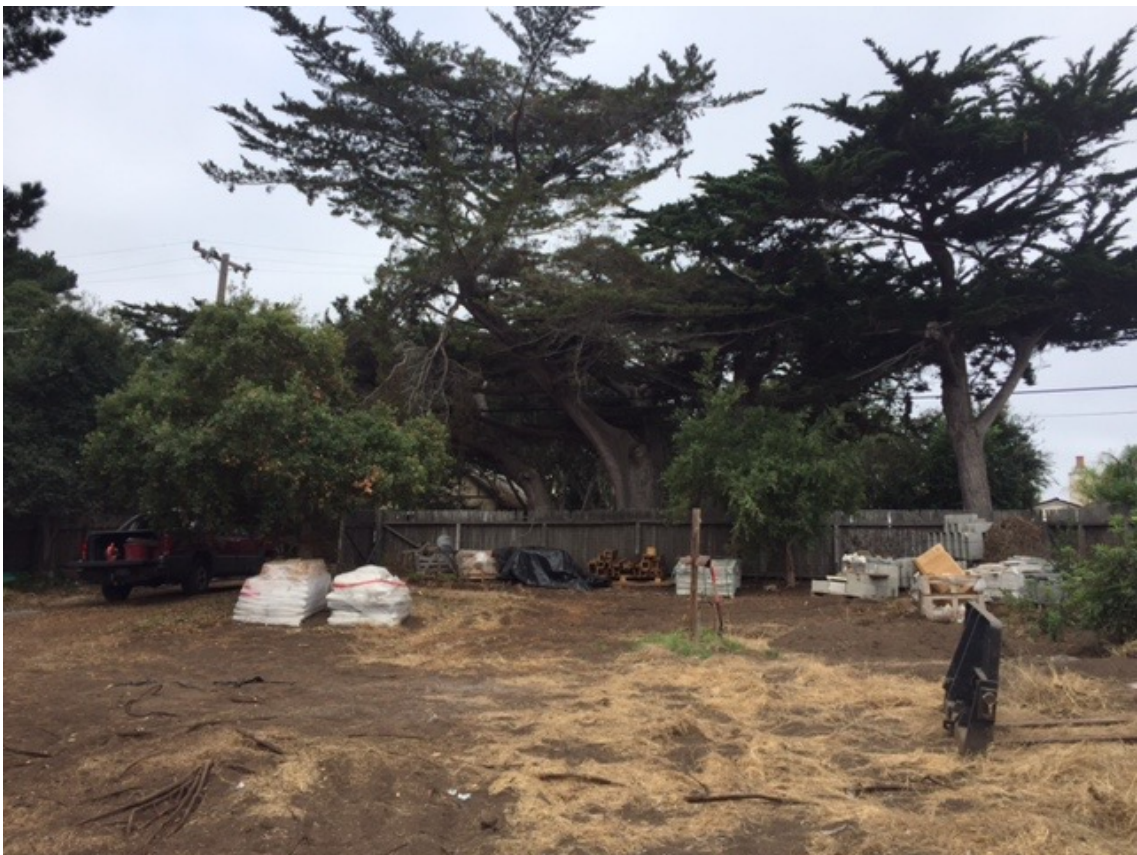
This mixed woodland environment is significantly influenced by seasonally temperate coastal environmental conditions. Native tree species occurring in this coastal area of Carmel are dominated by mid to upper canopy Monterey Cypress (*Cupressus macrocarpa*), Monterey Pine (*Pinus radiata*) and mid to lower canopy Coast Live Oak (*Quercus agrifolia*). Mature and aging Monterey Cypress and Pine are the most visible and conspicuous upper canopy trees in the area with crown classes primarily ranging from co-dominant to dominant. On this particular disturbed and impacted lot, there are no upper canopy trees occurring on the property, however there is a relatively small and immature Coast Live Oak tree. This native oak as well as a introduced Cork Oak (*Quercus suber*) will be retained and protected. This property has little canopy cover; however, it should be noted that larger and more conspicuous cypress, pines and oaks are occurring on nearby adjacent properties.

Figure 2. Mature mid to upper canopy roadside Monterey Cypress trees are bordering property.
