April 19, 2024

Polk Residence
1472 Padre Lane
Pebble Beach, CA. 93953
APN: 008-453-015-000

Subject: 1472 Padre Lane Pre-Construction Tree Impact Assessment

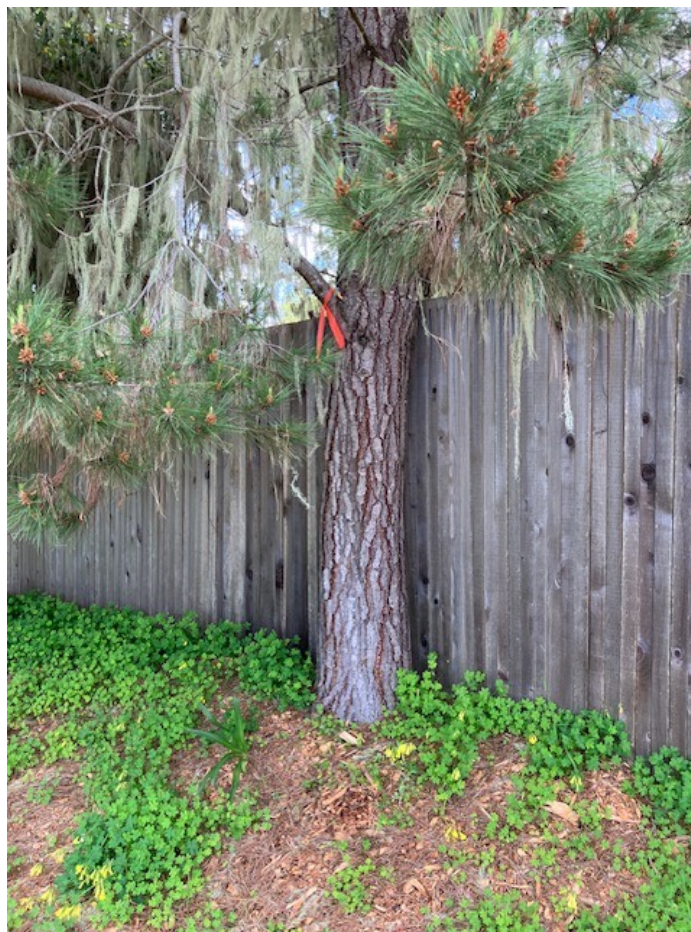
Per the assessment, it has been determined that one 12 inch DBH (diameter at breast height) Monterey pine will need to be removed in preparation for construction activities

due to its location with the proposed building footprint (refer to attached photos, *Figures 1 & 2* and the *Exhibit A: Tree Removal & Protection Fencing Map* and project site plan). This fairly small and immature pine is approximately 30 feet in height and is in good physiological health and structural condition.

Figure 1. This fairly small and immature Monterey pine will need to be removed due to its location within the proposed construction footprint.

Upon obtaining a permit, tree removal should be performed by licensed and insured tree workers trained in accordance with ANSI Z133.1 safety regulations, as required by OSHA. If necessary, tree protection measures should be installed to nearby trees that could be impacted and affected by tree removal and/or construction operations. Additionally, if substantial soil disturbance occurs at the removal site it may be necessary to install erosion and sedimentation control measures to effectively stabilize exposed soil surfaces and contain sediment runoff. Furthermore, best management practices involved with tree removal, disposal, and the cleaning and sterilization of tools and equipment should be implemented to minimize the movement of potentially harmful biotic disorders.

Based on the current building footprint and design plan, there is no alternative to removing the subject pine tree. Following tree removal, one 5 to 15-gallon container size replacement Monterey pine, coast live oak and/or Monterey cypress seedling or sapling of good physiological health and structural condition shall be planted on the subject property to replace the removed pine tree, which will assist in sustaining and supporting the long-term health, viability and character of this woodland residential community. Planting a coast live oak or Monterey cypress should be an acceptable alternative to planting a Monterey pine, due to these two species being native to this area of Del Monte Forest and appropriate to this mixed woodland habit type.

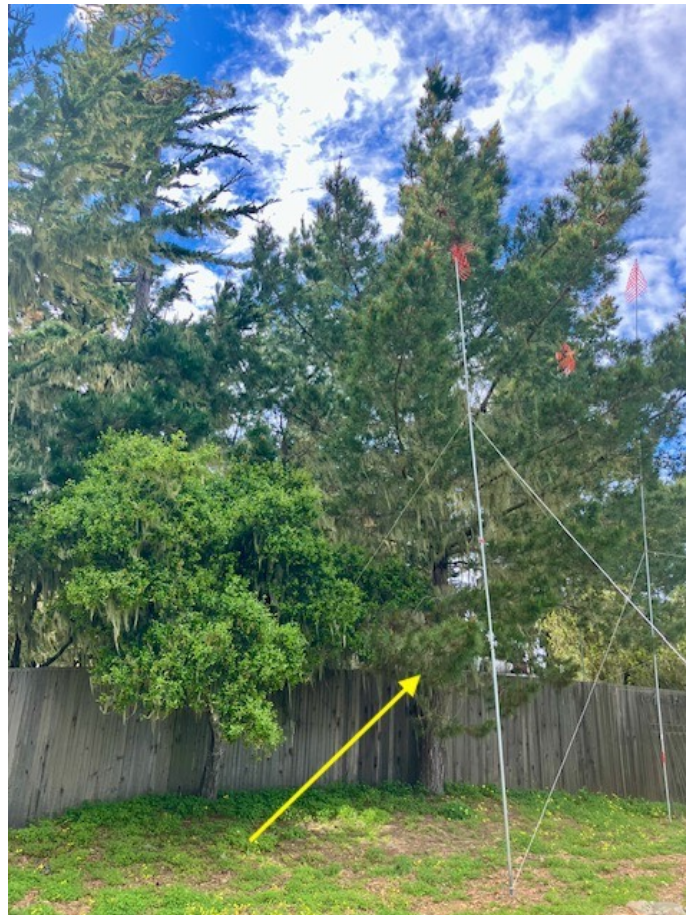
Figure 2. Yellow arrow identifies this insignificant pine that is proposed for removal. All other trees on the property will be retained and protected.
