PHASE TWO HISTORIC ASSESSMENT

**The Hatton Dairy Barn
6540 Carmel Valley Road
Carmel Valley, CA.
APN: 015-201-012**

July 10, 2025

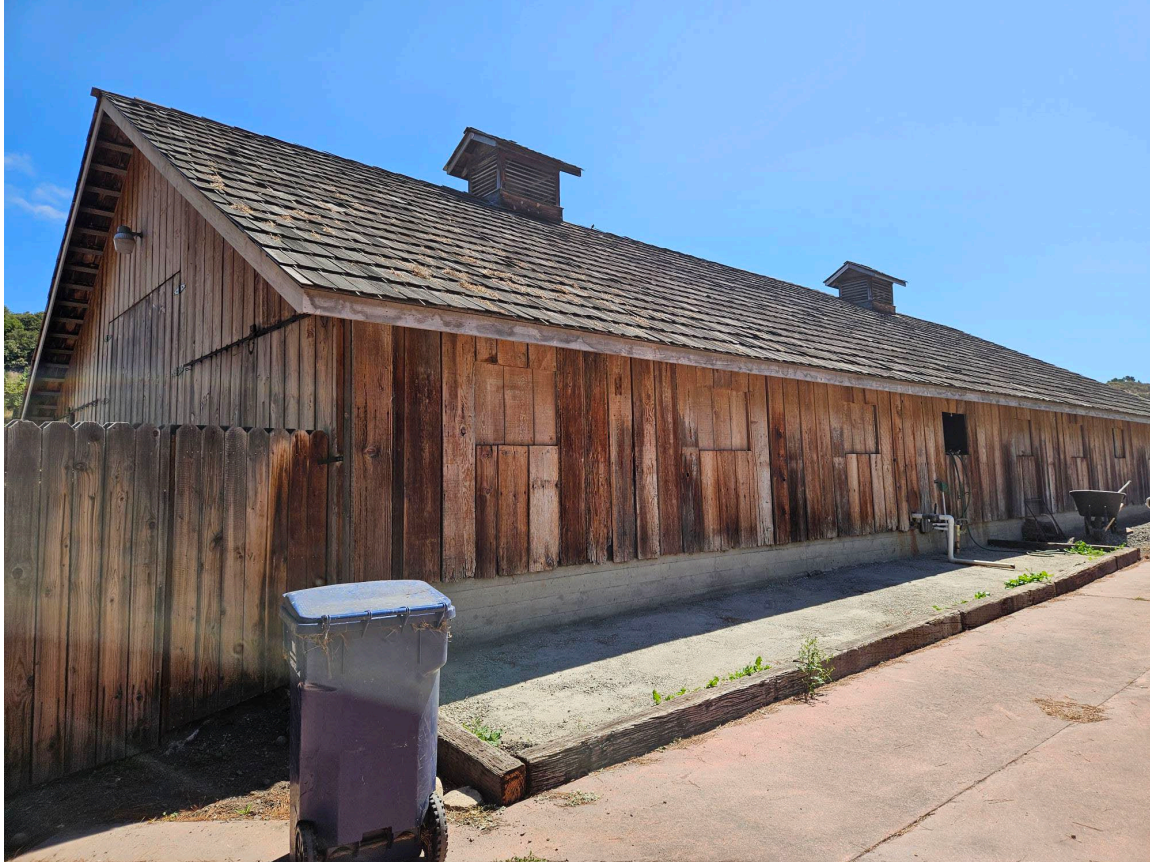
The barn was rehabilitated in 2011. The wood siding on the west, east, and north elevations was replaced with Douglas fir siding that matched the original. The south elevation is original wood that was patched from pieces of wood taken from the other elevations. A new roof was installed using custom-made, 36-inch wood shakes that replicate the original.

Figure 4: View of the south elevation looking northeast.

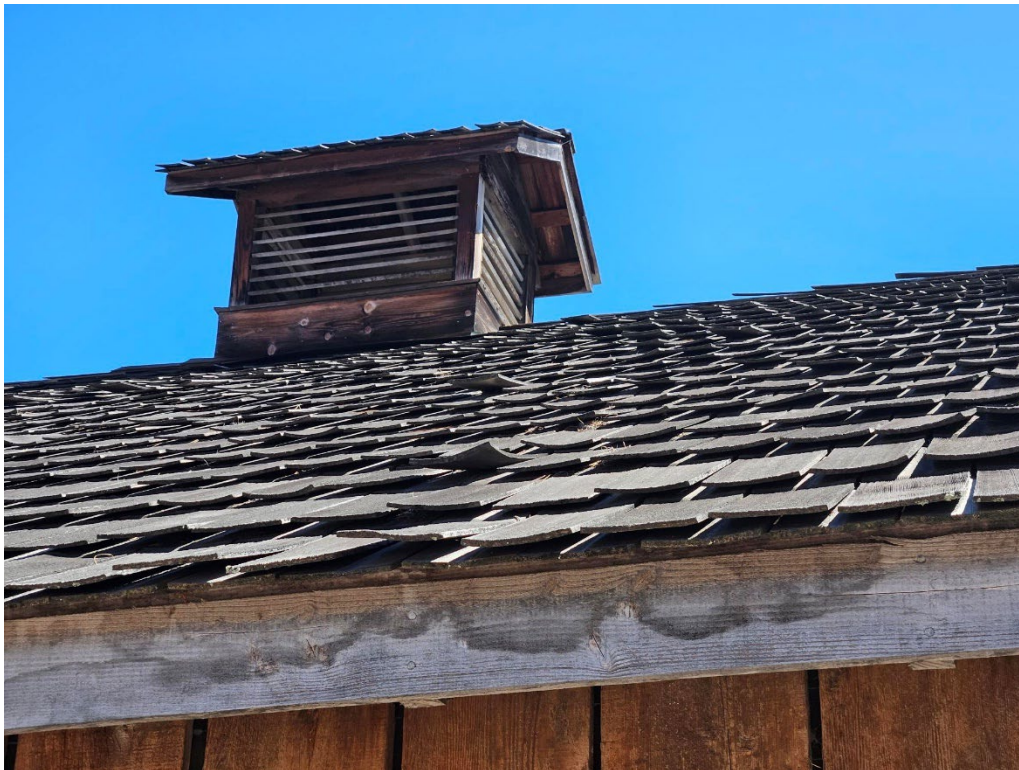
The wood shingle roof that was installed in 2011 has reached the end of its life span (see Figure 6) and is not considered a distinctive feature. The proposed new roofing material is not wood but it will provide a higher level of fire protection, which in turn will help protect the barn. When the original roof was replaced in 2011, the shakes were replicated, which provides some evidence of the original installation pattern, look and size. Every effort should be made to replicate the look and pattern of the old shakes with the new material so the overall historic aesthetic of the barn will be compatible including design, color, and texture. It is recommended that a sample of the proposed asphalt shake be submitted to the Historic Resources Review Board (HRRB) for approval. Upon HRRB approval, the proposed work will be consistent with Standard Six.

Figure 6: detail of barn roof condition.

The wood shingle roof will not be replaced in kind due to fire concerns since the barn is in a high fire hazard area. The contractor has proposed to replace the wood shingles with asphalt shingles. Prior to installing the shingles, new plywood and an additional layer of a fire-rated membrane will be installed for further fire protection.

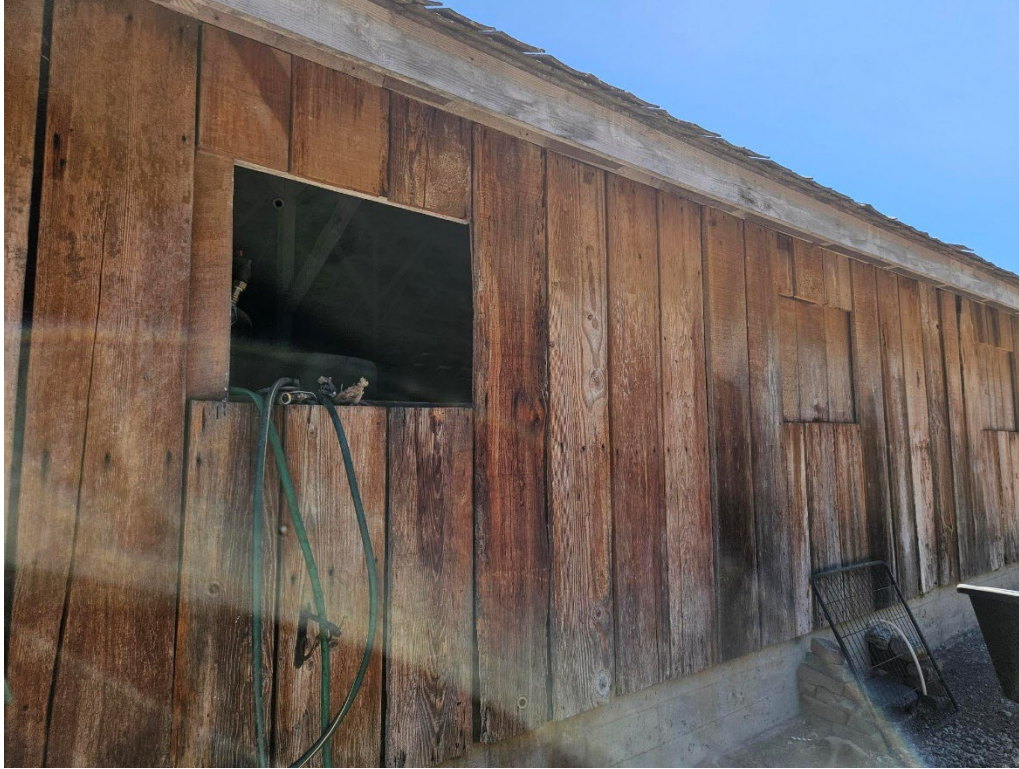
To prevent water intrusion through the stall windows, new storm windows will be installed behind each stall window. The storm windows will only be visible if the sliding wood shutters are open.

Figure 5: Detail of stall windows, opened and closed with sliding wood shutters.

Operable storm windows will be installed behind the sliding wood shutters in each stall. The storm windows will not be visible from the exterior of the barn when the wood shutters are closed. The Secretary of the Interior's Guidelines for windows recommends adding interior storm windows when appropriate because they improve energy efficiency. The proposed work is consistent with Standard Nine.
