October 3, 2023

Glass Residence  
 124 Fern Canyon Road  
 Carmel, CA. 93923  
 APN: 241-131-024-000

Subject: 124 Fern Canyon Road Pre-construction Tree Impact Assessment

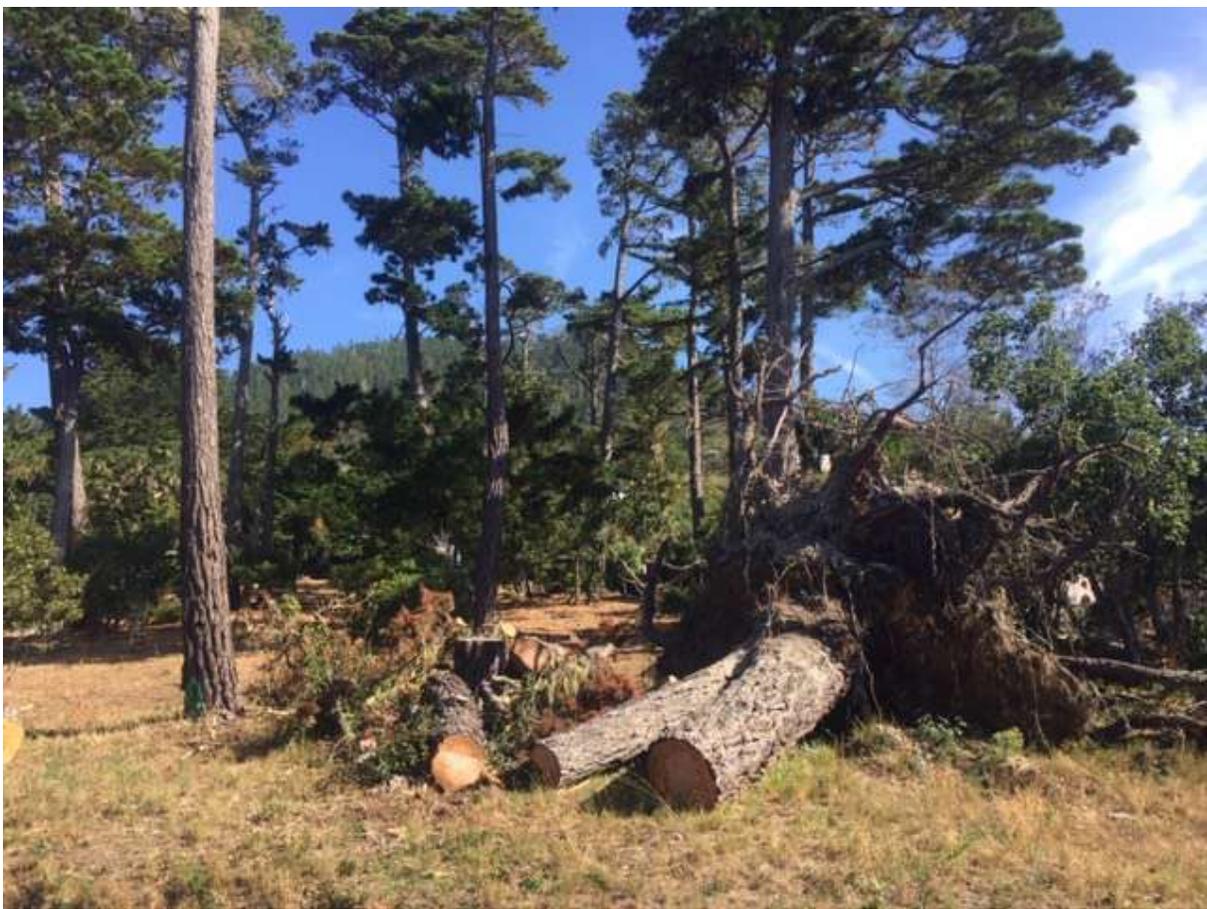
Figure 1. View of subject lot from Fern Canyon Rd that is dominated by mature and aging Monterey pine trees. A few large pine trees fell last winter.

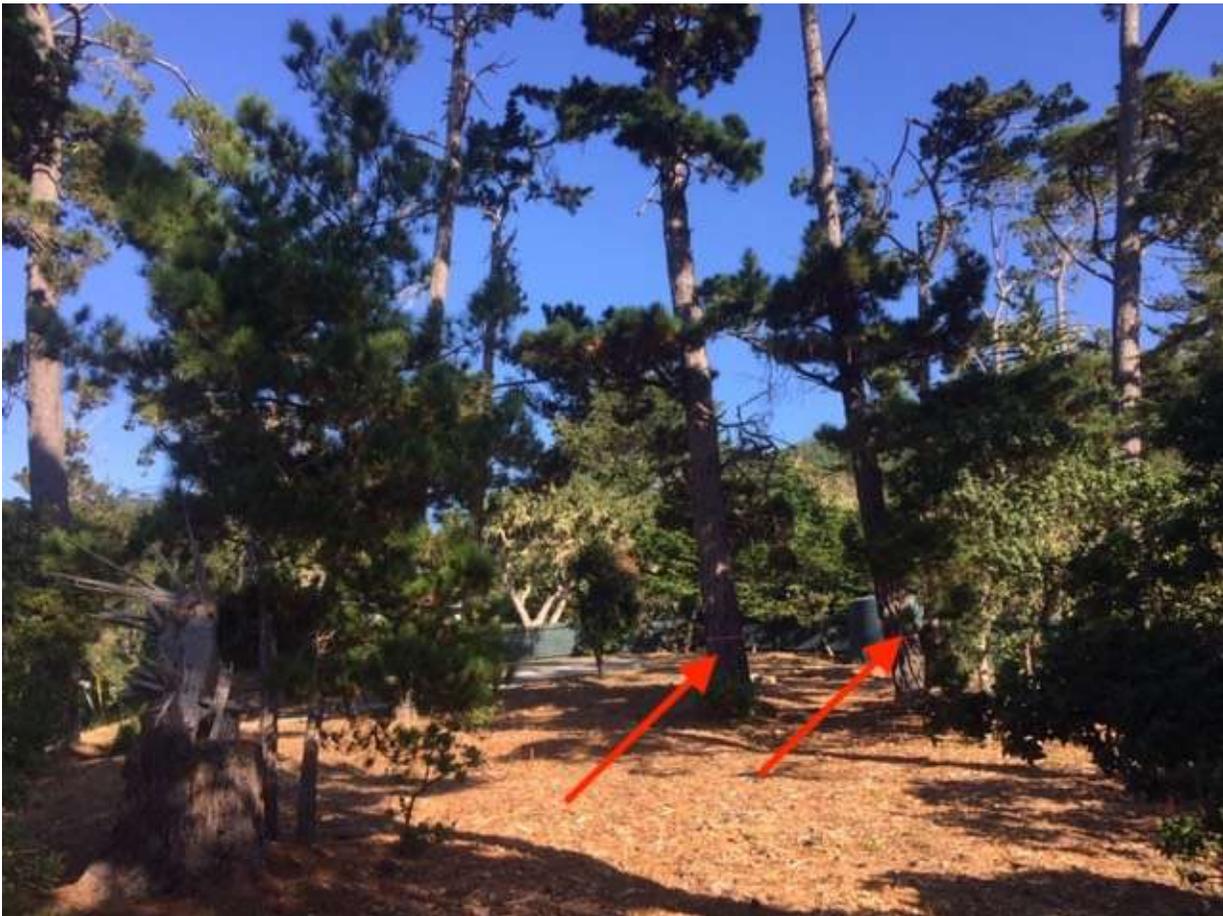
Figure 6. More mixed pine and oak looking towards homesite. Pines identified as Tree#s 4 & 5 (red arrows) are proposed for removal due to construction impacts.

| <b>Tree &amp; Tag #s</b> | <b>Tree Specie</b> | <b>DBH (inches)</b> | <b>Crown Class</b> | <b>Balance &amp; Symmetry</b> | <b>Physiological Condition</b> | <b>Structural Condition</b> | <b>Overall Health</b> | <b>Reason for Removal</b> | <b>Replacement Ratio</b> | <b>Comments</b> |
|--|---|---|---|---|---|---|---|---|---|---|
| 4 | Monterey Pine | 31 | Codominant | Good | Fair | Fair | Fair | Construction | 2:1 | |
| 5 | Monterey Pine | 27 | Codominant | Fair | Fair | Fair | Fair | Construction | 2:1 | |

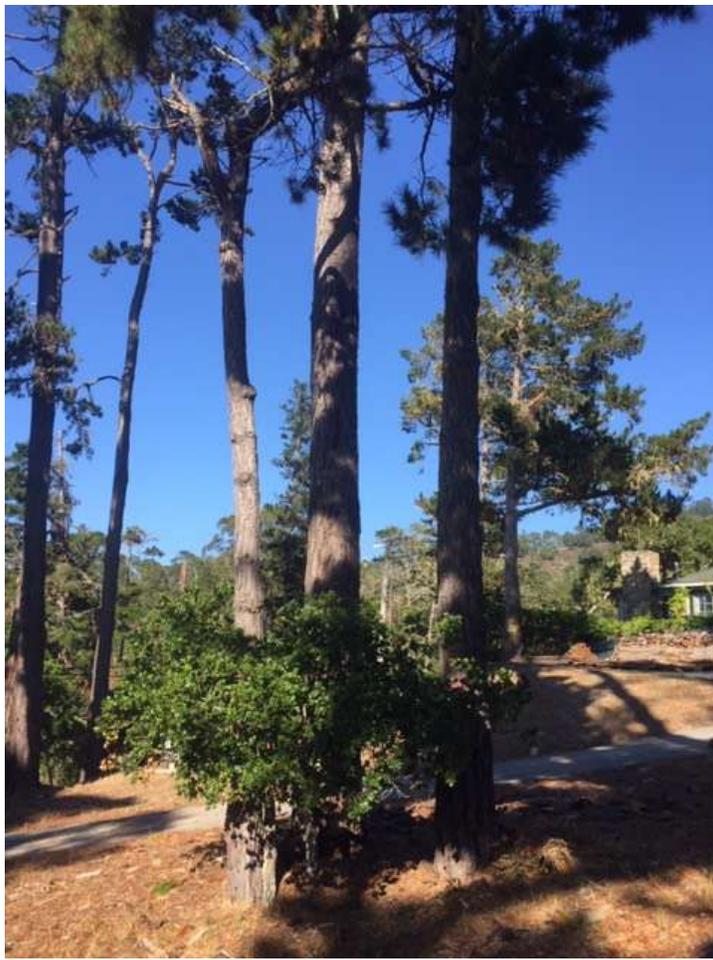
Figure 7. Three pines identified as Tree#s 1-3 are proposed for removal due to location with proposed driveway.

| <b>Tree &amp; Tag #s</b> | <b>Tree Specie</b> | <b>DBH (inches)</b> | <b>Crown Class</b> | <b>Balance &amp; Symmetry</b> | <b>Physiological Condition</b> | <b>Structural Condition</b> | <b>Overall Health</b> | <b>Reason for Removal</b> | <b>Replacement Ratio</b> | <b>Comments</b> |
|--|---|---|---|---|---|---|---|---|---|---|
| 1 | Monterey Pine | 27 | Codominant | Good | Fair | Fair | Fair | Construction | 2:1 | |
| 2 | Monterey Pine | 11 | Suppressed | Poor | Poor | Poor | Poor | Construction | 1:1 | |
| 3 | Monterey Pine | 13 | Intermediate | Poor | Poor | Poor | Poor | Construction | 1:1 | |

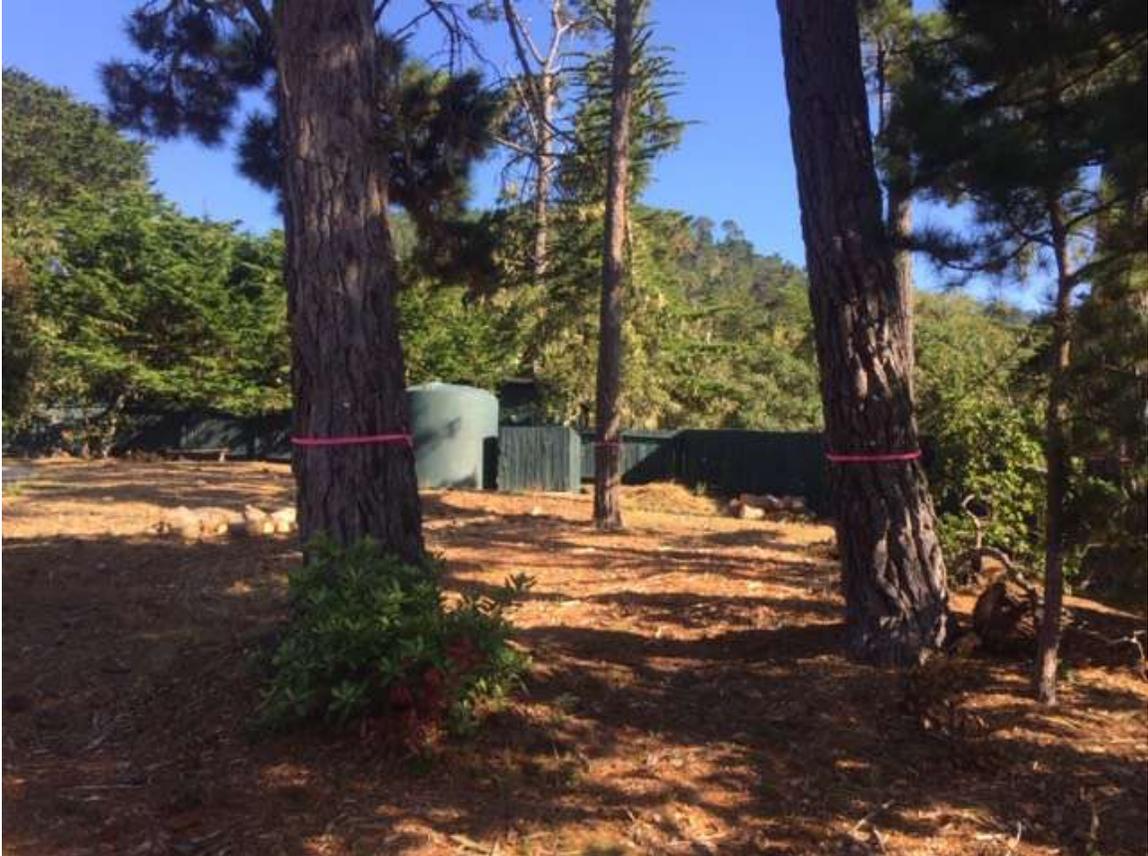
Figure 8. Closer view of pines identified as Tree#s 4 & 5 that are located within proposed building footprint and need to be removed.

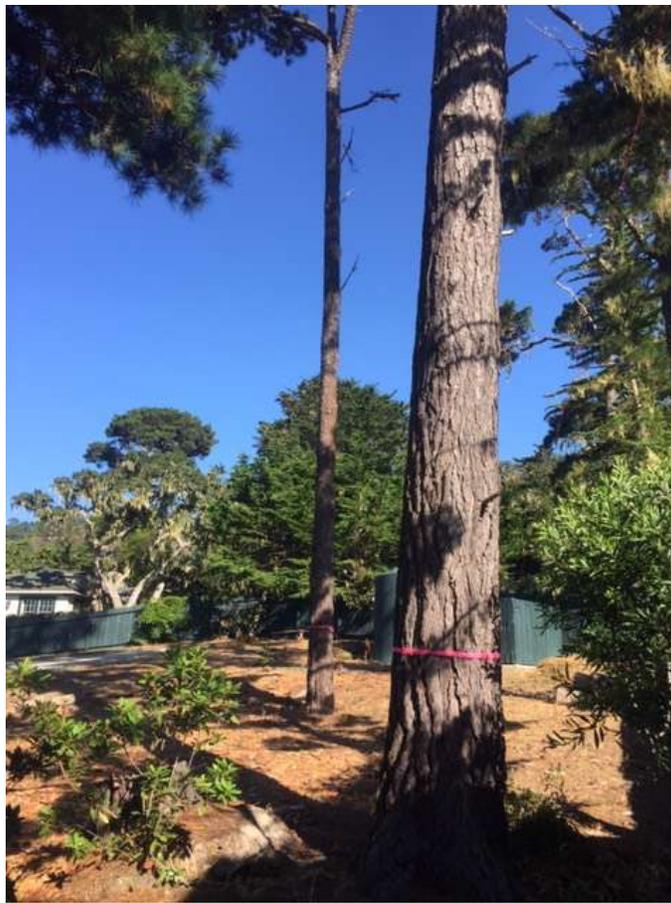
Figure 9. Pine in foreground identified as Tree#6 is located outside of building footprint, but is in declining condition and should be removed due to hazard concerns. Smaller pine in background is Tree#7 and needs to be removed due to construction impacts.

| <b>Tree &amp; Tag #s</b> | <b>Tree Specie</b> | <b>DBH (inches)</b> | <b>Crown Class</b> | <b>Balance &amp; Symmetry</b> | <b>Physiological Condition</b> | <b>Structural Condition</b> | <b>Overall Health</b> | <b>Reason for Removal</b> | <b>Replacement Ratio</b> | <b>Comments</b> |
|--|---|---|---|---|---|---|---|---|---|---|
| 6 | Monterey Pine | 30 | Codominant | Fair | Poor-Fair | Poor-Fair | Poor-Fair | Hazardous | 2:1 | |

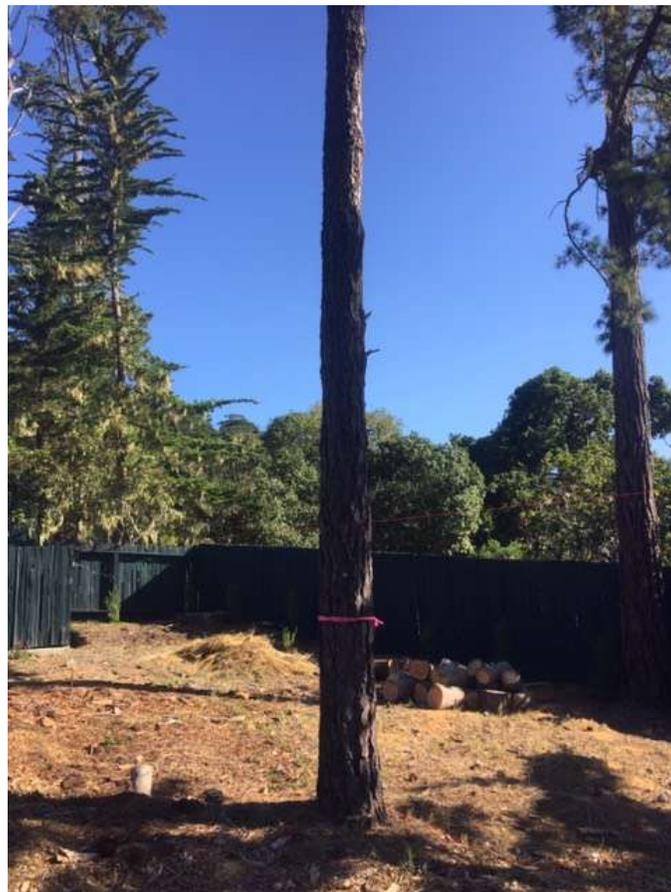
Figure 10. Pine identified as Tree#7 is proposed for removal due to location with building footprint.

| <b>Tree &amp; Tag #s</b> | <b>Tree Specie</b> | <b>DBH (inches)</b> | <b>Crown Class</b> | <b>Balance &amp; Symmetry</b> | <b>Physiological Condition</b> | <b>Structural Condition</b> | <b>Overall Health</b> | <b>Reason for Removal</b> | <b>Replacement Ratio</b> | <b>Comments</b> |
|--|---|---|---|---|---|---|---|---|---|---|
| 7 | Monterey Pine | 15 | Intermediate | Poor | Poor | Poor | Poor | Construction | 1:1 | |

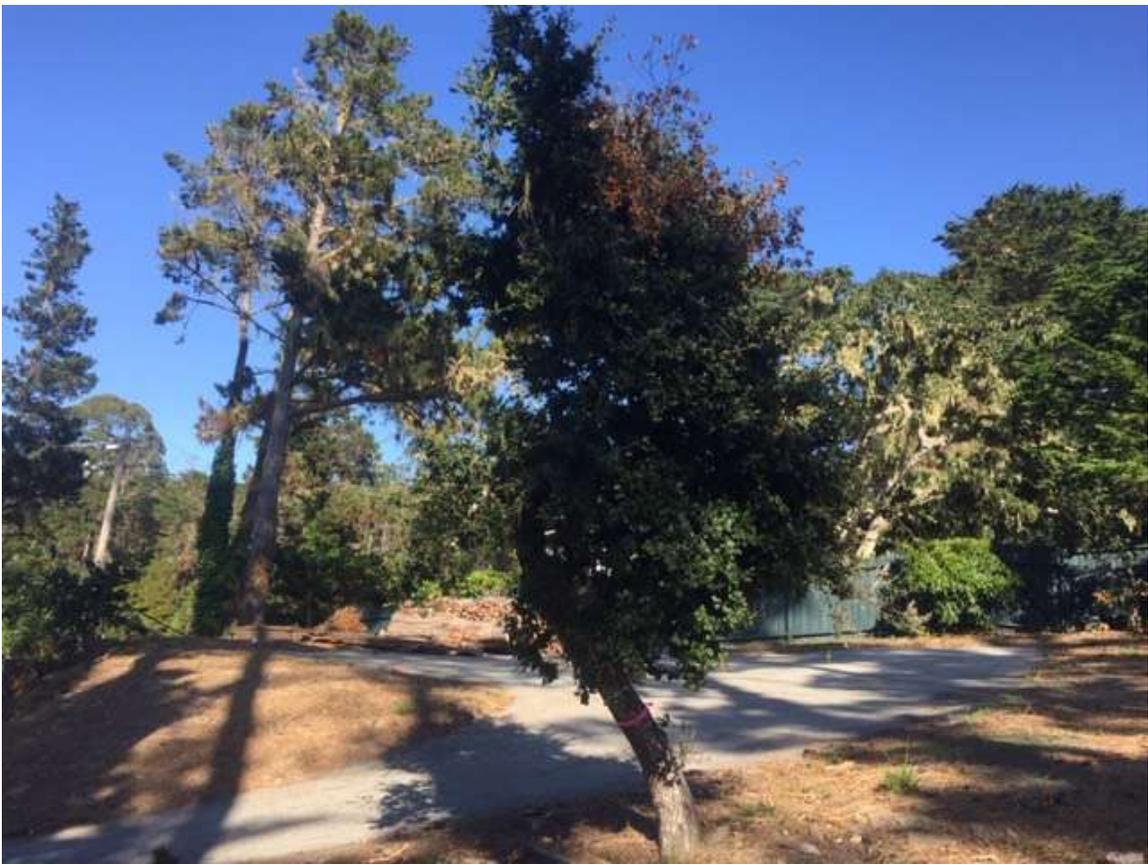
Figure 11. Oak identified as Tree#8 is proposed for removal due to construction impacts.

| <b>Tree &amp; Tag #s</b> | <b>Tree Specie</b> | <b>DBH (inches)</b> | <b>Crown Class</b> | <b>Balance &amp; Symmetry</b> | <b>Physiological Condition</b> | <b>Structural Condition</b> | <b>Overall Health</b> | <b>Reason for Removal</b> | <b>Replacement Ratio</b> | <b>Comments</b> |
|--|---|---|---|---|---|---|---|---|---|---|
| 8 | Coast Live Oak | 8 | Suppressed | Poor | Poor | Poor | Poor | Construction | 1:1 | |

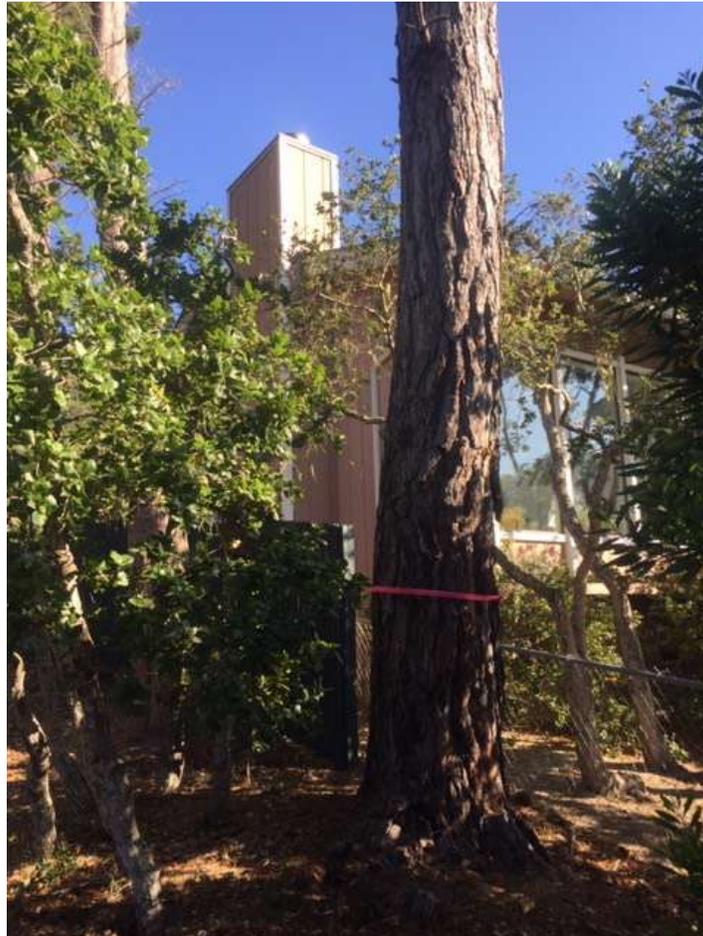
Figure 12. Large and aging pine identified as Tree#9 is in declining health and condition and is recommended for removal due to hazard concerns.

| <b>Tree &amp; Tag #s</b> | <b>Tree Specie</b> | <b>DBH (inches)</b> | <b>Crown Class</b> | <b>Balance &amp; Symmetry</b> | <b>Physiological Condition</b> | <b>Structural Condition</b> | <b>Overall Health</b> | <b>Reason for Removal</b> | <b>Replacement Ratio</b> | <b>Comments</b> |
|--|---|---|---|---|---|---|---|---|---|---|
| 9 | Monterey Pine | 31 | Codominant | Fair | Poor | Poor | Poor | Hazardous | 2:1 | |

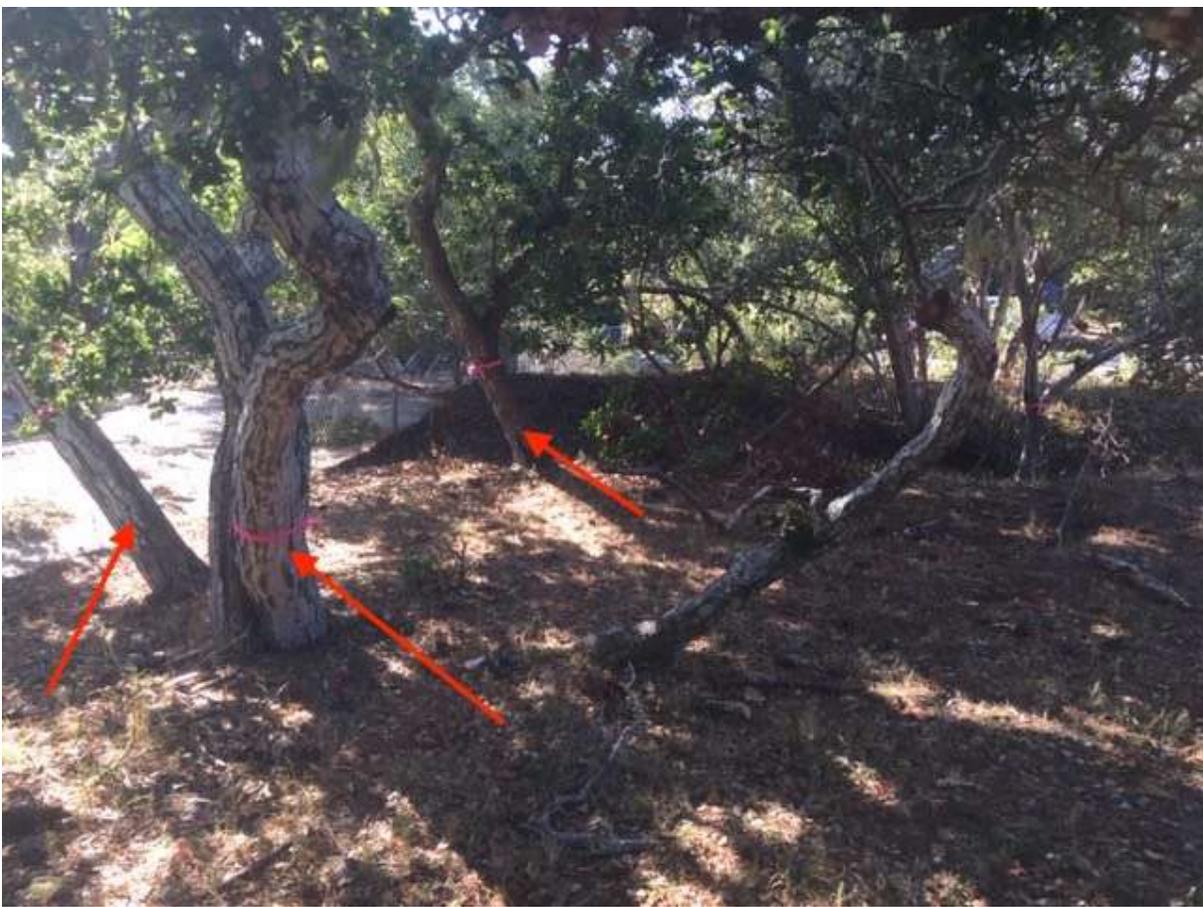
Figure 13. Three oaks identified as Tree#s 10-12 are located within driveway footprint and will need to be removed. Other nearby trees are less than 6" diameter.

| <b>Tree &amp; Tag #s</b> | <b>Tree Specie</b> | <b>DBH (inches)</b> | <b>Crown Class</b> | <b>Balance &amp; Symmetry</b> | <b>Physiological Condition</b> | <b>Structural Condition</b> | <b>Overall Health</b> | <b>Reason for Removal</b> | <b>Replacement Ratio</b> | <b>Comments</b> |
|--|---|---|---|---|---|---|---|---|---|---|
| 10 | Coast Live Oak | 13 | Intermediate | Fair | Good | Fair | Fair | Construction | 1:1 | |
| 11 | Coast Live Oak | 9 | Intermediate | Poor | Fair | Poor | Fair | Construction | 1:1 | |
| 12 | Coast Live Oak | 9 | Intermediate | Fair | Fair | Fair | Fair | Construction | 1:1 | |

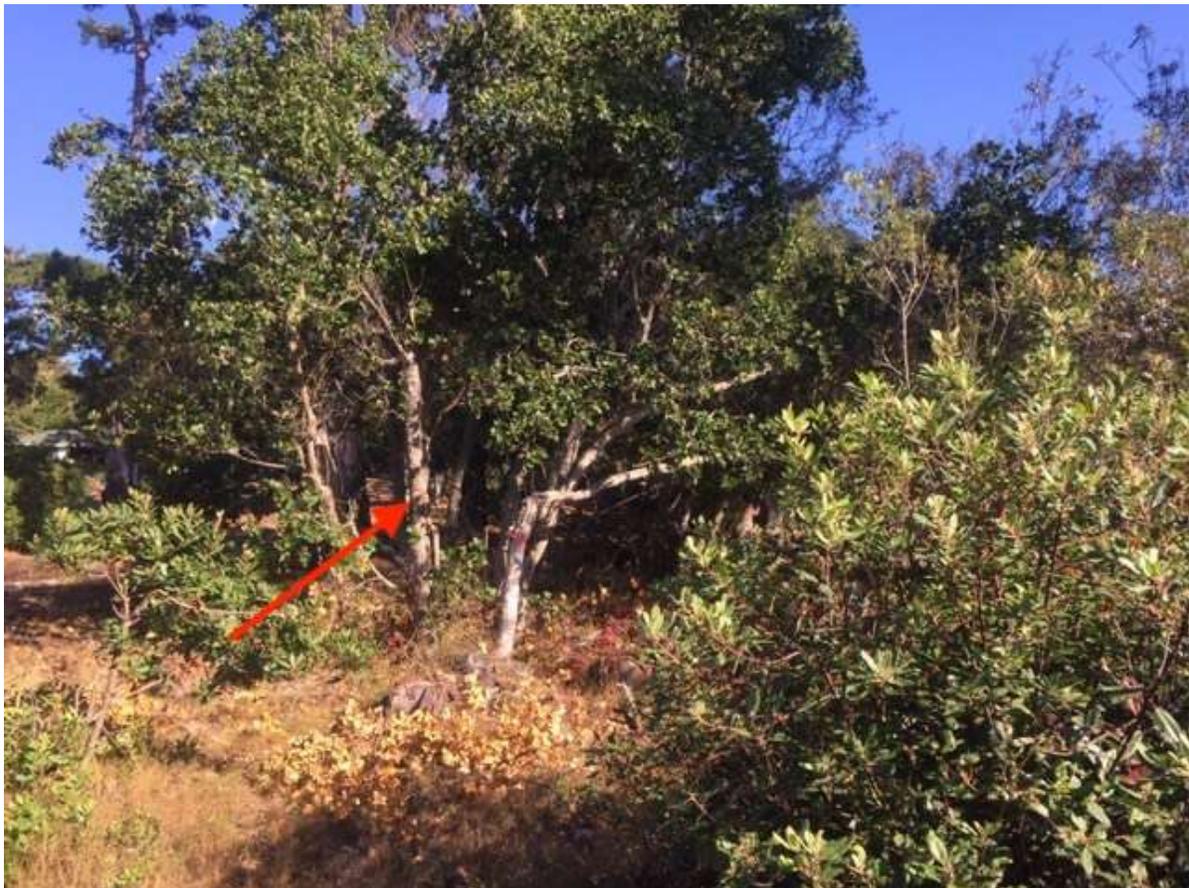
Figure 14. Multi-trunk oak identified as Tree#13 is proposed for removal due to construction impacts.

| <b>Tree &amp; Tag #s</b> | <b>Tree Specie</b> | <b>DBH (inches)</b> | <b>Crown Class</b> | <b>Balance &amp; Symmetry</b> | <b>Physiological Condition</b> | <b>Structural Condition</b> | <b>Overall Health</b> | <b>Reason for Removal</b> | <b>Replacement Ratio</b> | <b>Comments</b> |
|--|---|---|---|---|---|---|---|---|---|---|
| 13 | Coast Live Oak | 22 | Intermediate | Fair | Fair | Fair | Fair | Construction | 1:1 | |
