MON-1 Coastlands II Project

Arborist Report

On State Route 1 in Monterey County District 5-MON-1-PM 44.3 Project Number 0521000188 / EA 05-1P210

August 2024

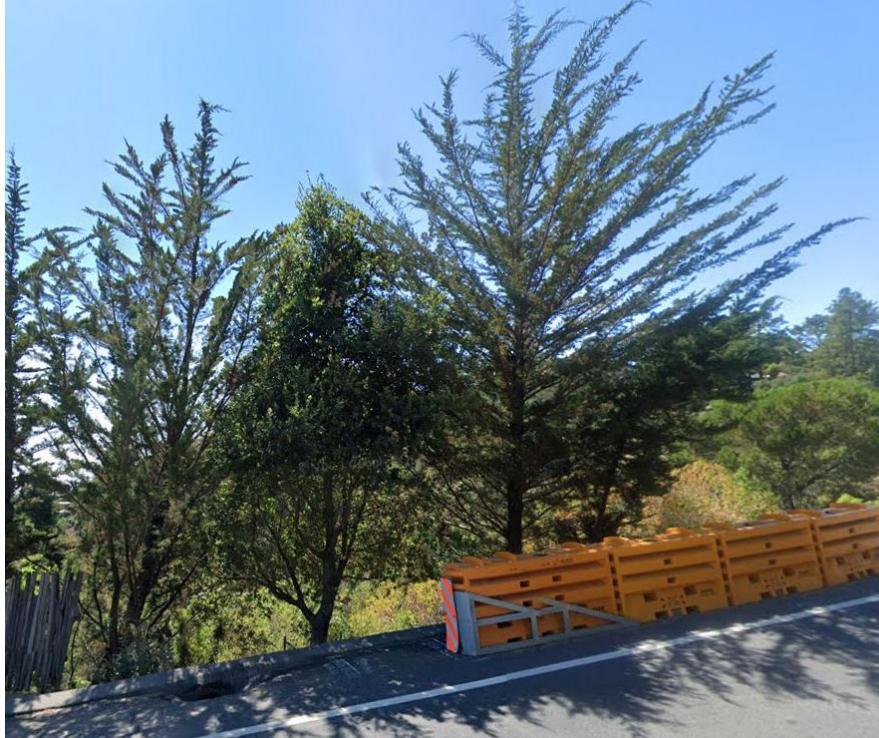
The five Monterey cypress trees studied for this report are young and generally in moderate to good health. Trees 1, 3, and 6 are the larger of the Monterey cypress trees and have good structure typical of the species. Trees 4 and 8 both appear to be <u>volunteers</u> growing under the <u>canopy</u> of larger neighboring trees. These younger trees exhibit poor structure associated with <u>phototropism</u>. All five Monterey cypress are within the limit of disturbance required for construction of the soldier pile retaining wall.

Trees 1-4 (left to right). Viewed from the SR-1 northbound lane looking west. August 2023.

Recommendations: Remove all five Monterey cypress trees to facilitate the demolition of the failed timber wall and construction of the proposed soldier pile wall.

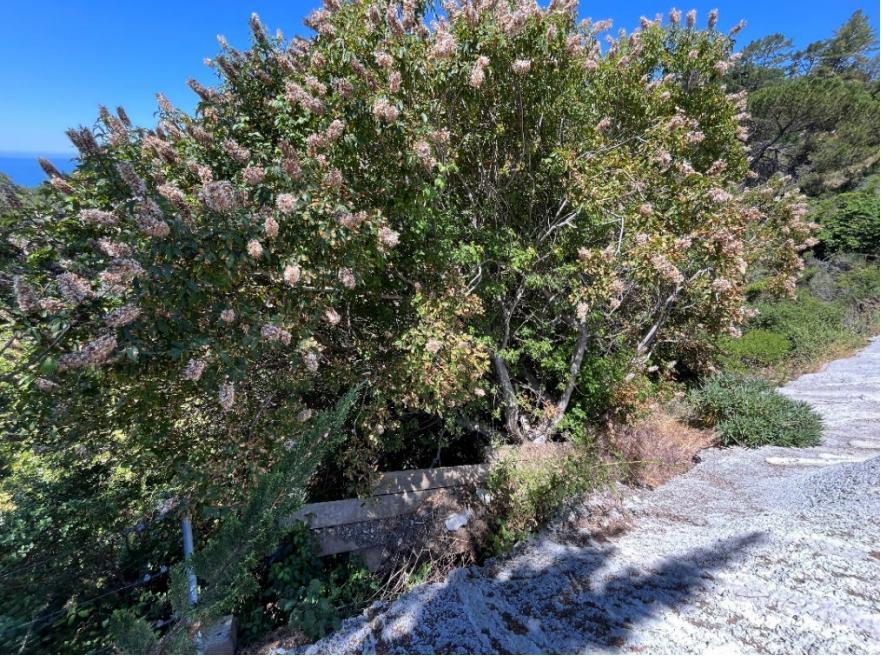
The failure of the southern portion of the existing timber retaining wall appears to be limited by the main stem of tree 5, which may be partially supporting the weight of the wall and retained soil. Mechanical bark damage is visible on the main stem from the initial impact of the wall with more damage suspected below the resting point of the wall on the main stem. Additionally, the tree appears to be leaning downslope from the weight of the timber wall and soil it is supporting. California buckeye is a deciduous tree that typically experiences summer dormancy, and sometimes full or partial winter dormancy. Early summer dormancy of just the foliage on the damaged side of the tree was visible during a July 2024 site visit, indicating stress. This may be traced back to the mechanical bark damage and the disruption of water and nutrient flows between the upslope portion of the crown and roots. It may also indicate damage to the upslope root system from the increased tension forces exerted on the main stem and roots from the weight of the resting retaining wall and soil.

Tree 5. Viewed from the southbound shoulder looking west. July 2024.

Recommendations: Remove the damaged California buckeye tree to facilitate the demolition of the failed timber wall and construction of the proposed soldier pile wall.

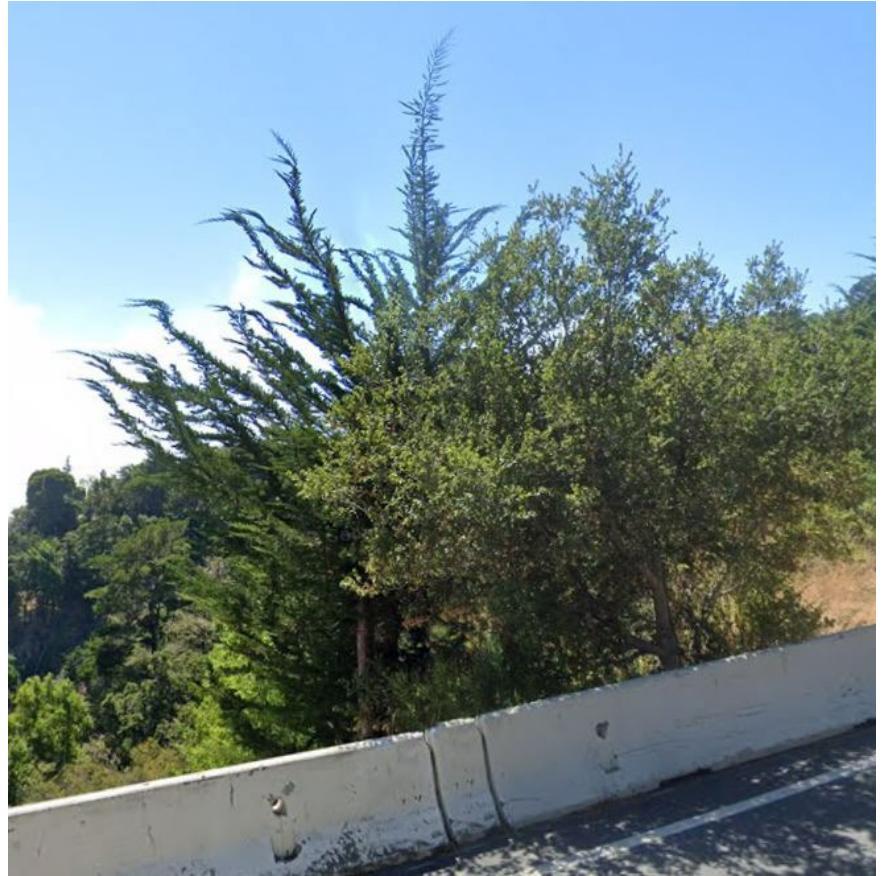
Observations: There are two coast live oak trees located within the limit of disturbance required for construction of the soldier pile retaining wall. Trees 2 and 7 are young coast live oaks in moderate to good health with structure typical of the species natural form. Tree 2 is the larger of the two and is equally spaced between Monterey cypress trees 1 and 3 along the top of the slope adjacent to the State Route 1 southbound lane. Tree 2 appears to be similar in age to Monterey cypress trees 1 and 3 and its location within the grove at the top of the slope suggests it may have been planted around the same time the Monterey cypress trees to screen nearby properties from motorists on State Route 1. Tree 7 appears to be a younger volunteer coast live oak located close to the edge of pavement along the southbound lane of State Route 1. It is growing in very close proximity to Monterey cypress trees 6 and 8.

Trees 6-8 (left to right). Viewed from the northbound lane looking west. August 2023.

Recommendations: Remove both coast live oak trees to facilitate the demolition of the failed timber wall and construction of the proposed soldier pile wall.
