4161 Sunridge Road
Tree Assessment
Arborist report

August 10, 2023

Rivera A.D.U.
 4161 Sunridge Rd
 Pebble Beach, CA 93953
 A.P.N. 008-071-012-000

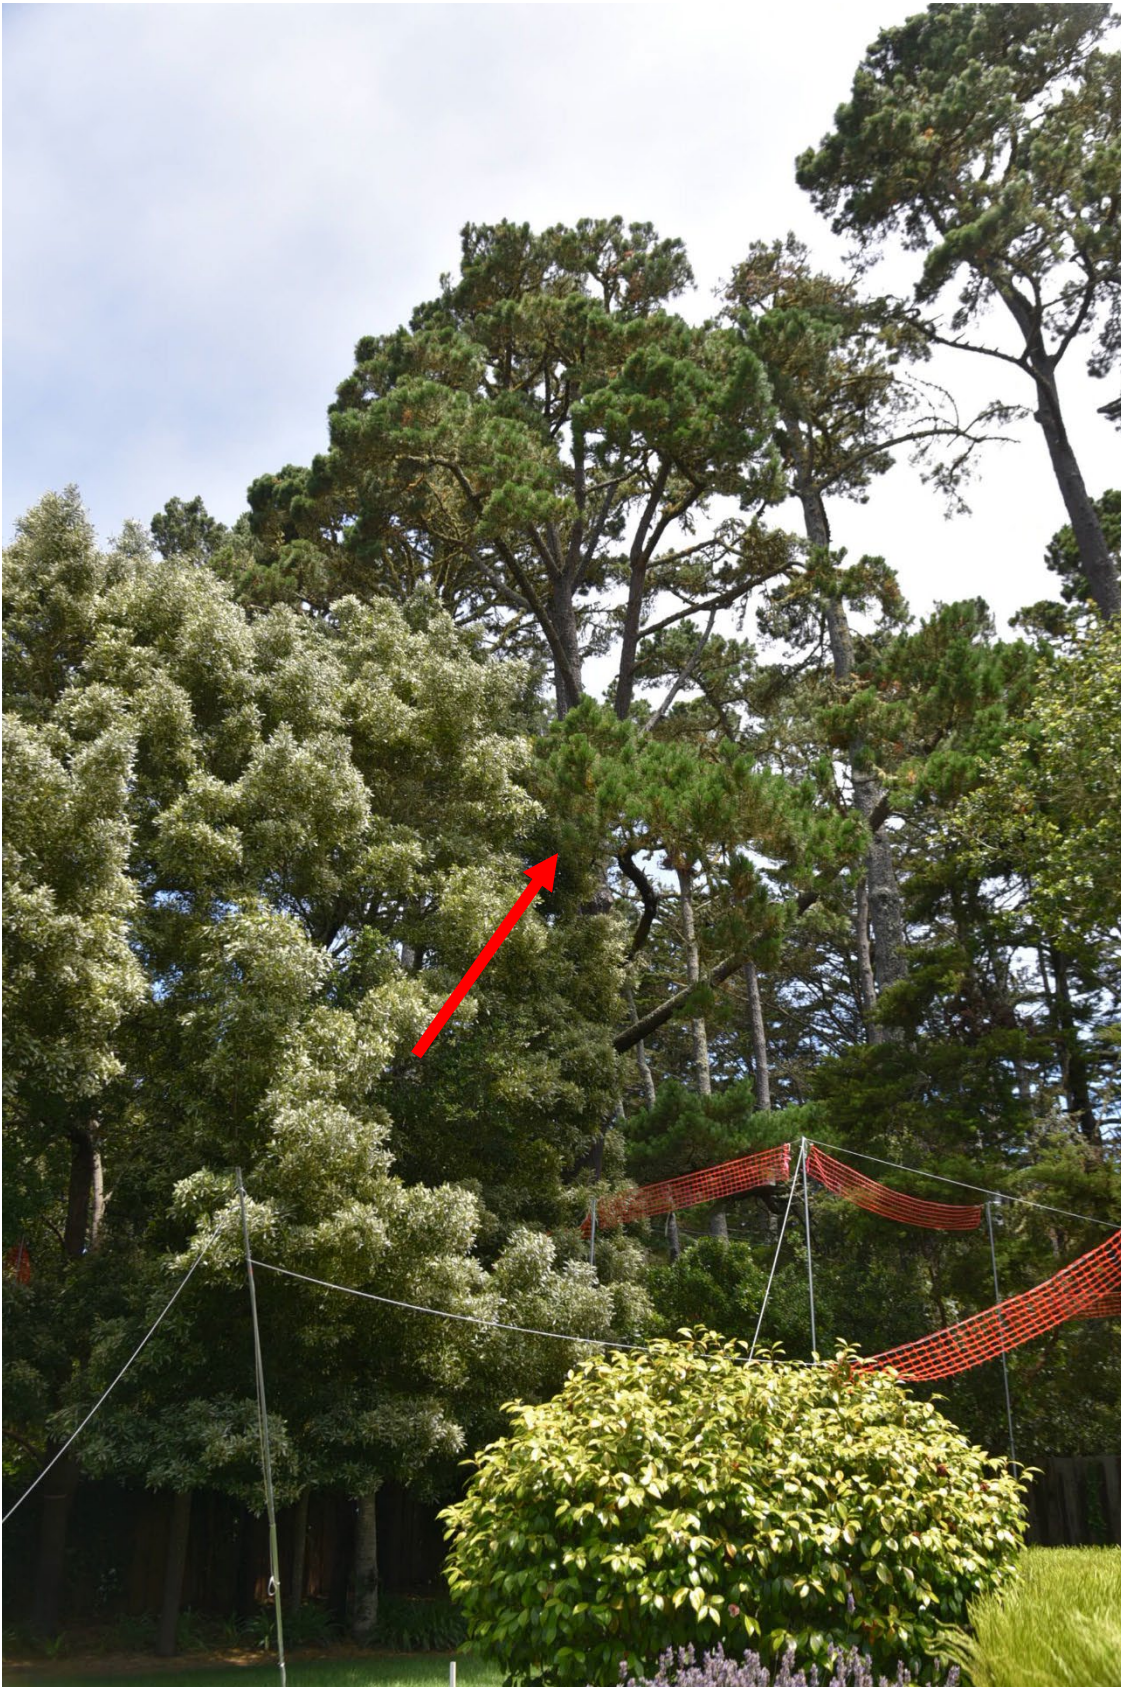
- #766 – 10" Coast live oak is within the building footprint.
 - #763 – 36" Monterey pine will require root loss, (approximately 24% or more); thus, its stability will be questionable.

Tree #763 is a large-diameter pine that will become impacted by grading

Two county-protected trees are proposed for removal on this project; a 10" diameter oak and a 33" diameter Monterey pine. The pine should be replaced at a minimum with two 5-gallon size Monterey pines to sustain the forested environment and the oak should be replaced by a five-gallon size or larger oak. All other County-protected trees are to remain and be protected from construction effects when closer than 25 feet from construction.

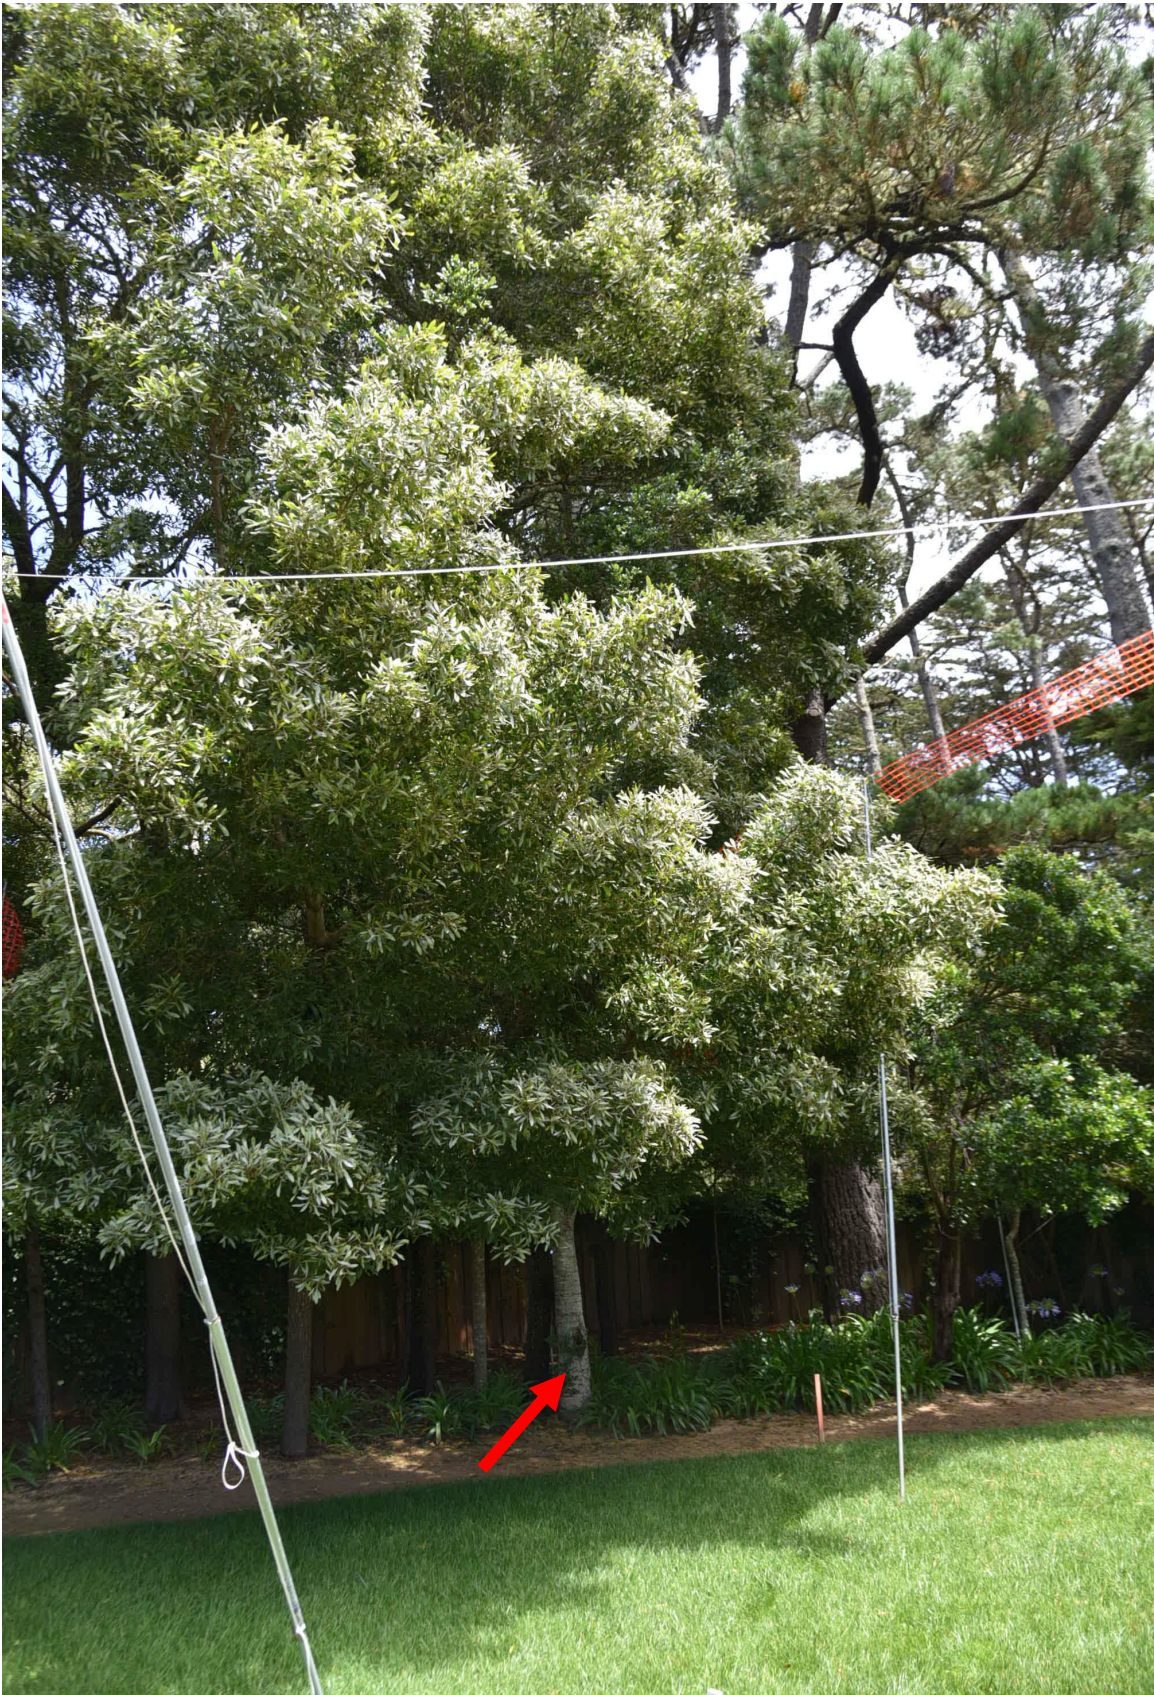
Oak #766 is hidden by Black acacia that must be removed.
