THOMPSON WILDLAND MANAGEMENT

August 14, 2024

Ms. Tracy Piazza
58 Mt. Devon Road
Carmel, CA. 93923
APN: 241-142-002
Project File # PLN230339

Subject: 58 Mt. Devon Road Non-Permitted Tree Removal Assessment

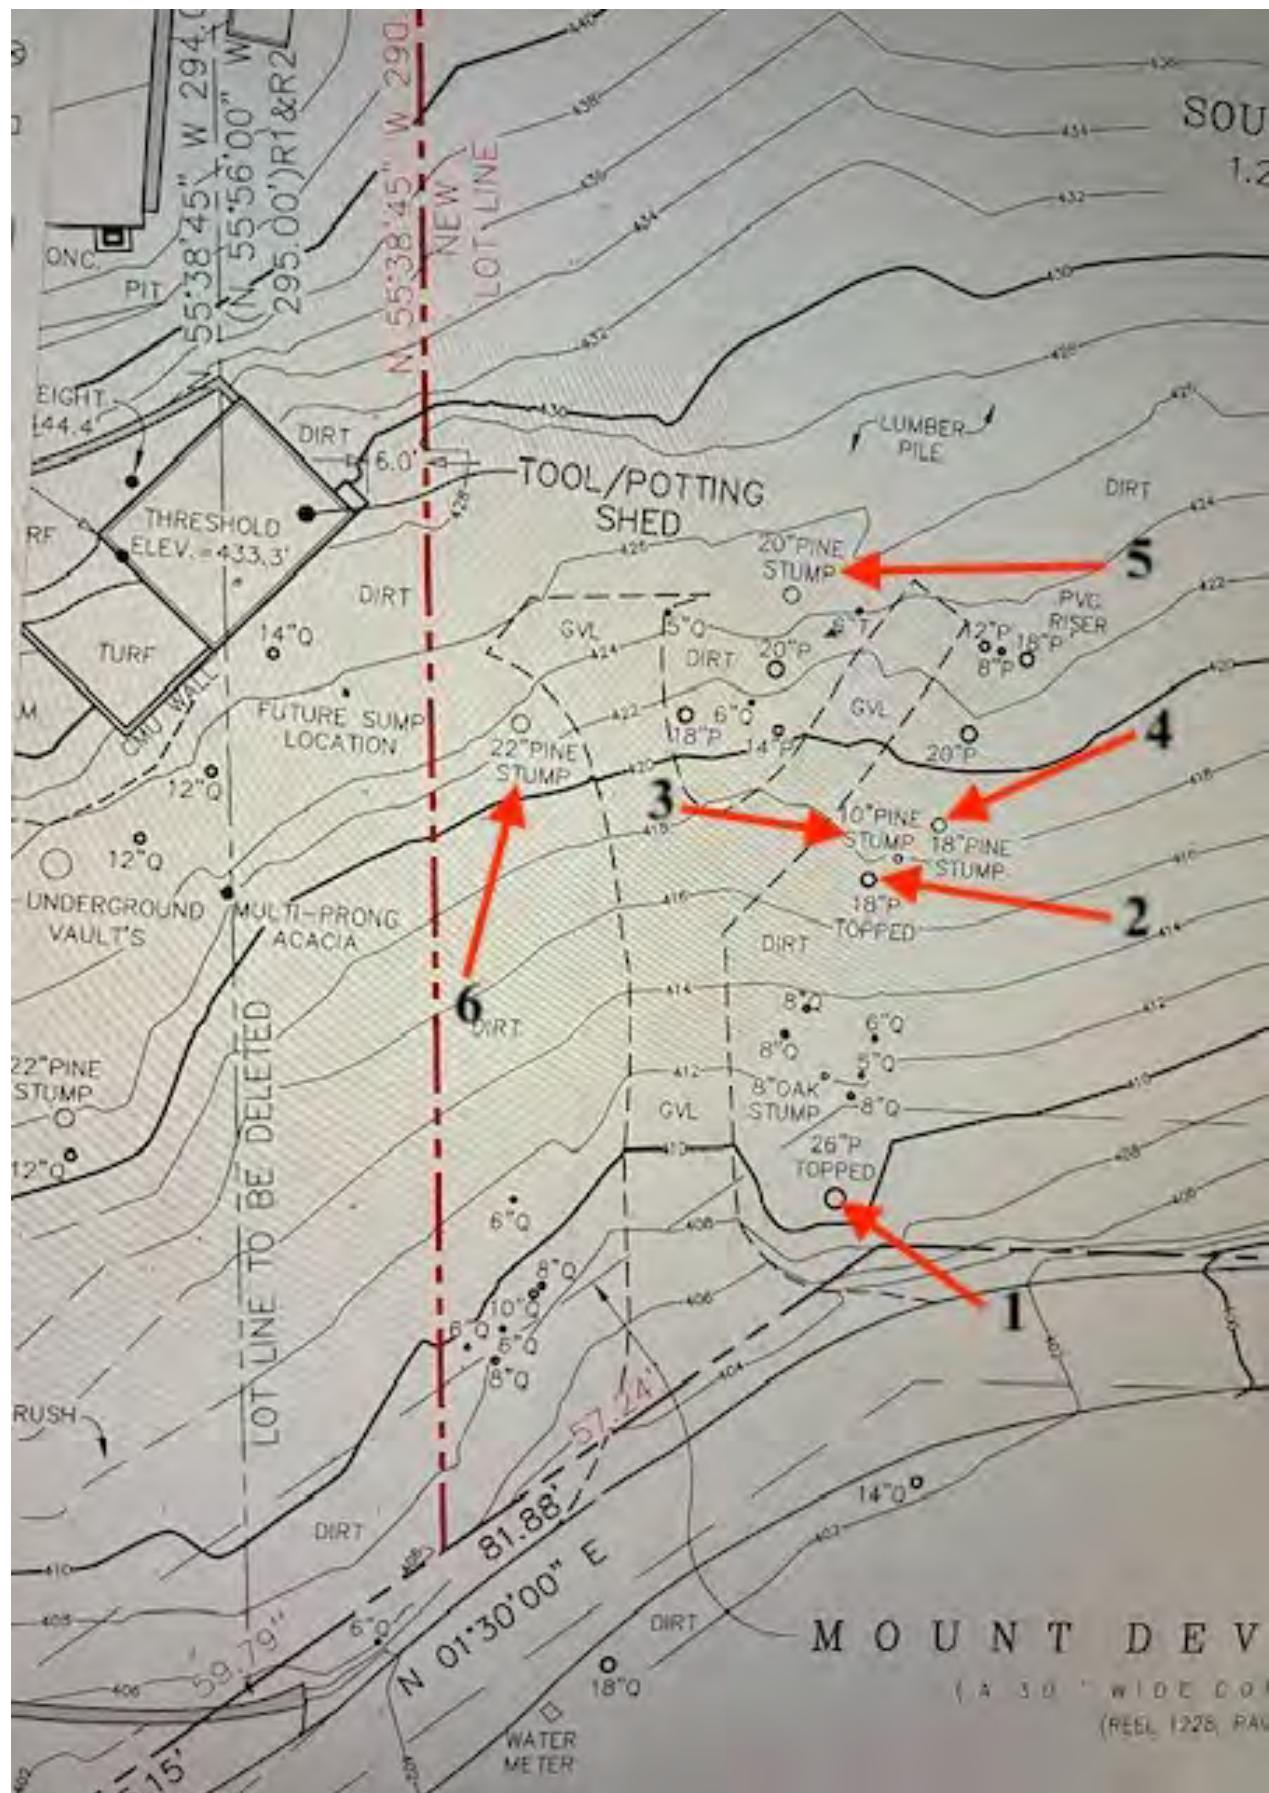
Exhibit A: Tree Removal Location Map shows the location of 6 mature and aging Monterey pine trees (identified as Tree#s 1-6) that were removed from the south parcel without a County tree removal permit.

As a result of tree removal activities, it will be necessary to plant six (6) 5 to 15-gallon Monterey pine seedlings or saplings (a 1:1 replacement ratio) in order to mitigate impacts of non-permitted tree removal and to satisfy Monterey County tree removal permit requirements. The 6 replacement plantings shall be planted in suitable and appropriate locations on the subject parcel (there are several suitable planting locations to choose from) using proper tree planting methods and best management practices (BMP's). Additionally, these 6 Monterey pine replacement plantings shall be properly cared for and maintained to assist in healthy establishment and maturation, and will be required to survive a 1-year monitoring period to satisfy Monterey County tree removal permit conditions.

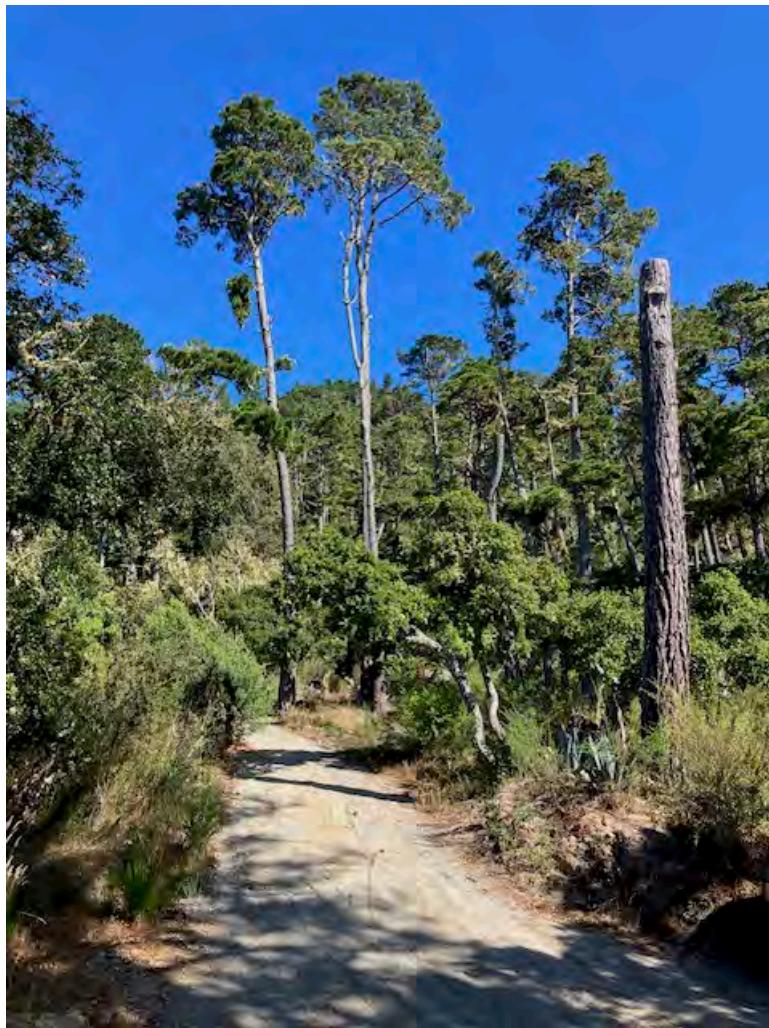
removed, which is based on the current condition of the remaining 2 stems/snags (*Tree#s 1 & 2*; refer to *Figures 2 & 3*) and 4 stumps (*Tree#s 3-6*; refer to *Figures 4-7*).

Figure 2. Unpaved entrance to the south parcel. The pine stem/snag identified as Tree#1 is near right edge of photo.

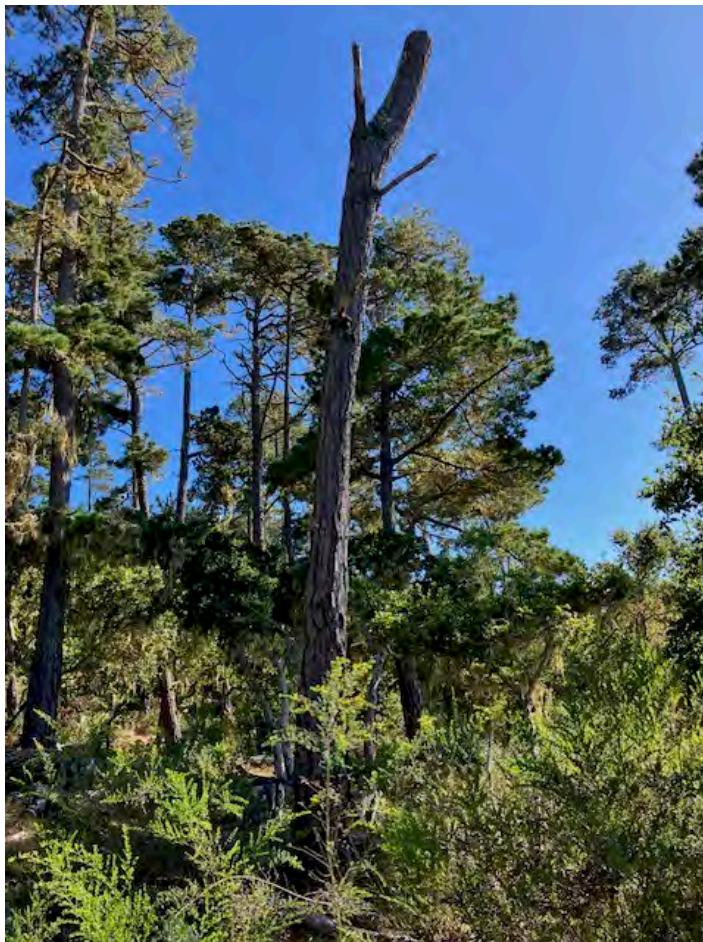
Figure 3. The other pine stem/snag identified as Tree#2 that was removed without a permit is in center of photo and is surrounded by non-native invasive French broom.

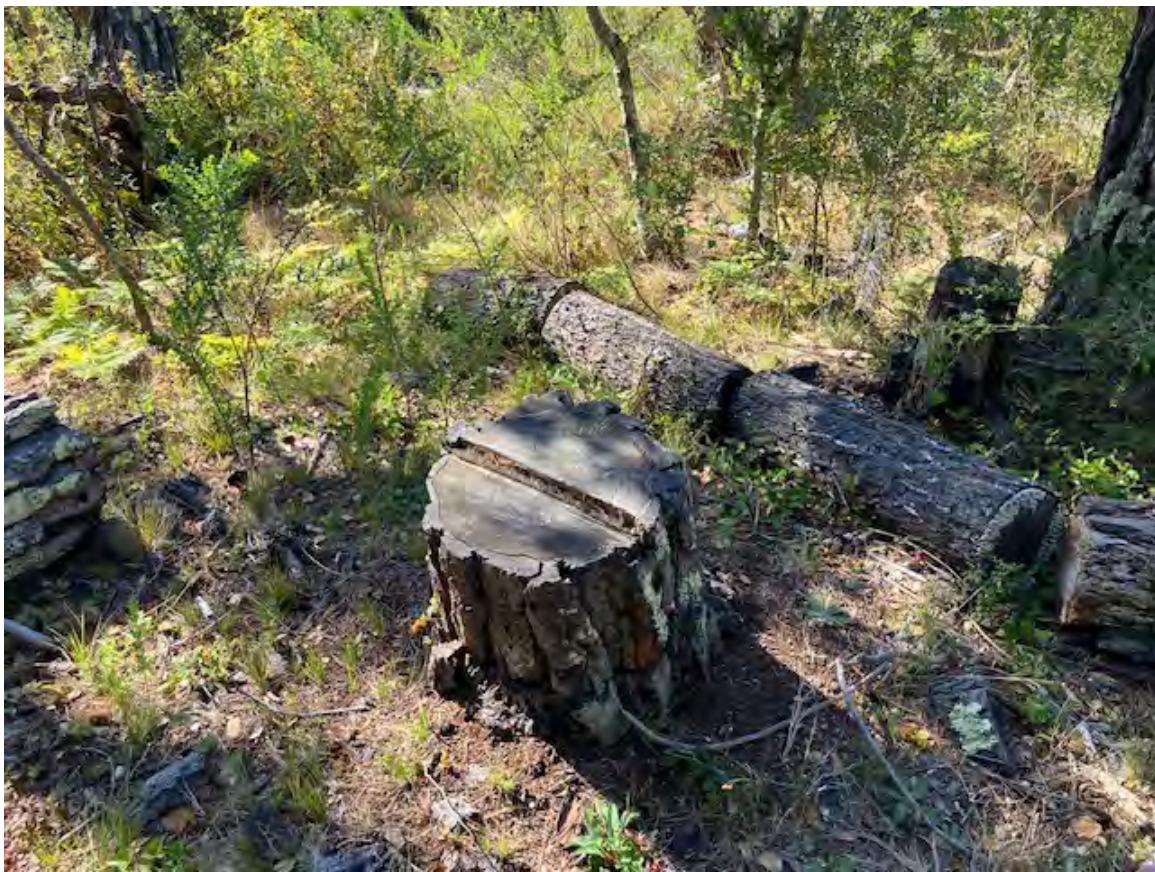
It should be noted that the remaining stumps have some wood rot and decay, which indicates that they may have been significantly declining, or perhaps dead, and/or structurally unsound and compromised at the time of removal; however, there is not enough wood decay and deterioration to conclusively say that the 6 subject pines were dead, significantly declining and/or structurally unsound when they were removed. While, based on the current evidence available, it can not be concluded that the subject pine trees were dead and hazardous at the time of removal, in my professional opinion, it is likely that these 6 pines were in declining health and condition when they were

Figure 4. Pine stump identified as Tree#3 was removed without a permit.

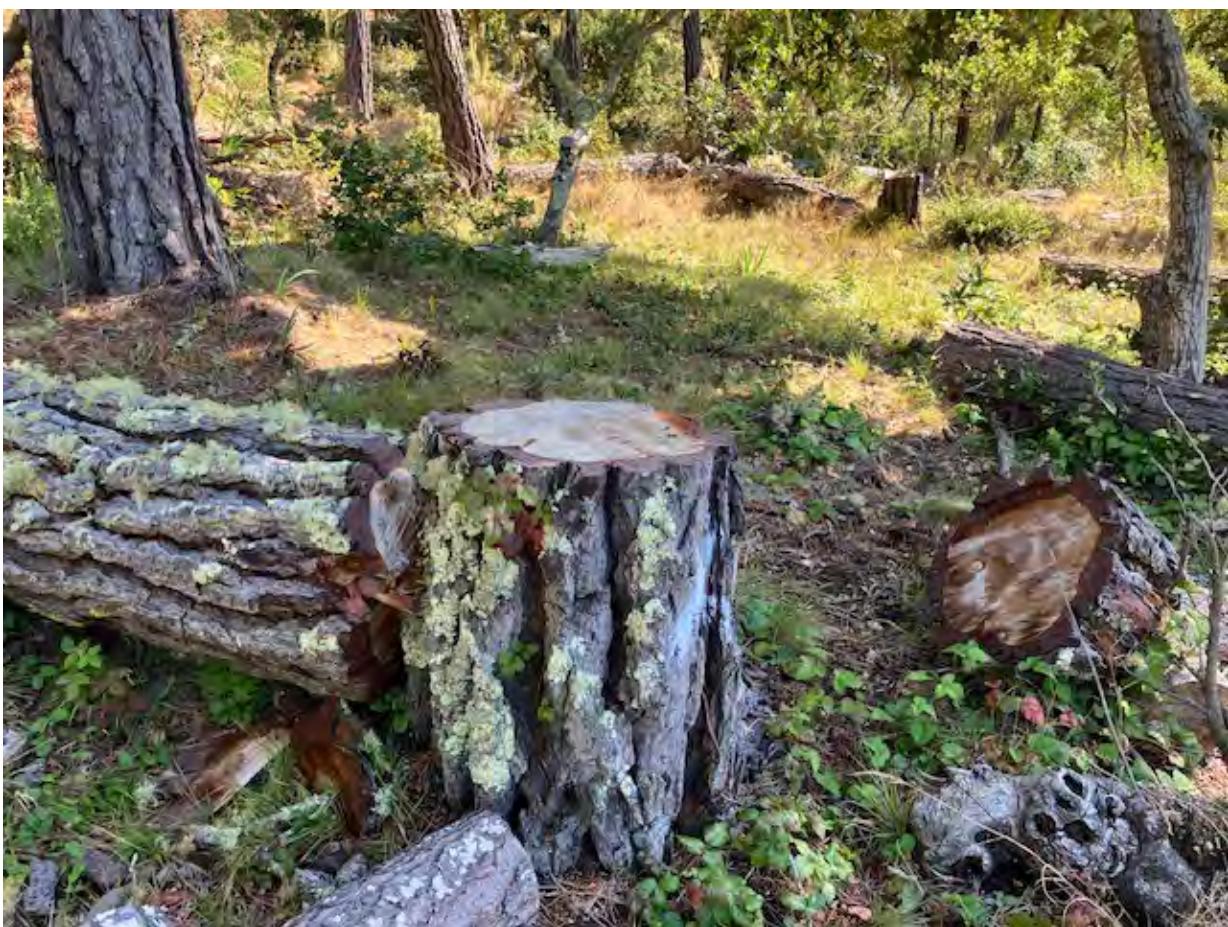
Figure 5. Pine stump identified as Tree#4 was removed without a permit.

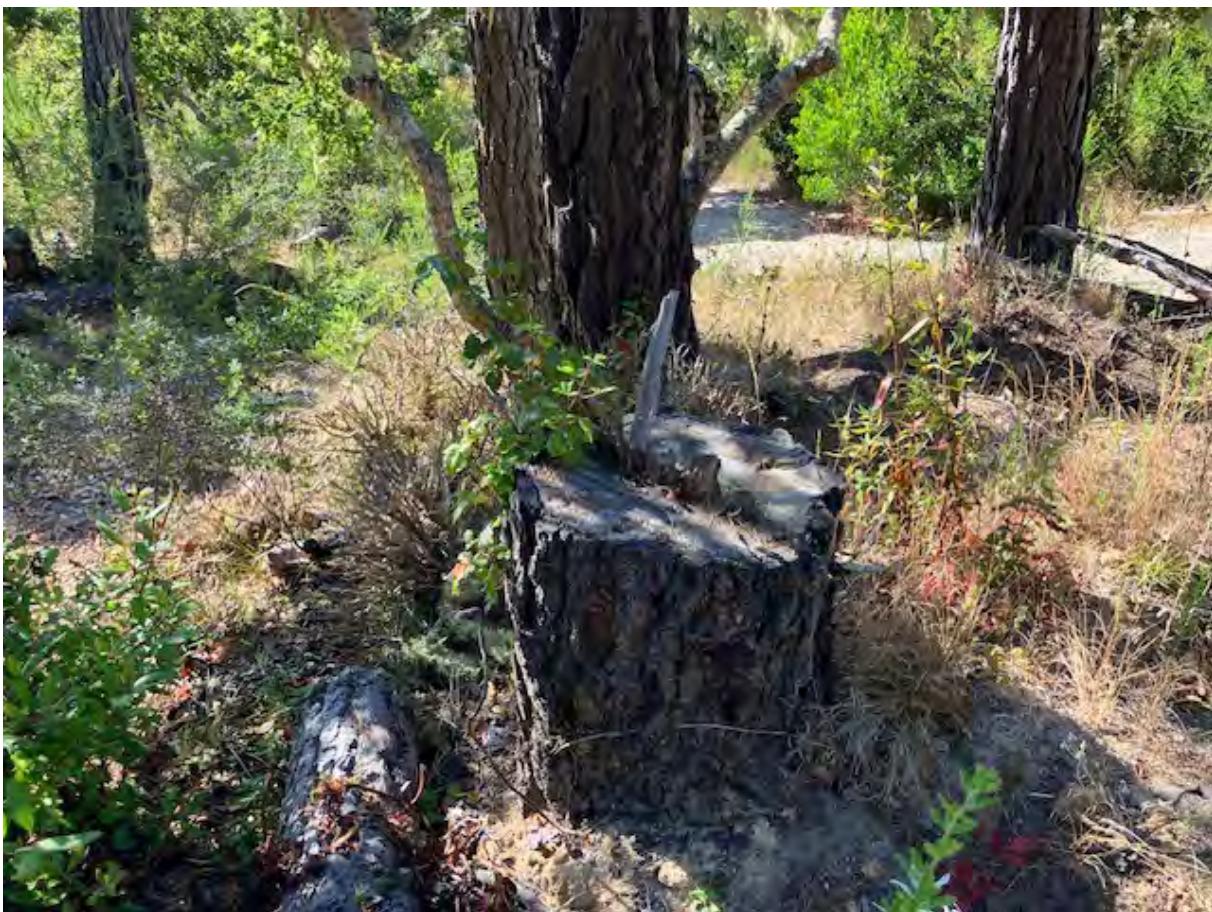
Figure 6. Pine stump identified as Tree#5 was removed without a permit.

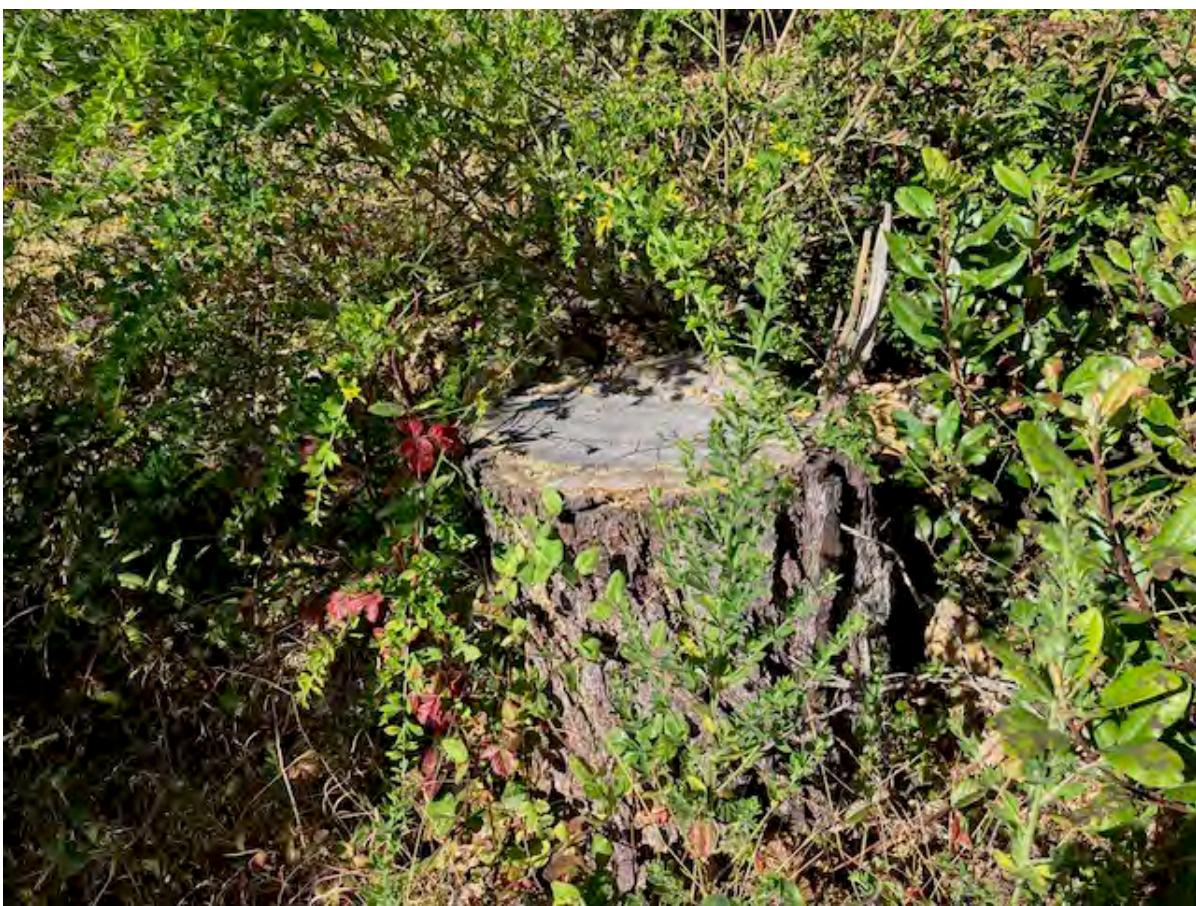
Figure 7. Pine stump identified as Tree#6 was removed without a permit.

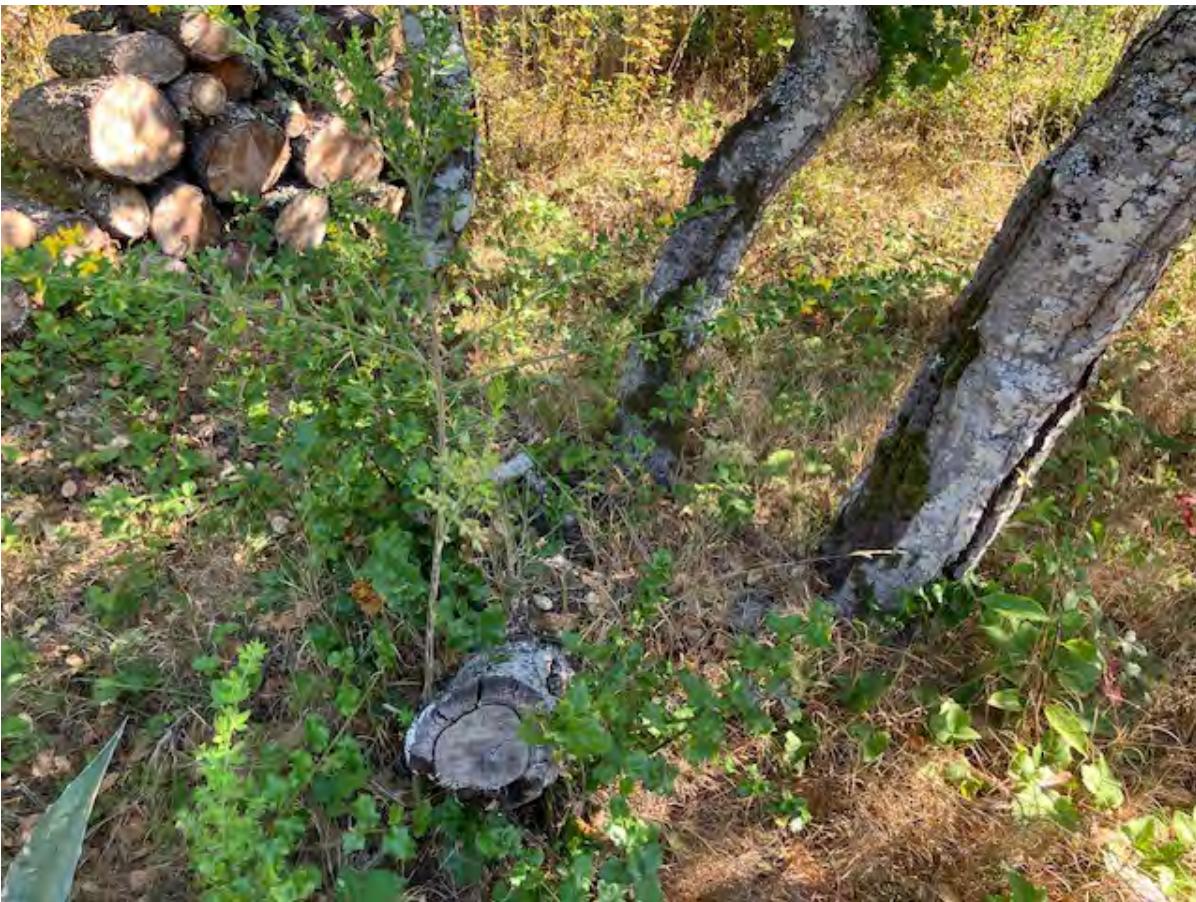
It should also be noted that a 8 inch oak stump identified on the *Exhibit A: Tree Removal Location Map* (located near the pine stem/snag identified as *Tree#1*) is actually less than 6 inches diameter, so no tree removal permit was required and the removal of this oak is not considered a violation (refer to *Figure 8*).

Figure 8. Oak stump identified on the parcel map and tree removal map is less than 6 inch diameter and no tree removal permit or mitigation planting is required.

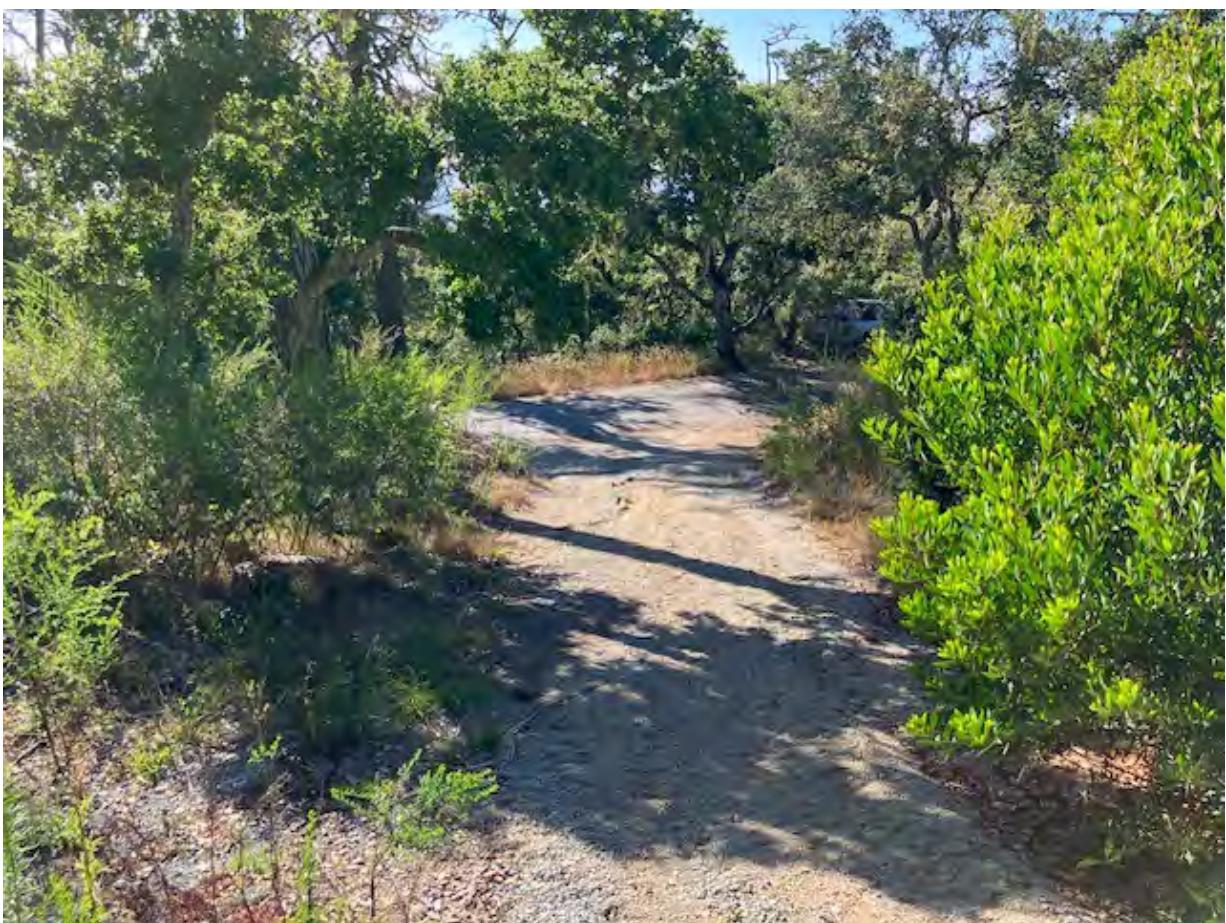
Figure 9. Unpaved gravel entrance to south parcel is surrounded by an abundance of non-native invasive French broom and acacia.
