# Exhibit C

May 2, 2016

Subject: 113 San Benancio Road Forest Management Plan

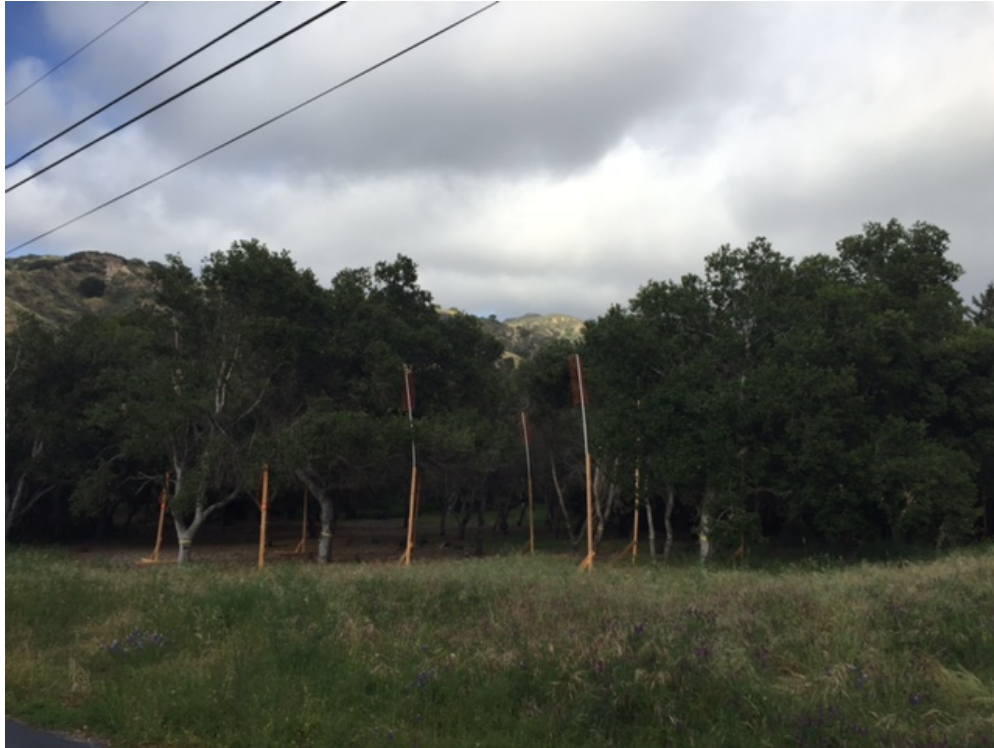
This particular residential community is located in a oak woodland dominated environment that is significantly influenced by seasonally temperate weather conditions. Native tree species inhabiting this area primarily consist of indigenous mid to lower canopy Coast Live Oak (*Quercus agrifolia*) trees and to a lesser extent mature upper canopy Monterey Pine (*Pinus radiata*) trees, as well introduced species such as Blue Gum Eucalyptus that are also common in the area. Plant composition on this specific undeveloped woodland lot consist of a fairly dense population of mature but fairly small in stature Coast Live Oak trees ranging from 15 to 30 feet in height, and understory vegetation is dominated by non-native annual grasses (e.g., Ripgut Brome) and native forbs, such as Lupine and California Poppy (refer to *Figure 1*).

Figure 1. View of proposed home development site from adjacent roadway. Coast Live Oaks proposed for removal have been assigned numbers and are identified with yellow flagging tape.

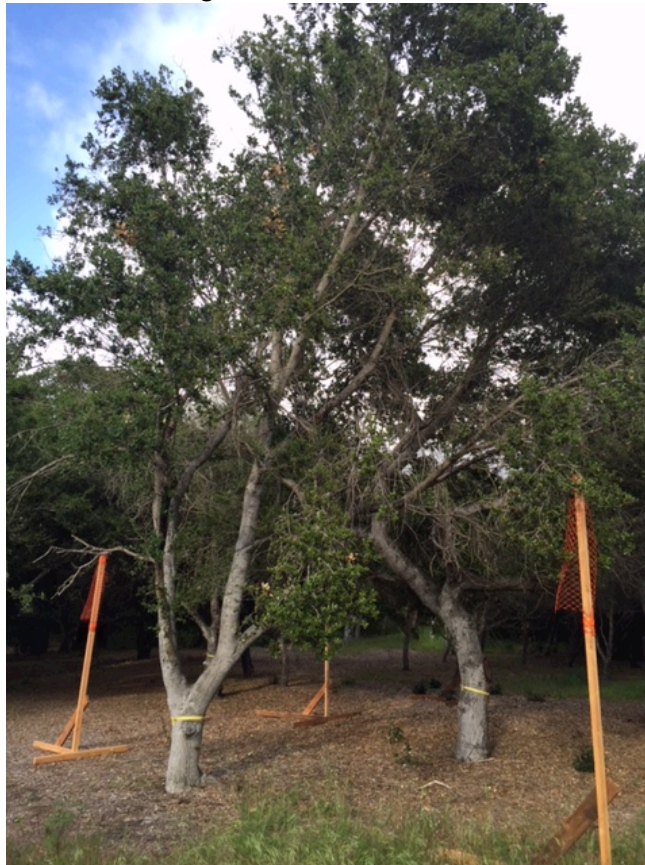
Figure 2. Coast Live Oaks #s 1 & 2 are proposed for removal.

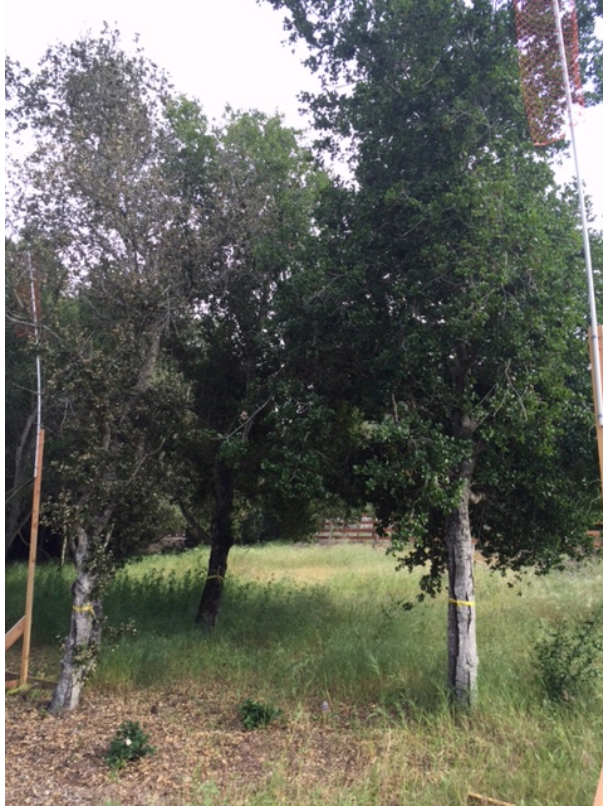
Figure 3. Coast Live Oaks #s 3, 4 & 5 are proposed for removal.

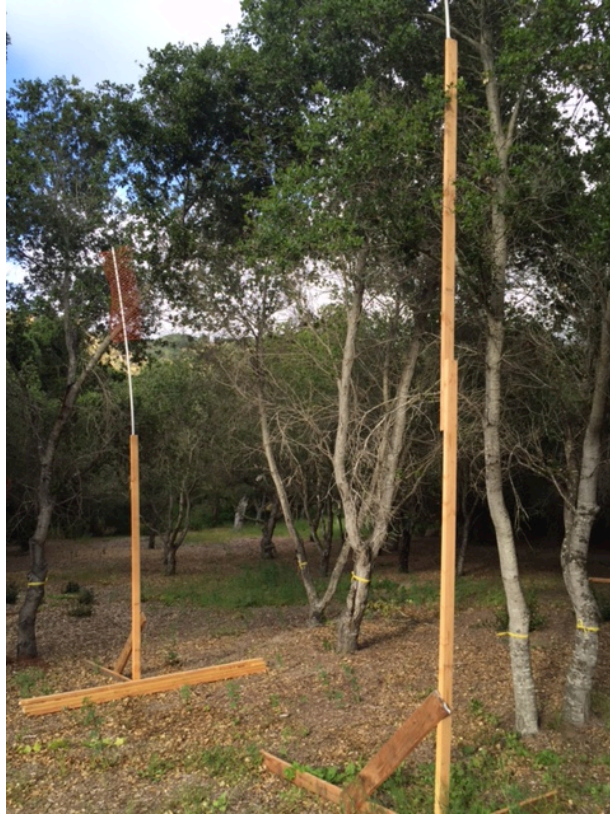
Figure 4. Coast Live Oaks #s 6-11 are proposed for removal. Tree #11 is faintly visible in background.

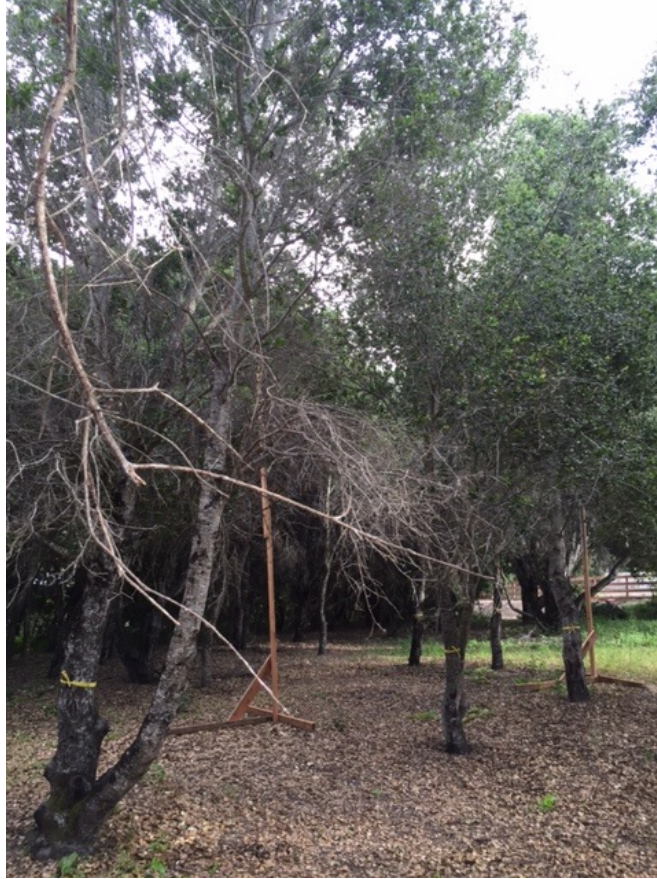
Figure 5. Coast Live Oaks #s 12-17 are proposed for removal. Tree #17 is difficult to see in background.

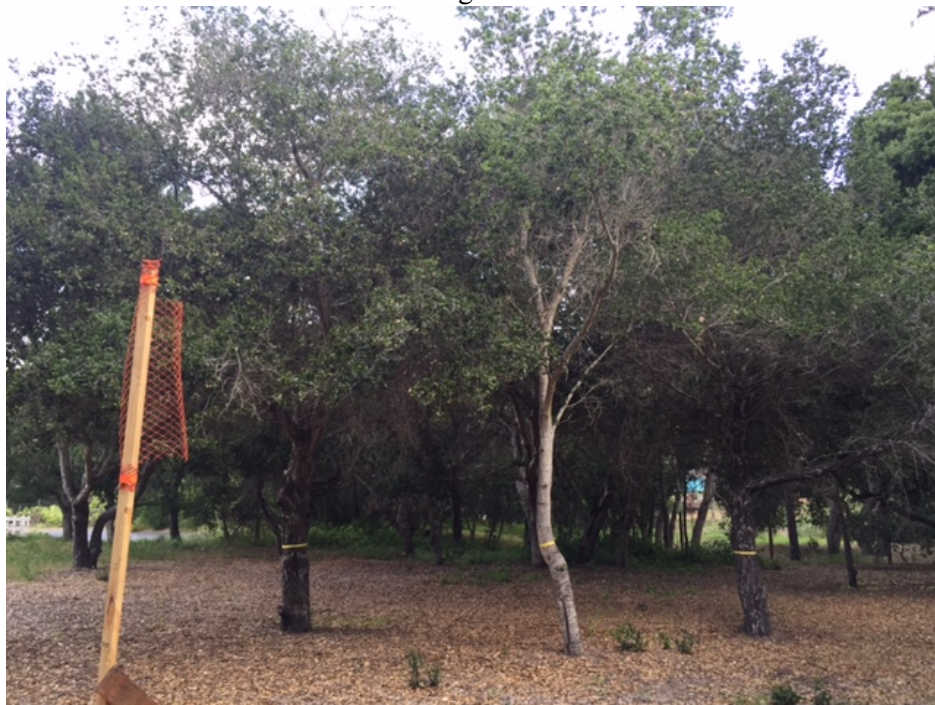
Figure 6. Coast Live Oak # 18 (left of center) is proposed for removal. Two flagged oaks in center and right of center will be retained.

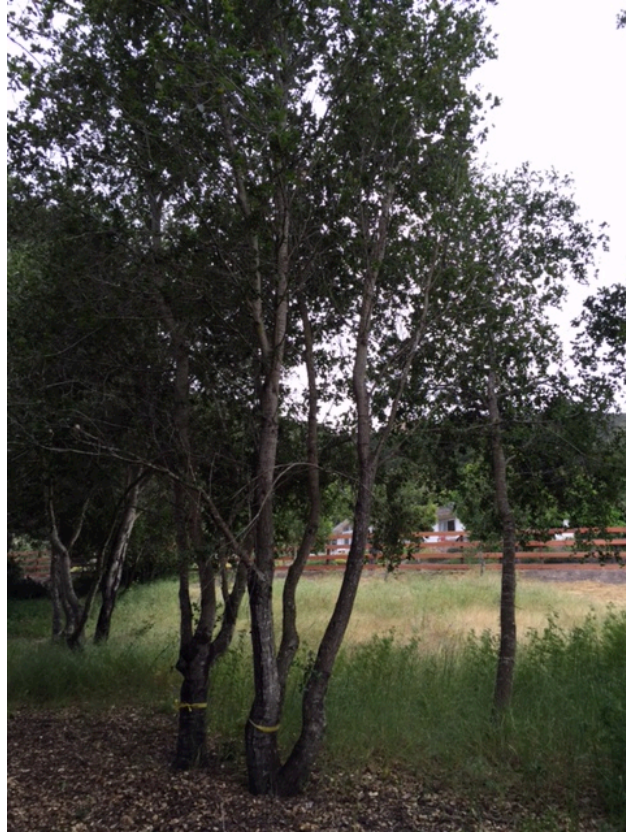
Figure 7. Coast Live Oaks #s 19 & 20 are proposed for removal.

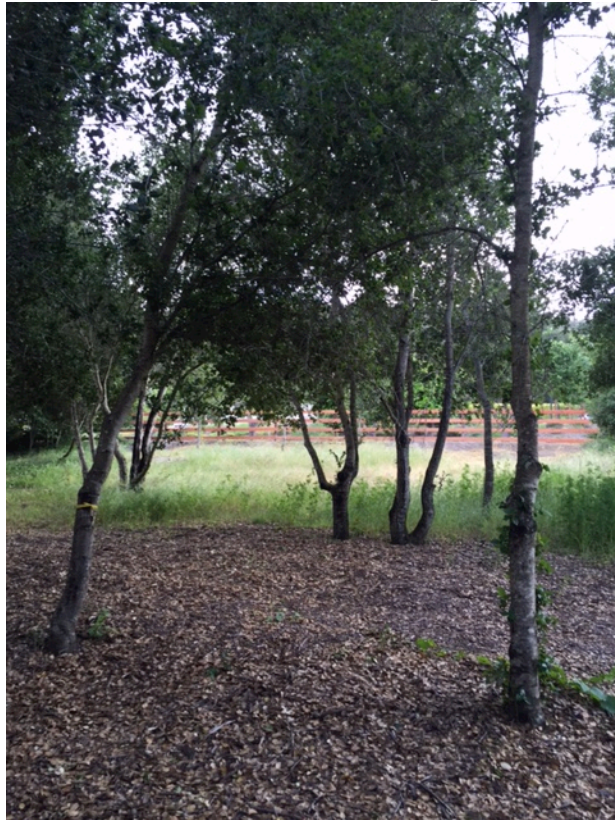
Figure 8. Coast Live Oak # 21 (left side of photo) is proposed for removal.
