Re: 3196 17 Mile Drive - Existing Cypress Tree Assessment / Proposed Plan

EVALUATION OF KEY CYPRESS TREE DETERIORATING CONDITIONS

## **EVALUATION OF 4 KEY MONTEREY CYPRESS** 3196 SEVENTEEN MILE DRIVE, PEBBLE BEACH, CA.

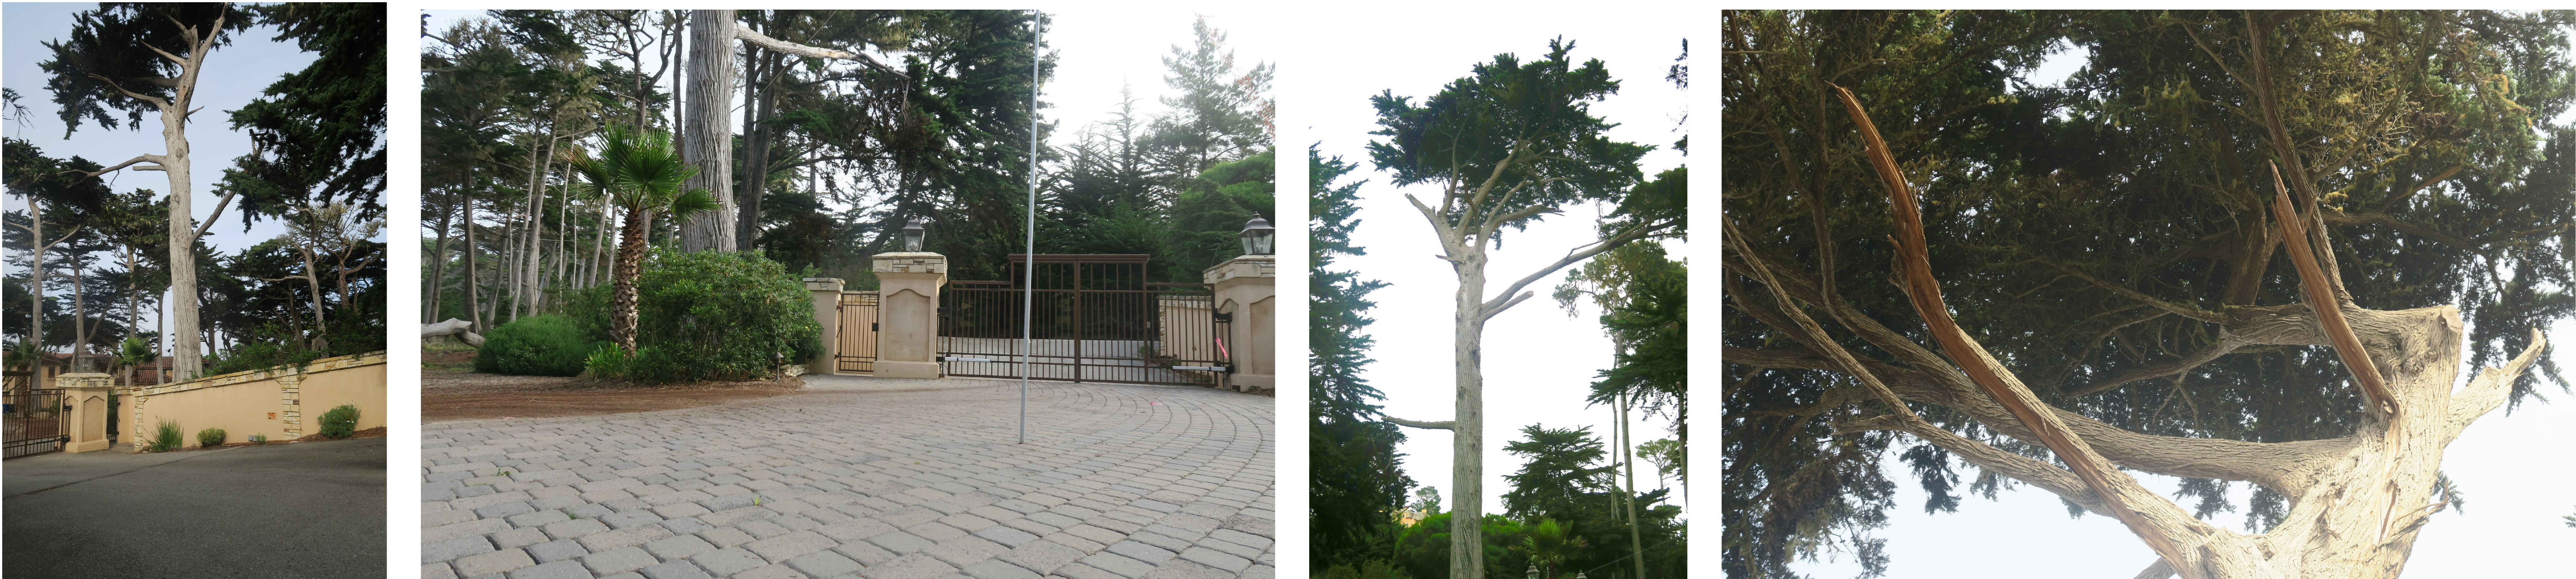
60 " CYPRESS AT EXISTING DRIVEWAY ENTRANCE - EXISTING ROOT ZONE 45 % IMPERMEABLE

This report is in response to the decline and large branch drop shown on 4 large (60", 26", 36", 44") Monterey Cypress at 3196 17 Mile Drive. In observing these trees, one immediately notices the raw, splintered areas where large, upper story branches have snapped and fallen off. In several cases there are several branches that have dropped within the year. Maintenance pruning notes many more upper story branches were cleaned up and removed over the past 5 years. Please refer to cover page A 0.0 for photos of cypress conditions and branch splintering.

- Current hardscape in the rooting zone is 45%; following the proposed project hardscape is at zero; an excellent improvement
- Details are shown on Sheet A 3.0

- 1 - RELOCATE DRIVE ENTRY AT 17 MILE AND REMOVE ALL IMPERMEABLE PAVING AND WALLS - RESTORE ROOT ZONE
- 2 - LOCATE PROPOSED DRIVE IN AREA OUTSIDE OF CYPRESS ROOT ZONE / DRIP - OPEN ZONE
- 3 - REPLACE EXISTING ASPHALT DRIVE MATERIAL WITH GRAVEL ON POROUS "CORE" HYDRO-CELL BASE

Removal of any hardscape and especially on a large scale basis such as proposed in the plan is critical to the survival and recovery of the failing trees. In particular, the 60" cypress will, no doubt, reverse the failing mode it currently is in and begin to recover with the 100% removal of the impervious asphalt as will the other cypress.

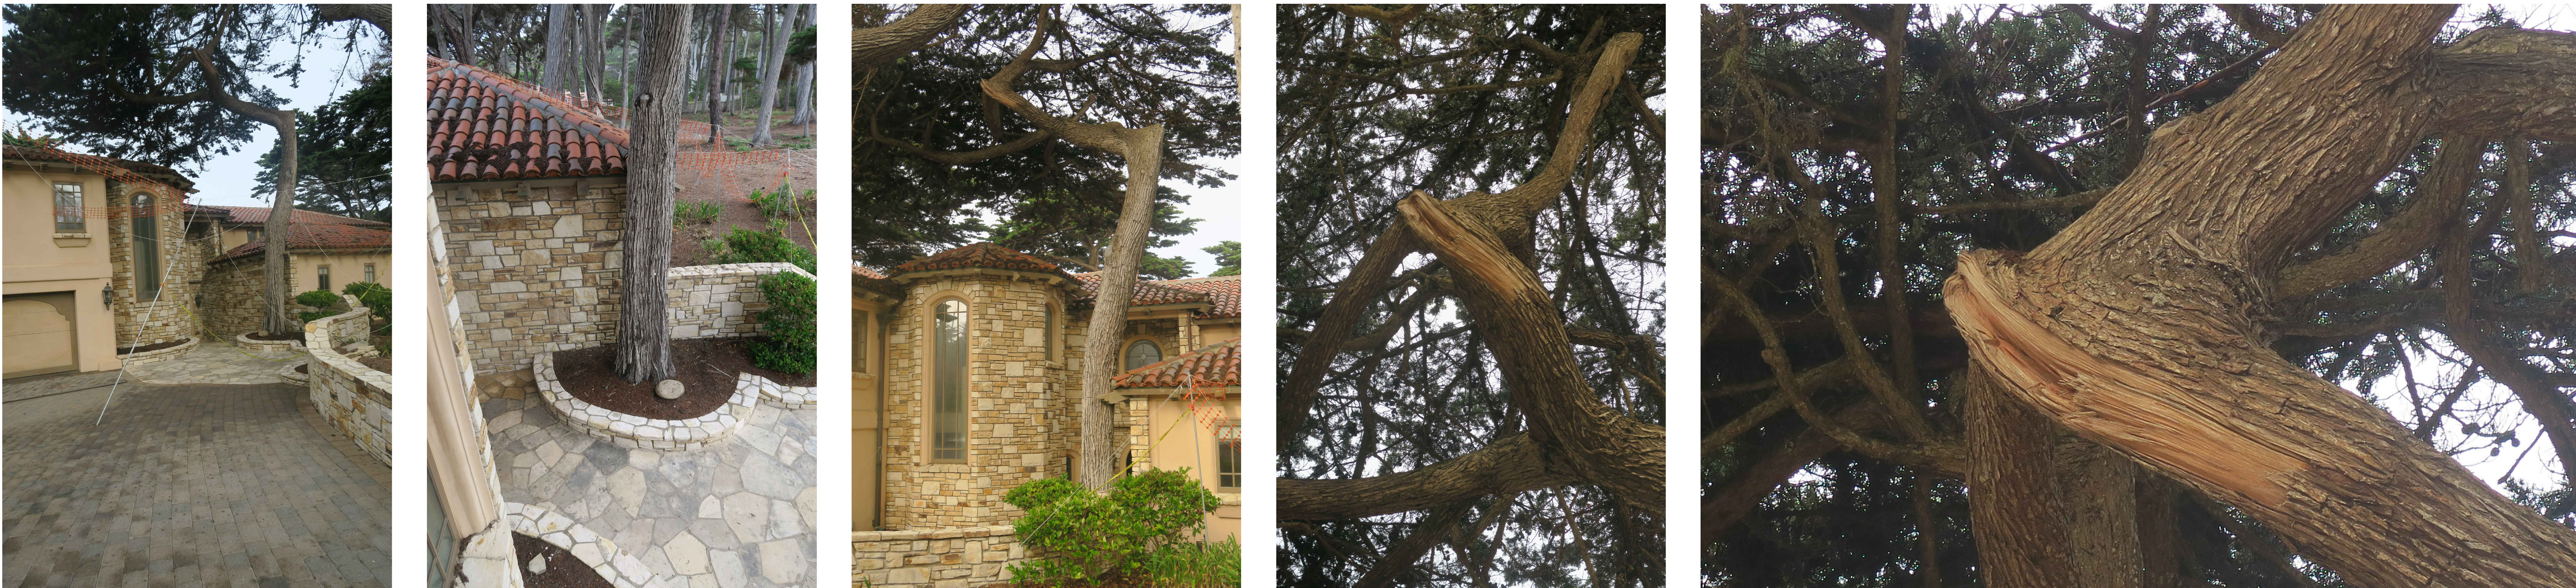
26 " CYPRESS AT EXISTING HOUSE ENTRY - EXISTING ROOT ZONE 76 % IMPERMEABLE

- Current hardscape is 75%; following the proposed project, hardscape will be reduced to 16%; an excellent improvement
- Details are shown on Sheet A 3.1

- 1 - RELOCATE EXISTING HOUSE / GARAGE AREA AND ALL ON SLAB PAVING FROM CYPRESS ROOT ZONE
- 2 - CREATE LARGE GARDEN COURTYARD AROUND CYPRESS
- 3 - CREATE DETACHED GARAGE IN AREA OUTSIDE OF ALL CYPRESS ROOT ZONES
- 4 - REPLACE EXISTING ASPHALT DRIVE MATERIAL WITH GRAVEL ON POROUS "CORE" HYDRO-CELL BASE
- 5 - REPLACE ALL ON SLAB PAVING WITH STEPPING STONES ON SAND AND SOIL- PLANTING POCKETS

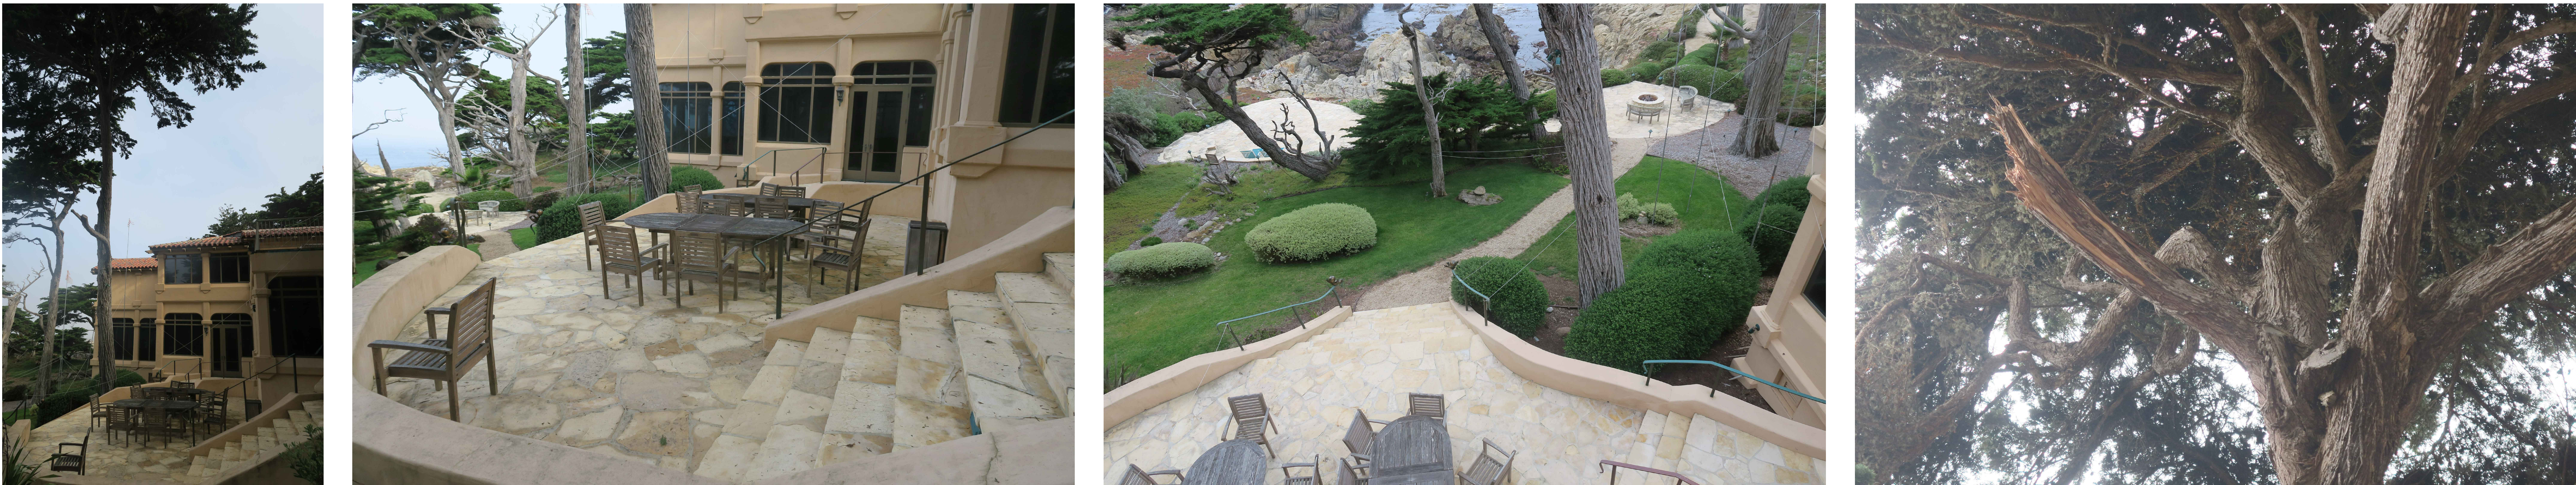
36 " & 44 " CYPRESS AT OCEANSIDE OF EXISTING HOUSE - EXISTING ROOT ZONES 52 % AND 36 % IMPERMEABLE

- 36" tree the hardscape is reduced from 52% to proposed project is 14% - excellent improvement
- 44" tree hardscape is reduced from 36% to 19% with the project – significant improvement

- 1 - PULL BACK EXISTING BUILDING FOOTPRINT FROM CYPRESS ROOT ZONE AREA - RESTORE ROOT ZONE
- 2 - REMOVE 1,334 SF OF TERRACE ON SLAB, 110 LF OF WALL FROM CYPRESS ROOT ZONE AREA
- 3 - RELOCATE ALL EXTERIOR SITTING AREAS TO OUTSIDE OF CYPRESS ROOT ZONE
- 4 - REPLACE ALL SLAB TERRACE WITH STEPPING STONES ON SAND AND SOIL- PLANTING POCKETS
- 5 - RETURN 4,017 SF OF IRRIGATED GARDEN AND TERRACES TO SCENIC EASEMENT - RESTORE ROOT ZONE

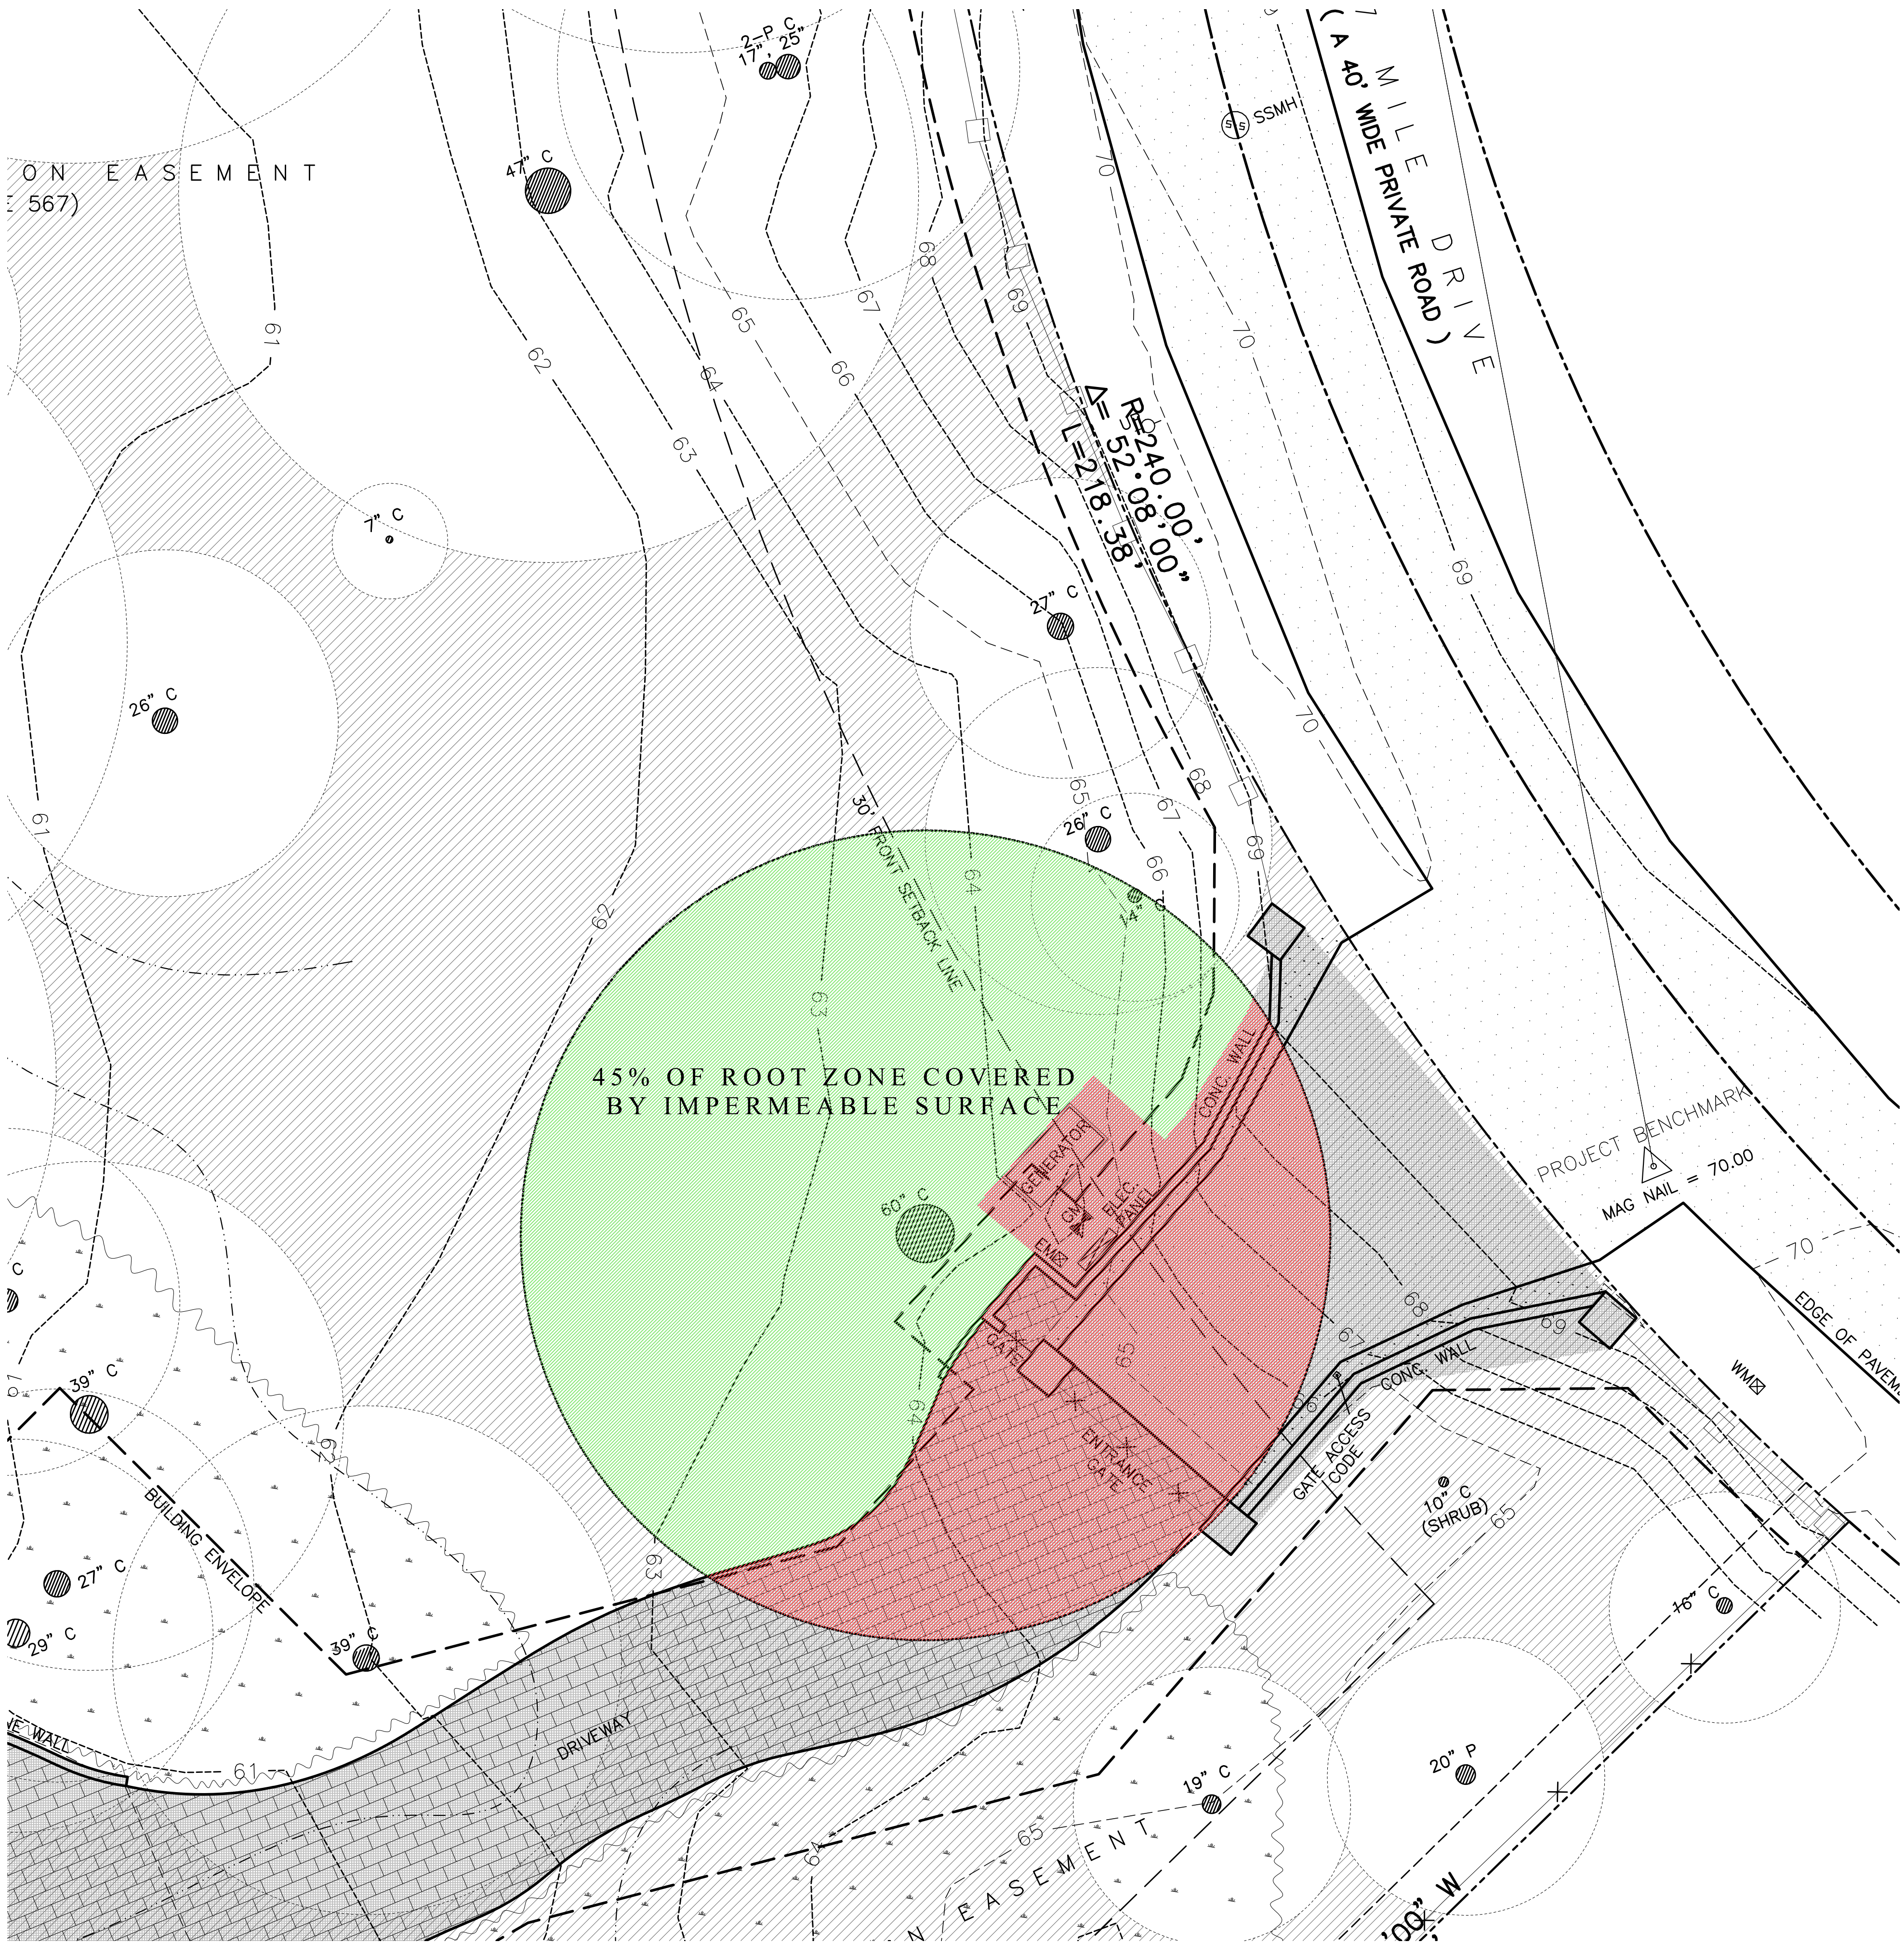
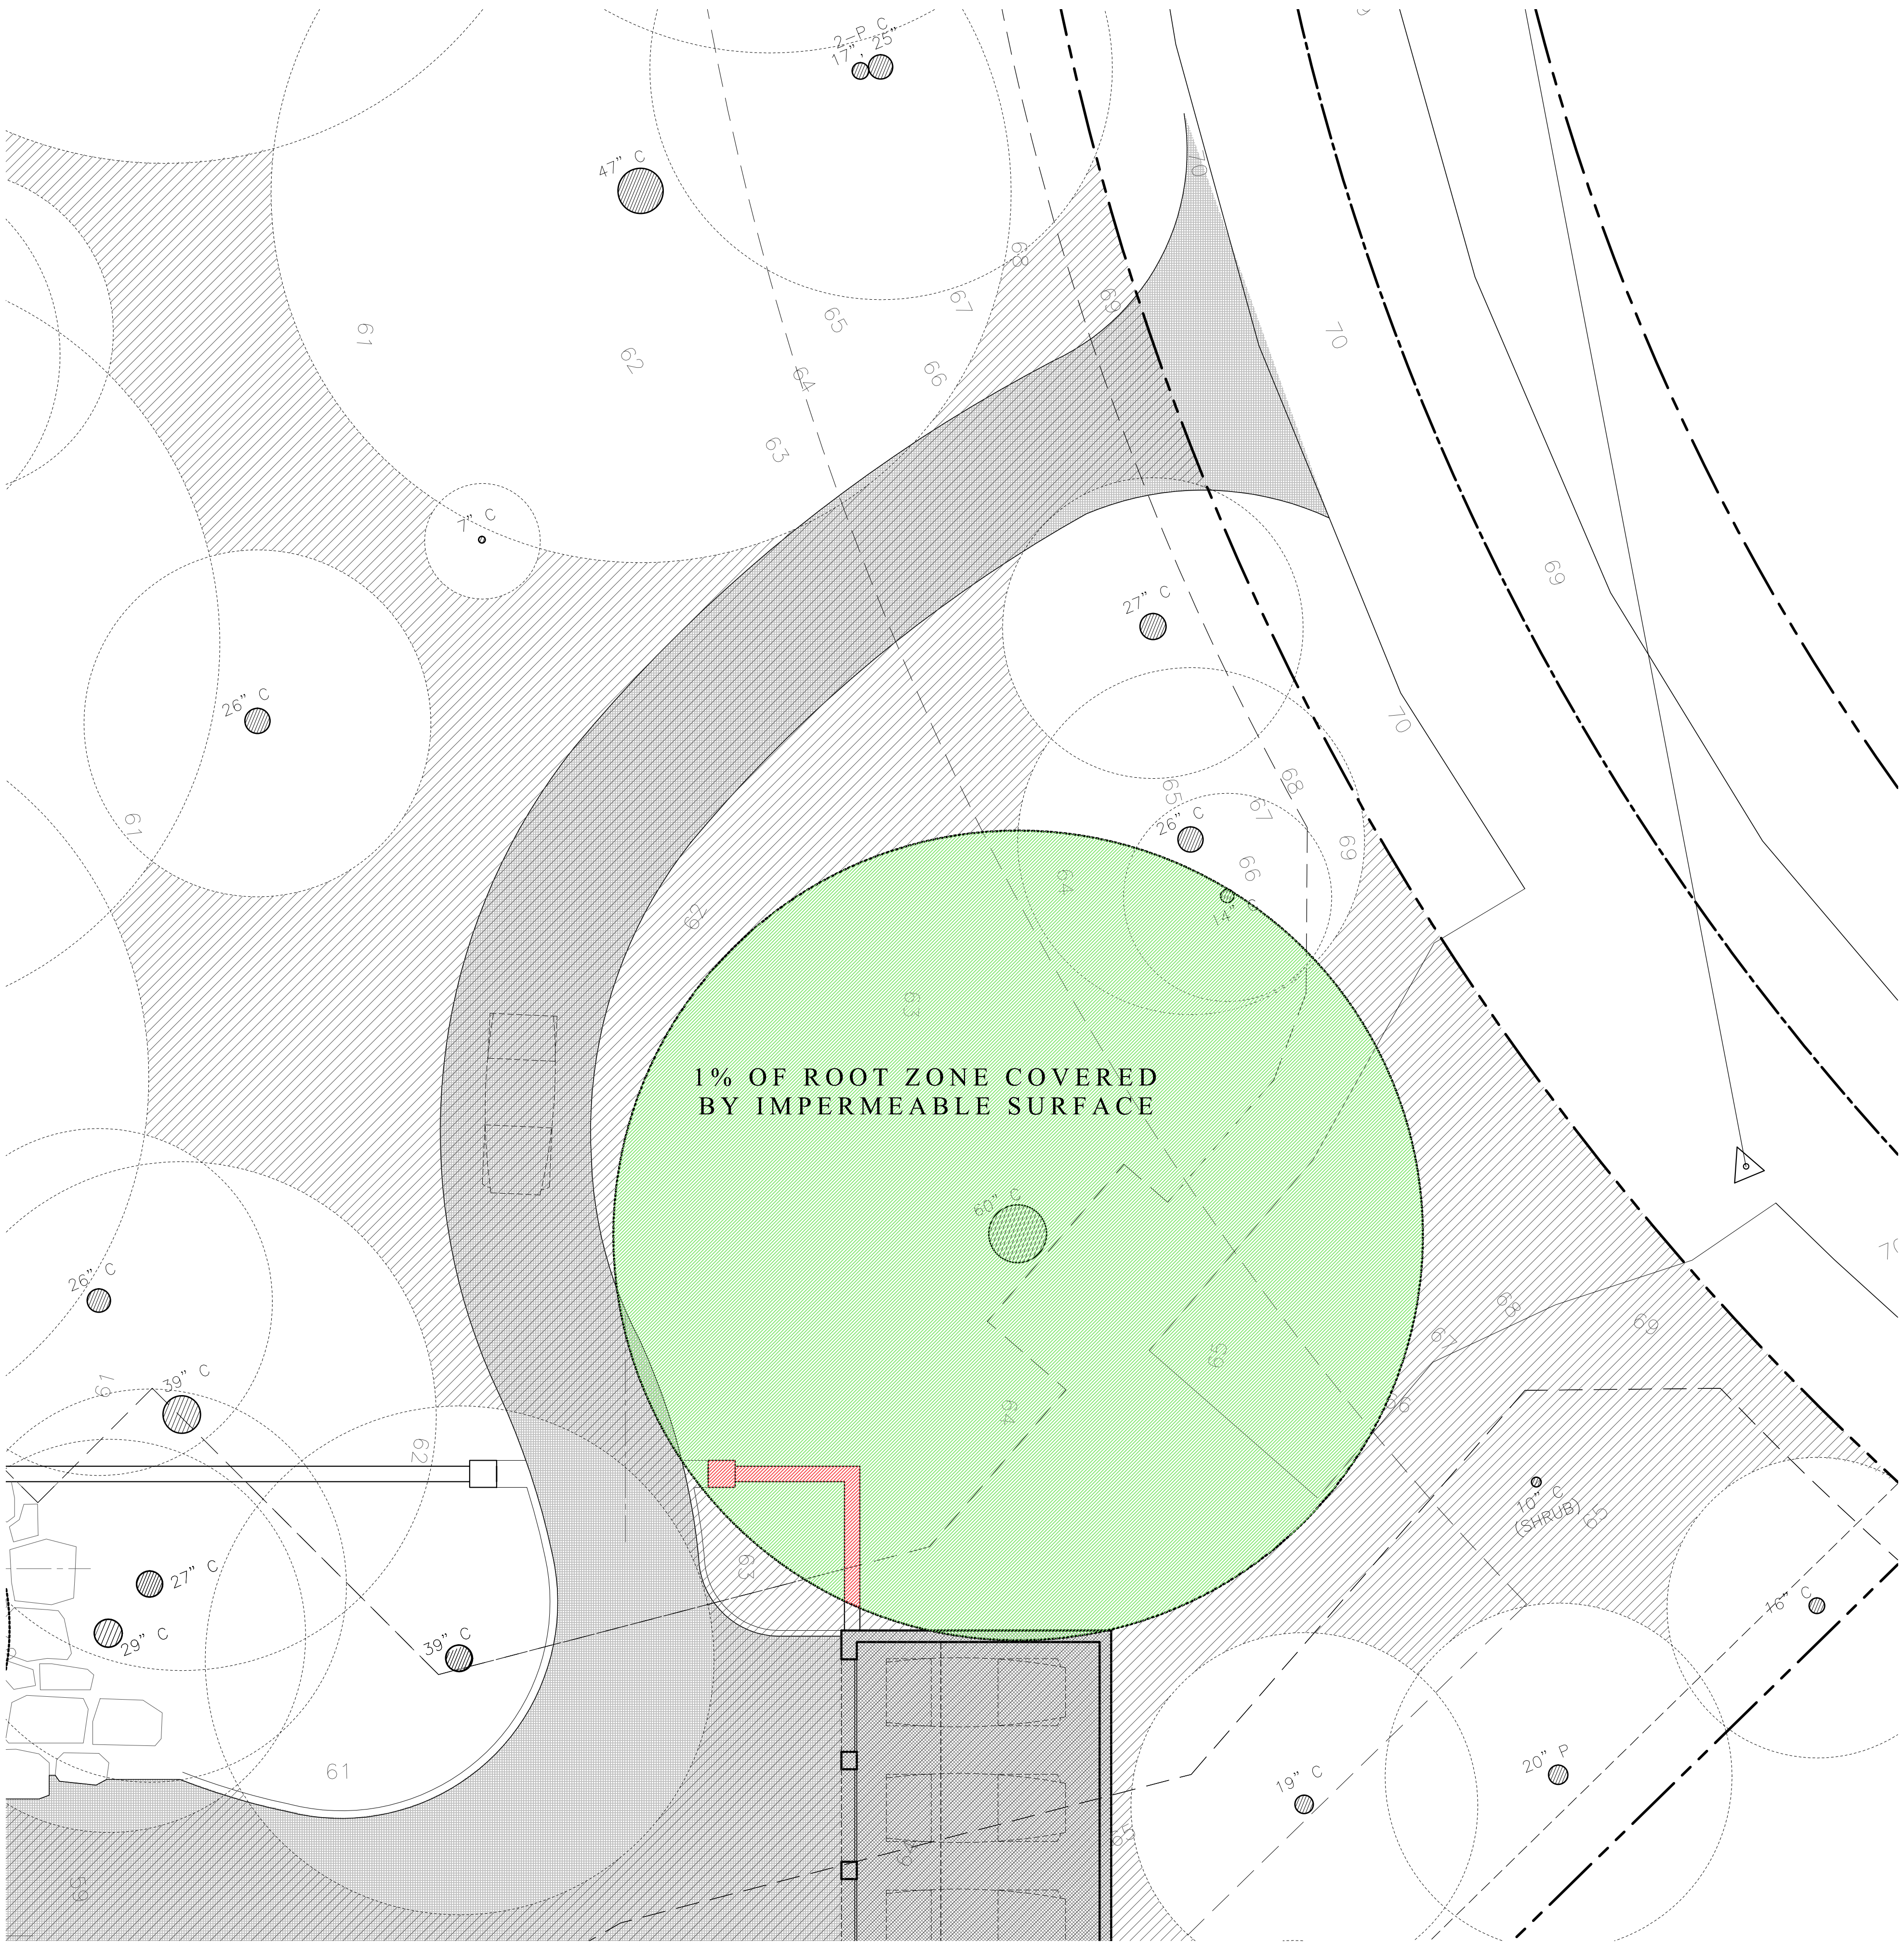
A 3.0

60" CYPRESS AT EXISTING DRIVEWAY ENTRANCE

60" CYPRESS AT PROPOSED DRIVEWAY ENTRANCE

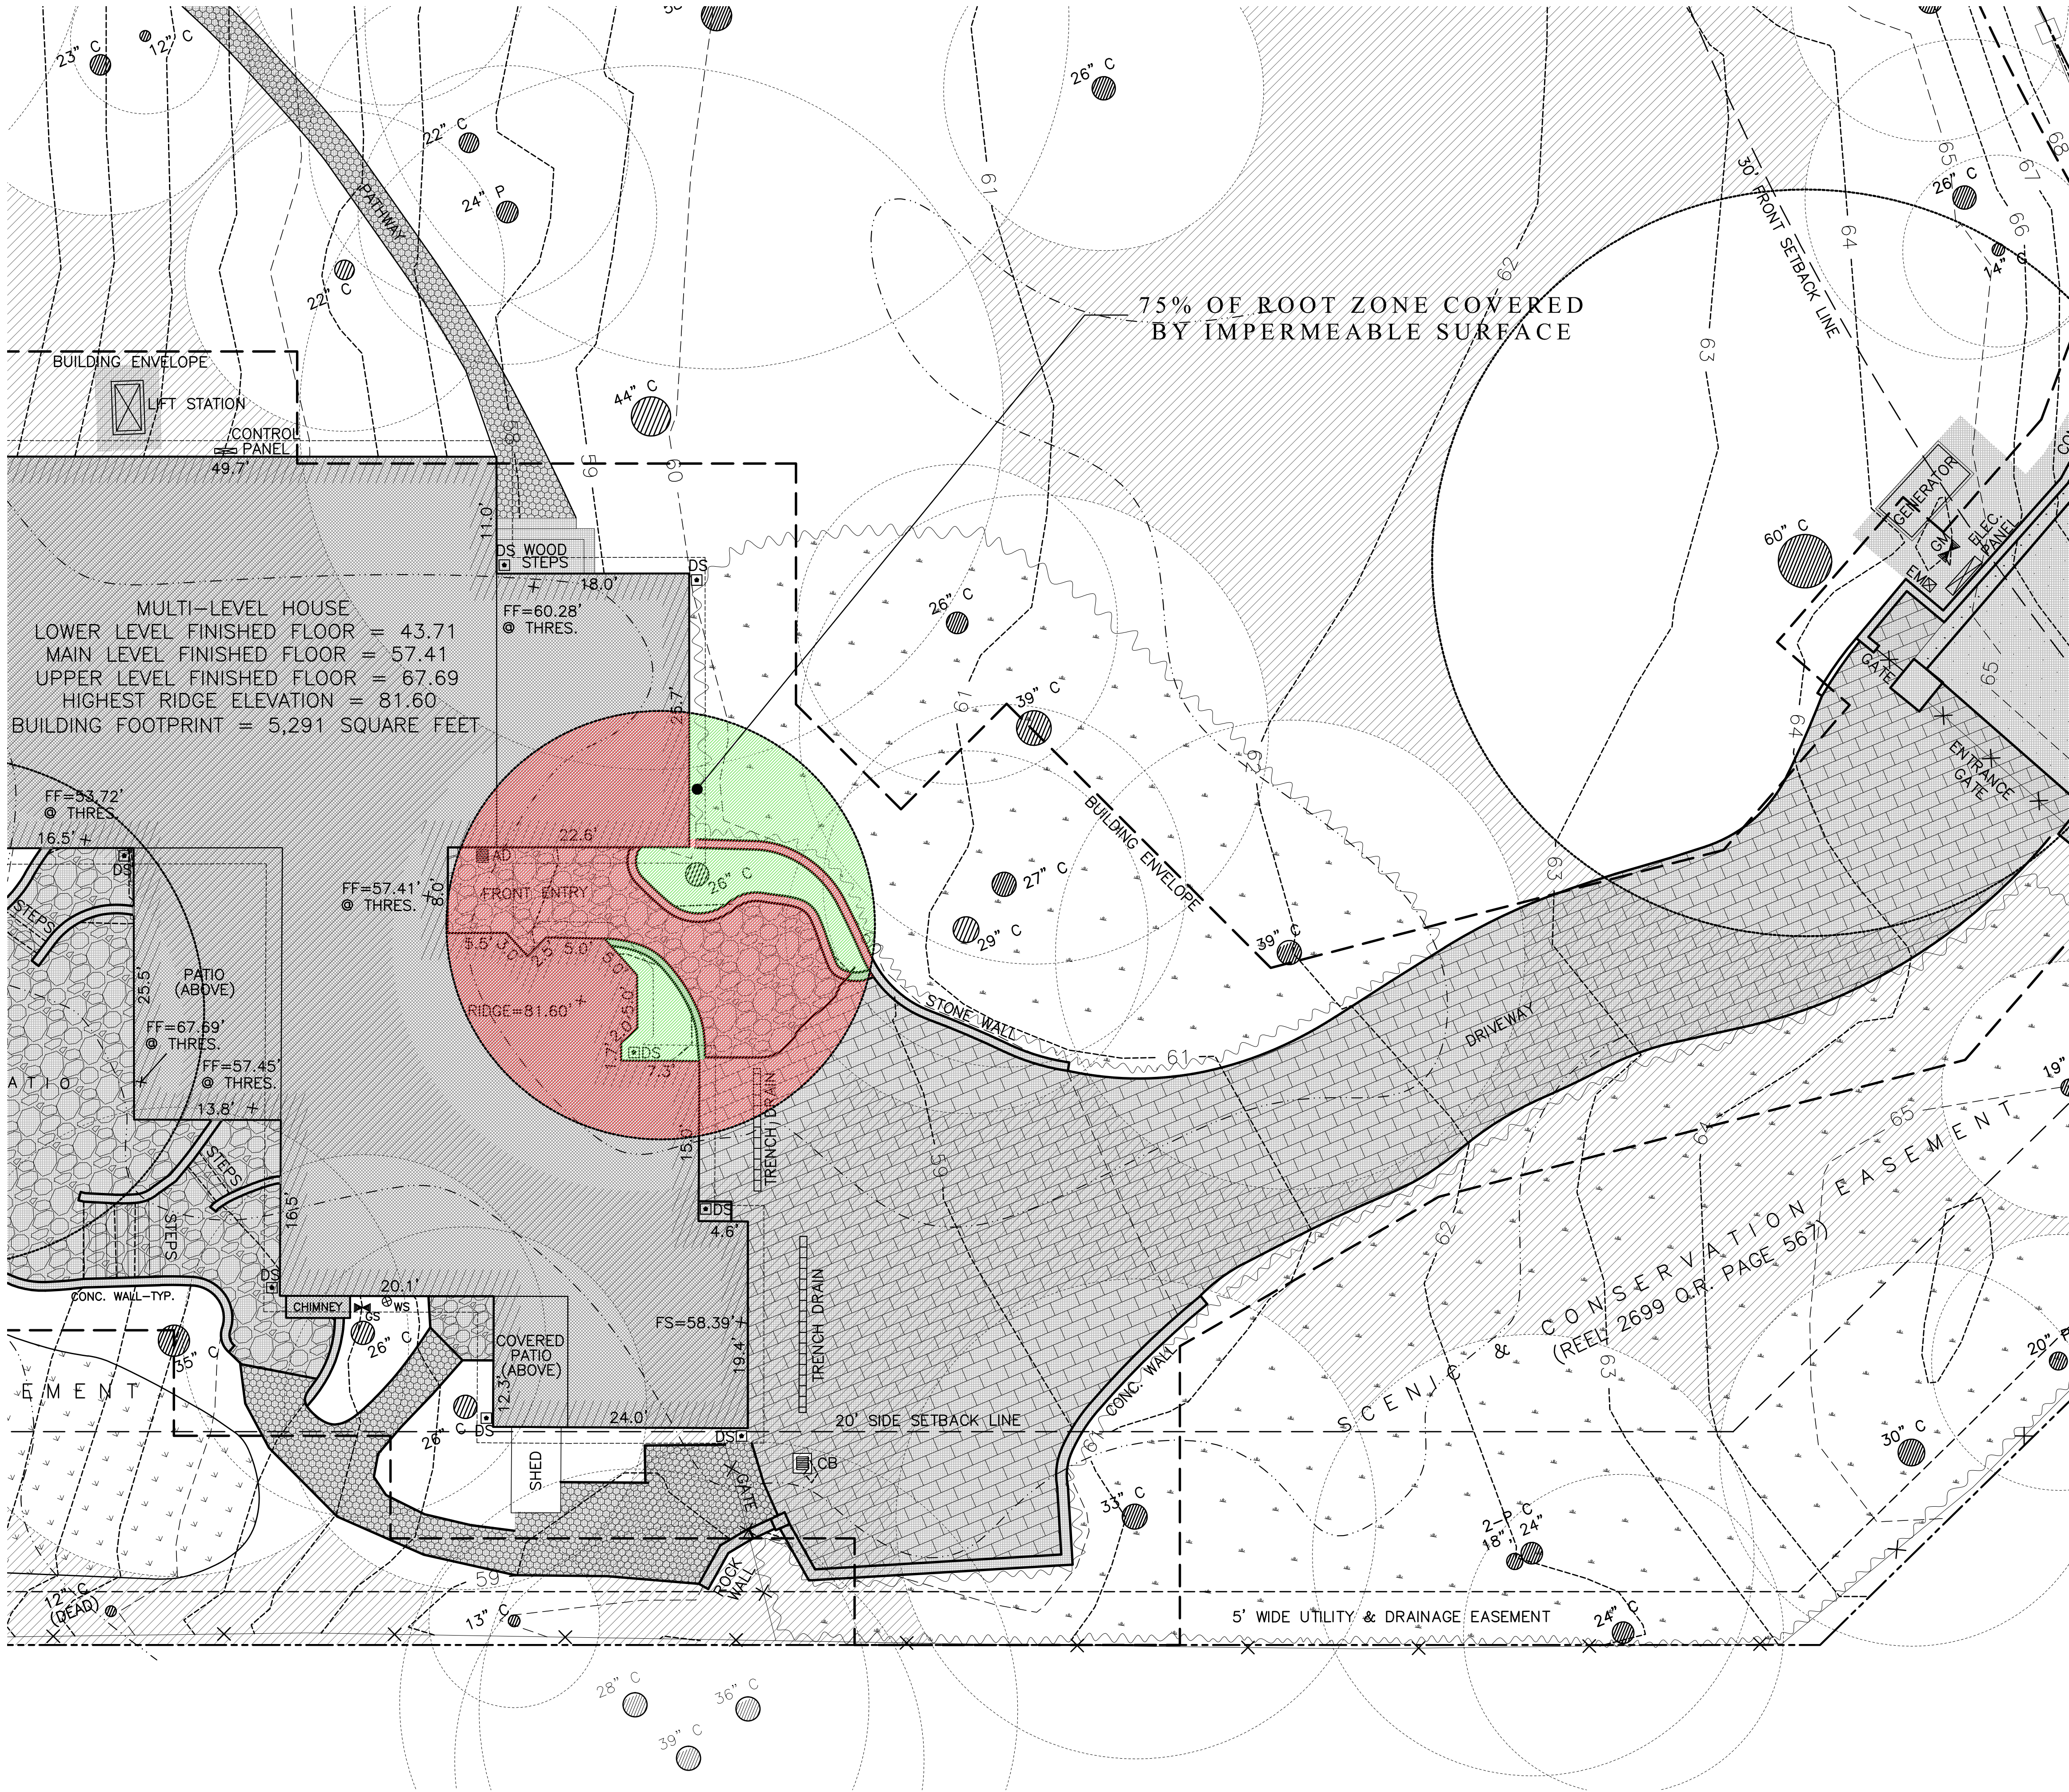
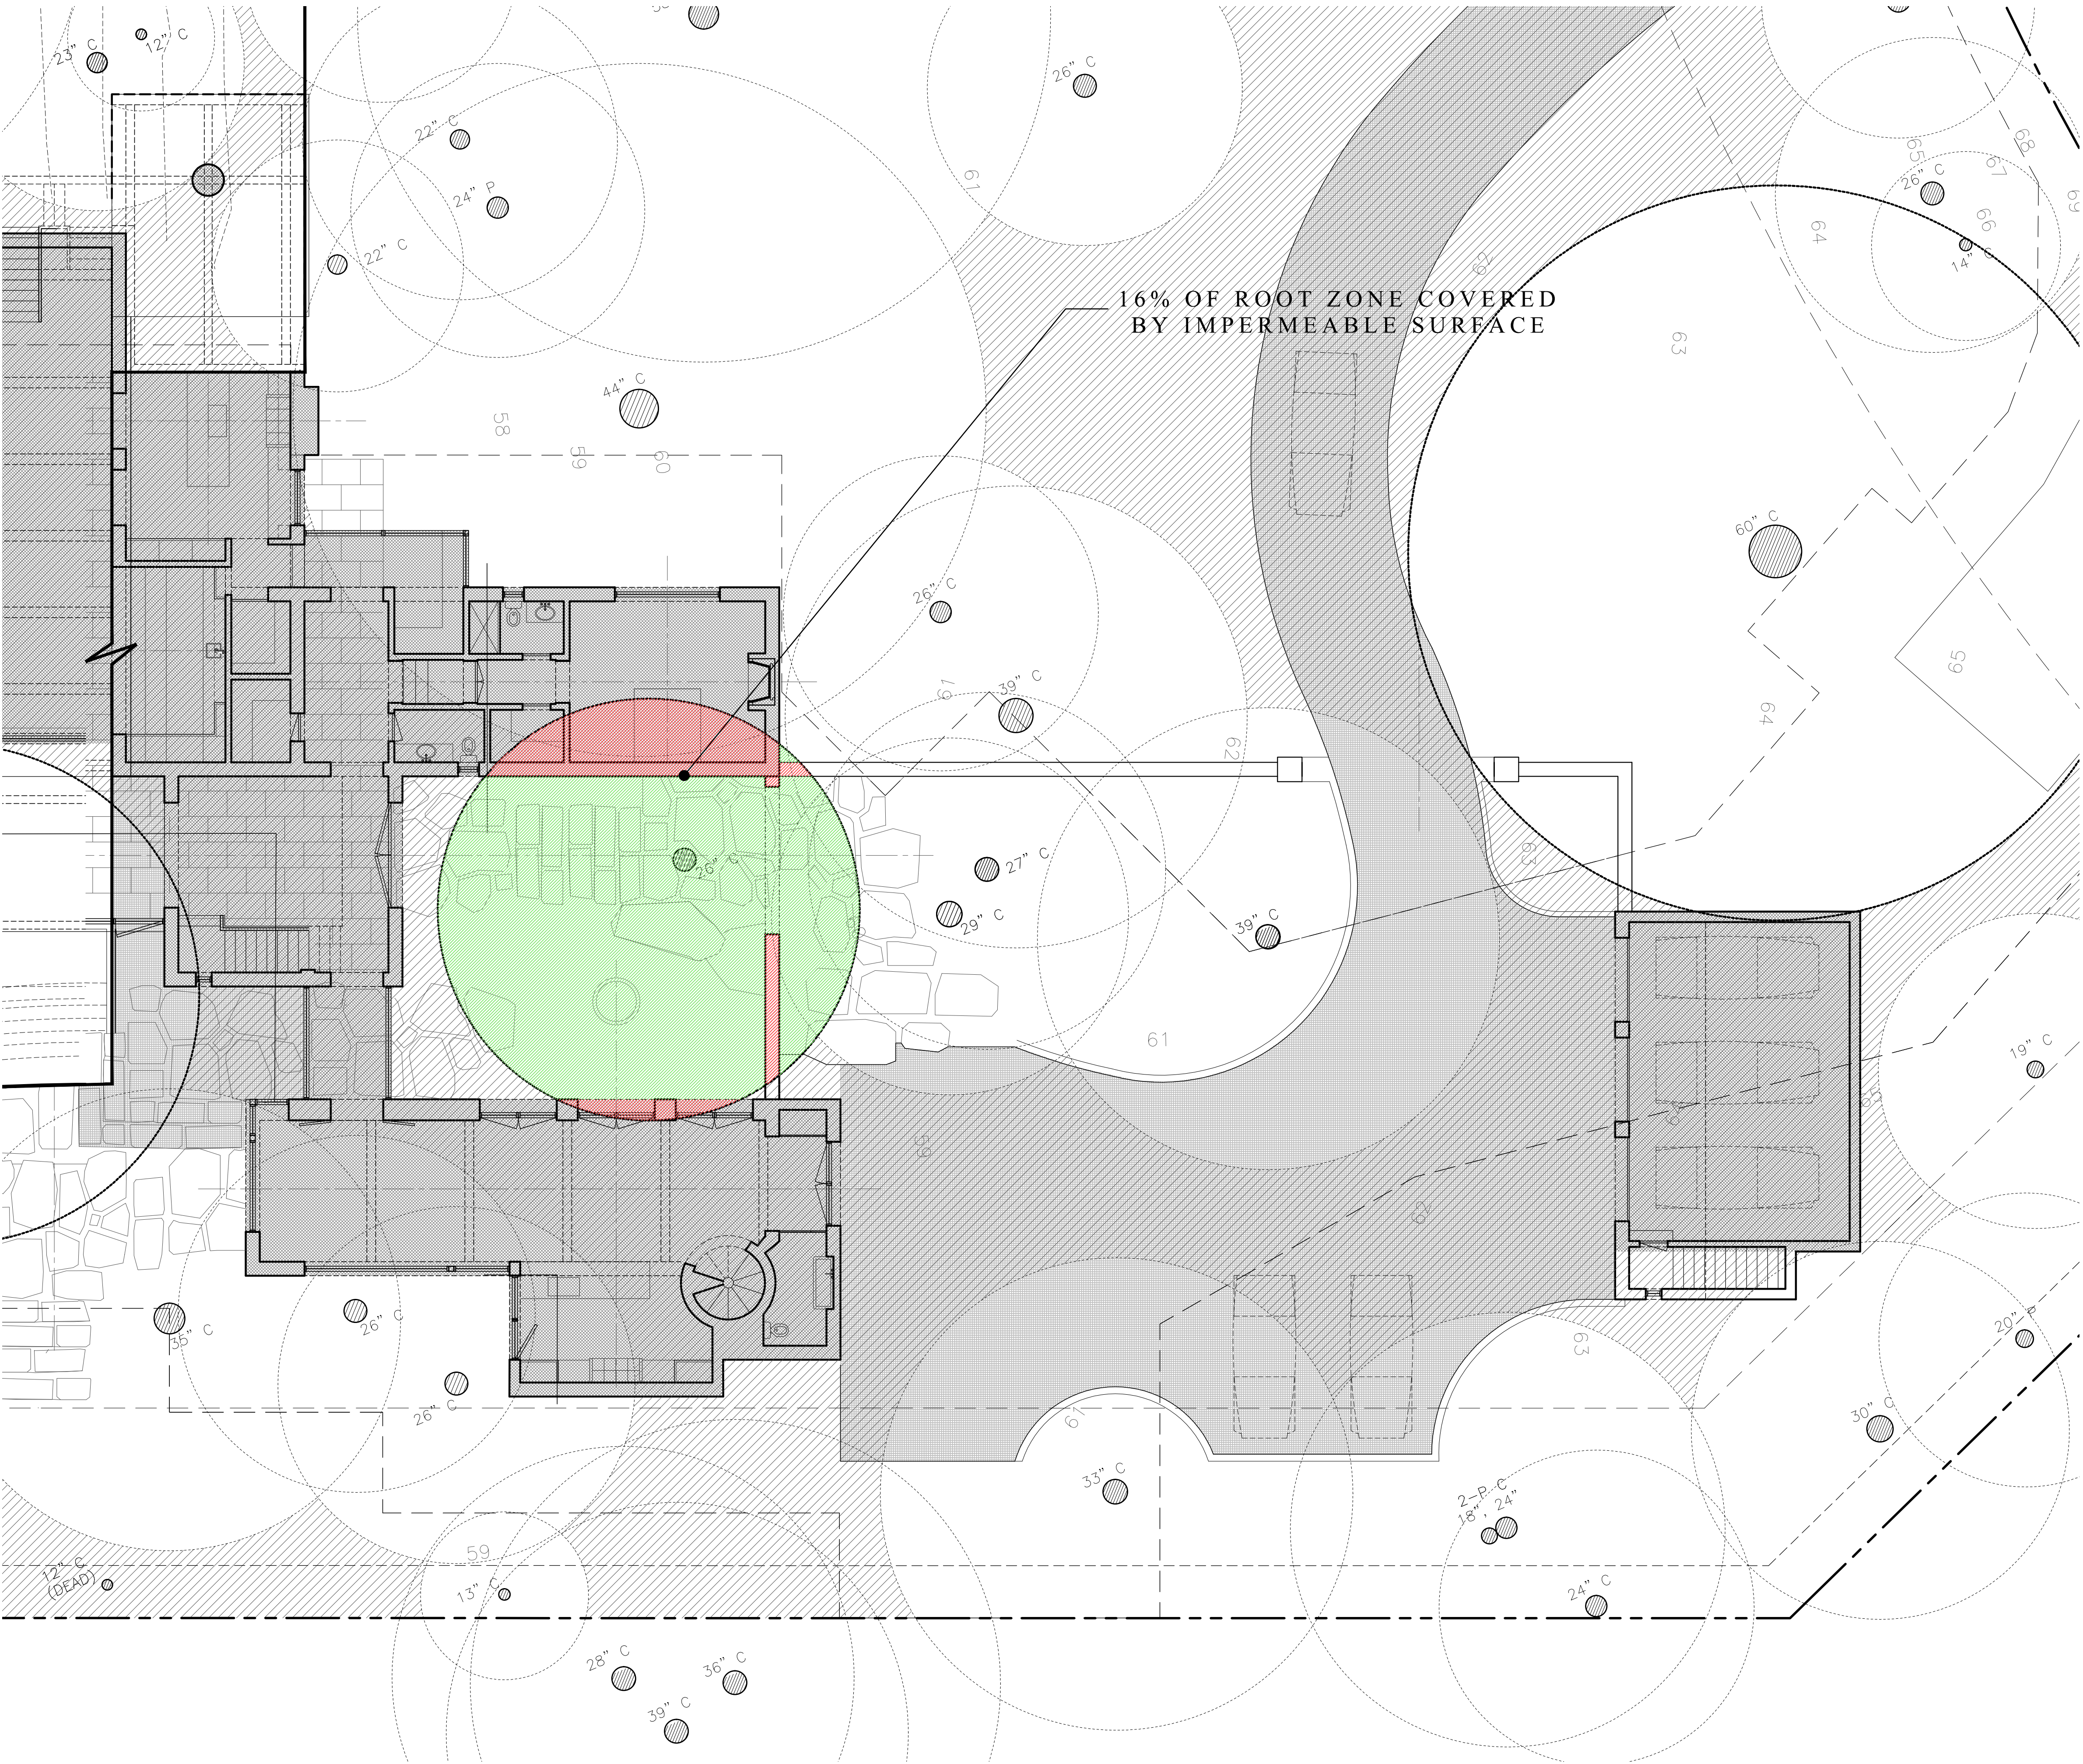
A3.1

26" CYPRESS AT EXISTING HOUSE ENTRY - BUILDING MASS AND PAVING

26" CYPRESS AT PROPOSED HOUSE ENTRY - GARDEN COURTYARD
