Re: 3196 17 Mile Drive - Existing Cypress Tree Assessment / Proposed Plan

EVALUATION OF KEY CYPRESS TREE DETERIORATING CONDITIONS

## **EVALUATION OF 4 KEY MONTEREY CYPRESS** 3196 SEVENTEEN MILE DRIVE, PEBBLE BEACH, CA.

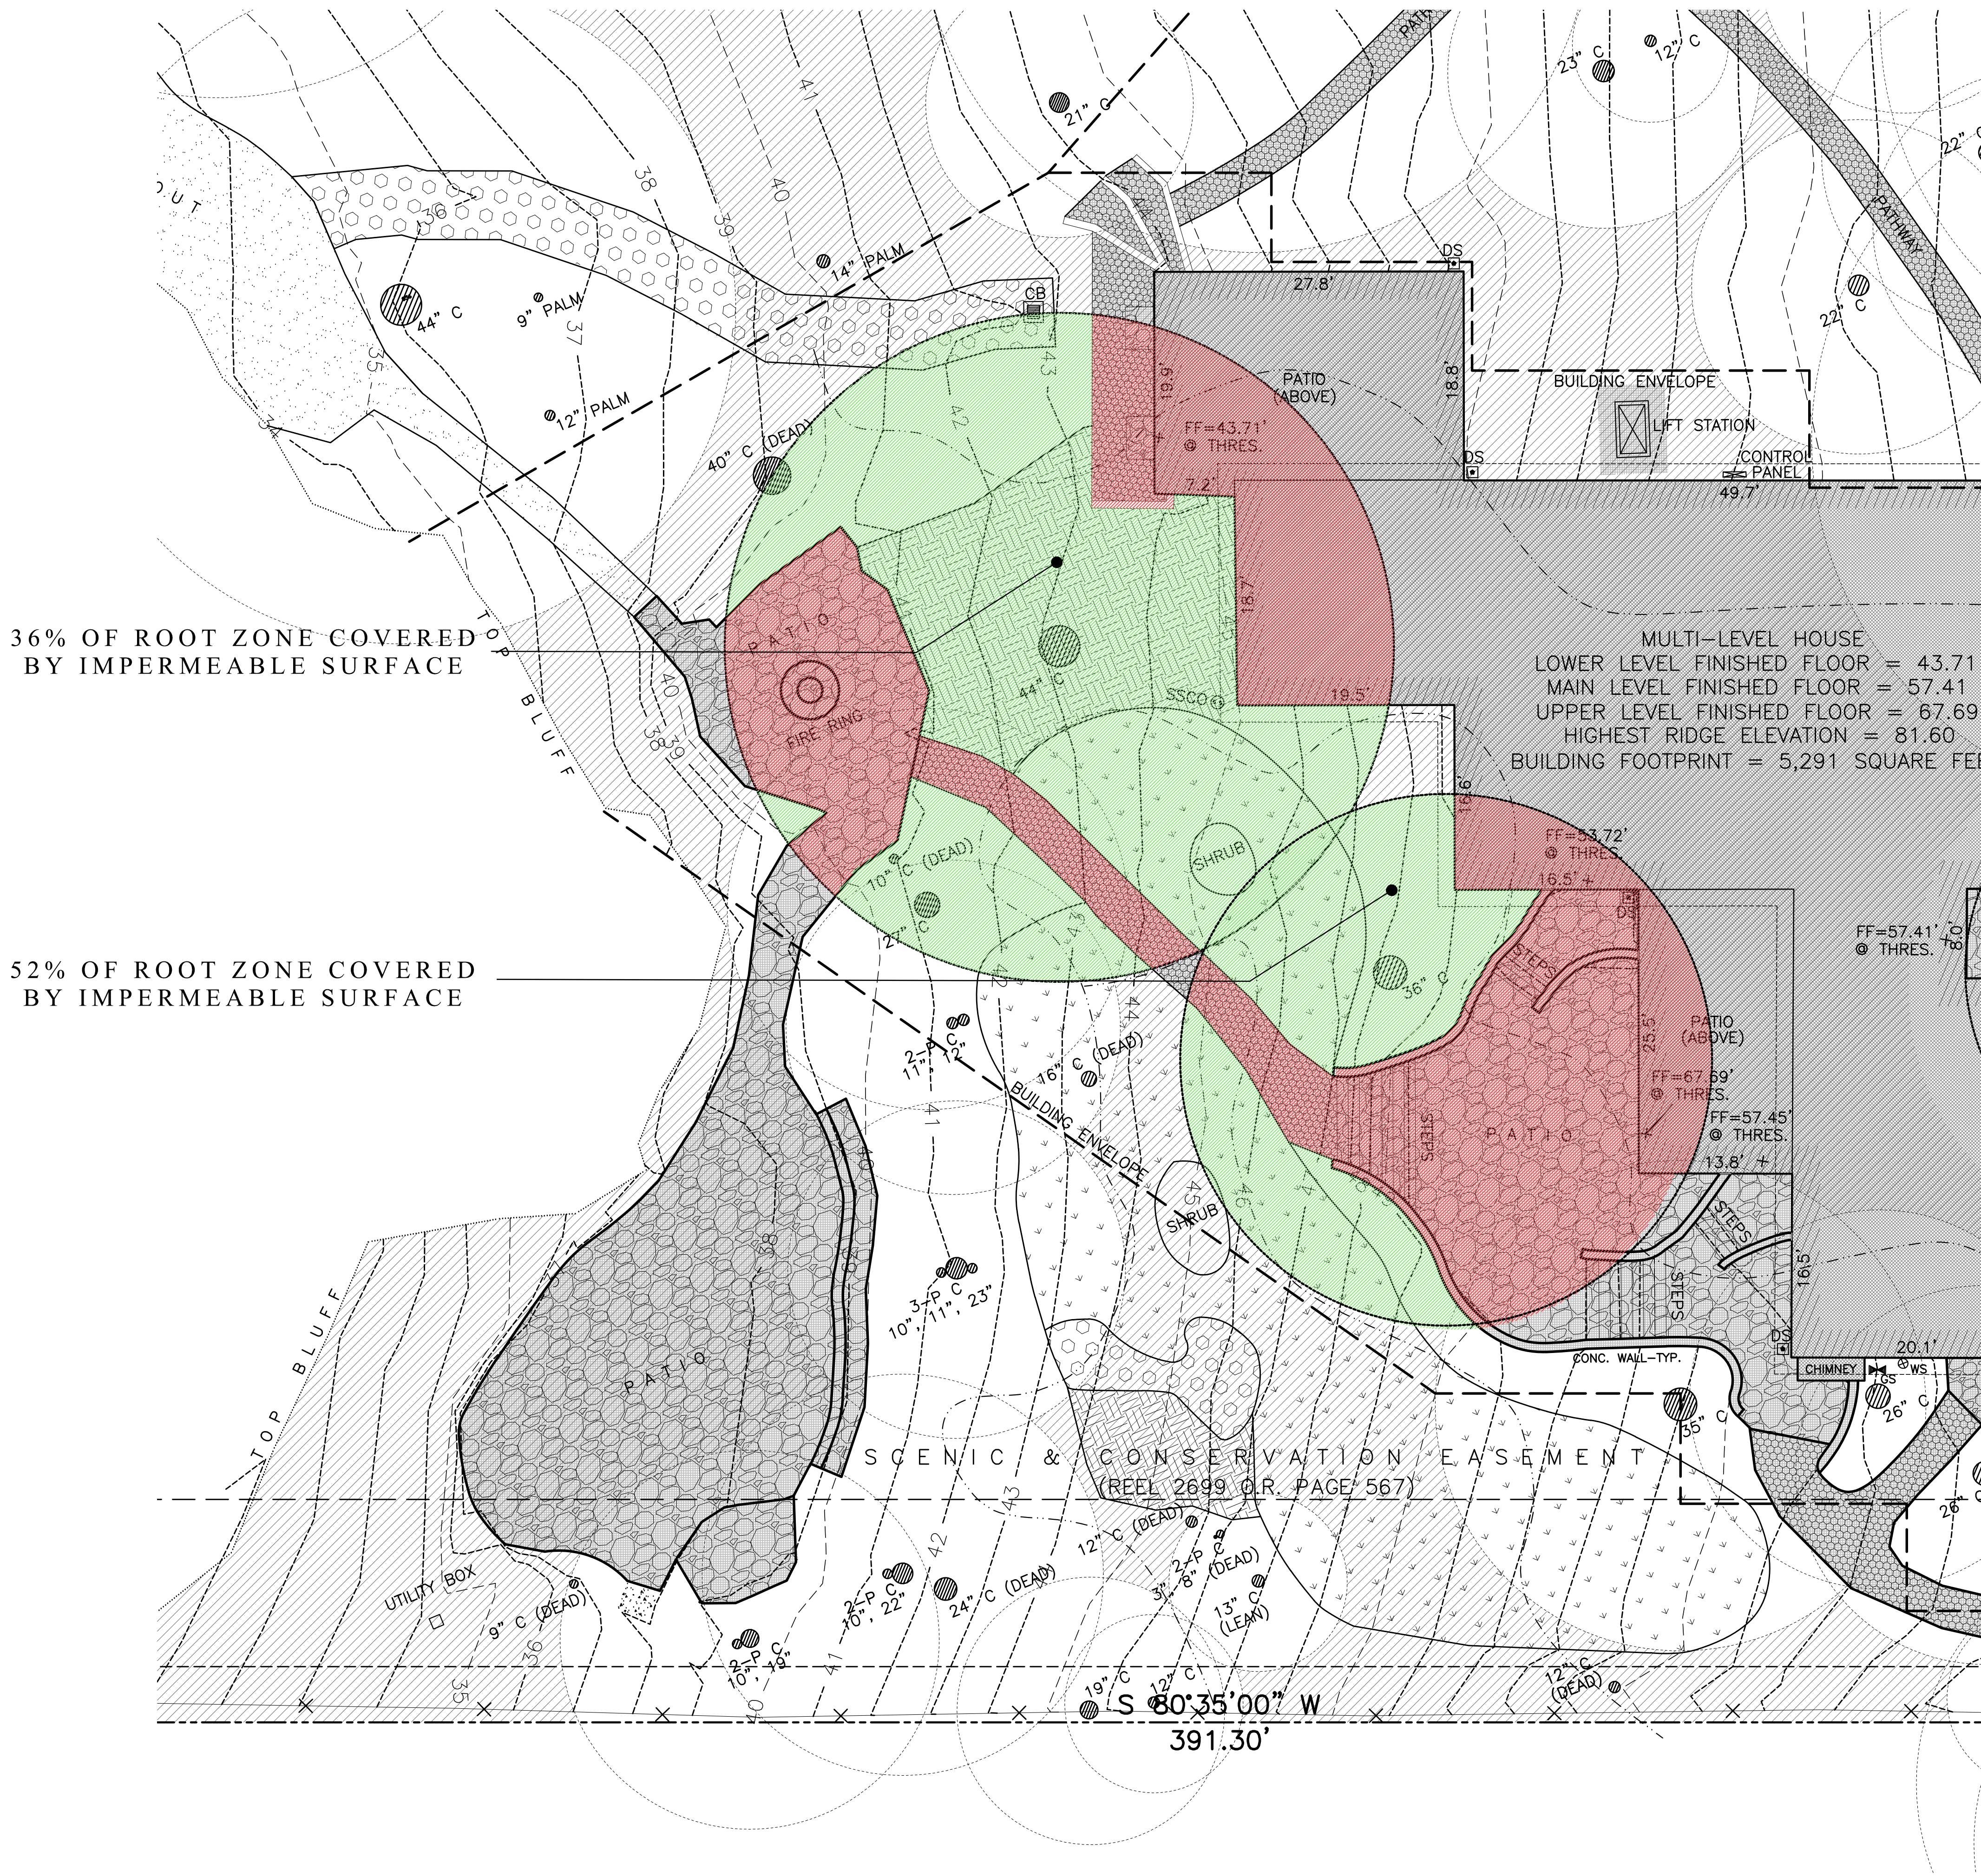
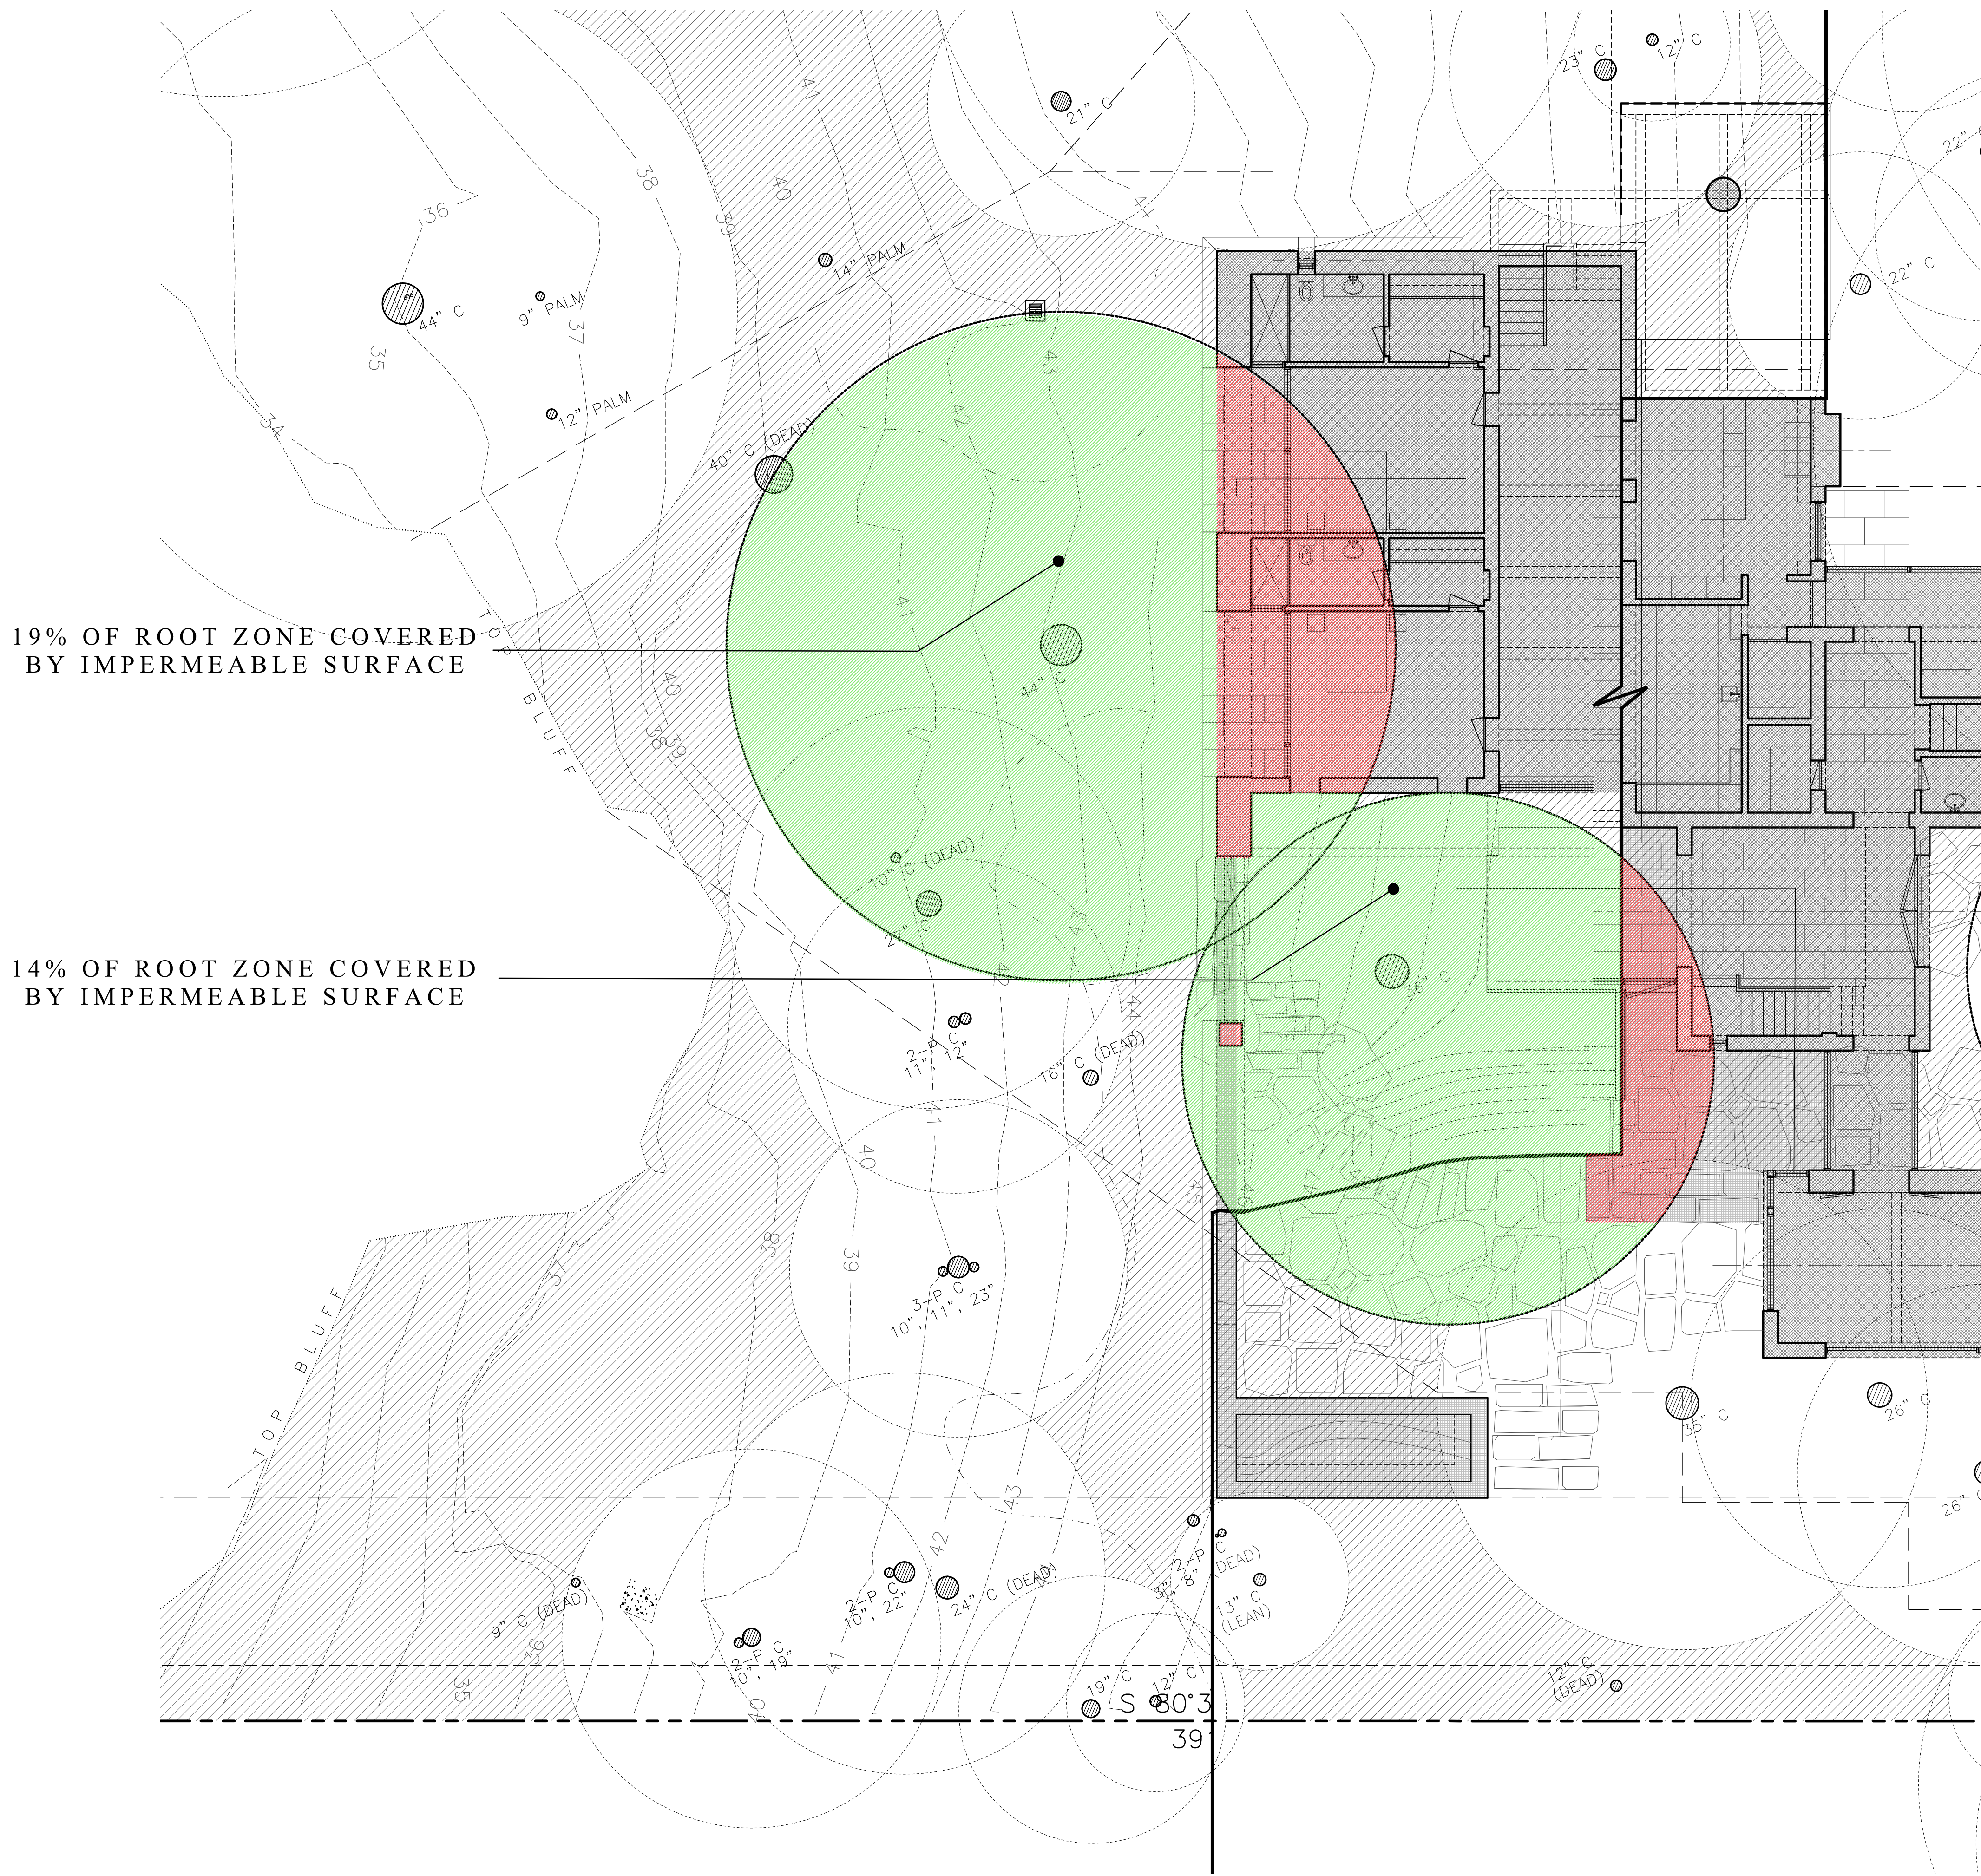
A3.2

36" & 44" CYPRESS AT OCEANSIDE OF EXISTING HOUSE - ADJACENT TO HOUSE AND LARGE PATIO AREA

36" & 44" CYPRESS AT OCEANSIDE OF PROPOSED HOUSE - GARDEN COURTYARD

- 36" tree the hardscape is reduced from 52% to proposed project is 14% - excellent improvement
- 44" tree hardscape is reduced from 36% to 19% with the project – significant improvement

- 1 - PULL BACK EXISTING BUILDING FOOTPRINT FROM CYPRESS ROOT ZONE AREA - RESTORE ROOT ZONE
- 2 - REMOVE 1,334 SF OF TERRACE ON SLAB, 110 LF OF WALL FROM CYPRESS ROOT ZONE AREA
- 3 - RELOCATE ALL EXTERIOR SITTING AREAS TO OUTSIDE OF CYPRESS ROOT ZONE
- 4 - REPLACE ALL SLAB TERRACE WITH STEPPING STONES ON SAND AND SOIL- PLANTING POCKETS
- 5 - RETURN 4,017 SF OF IRRIGATED GARDEN AND TERRACES TO SCENIC EASEMENT - RESTORE ROOT ZONE
