# Exhibit E

# Tree Resource Assessment Patterson Residence

February 23, 2017

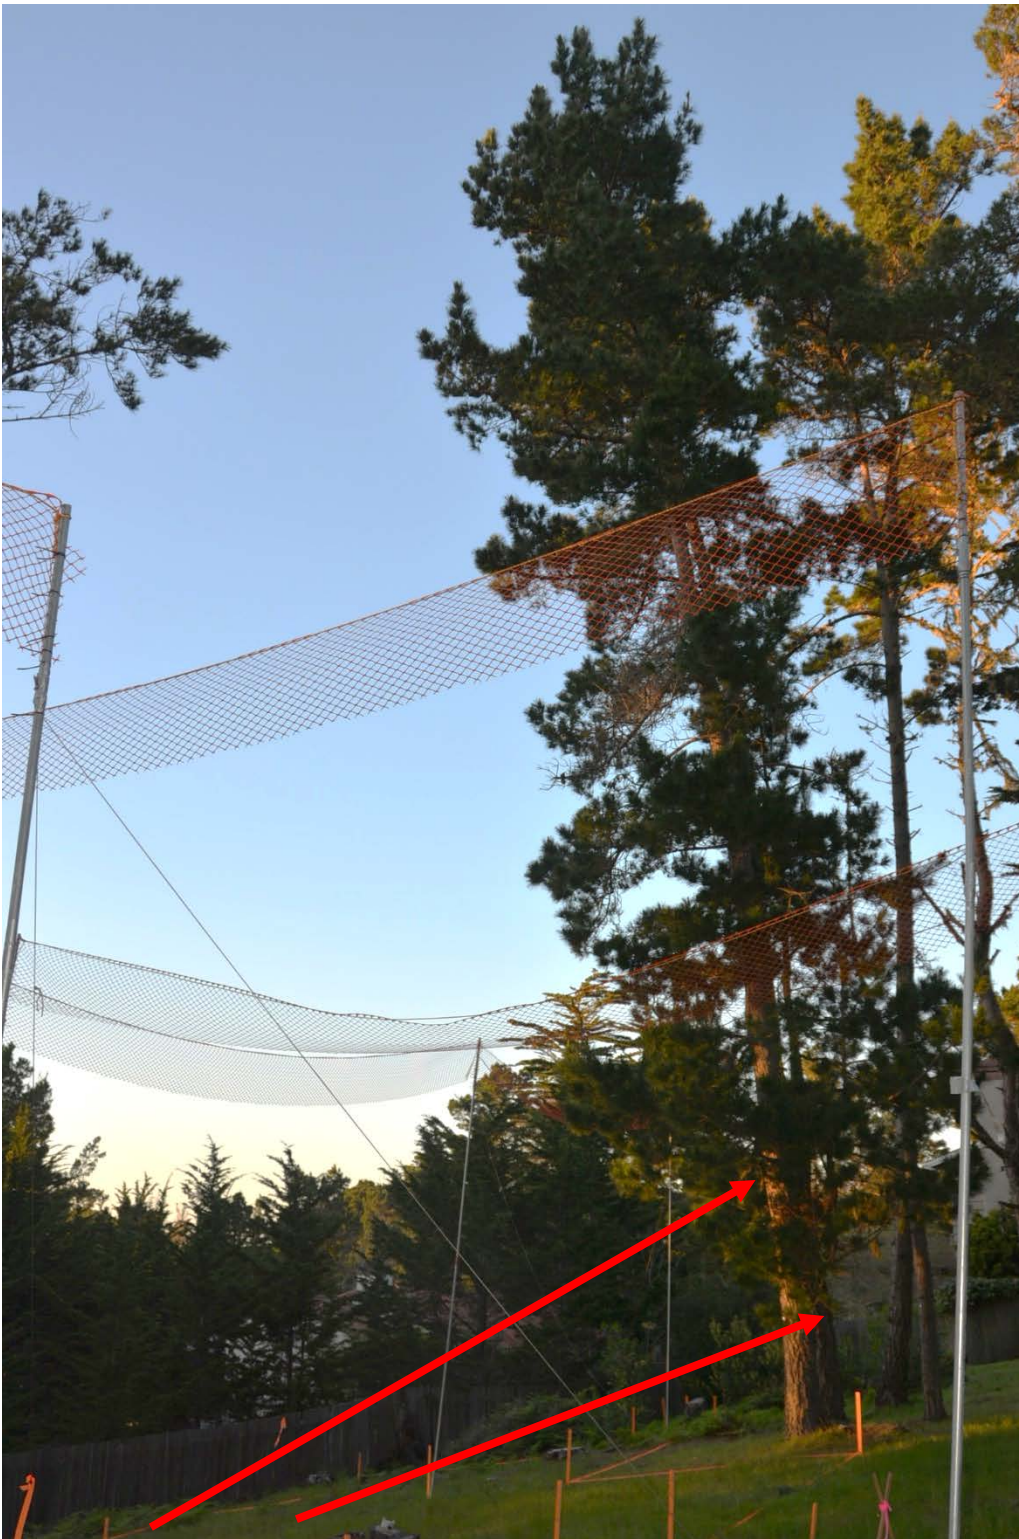
Tree #23 and #24

| ID# | Diameter | Species | Condition | Remove | Comments |
|---|---|---|---|---|---|
| 23 | 16 | M. Pine | Fair | X | In Building Footprint |
| 24 | 16 | M. Pine | Fair | X | Adjacent Building Footprint |

The following trees are identified as trees which will be impacted by construction and need removal. Tree identified for removal outside the building footprint is a tall slender tree capable of wind throw failure when roots are disturbed.

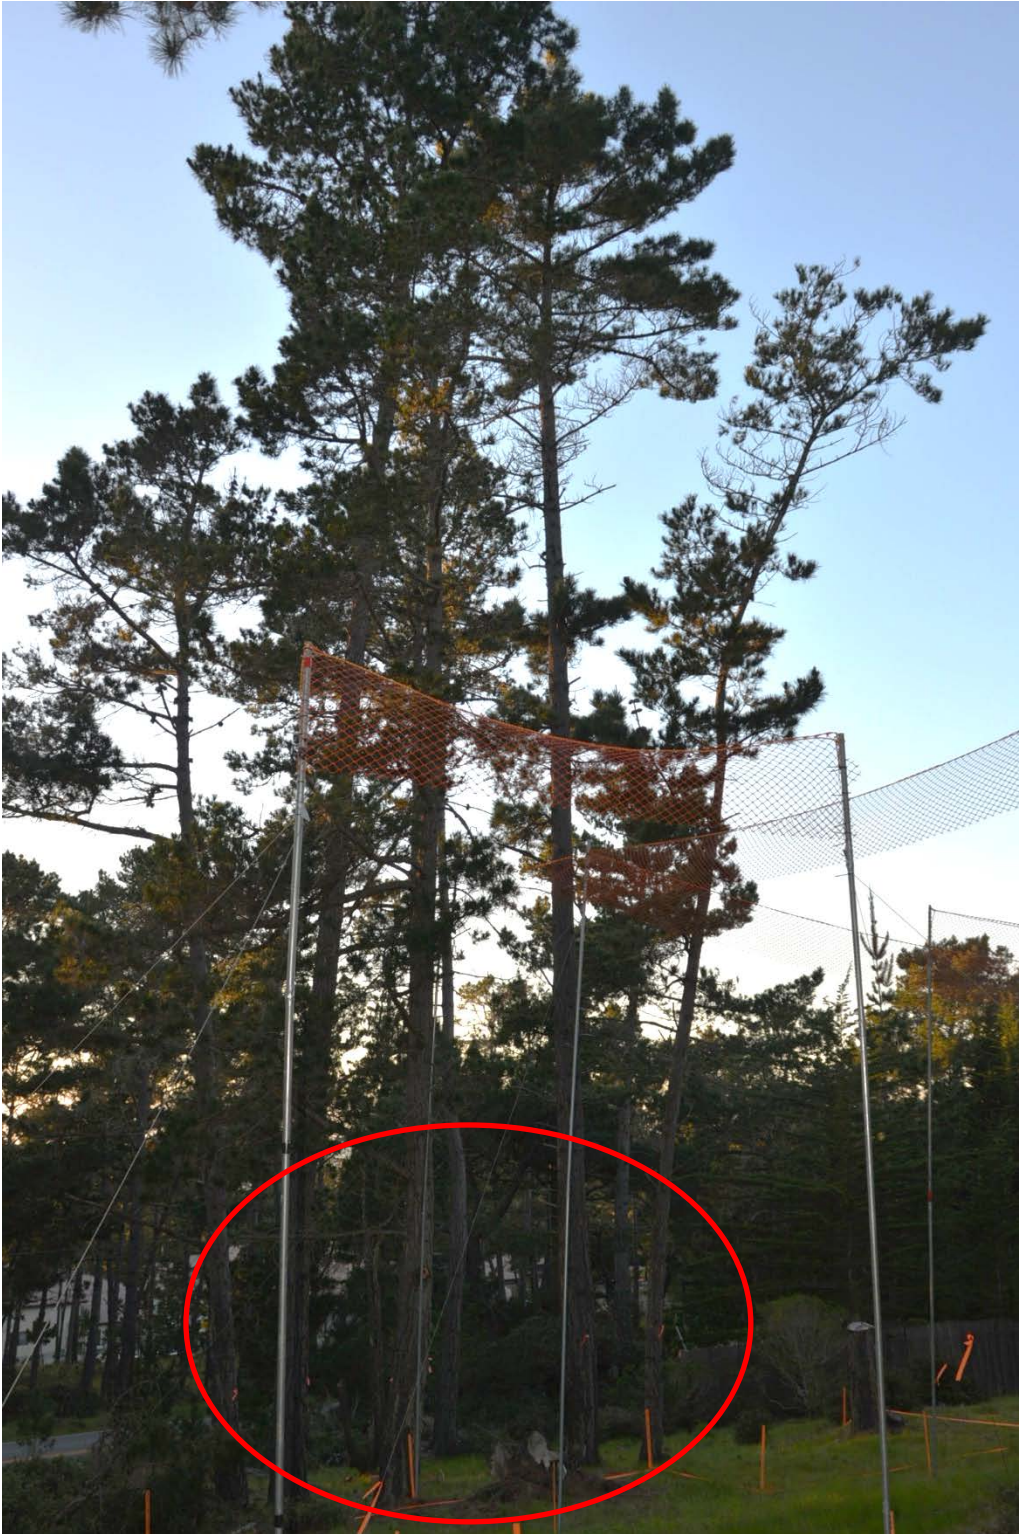
Trees #27-28

| ID# | Diameter | Species | Condition | Remove | Comments |
|---|---|---|---|---|---|
| 27 | 8 | M. Pine | Poor | X | In Building Footprint, Stem Decay |
| 28 | 18 | M. Pine | Poor | X | In Building Footprint, Exposed Roots, Uplifted Soil |
