# Tree Resource Assessment Management Plan

Frank Ono  
Urban Forestry  
Member Society of American Foresters #48004  
ISA Certified Arborist #536  
1213 Miles Avenue  
Pacific Grove, CA 93950

December 29, 2015

This tree assessment/arborist report is prepared for Mr. Werner Nase, the owner of the property located at 1412 Lisbon Lane by Frank Ono, Urban Forester and Certified Arborist (Society of American Foresters #48004 and International Society of Arboriculture Certified Arborist #536) due to proposed construction. The Del Monte Forest Land Use Plan and Monterey County Zoning Ordinance Title 20 identify Monterey pine and Coast live oak trees as native tree species requiring protection and special consideration for their management.

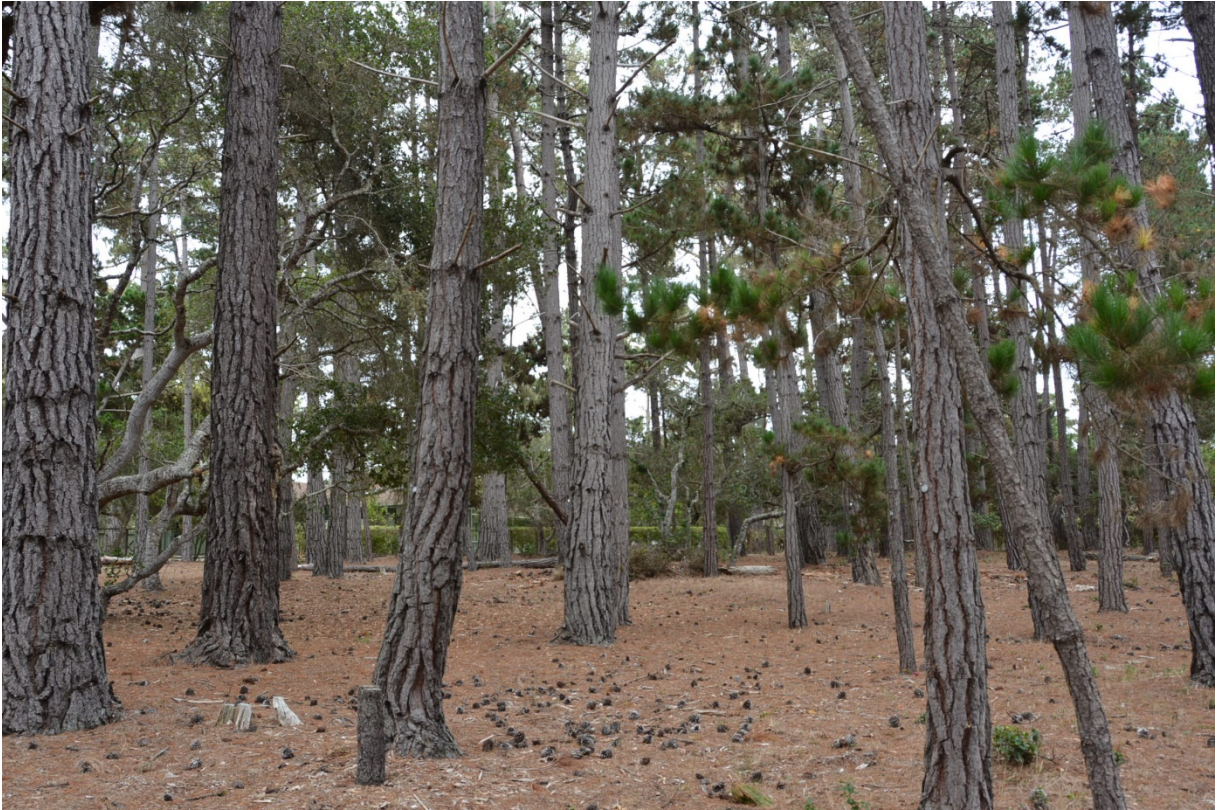
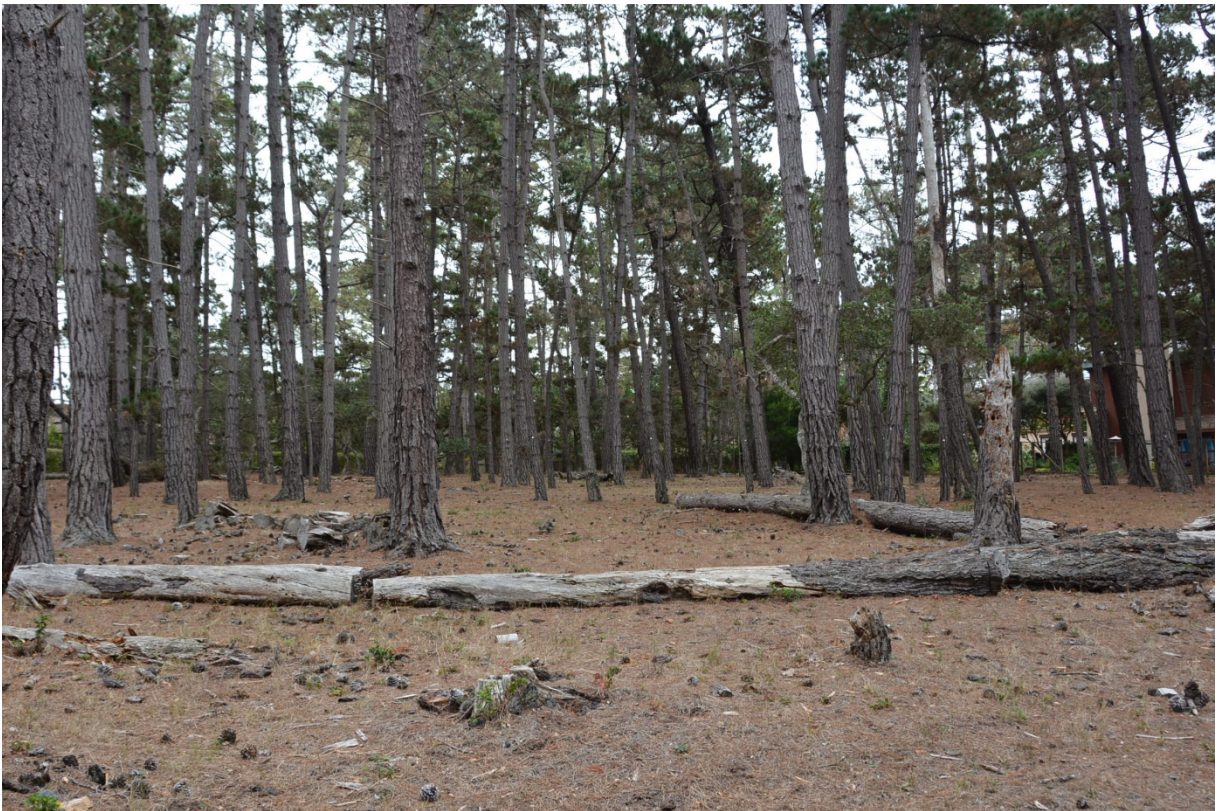
View of the lot to the south west from center of Lisbon Lane

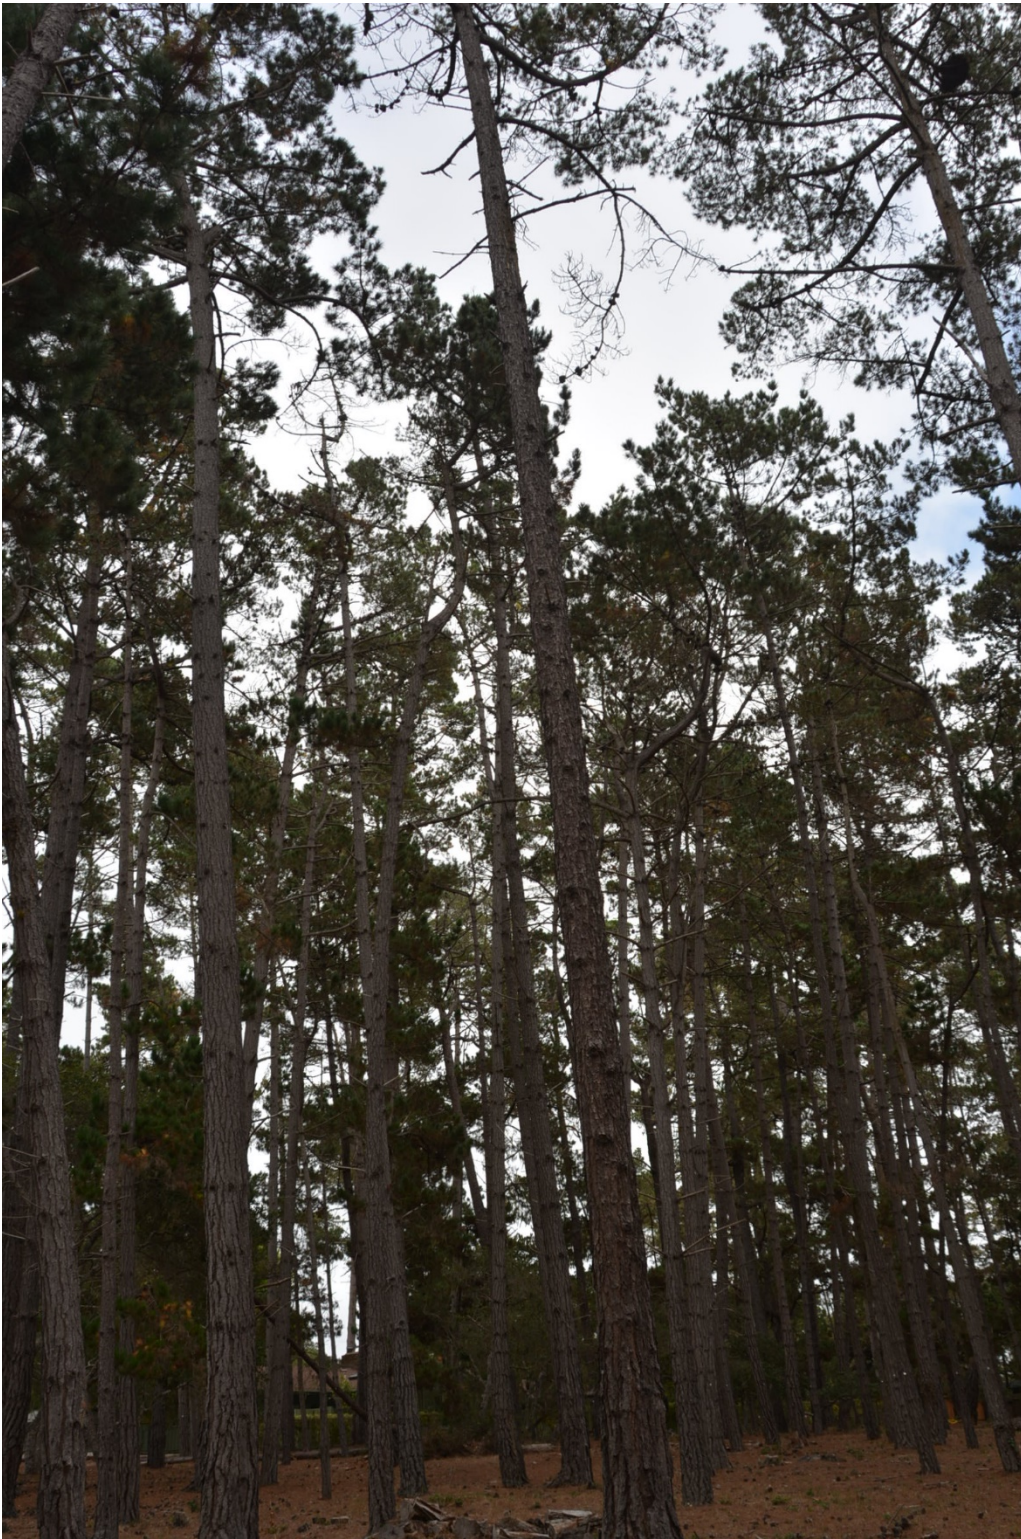
View of the lot from Lisbon Lane to the south east
