# Exhibit E

#### GEOTECHNICAL INVESTIGATION

#### FOR THE PROPOSED NEW SINGLE FAMILY RESIDENCE AND GUESTHOUSE

#### APRIL 21, 2017; JOB #6814

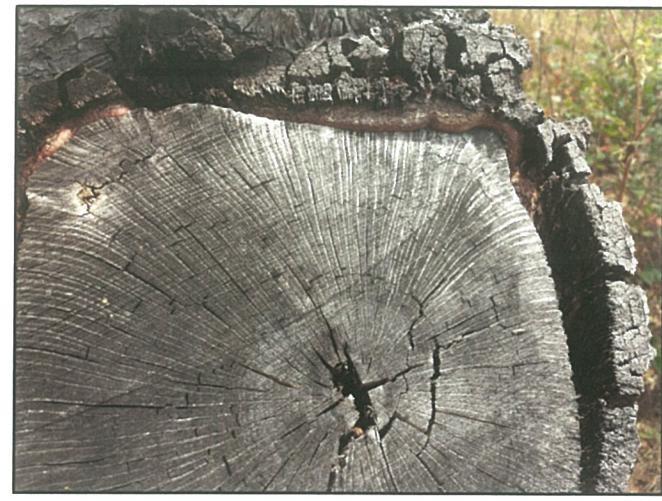
Figure 1 is a cut limb from a coast live oak near your proposed water tank site. The cut is approximately 4 feet off the ground and I estimate it to be approximately 5 or 6 years old. Note the callous developing on the upper, center portion of the cut. Figure 2 is a much older callous from a cut limb that is in excess of 15-20 years old – this older, calloused cut is located on Tree #15 (marked with a metal tag) along the access road in the general vicinity of the building site. The metal tag on Tree #15 corresponds with the "Tree Resource Evaluation and Protection Plan" prepared by Certified Arborist Maureen Hamb, April 2017. The well-formed callous seen in Figure 2 demonstrates that there was a much older episode of tree thinning (and possibly tree removal) that occurred on the subject parcel at some time in the past.

Figure 1 – Callous on limb cut approximately 5-6 years ago (photo August 2, 2017).

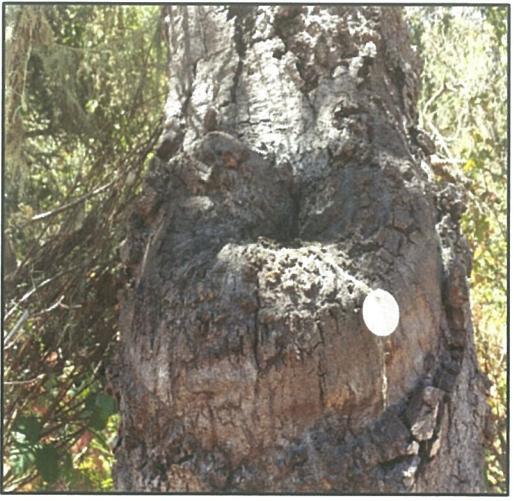
Figure 2 – Callous on limb cut more than 15 ago on Tree #15 (photo July 25, 2017).

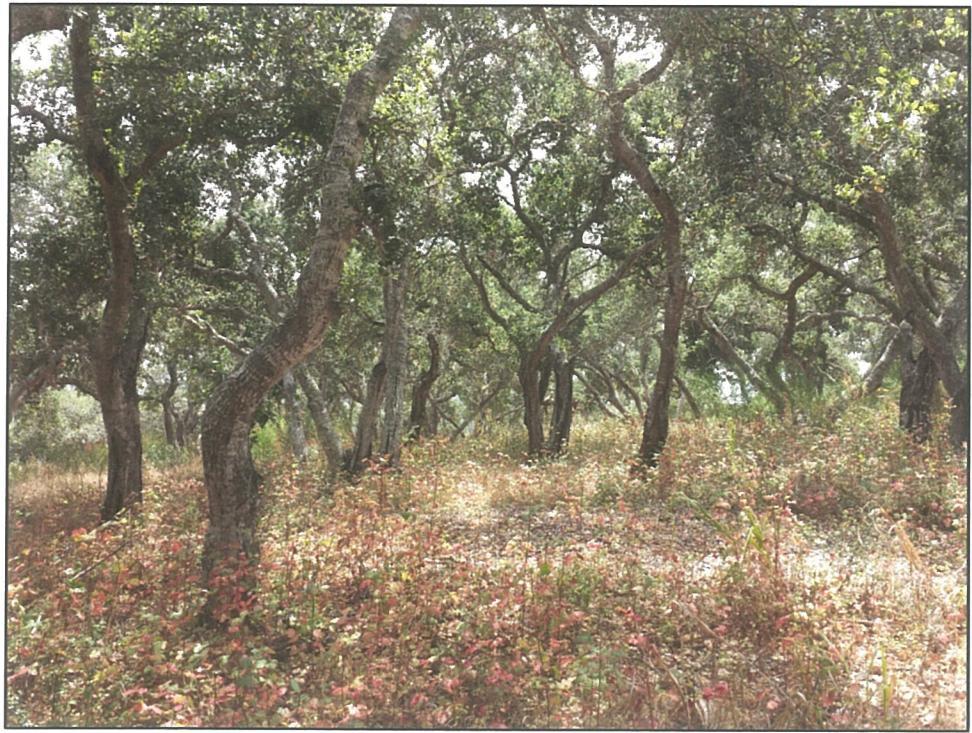
Figure 7 – Wood chip pile (lower center of photograph) in the general vicinity of tree stump #22. Photograph August 2, 2017.

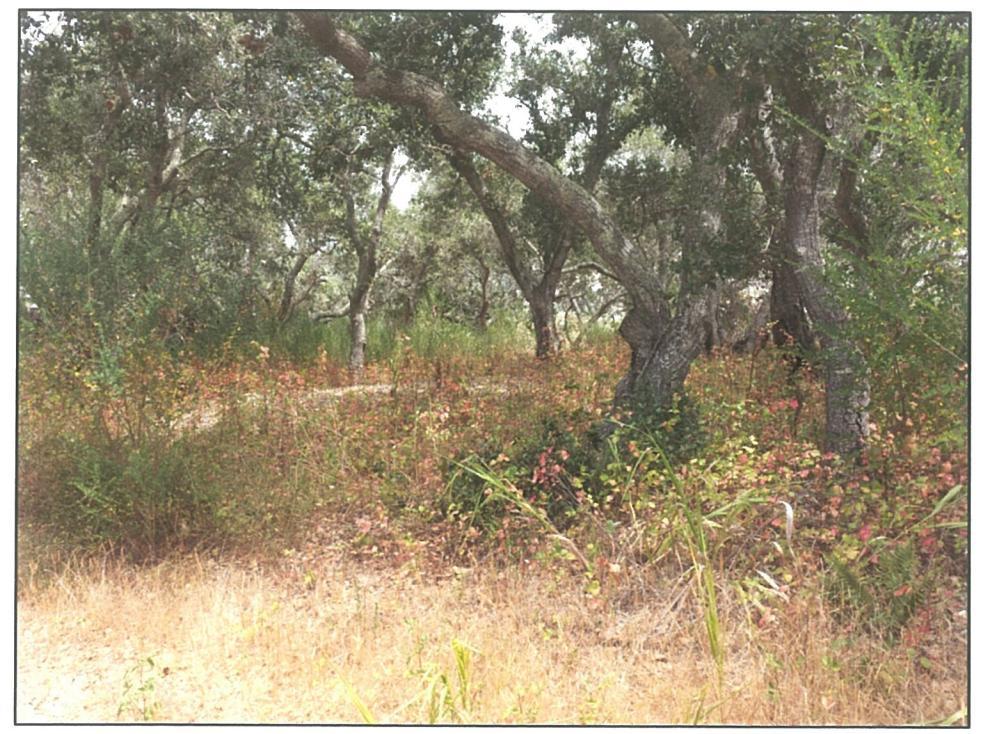
Figure 8 – Sprouts of tree stump #22 in lower center of photograph (August 2, 2017).

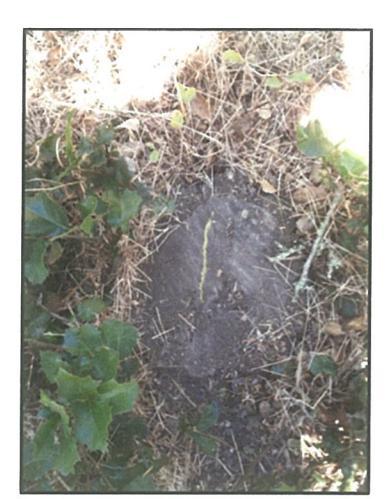
Tree 1 – hole in center

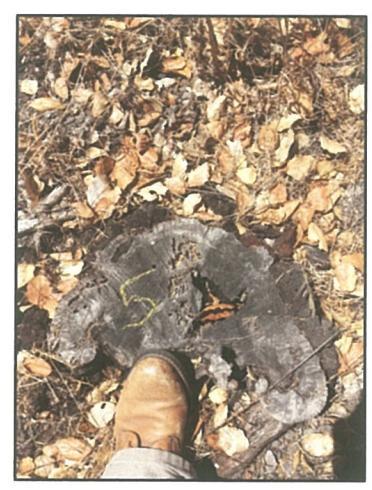
Tree 5 – multiple holes

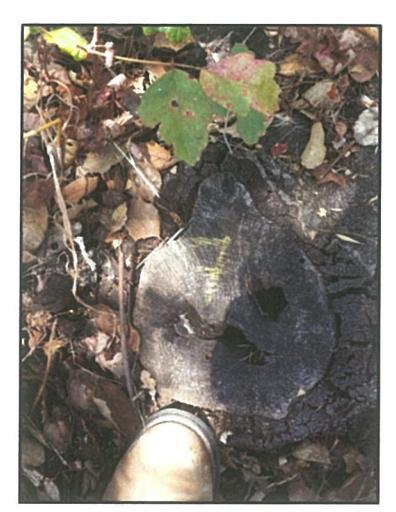
Tree 7 – multiple holes

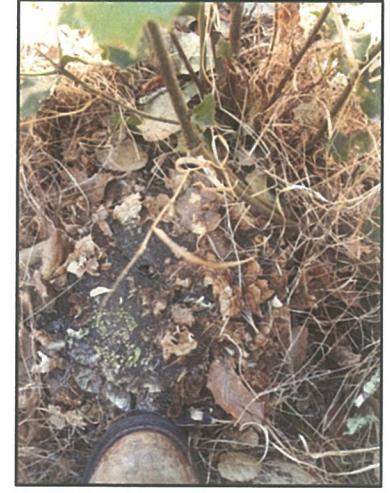
Tree 8 – decay fungus

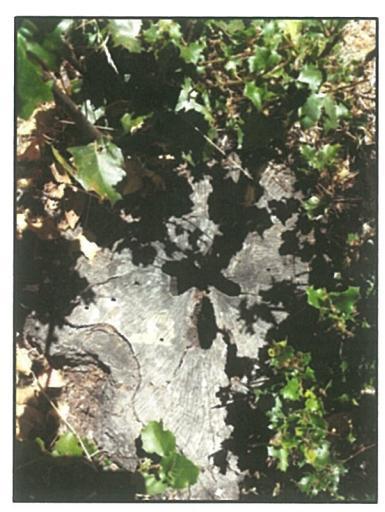
Tree 9 – big holes in center

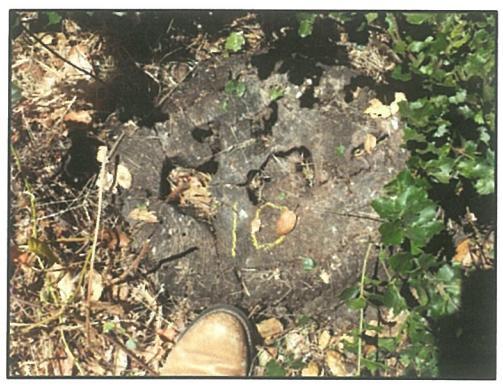
Tree 10 – large cavities in center

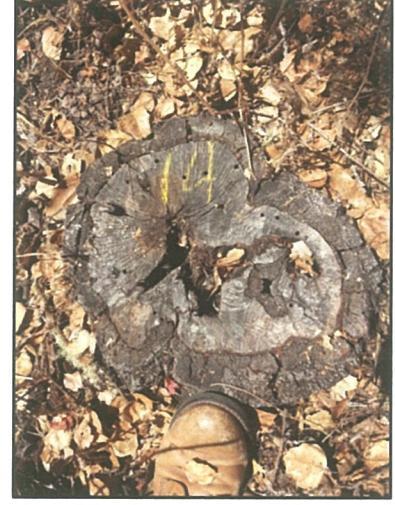
Tree 14 – heart rot and holes

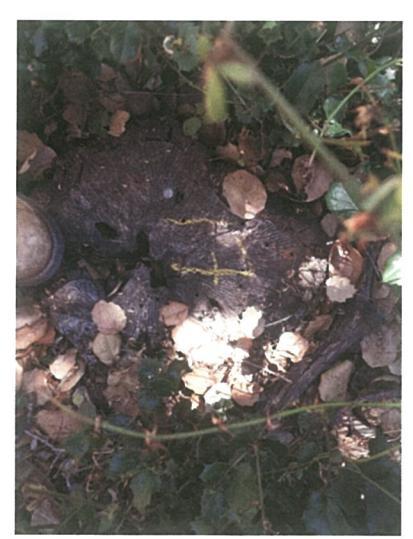
Tree 17 – heart rot and holes

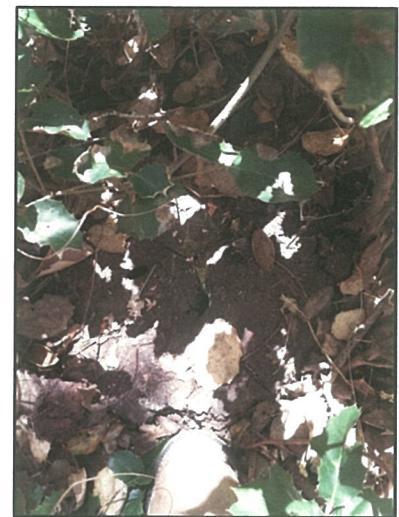
Tree 20 – holes

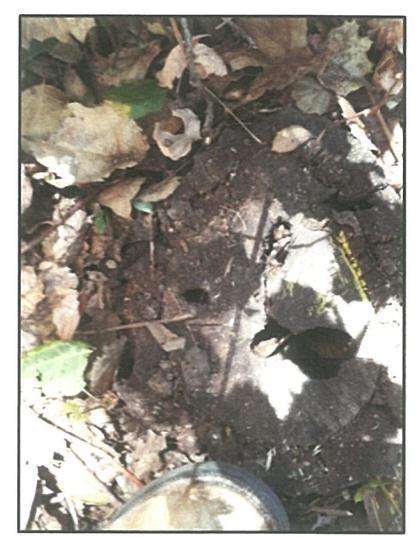
Tree 21 – holes

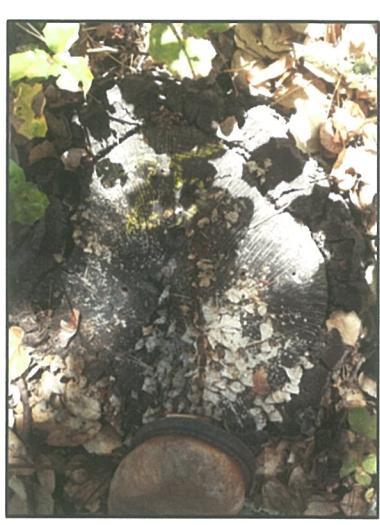
Tree 25 – decay fungus

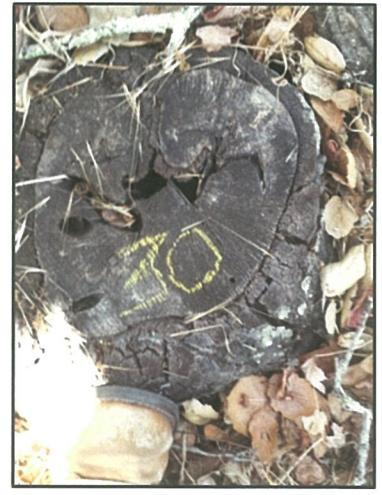
Tree 30 – holes

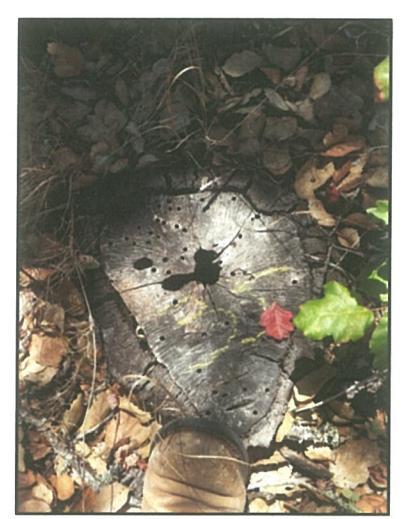
Tree 35 – termite damage

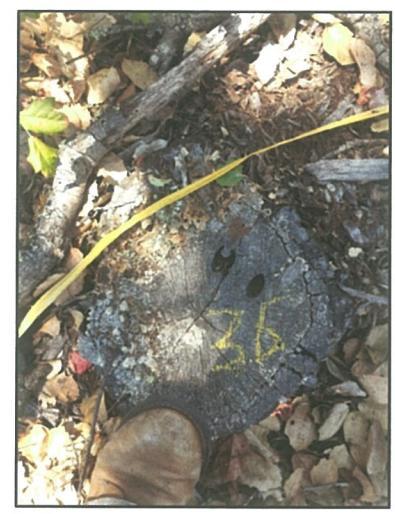
Tree 36 – decay fungus

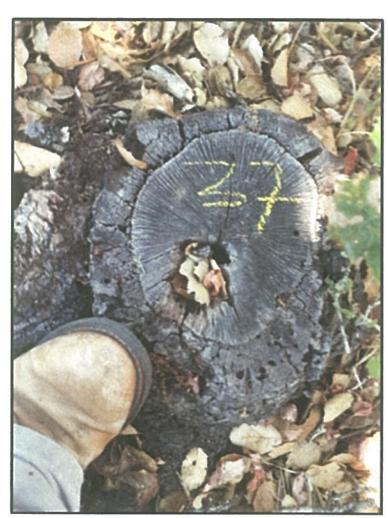
Tree 37 – big hole

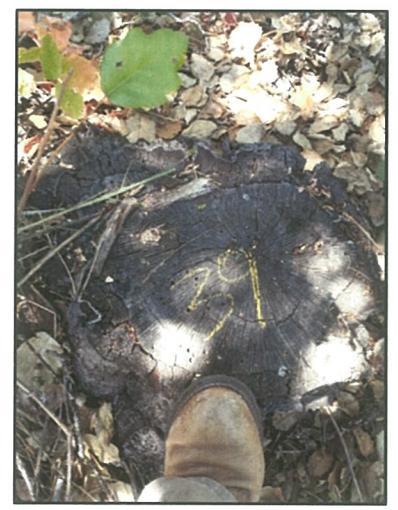
Tree 39 – termite damage
