Mendoza Residence
17090 Wallace Court Aromas, CA
Tree Resource Assessment

Frank Ono
Urban Forester
Member Society of American Foresters #48004
ISA Certified Arborist #536

September 6, 2016

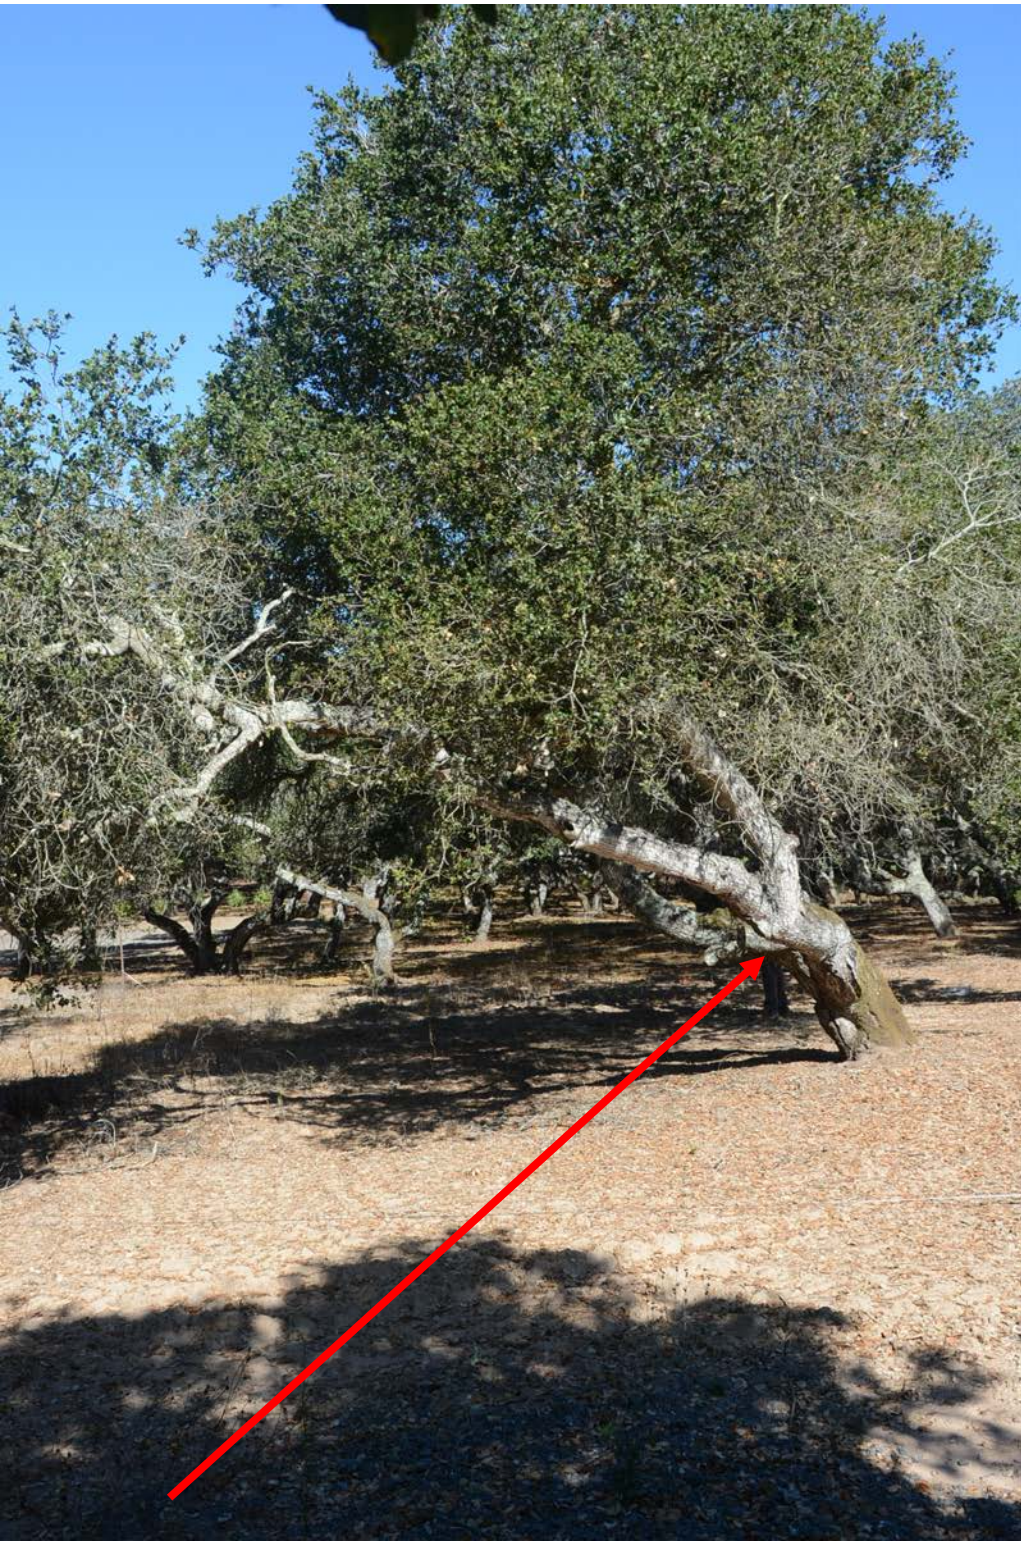
Tree #896

- #896 – 22” diameter tree with the stem cracked and splitting open
 - #897 – 17” diameter tree with decay at the base
- One tree is located near the edges of the construction envelope and may need root pruning. Tree #884 may have its root zone encroached, however root loss will be minimal and it is expected that the tree will not be affected negatively; the tree is expected to satisfactorily survive construction.

ID#	Diameter	Species	Condition	Remove	Comments
881	9"	Coast Live oak	Fair		
882	8"	Coast Live oak	Fair		
883	14"	Coast Live oak	Fair/Poor		Sunscald
884	9", 15", 18"	Coast Live oak	Fair/Poor		3 Stems and Sunscald
885	10" 13", 18"	Coast Live oak	Fair/Poor		4 Stems and Sunscald
886	24" Cluster	Coast Live oak	Fair/Poor		3 Stems and Sunscald
887	24"	Coast Live oak	Fair		
888	12"	Coast Live oak	Fair		
889	16"	Coast Live oak	Fair		
890	24" Cluster	Coast Live oak	Fair		4 Stems
891	15"	Coast Live oak	Fair		
892	13", 15"	Coast Live oak	Fair/Poor		Sunscald
893	12", 20"	Coast Live oak	Fair/Poor		South limb is leaning over the and Sunscald
894	24"	Coast Live oak	Fair		
895	15"	Coast Live oak	Fair/Poor		Topped and Sunscald
896	22"	Coast Live oak	Poor	X	Stem is cracking at the base
897	17"	Coast Live oak	Poor	X	Decay at the base of stem

Two trees are to be removed (#896 and #897) which are within the building envelope. The site may sustain additional oak replanting, therefore it is recommended replanting be with five gallon size or larger Coast live oak in locations near or adjacent the removed trees. In addition, the County also requires independent monitoring of replanted trees to insure replanting is successful (the term of monitoring is at County discretion, typically one –three years dependent on the type of permit). Remaining trees are outside the construction envelope and to be protected from construction impacts.
