Project Number M11771

8 June 2020

Subject: Cypress Point Fault Study and Focused Geologic Report

Reference: Proposed New Residence  
APN 009-422-023  
26195 Scenic Road, Carmel, CA 93923  
Monterey County, California

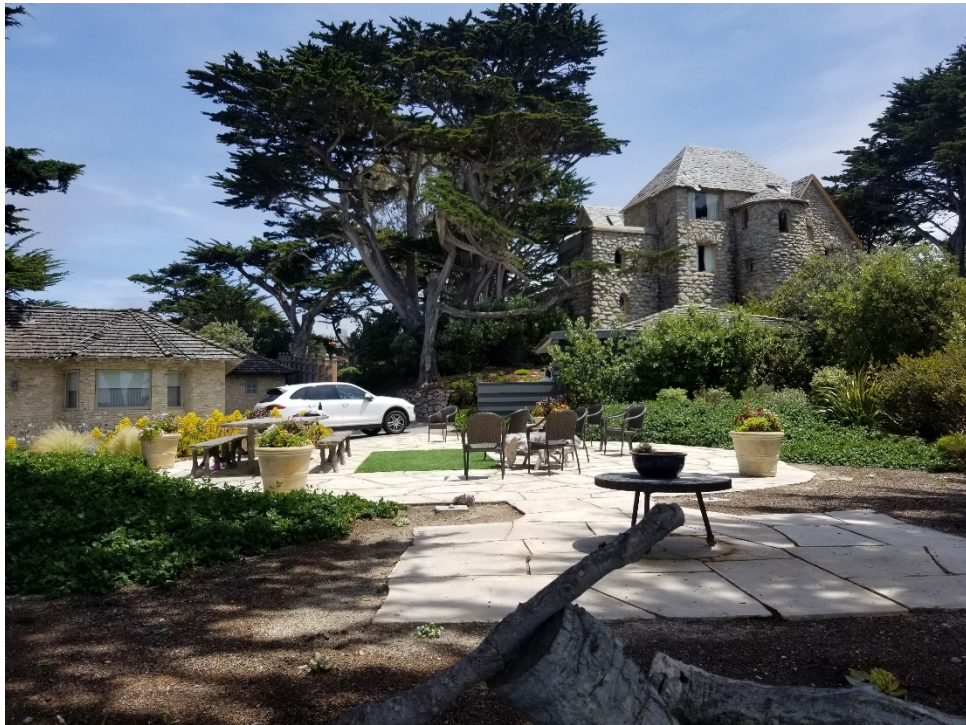
The coastal terrace the site is located on slopes gently seaward and the proposed home is located at an elevation of approximately 25 feet NAVD88. Photograph 1 shows the building site:

**Photograph 1: Proposed Building Site**

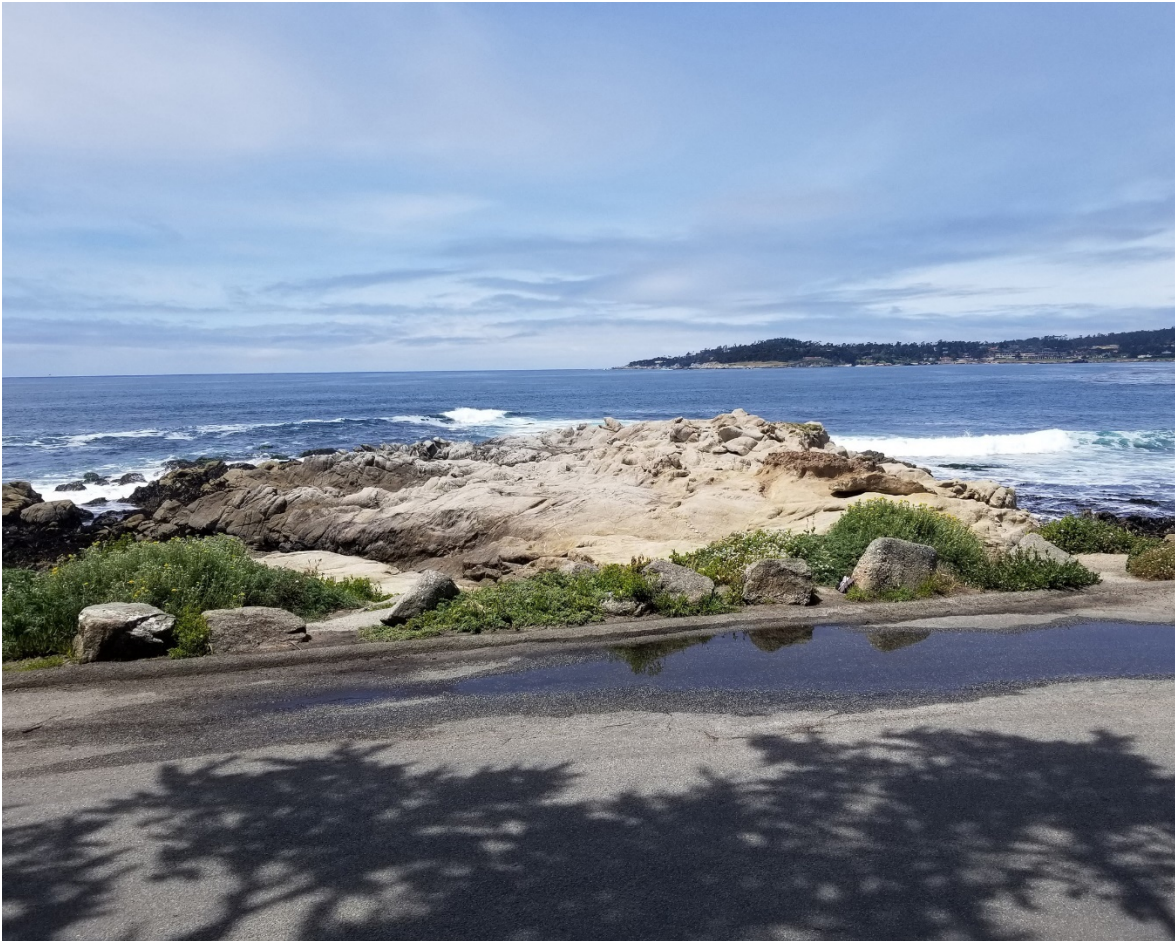
Massive areas of granitic bedrock are exposed in outcrops along the shoreline seaward of the proposed home.

**Photograph 2: Massive Granite Bedrock Outcrops Seaward of Site**

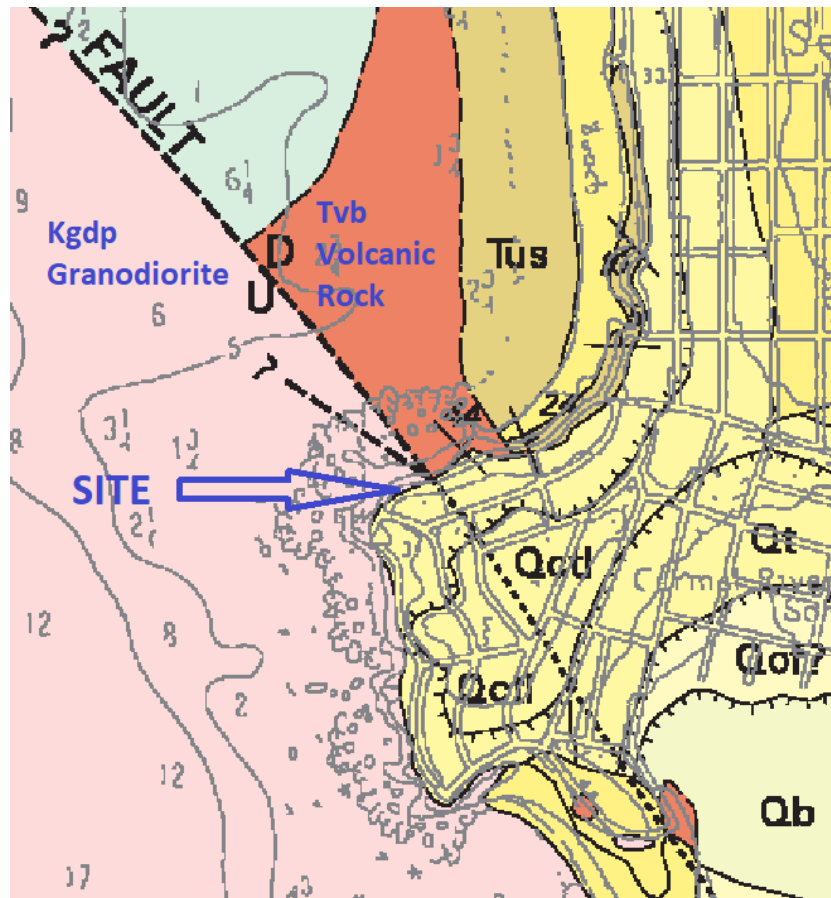
The Cypress Point Fault Zone is shown on the map in close proximity to the proposed home. It juxtaposes Oligocene age volcanic rocks (Tvb) against Cretaceous age porphyritic granodiorite (Kgdg). Figure 3 shows a closeup of the geologic map in the vicinity of the proposed home.

Figure 3: US Geological Survey Regional Geologic Map  
In the Vicinity of the Proposed Home

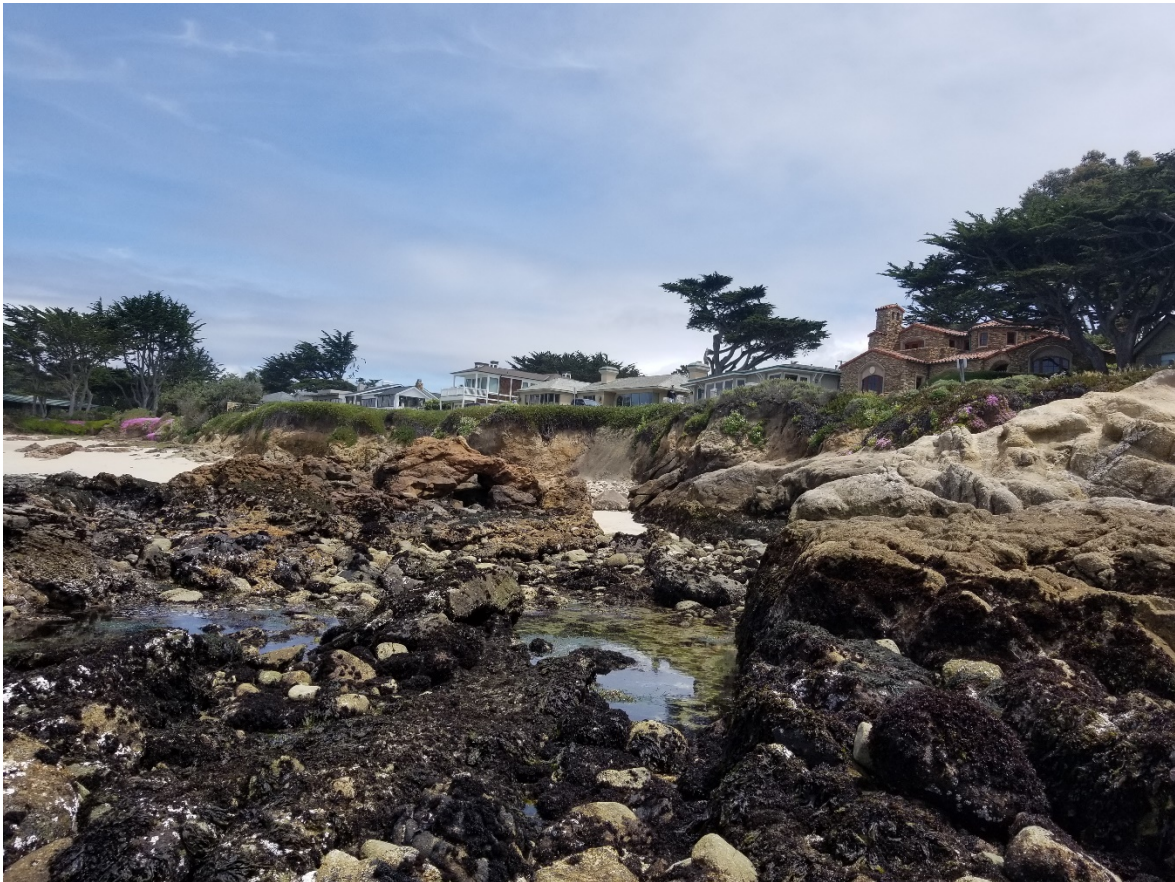
We visited Carmel Point at low tide and easily identified the location of the fault. Shotcrete that has been placed on the bluff face to retard coastal erosion covers much of the fault zone there, but the fault zone is visible by the change in geology in the tidelands. Photograph 3 below was taken looking inland along the alignment of the Cypress Point Fault.

**Photograph 3: Looking Inland Along the Trend of the Downcoast Edge of the Cypress Point Fault**

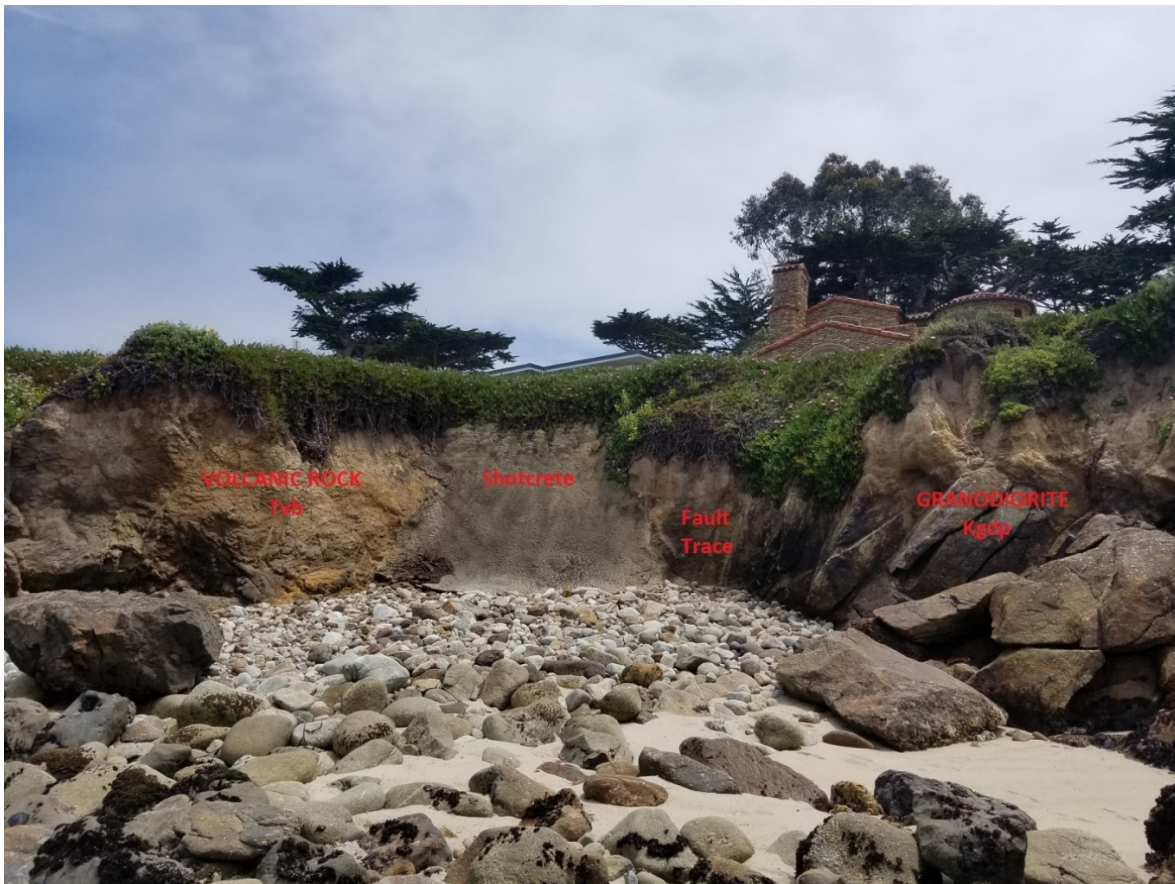
The actual fault is covered by beach sediments consisting of sand and cobbles. Granodiorite bedrock outcrops are visible to the right and volcanic rock outcrops are visible to the left. Another trace of the Cypress Point Fault is located further upcoast.

**Photograph 4: Bluff Face at the Cypress Point Fault Zone**

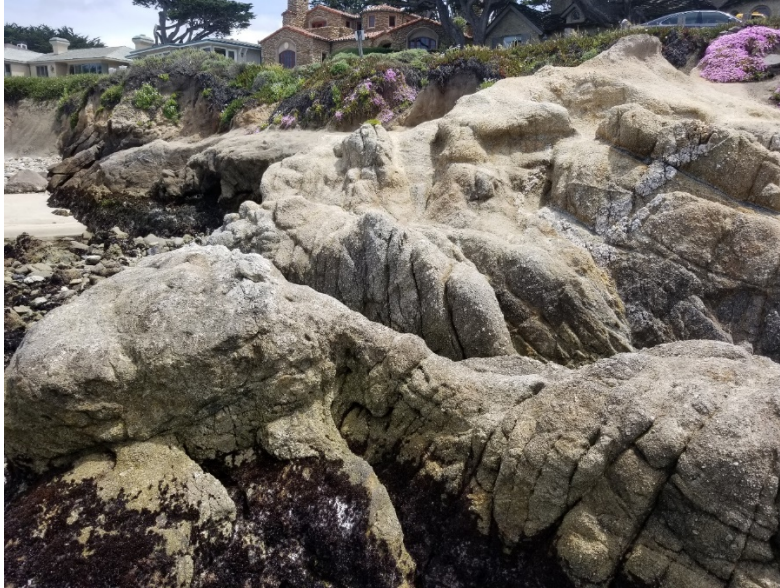
**Photograph 5: Granodiorite Immediately Downcoast of the Cypress Point Fault**

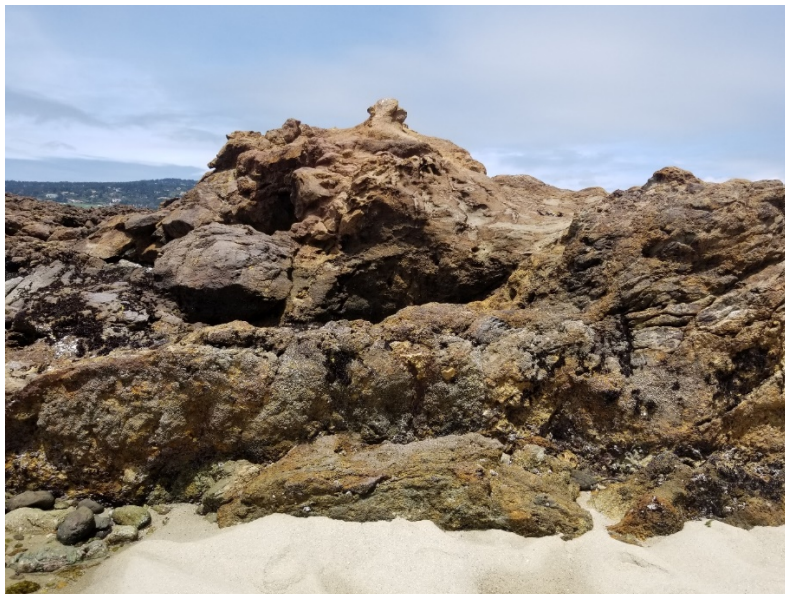
**Photograph 6: Volcanic Rock Immediately Upcoast of the Cypress Point Fault**

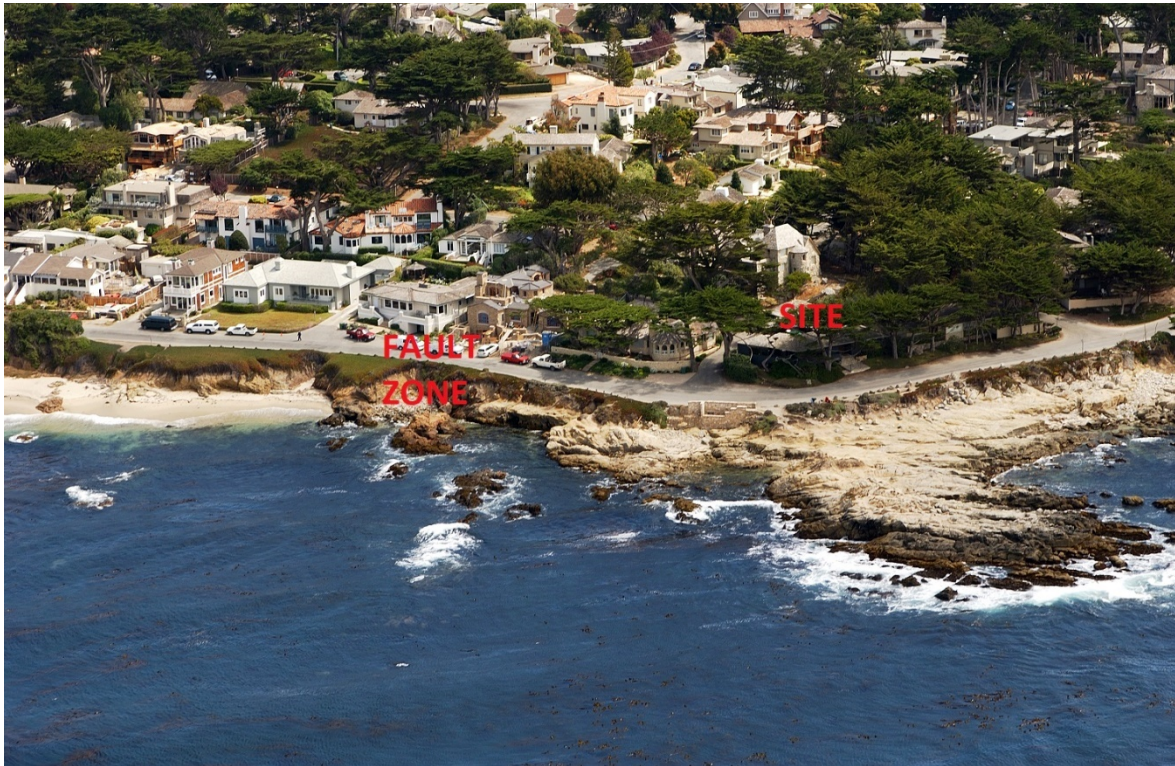
the proposed home. Where exposed in the coastal bluff face, the closest portion of the Fault Zone is approximately 200 feet from the property line of the property where the home is proposed. Photograph 7 shows a 2002 Photograph depicting the proximity of the Cypress Point Fault Zone to the Building Site.

**Photograph 7: Cypress Point Fault Zone and Building Site Locations  
(2002 photo courtesy of [www.californiacoastline.org](http://www.californiacoastline.org))**

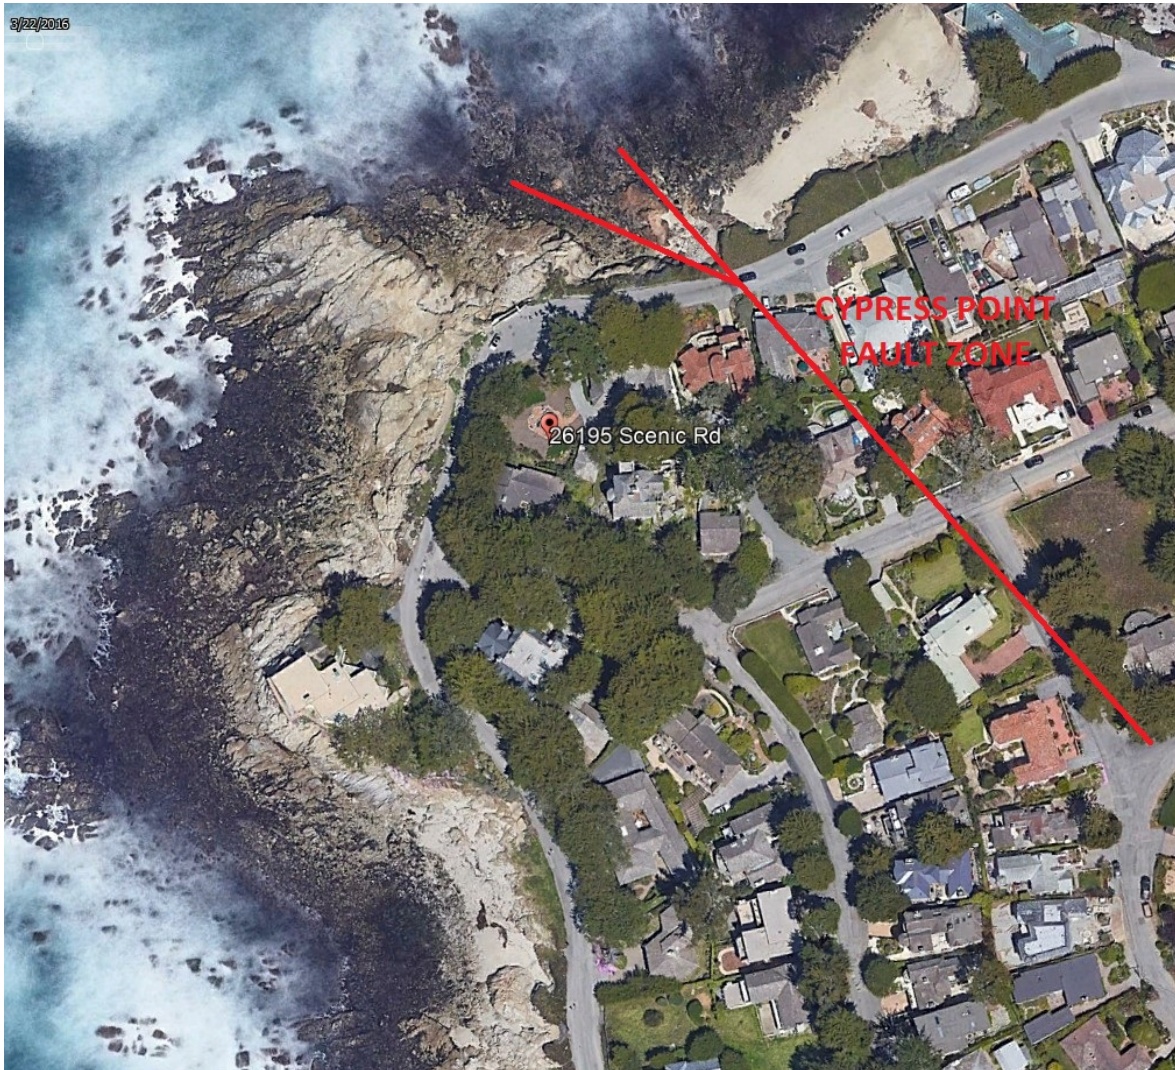
Photograph 8 is a 2016 Google Earth satellite image depicting the proximity of the Cypress Point Fault Zone to the Building Site at 26195 Scenic Road. At the closest point, the mapped Cypress Point Fault is more than 150 feet from the Building Site.

**Photograph 8: Cypress Point Fault Zone and Building Site at 26195 Scenic Road (2016 satellite image courtesy of Google Earth)**

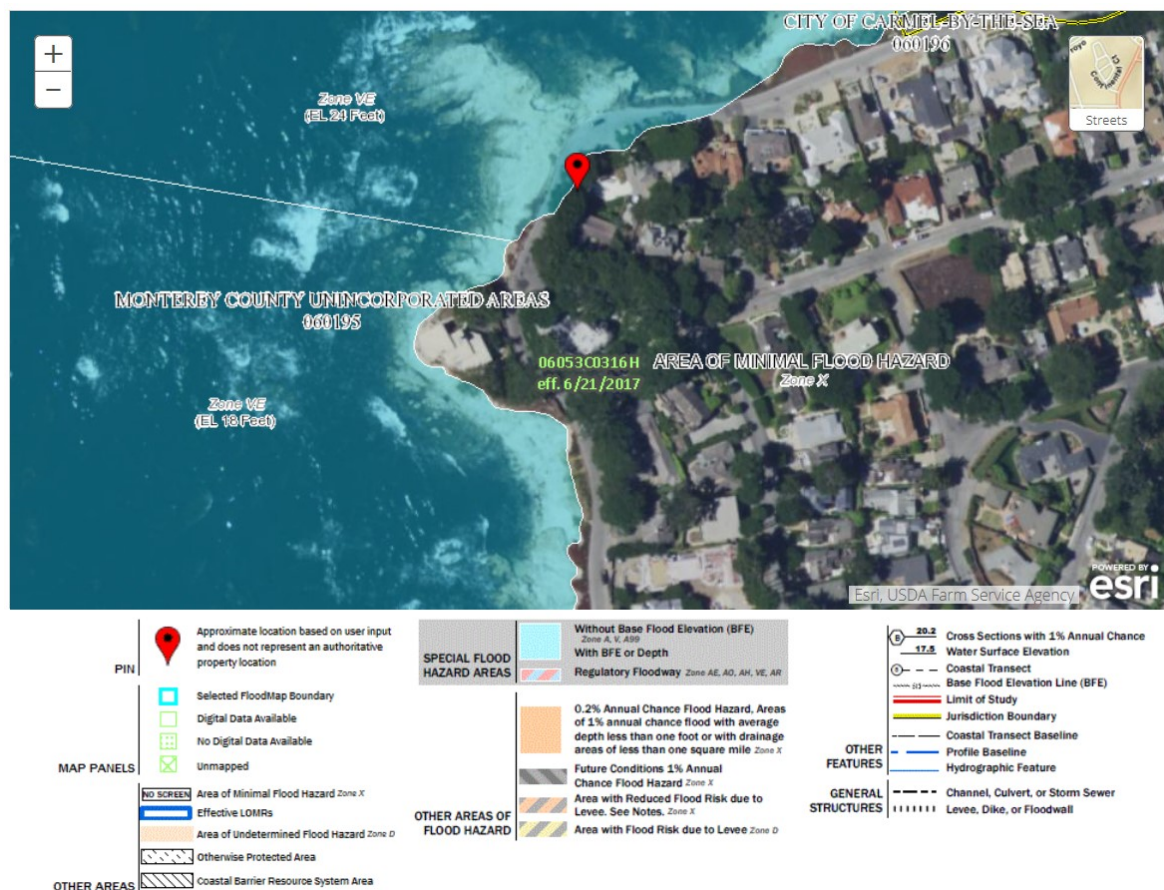
Elevation of +24 feet NAVD88 extends onto the seaward portion of the property at 26195 Scenic Road, as shown in Figure 3 below. Zone VE is an area subject to inundation by the 1-percent-annual-chance flood event with additional hazards due to storm-induced velocity wave action. Areas of the property below an Elevation of +24 feet NAVD88 are in this Special Flood Hazard Area. We note that the surveyed lowest adjacent grade to where the proposed home will be located is about +26 feet NAVD1988 elevation which is 2 feet higher than the FEMA Base Flood Elevation. The existing home is landward of the depicted FEMA 100 year flood zone.

7. There is a potential flood hazard at the seaward portion of the property. The flood elevation has been determined by FEMA as 24 feet using the NAVD 1988 Vertical Datum. As mapped by FEMA on the map shown in Figure 3, and based on the elevations shown on the topographic map prepared by Central Coast Surveyors, the flood hazard zone is seaward of the proposed home

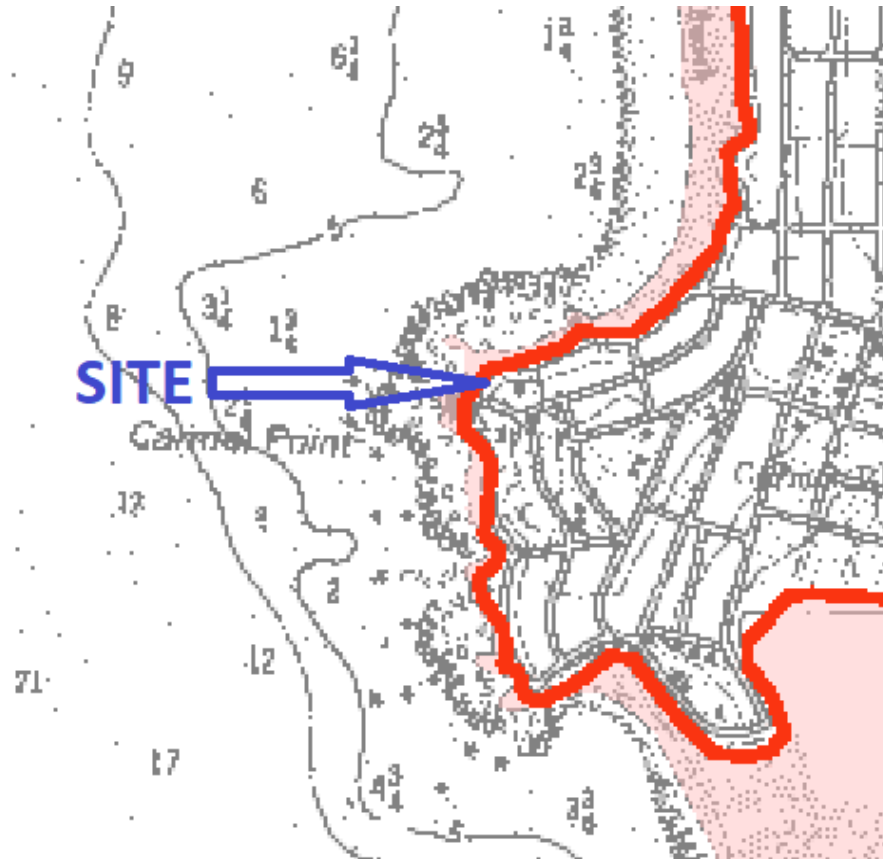
California Emergency Management Agency, California Geological Survey and University of Southern California. A partial copy of that map is shown below in Figure 4, and shows the inland edge of the inundation zone is mapped at the inland edge of Scenic Road. It is possible that ocean wave runup will inundate Scenic Road during extreme storms. The frequency with which inundation occurs will increase as sea level rises in the future.

**Figure 4: Monterey County Tsunami Inundation Map**

8. There is a potential tsunami hazard along Scenic Road. As mapped by the California Emergency Management Agency, California Geological Survey and University of Southern California, and based on the map shown in Figure 4, the tsunami hazard zone is seaward of the proposed home.

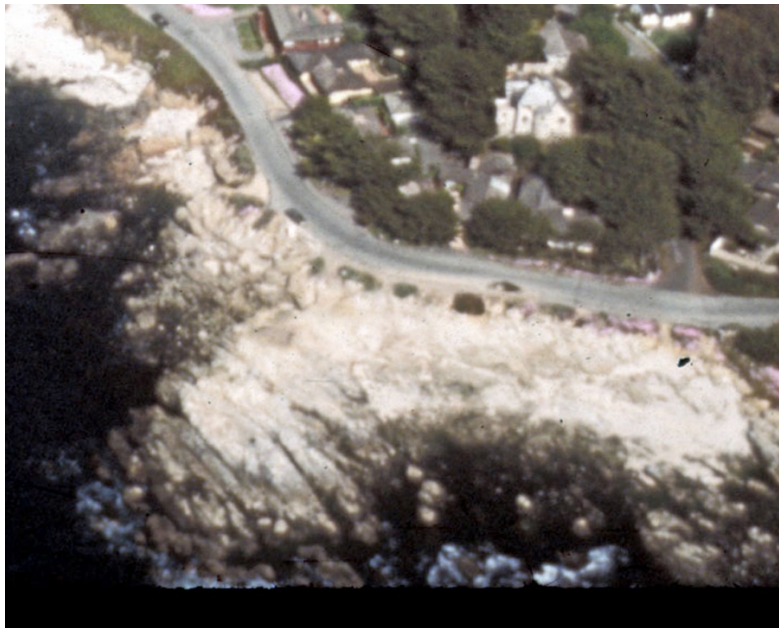
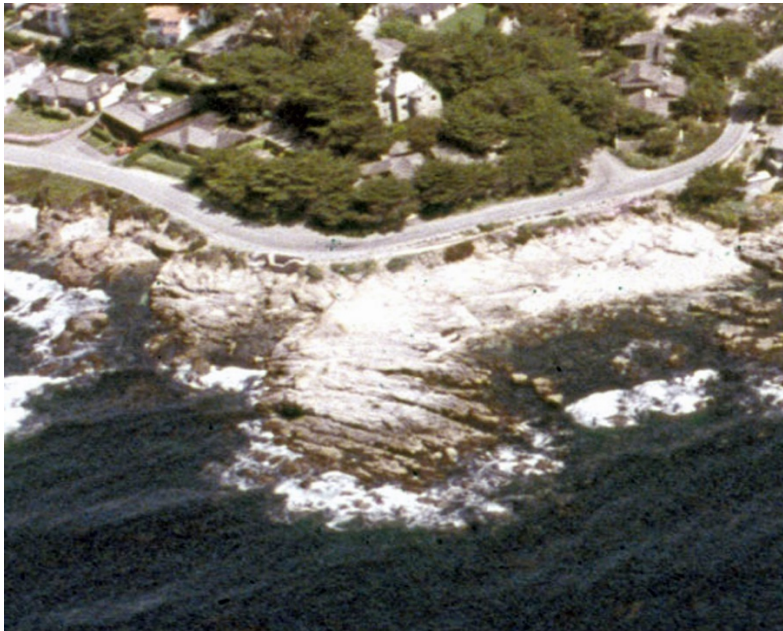
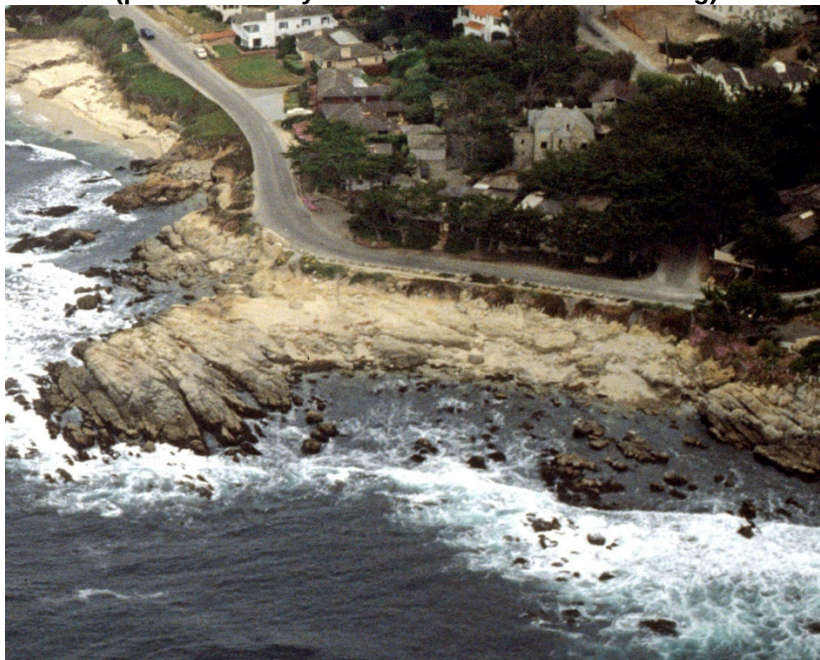
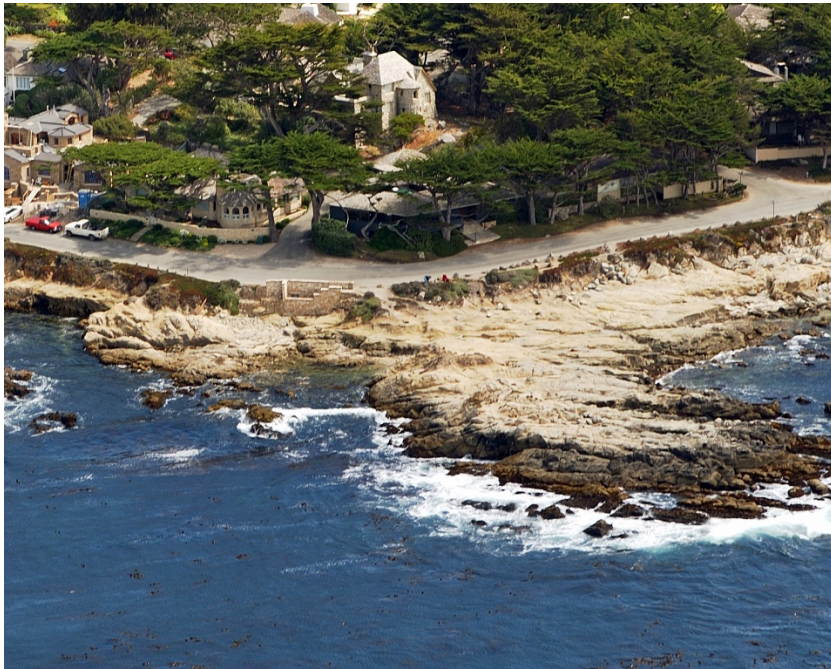
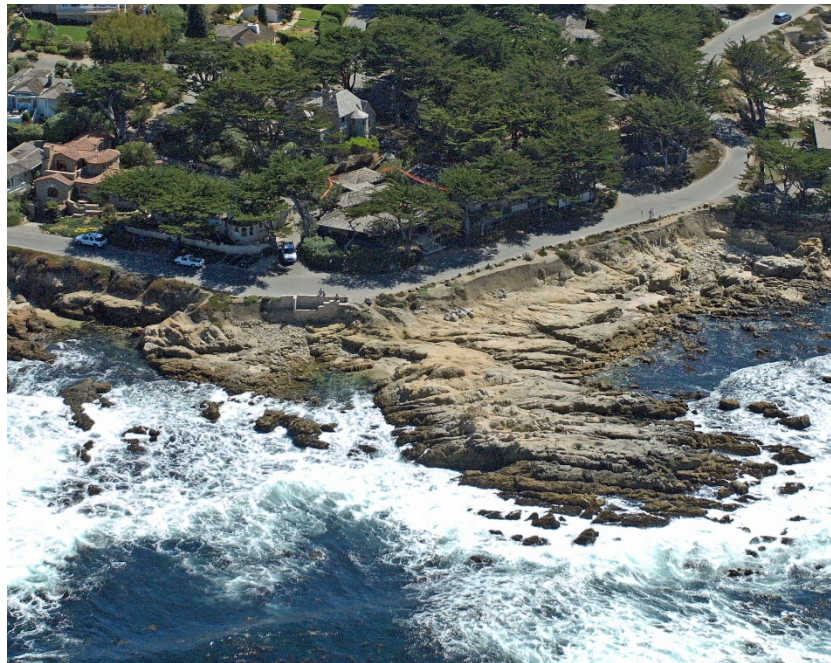
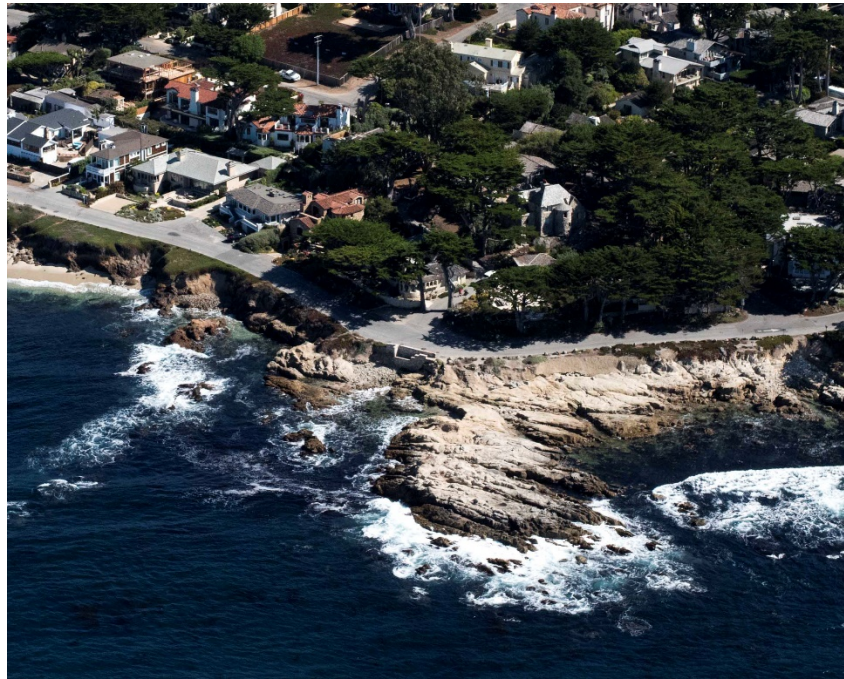
obtained from [www.californiacoastline.org](http://www.californiacoastline.org) revealed there has been relatively little discernible change in the bluff edge and terrain seaward of Scenic Drive in that 47 year period. We attribute the relatively low amount of discernible erosion to the competence of the granodiorite and the prominent broad bedrock outcrop that forms Carmel Point immediately seaward of Scenic Drive and the proposed home. Copies of 1972, 1979, 1987, 2002, 2008 and 2019 oblique aerial photographs obtained from the California Coastal Records Project ([wwwcaliforniacoastline.org](http://www.californiacoastline.org)) are shown below.

Our review of these oblique aerial photographs revealed there has been relatively little erosion and retreat of the bluff edge and terrain seaward of Scenic Drive in that 47 year period. We attribute the relatively low amount of erosion and slow bluff retreat to the competence of the granodiorite and the prominent broad bedrock outcrop that forms Carmel Point immediately seaward of Scenic Drive and the proposed home.
