Arborist Report
Fang & Lui Residence
2897 17 Mile Dr., Pebble Beach Ca

Prepared for:
Fang Fang

Prepared by:
Prepared by:
Andrew Tope
Board Certified Master Arborist WE-7621A
Tree Risk Assessor Qualified
P.O. Box 223436
Carmel, Ca 93922

December 26, 2024

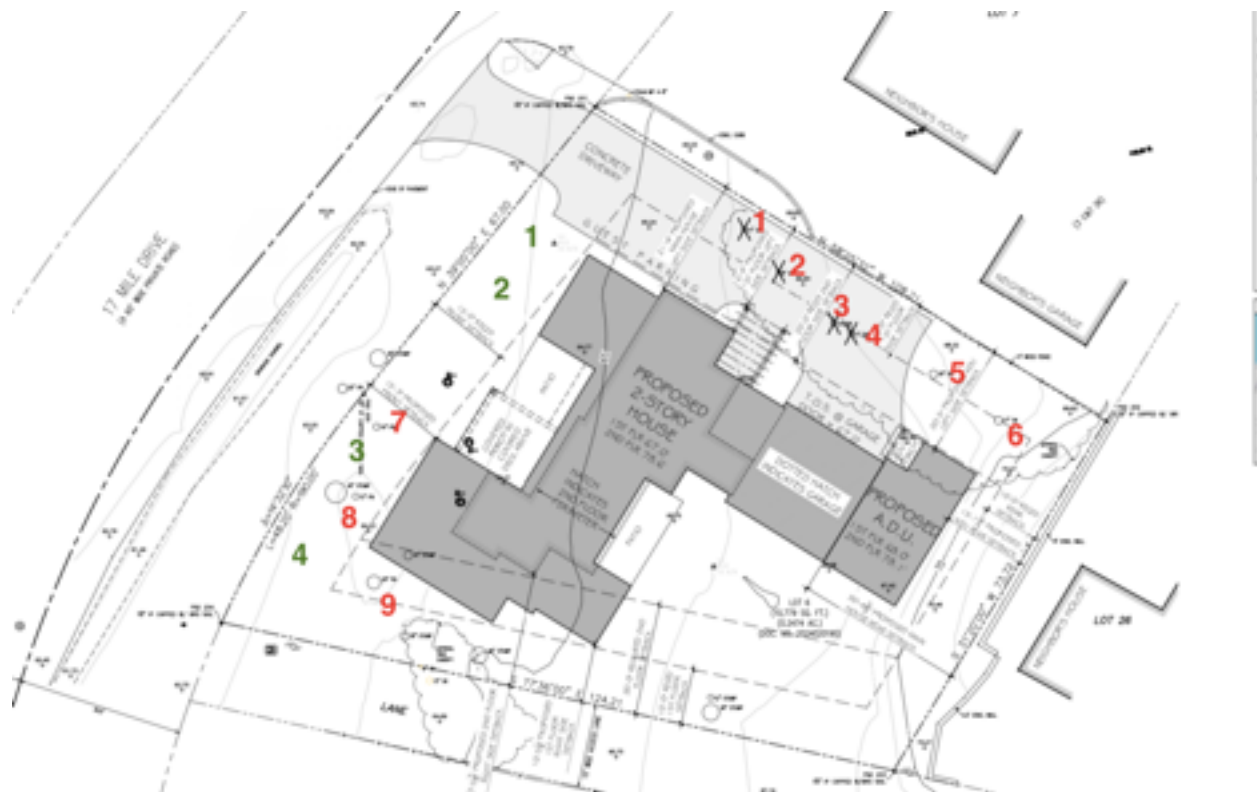
Image 1: Site map. Red numbers are the trees inventoried. Green numbers are the potential locations of the replanting sites. Final replanting locations should be determined on the landscape plan.

Replanting should take place at a 1 for 1 ratio for trees 24 inches and smaller and 2 for 1 ratio for trees 25 inches and larger. In total Plant 4, 24inch box or larger California Live Oaks. These should be planted close to areas indicated on the site map. Trees shall be planted making sure the root ball is equal to or slightly higher than the surrounding soil height. Mulching the area around the newly planted tree will help keep soil moist and provide nutrients to the tree.

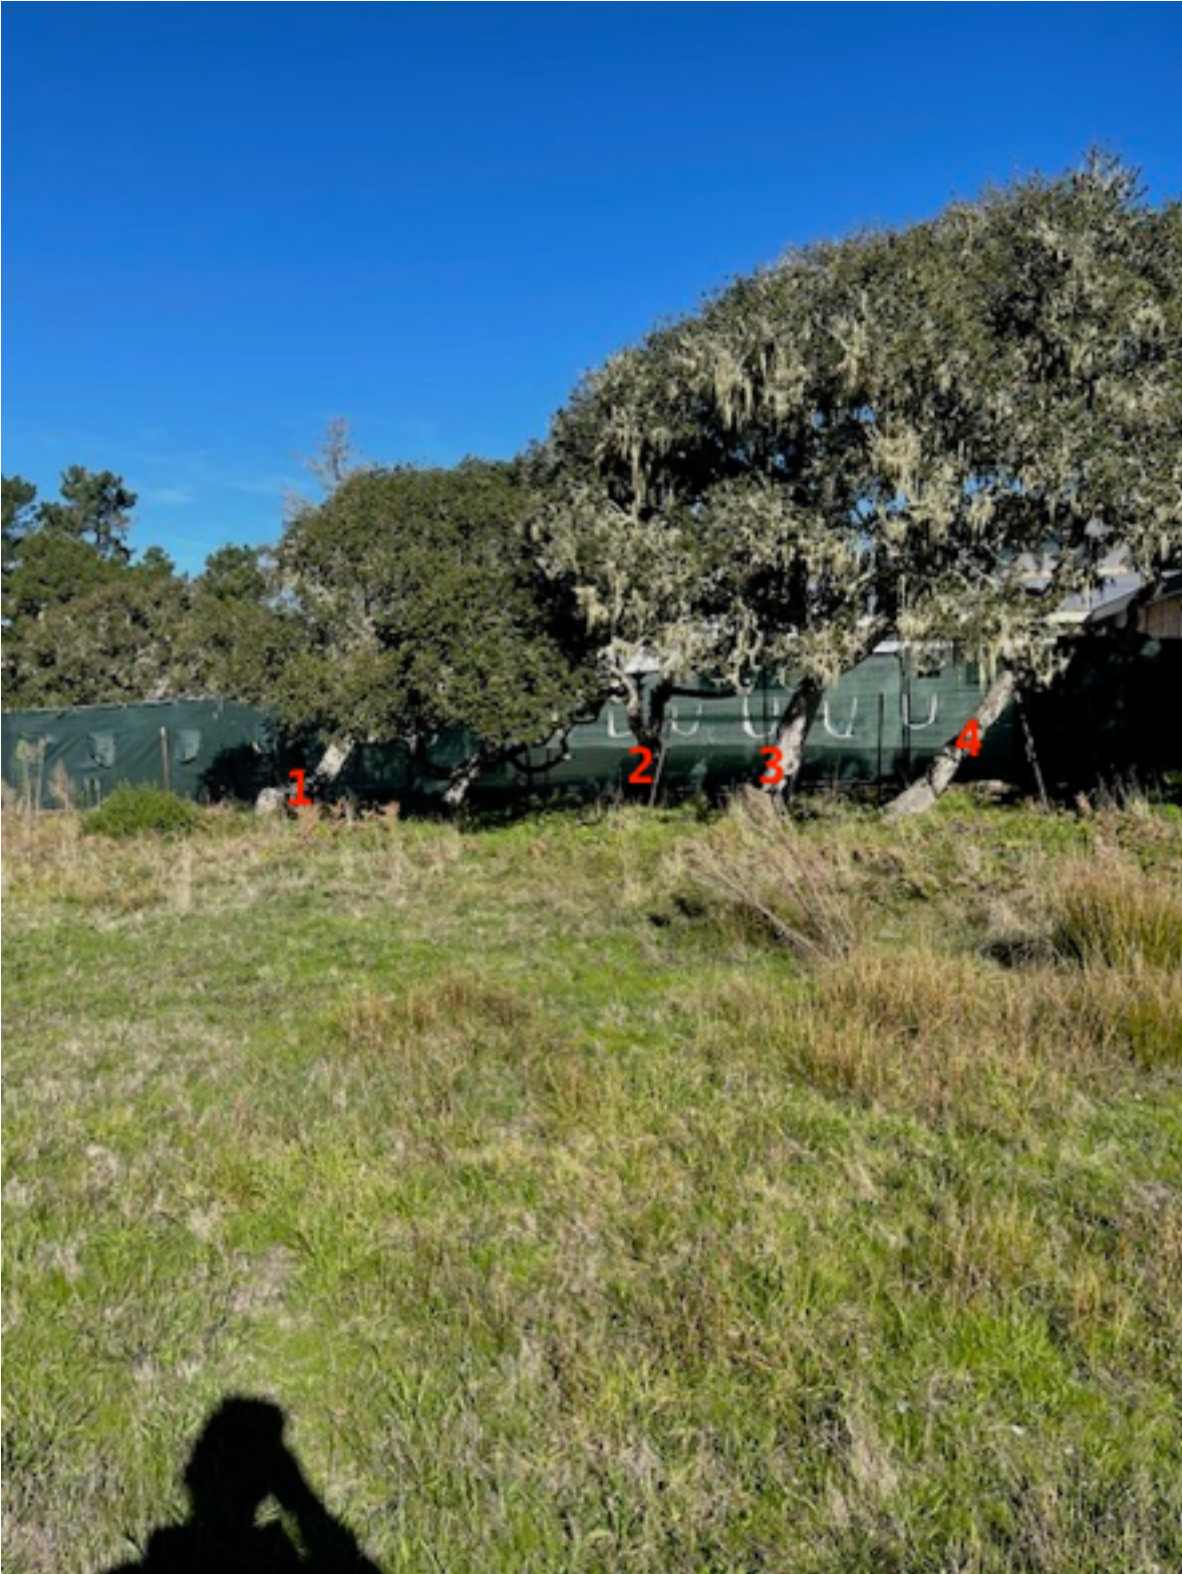
Image 2. Trees 1-4.

ID #	Species	DBH	Condition	Recommendation	Notes
1	Oak	11	Moderate	Remove	Partially uprooted, resting on #2
2	Oak	8	Moderate	Remove	Suppressed canopy, decay on trunk
3	Oak	13	Moderate	Remove	thin canopy, dieback
4	Oak	11	Moderate	Remove	thin canopy, dieback
5	Oak	18	Moderate	Preserve	canopy cleaning needed
6	Oak	17	Moderate	Preserve	canopy cleaning needed
7	Pine	14	Moderate	Preserve	bow in trunk, monitor.
8	Pine	13	Moderate	Preserve	thinning canopy
9	Pine	29	Moderate	Preserve	unbalanced canopy

There are 4 trees (#1, 2, 3, 4) that I deemed necessary to be removed due to their location in the proposed driveway. None of these trees would be good candidates for tree relocation either due to location, structural issues, or proximity to other trees. None of the trees to be removed would be considered specimen trees, and removal of the trees would have a minimal impact on total canopy coverage of the lot. The trees should be removed by a licensed contractor with special attention taken to not damage the remaining trees or their TPZ fencing.
