Askar/Zohori  
Tree Resource Assessment  
2972 Colton Road  
Pebble Beach CA

Frank Ono  
Urban Forester  
Member Society of American Foresters #48004  
ISA Certified Arborist #536  
1213 Miles Avenue  
Pacific Grove, CA 93950

April 16, 2025

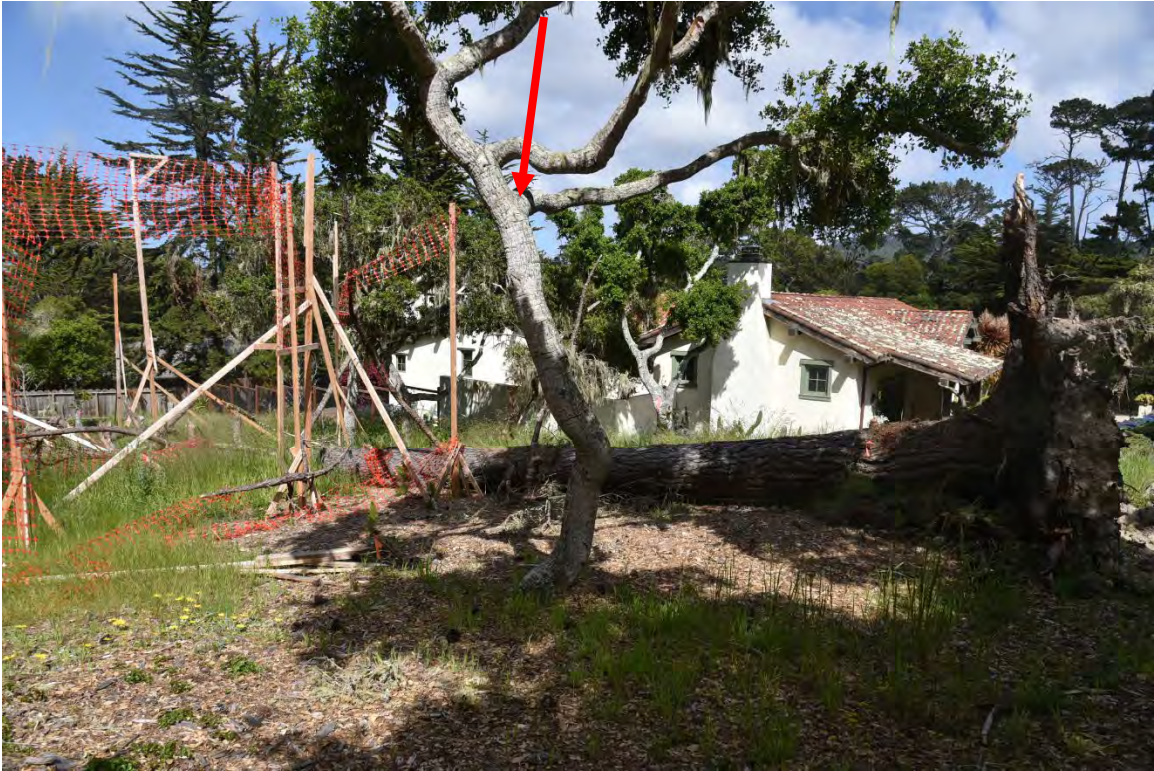
- There is a 30" diameter Monterey pine (#97) on the property that has been uprooted and will need to be removed. Judging by the tree's trunk, the tree appears to have been in poor condition before its failure.

Tree #97 has uprooted and fallen, tree #377 is in the concrete walk

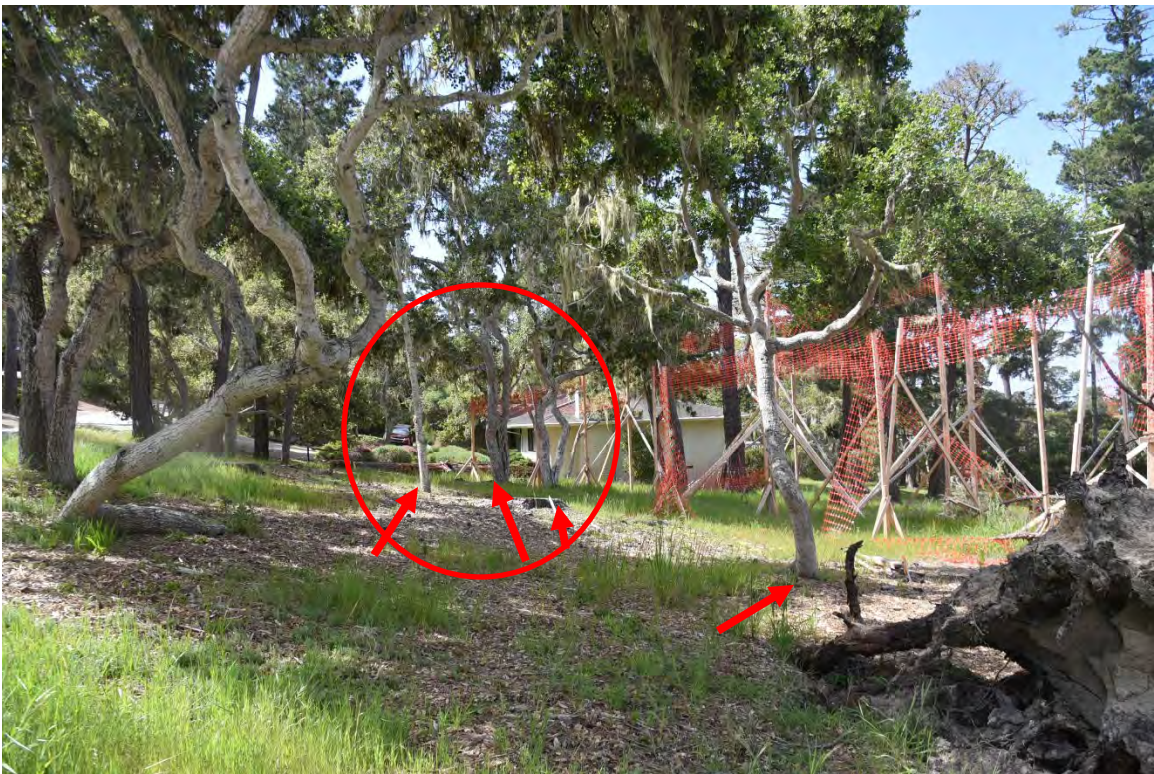
- Two oaks were found that were not indicated for removal on the site map but are affected by the design:
  - #377 is a 10" diameter oak that is located in the front yard where a concrete walk is to be installed. The tree is in fair or better condition.

Trees to be removed , #390, #391, #392, and 377

| ID# | Diameter | Species | Condition | Remove | Comments |
|---|---|---|---|---|---|
| 377 | 10 | Coast oak | Fair | x | Concrete Walk |

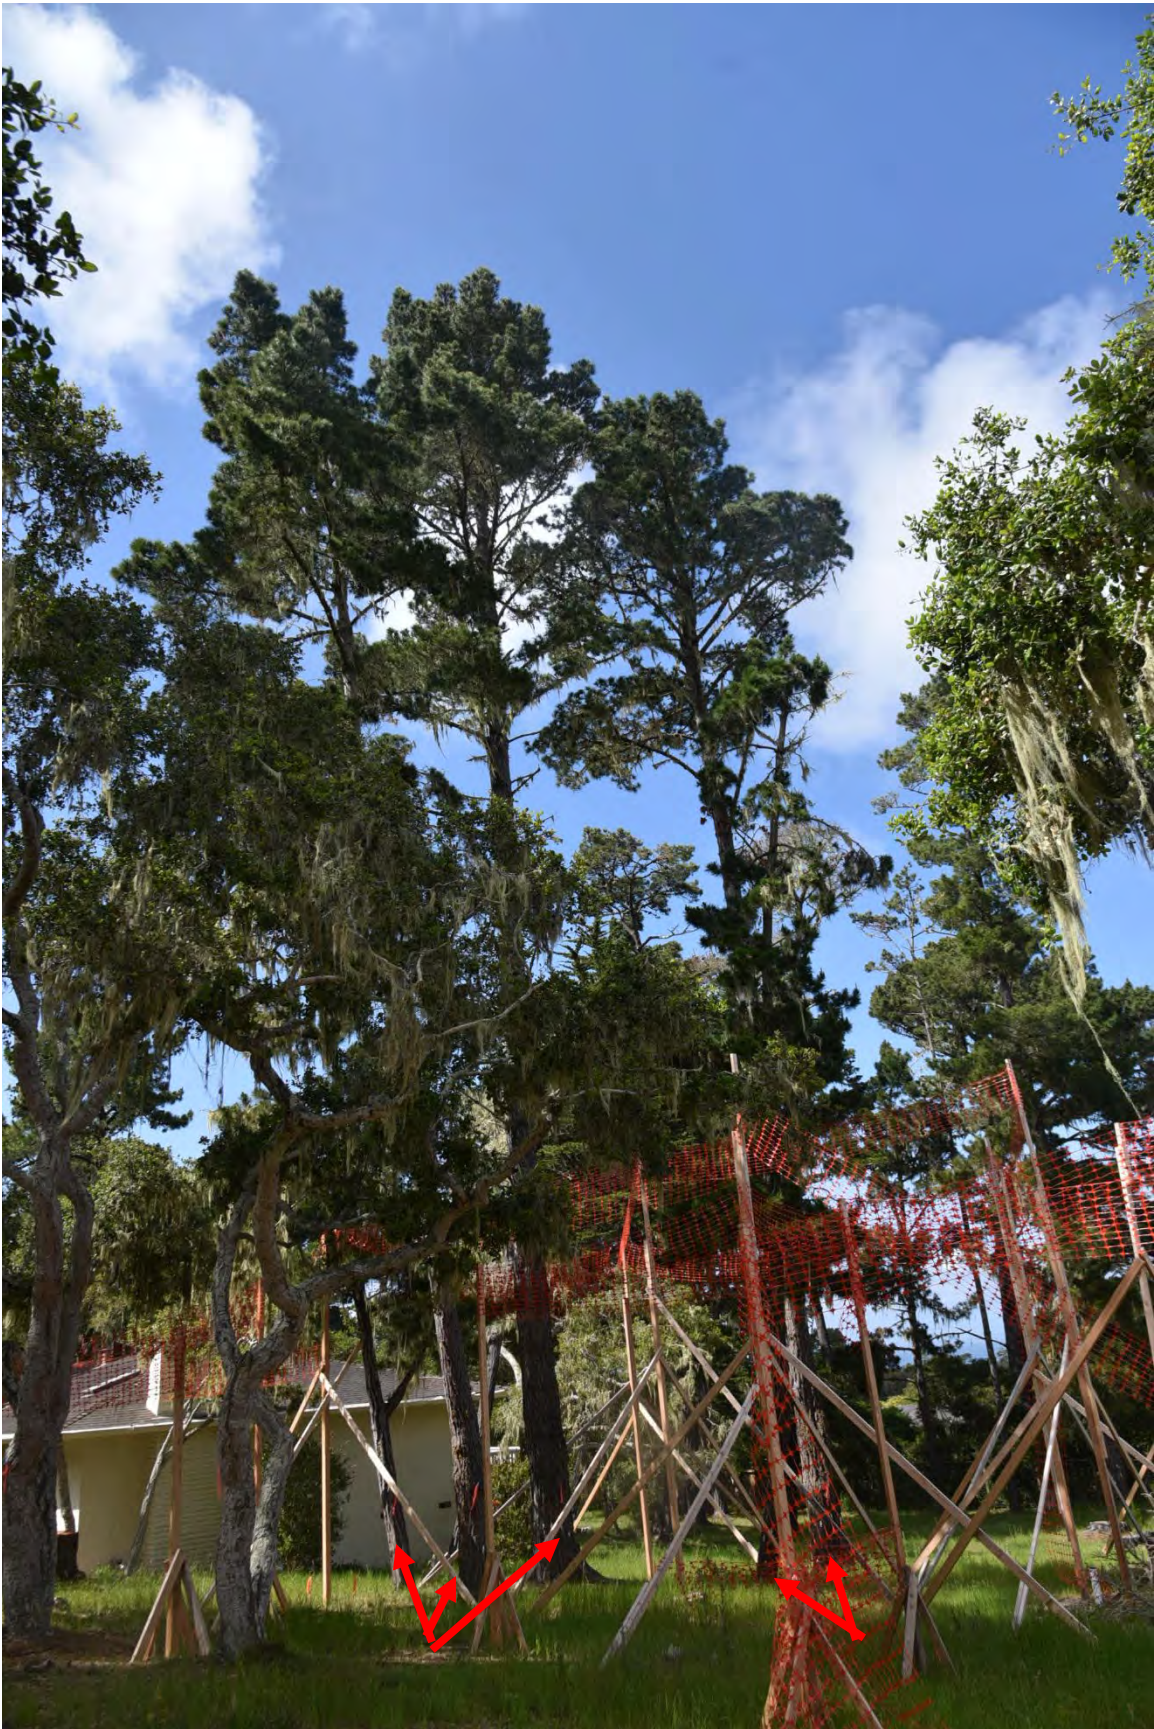
- The site map submitted shows an elaborate drainage system around the structure. This appears to incorporate several retaining walls and terracing of the soil. Grading will affect trees #377, #390-#392 because the terracing grading will require excavation into the critical root zones of these trees.

Trees #390, #391, and #392
