Beck Residence  
Tree Resource Assessment  
Construction Impact Analysis

February 4, 2025

Revised  
Beck Residence  
Tree Resource Assessment  
Construction Impact Analysis

April 8, 2026

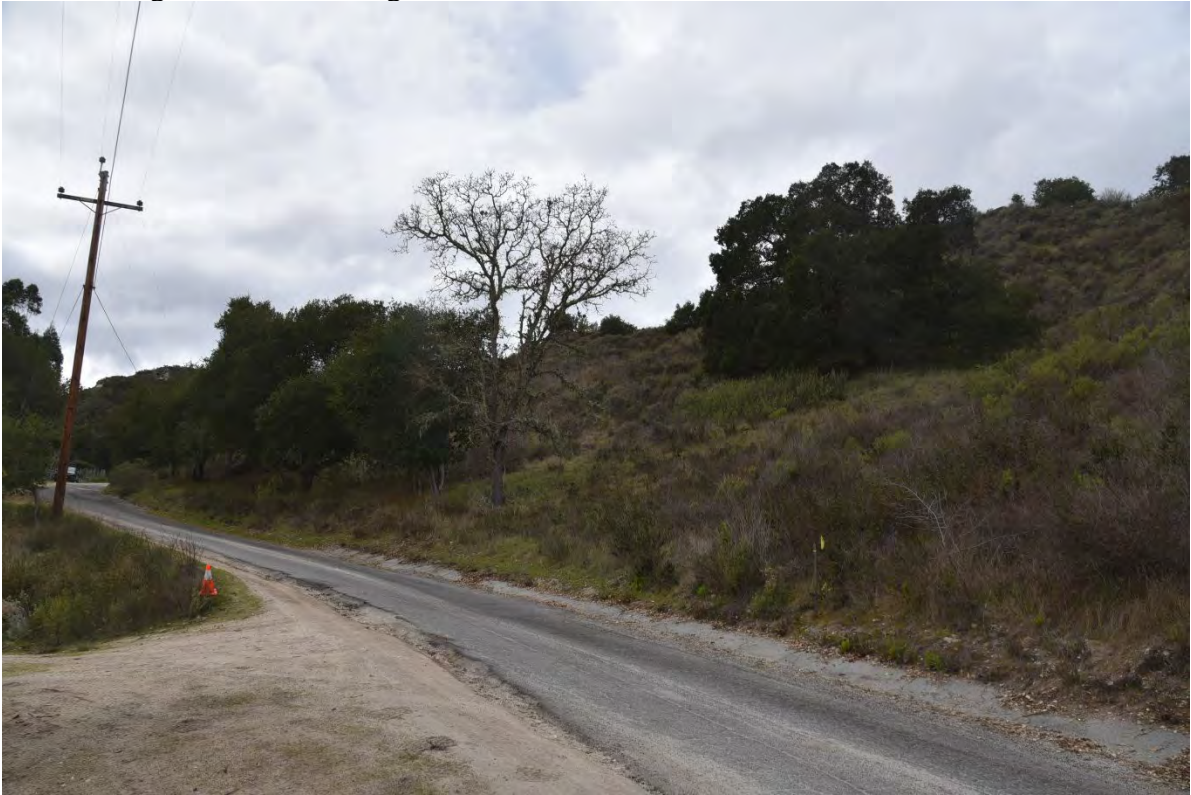
The building site, view looking to the south

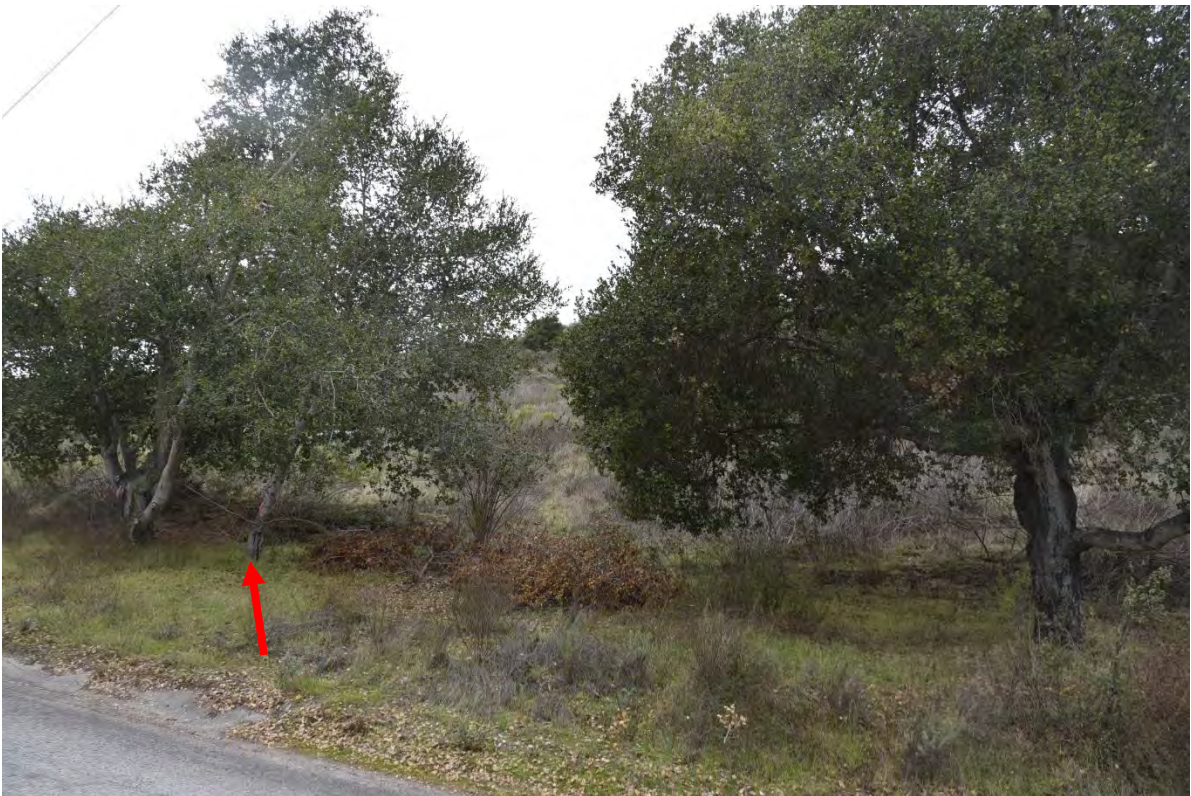
Trees #398 will be removed to access the property

One tree will need removal, #398 a 30-foot-tall 20” diameter oak, because it is within the driveway footprint.

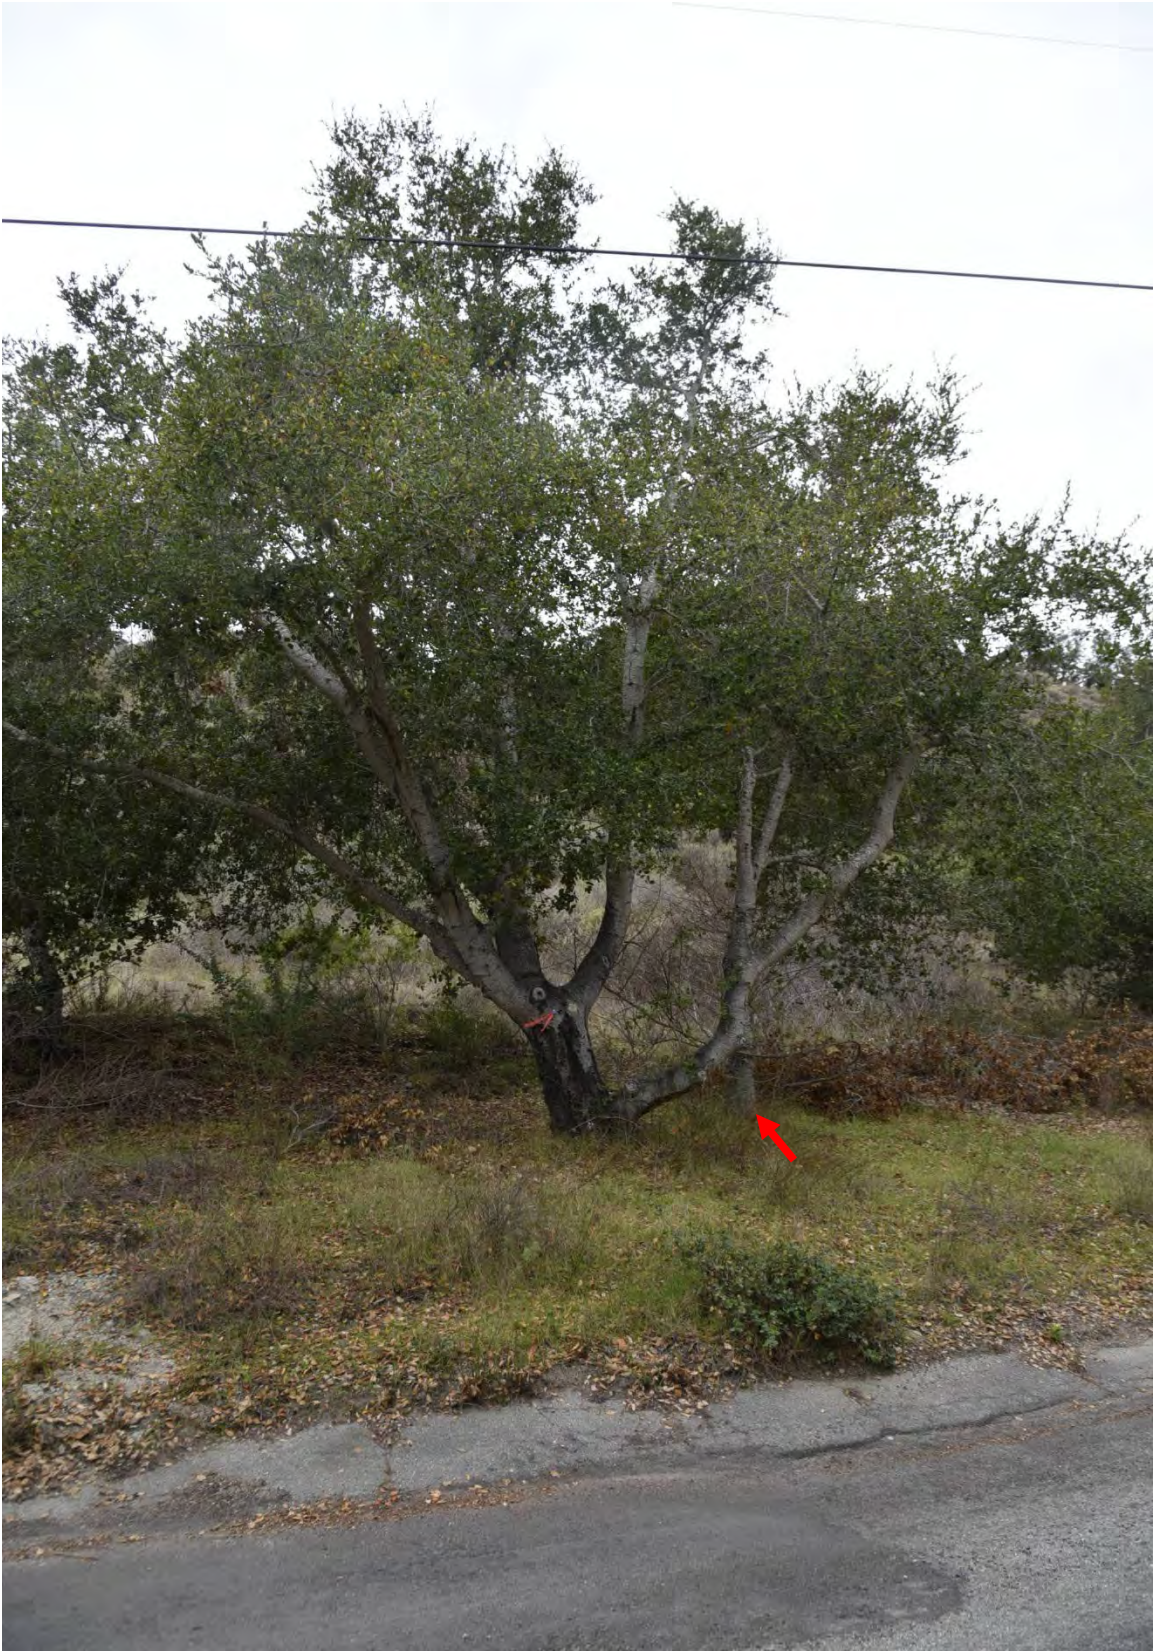
Tree #398 is behind #399 (on the neighboring property) just to the right

The base of tree #399 is being attacked by bark beetles but is on the neighboring property

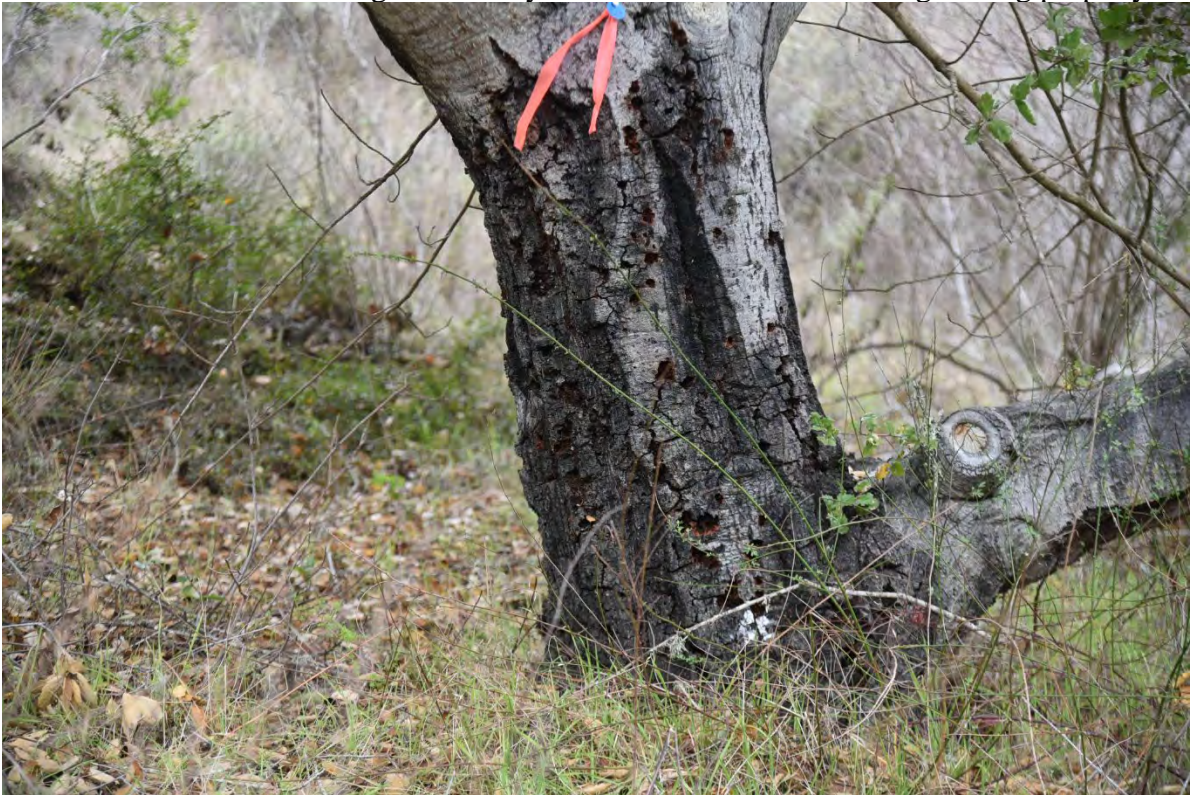
Tree #368 is upslope of the project and will not be affected

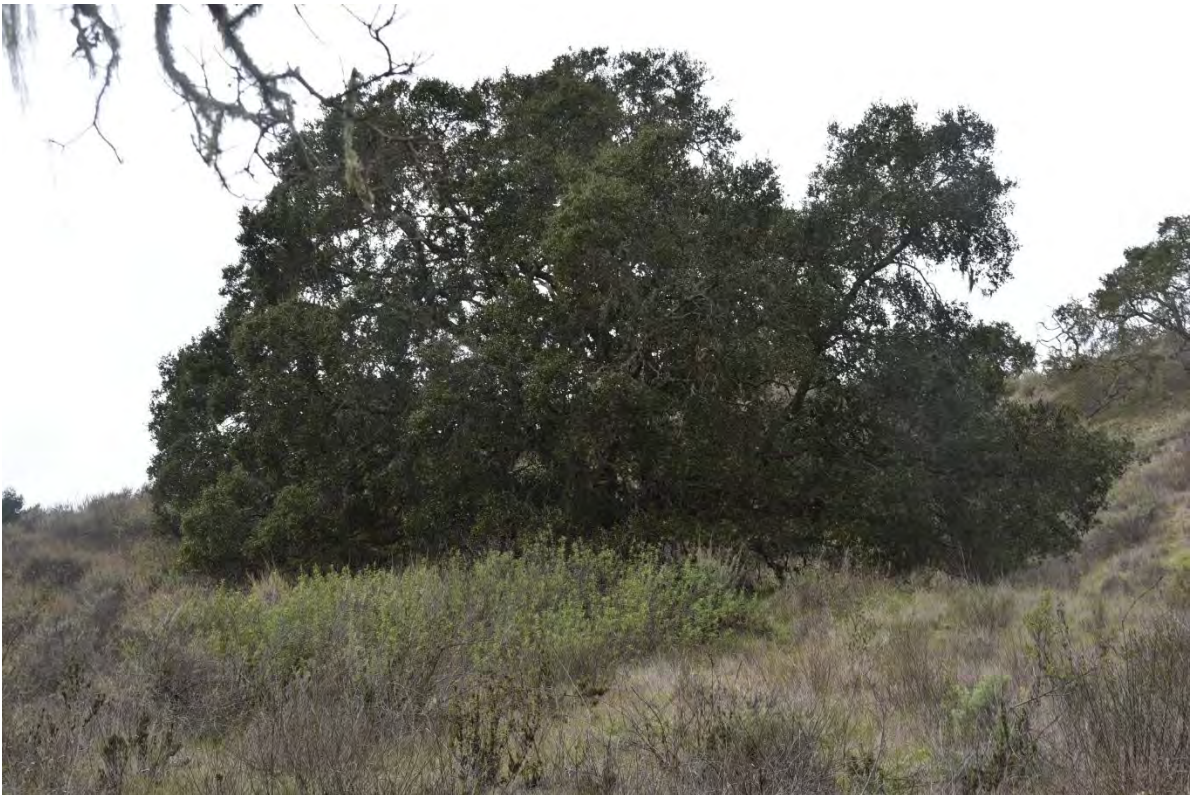
The structure will be located between #368 (upslope) and trees located along the road way

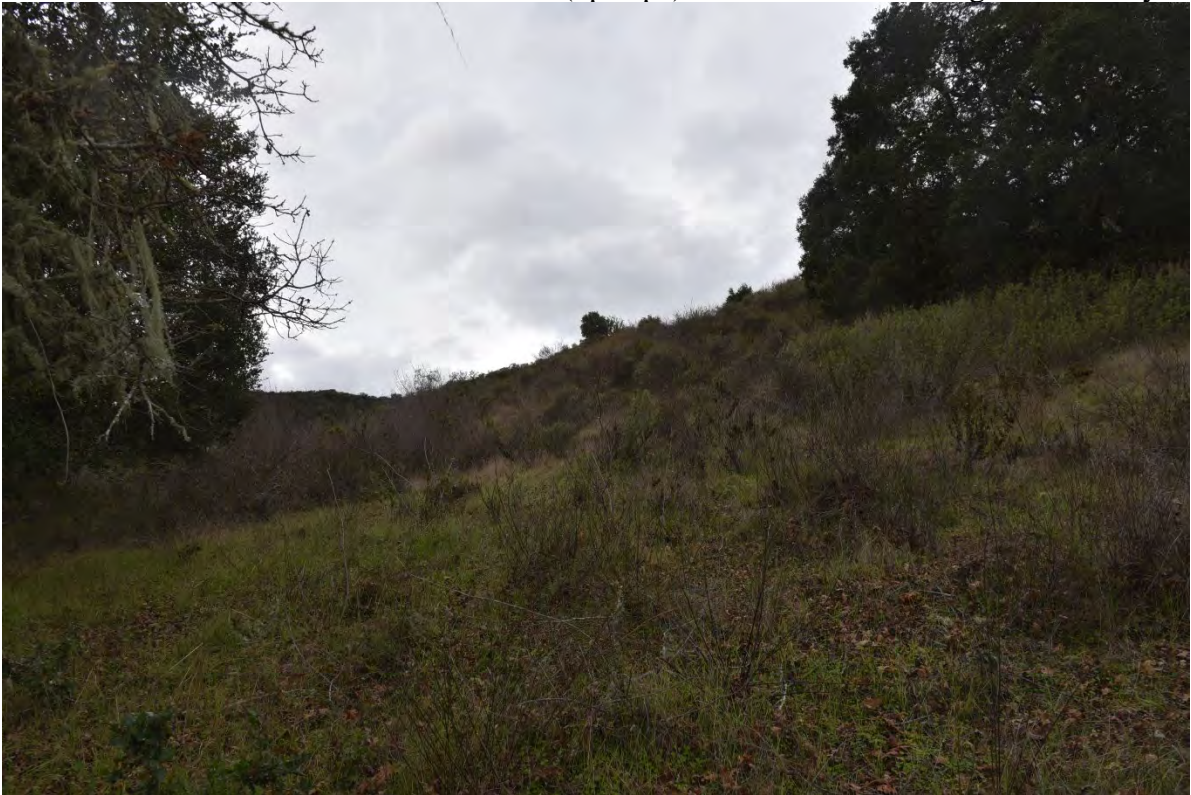
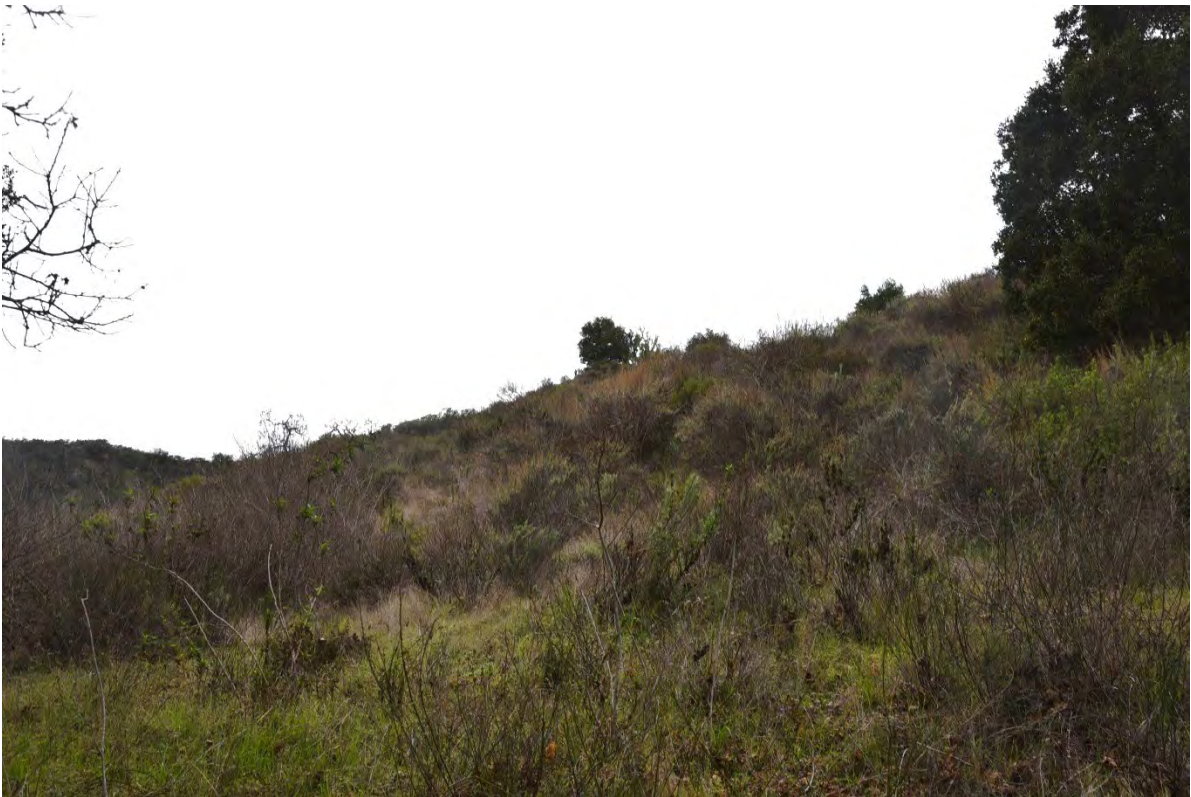
Are where structure is to be located

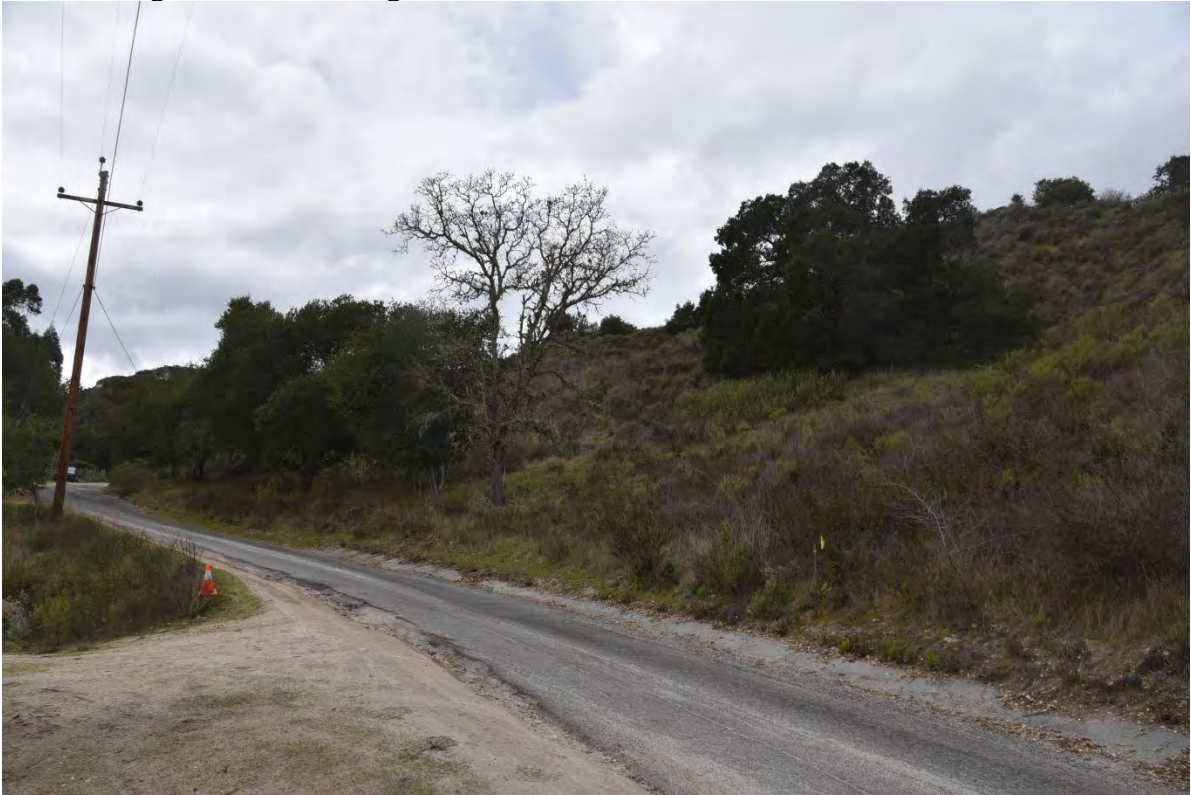
The building site, view looking to the south

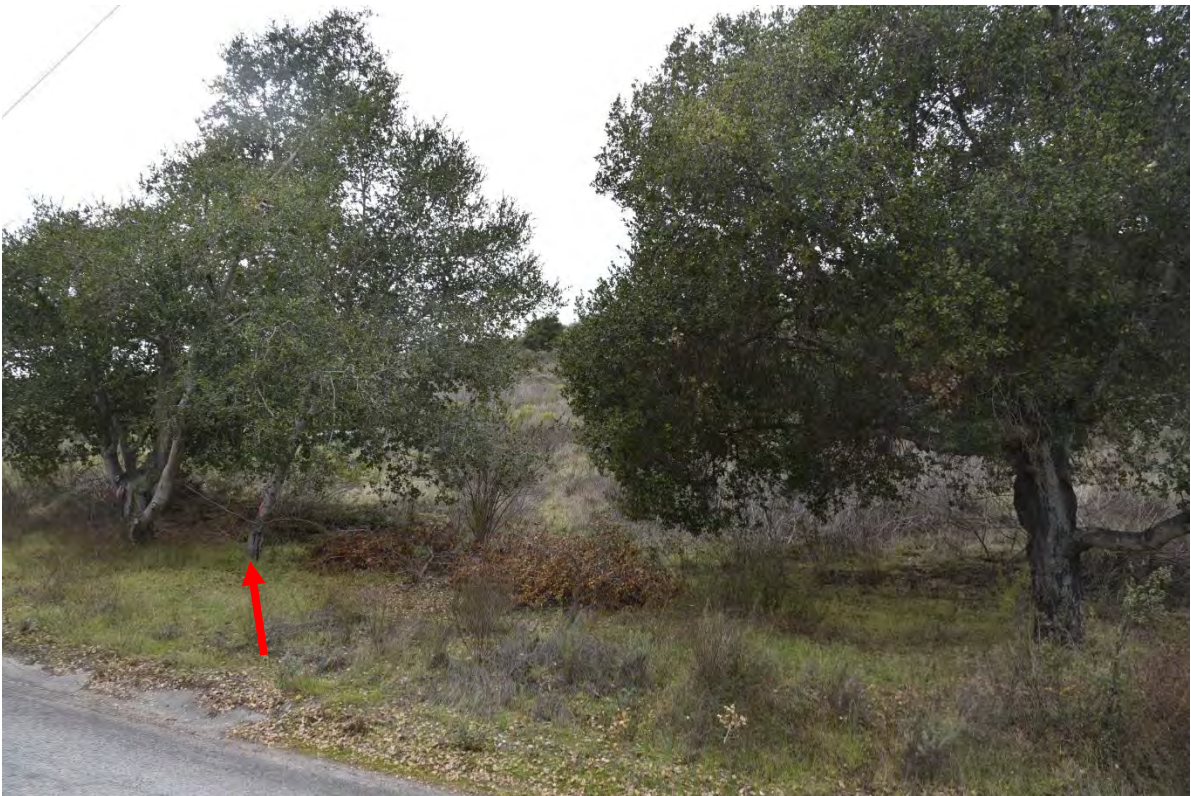
- The oak located within the proposed driveway area that will be impacted is as follows:
  - #398 is a single-stemmed 11" diameter semi-mature oak located within the driveway prism. The tree is 30 feet tall but somewhat suppressed by a more dominant oak (#399) and appears in fair-to-good condition.

Trees #398 will be removed to access the property

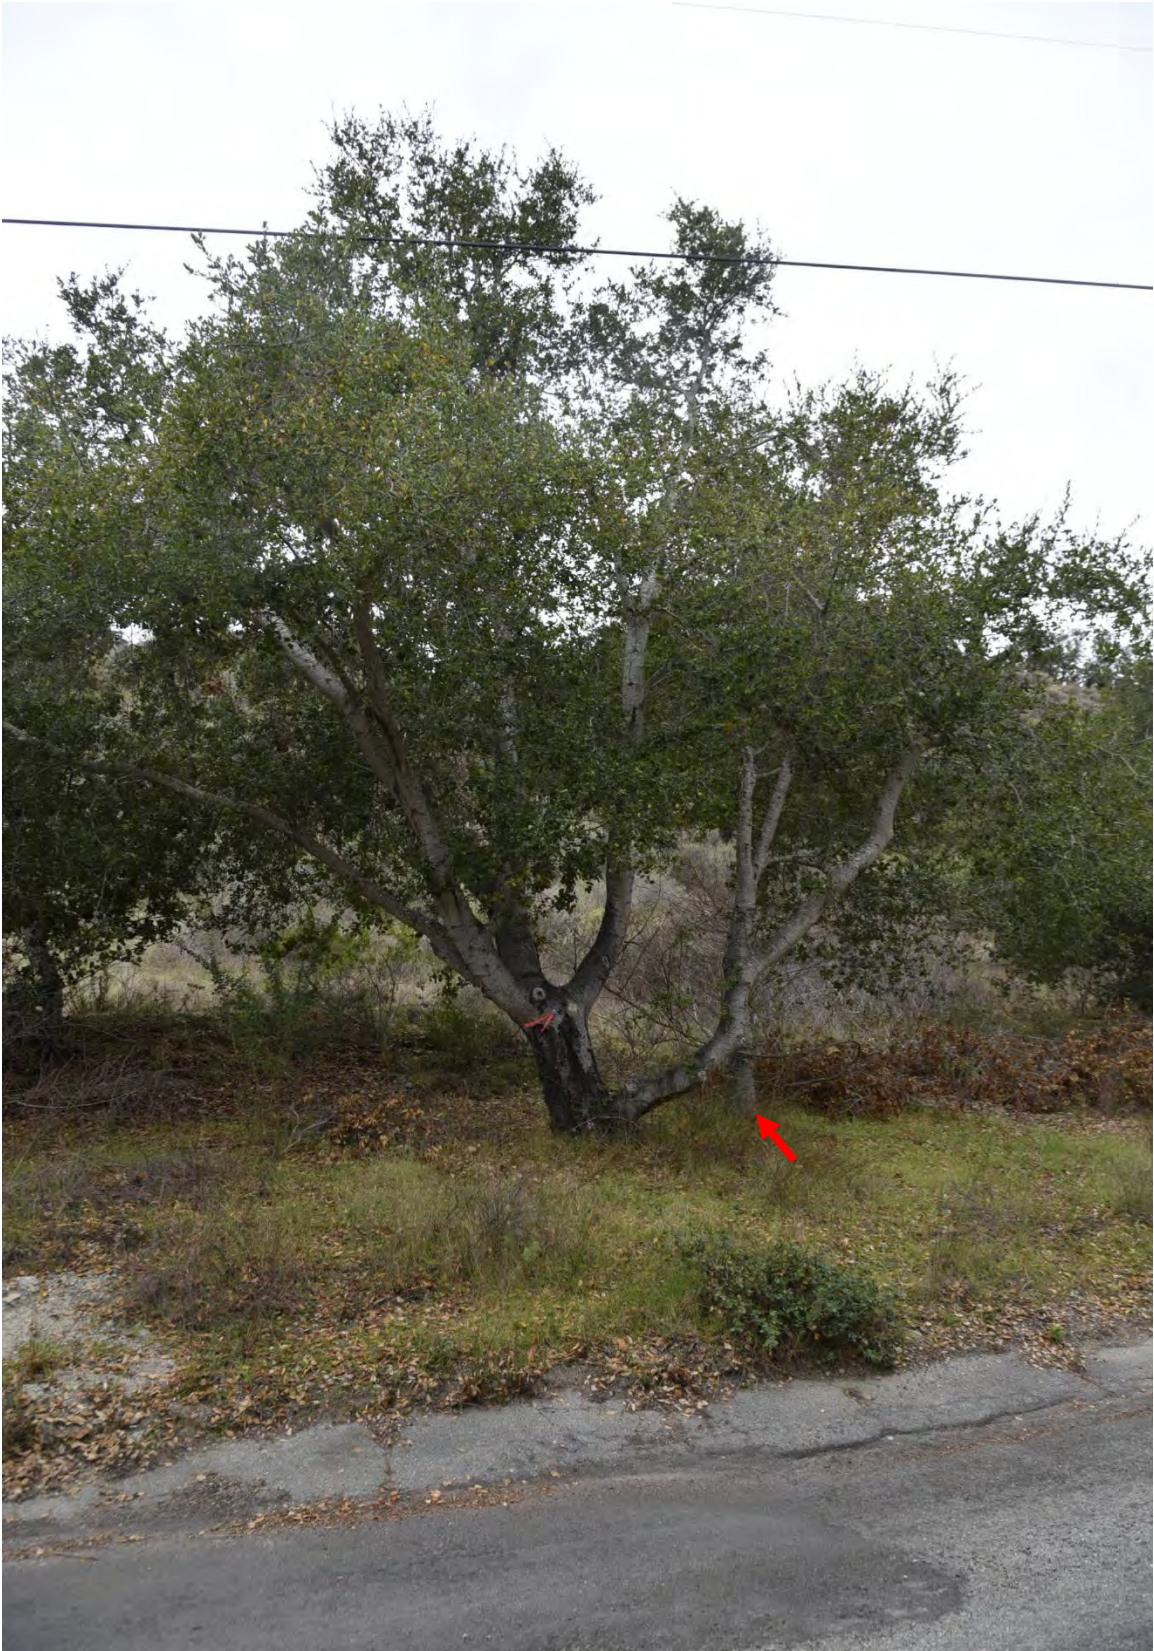
Tree #398 is behind #399 (on the neighboring property), just to the right

The base of tree #399 is being attacked by bark beetles but is on the neighboring property

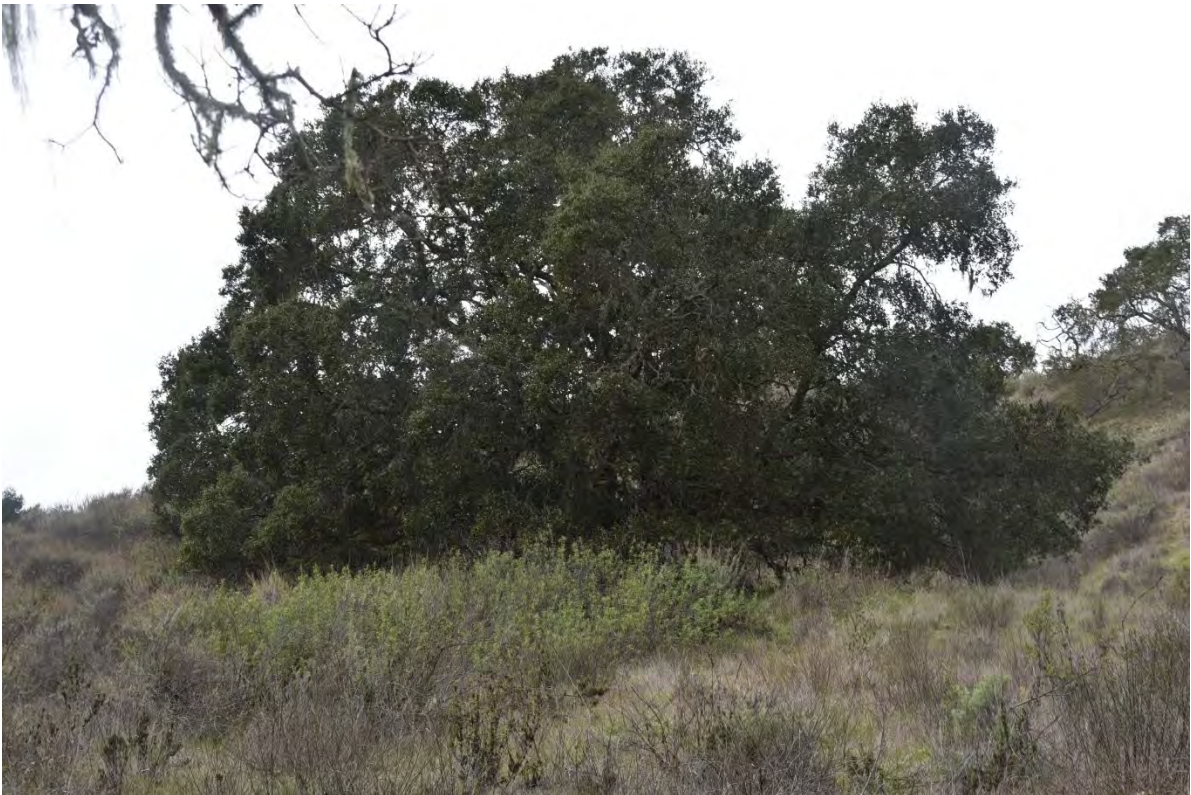
The structure will be located between #368 (upslope) and trees located along the road way

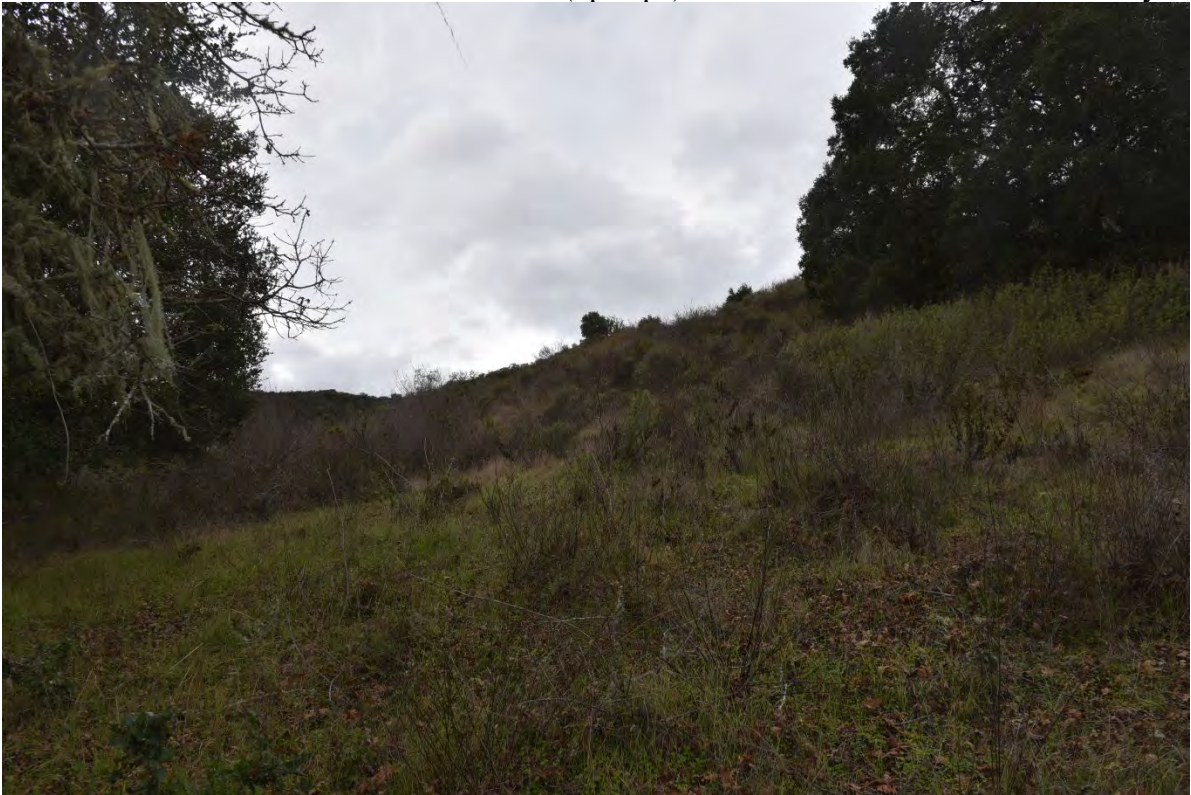
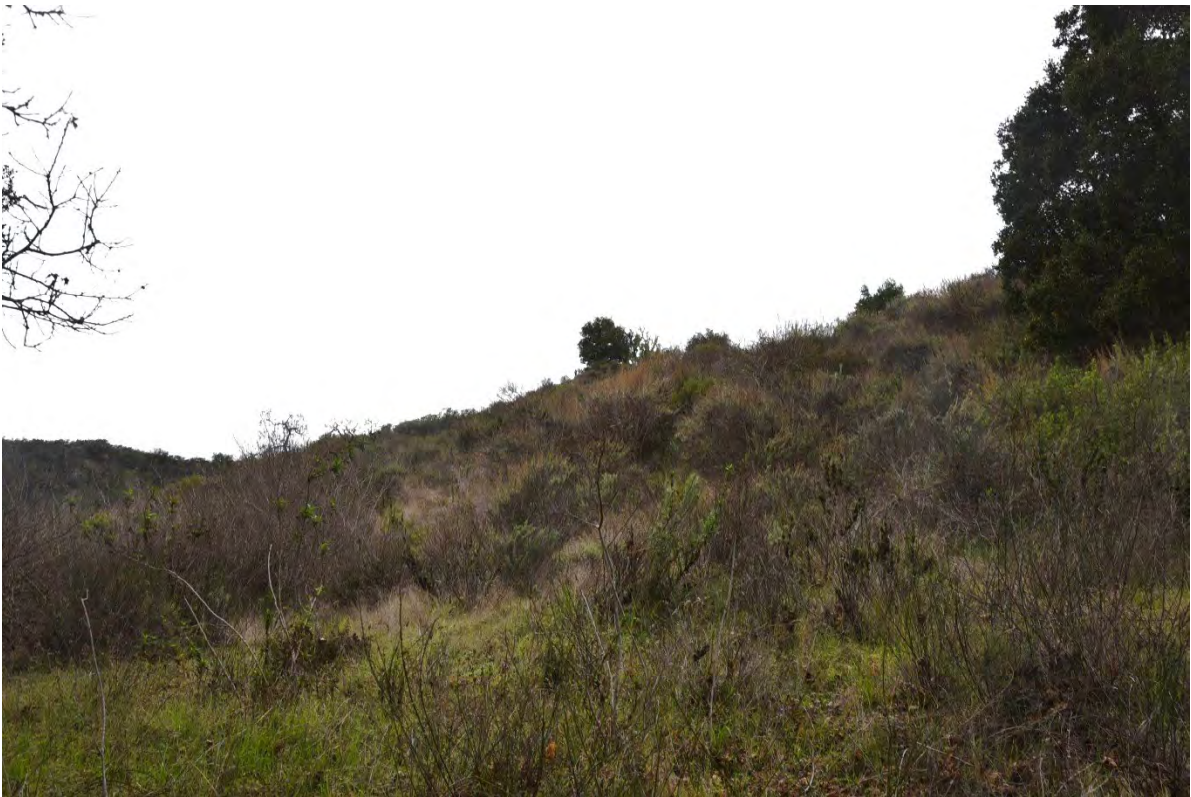
Are where structure is to be located
