Arborist Report  
Fang & Lui Residence  
2897 17 Mile Dr., Pebble Beach Ca

Prepared for:  
Fang Fang

Prepared by:  
Prepared by:  
Andrew Tope  
Board Certified Master Arborist WE-7621A  
Tree Risk Assessor Qualified  
P.O. Box 223436  
Carmel, Ca 93922

December 26, 2024

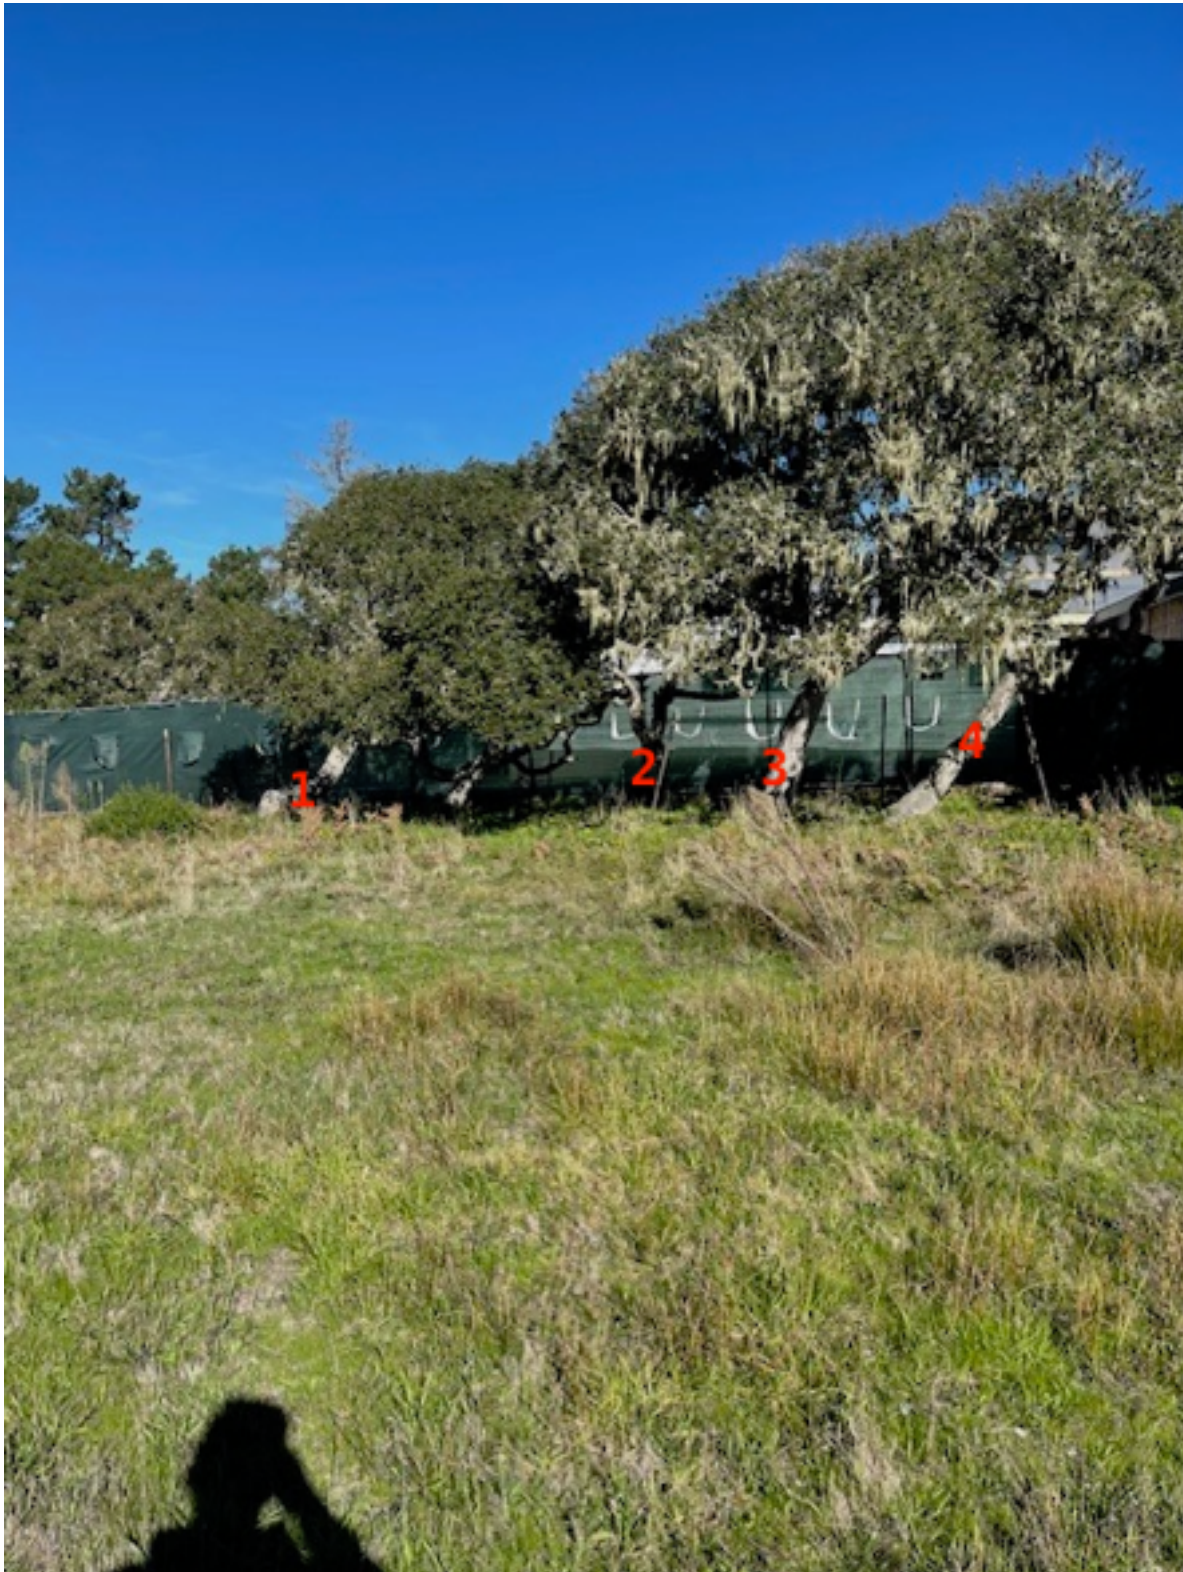
Image 2. Trees 1-4.

| ID # | Species | DBH | Condition | Recommendation | Notes |
|---|---|---|---|---|---|
| 1 | Oak | 11 | Moderate | Remove | Partially uprooted, resting on #2 |
| 2 | Oak | 8 | Moderate | Remove | Suppressed canopy, decay on trunk |
| 3 | Oak | 13 | Moderate | Remove | thin canopy, dieback |
| 4 | Oak | 11 | Moderate | Remove | thin canopy, dieback |

There are 4 trees (#1, 2, 3, 4) that I deemed necessary to be removed due to their location in the proposed driveway. None of these trees would be good candidates for tree relocation either due to location, structural issues, or proximity to other trees. None of the trees to be removed would be considered specimen trees, and removal of the trees would have a minimal impact on total canopy coverage of the lot. The trees should be removed by a licensed contractor with special attention taken to not damage the remaining trees or their TPZ fencing.

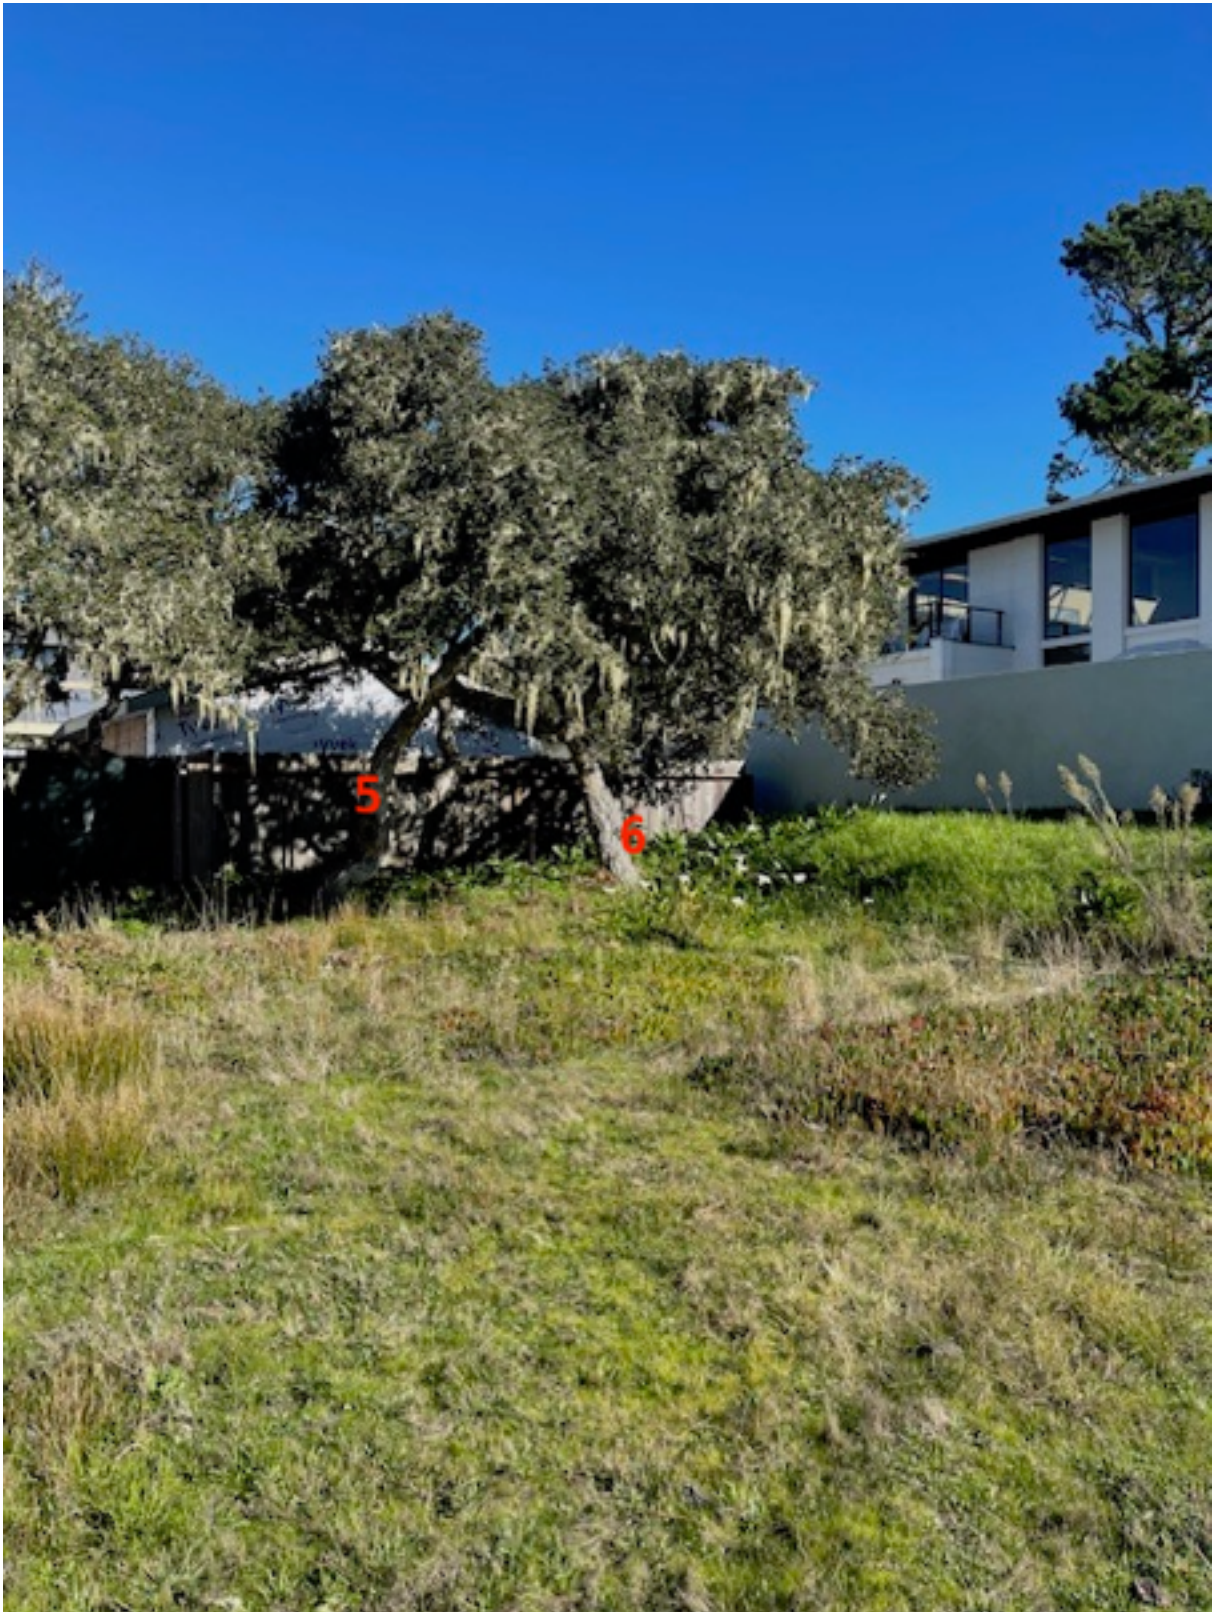
Image 3: Trees #5,6.

| ID # | Species | DBH | Condition | Recommendation | Notes |
|---|---|---|---|---|---|
| 5 | Oak | 18 | Moderate | Preserve | canopy cleaning needed |
| 6 | Oak | 17 | Moderate | Preserve | canopy cleaning needed |

A crown cleaning could be performed on the trees in close proximity to the building site. Crown cleaning consists of removing dead, diseased, and/or broken limbs. Other advisements for pruning include:

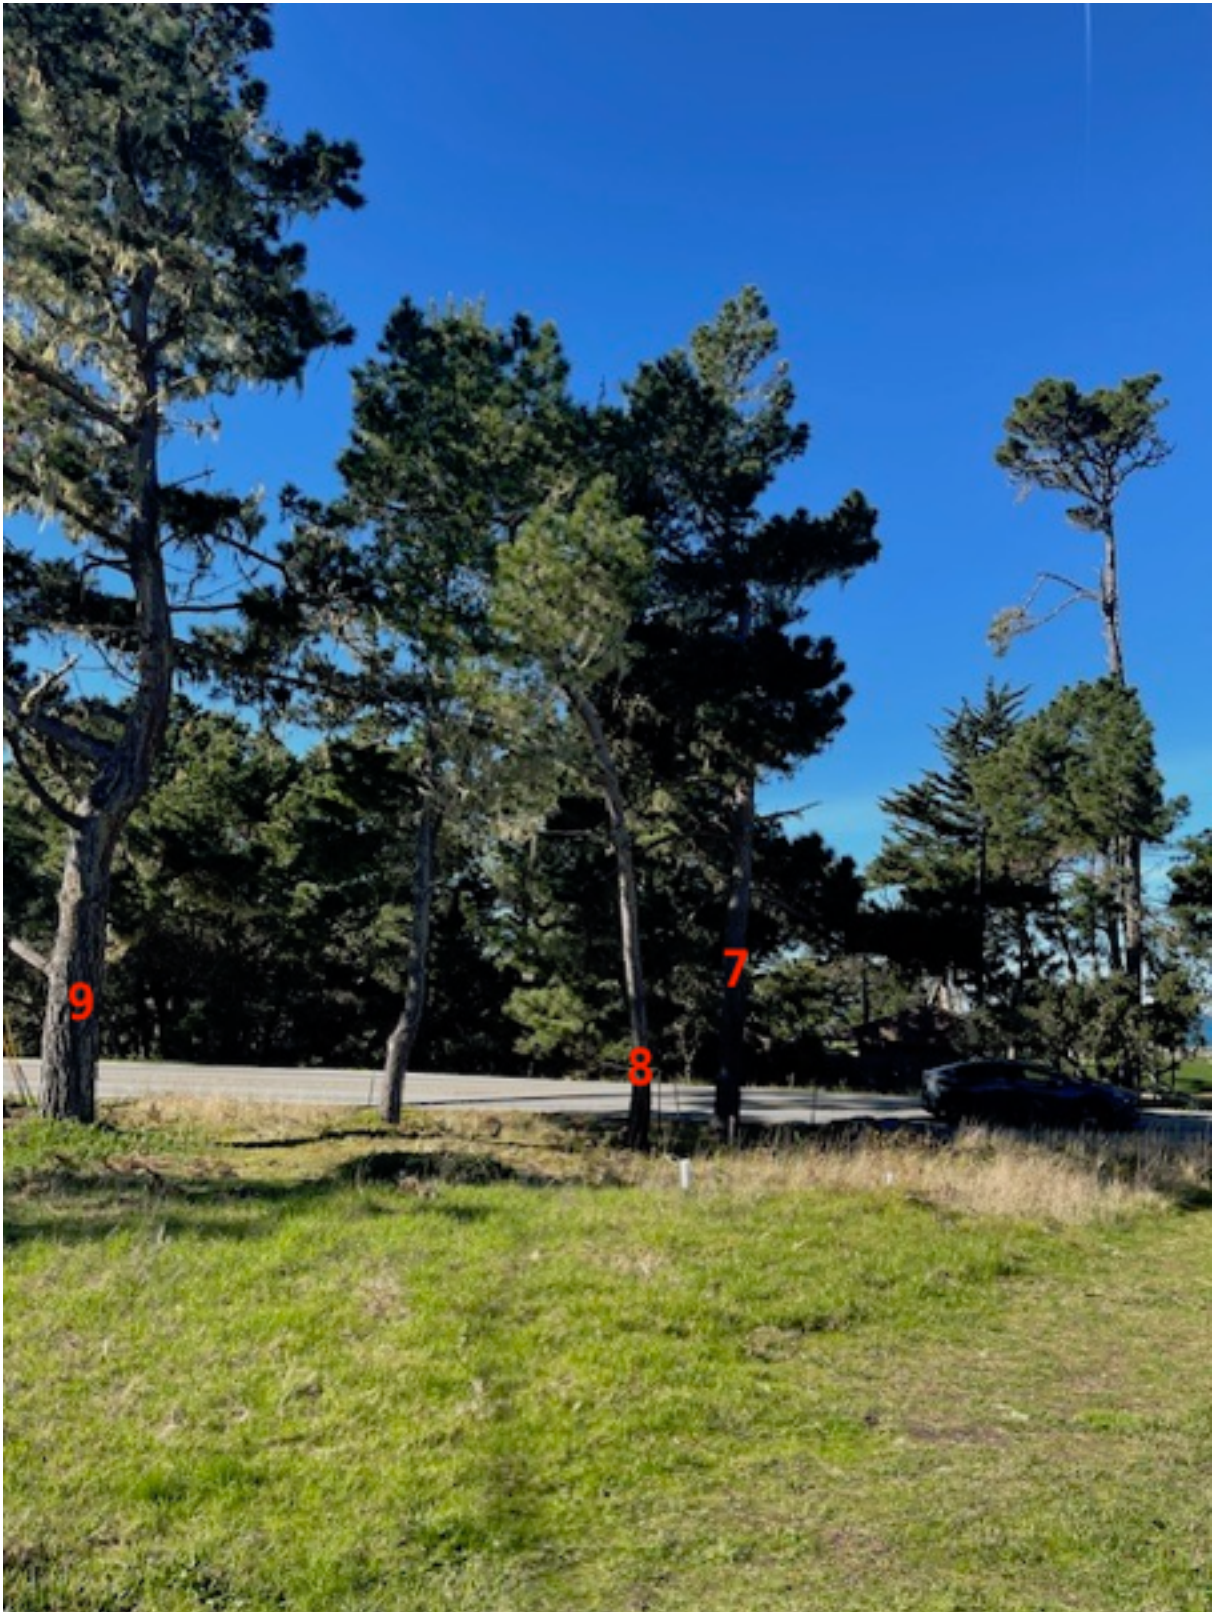
Image 4: Trees #7,8,9

| ID # | Species | DBH | Condition | Recommendation | Notes |
|---|---|---|---|---|---|
| 7 | Pine | 14 | Moderate | Preserve | bow in trunk, monitor. |
| 8 | Pine | 13 | Moderate | Preserve | thinning canopy |
| 9 | Pine | 29 | Moderate | Preserve | unbalanced canopy |
