Forest Management Plan  
for the  
Jack Rabbit Ranch (Knoop) Property  
Project – Driveway Phase

**July 2025**

ATTACHMENT C. Arborist Report and Tree Assessment for the Jack Rabbit Ranch (Knoop) Property  
Project – Driveway Phase June 2025

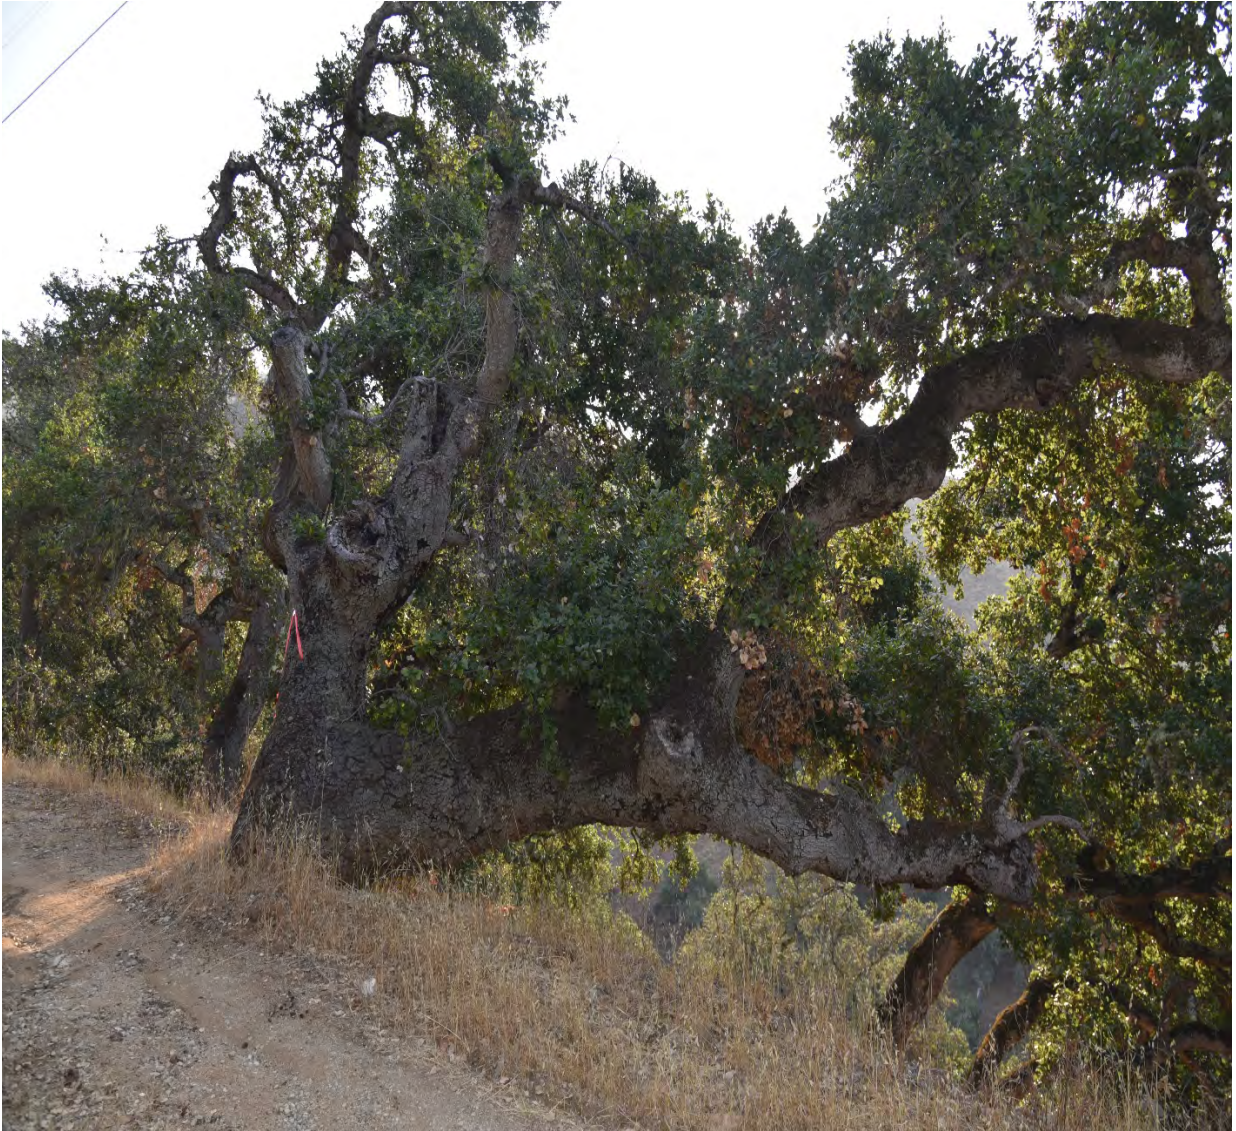
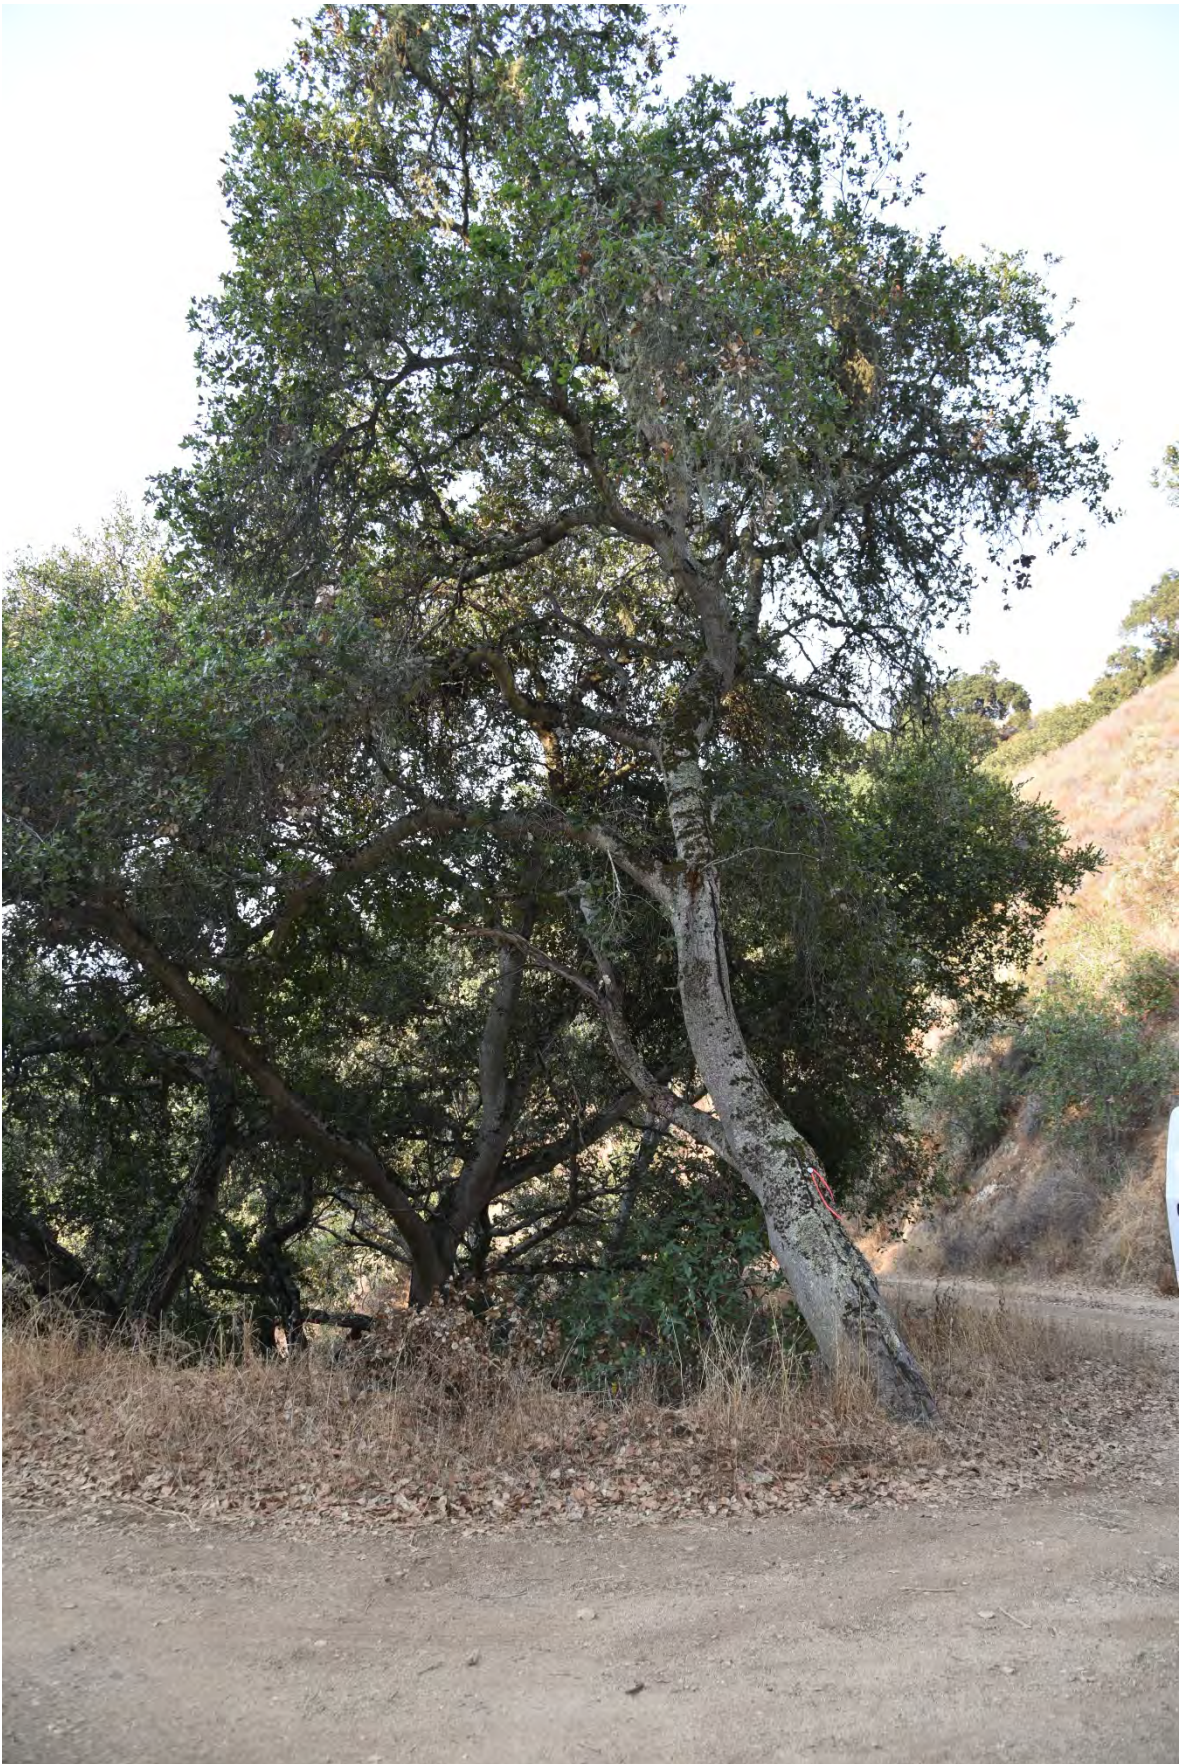
- Tree #1 is a 40" diameter Coast live oak in poor condition. The tree has been topped for utility clearance and has fungal
  - Tree #2 is a 16" diameter Coast live Oak in poor condition. This tree has decay within its stem and is located within the road prism where there is a tight turn to be improved.

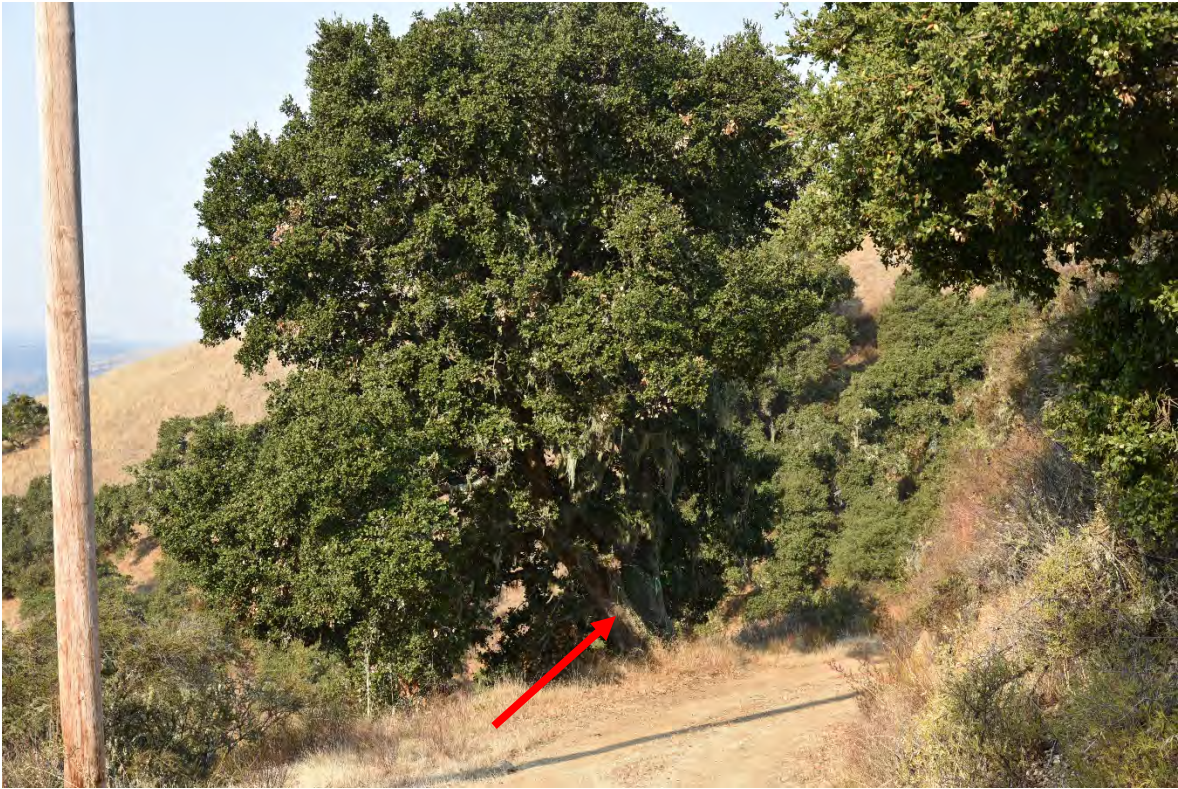
Tree #2

| ID# | Diameter | Species | Health | Structure | Remove | Comments |
|---|---|---|---|---|---|---|
| 2 | 16 | Coast Live Oak | Fair | Poor | x | Decayed stem, in road prism |

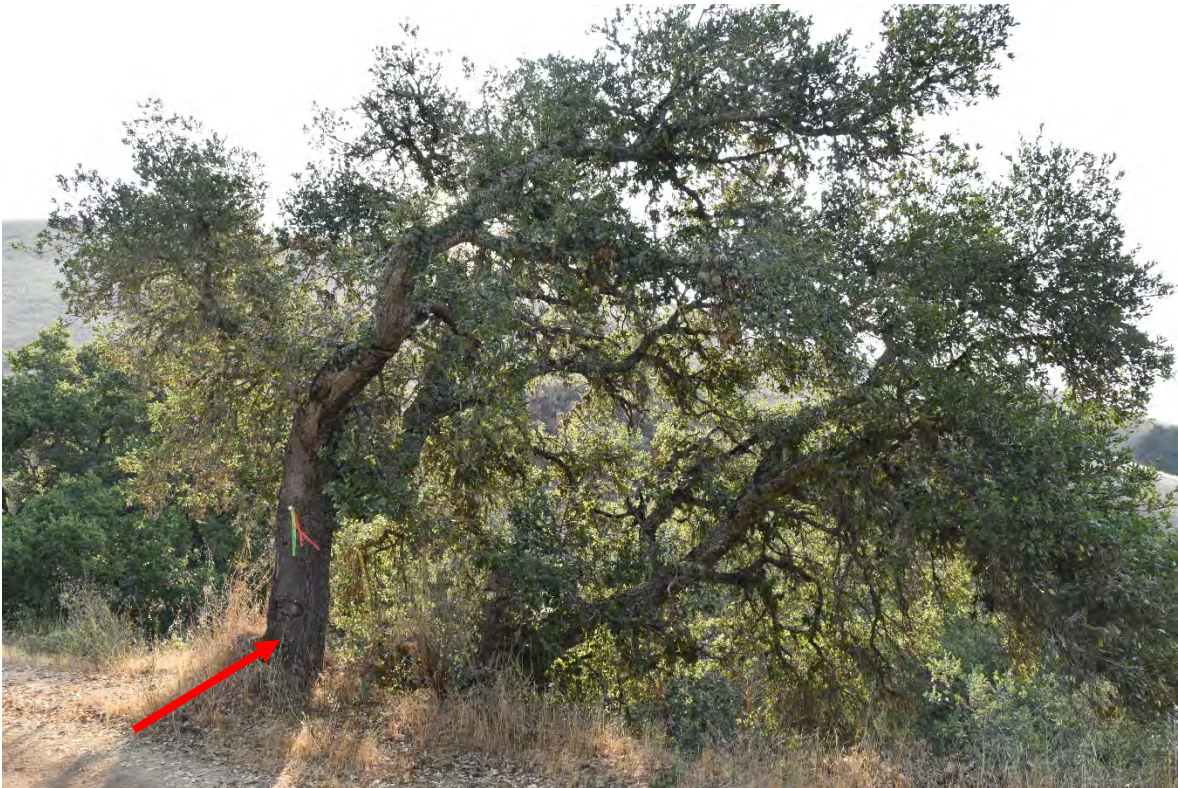
Trees #'s 3 with #4 behind

- Tree #4 is a 24" diameter coast live oak that along the roadway prism that will be potentially affected because of grading and damage to its roots. It is adjacent to tree #3 which is further downslope that will not be affected.

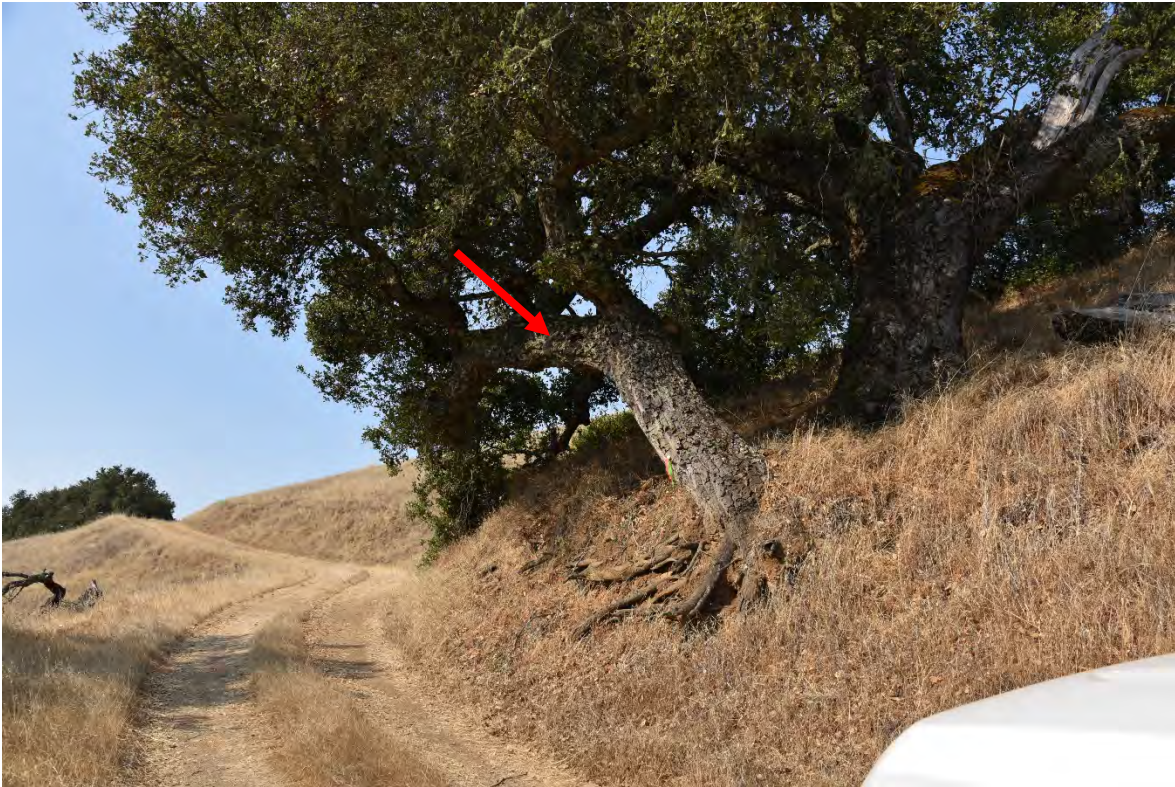
- Tree #5 is a 16" diameter tree in poor condition that has been continually topped for line clearance and has a significant amount of soil mounded at its base.

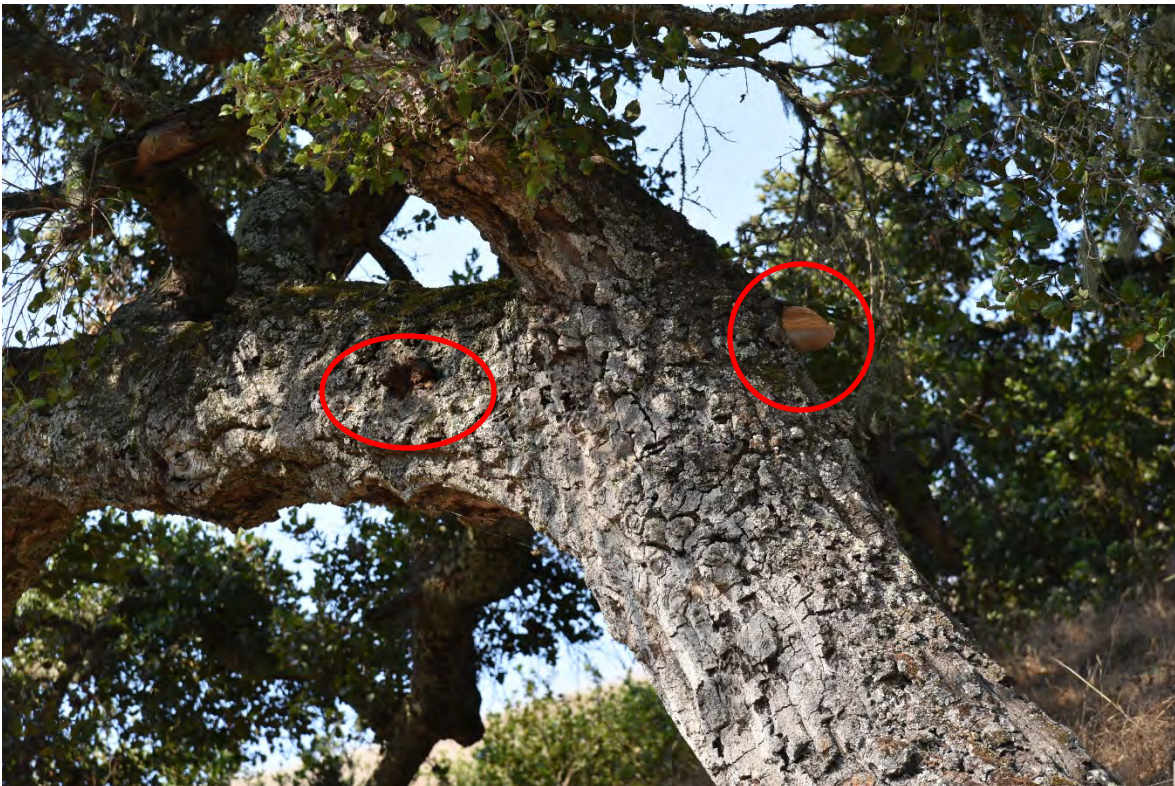
- Tree #13 is a 24" diameter Tree also in poor condition. It will be impacted by the inclusion of a retaining wall for the roadway. This tree is seriously decaying as evidenced with fungal conks emerging on its trunk.

| ID# | Diameter | Species | Health | Structure | Remove | Comments |
|---|---|---|---|---|---|---|
| 13 | 24 | Coast Live Oak | Poor | Poor | x | Decay in the stem, fungal conks |

Fungal conks on stem

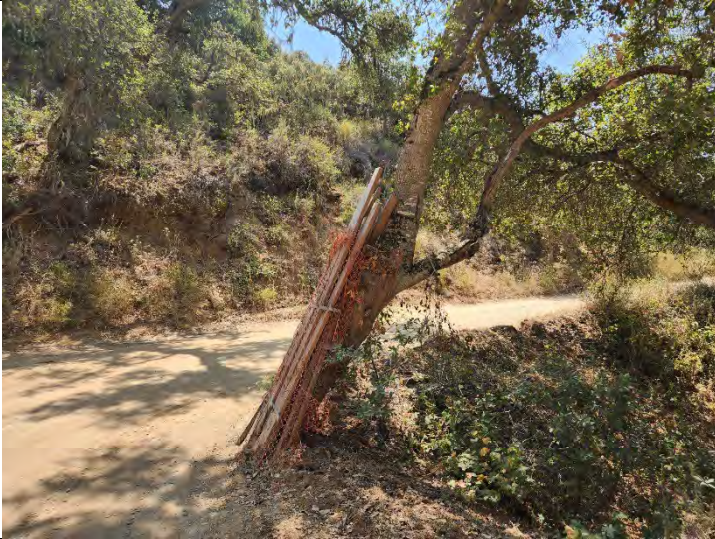
Tree #2; Within grading limits, recommended for removal.

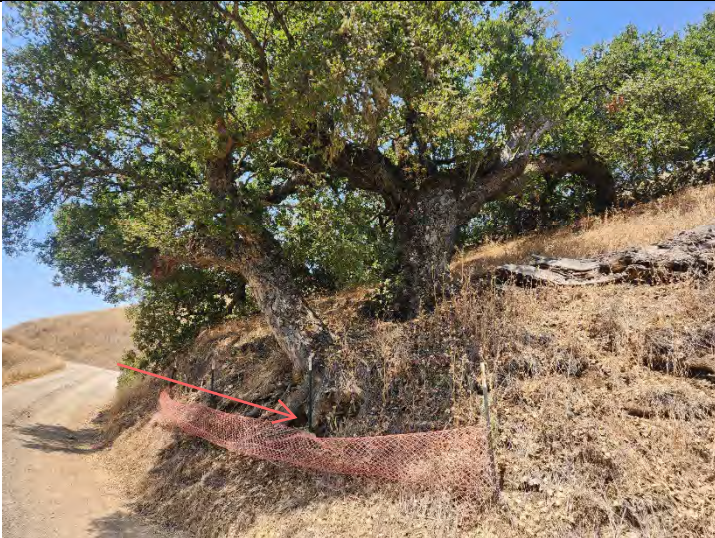
Tree 13. Hazardous tree. Remove, tree is in declining health and recommended for removal. roots are exposed.

Tree #13 (left); Recommended for removal, soil eroding under tree.  
Tree #36 (right); Within grading limits for retaining wall footprint.

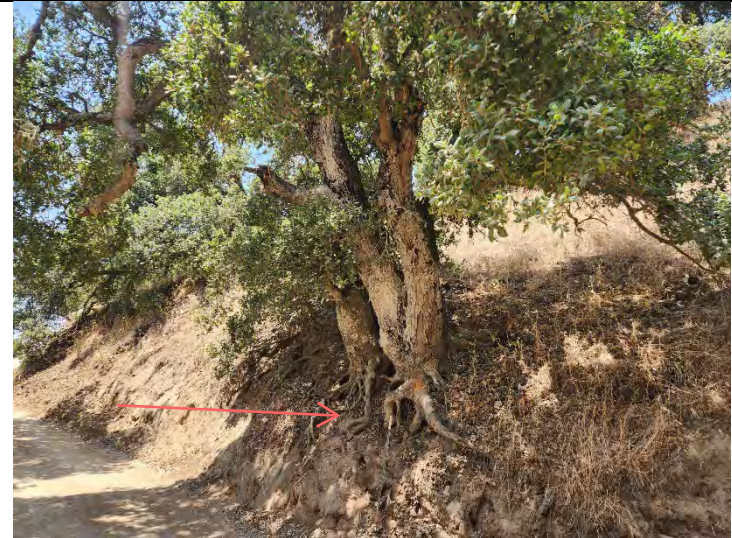
Tree 34. Hazardous tree. Remove, tree is in declining health and recommended for removal. roots are exposed.

Tree #34; Recommended for removal, soil eroding under tree.
