MEMO

Subject: Addendum to Potential Impacts to the State Parks Barn Complex Due to the Carmel River Floodplain Restoration and Environmental Enhancement Project

Subject: Potential Impacts to the State Parks Barn Complex Due to the Carmel River Floodplain Restoration and Environmental Enhancement Project

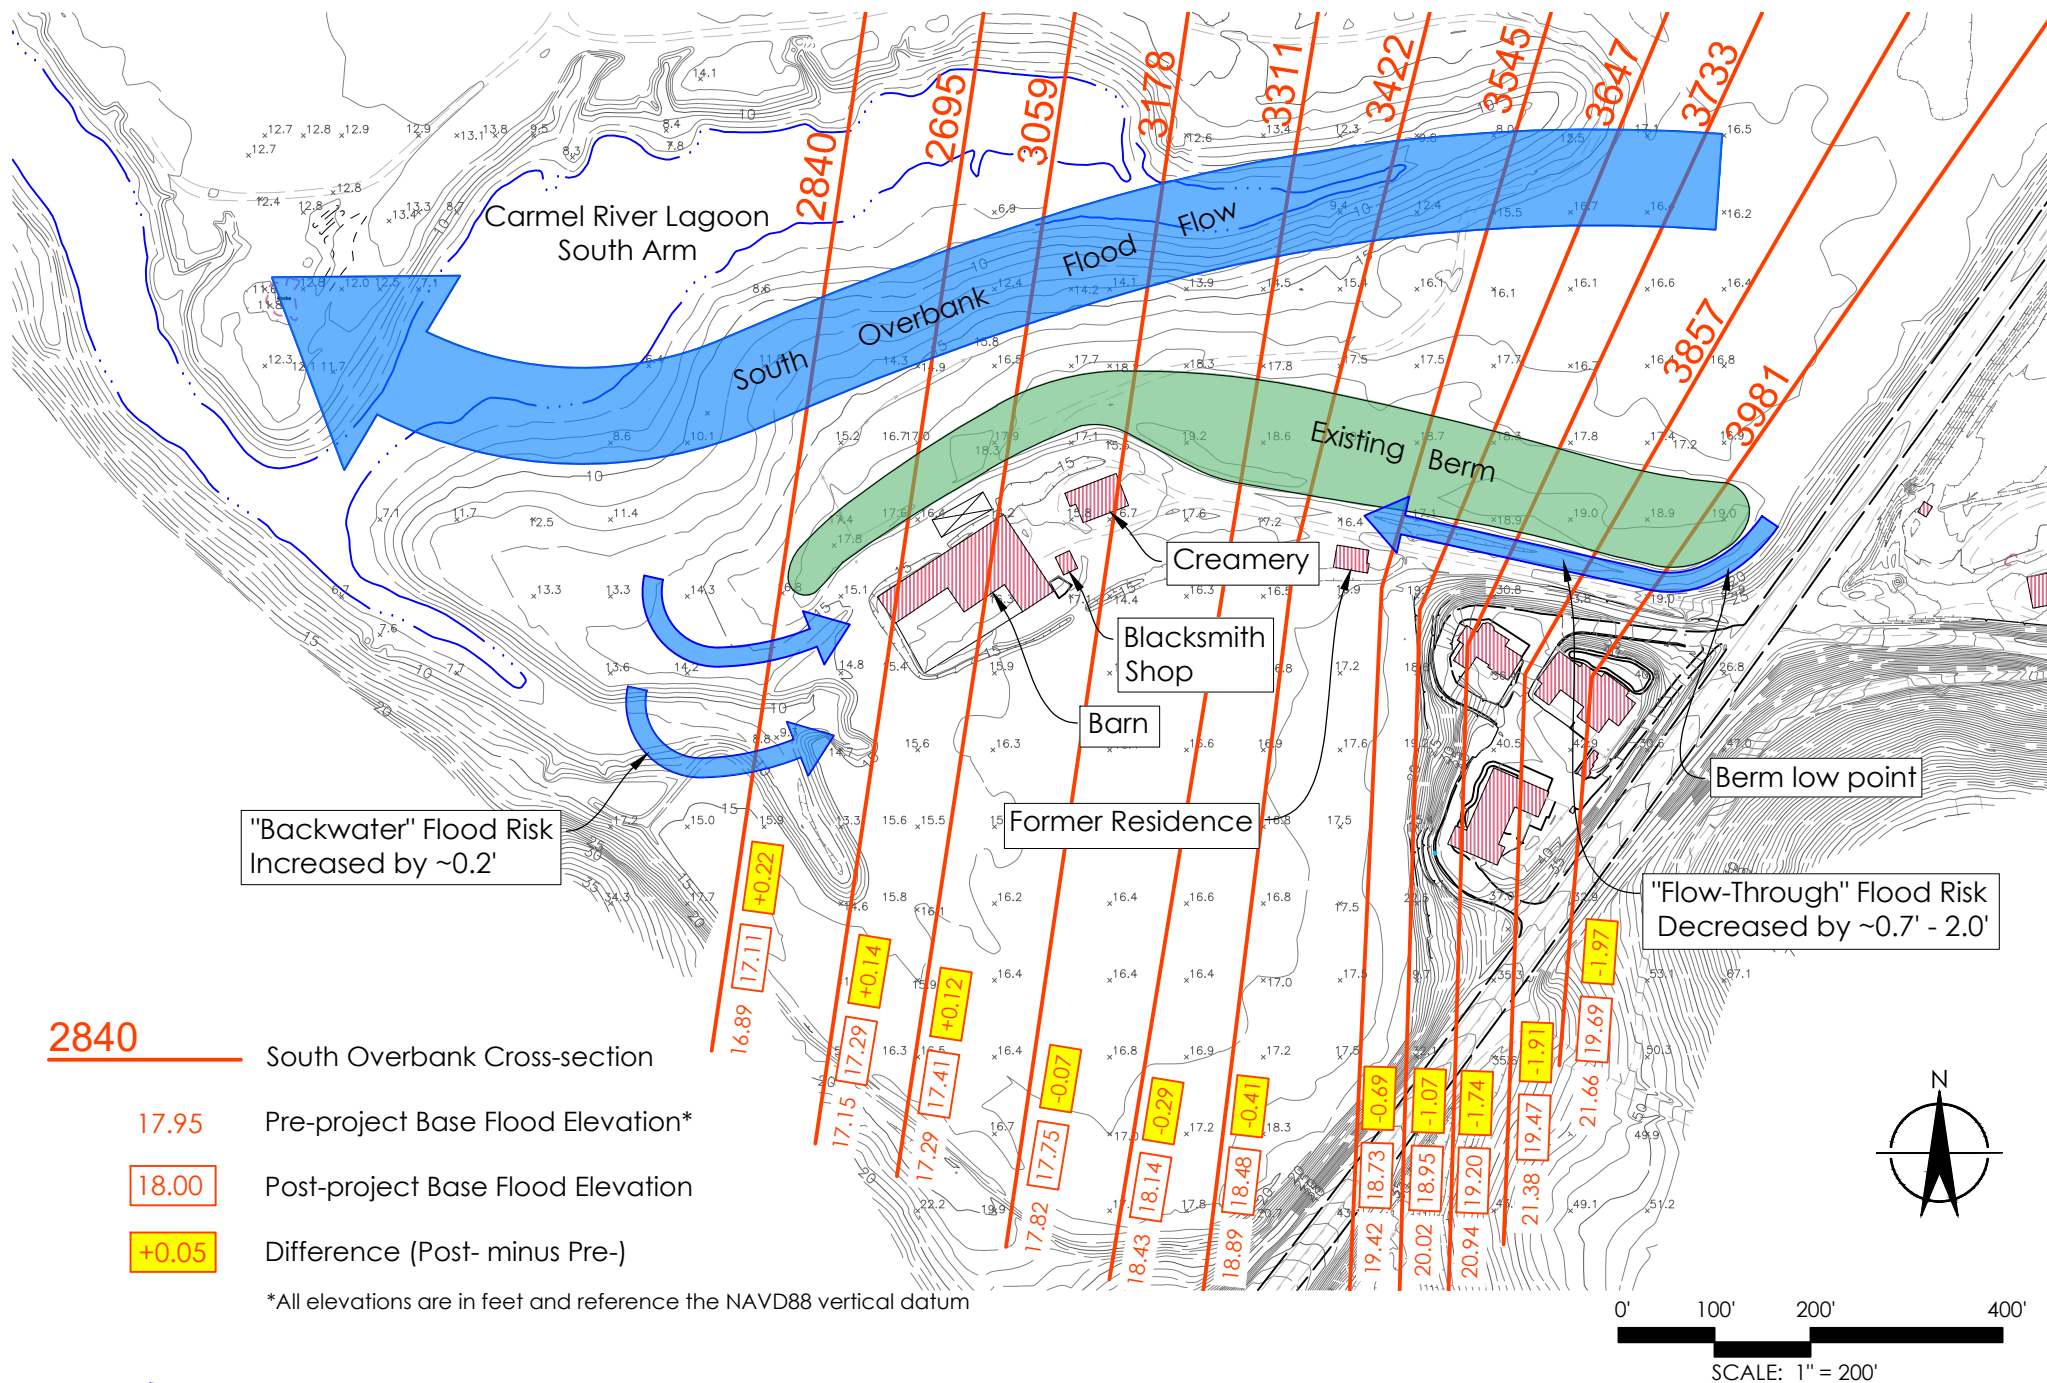
As an addendum to the prior memo, we have updated **Table 1** and **Figure 1** to reflect the most recent modeled BFEs and revised target First Floor Elevations (FFE). Although the BFEs have changed slightly, the flood risk mitigation recommendations of the 2016 memo still apply.

Building	Existing FFE (ft) ¹	LAG (ft)	Pre-Project BFE (ft)	Post-Project BFE (ft)	Target FFE (ft)
Barn	17.7 (concrete floor, southern bay)	17.1 (next to concrete floor) 14.3 (next to NE corner)	17.29	17.41	18.41
Blacksmith Shop	18.5	16.1	17.63	17.63	18.63
Creamery	16.7 (western addition, slab on grade) 17.3 (eastern addition, slab on grade) 17.5 (raised wood floor)	15.5	17.82	17.75	18.75
Former Residence	18.7	16.0	19.16	18.61	19.61

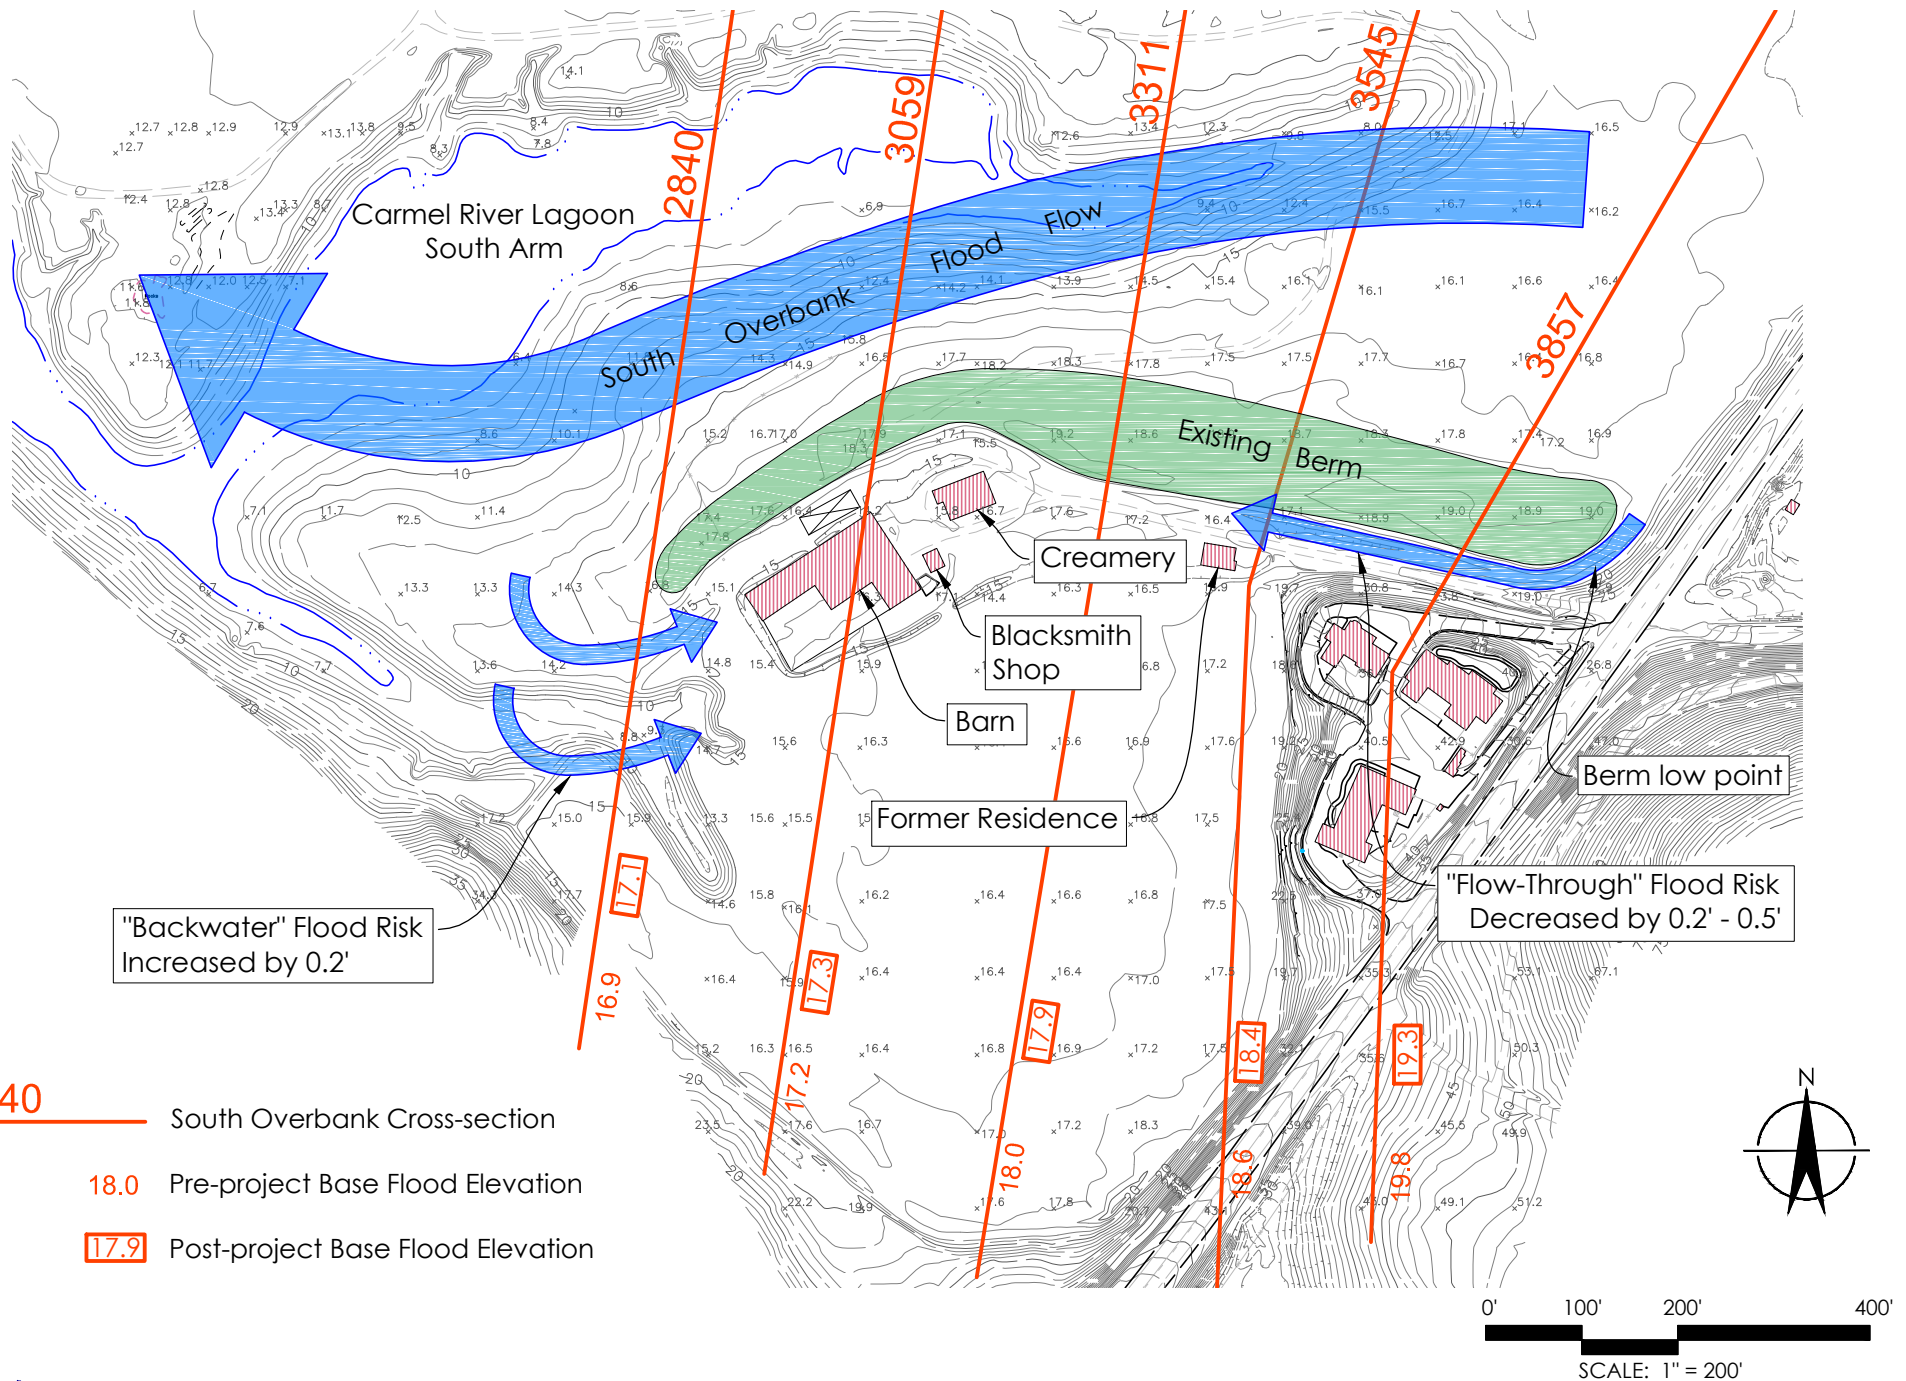
Figure 1. 100-year flood risk assessment at the State Parks Barn Complex, Monterey County, California.

1. **Flow-Through Flooding Risk.** While the top of berm is, in general, above or just at the existing 100-year BFE, a low point exists near Highway 1 (see Figure 1). Under existing conditions, the modeled BFE at this low point is 19.8 feet compared to a low ground elevation of just under 18.0 feet based on best available topographic data. Actual flood elevations at the Barn Complex would be expected to be lower than this modeled elevation because the 100-year peak flow would likely not crest long enough and the low point would not be wide enough to equalize the water surface elevations on the inboard

While some water surface elevations are expected to decrease with the construction of the Causeway, all four properties would still be mapped in the FEMA 100-year floodplain unless substantial work is completed to convert the berm to a FEMA-certified levee with the appropriate freeboard and structural integrity. The pre- and post-project mapped BFEs are shown on the cross-sections in Figure 1.

1. **Flow-Through Flooding Risk.** The aforementioned flow-through risk decreases for all structures as the post-project BFE at the low point in the berm upstream of the Barn Complex is decreased by 0.5 feet².
2. **Backwater Flooding Risk.** Due to the larger volume of flow that will be routed under the Causeway and out to the South Arm of the Carmel Lagoon, the backwater flooding elevation increases by 0.2 feet (from elevation 16.9 to 17.1 feet) immediately downstream of the berm protecting the Barn Complex.

As the table shows, the post-project BFE (the mapped flooding risk) is expected to increase by 0.1 feet in the vicinity of the barn. No change in mapped flooding risk is expected at the Blacksmith Shop and the Creamery. The Former Residence should expect to see a 0.2-foot reduction in BFE (see footnote 2 above).

Regardless of whether changes in the mapped risk are expected, the existing FFEs of the Barn, the Blacksmith Shop, and the Former Residence buildings are higher than both the pre- and post-project BFEs³. These FFEs are also higher than the pre- and post-project backwater elevations of 16.9 and 17.1 feet, respectively. Without improvements to the berm, the buildings are still subject to flow-through flooding, but the risk is reduced in the post-project scenario as the flood elevation at the low point in the berm decreases from 19.8 to 19.3 feet. Therefore, the CRFREE

While the Creamery first floors (slab on grade and raised wood floor portions) are below the pre-project BFE, the CRFREE project does not increase the BFE at this location. The western addition of this building is subject to backwater flooding in pre-project conditions (flooding elevation of 16.9 feet compared to an FFE of 16.7 feet). Without further improvements, this risk is increased by 0.2 feet as the post-project backwater elevation increases to 17.1 feet. Similarly to the other buildings, the Creamery is subject to flow-through flooding if no berm improvements are made, but the risk is reduced in the post-project scenario.

1. **Flow-Through Flooding Risk.** Although the flow-through flooding risk decreases with the construction of the Causeway, it is not fully eliminated. One option is to eliminate the flow-through risk altogether by improving the existing berm to provide additional freeboard and closing off the low point that allows flow-through flooding.
2. **Backwater Flooding Risk.** Backwater flooding risk will remain unless a) the existing berm is improved as above and the protection is extended around the west and south boundaries of the Barn Complex with a berm or a low flood wall or b) the affected buildings and/or the entire site is elevated.
