**THOMPSON**  
**WILDLAND MANAGEMENT**

December 19, 2023

Terranova Residence  
 12167 Saddle Road  
 Carmel Valley, CA 93924  
 APN: 416-122-036-000

Subject: Pre-construction tree removal report for 12167 Saddle Road in Carmel Valley

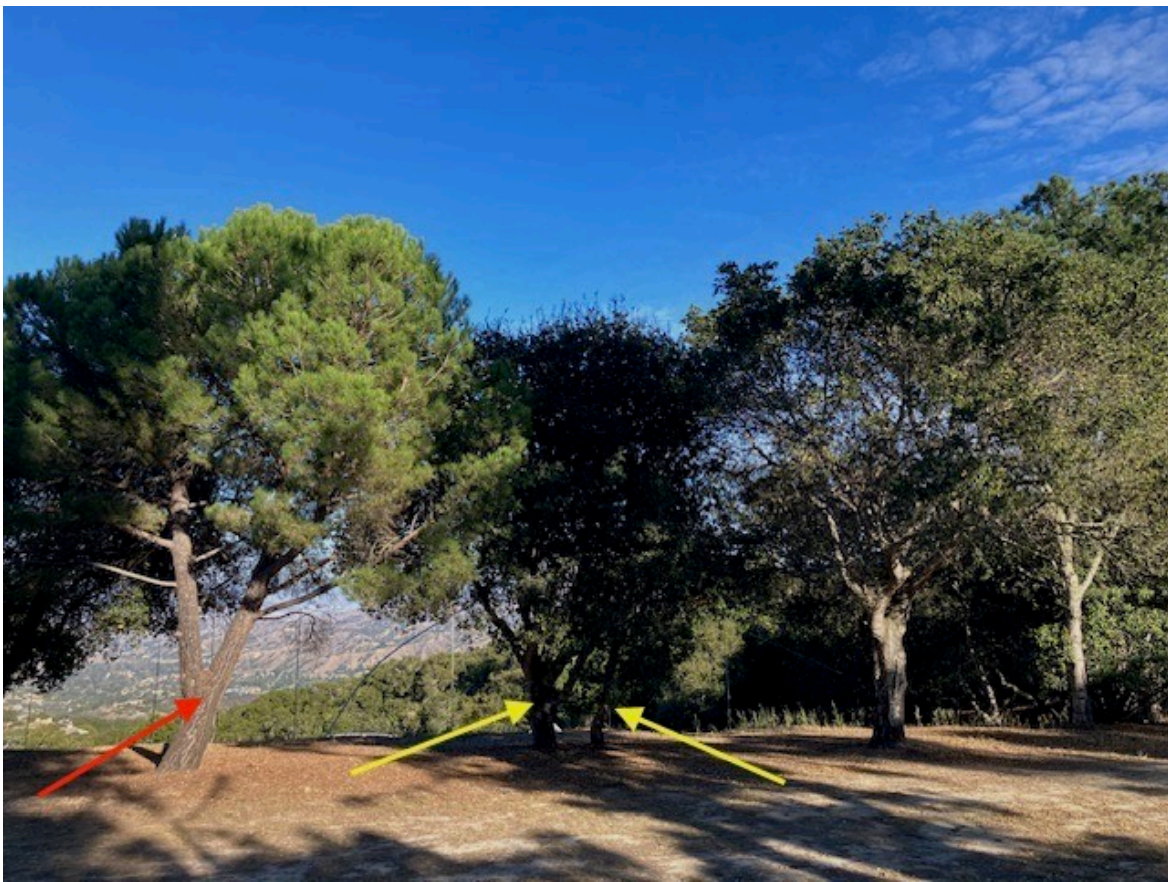
The relatively small 15 inch DBH Coast Live Oak (*Quercus agrifolia*) identified as *Tree#1* on the construction site plans is proposed for removal due to its location within the driveway turn around and parking area (refer to *Figures 1-3*). This oak has a height of approximately 15 feet and is in good physiological health and fair structural condition. Notable structural deficiencies include multiple co-dominant stem attachments in the trunk and mid-stem of the tree. Per County requirements, one 5 to 15-gallon replacement oak will need to be planted on the property to satisfy tree removal permit conditions.

The small and relatively immature 8 inch DBH single stem Coast Live Oak identified as *Tree#2* on the construction plans is located within a few feet of *Tree#1* and will also need to be removed due to its location within the proposed driveway footprint (refer to *Figures 1-3*). This oak has a height of approximately 10 feet and is in fair physiological health and poor structural condition. This oak is somewhat suppressed by the larger and more dominant oak identified as *Tree#1*. Structural deficiencies include poor canopy balance and symmetry due to its suppressed growth habit. As with *Tree#1*, per County

The 15 inch DBH Italian Stone Pine (*Pinus pinea*) that is located in close proximity to the two oaks identified as *Tree#s 1 & 2* (refer to *Figures 1 & 2*) will also need to be removed, but does not require a County tree removal permit due to it being introduced to the property and not native to the region.

Figure 1. The two oaks proposed for removal (identified as Tree#s 1 & 2) due to construction impacts are pointed out with yellow arrows. The Italian Stone Pine proposed for removal (red arrow) is non-native and does not require a County tree removal permit.

In regards to tree replacement, three (3) 5 to 15-gallon container size Coast Live Oak (*Quercus agrifolia*) replacement trees of good physiological health and structural condition shall be planted on the subject property to replace the 3 removed oaks and to help preserve and sustain the long-term health, viability and character of this mixed oak woodland environment. The 3 replacement trees should be acquired from a local plant nursery that has a good selection of specimens that are free from harmful pathogens, insect pests and/or significant structural disorders. Furthermore, the replacement oak plantings should be planted during the appropriate time of year (preferably fall or winter) using proper tree planting techniques and best management practices, and should be planted in suitable locations that will support healthy establishment and maturation. The replacement plantings should be provided the necessary irrigation, mulching and protection (i.e., welded wire fence secured with T-posts around the plantings to protect from wildlife) until they are successfully established. Successful completion of this County tree removal permit compliance action shall be achieved when the 3 replacement plantings survive a one-year monitoring period.

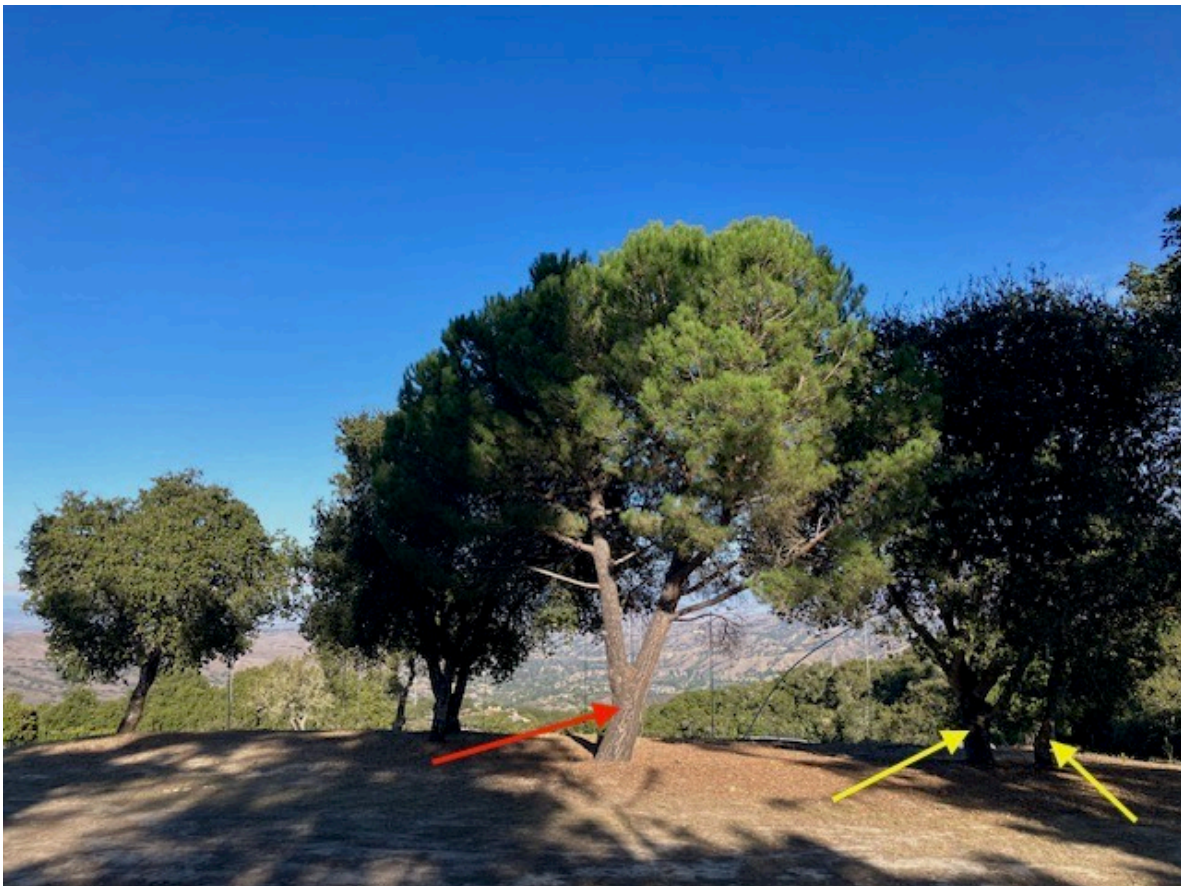
Figure 2. Two fairly small oaks proposed for removal are to the right and Italian Stone Pine is in center of photo. Other nearby trees will be retained and protected during construction activities.

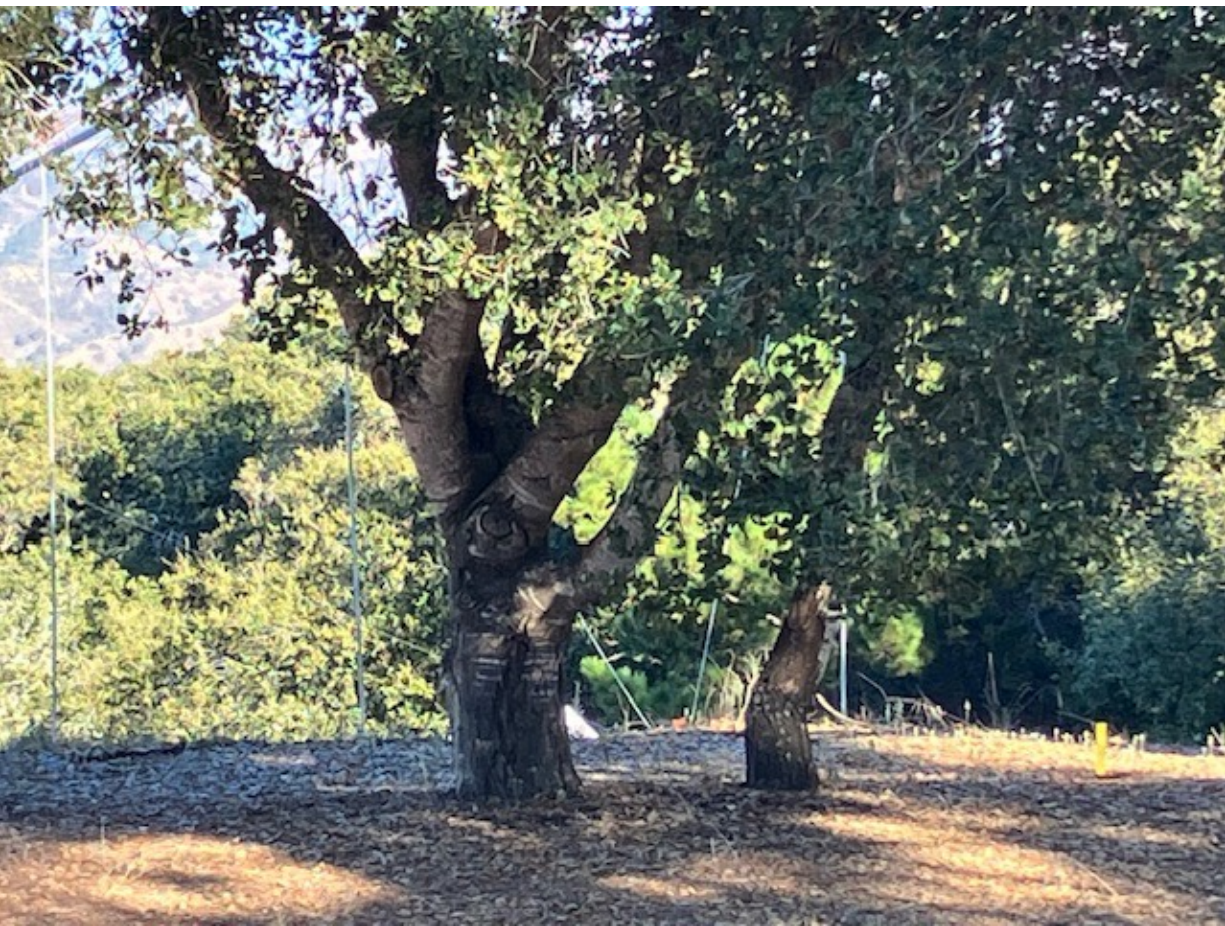
Figure 3. Two oaks proposed for removal. Tree#1 is to the left and Tree#2 is to the right.

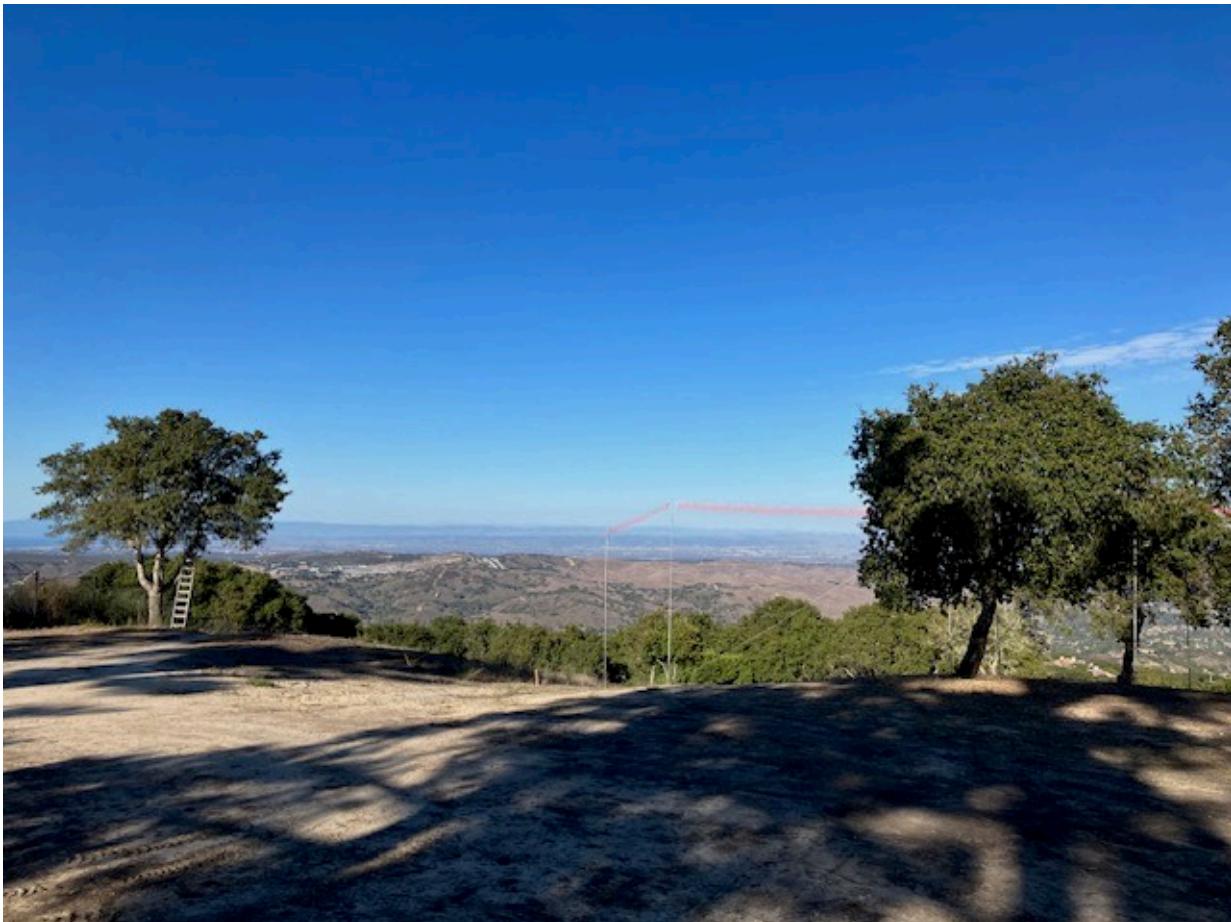
Figure 4. Proposed homesite and a few other oaks that will be retained and protected.

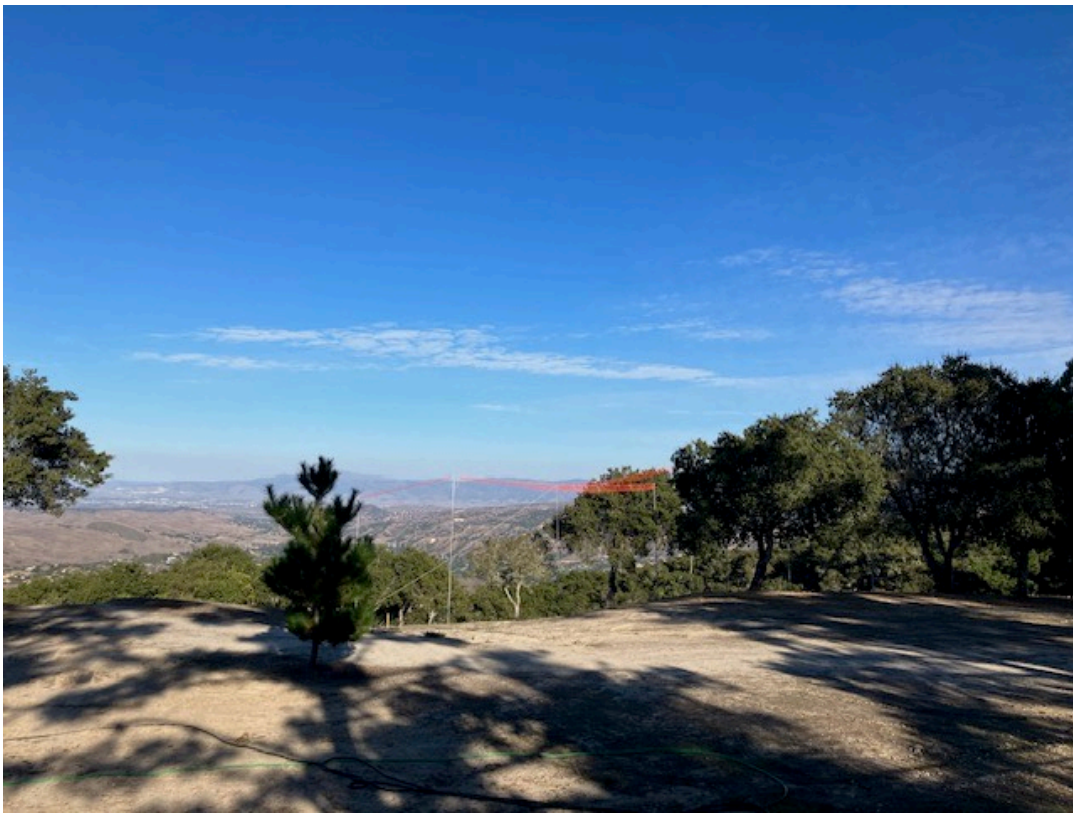
Figure 5. Another view of proposed homesite and trees that will be retained and protected.

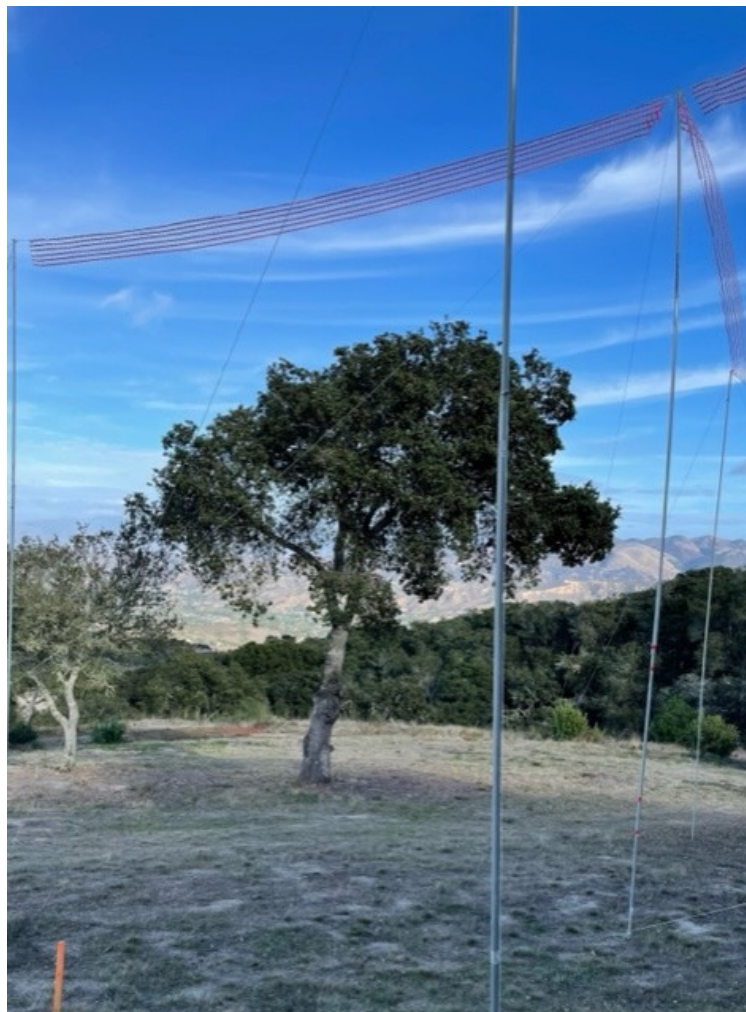
The relatively small and immature 13 inch DBH Coast Live Oak (*Quercus agrifolia*) identified as *Tree#3* on the construction site plans is planned for removal due to its proximity to the main house, which increases construction related impacts and elevates combustible fuel loads and wildland fire hazard concerns to the proposed home (refer to *Figure 6*). This oak has a height of approximately 15 feet and is in generally good physiological health and structural condition. Notable structural deficiencies include co-dominant stem attachments in the mid and upper-stem of the tree. Per County requirements, one 5 to 15-gallon replacement oak will need to be planted on the property to satisfy tree removal permit conditions.

Figure 6. The fairly small and immature oak identified as Tree#3 is also proposed for removal.
