103A Laguna Place
Amended Tree Resource Assessment
Forest Management Plan

July 3, 2024

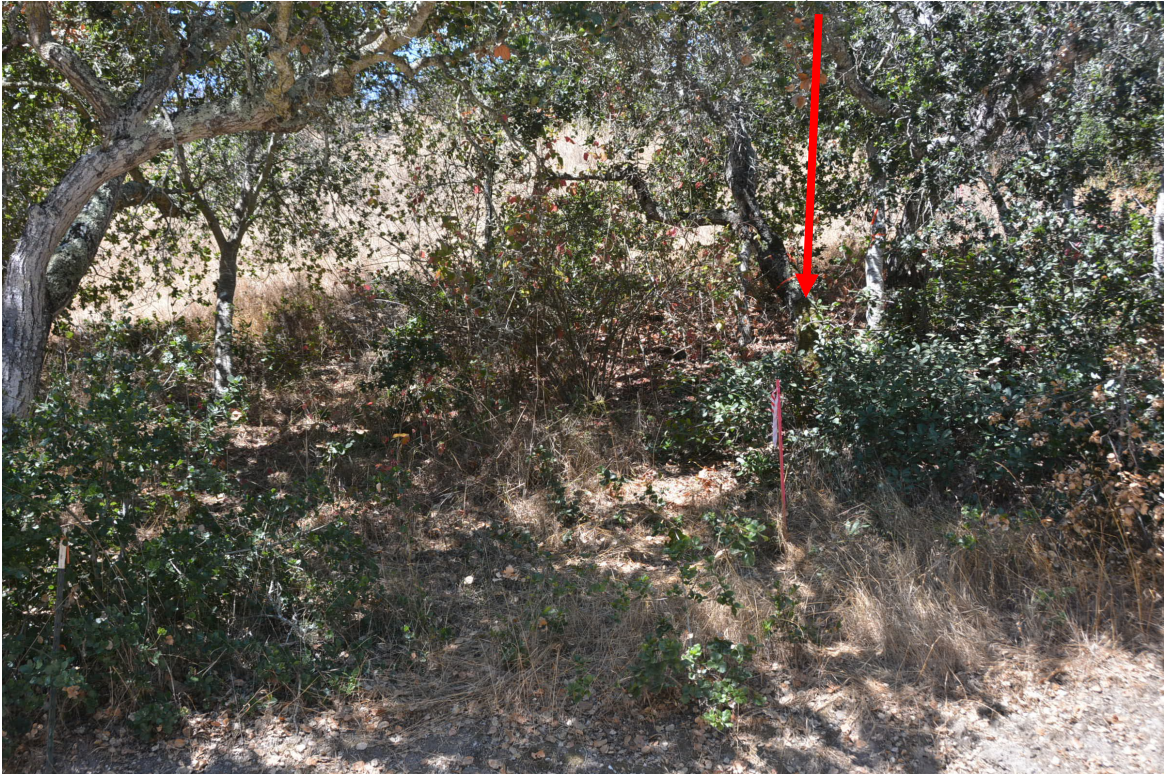
Site entrance –smaller diameter trees will need to be removed (2003)

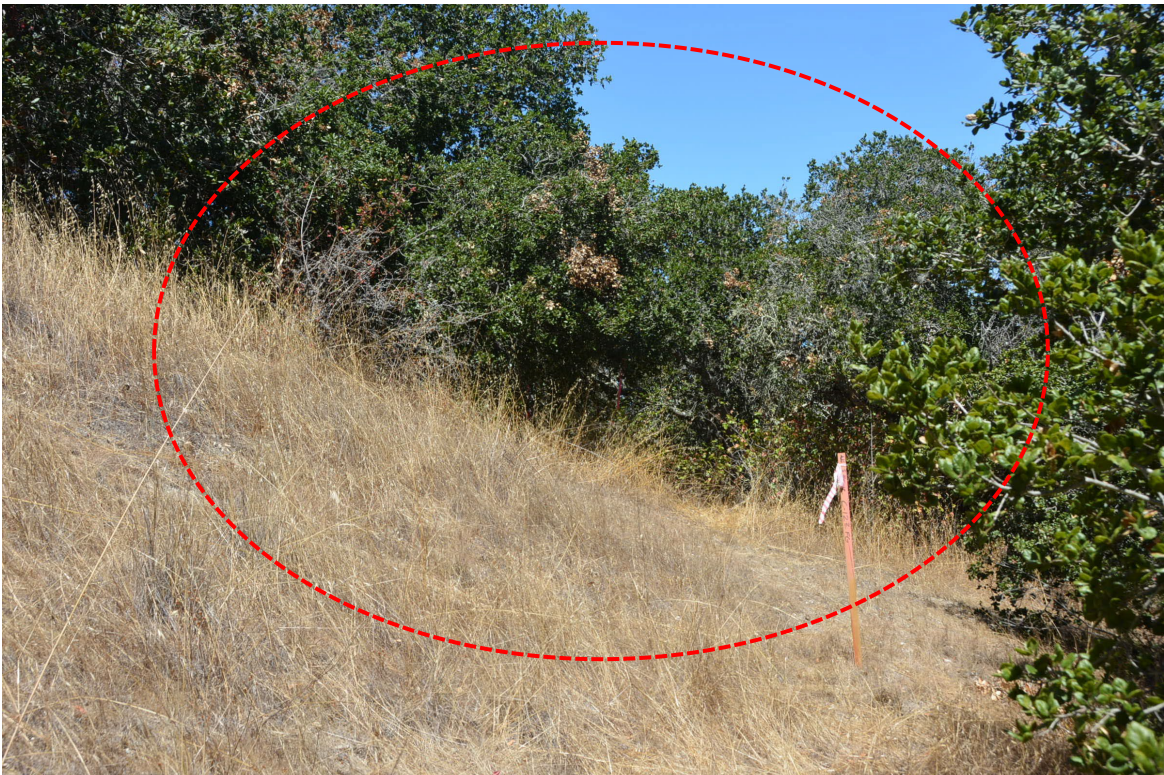
The site marker is the centerline of the roadway prism where trees will need to be removed. Pictured are #2006-#2009 to the left, tree #2005 is directly behind the marker.

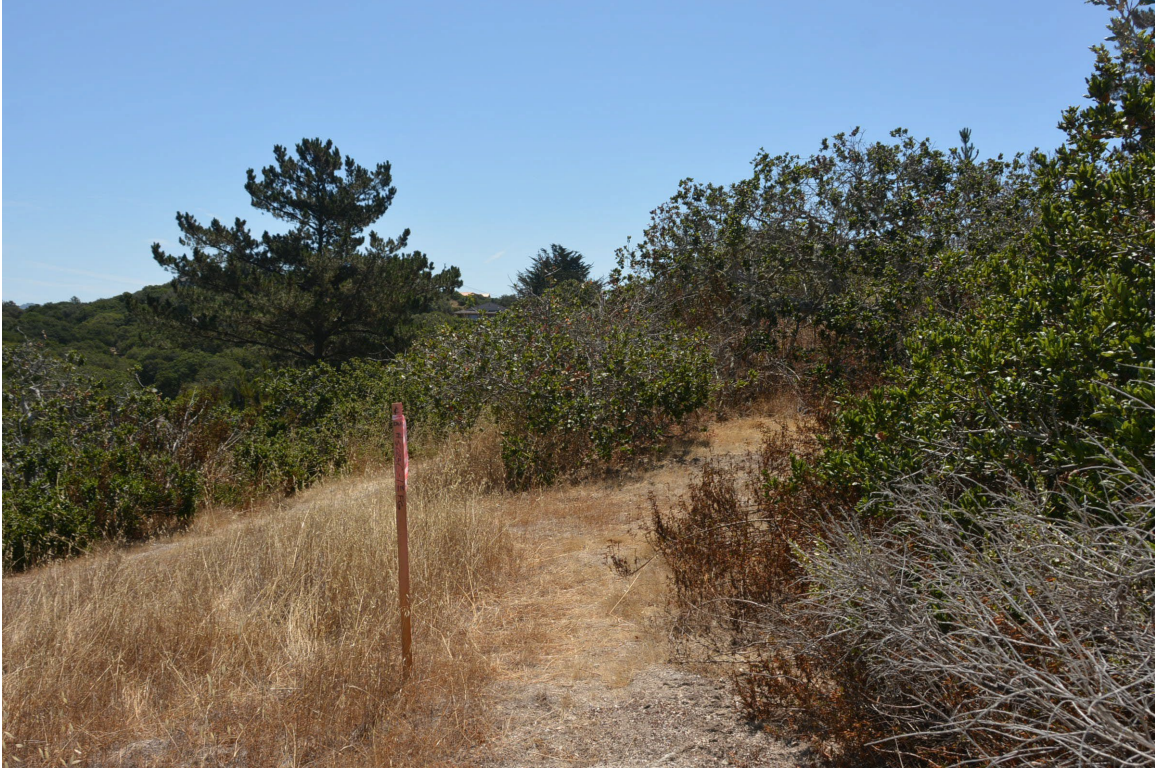
The upper slope road centerline will travel along tree line; tree #2017 is to the right.

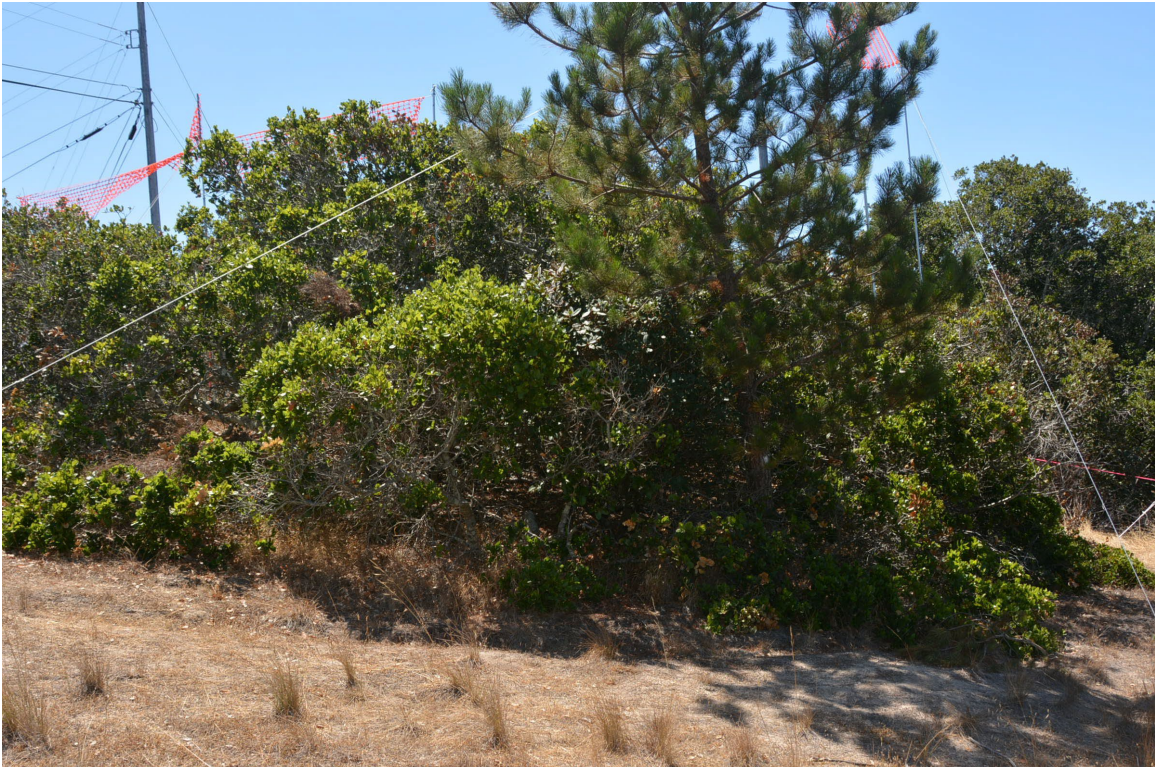
The area for the structure will require tree removal (pictured are trees #2027, 2028, and 2029)
