# Evans Residence Construction Impact Assessment and Forest Management Plan

May 2, 2024

1) Assessor's Parcel Number: 418-161-006-000

2) Location: 38793 Palo Colorado Road, Carmel CA 93923

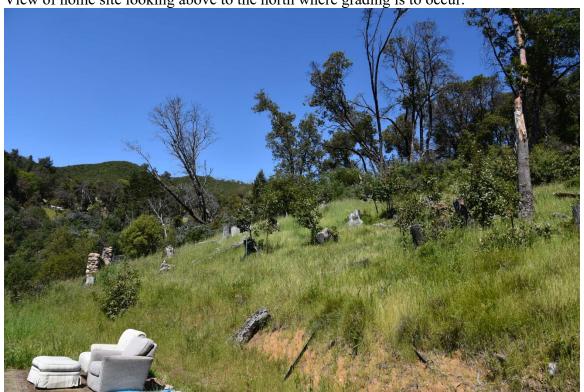
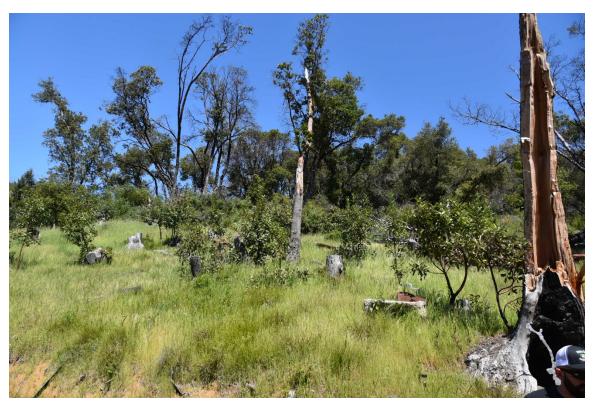
View of home site looking above to the north where grading is to occur.

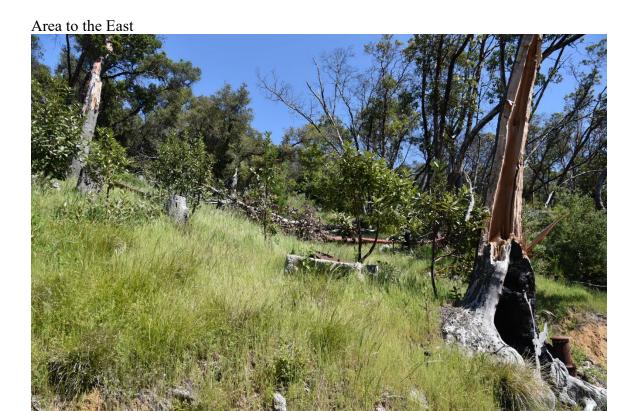
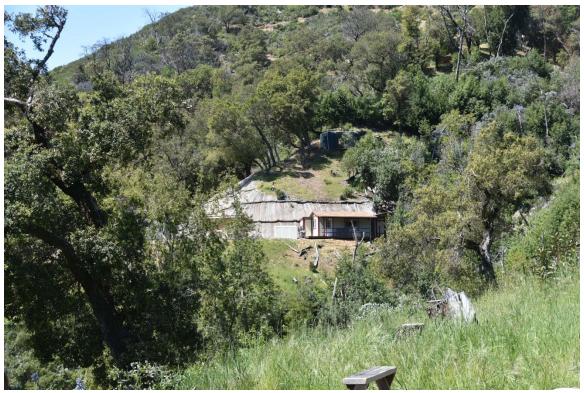
Area above the homesite with stumps and basal sprouts.
