## ***MON-1 Coastlands II Project***

## **Arborist Report**

On State Route 1 in Monterey County

Project Number 0521000188 / EA 05-1P210

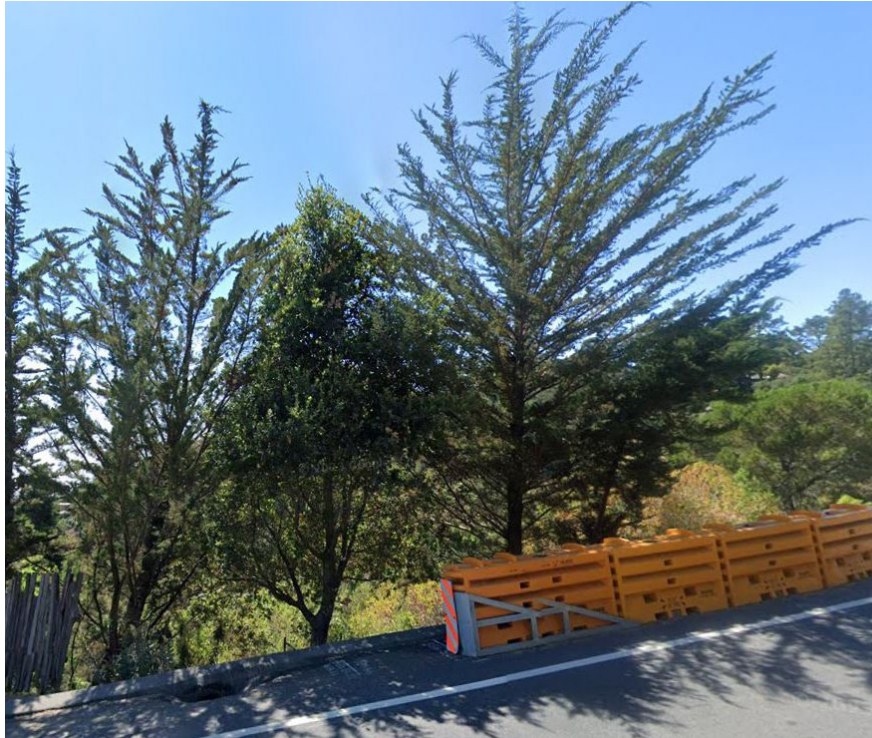
| Tree # | Botanical & Common Names | DBH | Native | Tree Health | Vigor | Crown Opacity | Notes |
|---|---|---|---|---|---|---|---|
| 4 | <i>Hesperocyparis macrocarpa</i><br>Monterey cypress | 7.75" | No | 2 | High | Low | Volunteer beneath crown of tree 3. Severe uncorrected lean |

Trees 1-4 (left to right). Viewed from the SR-1 northbound lane looking west. August 2023.

**Recommendations:** Remove all five Monterey cypress trees to facilitate the demolition of the failed timber wall and construction of the proposed soldier pile wall.

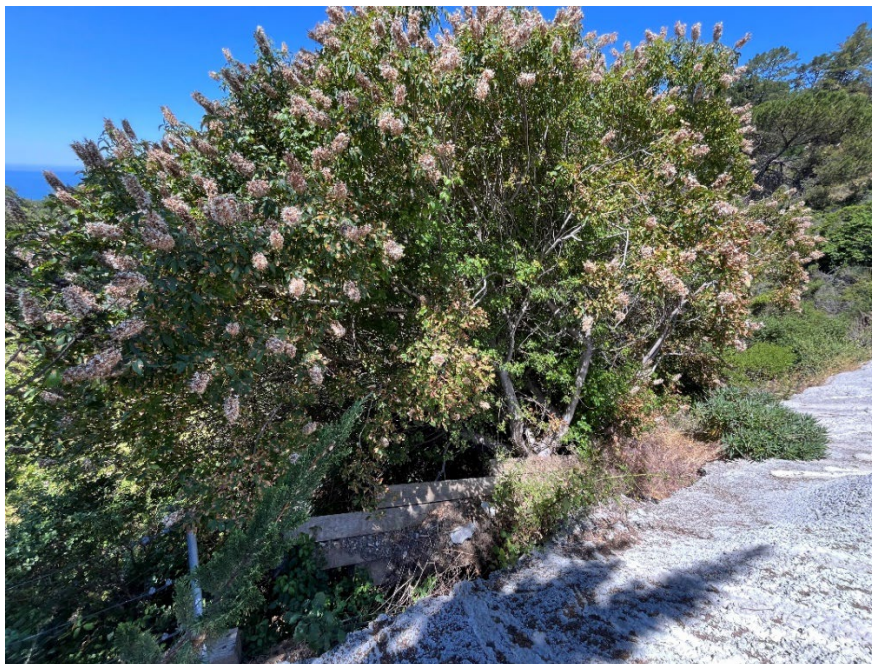
The failure of the southern portion of the existing timber retaining wall appears to be limited by the main stem of tree 5, which may be partially supporting the weight of the wall and retained soil. Mechanical bark damage is visible on the main stem from the initial impact of the wall with more damage suspected below the resting point of the wall on the main stem. Additionally, the tree appears to be leaning downslope from the weight of the timber wall and soil it is supporting. California buckeye is a deciduous tree that typically experiences summer dormancy, and sometimes full or partial winter dormancy. Early summer dormancy of just the foliage on the damaged side of the tree was visible during a July 2024 site visit, indicating stress. This may be traced back to the mechanical bark damage and the disruption of water and nutrient flows between the upslope portion of the crown and roots. It may also indicate damage to the upslope root system from the increased tension forces exerted on the main stem and roots from the weight of the resting retaining wall and soil.

| Tree # | Botanical & Common Names | DBH | Native | Tree Health | Vigor | Crown Opacity | Notes |
|---|---|---|---|---|---|---|---|
| 5 | <i>Aesculus californica</i><br>California buckeye | 10" | Yes | 2 | Mod. | Low | Large wound on main stem from timber wall failure |

Tree 5. Viewed from the southbound shoulder looking west. July 2024.

**Recommendations:** Remove the damaged California buckeye tree to facilitate the demolition of the failed timber wall and construction of the proposed soldier pile wall.

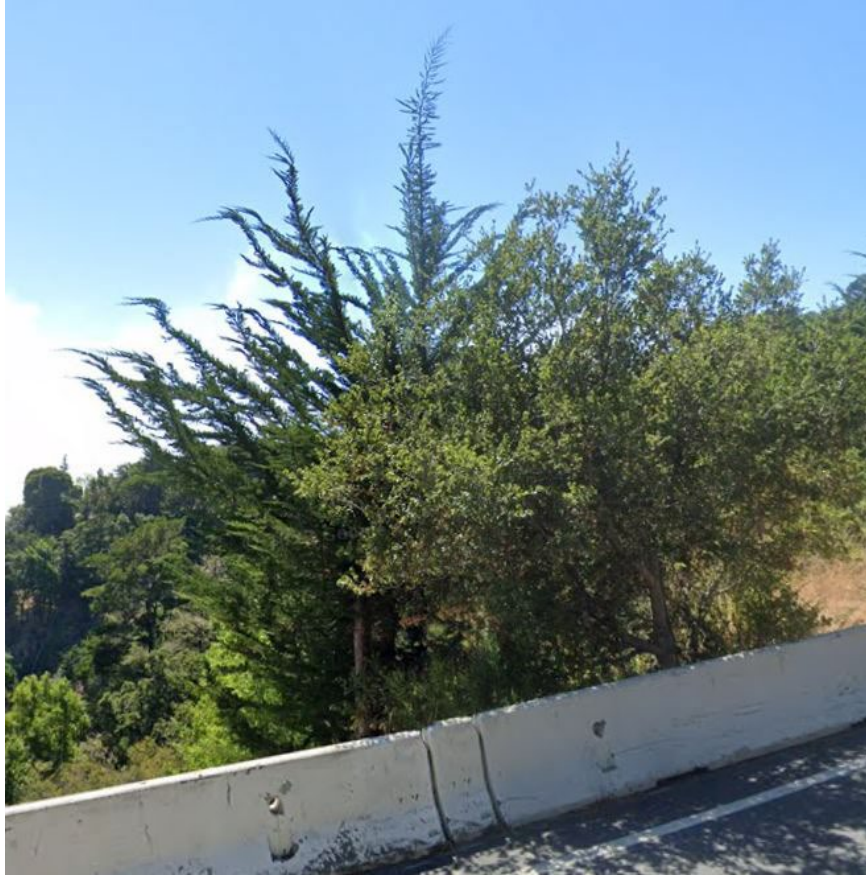
| Tree # | Botanical & Common Names | DBH | Native | Tree Health | Vigor | Crown Opacity | Notes |
|---|---|---|---|---|---|---|---|
| 7 | <i>Quercus agrifolia</i><br>coast live oak | 5" | Yes | 3 | Mod. | Mod. | Severely crowded by trees 6 & 7 |
| 8 | <i>Hesperocyparis macrocarpa</i><br>Monterey cypress | 4" | No | 2 | High | Low | Volunteer beneath crown of tree 6. Severe uncorrected lean |

Trees 6-8 (left to right). Viewed from the northbound lane looking west. August 2023.

**Recommendations:** Remove both coast live oak trees to facilitate the demolition of the failed timber wall and construction of the proposed soldier pile wall.
