# Exhibit D

June 13, 2024

Tromp Residence  
6820 Long Valley Spur  
Castroville, CA. 95012  
APN: 129-201-052-000

Subject: 6820 Long Valley Spur Pre-construction Tree Impact Assessment

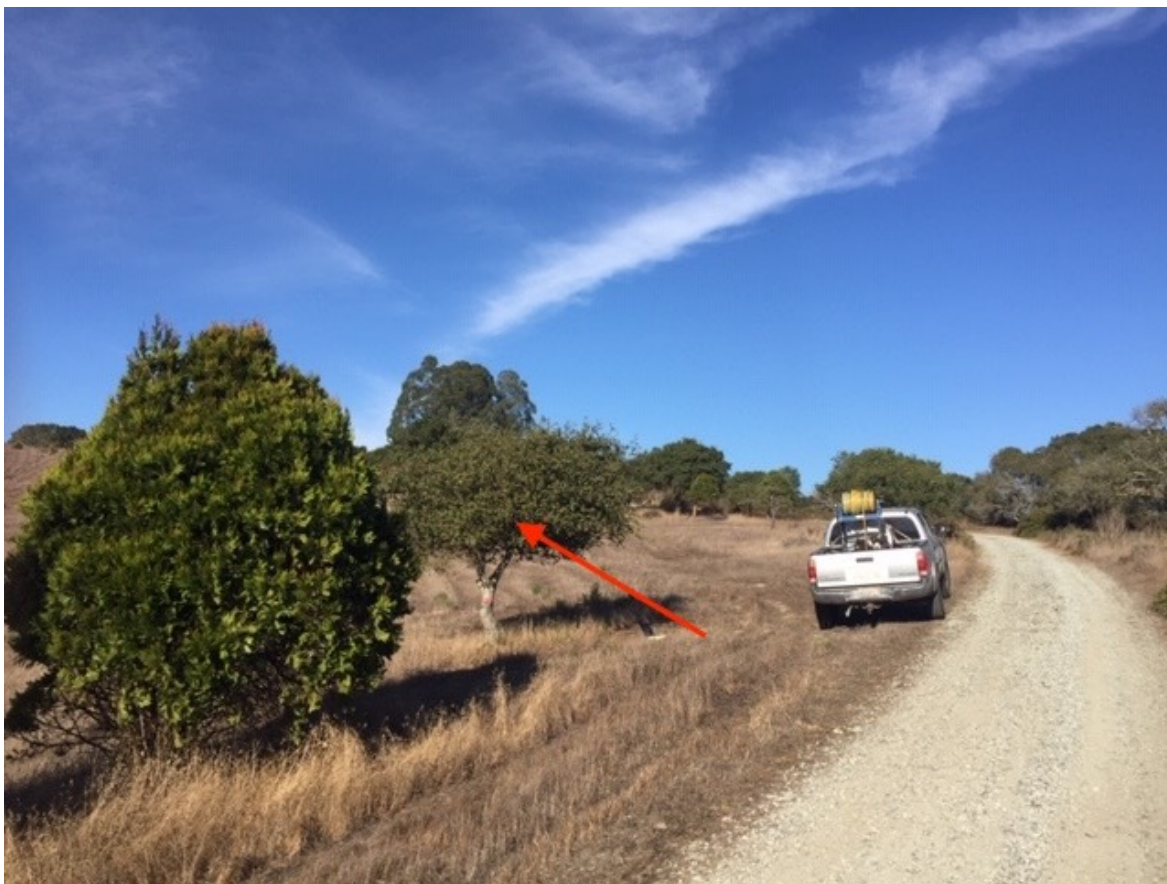
The coast live oak identified as *Tree#1* on the project site plans is a small and immature 7 inch DBH tree with a height of approximately 8 feet (refer to *Figures 1 & 3*). This insignificant oak is proposed for removal due to its location directly adjacent to grading activities for proposed driveway improvements. This fairly young oak is in overall fair to good health and condition with no significant biotic disorders and/or physiological deficiencies and structural defects observed. Per *Monterey County Housing & Community Development Department-Planning Services* tree removal permit conditions, one 1 to 15-gallon coast live oak tree will need to be planted and survive a one-year monitoring period.

Figure 1. Oak identified as Tree#1 (red arrow) is proposed for removal due to driveway turnout that will be installed. Small non-native cedar tree is occurring in left foreground.

In regards to tree replacement, a total of two (2) 1 to 15-gallon container size coast live oak (*Quercus agrifolia*) replacement seedlings or saplings (container size depends on the health, quality and availability of nursery stock) of good physiological health and structural condition shall be planted on the subject property to replace the 2 removed oaks and to comply with *Monterey County* tree removal permit conditions. Proper implementation of this tree replacement action will mitigate tree removal impacts and will assist in supporting and sustaining the health, viability and character of oak woodland habitat. Successful completion of this *Monterey County Housing & Community Development Department-Planning Services* tree removal permit condition shall be achieved when the 2 replacement plantings survive a one-year monitoring period.

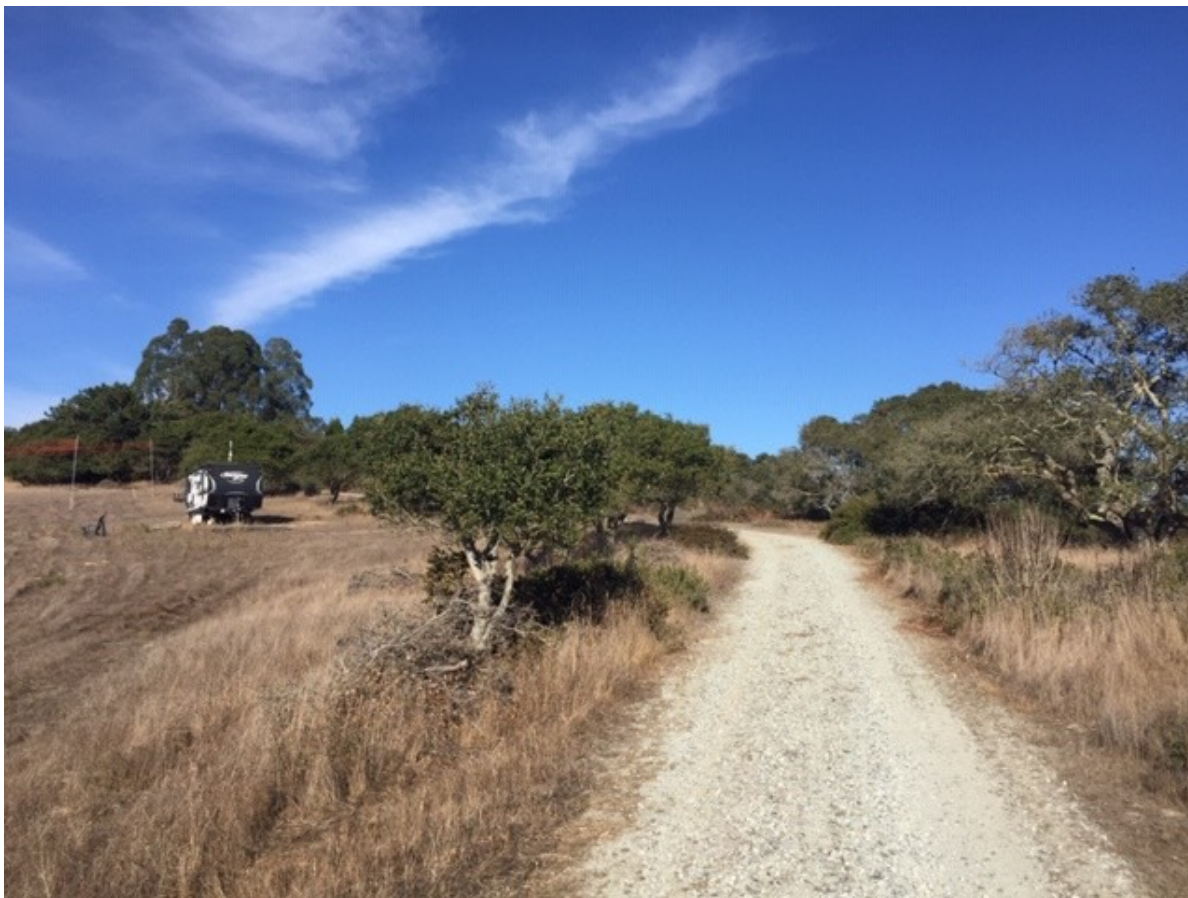
Figure 2. New all-weather aggregate driveway will use existing driveway route, but will need to be widened. Oaks in photo will be retained.

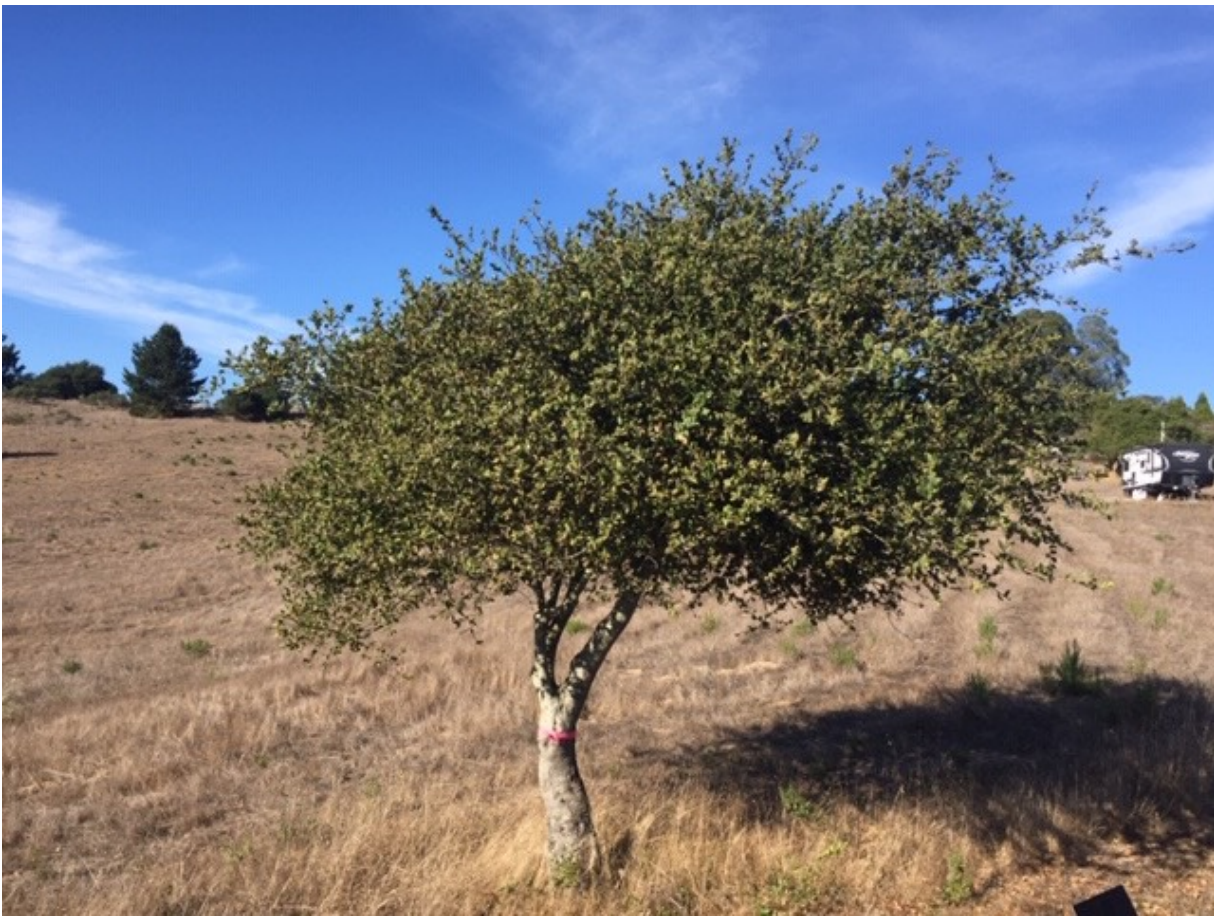
Figure 3. Small and immature oak identified as Tree#1 is proposed for removal due to planned driveway improvements.

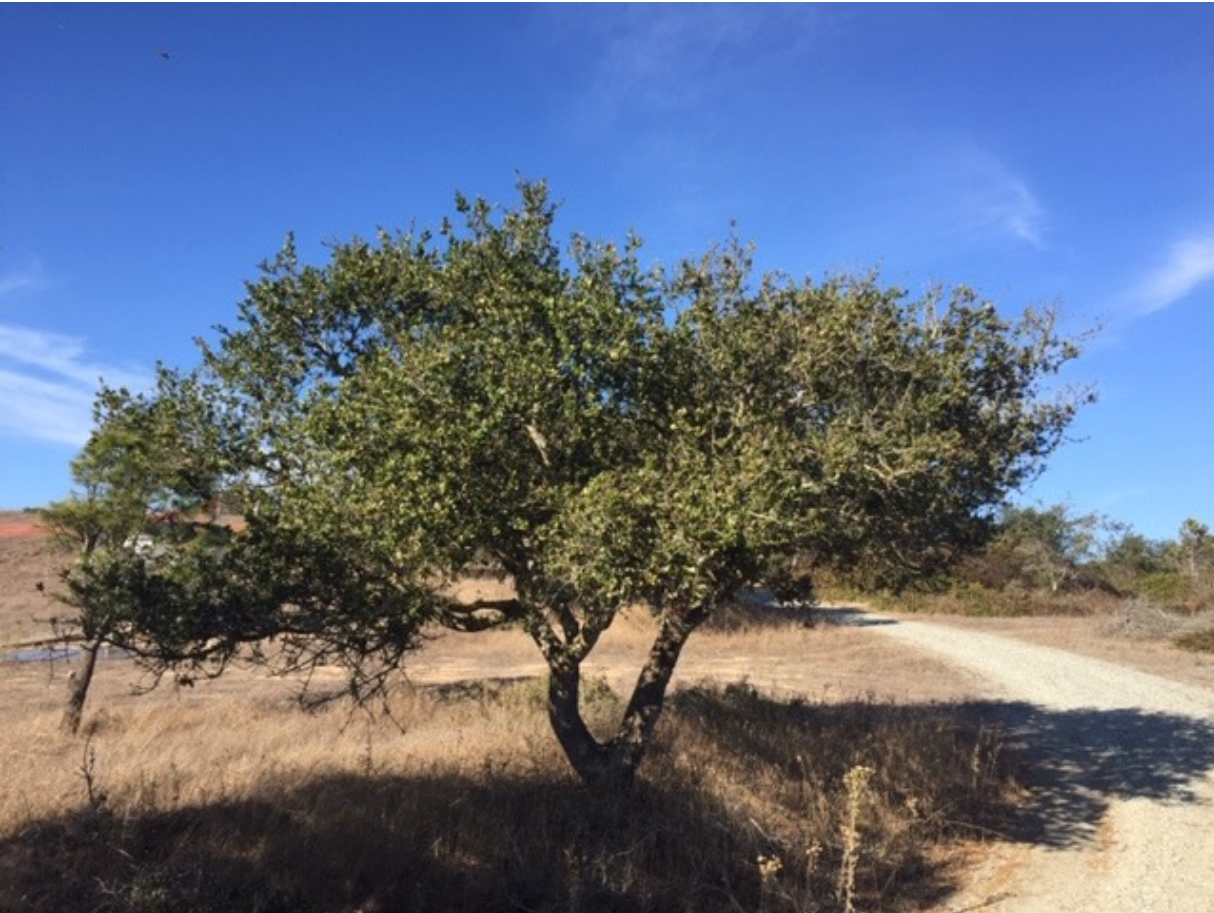
The coast live oak identified as *Tree#2* on the project site plans is a small and immature 10 inch DBH tree with a height of approximately 9 feet (refer to *Figure 4*). As with *Tree#1*, this oak is proposed for removal due to its location directly adjacent to grading activities for proposed driveway improvements. This fairly young oak is also in fair to good health and condition with no significant biotic disorders and/or physiological deficiencies and structural defects observed. Per *Monterey County Housing & Community Development Department-Planning Services* tree removal permit conditions, one 1 to 15-gallon coast live oak tree will need to be planted and survive a one-year monitoring period.

Figure 4. Small and immature oak identified as Tree#2 is proposed for removal due to planned driveway improvements.

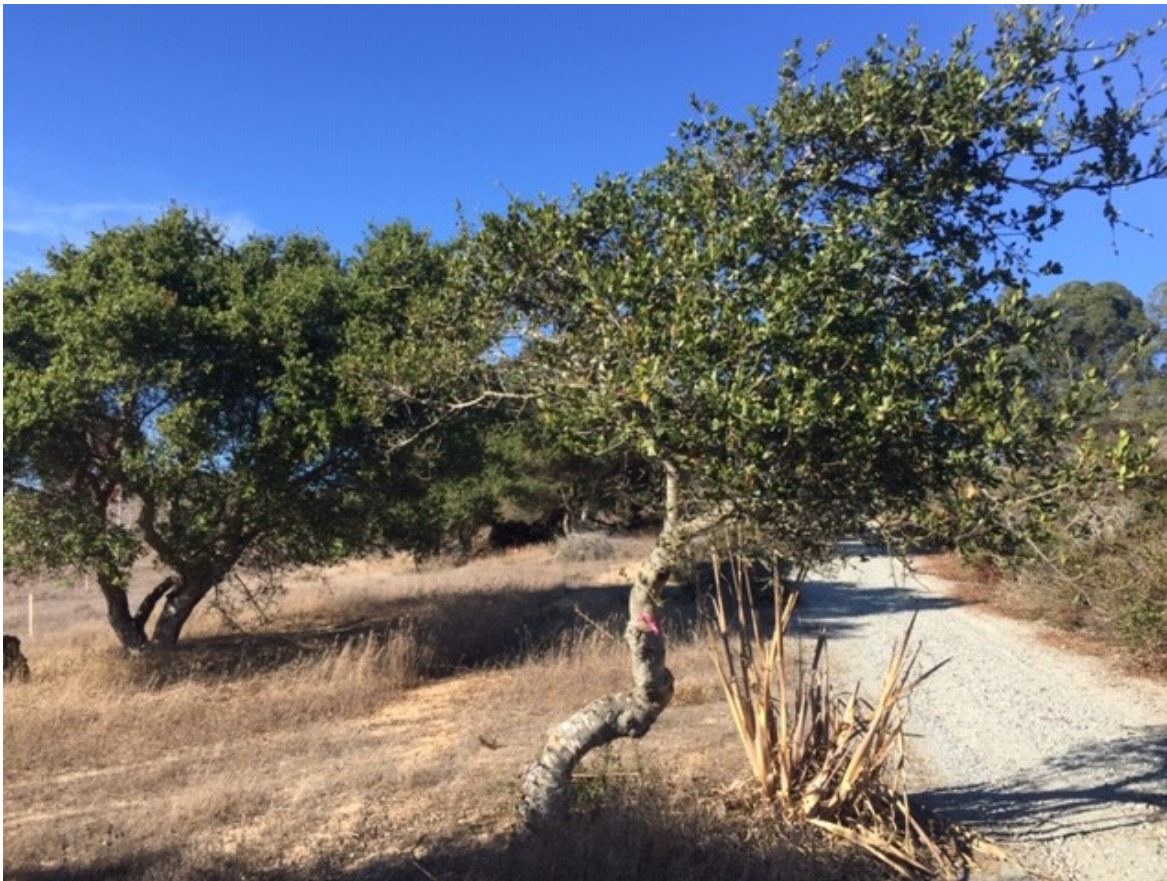
Figure 5. Another small and immature oak identified as Tree#3 was previously proposed for removal due to planned driveway improvements, but will now be retained due to a design change in the driveway. A small exotic invasive jubata grass plant is to the right of the oak next to the road. Oak to the back left will be retained & protected.

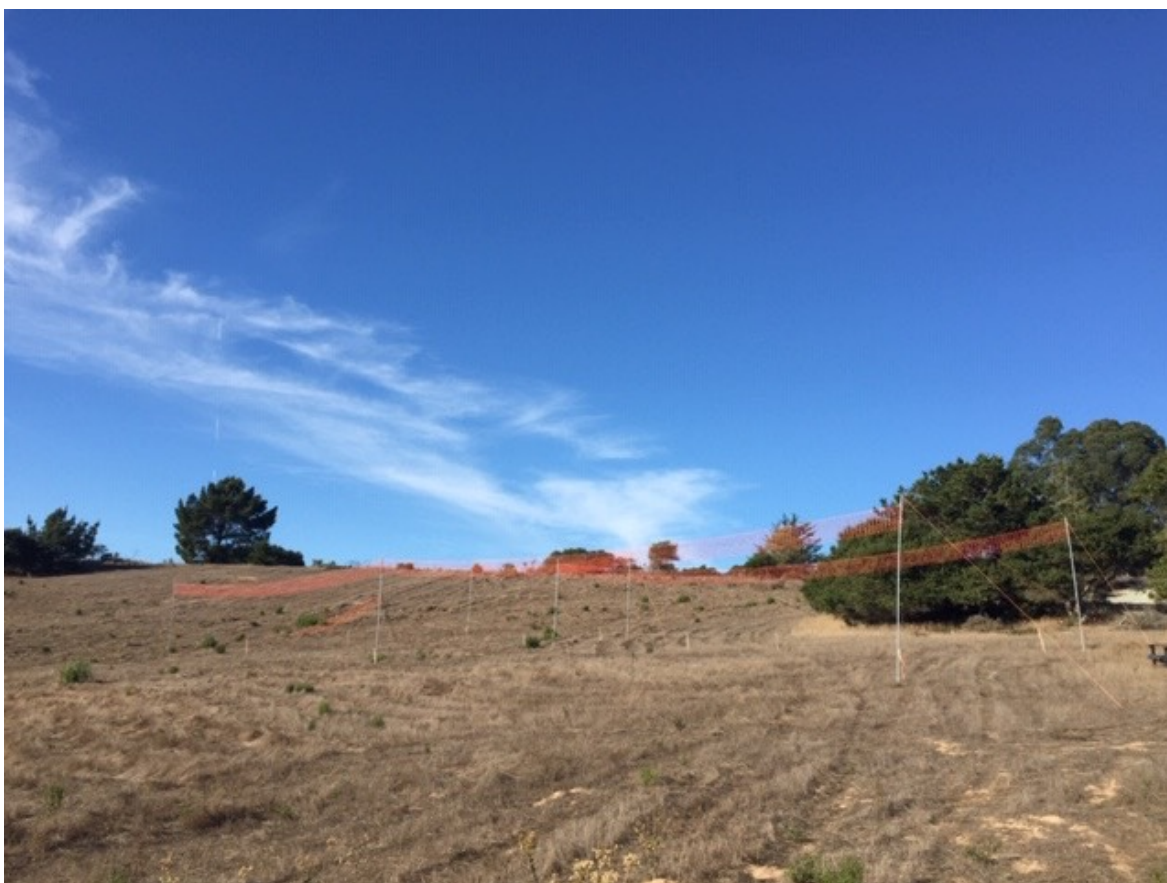
Figure 6. Proposed homesite located in previously disturbed annual grassland.

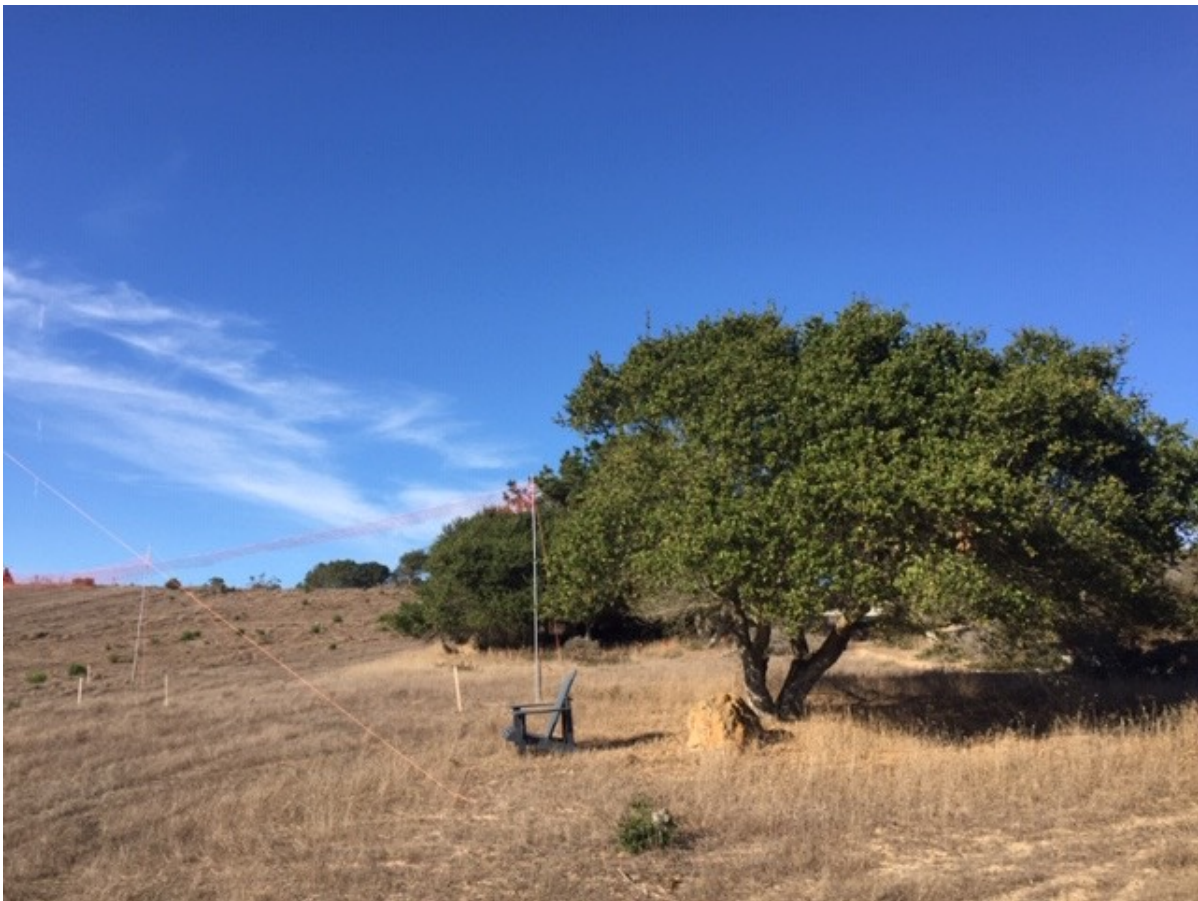
Figure 7. Larger and more mature oaks near home construction site will be protected and are not expected to be significantly impacted by home construction activities.

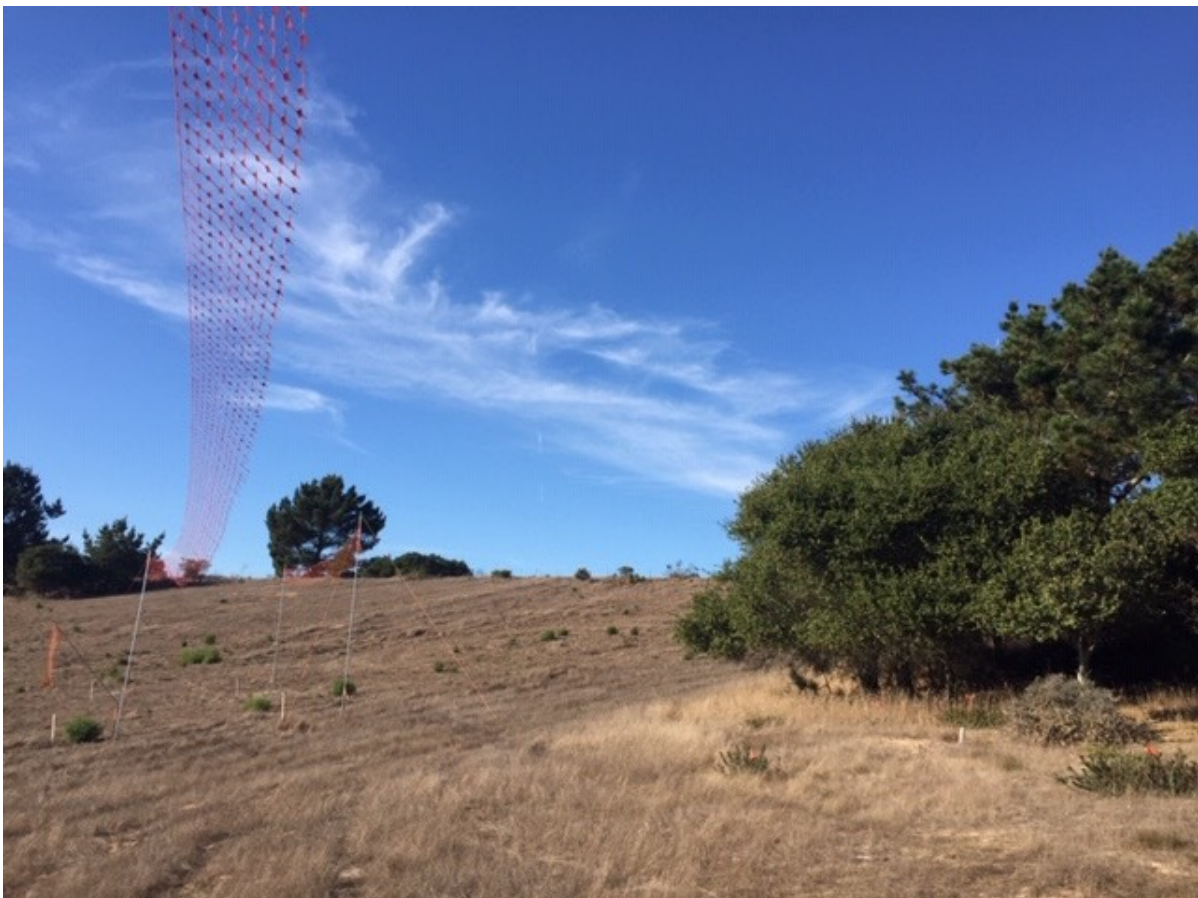
Figure 8. Oaks near homesite will be protected with tree protection fencing.

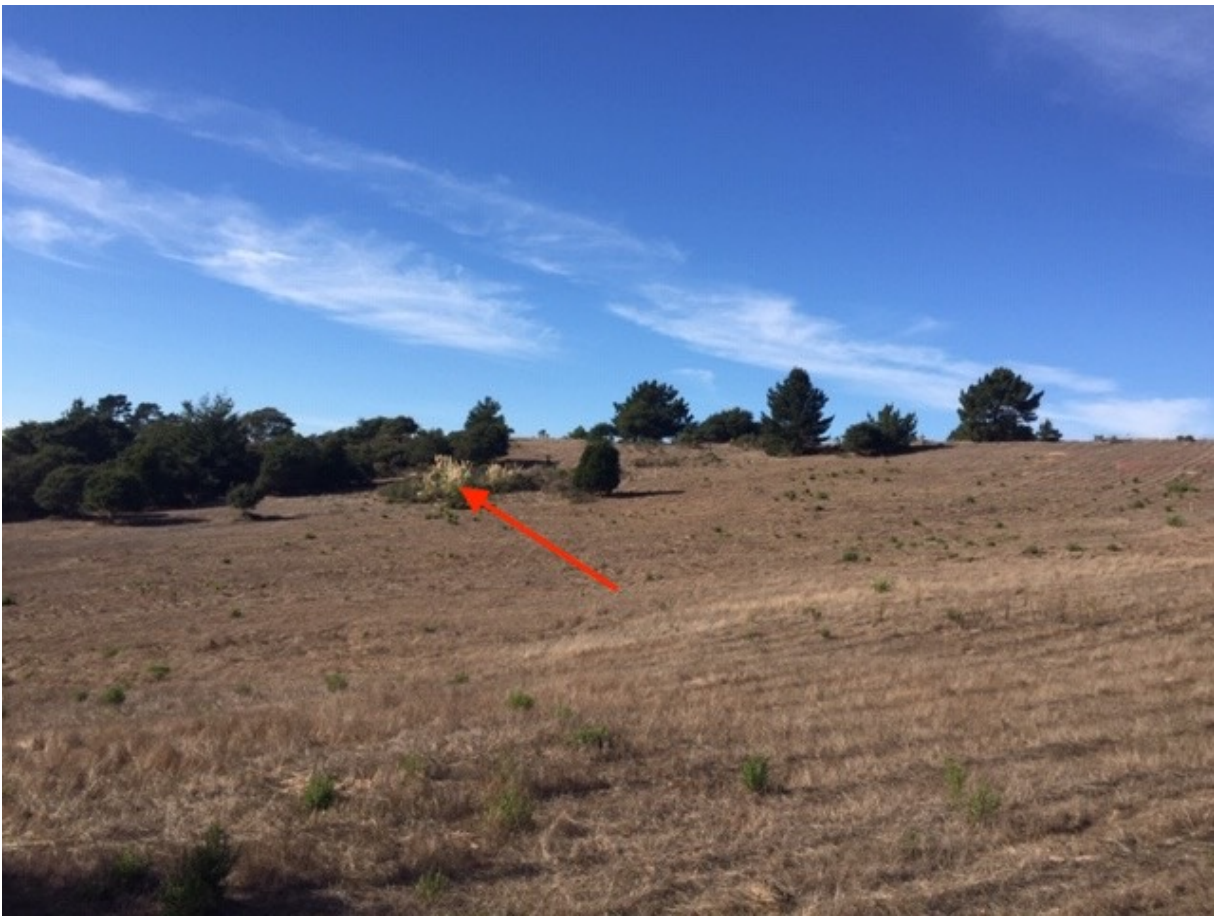
Figure 9. Large annual grassland area near home. Red arrow shows location of non-native invasive jubata grass population.

include several species of exotic grasses (e.g., jubata/pampas grass, wild oat grass, ripgut brome, foxtail brome and Italian ryegrass, among others) and broadleaf invasive weeds (e.g., Italian thistle, bull thistle, French broom and maltese star-thistle, among others). Non-native invasive weeds are degrading to habitat and increase combustible fuel loads, and, where possible, should be controlled, managed and eradicated.

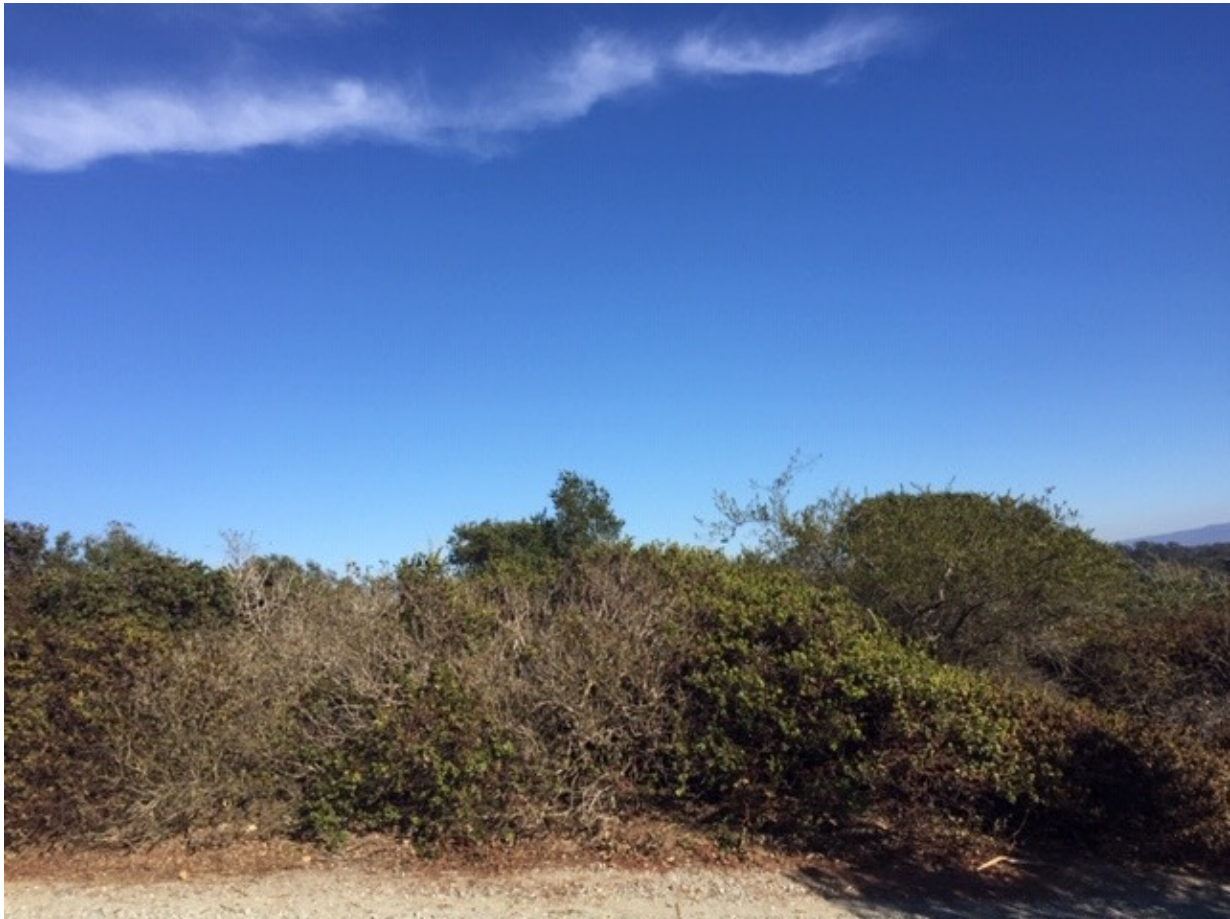
Figure 10. Densely vegetated chaparral habitat to the east of proposed driveway is largely composed of manzanita.
