GEOLOGIC EVALUATION OF FAULT HAZARD  
PROPOSED RESIDENCE FOR CODDING/MAXWELL  
21 PRONGHORN RUN  
SANTA LUCIA PRESERVE  
MONTEREY COUNTY, CALIFORNIA

October 16, 2023

October 16, 2023  
Project: G-896.1

Subject: Geologic Evaluation of Faulting

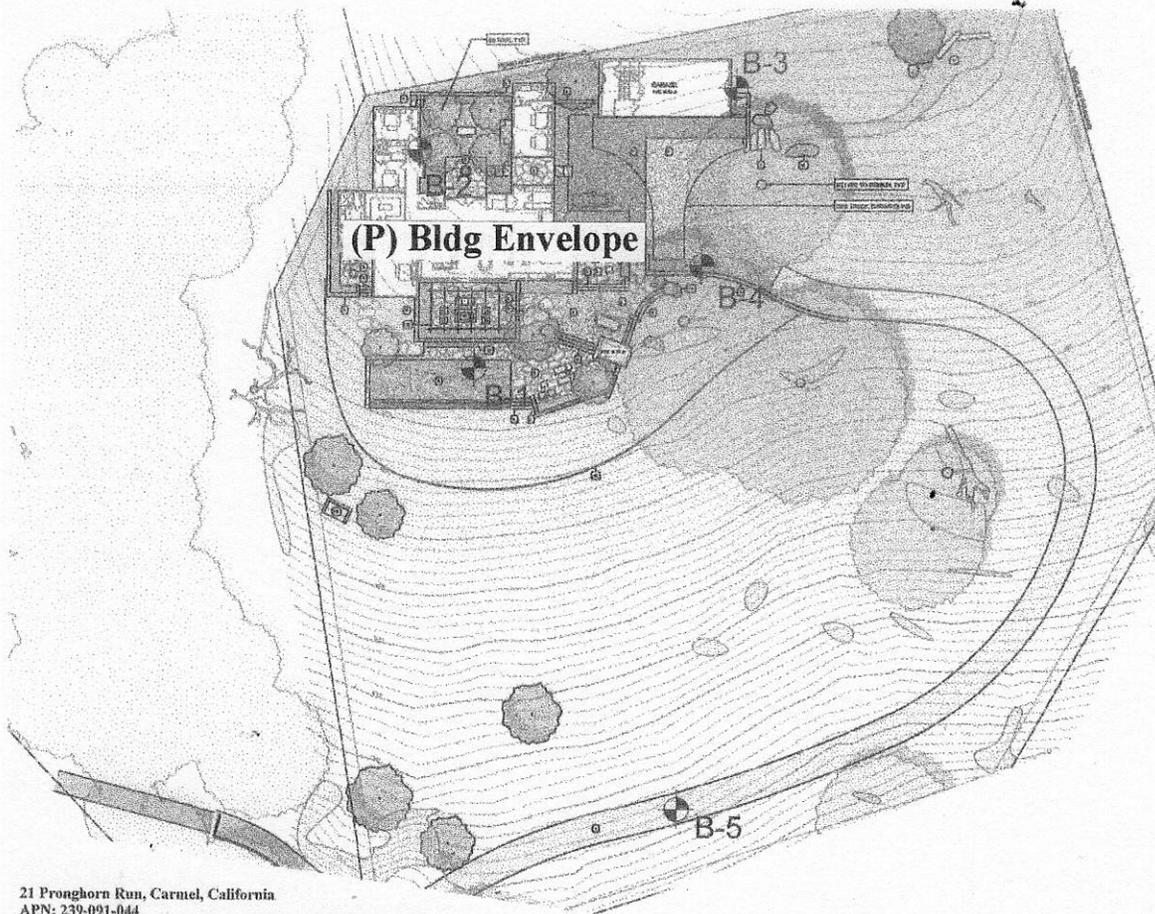
# Building Envelope Map

Soil Surveys Group, Inc. (“SSG”) conducted a geotechnical investigation of the site which included five exploratory borings in the general building envelope area in February of 2023. Their field investigation consisted of advancing, logging and sampling within four exploratory borings which ranged in depth from 3.5 feet (B-5) to 16.58 feet (B-1) below the nearest adjacent ground surface. Their borings encountered a surficial layer of residual soil (1.5 to 2 feet thick) overlying sandstone bedrock (“Tts”). The SSG field logs characterize the bedrock formation as silty and clayey sand of a very dense condition. Field (geotechnical) blow counts obtained within the Tts geologic unit typically produced blow counts that fall within the range of practical sampling refusal ( $N_{60} = 100$  blows per foot). All of their borings were bottomed within the Tts geologic unit. Copies of the HKA graphic boring logs are included in Appendix B of this report.

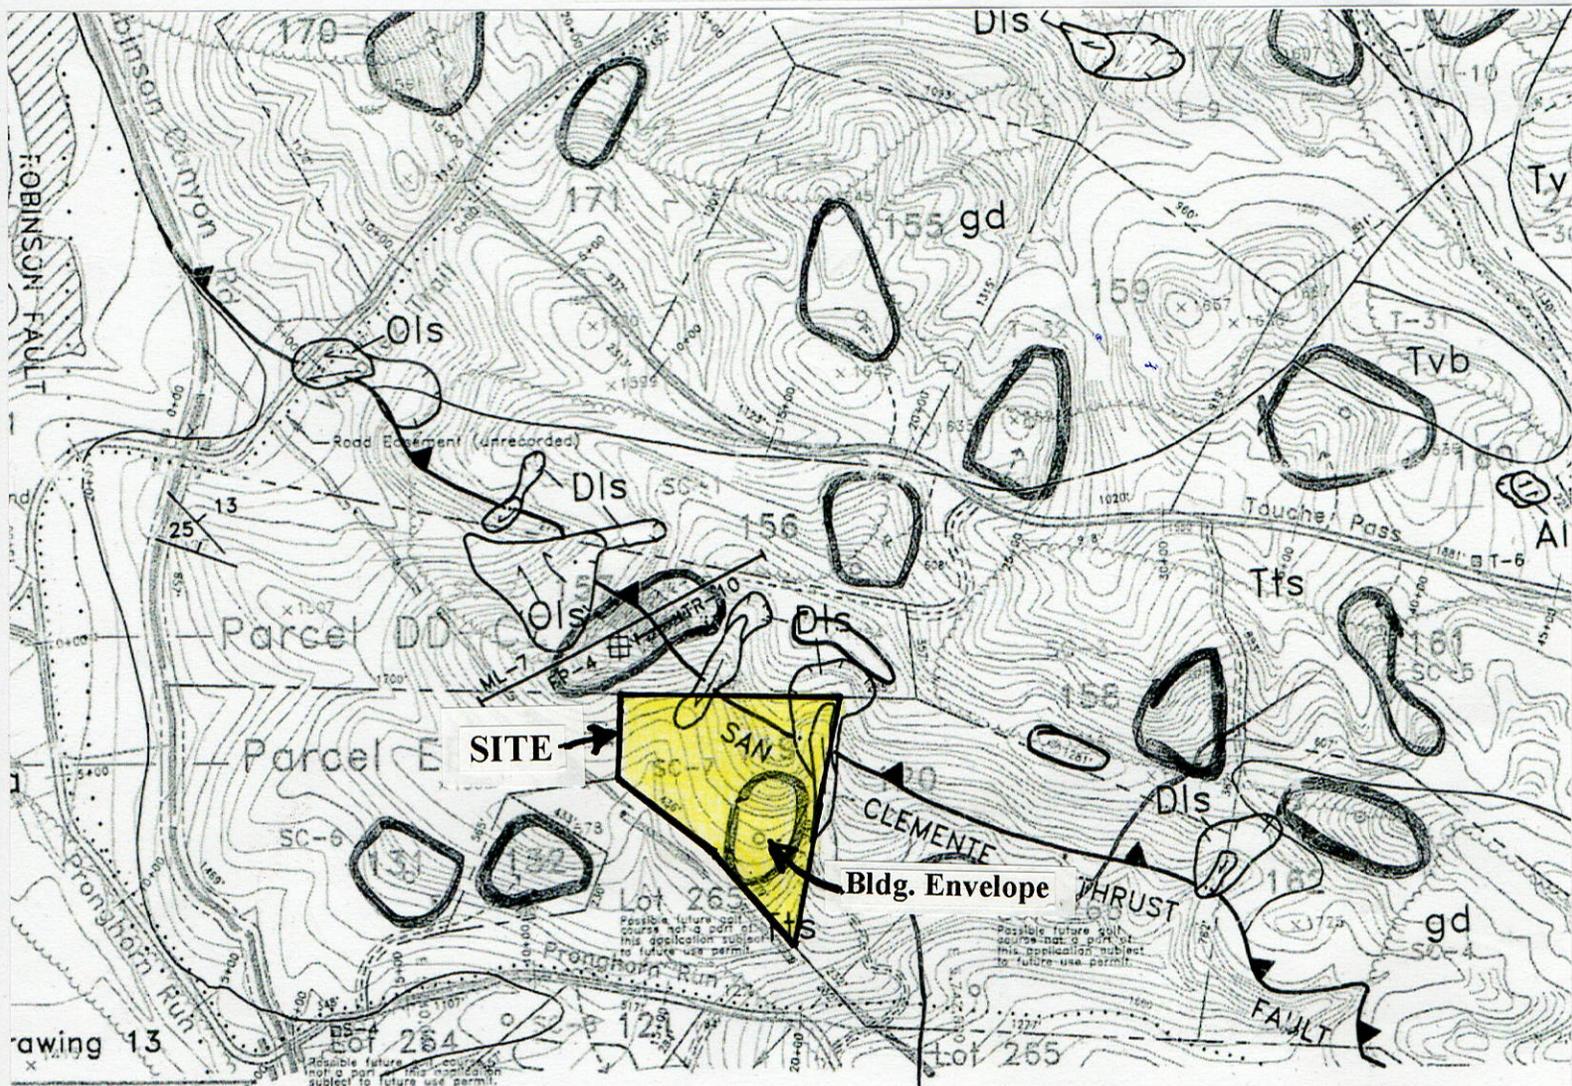
# Local Geologic Map

that has been conducted in the vicinity. The Local Geologic Map (Appendix A) is a partial reproduction of Cleary Consultants geologic map. The map of Cleary (1994) suggests the building envelope area is underlain by a Miocene age sandstone unit (geologic symbol “Tts”). A Cretaceous granodiorite bedrock unit (geologic symbol “gd”) is shown to be underlying the northern portion of the parcel (see report section on Faulting, and Local Geologic Map in Appendix A).

Our research, site reconnaissance, review of previous subsurface data and our review of LiDAR Hillshade imagery did not reveal any evidence indicative of the presence of faults at or immediately adjacent to the building envelope. During our reconnaissance we noted sandstone detritus containing subrounded clasts at the ground surface locally in the general building envelope area. Over 200 feet upslope of the building pad area we noted a large granitic bedrock outcrop exposed at the ground surface which is associated with a pronounced topographic slope break at the downslope limits of the granitic outcrop and sandstone is exposed locally at the ground surface just below this slope break. Because the fault is defined as juxtaposing the Tts geologic unit on the south, against the gd geologic unit on the north, we infer that the fault is located at or just downslope of the slope break. This location for the fault is generally consistent with the mapping of Cleary Consultants (1994) and is shown on the figures titled Local Geologic Map and County Fault Map (Appendix A).

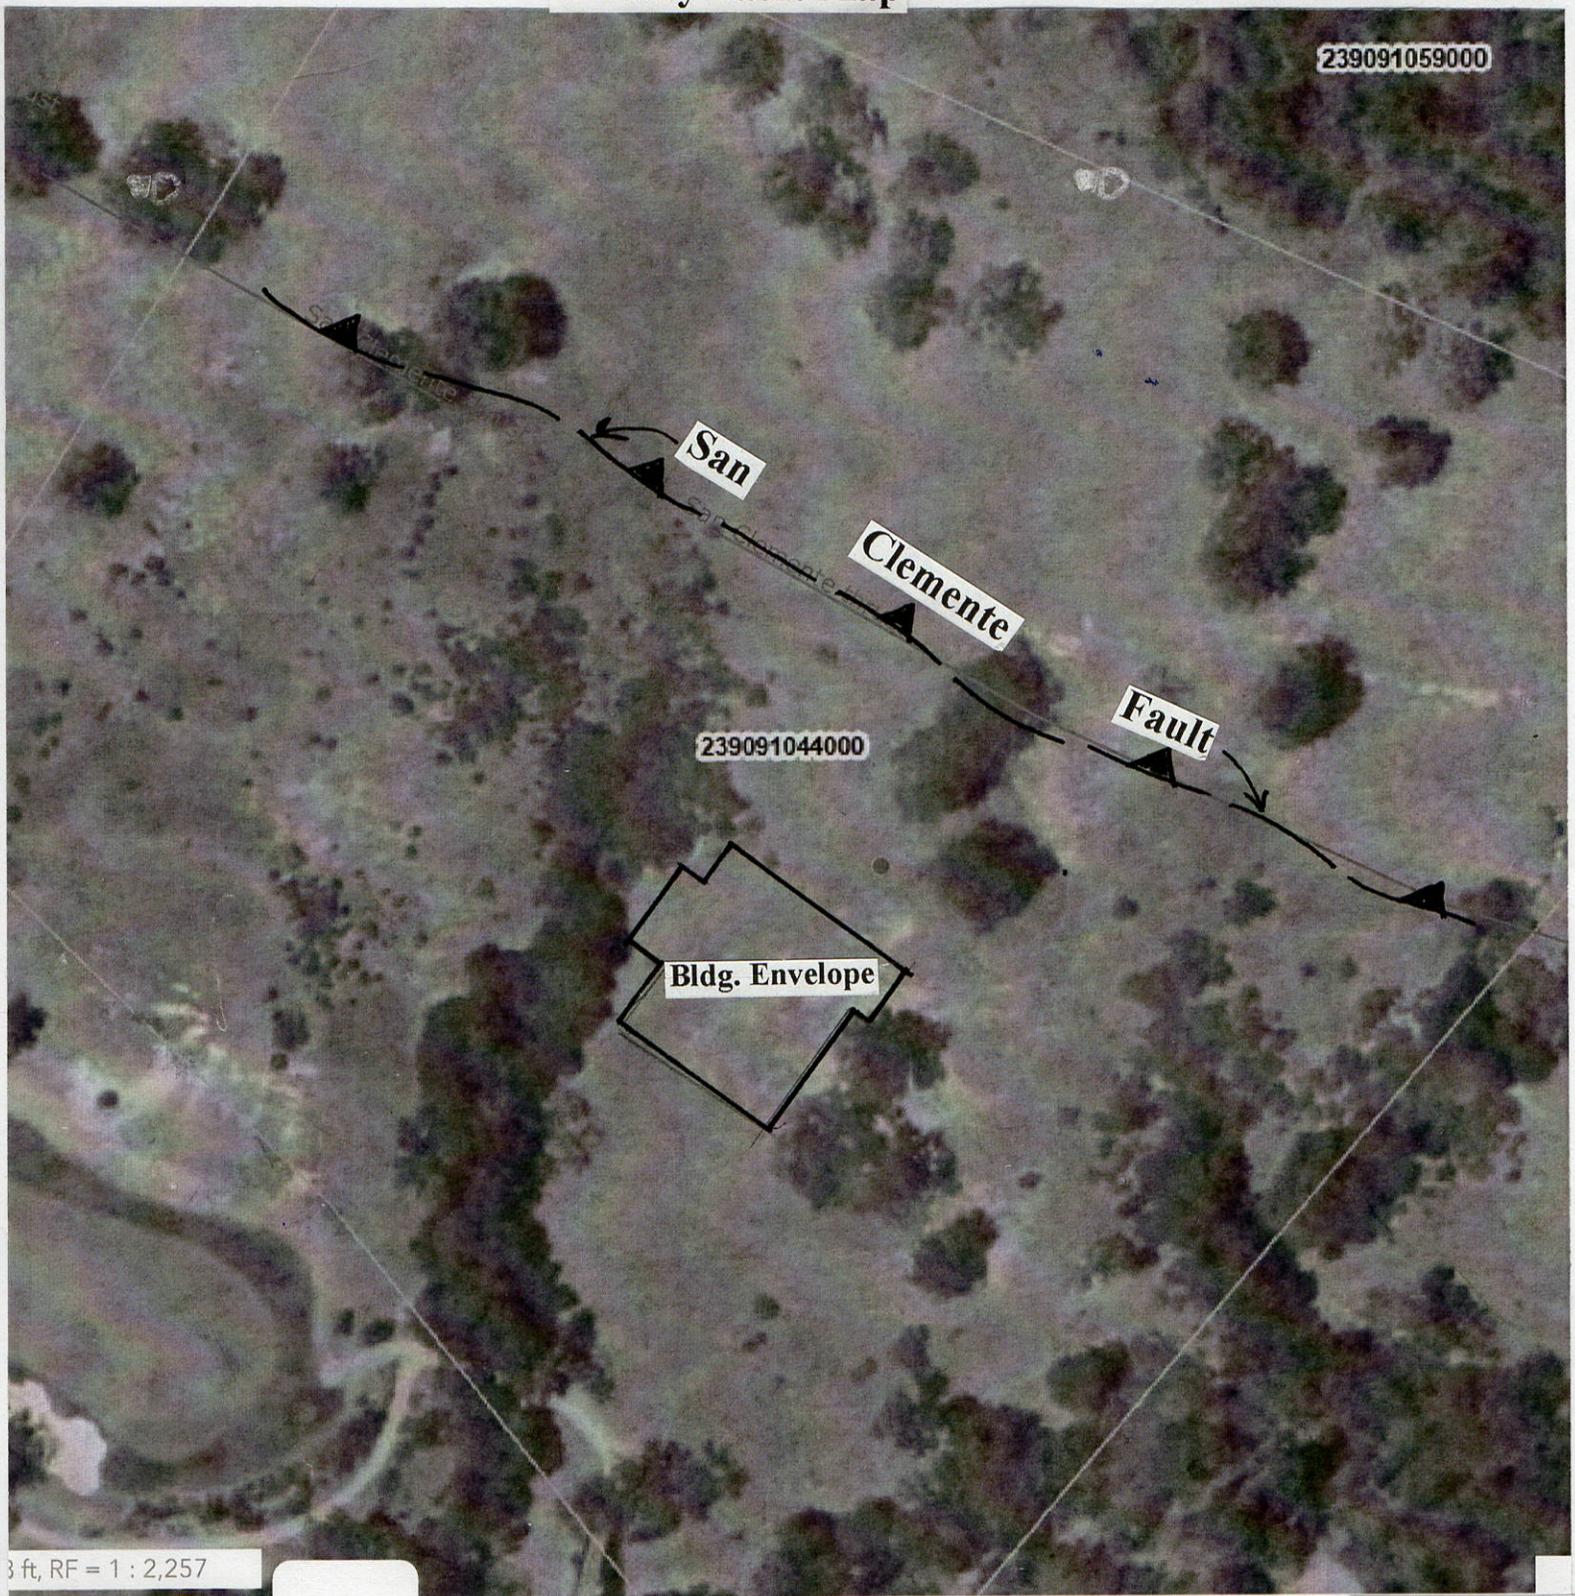
# County Fault Map

We understand that the Monterey County Planning Department is requiring a fault evaluation for the proposed project due to the fact that the parcel is located within a county fault hazard regulatory zone due to the mapping of the San Clemente Fault trending through the property (see County Fault Map, Appendix A). The scope of work included but is not necessarily limited to; review of available geologic and geotechnical reports and maps, a review of stereo aerial photo pairs covering the site area, geologic mapping of the site and evaluation of the data collected and preparation of this report.

Based on the information obtained during this geologic evaluation, we have concluded that the residential building pad is not transected by a fault. All evidence indicates the San Clemente Fault is located approximately 230 feet north of the building pad area. It is our professional opinion that the proposed residence is not potentially impacted by the hazard of fault surface rupture.
