March 8, 2022

RE: Oak Restoration and Forest Management Plan – 146 Vega Road
APNs: 117-471-003-000, 117-471-004-000, 117-471-006-000. 117-471-007-000,
and 117-471-016-000

Oak Restoration/ Forest Management Plan 146 Vega Road

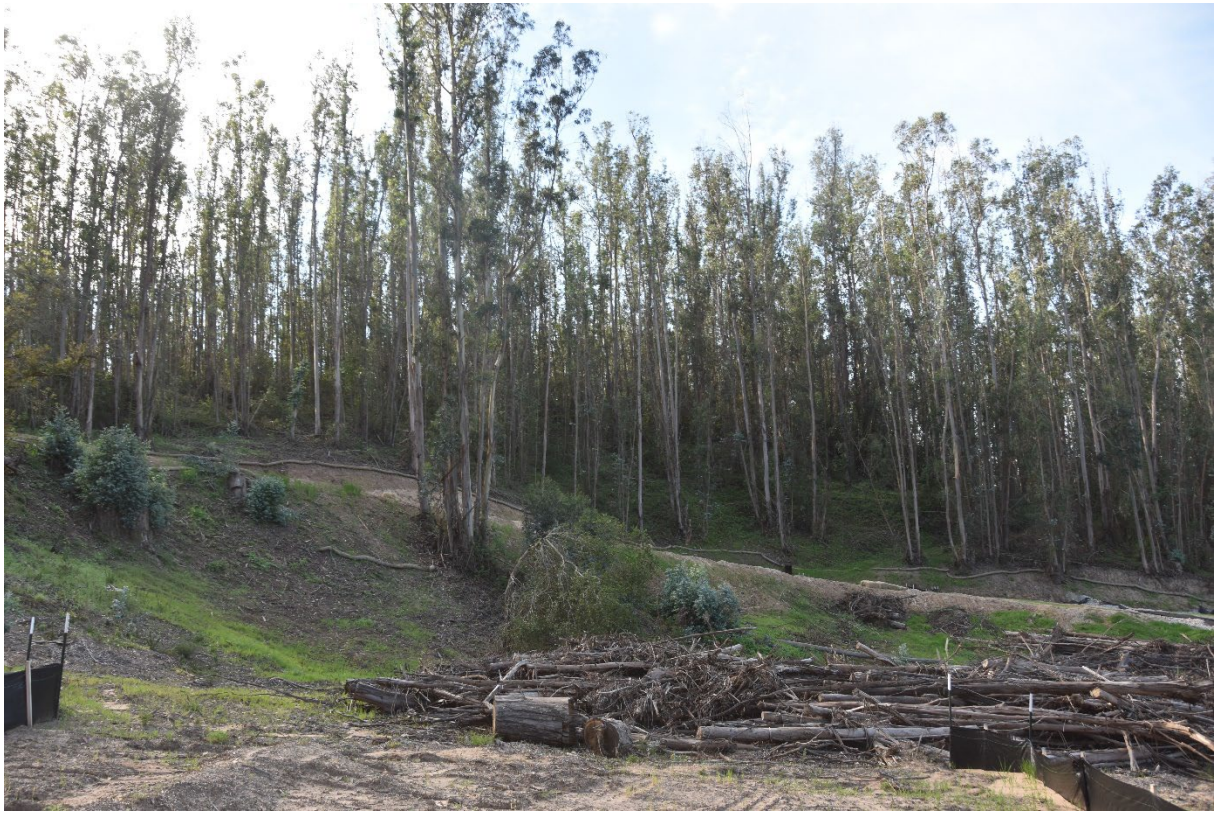
Evenly spaced Eucalyptus stumps adjacent to roadwork.

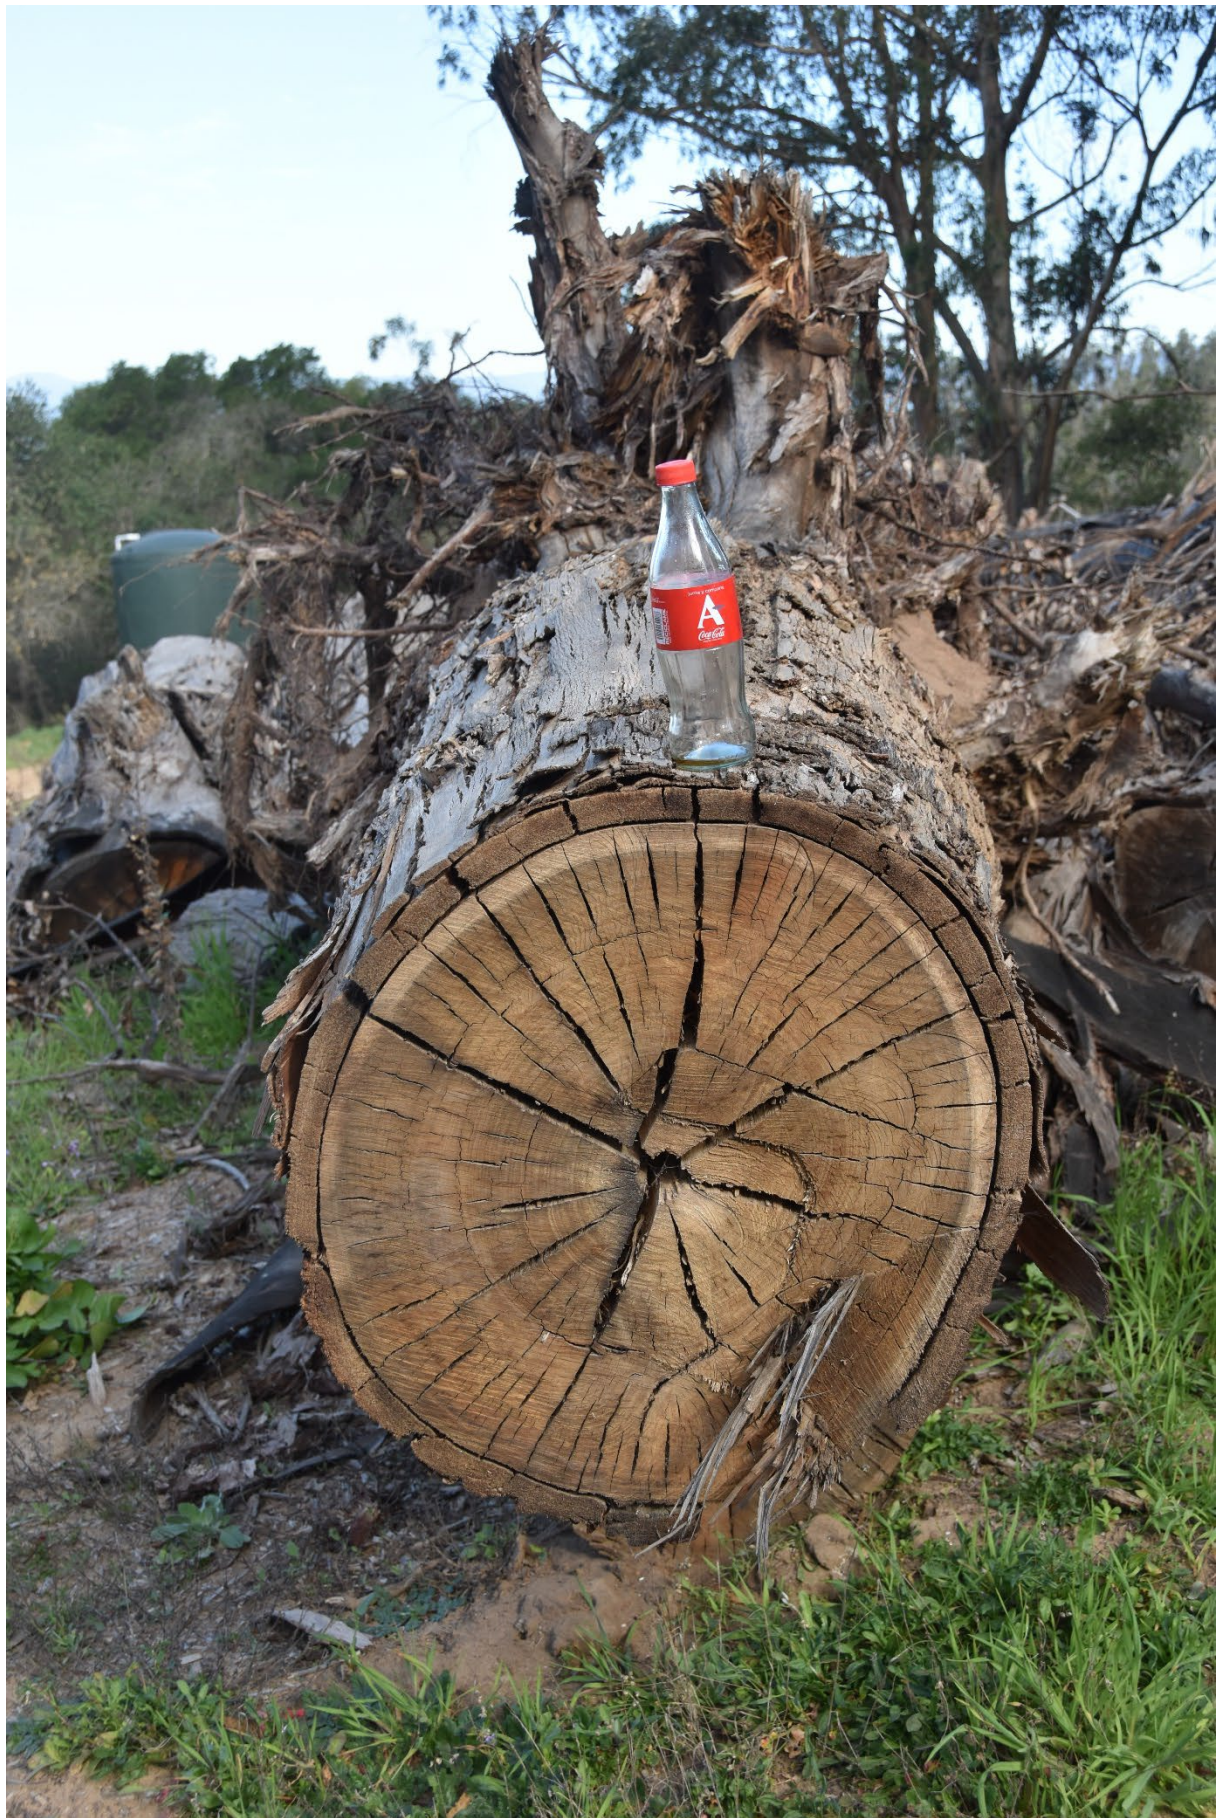
- The existing Eucalyptus trees appear to have been harvested two to three times with multi-clustered stems ranging from 10-24-inches in diameter.
- Trees removed for roadway construction are all Eucalyptus under 30-inches in diameter.

One of the larger stems observed removed. Approximately 22-inches.

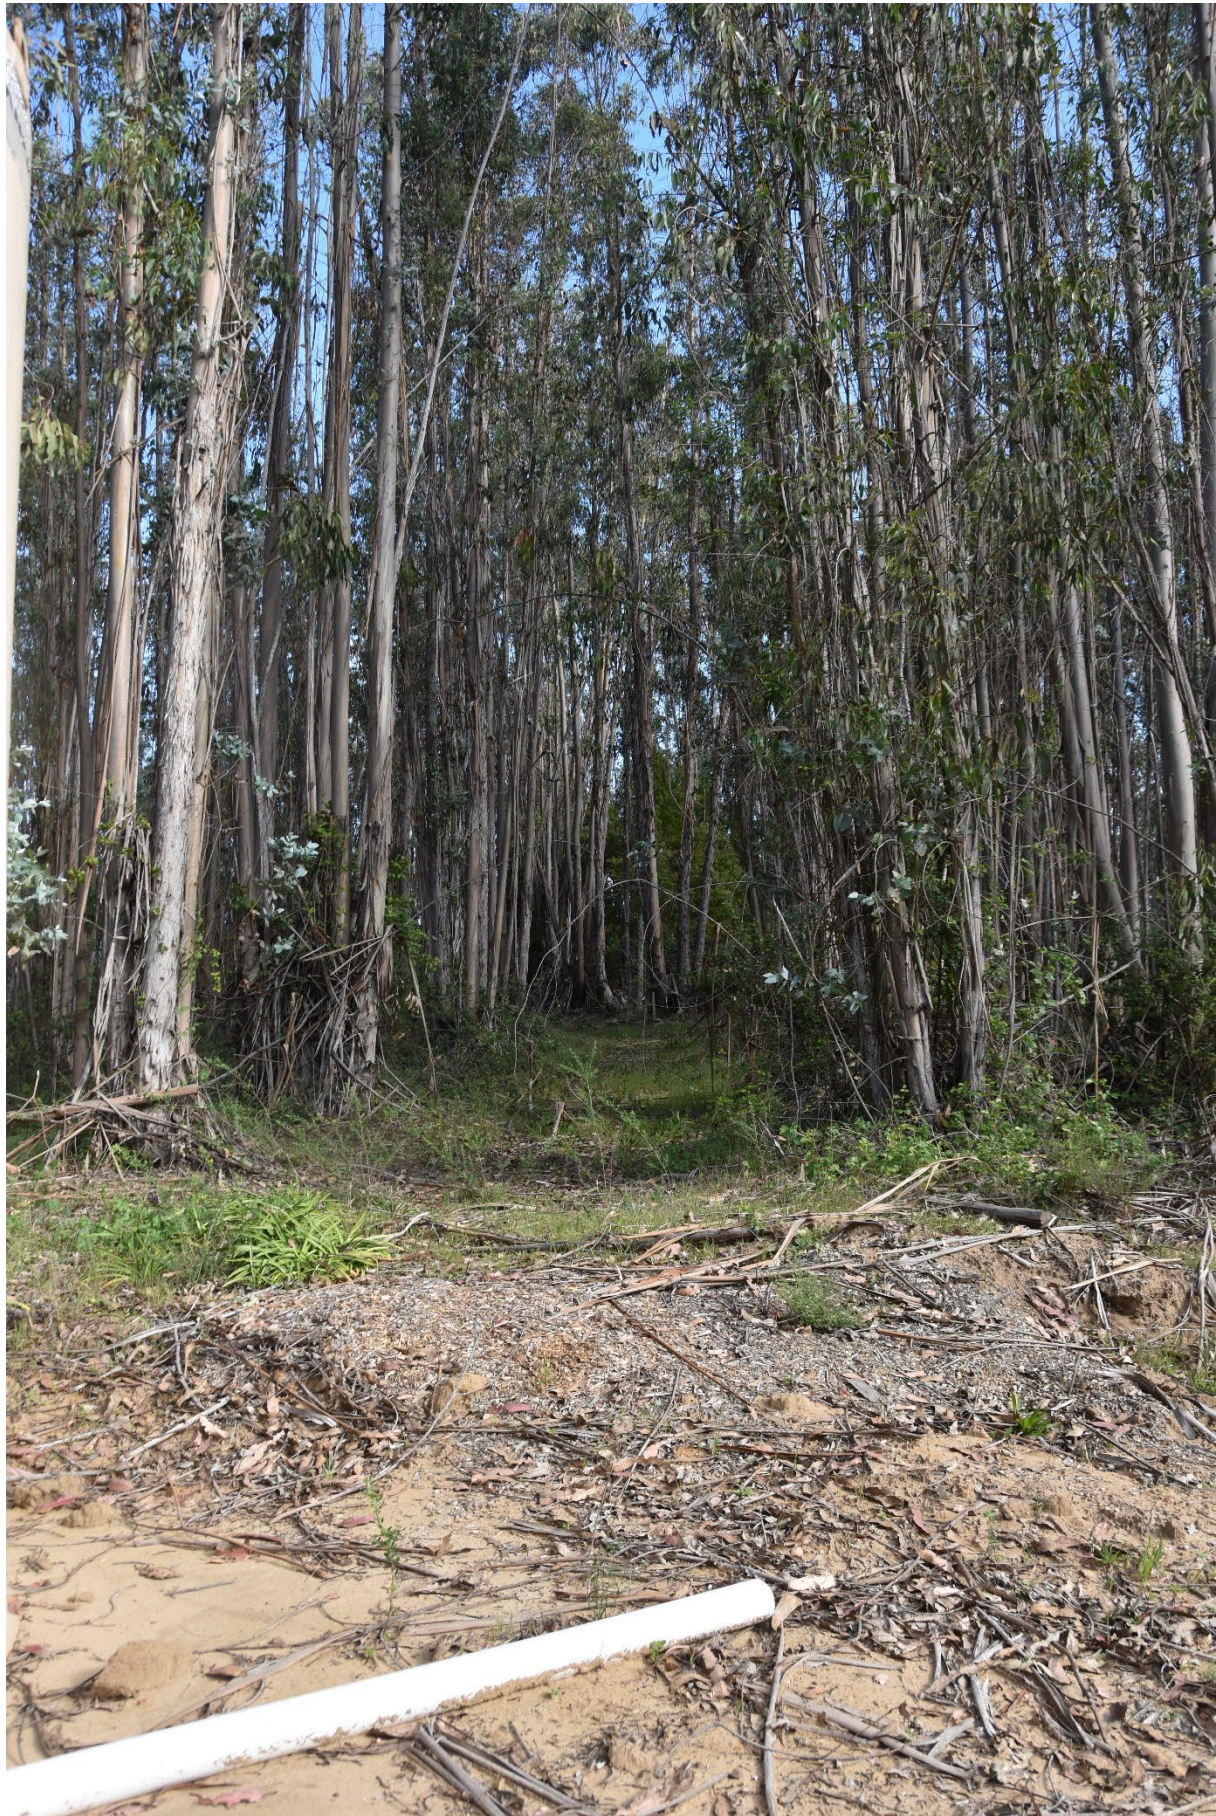
- The site was planted as a Eucalyptus plantation as was evidenced by uniform row crop planting 10 to 20-feet on center. Over 60% of the parcels' acreage is taken up by eucalyptus planting. In the densest areas, 200-400 trees per acre were calculated.

Eucalyptus trees were planted in rows 10-feet on center.

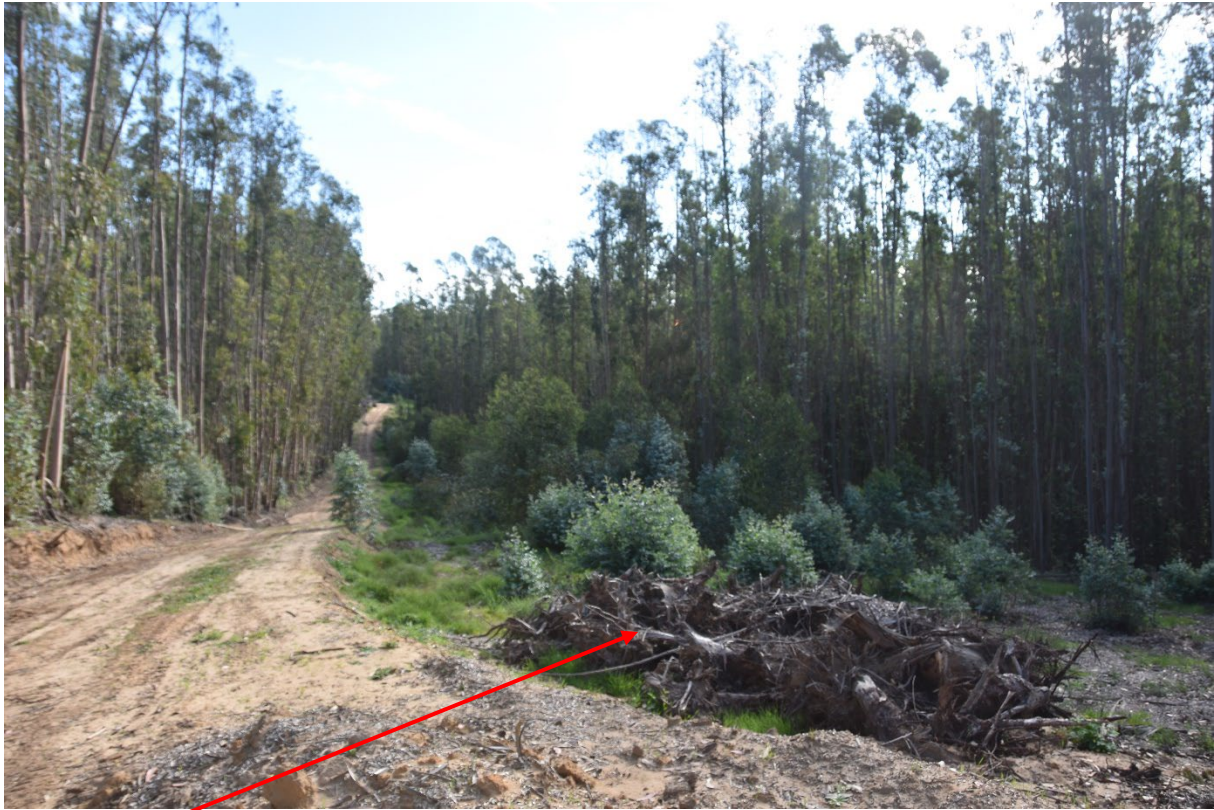
Previous stumps have been dug up and masticated.

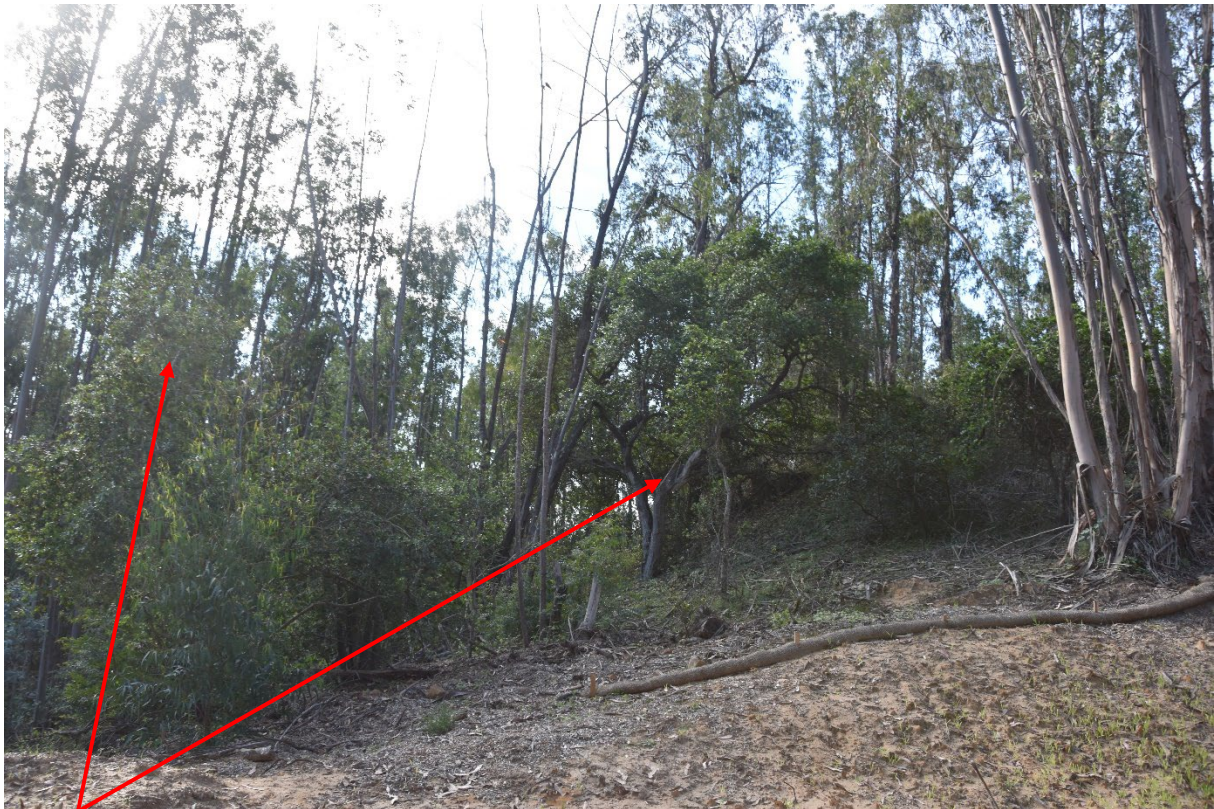
- Very little native vegetation was observed around the planted eucalyptus trees due to Allelopathy.
- Along the road, in parcel 117-471-003-000 there is a small stand of Coast live oak trees in poor condition.

A small number of existing oaks are growing in a small island next to the road in parcels 007 and 003.

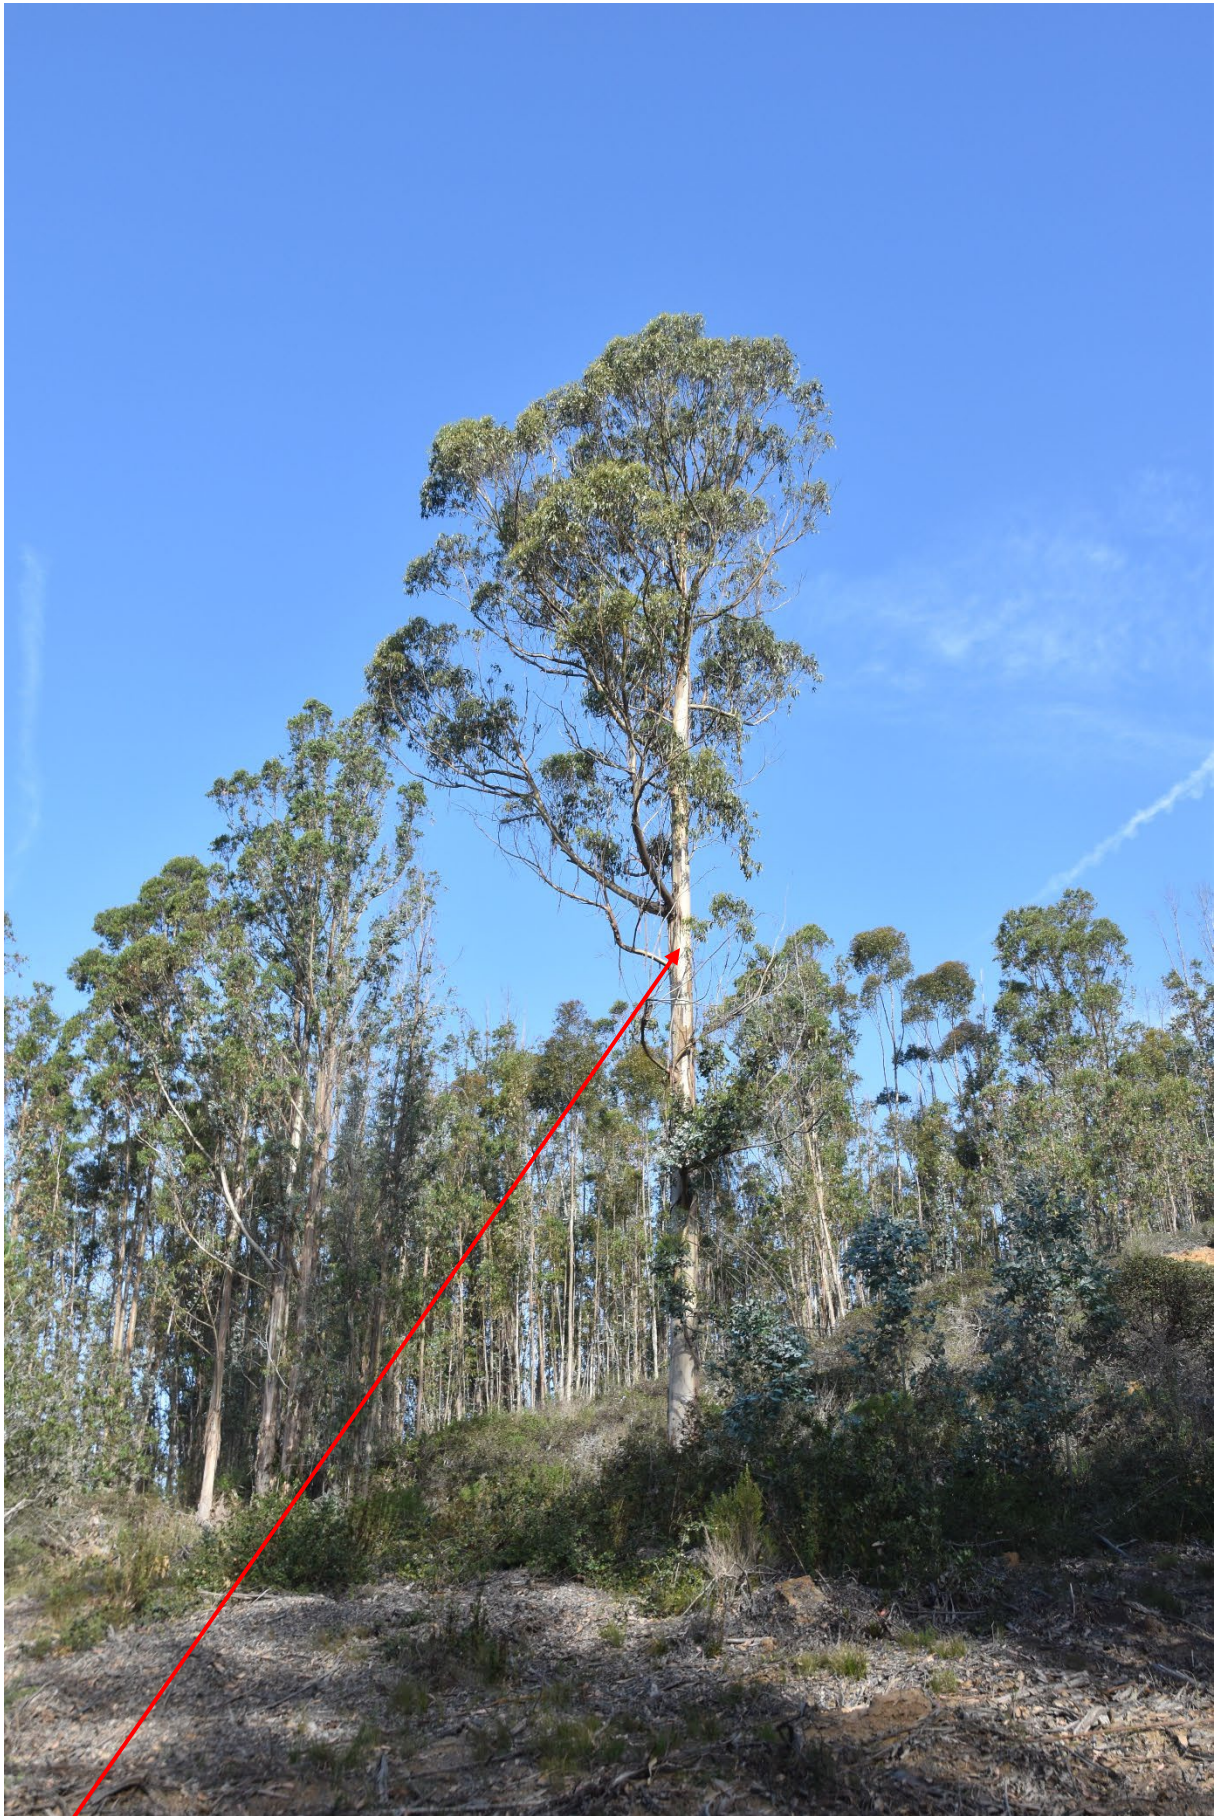
- Eucalyptus logs, both large and small cut pieces were left on site in piles.
- Only two (2) heritage Eucalyptus trees (greater than 36-inches in diameter) were observed on the sites. One in the clearing in parcel 117-471-003-000 upslope from the declining oak stand, and one off the road in parcel 117-471-004-000 where the landscape transitions from eucalyptus to more native plantings.

Large Landmark Eucalyptus can be left on site or removed if warranted by new development.

3. If Eucalyptus stumps are to be mechanically removed, a soil or grading erosion specialist will need to be consulted to avoid the risk of erosion.
4. The small number of landmark Eucalyptus trees observed can remain on site as they are outside of development areas. If the trees are proposed to be removed later, oak reforestation efforts will mitigate the removal of the landmark Eucalyptus.

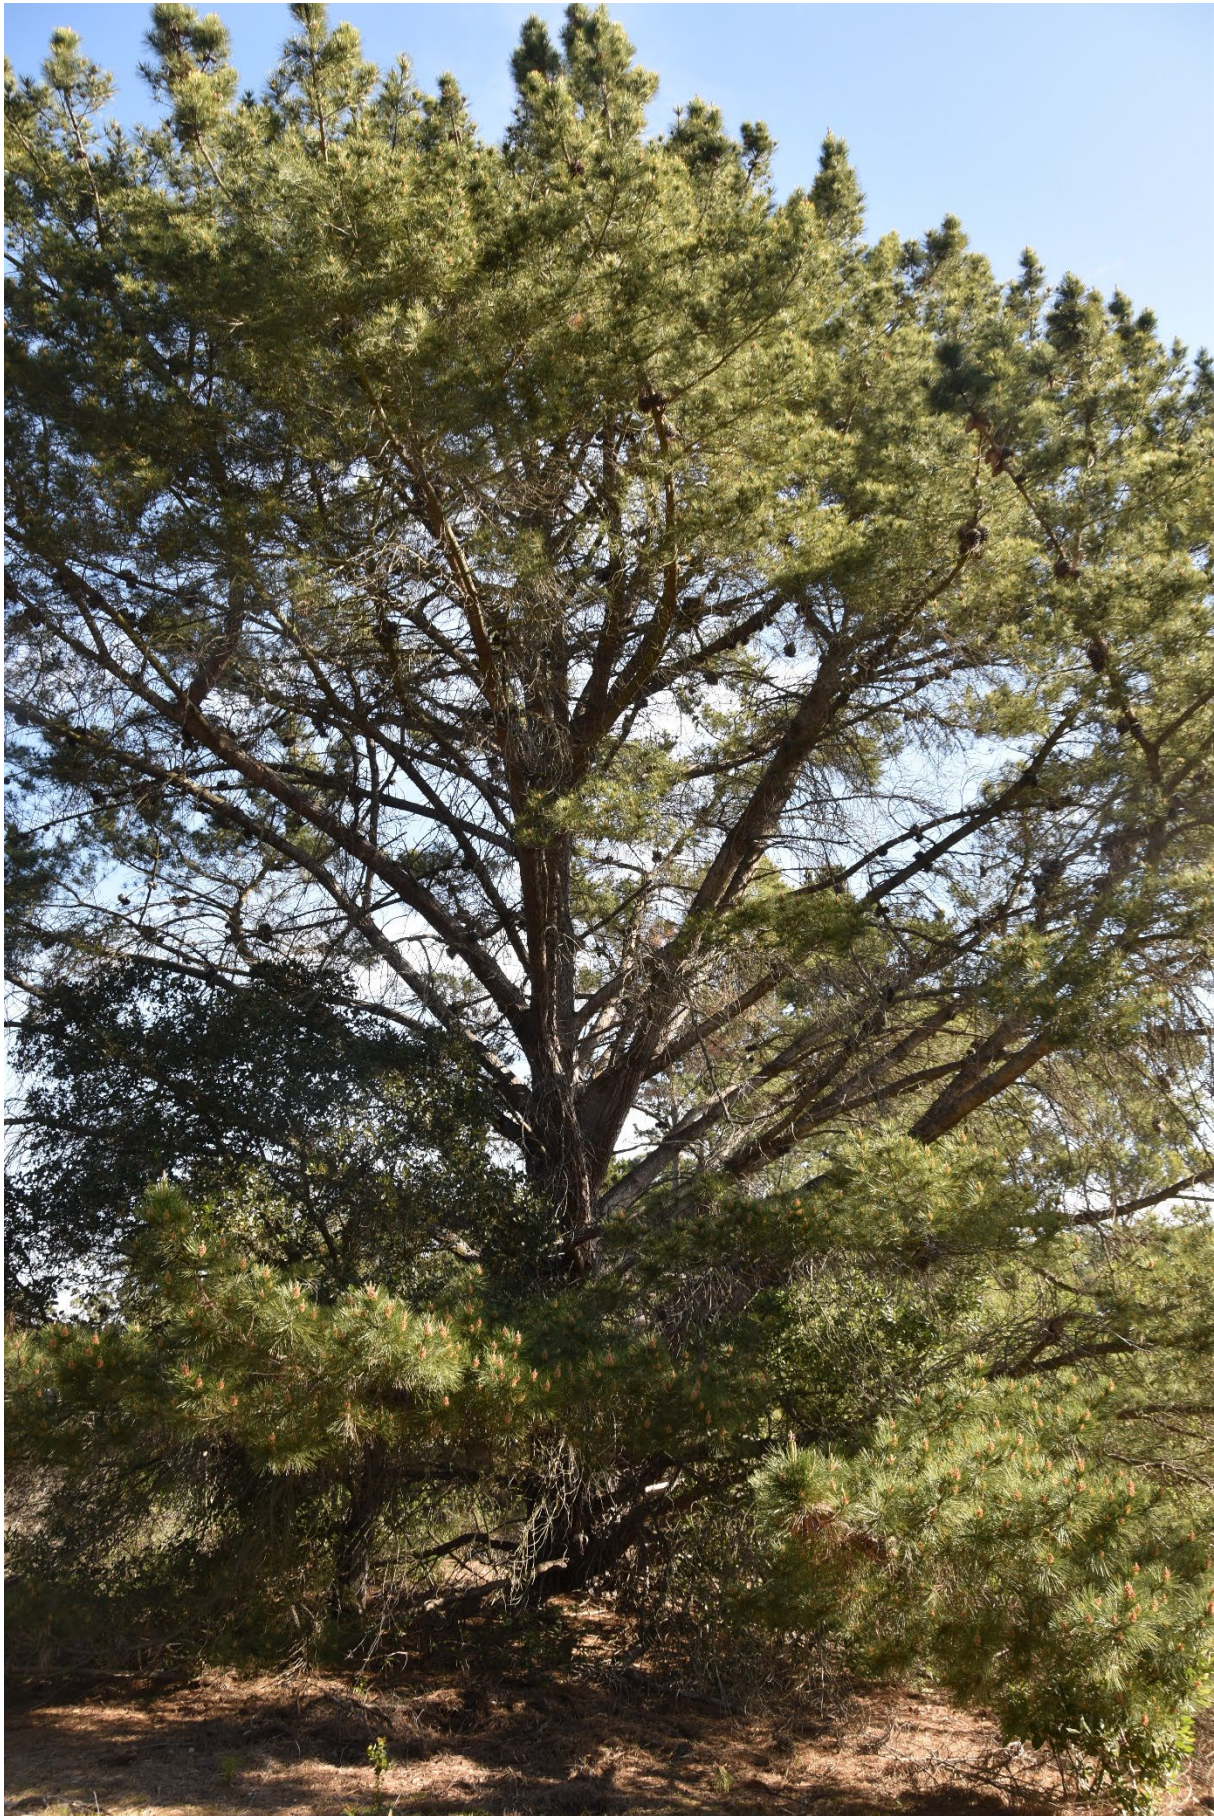
There are several smaller ($< 36''$) Monterey pine trees in the eastern section of the lots.
