# Exhibit C

June 10, 2022

Thank you for the opportunity to review the proposed removal of a non contributing c. 1935 construction office on the grounds of the Mission San Antonio de Padua, 1 Mission Rd. (APN#s 201-021-000 &002) in Southern Monterey County. The proposed removal is in order to continue the archeologic investigation and preservation of the original historic c. 1840 mission *Majordomo*'s residence, on which the c.1935 non contributing building partially rests (see maps & drawings provided).

**Mission San Antonio de Padua**  
**c.1935 Contractor's Office**

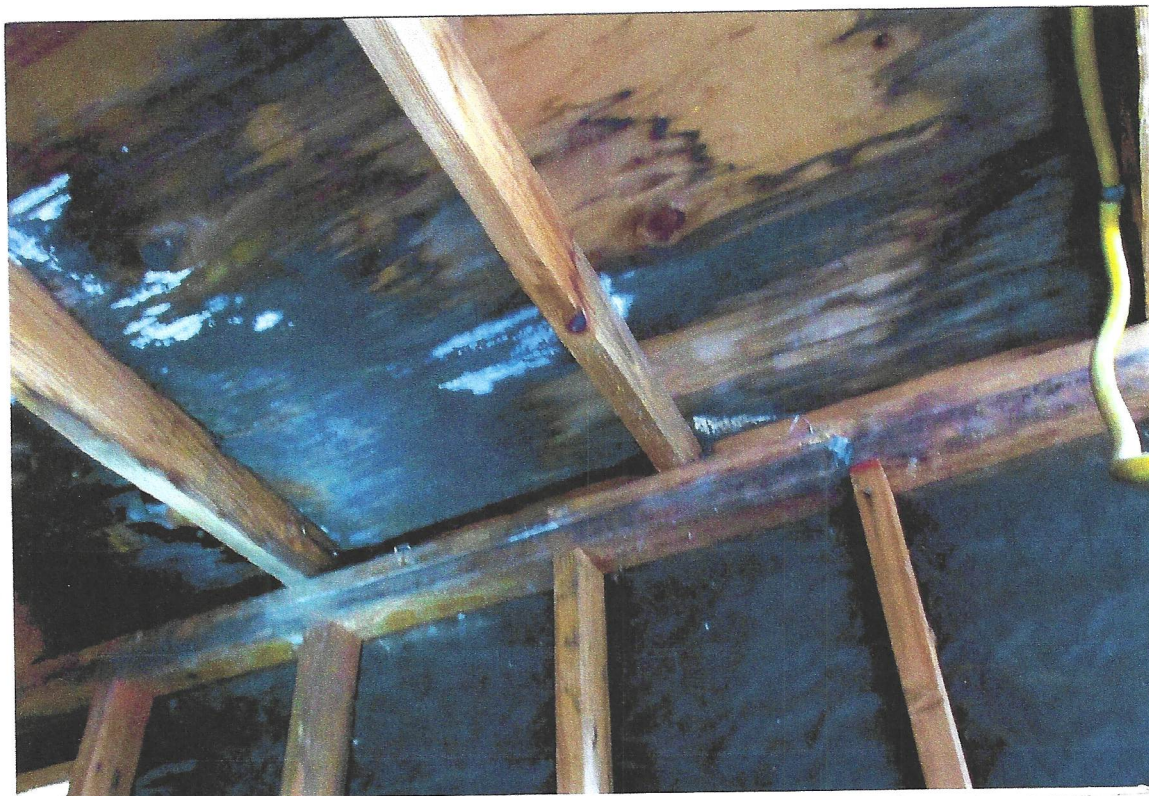
Photo #3. Looking at interior ceiling mold, found throughout bldg. Kent Seavey, June, 2022.

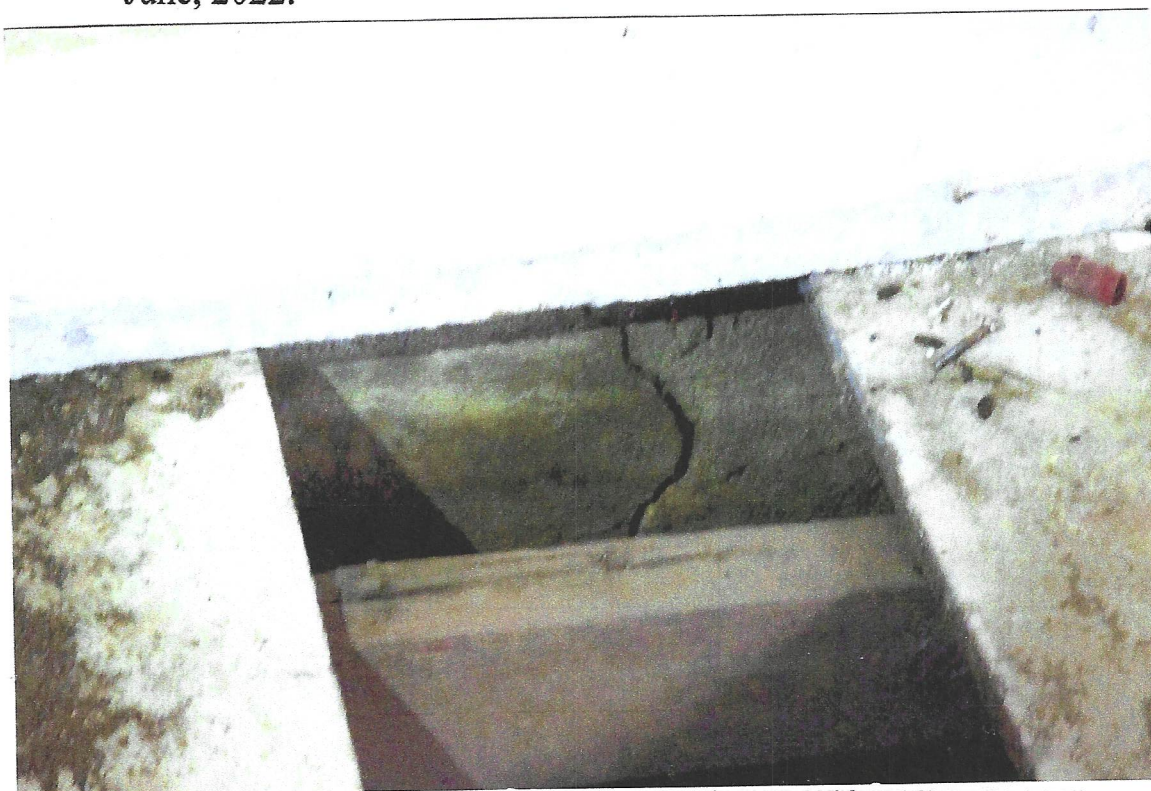
Photo #4. Looking at typical cement foundation failure in living room, Kent Seavey, June, 2022.

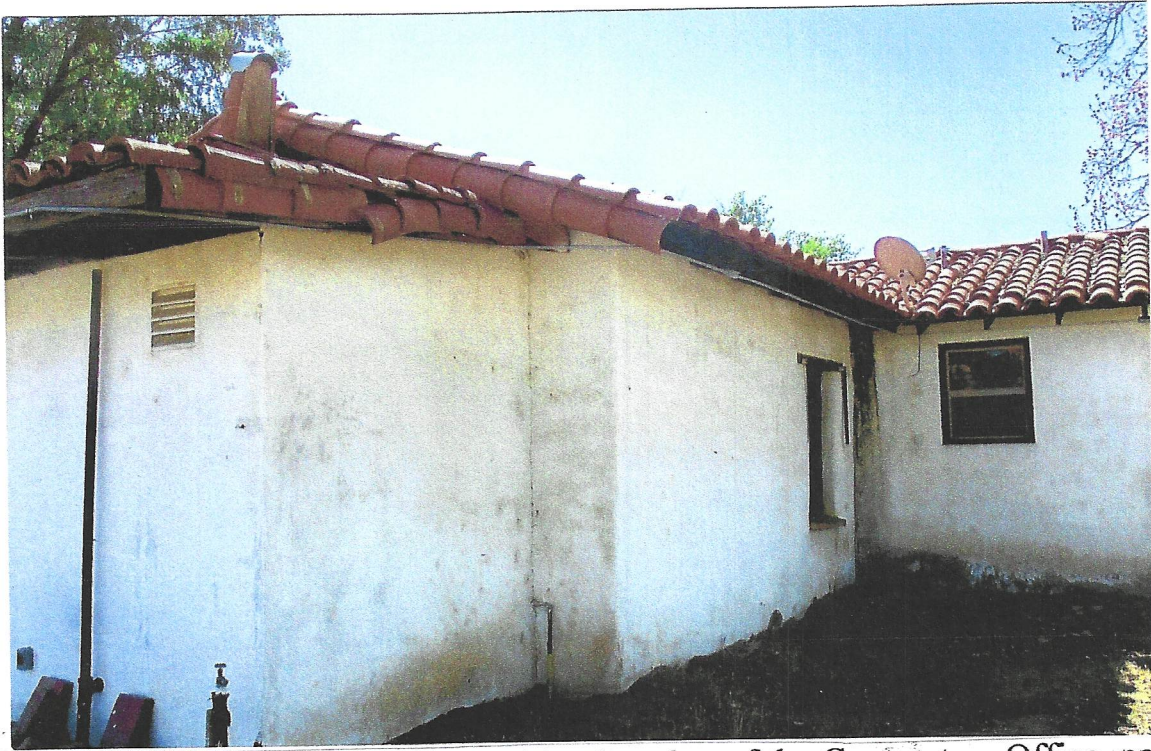
Photo #1. Looking East at the SW side-elevation of the Contractors Office, note mold, left & aluminum window, right, Kent Seavey, June, 2022.  
(Note: roof tile to be repurposed covering cemetery wall.)

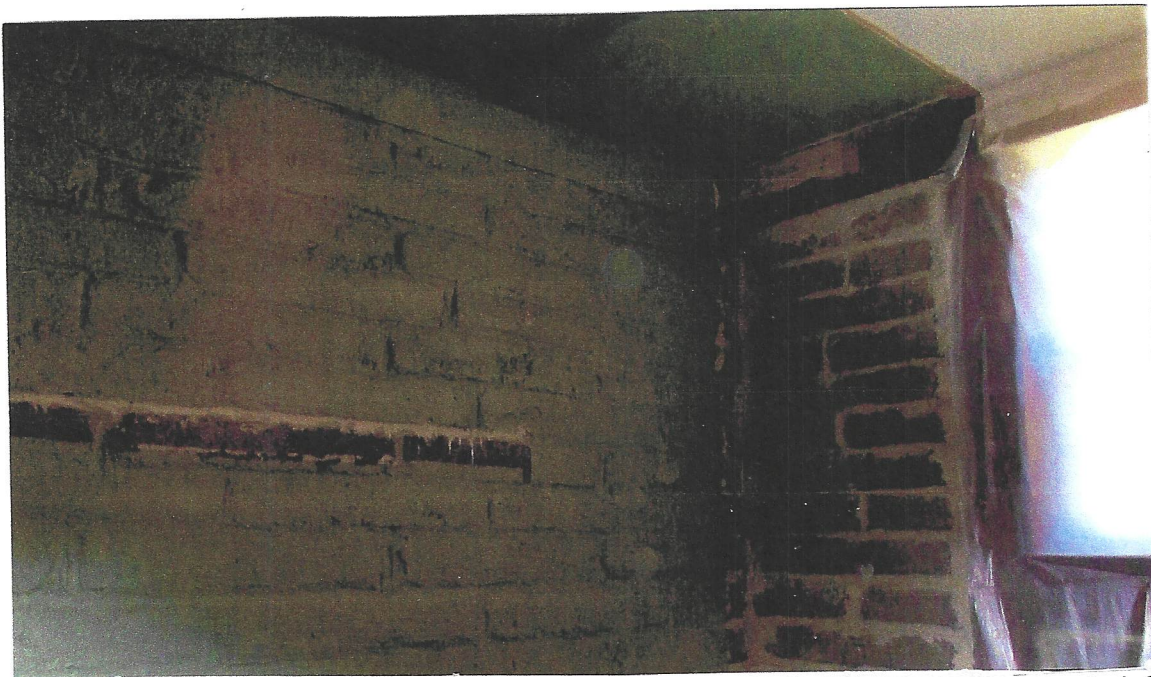
Photo #2. Looking NW at interior wall cladding, note single wythe adobe brick and use of cement mortar, Kent Seavey, June, 2022.

The subject property is a small, one-story, single-wythe, adobe-brick framed building, using cement as mortar. It is "T" shaped in plan. Commonly known as the "Casita", its low-pitched red-tiled roof was framed with both milled, and round wood members. The roof framing members pass through the top of the adobe walls, and there is no continuous structural wood roof plate tying the walls together. The floor-boards are only about 3 to 4 inches above the soil and the base of the building envelope has been riven by varmint's over time (see structural engineer's report by Urefer & Assoc., provided). The unreinforced cement foundation is cracked throughout and flooring is affected by both dry rot and mold. The kitchen was the contractor's original office. The bathroom & laundry later additions, with aluminum framed windows (see photos provided).
