Project: **Proposed Fire Protection Water Well
County File No. PLN230291**

Subject: **SUPPLEMENTAL GEOLOGIC EVALUATION OF FAULT HAZARDS
FOR FIRE PROTECTION WATER WELL**

Well Siting Map

Subject: ***Geologic Hazard Assessment Letter for 46820 Clear Ridge Road, Big Sur, CA
PLN:230291***

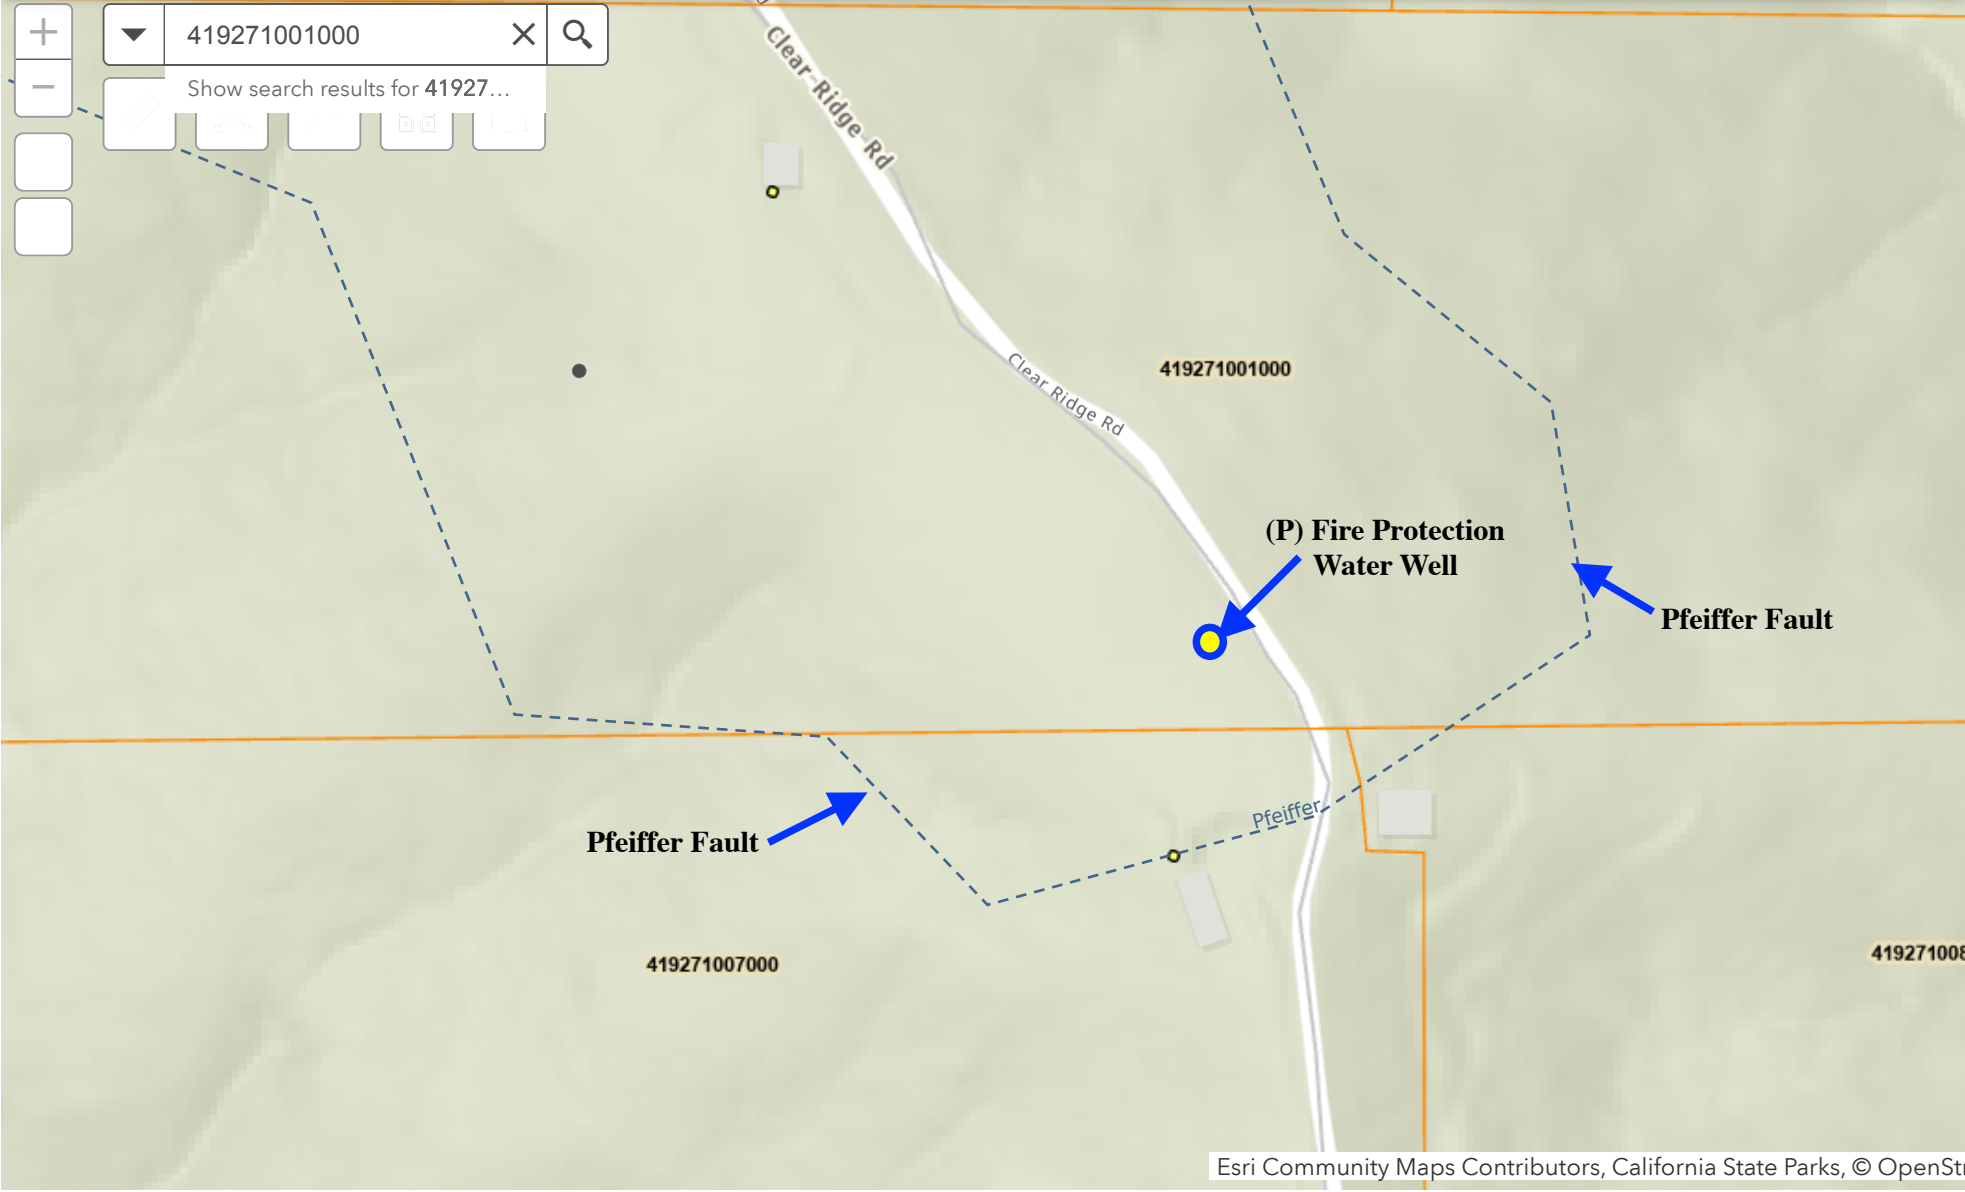
Proposed Fire Protection Water Well
APN 419-271-001
Clear Ridge Road, Big Sur, CA

Scale: 1 in = 188 ft, RF = 1 : 2,257
