**NOTICE OF COMPLETION OF INSPECTION**

Mine Name: <u>Carmel Stone/BLM Querfurth</u>	CA Mine ID Number: <u>91- 27-0030</u>
--	---------------------------------------

## SURFACE MINING INSPECTION REPORT

<b>I. Mine Name:</b> Carmel Stone aka BLM Querfurth
--

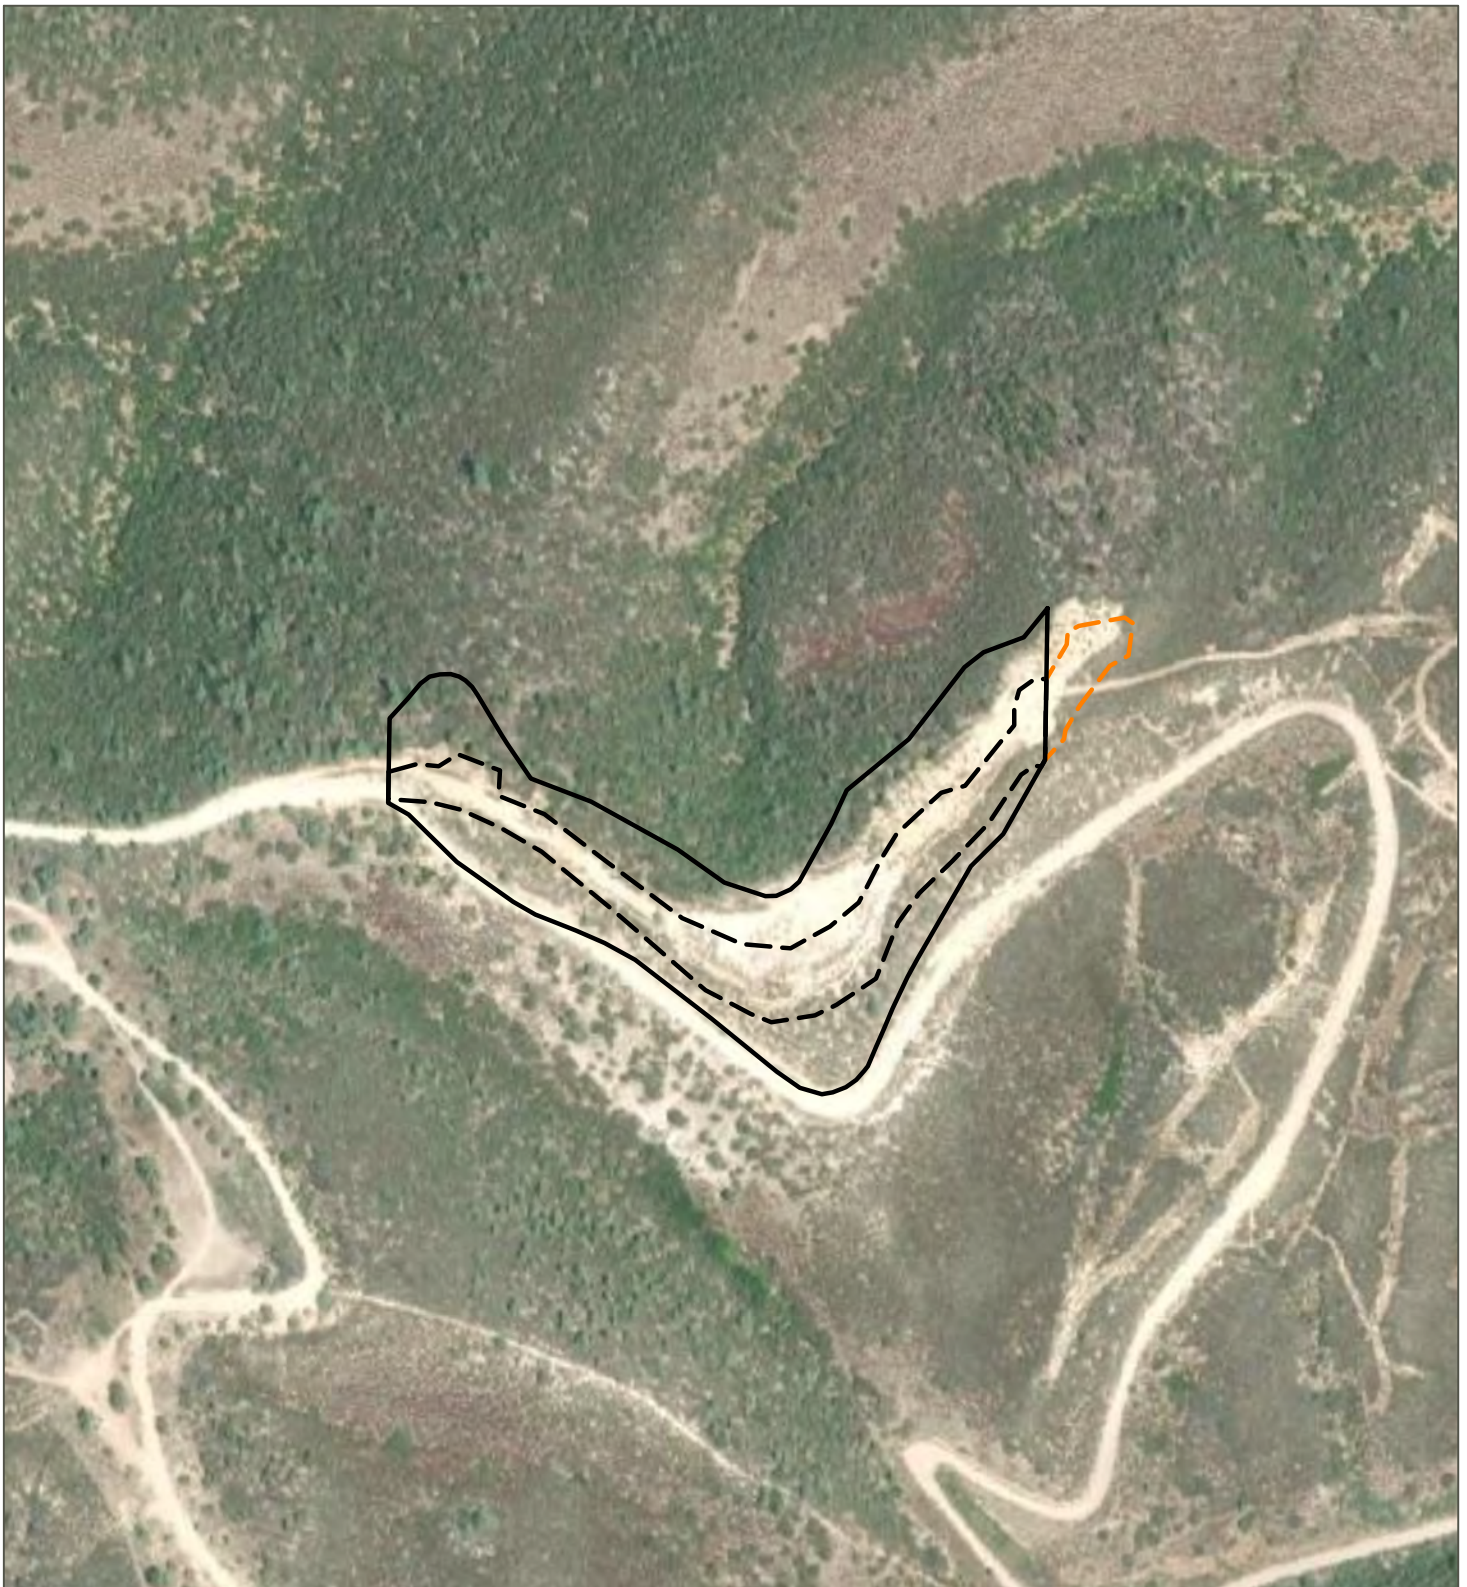
Based on overlaying the reclamation plan boundary with August 2013 aerial, it appears as though disturbance extending to the east (into required buffer area) is a result of mining activities. The operator has acknowledged the disturbance outside of the boundary.

SOURCE: Aerial—Google Earth (flown 8-17-2021);  
 compiled by Benchmark Resources in 2022

NOTES: Surface disturbance approximated from  
 photograph interpretation for annual inspection report  
 only. Actual field conditions (acreages) may vary.

- - - - -	Surface Disturbance Outside of Reclamation Plan Boundary	0.34 acres
- - - - -	Surface Disturbance	4.01 acres
—————	Reclamation Plan Boundary	±12 acres

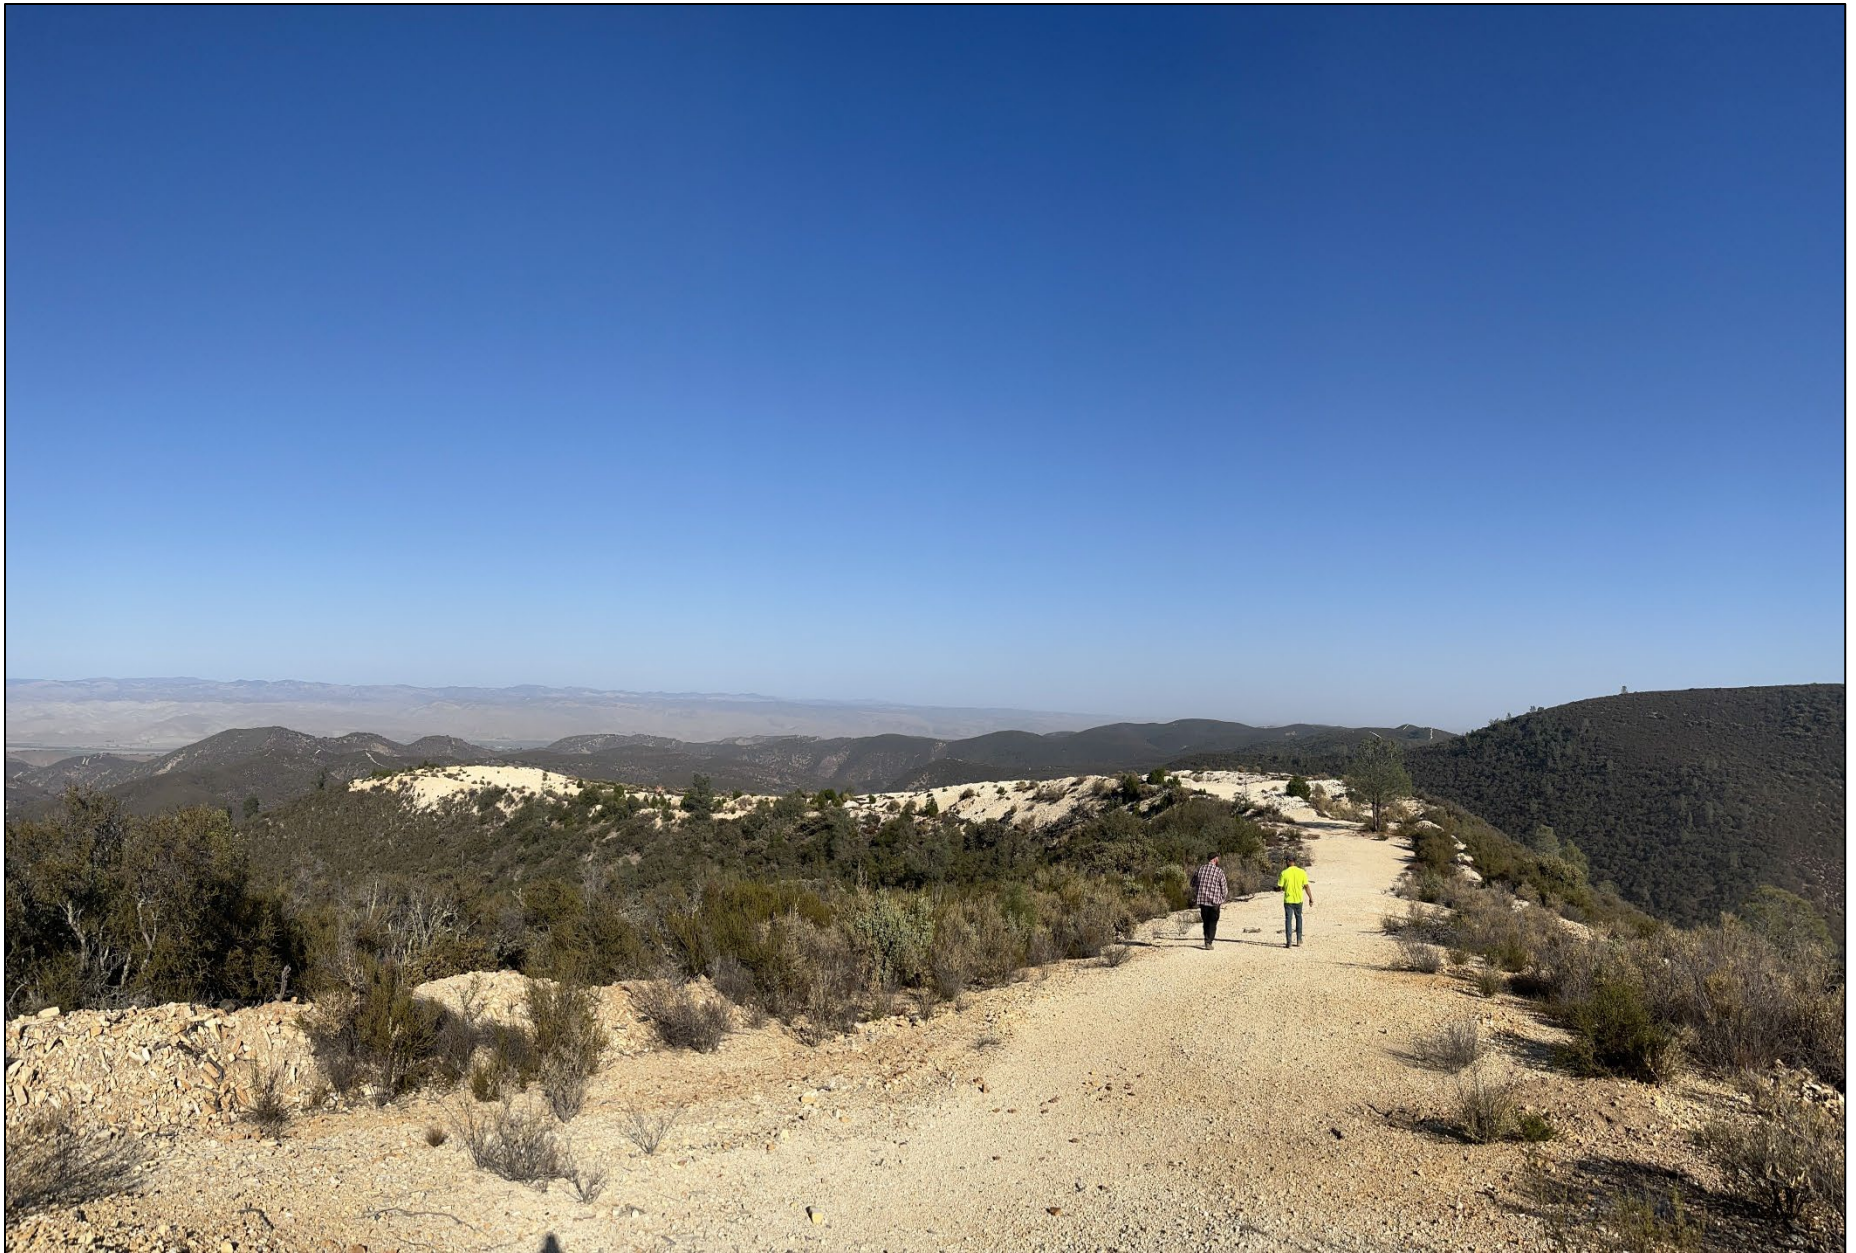
**Notes:** General View of the site.

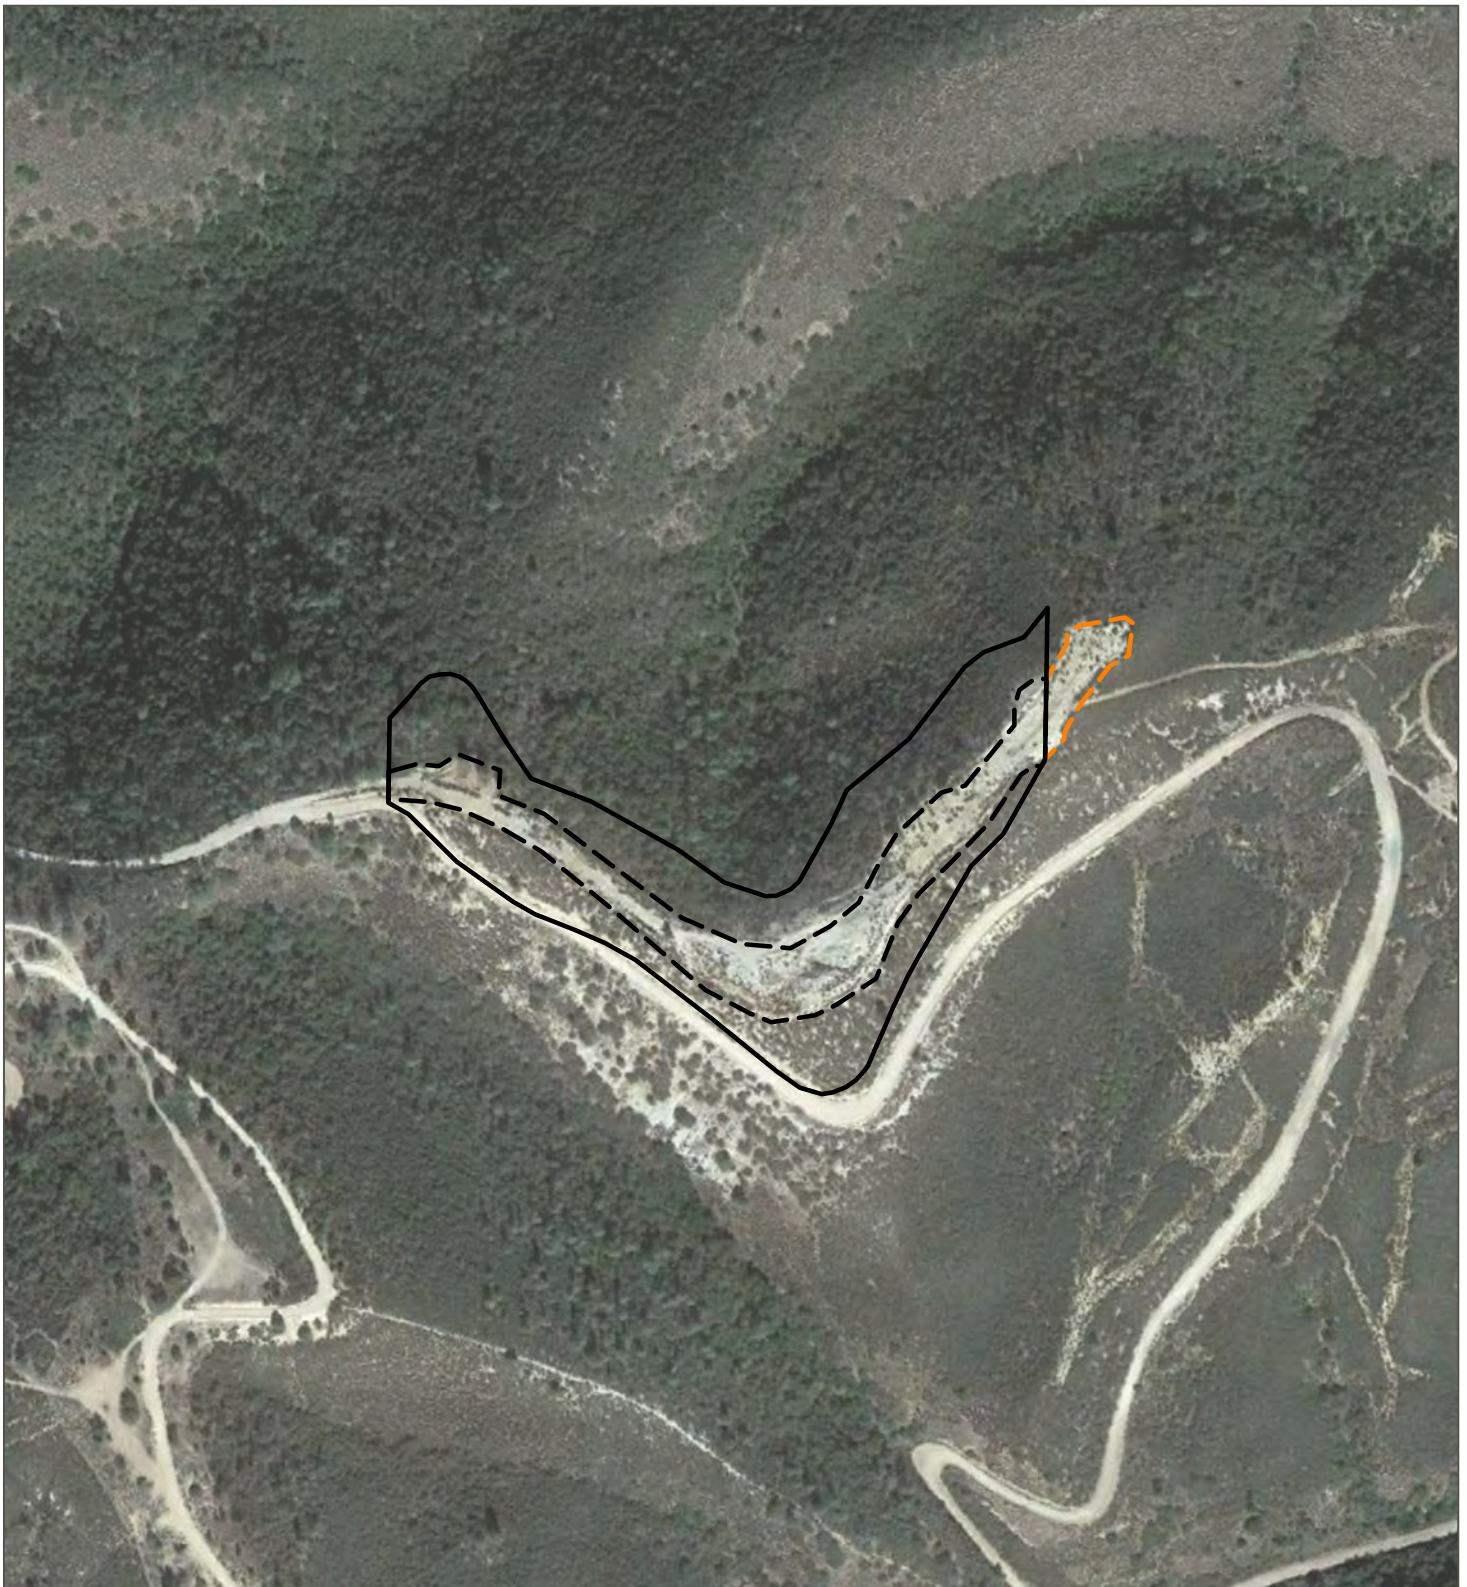
SOURCE: Aerial-Google Earth (flown 2-26-2021);  
 compiled by Benchmark Resources in 2021  
 NOTES: Surface disturbance approximated from  
 photograph interpretation for annual inspection report  
 only. Actual field conditions (acreages) may vary.

- - - - -	Surface Disturbance Outside of Reclamation Plan Boundary	0.34 acres
- - - - -	Surface Disturbance	4.01 acres
—————	Reclamation Plan Boundary	±12 acres

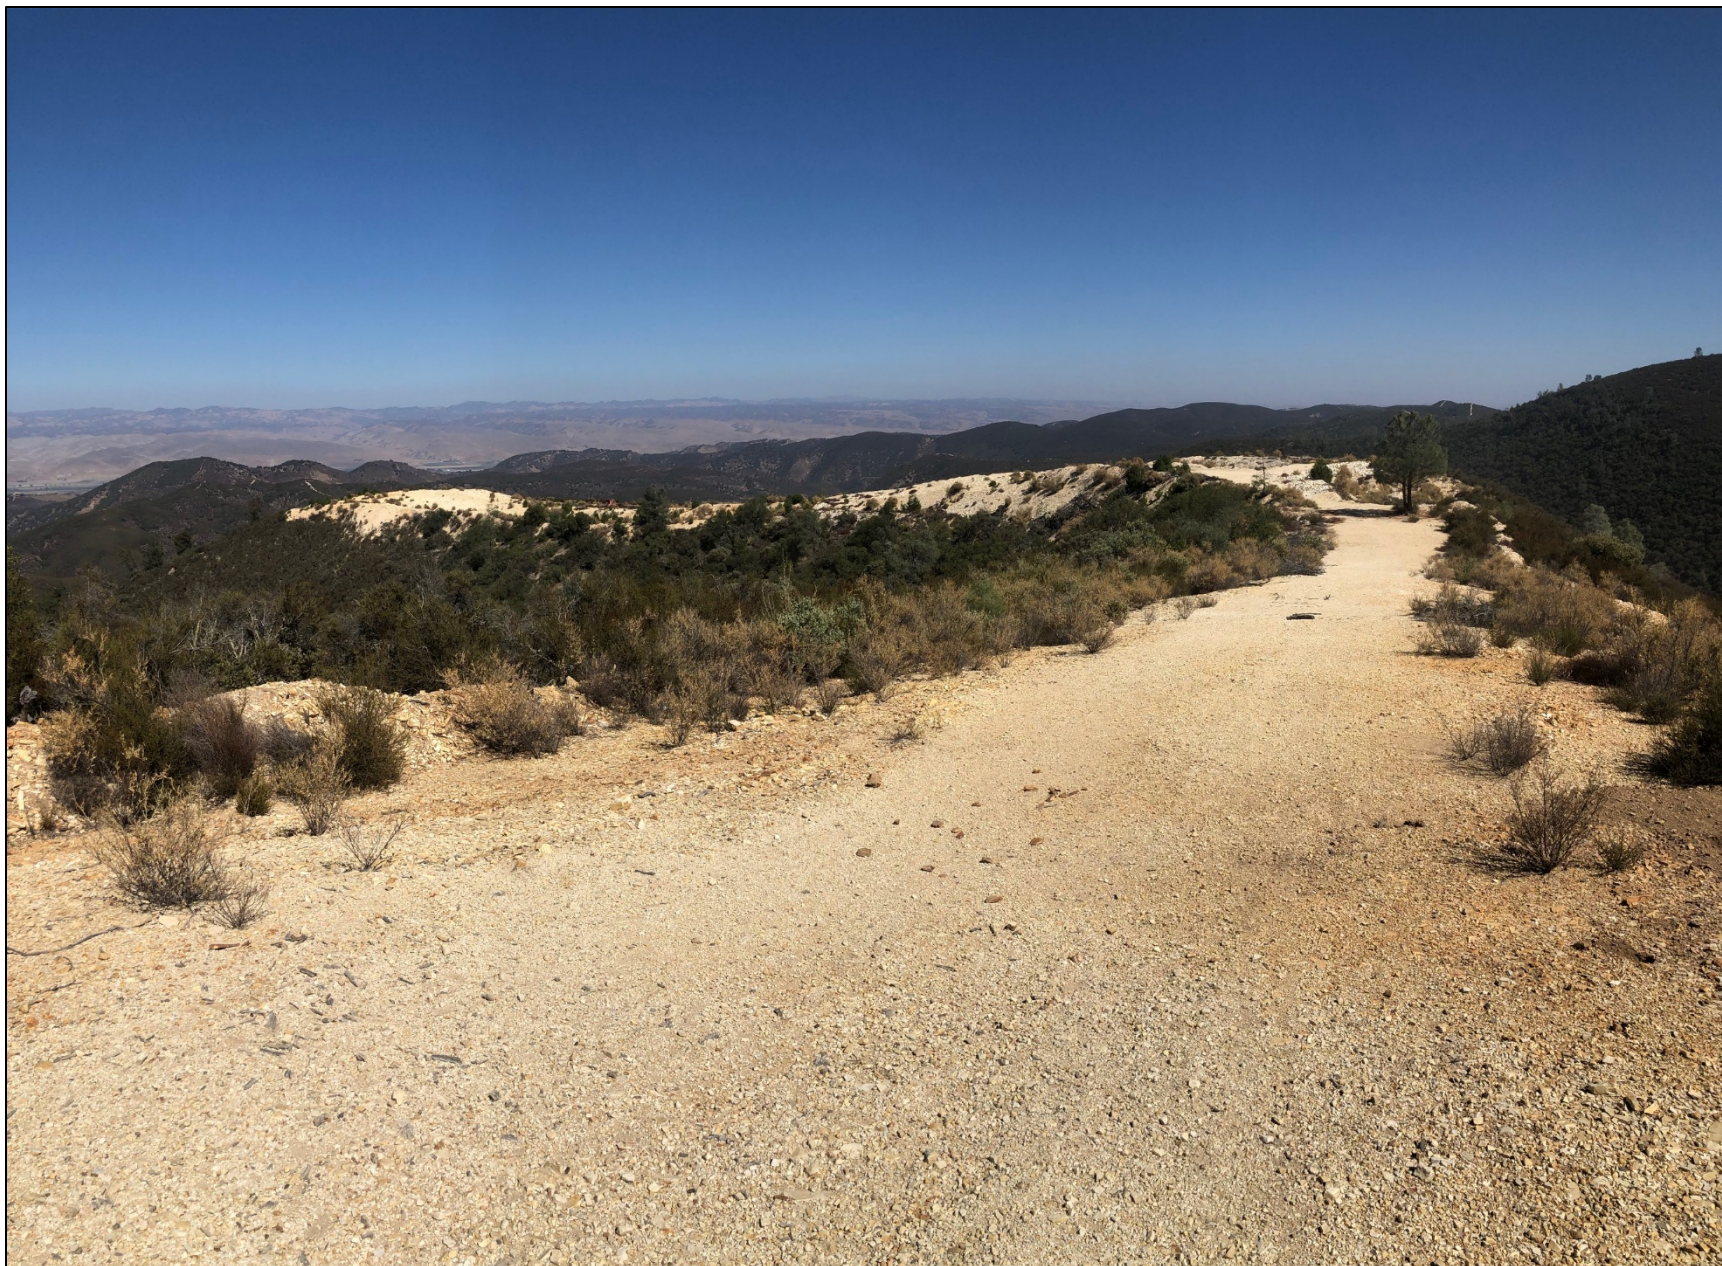
**Notes:** General View of the site.

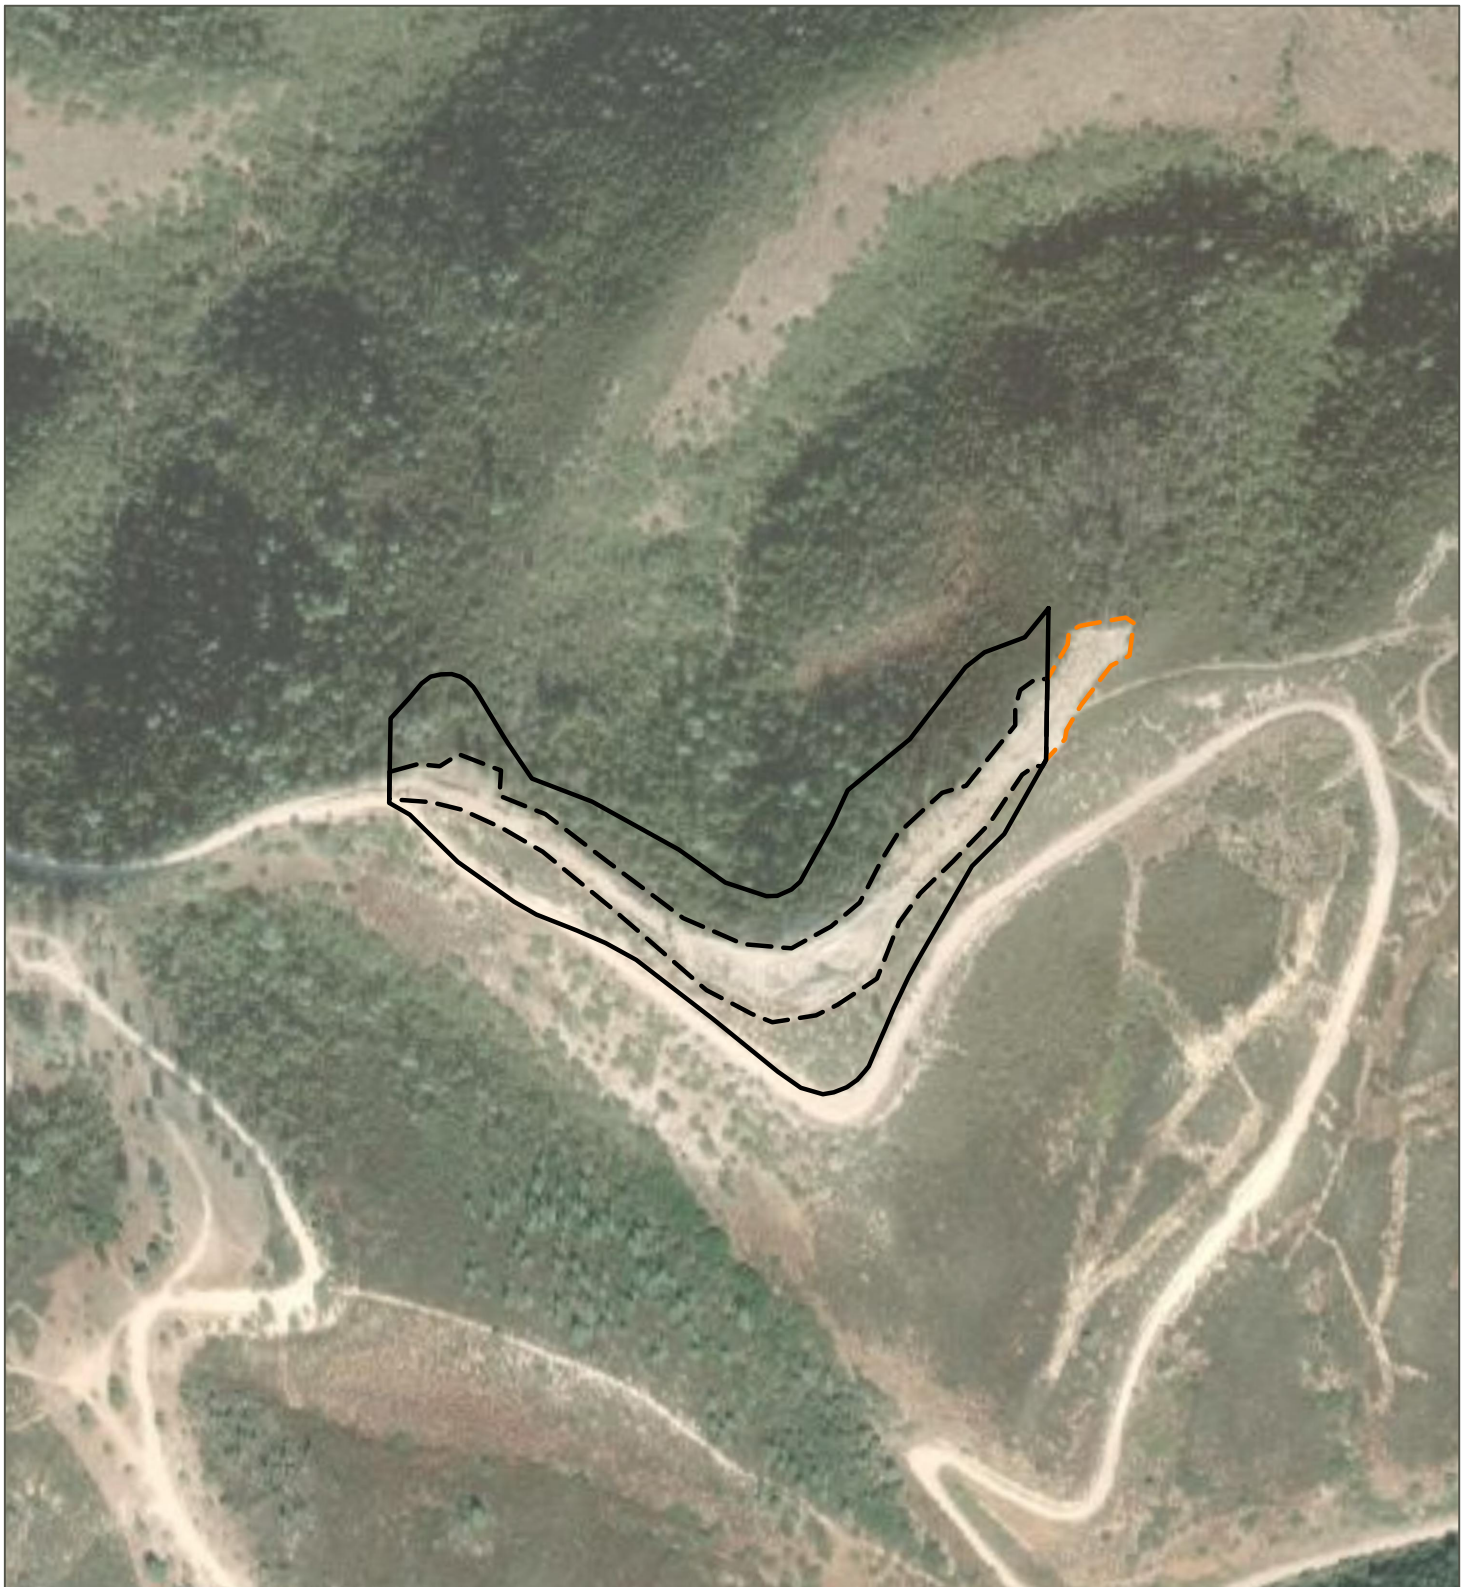
SOURCE: Aerial-Maxar (11-4-2019); compiled by Benchmark Resources in 2020

NOTES: Surface disturbance approximated from photograph interpretation for annual inspection report only. Actual field conditions (acreages) may vary.

Reclamation Plan Boundary	±12 acres

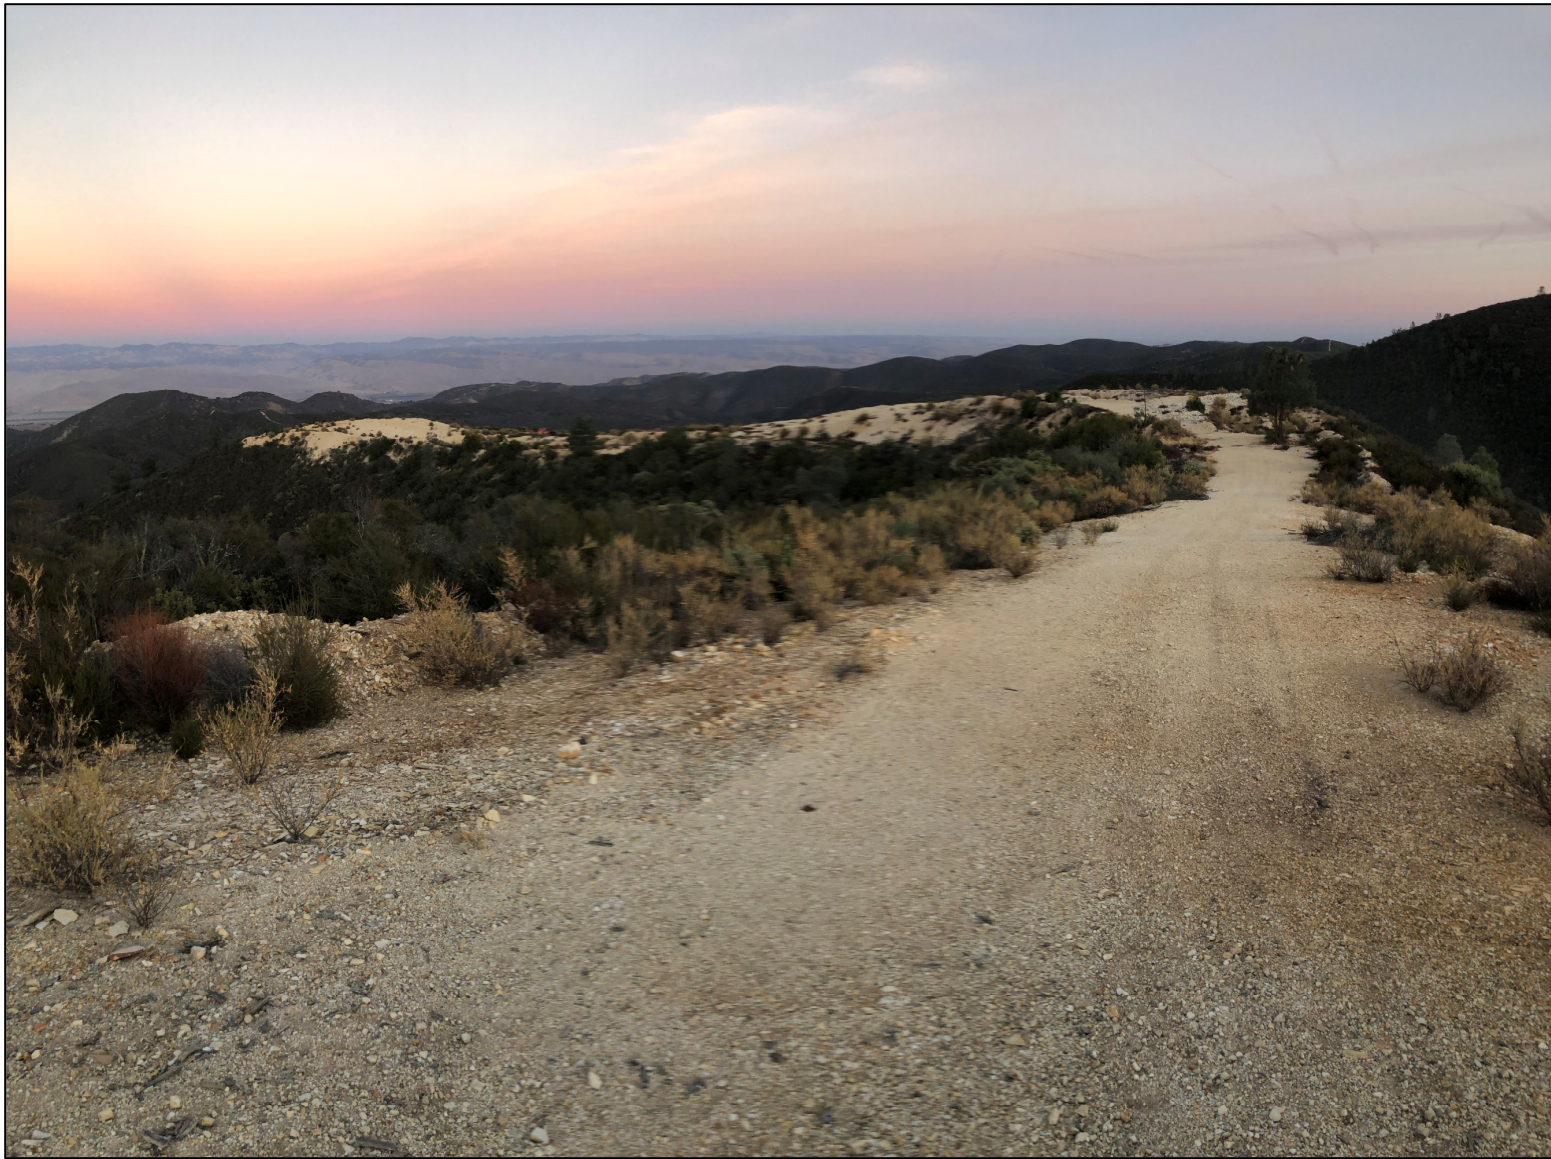
**Notes:** Most recent active mining area.
