THOMPSON
WILDLAND MANAGEMENT

W&Smith CA, Inc Residence
3180 Cortez Road
Pebble Beach, CA. 93953
APN: 008-233-010-000

Subject: 3180 Cortez Road Pre-Construction Tree Impact Assessment

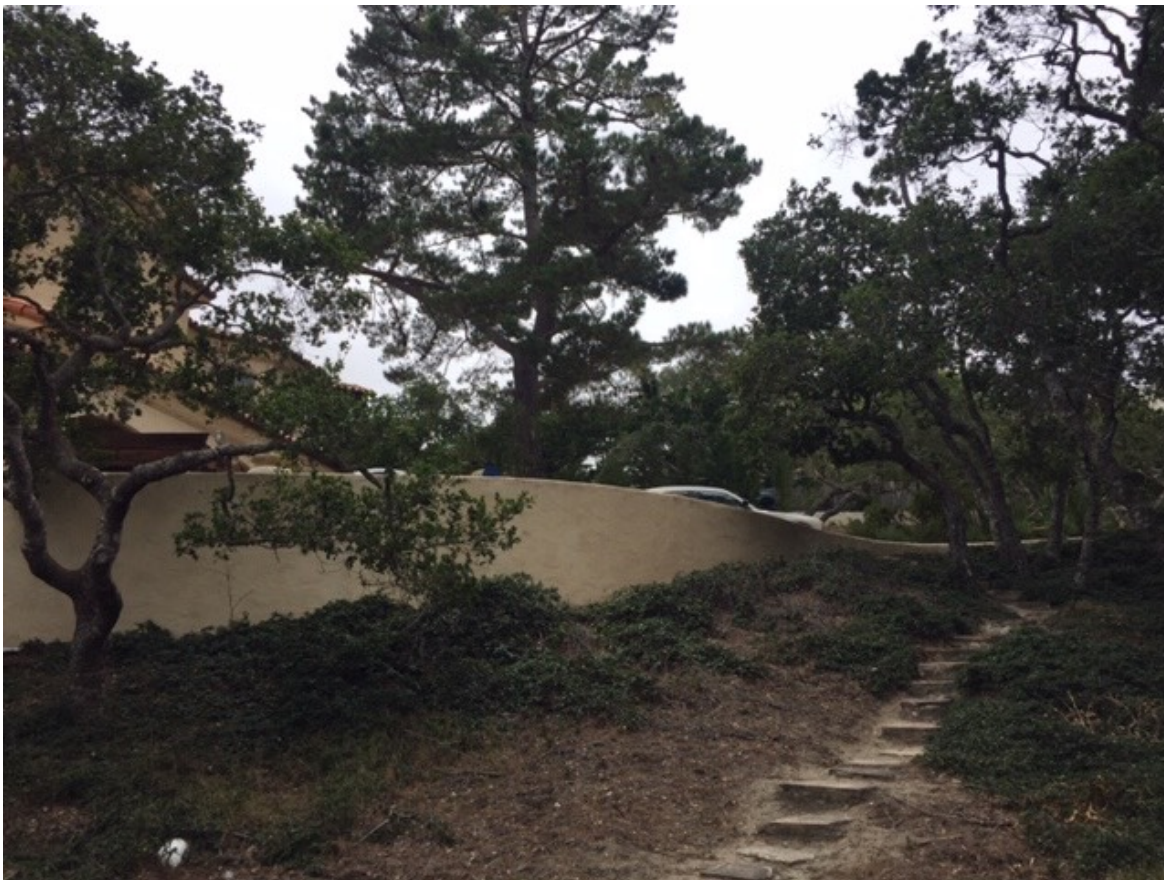
Figure 1. Proposed new driveway will pass between oaks to the left and right side of photo through previously disturbed landscaped area to connect with existing driveway. Retaining wall will be removed and nearby oaks will receive tree protection measures.

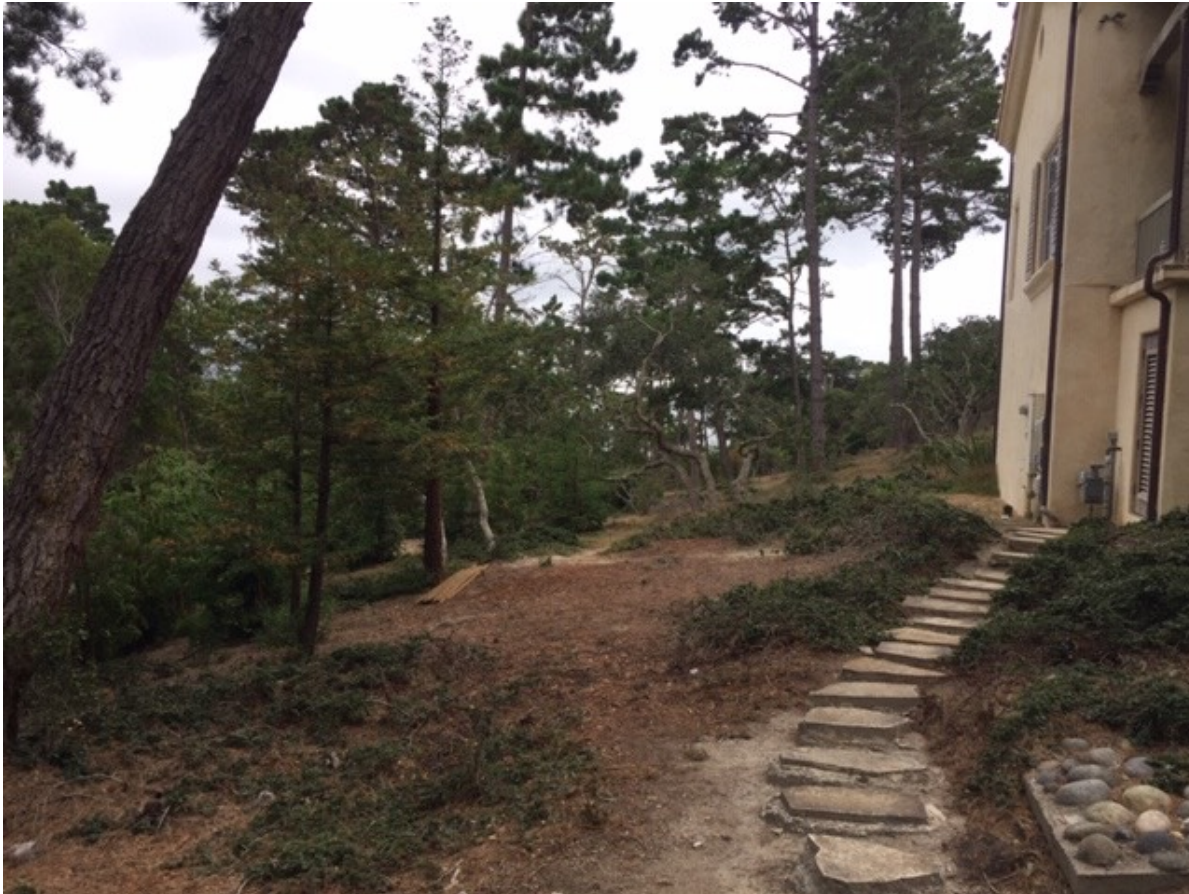
Figure 2. New driveway will continue along existing home through previously disturbed landscaped area. Trees will receive tree protection measures.

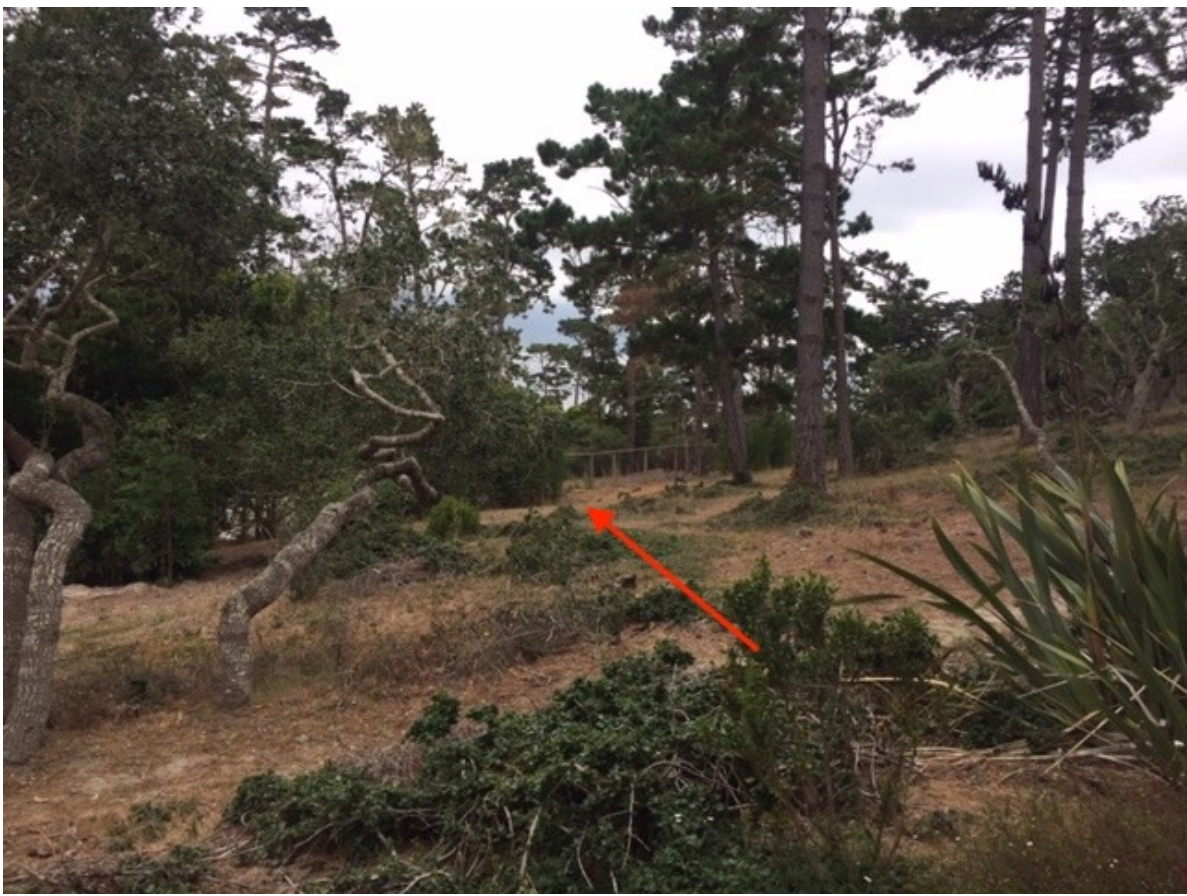
Figure 3. Proposed new driveway will continue into wooded area of lot going around mature pine and oak trees in the direction of the red arrow. Trees protection fencing will be installed and properly maintained and no trees are proposed for removal.

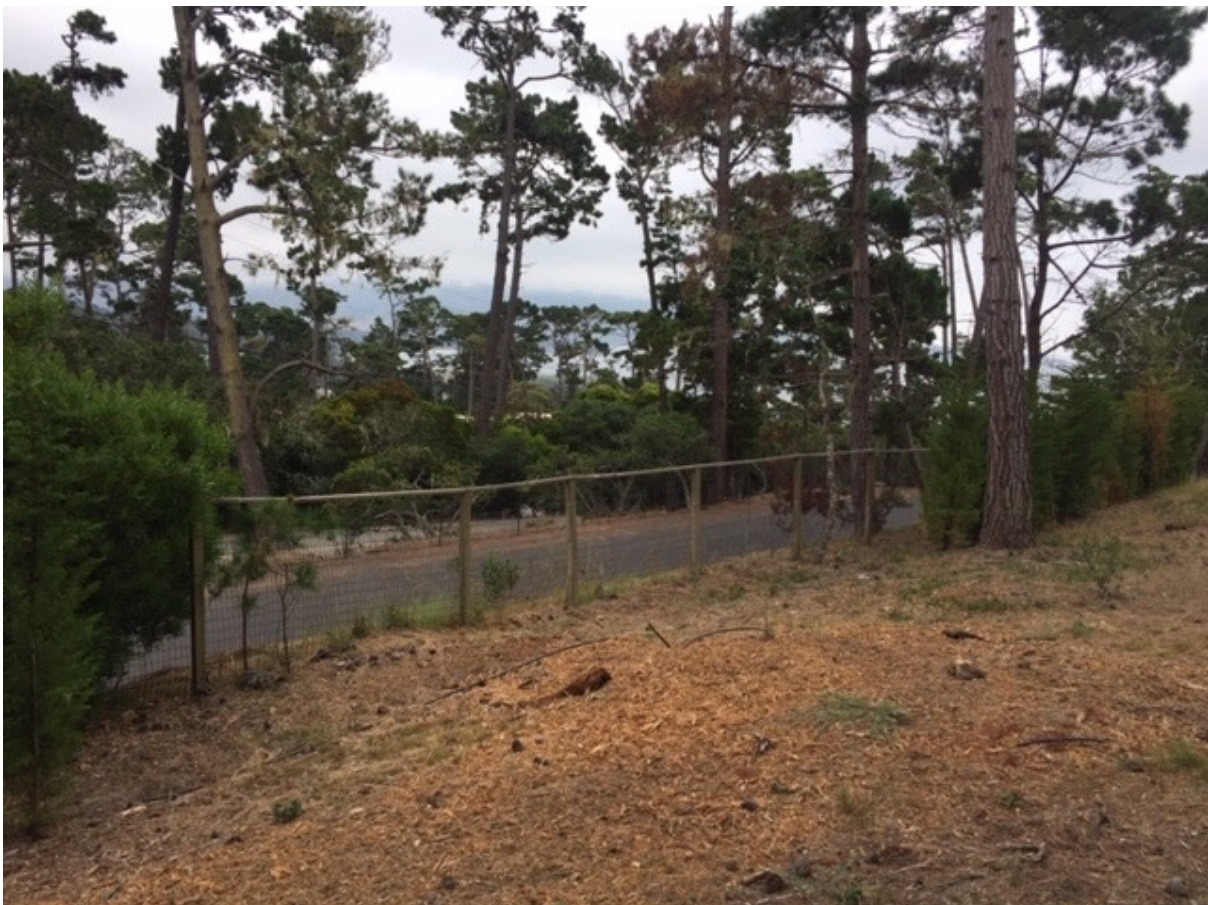
Figure 6. Proposed new driveway will enter property at this location off of Oleada Road.
