Re: Vega Road Project Citation
Restoration Challenges
Watsonville, CA

Oak Restoration/ Forest Management Plan 146 Vega Road

VEGA ROAD PROPERTIES GRADING PROJECT

GRADING PLANS MAY 10, 2022

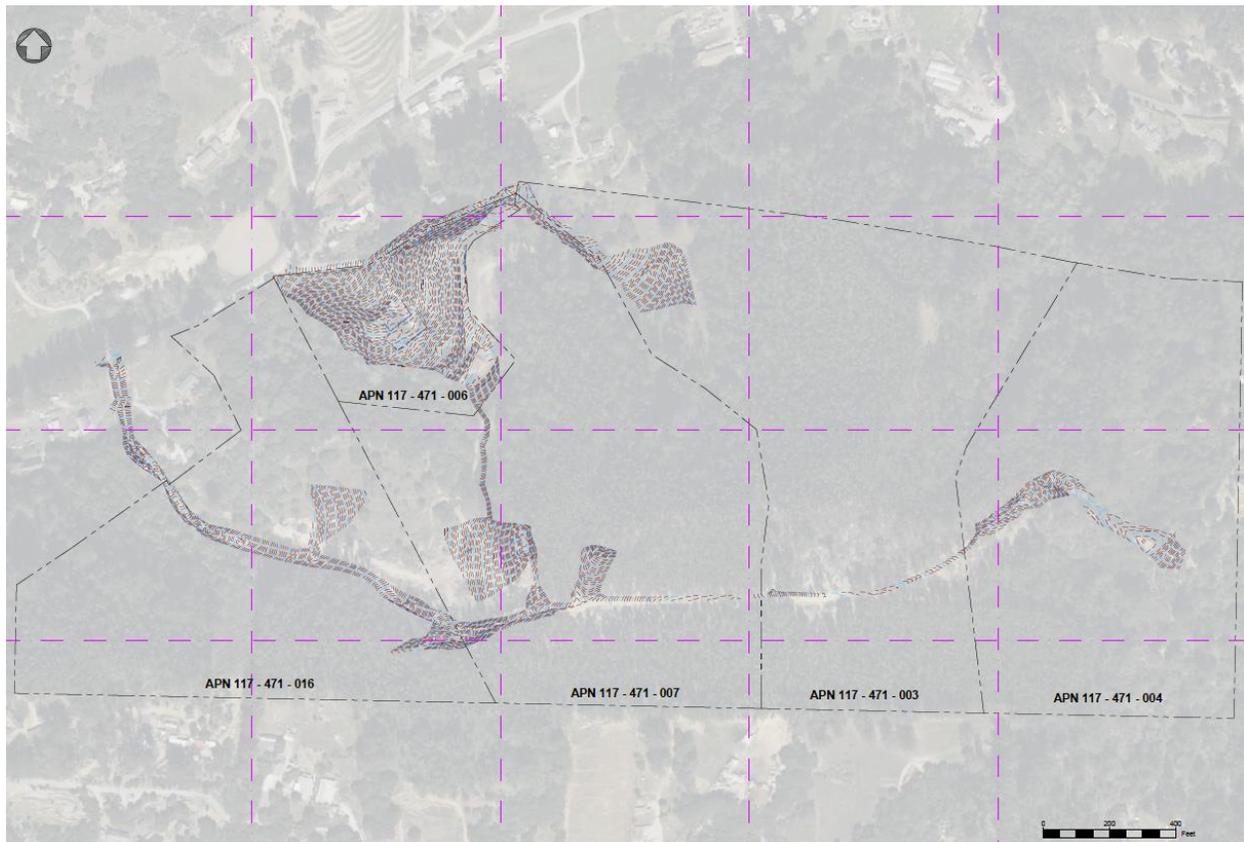
Figure 1: Overview of Hogan survey in 2019. Primarily focused on the existing jeep trail/access road.

Finally, we were unable to locate site-specific topographic information reliably establishing pre-disturbance conditions throughout the project area. Limited site surveying was completed by Hogan Land Services in 2019. The extents of their surveys are presented in Figure 1. Physical reconstruction of pre-disturbance geometry would be limited to the footprint associated with the Hogan 2019 survey, which is only a portion of the overall surficial site disturbance. The proposed site grading (associated with the current permit application) would also provide enhanced site stability as a result of construction of engineered slopes (especially steeper slope areas, $\geq 25\%$).

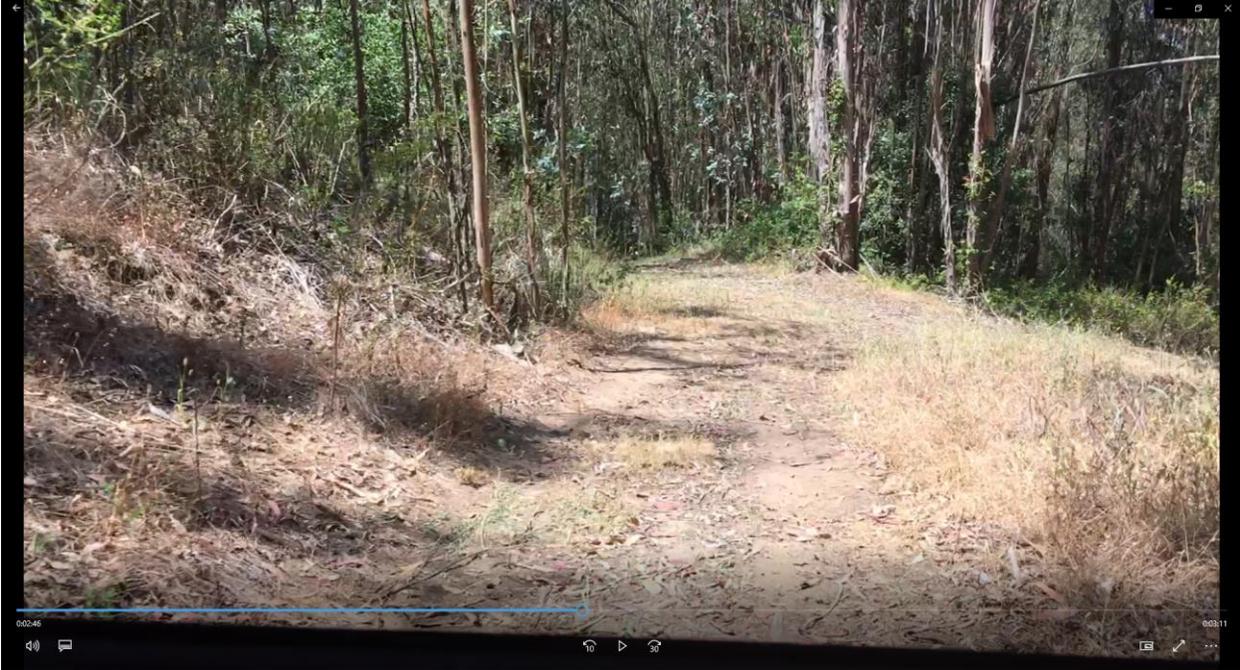
Figure 2: Screen capture of video taken by property owner in 2020 showing existing jeep trail/access road (36.886575N; 121.716222W, looking west).

Based on interviews of the project owner and review of video/photos of pre-disturbance conditions (Figure 2 through Figure 4) as well as review of available historical imagery (Figure 5 through Figure 14), it is apparent that the properties had an established access road prior to start of the limited grading activities in 2021. It was reported by the property owner that the substantial disturbance activity was the removal of invasive eucalyptus. This appears consistent with the available aerial imagery as well as the assessment of the project arborist (Ono Consulting).

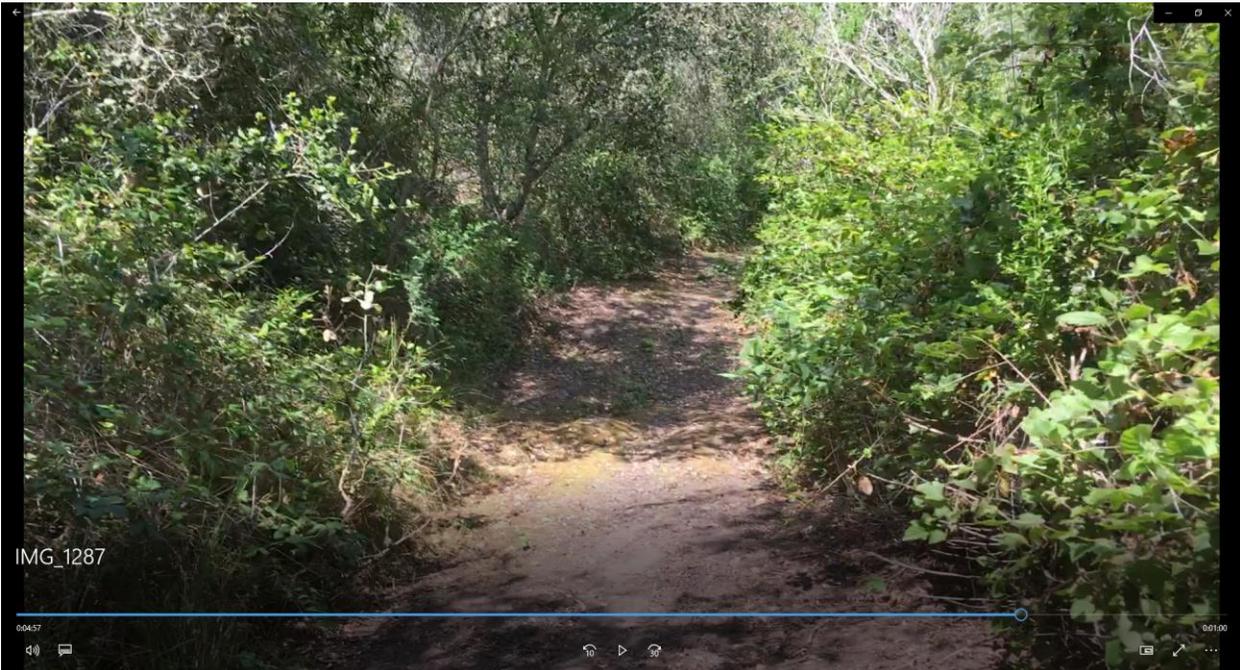
Figure 3: Screen capture of video taken by property owner in 2020 showing existing jeep trail/access road (36.887049N; 121.719776W, looking northwest).

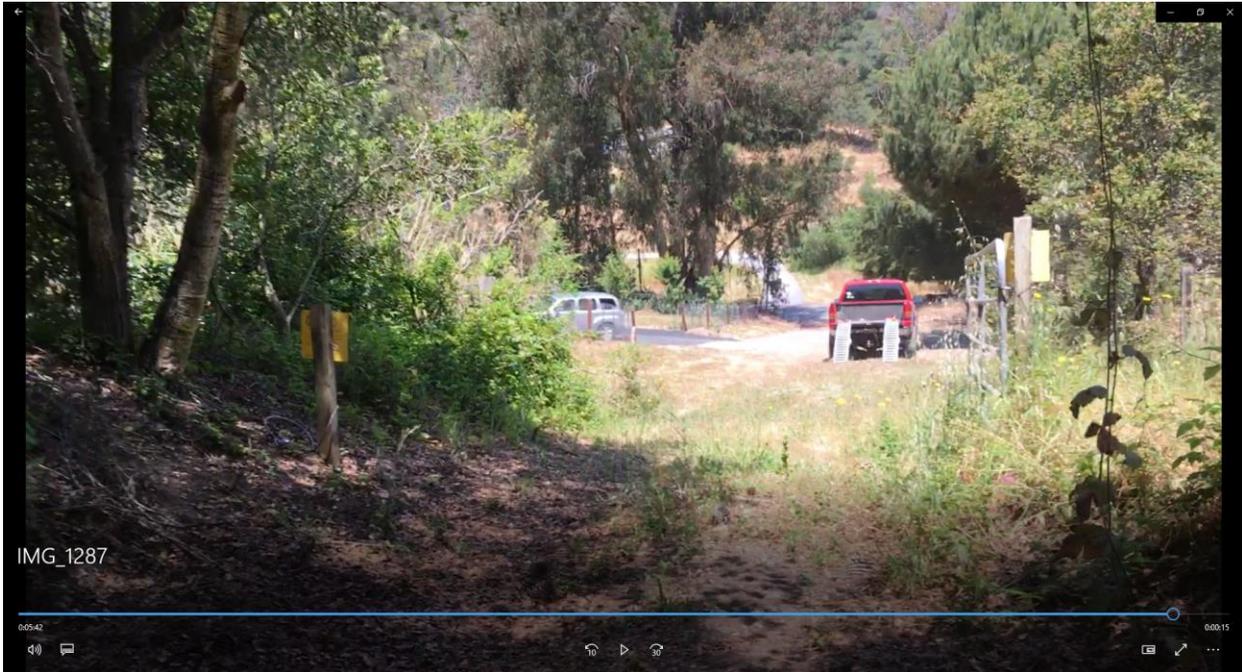
Figure 4: Screen capture of video taken by property owner in 2020 showing existing jeep trail/access road at the northern access point to Vega Road via the existing easement with adjacent neighbors (36.887727N; 121.720653W, looking north).

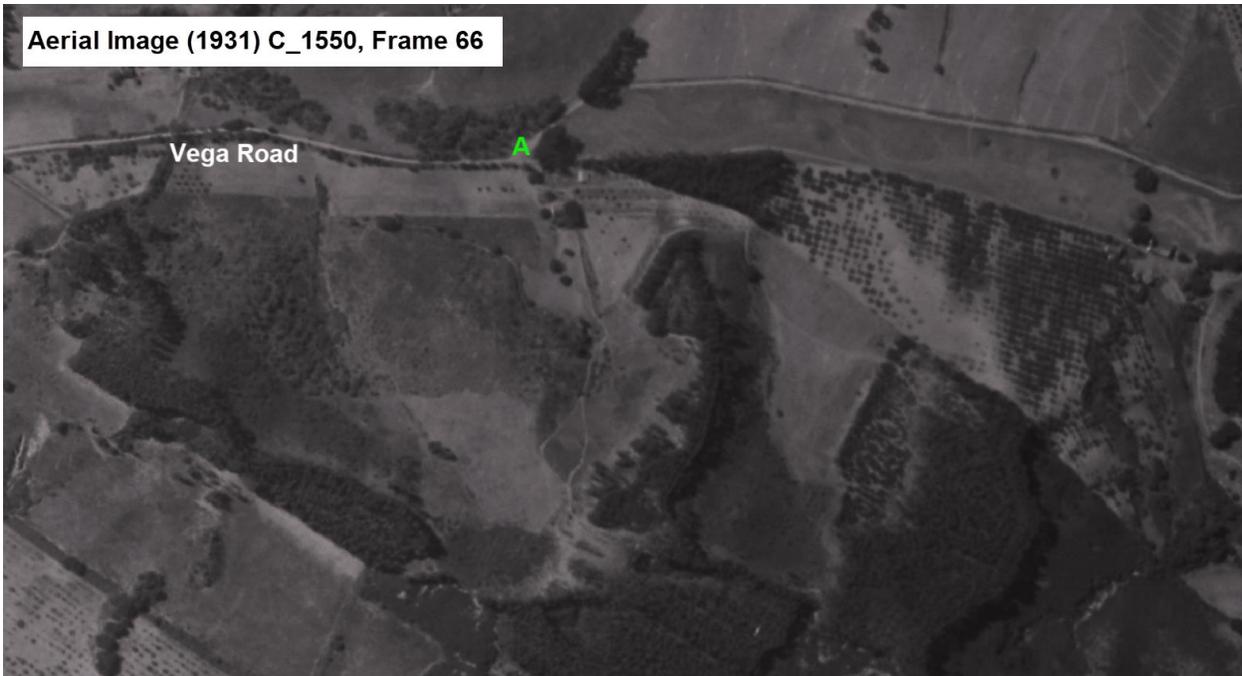
Figure 5: Aerial image from UCSB's Frame Finder showing site conditions in 1931. Vega Road is visible, but no observable development within the properties.

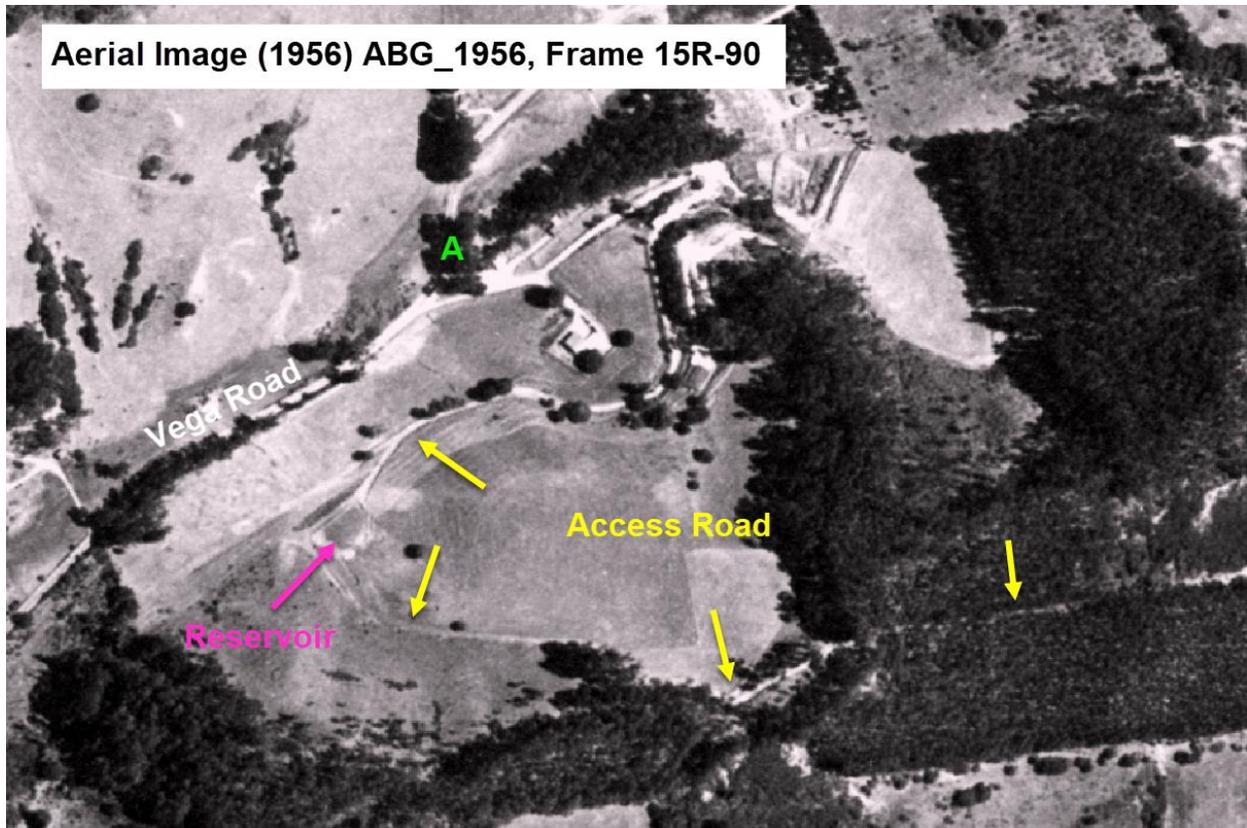
Figure 6: Aerial image from UCSB's Frame Finder showing site conditions in 1956. A residence has been constructed as well as a reservoir and access roads that traverse the property.

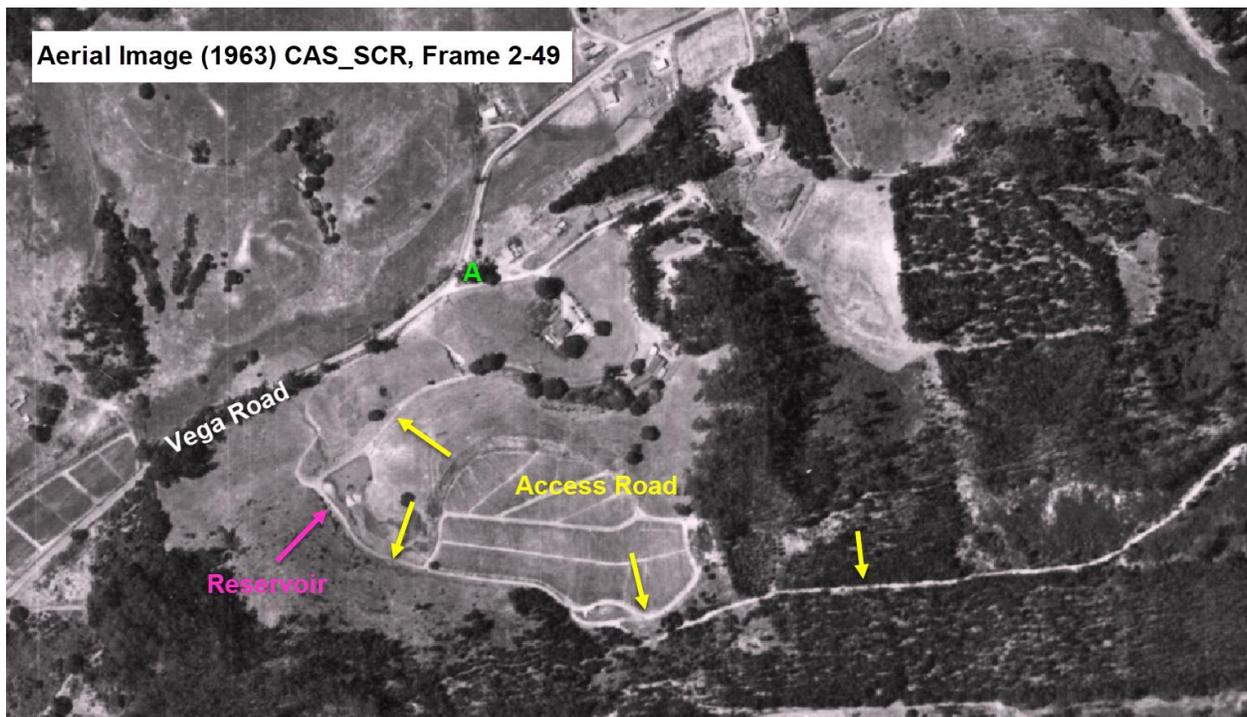
Figure 7: Aerial image from UCSB's Frame Finder showing site conditions in 1963. Access roads that traverse the property have been expanded.

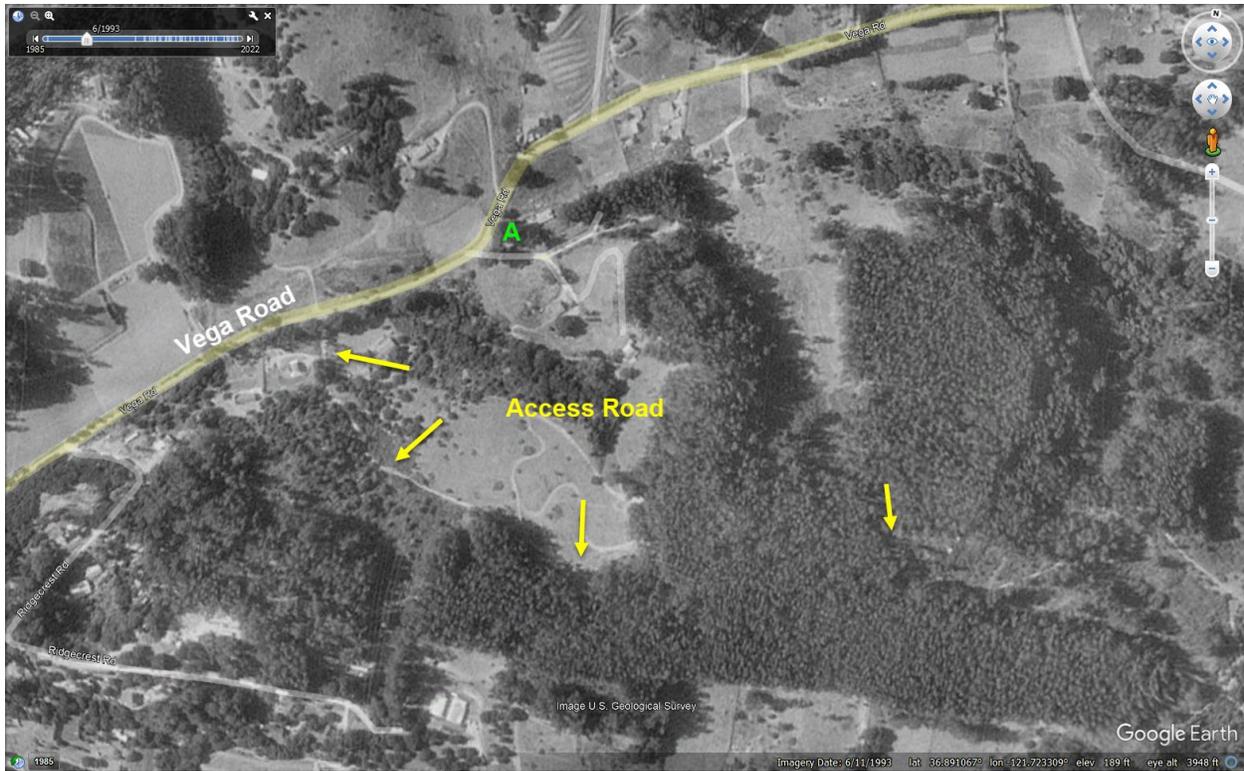
Figure 8: Aerial imagery from Google Earth showing site conditions in 1993. Formal connection to Vega Road in between the two new parcels (132 Vega Road and 136 Vega Road) is visible, likely established in late 1970s/early 1980s during development of 132 Vega Road and 136 Vega Road. Images between 1963 and 1993 were not readily available.

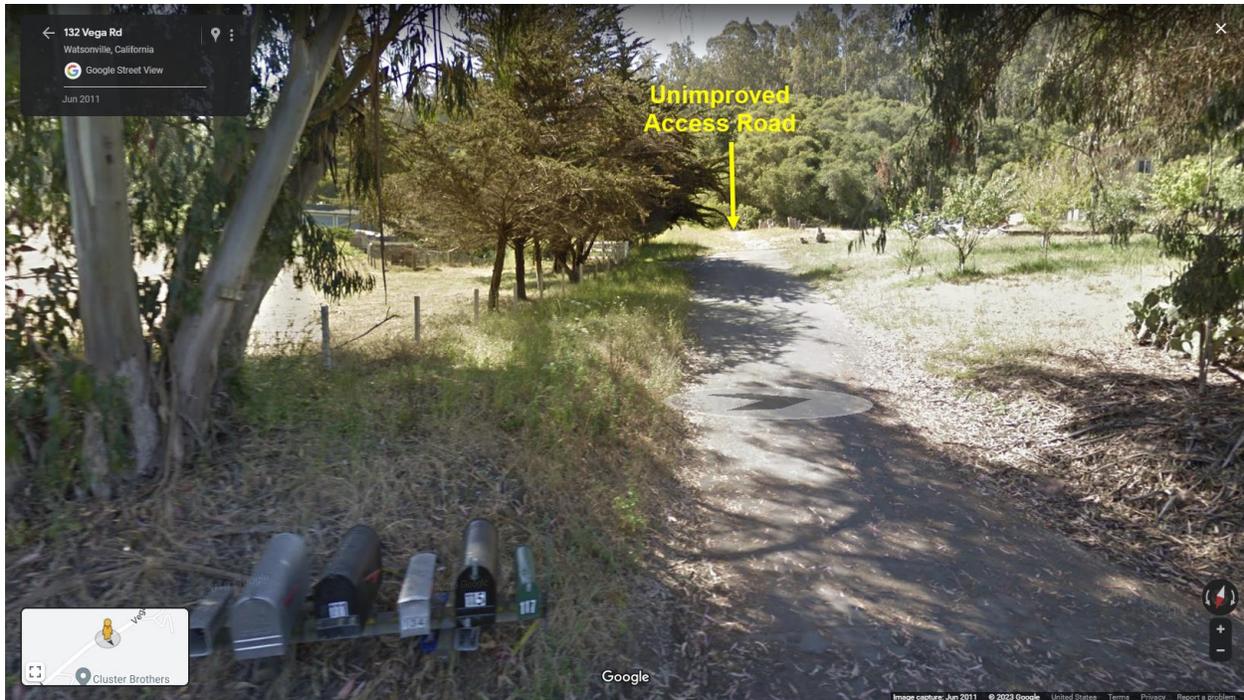
Figure 10: Southward looking view from Vega Road via Google Street View showing the unimproved access road via the access road to 132 and 136 Vega Road.

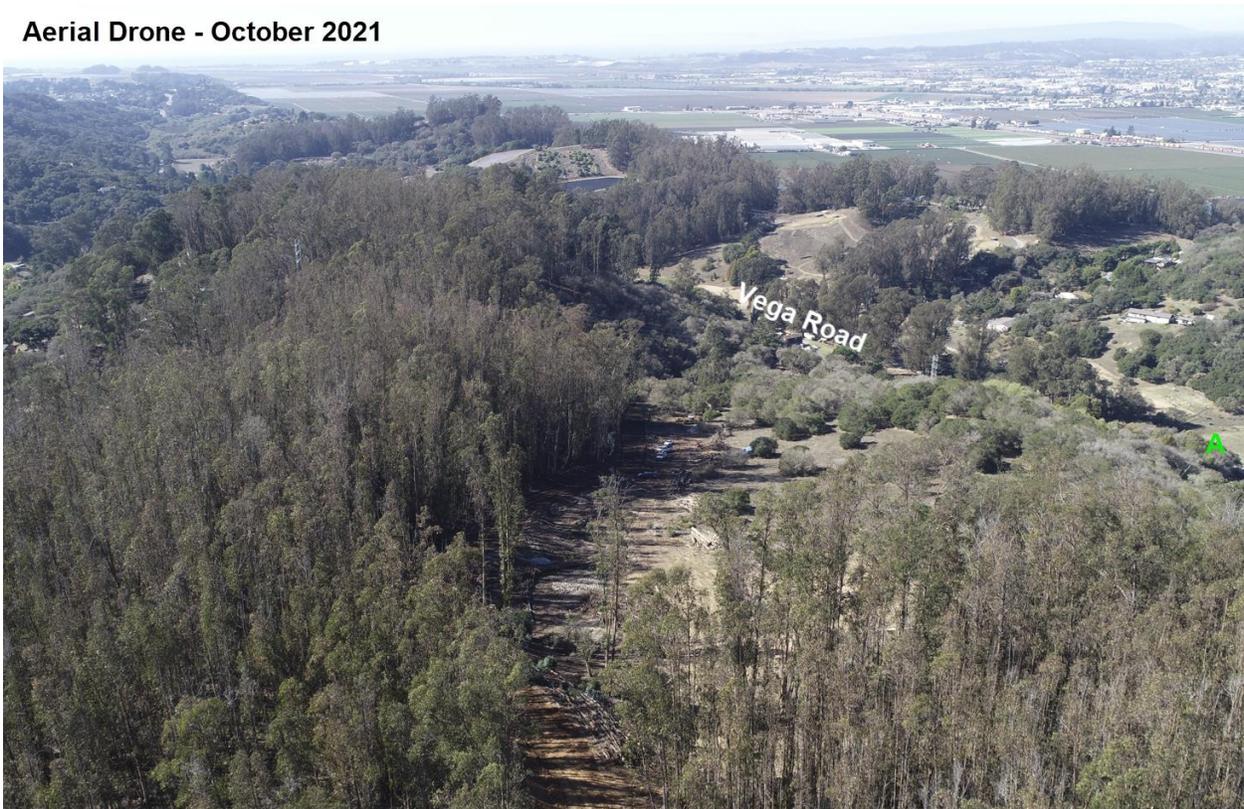
Figure 14: Westward-looking aerial oblique taken in October 2021 by R. Storesund showing site work consisting primarily of eucalyptus removal via pre-existing access roads.

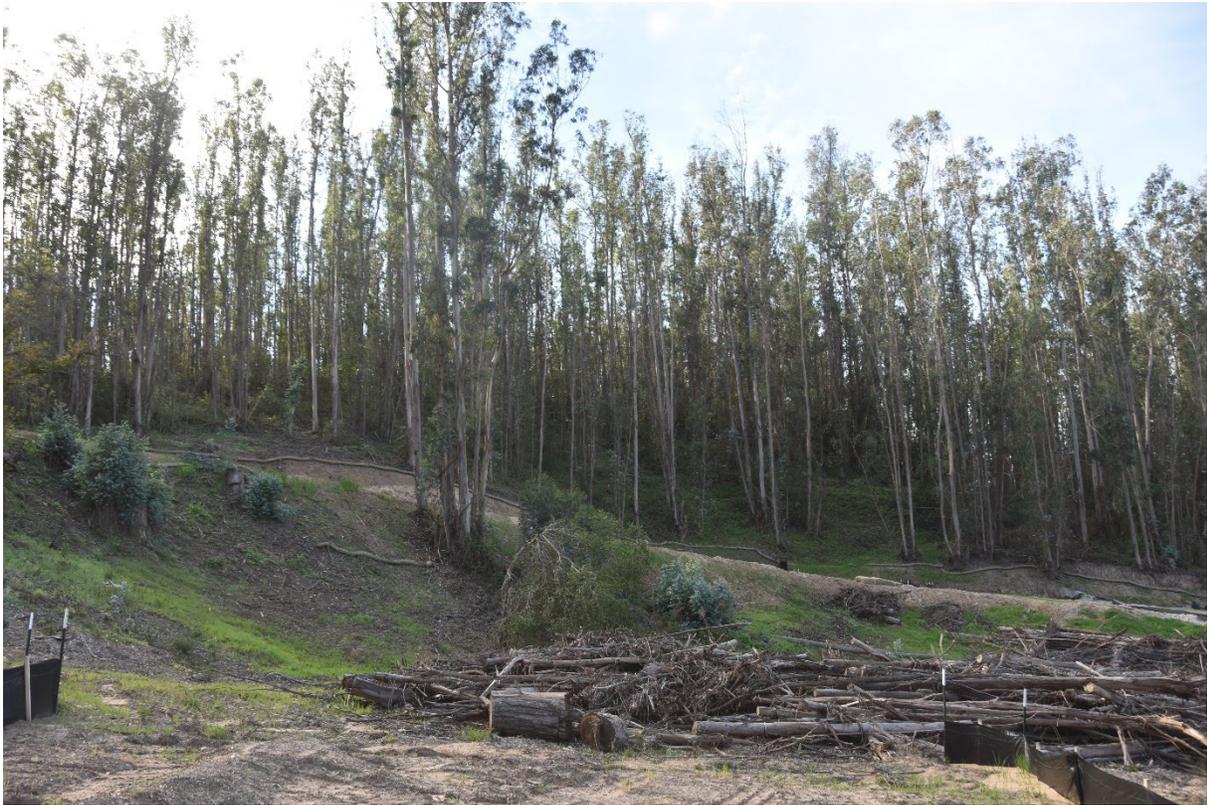
Evenly spaced Eucalyptus stumps adjacent to roadwork.

1. Remove Eucalyptus stump sprouts and treat with a woody herbicide to reduce the regrowth and allow space for planting new trees.
2. Eucalyptus stumps should be left in a mosaic pattern until their removal is necessary for development and/or proper native plant cover has been established to reduce the risk of erosion.

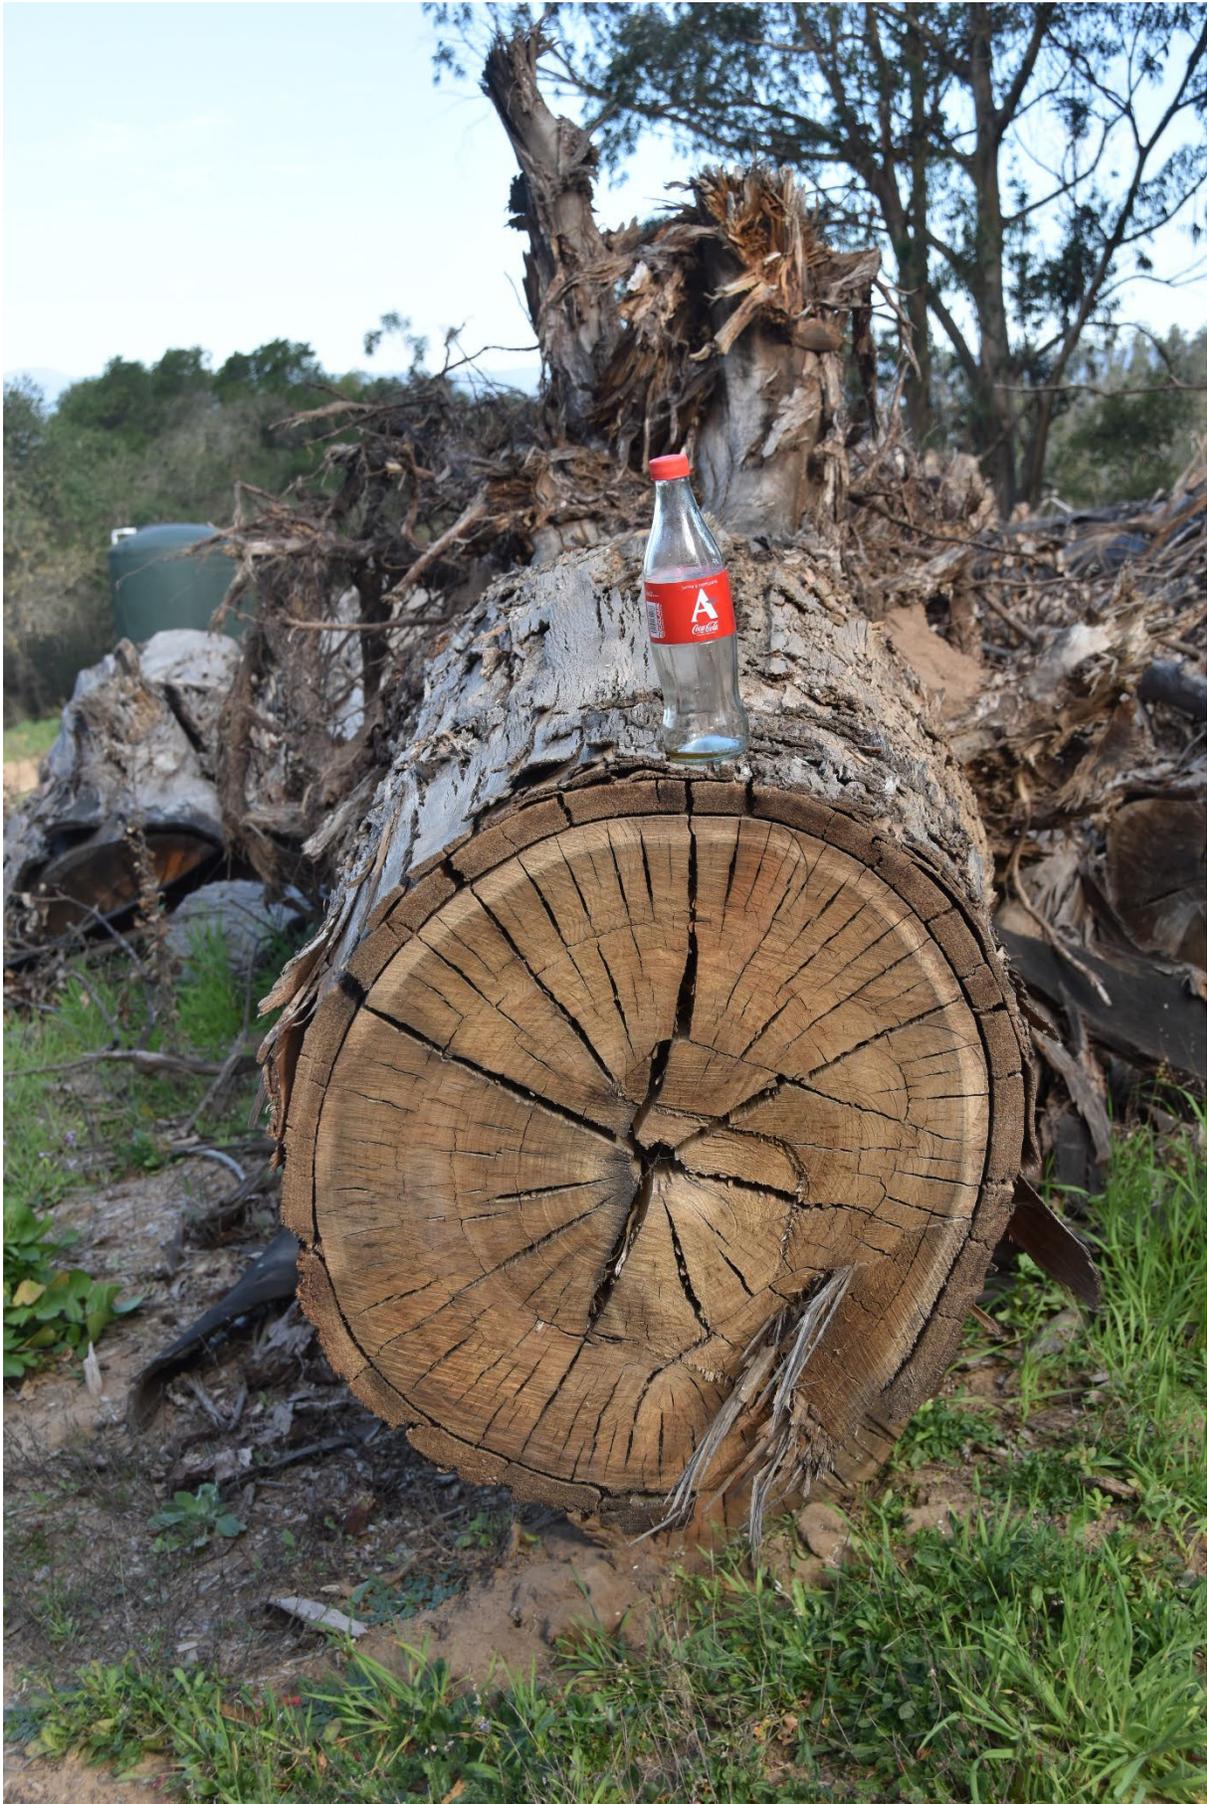
One of the larger stems observed removed. Approximately 22-inches.

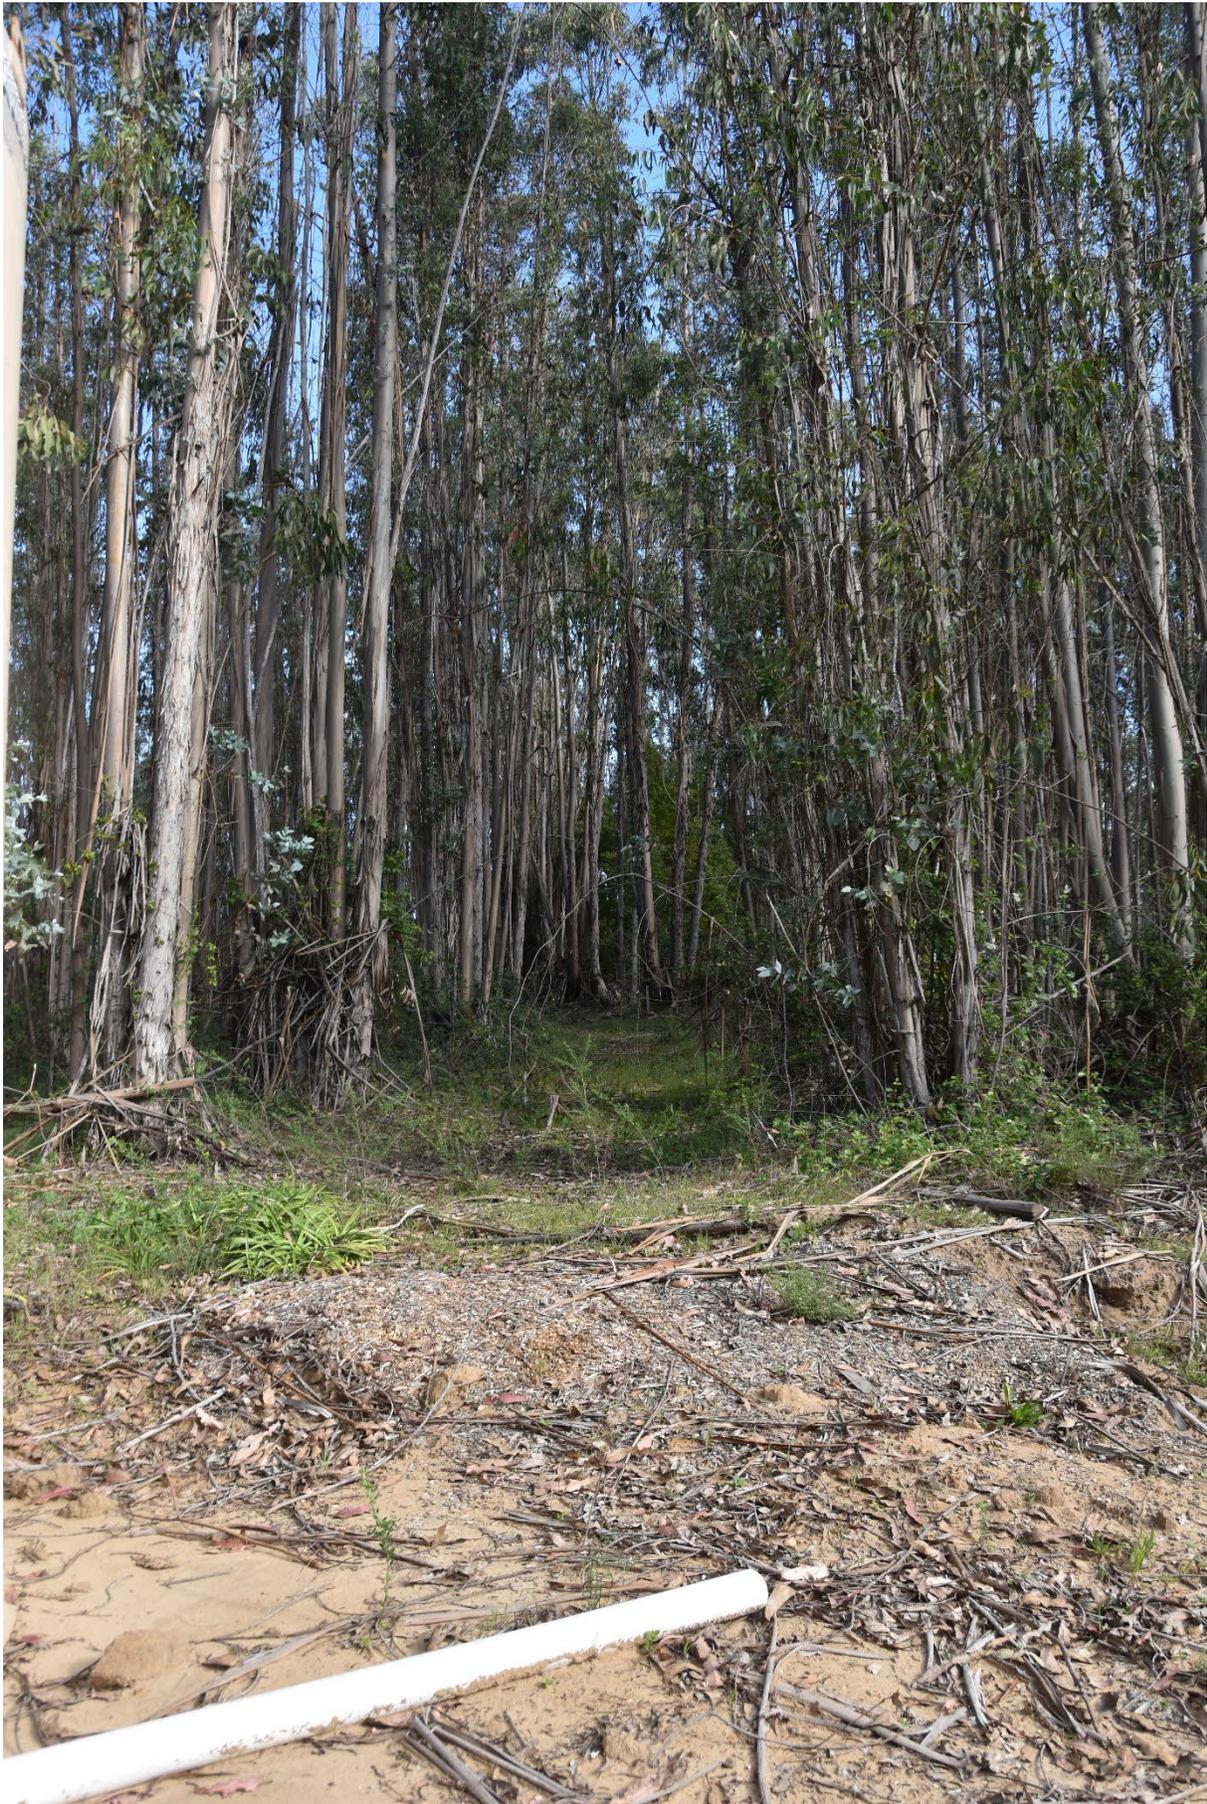
Eucalyptus trees were planted in rows 10-feet on center.

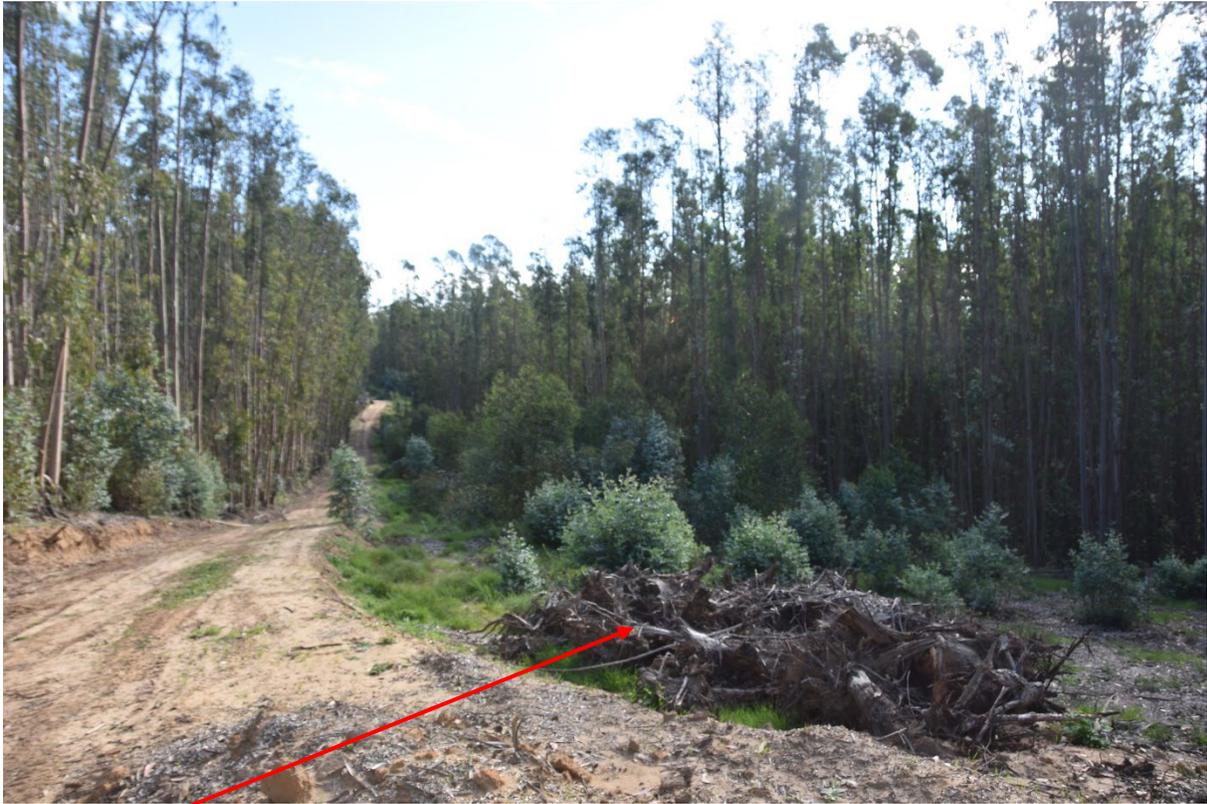
Previous stumps have been dug up and masticated.

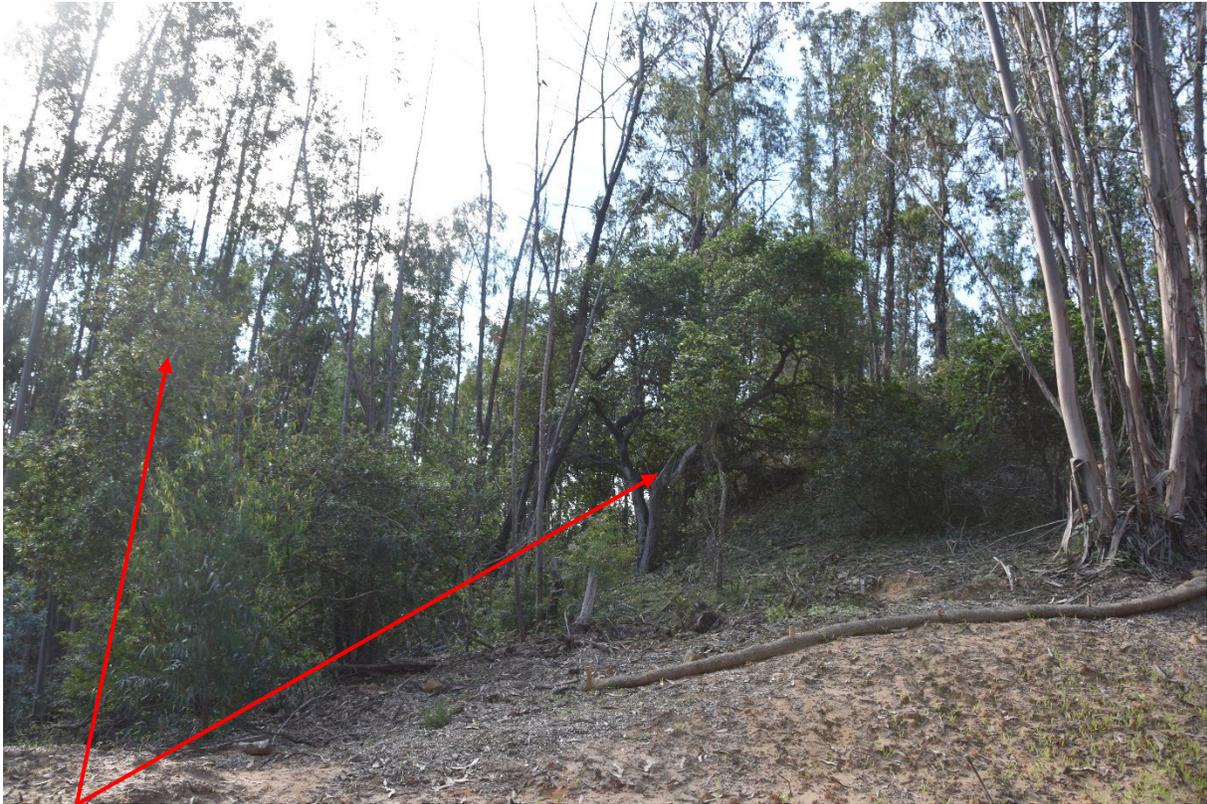
A small number of existing oaks are growing in a small island next to the road in parcels 007 and 003.

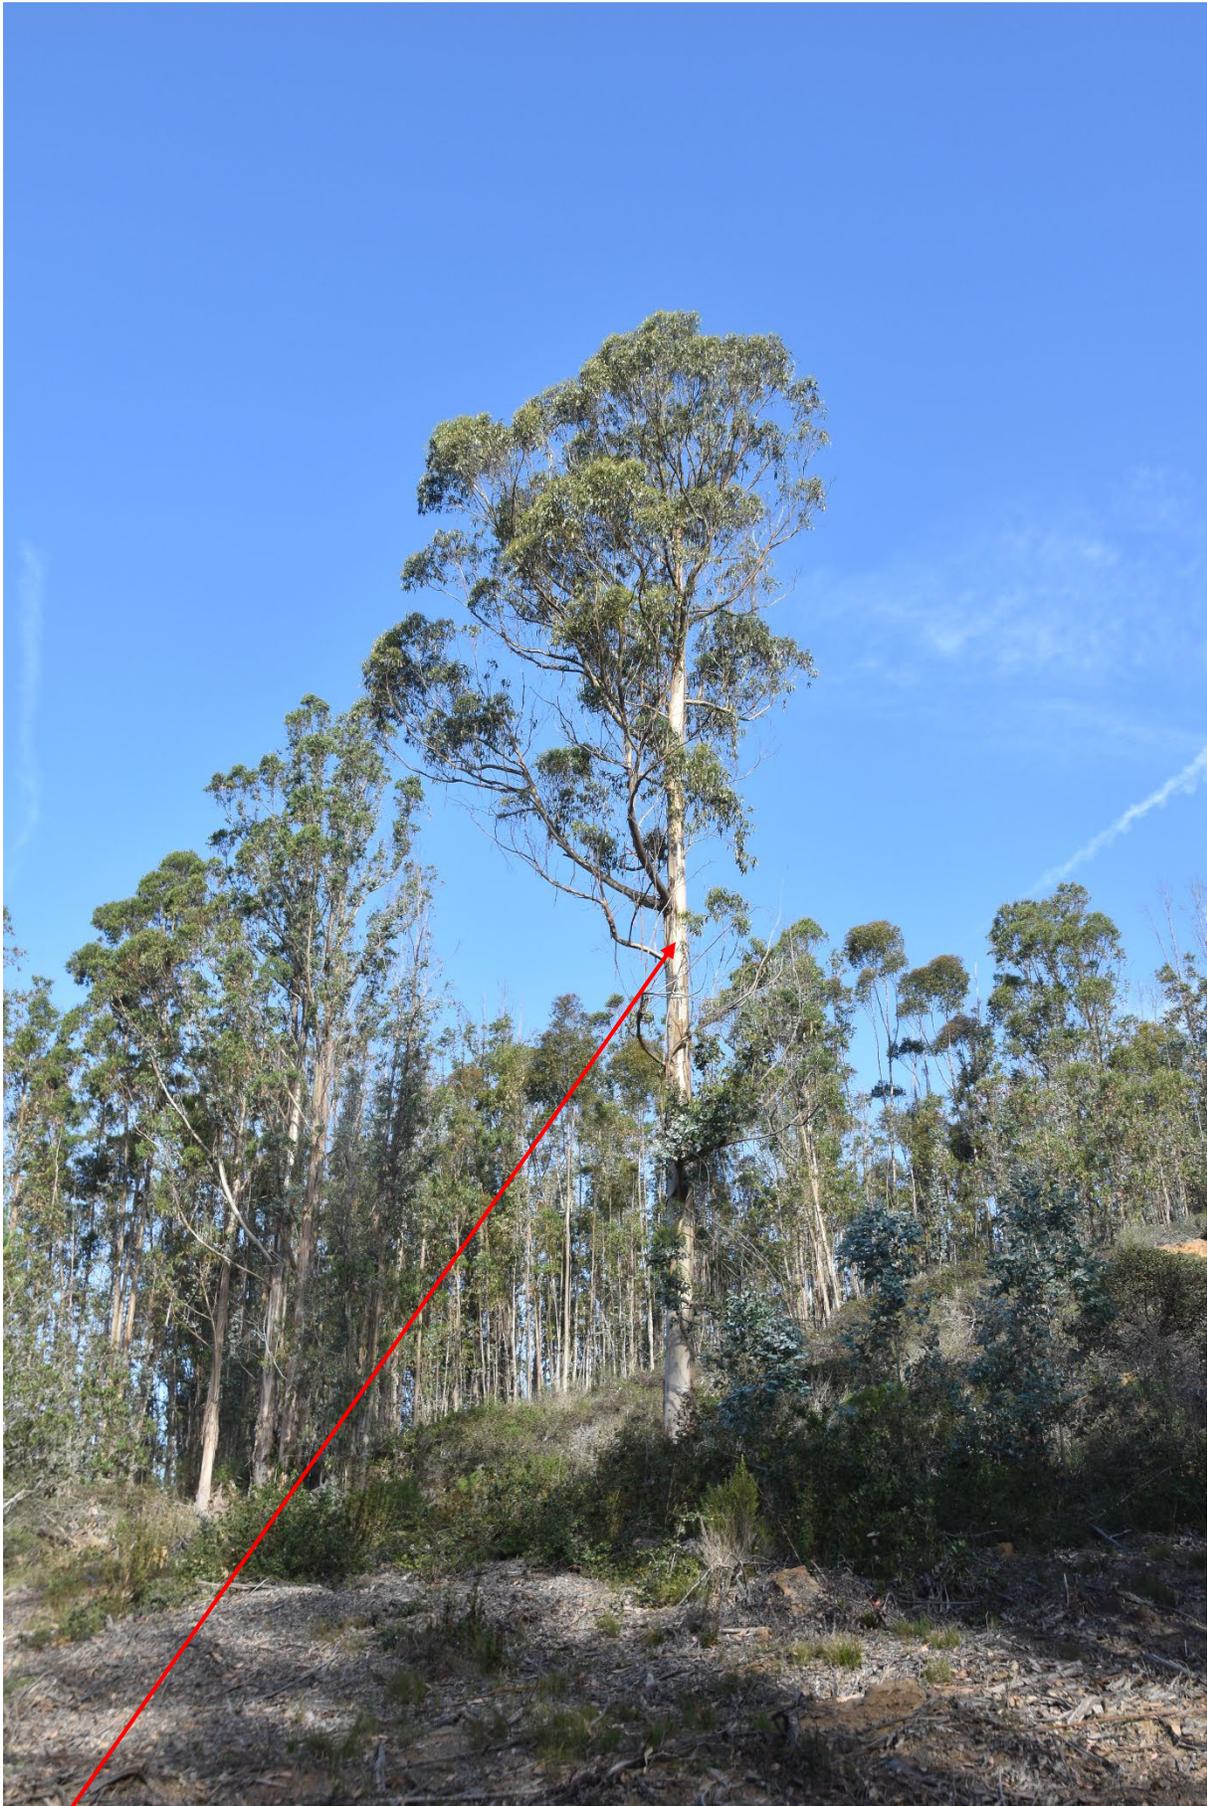
Large Landmark Eucalyptus can be left on site or removed if warranted by new development.

3. If Eucalyptus stumps are to be mechanically removed, a soil or grading erosion specialist will need to be consulted to avoid the risk of erosion.
4. The small number of landmark Eucalyptus trees observed can remain on site as they are outside of development areas. If the trees are proposed to be removed later, oak reforestation efforts will mitigate the removal of the landmark Eucalyptus.

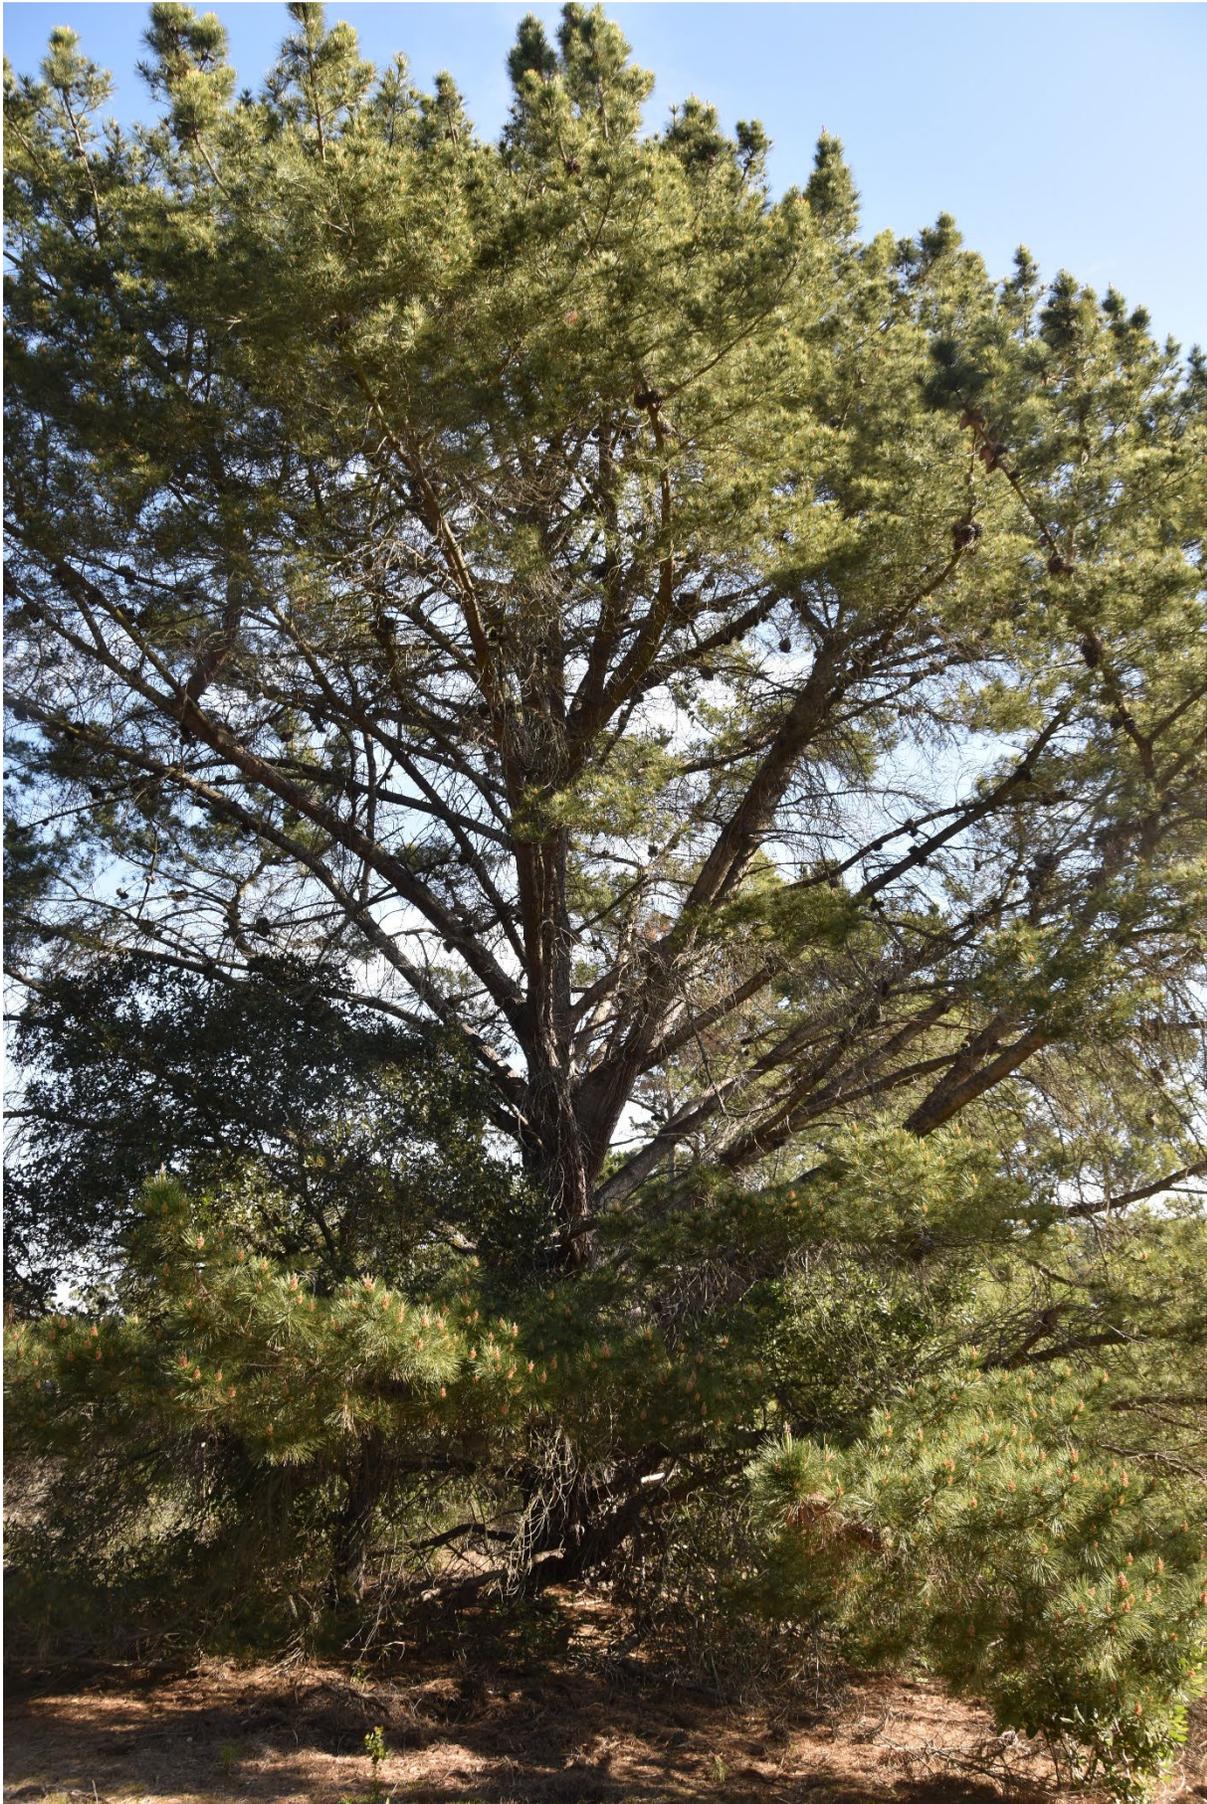
There are several smaller (< 36") Monterey pine trees in the eastern section of the lots.
