Re: Vega Road Project Citation
Restoration Challenges
Watsonville, CA

Oak Restoration/ Forest Management Plan 146 Vega Road

VEGA ROAD PROPERTIES GRADING PROJECT

GRADING PLANS MAY 10, 2022

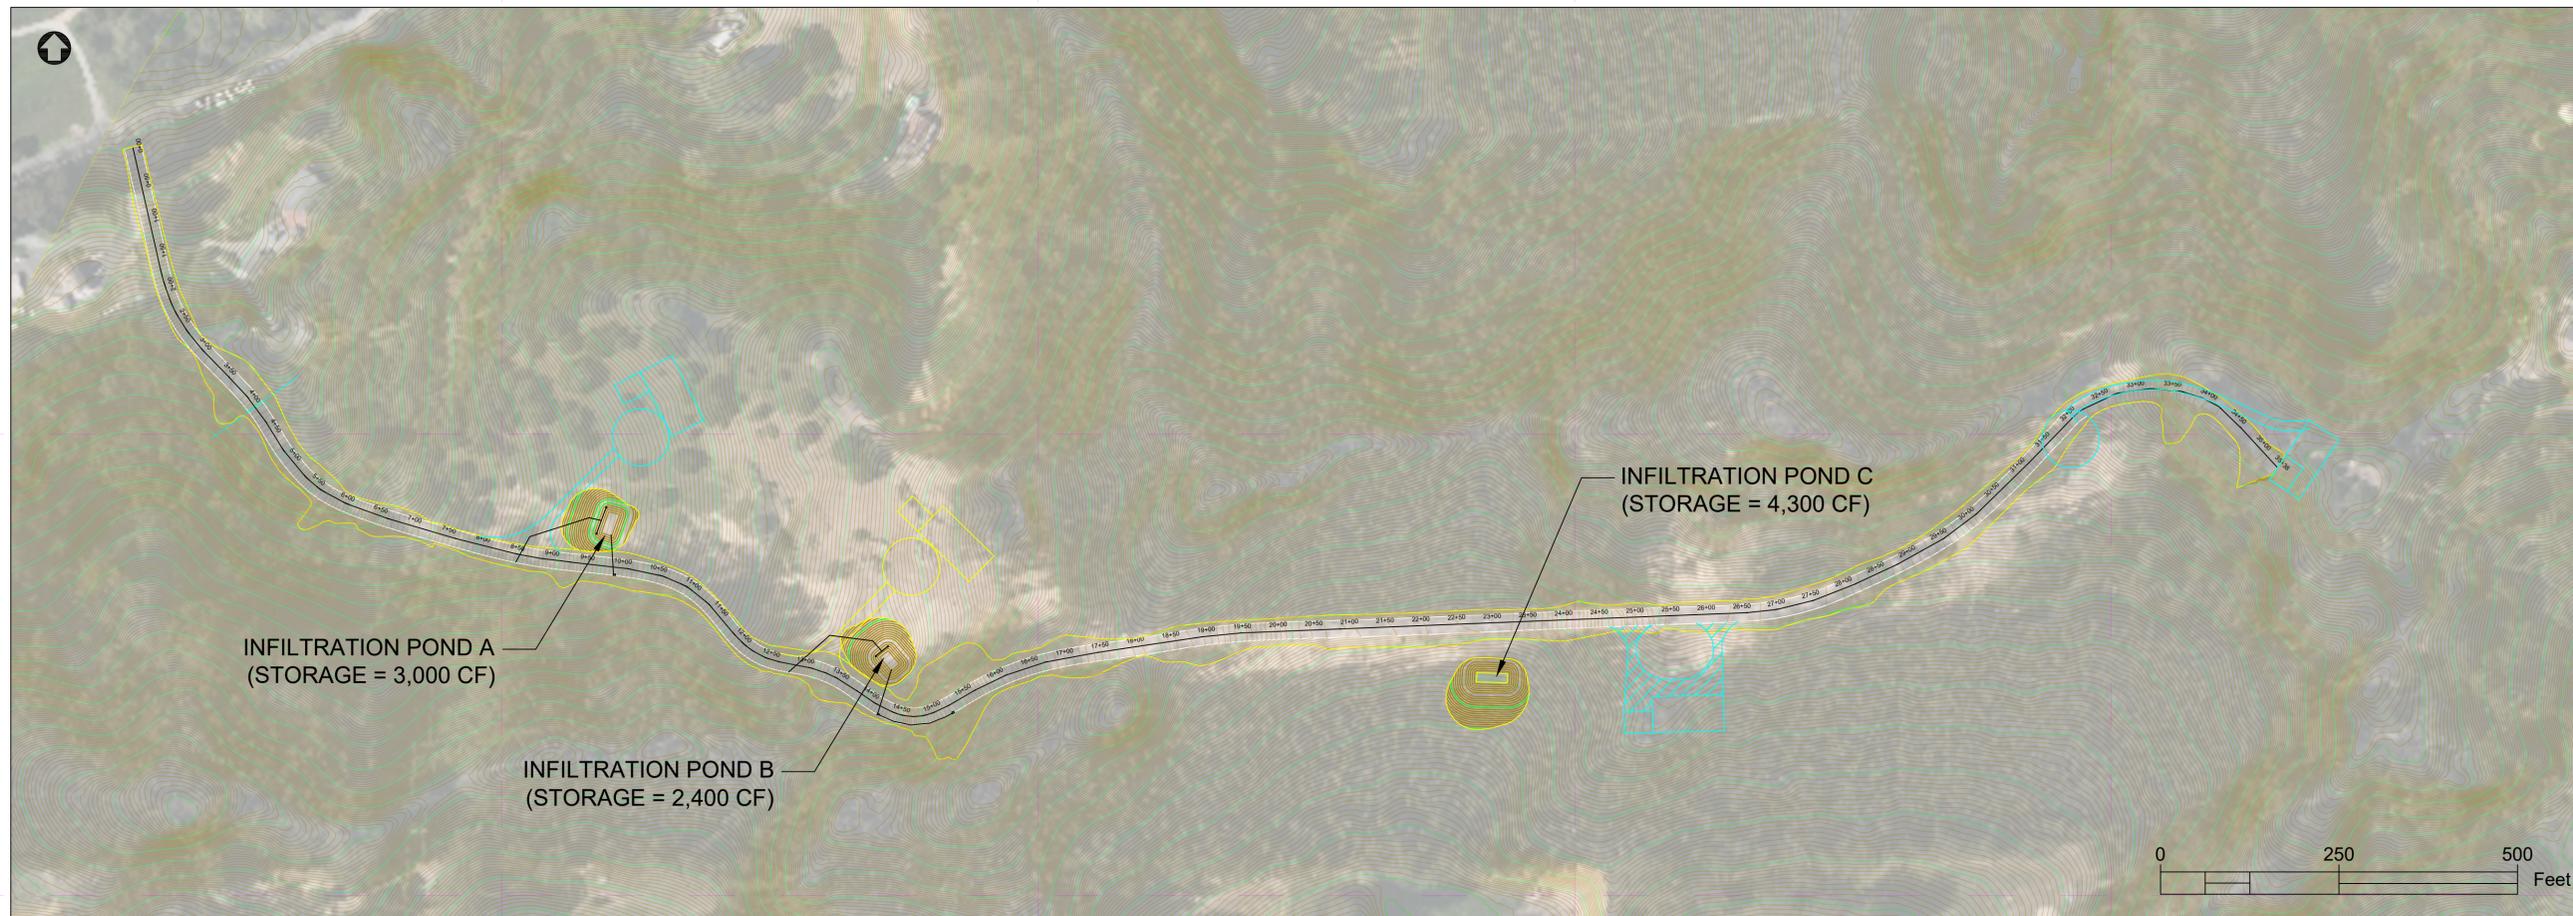
INFILTRATION TRENCH LAYOUT

Infiltration Volume Pond A: 3,000 CF

Infiltration Volume Pond B: 2,400 CF

Total Infiltration Pond Volume: $(3,000 \text{ CF} + 2,400 \text{ CF} + 2,400 \text{ CF}) = 7,800 \text{ CF}$

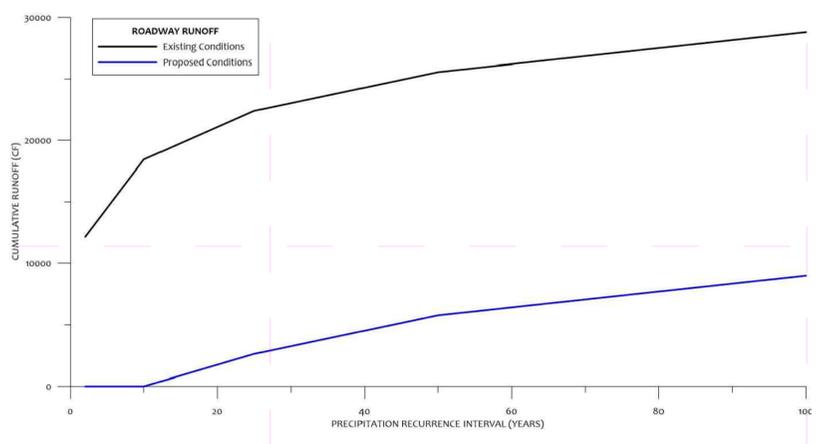
RUNOFF ESTIMATES (EXISTING & PROPOSED)
 SCALE: N/A

RECURRENCE	PRECIPITATION (IN)	RUNOFF (CF)	CF - ESTIMATED RUNOFF (EXISTING)	CF - ESTIMATED RUNOFF (PROPOSED)
2	2.70	12150	2070	0
10	4.10	18450	8370	0
25	4.98	22410	12330	2630
50	5.68	25560	15480	5780
100	6.40	28800	18720	9020
