Date: October 28, 2024
Project No.: 1539-1-1

Re: Geotechnical/Geologic Peer Review
226 Highway 1
Carmel, California

Introduction and Background

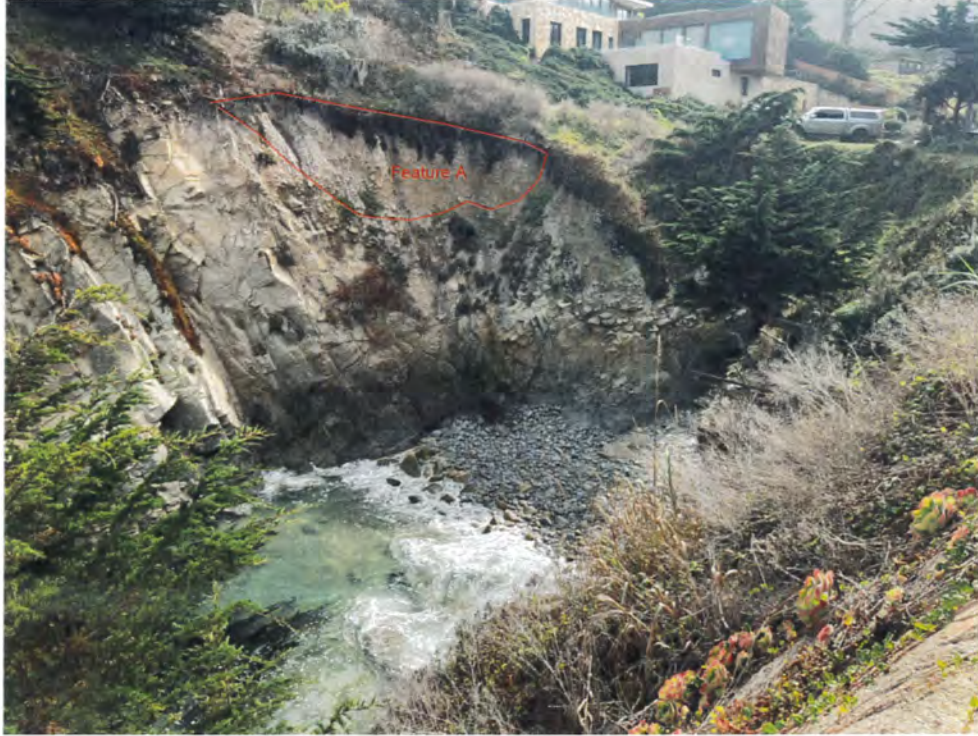
- a. A deposit of Qoal is located beneath the proposed autocourt and also downslope of the southeastern end of the proposed residence as shown on the Easton geologic map. This elongated deposit appears to occupy a sloping swale surface that steepens towards the face of the slope as shown in geologic cross-section D-D'. It would appear that this deposit might be a landslide. The unsupported toe of this deposit is shown as Feature "A" in the attached photo.

Feature A – A deposit of Qoal.

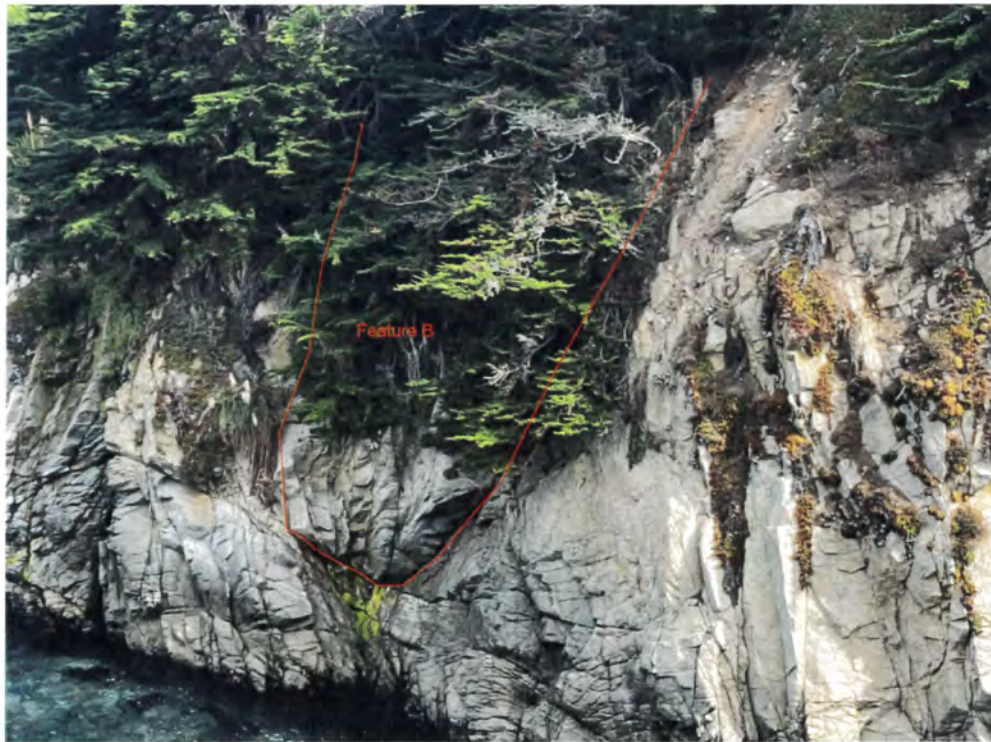
- b. Along the bottom of the steep slope is an exposure in the granodiorite that shows the intersection of 3 primary joint sets. At this location is a feature that appears to be a potential wedge failure with green moss indicative of seepage (see Feature "B" in the attached photo). Other areas, and potentially those covered by vegetation are indicative of potentially similar rock failure conditions.

Feature B – Potential Wedge Failure.

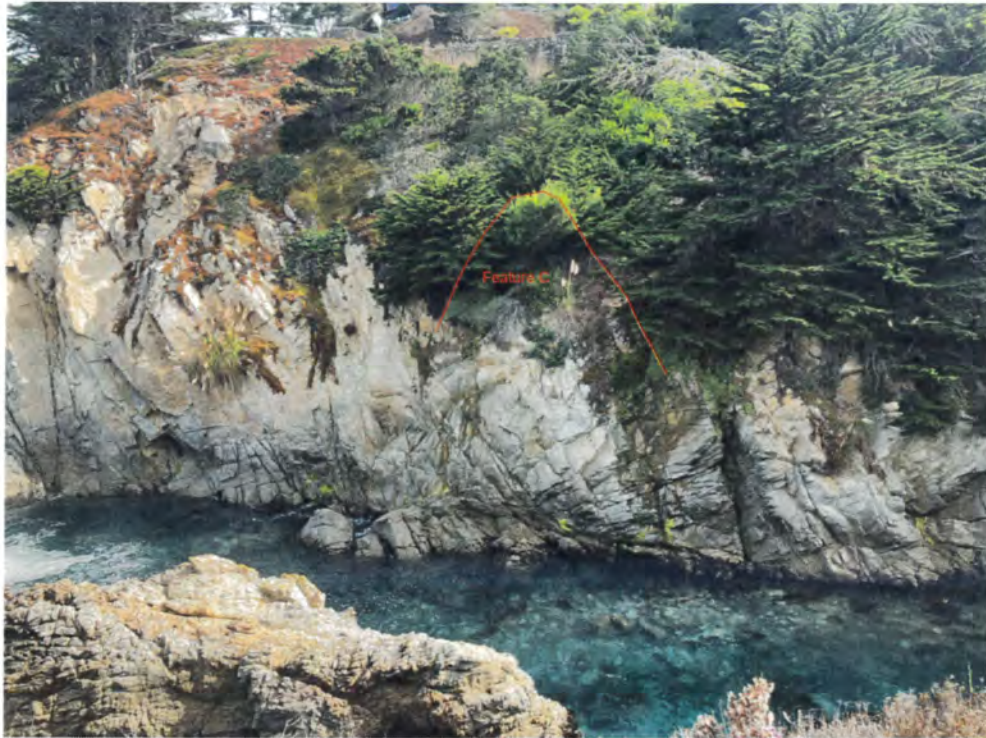
- c. The geologic map shows a headscarp near the northwest corner of the residence deck. The map indicates an 8' vertical joint-bounded scarp at this location with 5 joint attitudes showing random strikes and moderate to steep dips of between 52° and 81° in the granodiorite. Given the other observed joint sets in cliff exposure during our reconnaissance, this scarp (Feature "C" in the attached photo) represents an active slope instability condition.

Feature C – Location of headscarp.
