County of Monterey

Meeting Agenda - Final

County of Monterey Zoning Administrator

Condition/Mitigation Monitoring Measure: This Administrative permit (PLN240104) allows construction of a 1,200 square foot accessory dwelling unit. The property is located at 25745 Hatton Rd, Carmel (Assessor's Parcel Number 009-251-010-000), Carmel Area Land Use Plan. This permit was approved in accordance with County ordinances and land use regulations subject to the terms and conditions described in the project file. Neither the uses nor the construction allowed by this permit shall commence unless and until all of the conditions of this permit are met to the satisfaction of the Director of HCD - Planning. Any use or construction not in substantial conformance with the terms and conditions of this permit is a violation of County regulations and may result in modification or revocation of this permit and subsequent legal action. No use or construction other than that specified by this permit is allowed unless additional permits are approved by the appropriate authorities. To the extent that the County has delegated any condition compliance or mitigation monitoring to the Monterey County Water Res

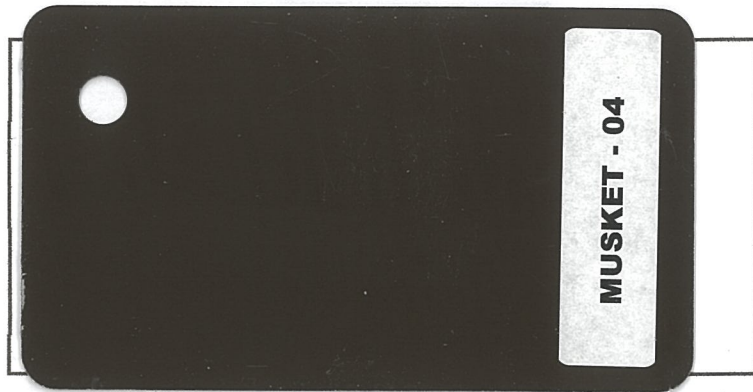
COLOR SAMPLES FOR PROJECT FILE NO. PLN 240104

Materials: METAL ROOF

Colors: DARK BROWN

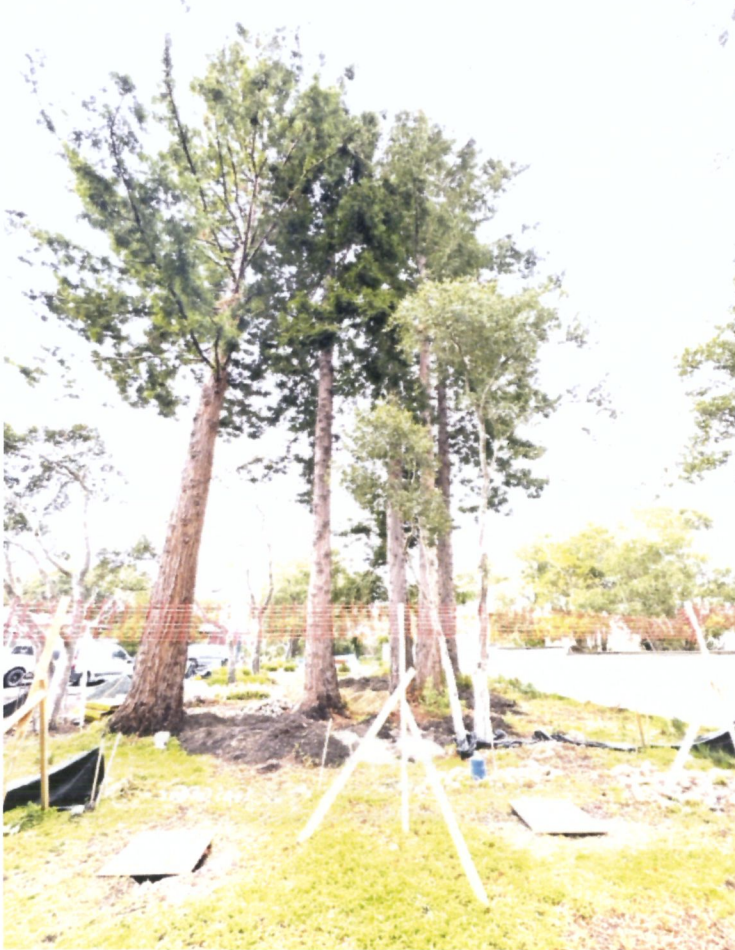
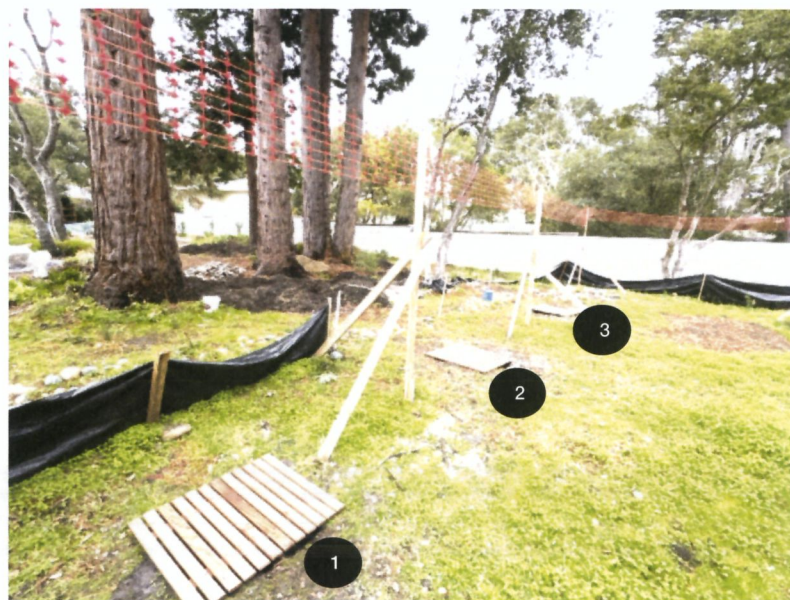
S. sempervirens with 3 test sites to determine if any roots are impacted by development.

Test site 1 has minimal $\leq 1"$ diameter non-woody roots and no primary roots. Impacts are none.

The arborists observed “non-woody” Redwood roots that were less than one inch in diameter in the three hand-dug test sites (2 feet x 2 feet wide, 2 feet deep). These roots, also known as feeder roots, have the primary purpose of absorbing water and nutrients in the upper layers of the soil, and do not serve any support for the tree. No woody roots, which provide the primary structural foundation while also facilitating water and nutrient uptake, were identified. Based on these observations, the project arborist determined that no impacts on Redwoods would occur with the implementation of the project and that these trees did not pose a hazard to nearby structures. Further, as recommended by the project-specific arborist report, an arborist will monitor all excavation within 10 feet of the proposed

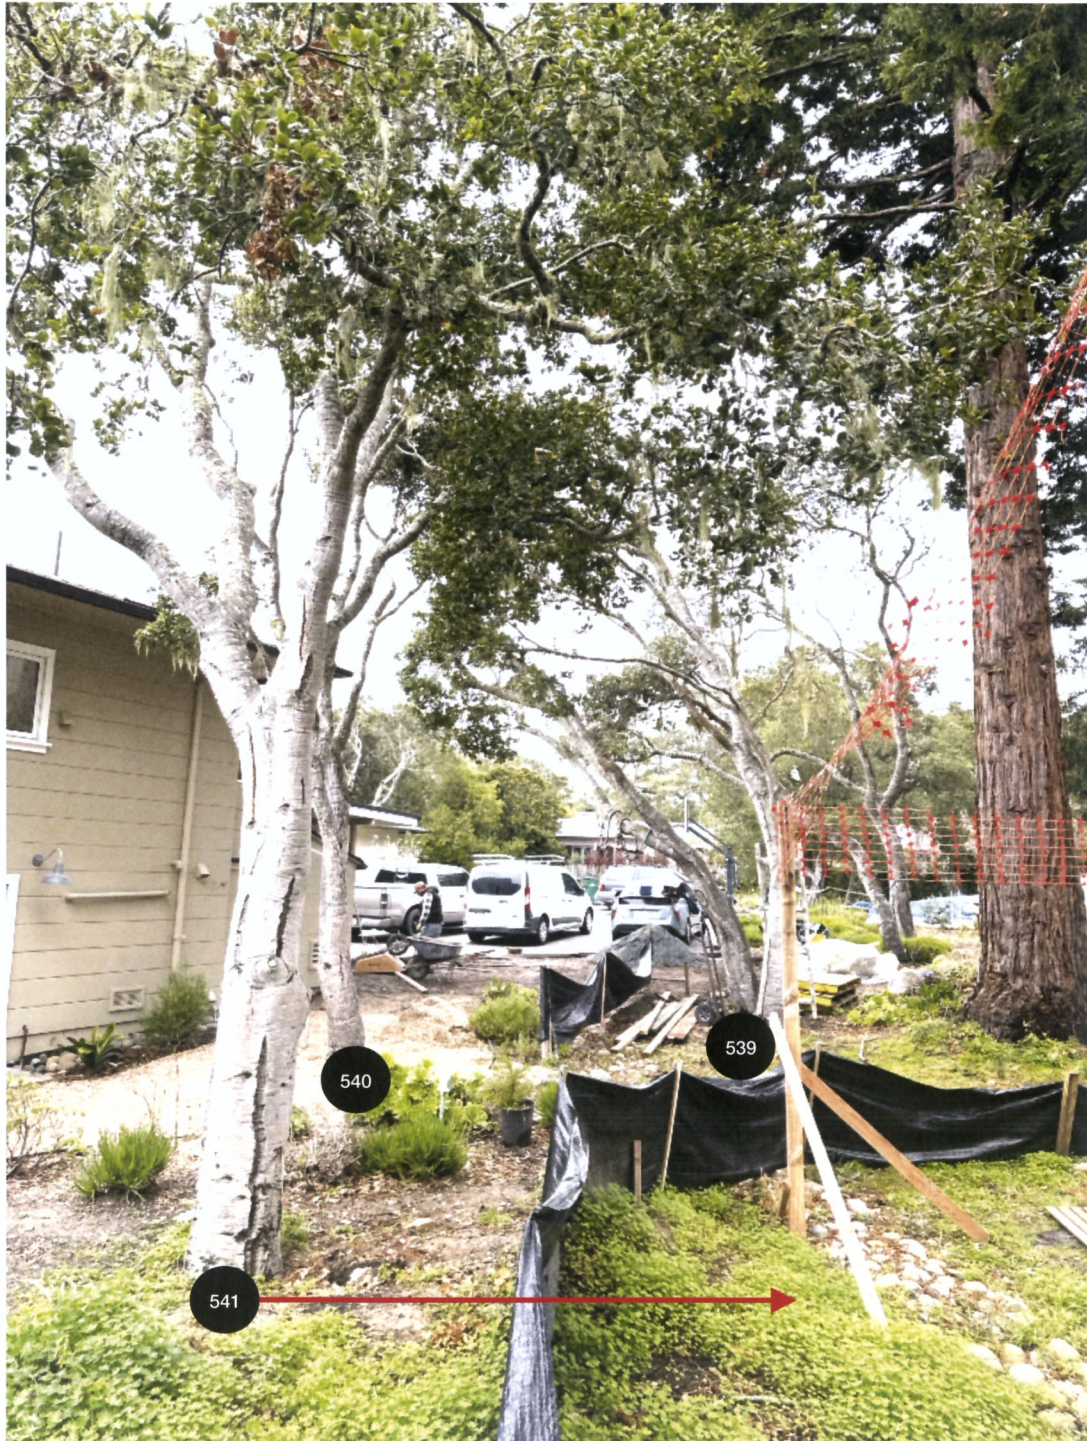
Q. Agrifolia trees 546-549

Tree 548 is within 5' of the project. All soil excavating will have to be completed by hand with any roots ≥ 2 " diameter will require inspection by the project arborist before cutting takes place.
