# CARMEL VALLEY MANOR MASTER PLAN

## PHASE TWO HISTORIC ASSESSMENT REPORT

PAST Consultants, LLC  
P.O. Box 721  
Pacific Grove, CA 93950  
February 10, 2025

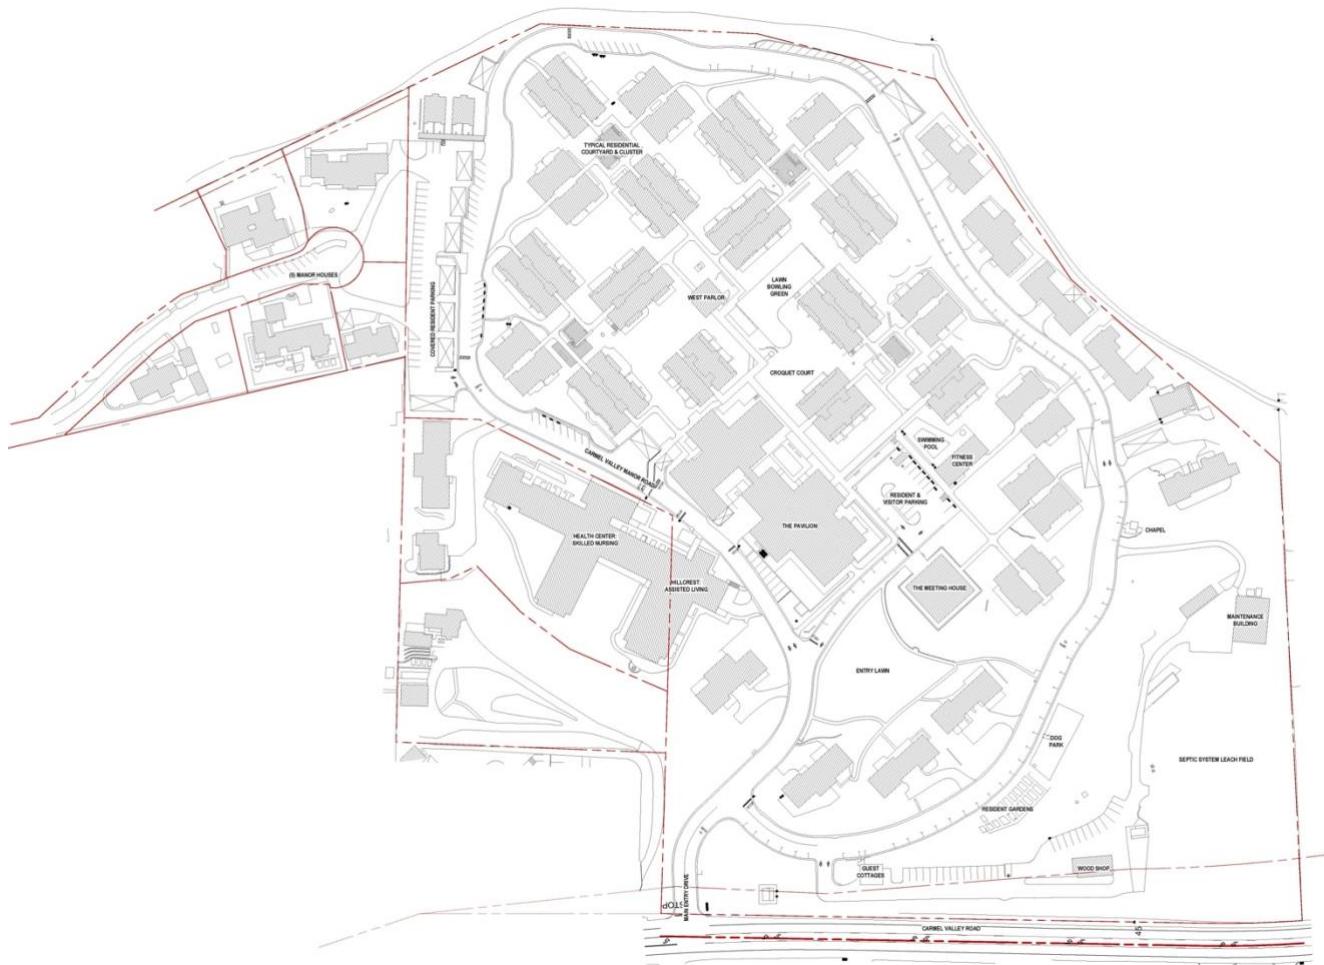
**Figure 2.** Site Plan showing existing buildings (*Courtesy: Perkins Eastman, 2025*).

The following shows the existing arrangement of buildings at Carmel Valley Manor (**Figure 2**).

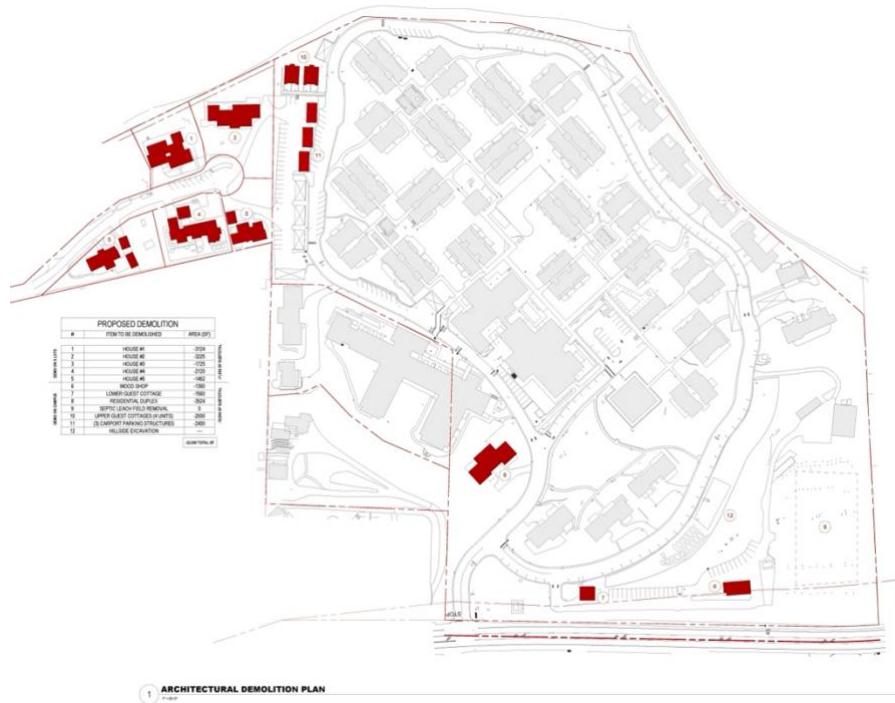
**Figure 3.** Site Plan showing buildings to be removed in red (*Courtesy: Perkins Eastman, 2025*).

The proposed project is presented on the design drawings, *Carmel Valley Manor Master Plan*, by Perkins-Eastman, dated January 9, 2025. The demolition plan indicates buildings to be removed (**Figure 3**).

To upgrade programmatic needs and provide for more residential occupancy, building demolitions and additions are proposed for the Master Plan. The building demolitions include:

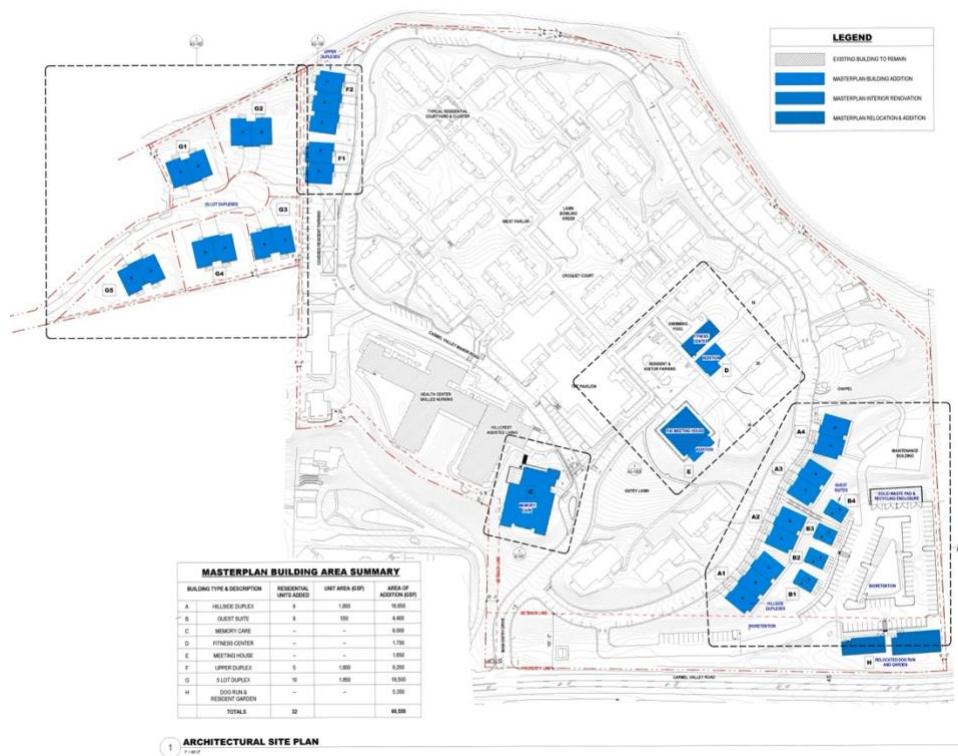
**Figure 4.** Site Plan showing buildings to be constructed in blue (*Courtesy: Perkins Eastman, 2025*).

The site plan showing new construction appears below (**Figure 4**).

New building construction includes:

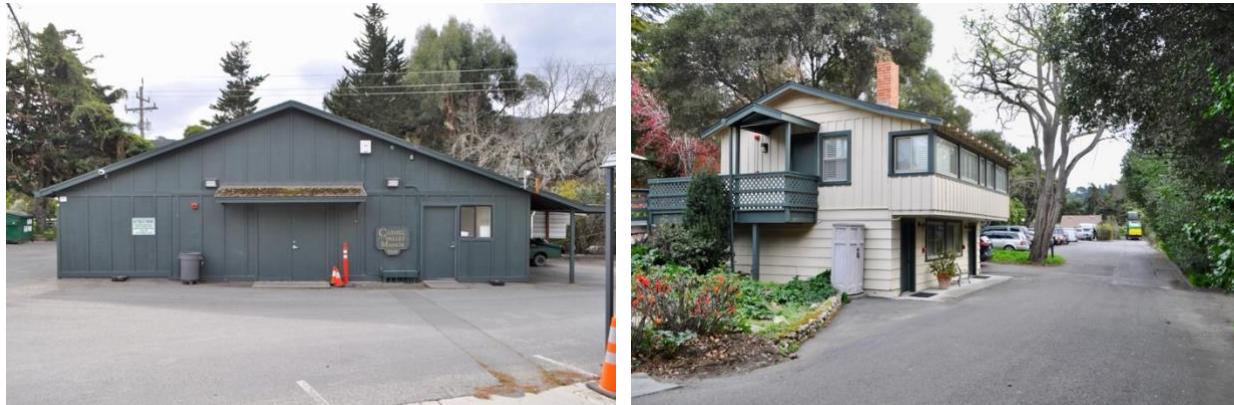
**Figures 6 and 7.** Left: north elevation of the Wood Shop/Maintenance Shed. Right: south and west elevations of the Lower Guest Cottage.

The Wood Shop/Maintenance Shed and the Lower Guest Cottage will be removed (**Figures 6 & 7**).

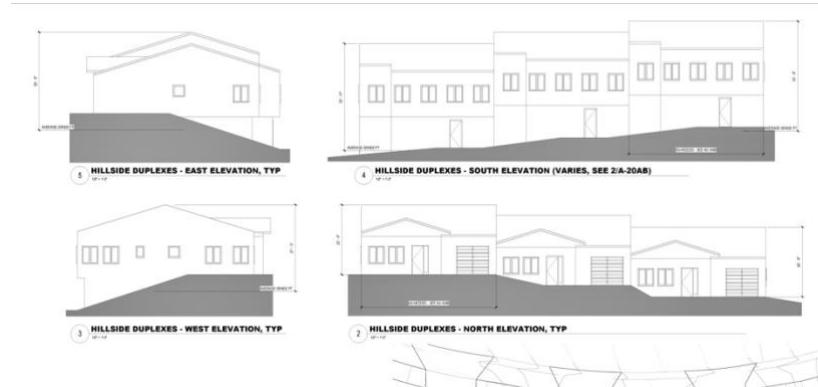
**Figure 8.** Elevations of proposed hillside duplexes, taken from Sheet A-10A of the Carmel Valley Master Plan design submittal.

The proposed addition of the four residential duplexes appears below (**Figure 8**).

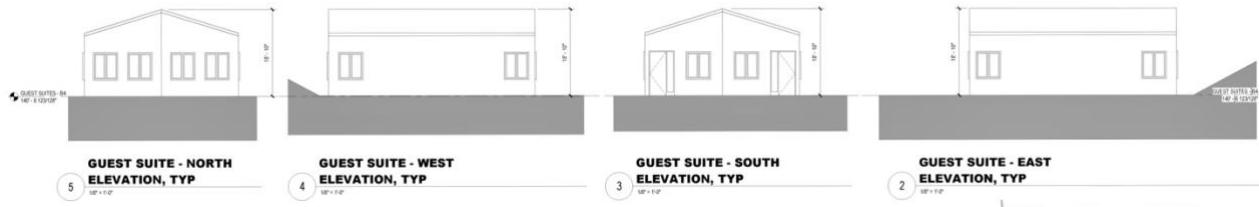
**Figure 9.** Elevations of proposed guest cottages, taken from Sheet A-10B of the Carmel Valley Master Plan design submittal.

Similarly, the hillside guest cottages (**Figure 9**) utilize the SOM-designed forms of gable rooflines with flush eaves but will be differentiated from the Core Campus designs by a variation of stucco finish.

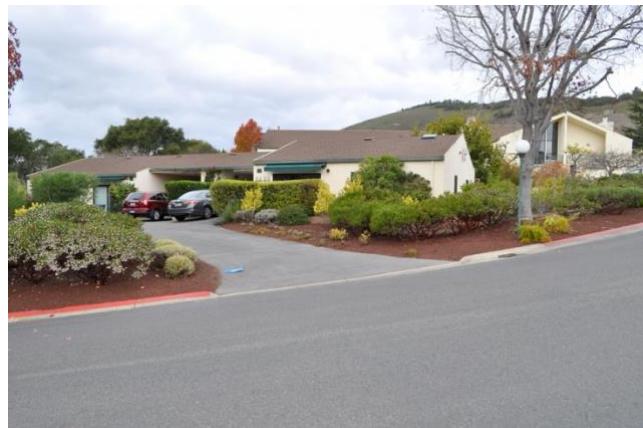
**Figure 10.** Site of proposed Memory Care Facility.

The construction of the proposed Memory Care facility adjacent to and southeast of the Hillcrest Assisted Living Facility will remove one duplex that was part of the 1963 SOM design (**Figure 10**). The removal of this duplex will not impact the historic integrity of the site substantially, as this building form is repeated in other locations on the Campus.

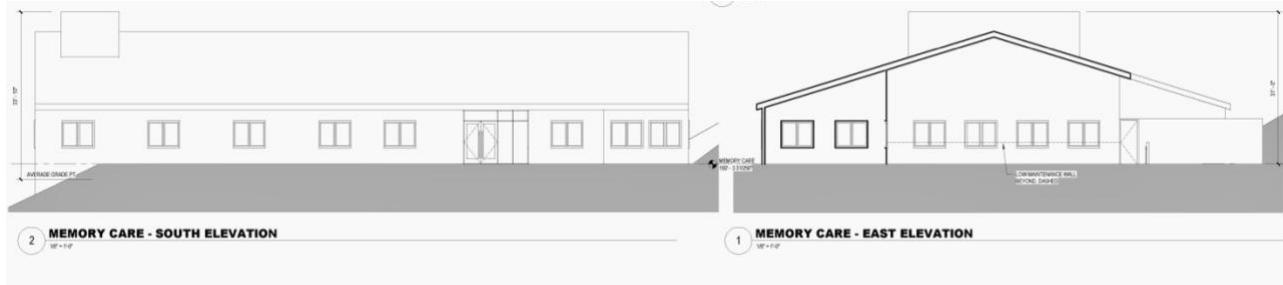
**Figure 11.** Elevations of proposed Memory Care Facility, taken from Sheet A-11C of the Carmel Valley Master Plan design submittal.

The proposed Memory Care Facility is a single-story design, using roof forms and materials that are in keeping with the design details of the site, but are differentiated from the adjacent buildings by a variation of stucco finish, in support of *Standard 9* (**Figure 11**).

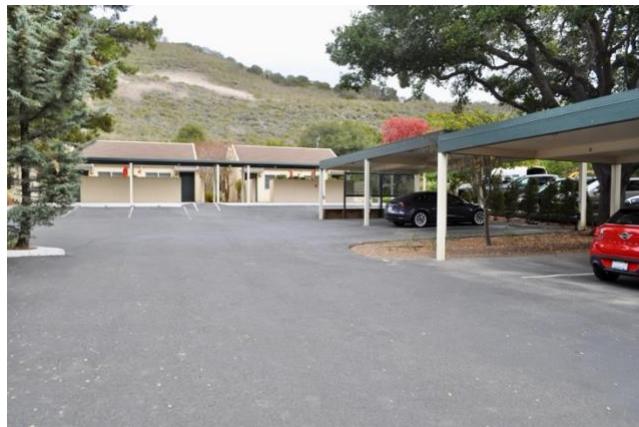
**Figure 12.** View of upper guest cottages and carport structure to be removed.

Two guest cottages and three carport parking structures will be removed for the construction of new duplexes in this location (**Figure 12**). Removal of these buildings is acceptable, as they are not part of the original 1963 SOM design.

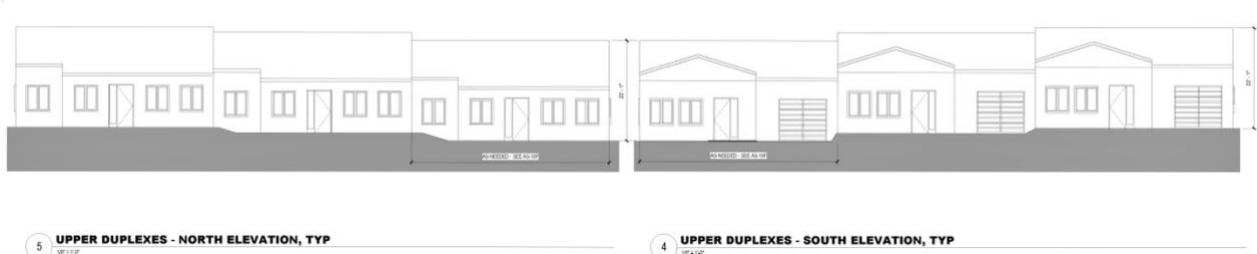
**Figure 13.** Elevations of proposed upper duplexes, taken from Sheet A-10F of the Carmel Valley Master Plan design submittal.

The proposed design of the duplexes appears below (**Figure 13**).

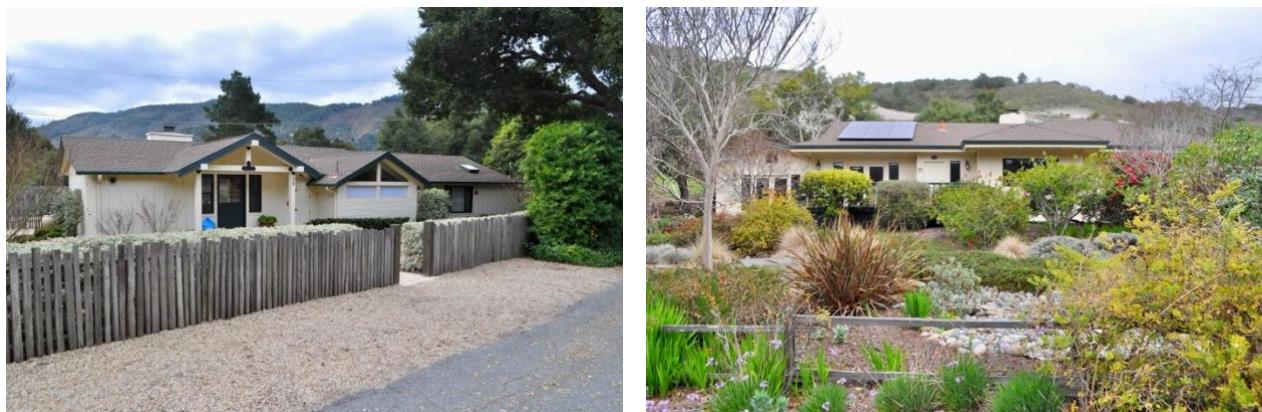
**Figures 14 and 15.** Examples of Los Arboles Drive properties, all of which are highly altered California Ranch designs.

Five California Ranch-style properties along Los Arboles Drive will be demolished for a series of duplexes. These properties were determined to be not historic due to a lack of historic integrity by PAST in 2015.<sup>3</sup>

Two examples of these properties appear below (**Figures 14 and 15**).

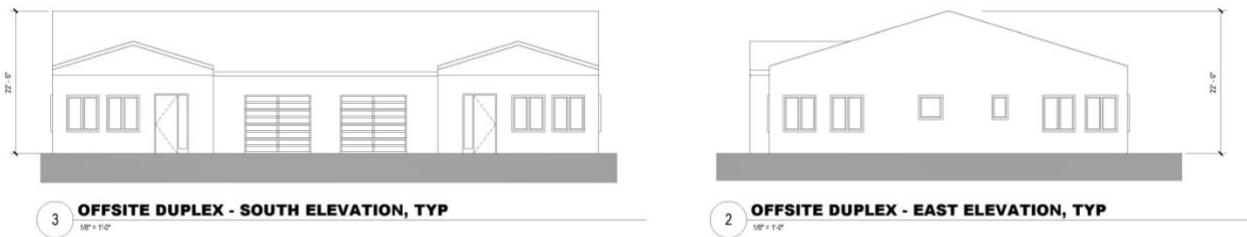
**Figure 16.** Elevations of the proposed Los Arboles Drive duplexes taken from Sheet A-10G of the Carmel Valley Master Plan design submittal.

The proposed design of the duplexes appears below (Figure 16).

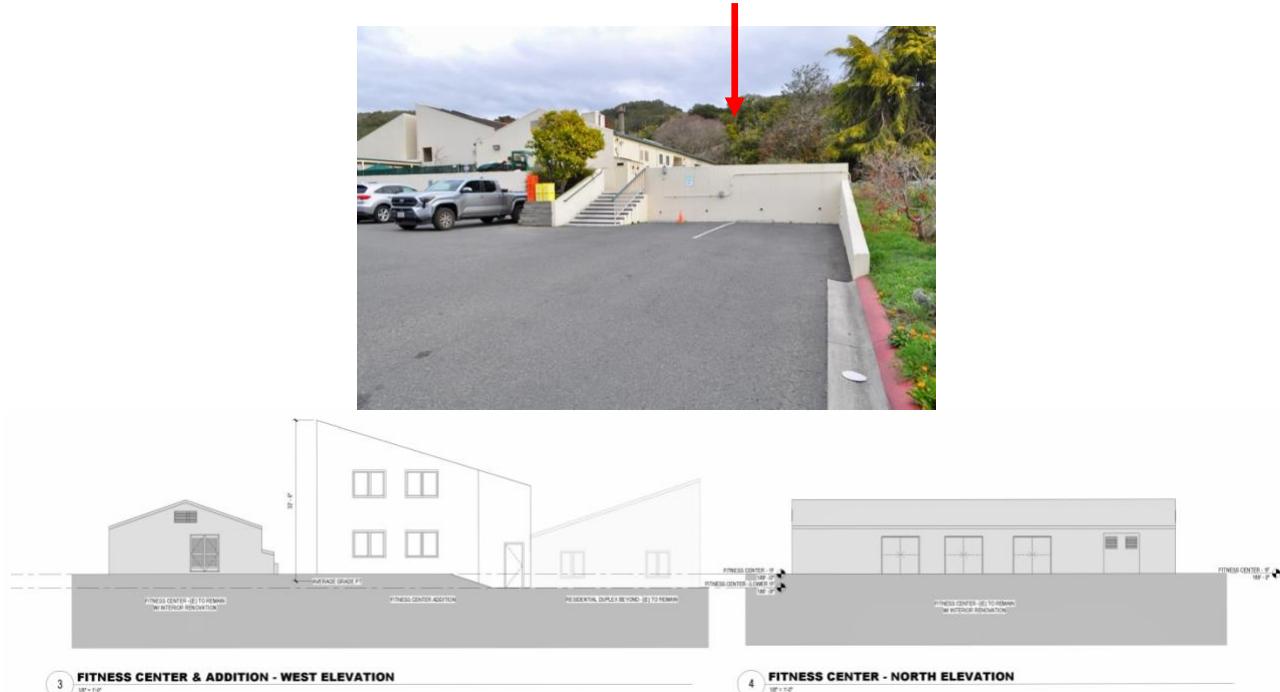
**Figures 17 and 18.** Top image shows the proposed location of new Fitness Center building. Bottom image shows the elevations of the proposed Los Arboles Drive duplexes taken from Sheet A-11D of the Carmel Valley Master Plan design submittal.

A two-story addition is proposed adjacent to and south of the existing Fitness Center. This building utilizes similar shed-roofed forms as the SOM-designed historic buildings but will be differentiated from the historic buildings in detailing and stucco finish (Figures 17 and 18).

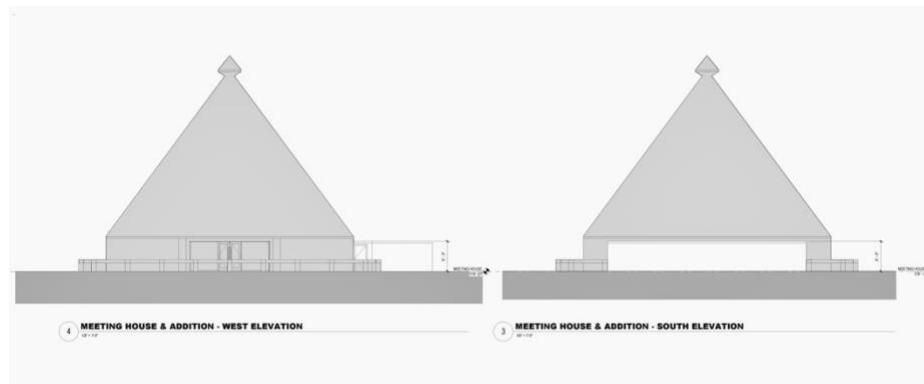
A rear (south elevation) addition is proposed for the Meeting House. The addition is of minimal size, on the least visible elevation of the building and will be differentiated from the historic building by using a flat roof and a different stucco finish, which satisfies *Standard 9* (**Figures 19 and 20**).

**Figures 19 and 20.** Top image shows the Meeting House's south elevation and the location of the rear addition. This elevation faces open space and is the least visible elevation of the building. Bottom image shows the elevations of the proposed Meeting House rear addition taken from Sheet A-11E of the Carmel Valley Master Plan design submittal.

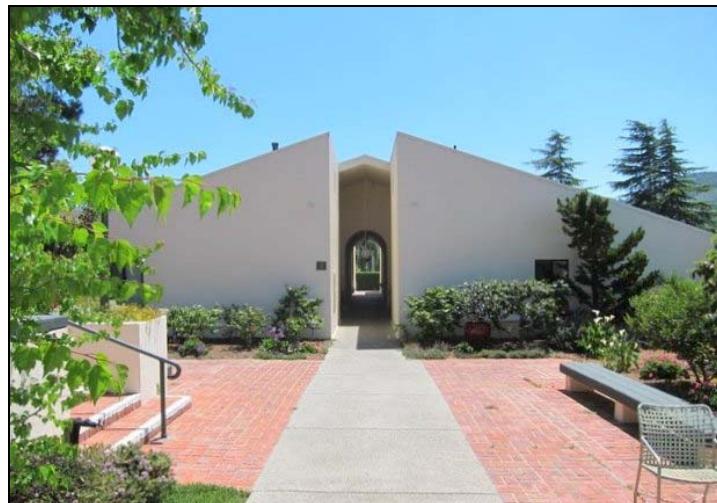
**Figure 18.** Typical pass-through feature of residential buildings.

A unique feature of the SOM design is the pass-through feature of all residential buildings, linking them with the network of paved pathways. All buildings have this central pass-through design element, an example shown on **Figure 18** below.

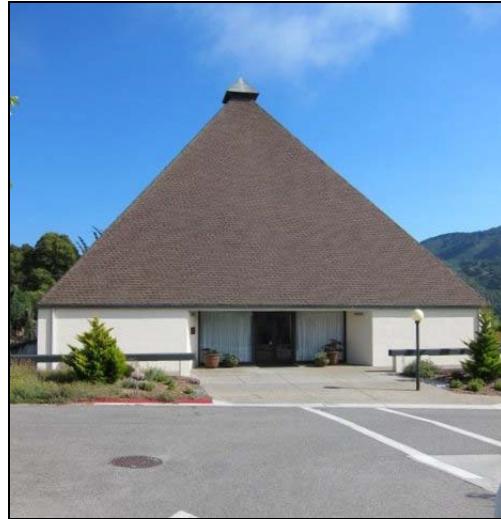
**Figure 22.** Front (north) elevation of Meeting House.

The most prominent building on the site, the Meeting House is square in plan with a tall pyramidal roof. It features symmetrical elevations with a recessed pair of anodized aluminum entry doors on every elevation except the south. Fixed glazing with thick aluminum frames flanks the entry doors. A concrete post and rail surrounds the building. With the exception of roofing material replacement from wood shake to asphalt shingle, the building is largely unaltered.

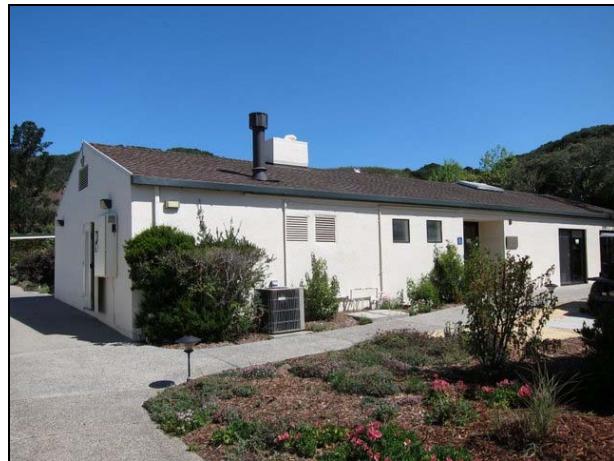
**Figure 24.** Rear (south) elevation of the Fitness Center.

Originally the Library, the building was highly altered when it was converted into the Fitness Center in 2001. It is a simple gable-roofed structure with an off-center chimney, a central rear entrance and modified openings containing paired sliding glass aluminum doors. Like all buildings on the campus, the Fitness Center has the same replaced asphalt shingle roof and box gutters painted green.

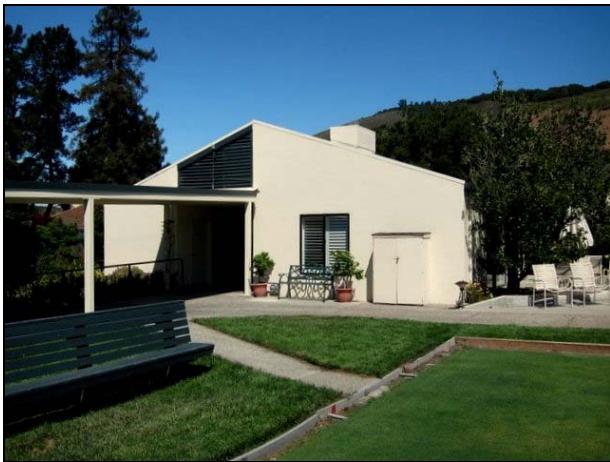
**Figure 25.** Front (south) elevation of the West Parlor.  
Note the covered walk leading to the façade.

The West Parlor/Laundry has the signature paired-shed roof massing that is common to the buildings on the SOM-designed campus. A covered walkway leads from the Pavilion to the West Parlor (Figure 25). The paired shed roof design places the shed roofs at different heights, emphasizing the geometry of the composition. A horizontal ceiling connects the two shed roof masses and provides shelter for residents. Like all buildings on campus, the West Parlor Building has flush eaves with metal corner flashing and metal box gutters painted green. Fenestration consists of anodized aluminum slider windows and sliding glass patio doors.

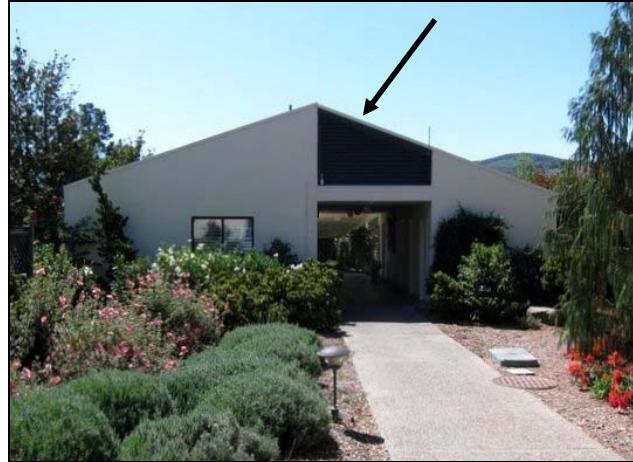
**Figure 26.** Rear (north) elevation of the West Parlor.  
Connection of two shed roofs shown with an arrow.

A subsequent alteration includes the connection of the shed roofs and placement of large louvered vents at each building end, apparently to improve ventilation (Figure 26). The vent carries the same roof pitch as the two sheds, making the massing appear as a gable end, rather than individual shed forms. Other alterations common to buildings on campus include the in-kind replacement of aluminum slider windows and patio doors; and replacement of original shake roof with asphalt shingles.

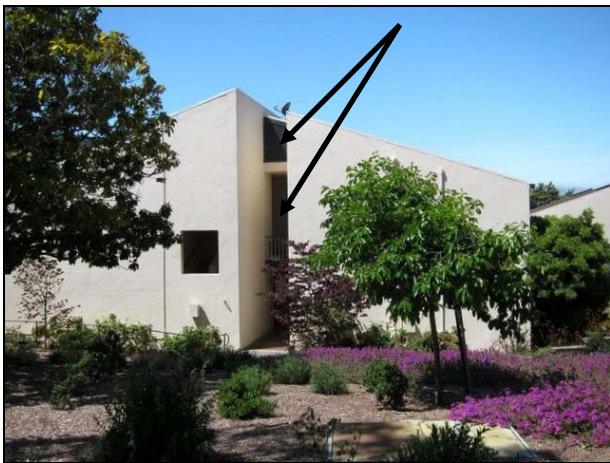
**Figure 27.** Rear (east) elevation of the Bldg. 17.  
 Louvered vent and glazing alteration shown with arrows.

A subsequent alteration includes the connection of the two roof forms and placement of large louvered vents at each building end, apparently to improve ventilation. The vent's roof carries the same roof pitch as the two sheds, making the massing appear as a gable end, rather than individual shed forms. The alteration is less prominent on this building type, as the vent is inset from the outer shed walls (Figure 27). Glazing is placed below the vents on the second floor to protect upstairs residents from the wind. Other alterations common to buildings on campus include the in-kind replacement of aluminum patio doors; replacement of original shake roof with asphalt shingles; the installation of retractable awnings over the sliding glass doors; and the installation of skylights and a satellite dish to the roof. Individual apartments have been combined on many of the buildings to provide more living space.

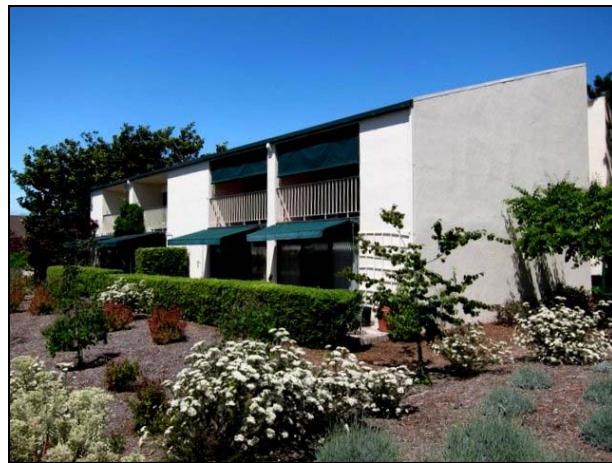
**Figure 28.** Side (north) elevation of Bldg. 14.

Three Type A buildings were constructed. Building Type A has the signature paired-shed roof massing that is common to the buildings on the SOM-designed campus. A stairwell is placed at opposite shed ends. A single opening in the shed ends lights the stairwell. An inset horizontal ceiling connects the two shed roof masses and provides the second-floor access to the upstairs units. The side elevations consist originally of 8 stacked apartments. Upper units have balconies with railings flush with the outer building walls. Like all buildings on campus, Building Type A has flush eaves with metal corner flashing and metal box gutters painted green. Fenestration consists of anodized aluminum sliding glass patio doors.

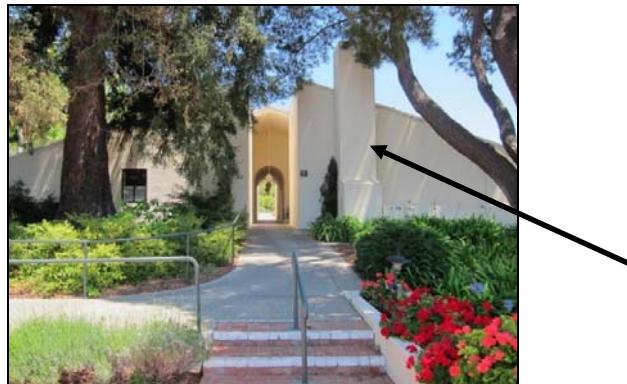
**Figure 31.** Front (west) elevation of Bldg. 2. Note chimney (arrow) and window in left shed end.

An alteration common to this building type consists of the addition of windows in the shed ends on most of the buildings. Chimneys for furnaces are installed on some of the shed ends. This feature does not appear on the SOM drawings, indicating that this may have been an early design change or is a subsequent alteration (Figure 31). Another common alteration is the extension of side façade outer building walls into the patio areas to provide greater living space. This has been done to most units (Figure 30). In-kind replacement of aluminum windows and patio doors, awnings, skylights and satellite dishes are also common.

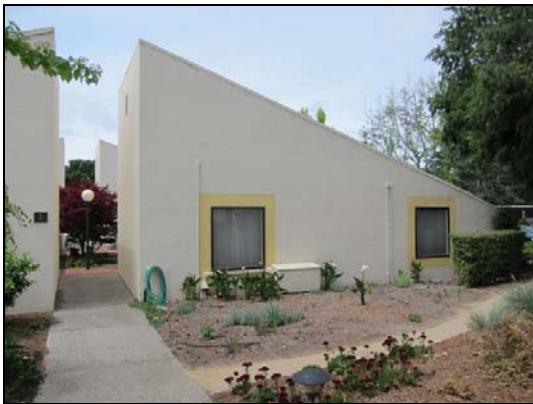
**Figure 32.** Front (east) elevation of the Bldg. 4.

Building Type C features paired-shed roof massing with no connection between buildings. The shed ends flank single-story gable roofed sections. The central pass-through opens to a courtyard with light posts located at each courtyard end. Each interior gable section has two aluminum slider windows. On the outer side facades, each unit has fenestration consisting of a single anodized aluminum slider window and sliding glass patio doors.

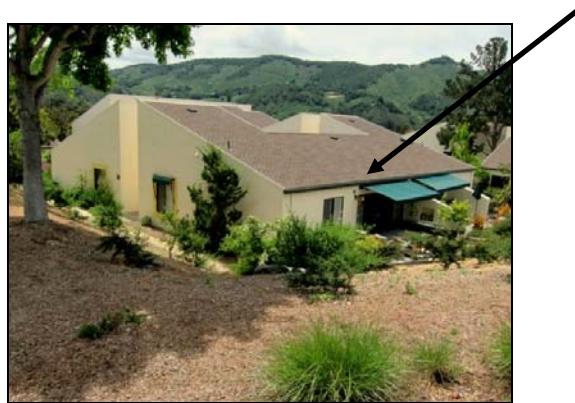
**Figure 34.** Overall view of Bldg. 18 with full outer wall extension (arrow).

An alteration common to this building type consists of moving the outer wall into the patio area, extension of the roofline, and installation of a window in the shed end. This has been done to most units (Figure 34). In-kind replacement of aluminum windows and patio doors, awnings, skylights and satellite dishes are also common alterations.

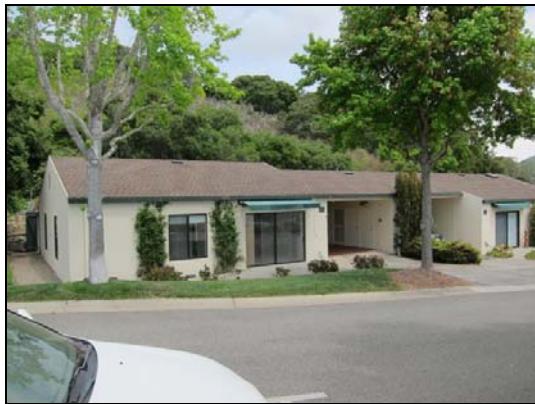
**Figure 35.** Front (west) elevation of the Bldg. 22.

Building Type D is a symmetrical duplex design separated by a garage. The building features gable roof massing with two aluminum slider windows in the gable end. Front and rear fenestration consists of a single aluminum slider window and aluminum sliding patio doors. Rear additions have been installed to several of the units. Original garages have multiple closets (**Figure 36**).

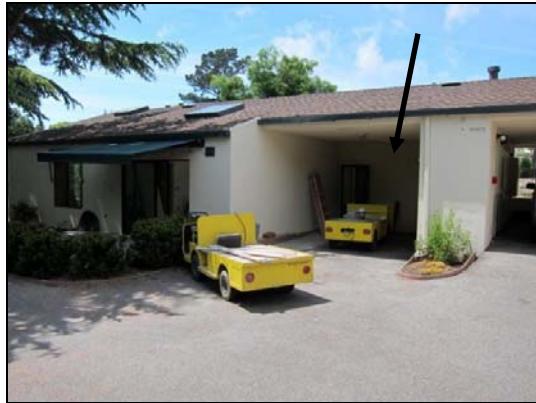
**Figure 37.** Bldg 29 conversion of garage to study.

A handful of units have undergone removal of the closets in the garage and conversion of the space into an additional room (**Figure 37**). A wide aluminum slider window is installed in the rear façade of units with the garage conversion (**Figure 38**). In-kind replacement of aluminum windows and patio doors, awnings and skylights are also common alterations.

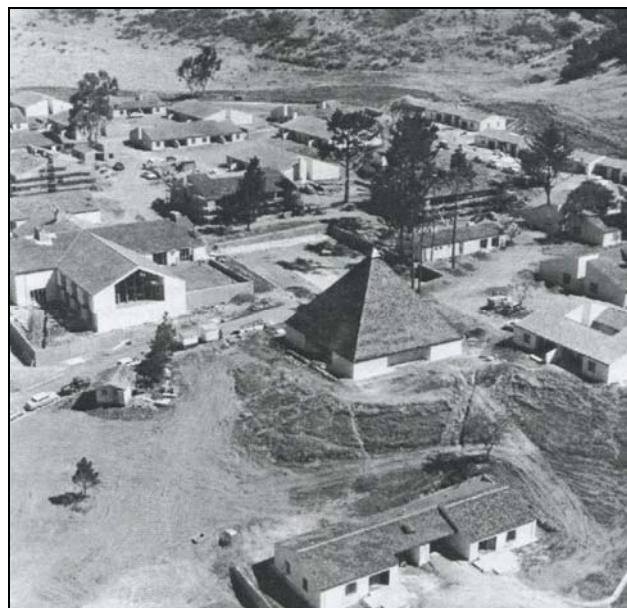
**Figure 39.** View of Carmel Valley Manor after completion of the buildings. (*Courtesy, Carmel Manor: A History, pp. 21*).

The SOM design for the Manor was unique in its departure from the institutional look of predating retirement communities. The Manor resembles a Modernist-designed college campus rather than a retirement community. Community buildings, such as the Pavilion and Meeting House are designed along bold lines and are placed on the site's prominent locations. The residential buildings are clustered around courtyards and open space, taking advantage of views to the surrounding mountainous landscape. All buildings are linked by a network of paved paths that also connect courtyards and recreational areas. A unique feature of the residential buildings is the central pass-through that connects the concrete paths to the rest of the campus. Residential buildings are expressed dramatically as paired shed-roofed masses or gable, symmetrically flanking a central passageway axial to the concrete walk that links to the network of paths throughout the Manor. An early image of the Manor shortly after the buildings were completed appears as **Figure 39** below.

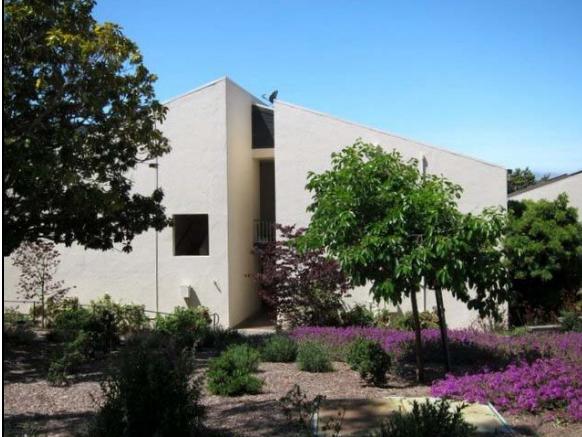
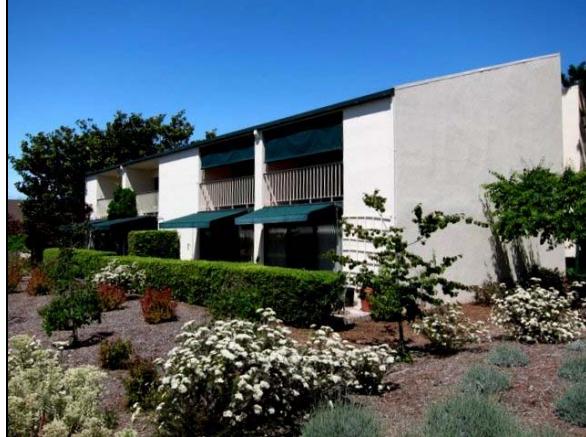
**Figures 2 and 3.** Typical front and side elevations of Building Type A.

1. Installation of fixed-pane glazing on second floor of shed ends for wind protection.
2. Extension of first-floor patio walls out to a maximum limit of the face of outer building wall. This alteration has been performed for all units on all three buildings.
3. In-kind replacement of black anodized aluminum patio doors and windows.
4. Installation of retractable green window awnings matching other campus buildings.
5. Installation of replacement asphalt shingle roofing to matching other campus buildings.

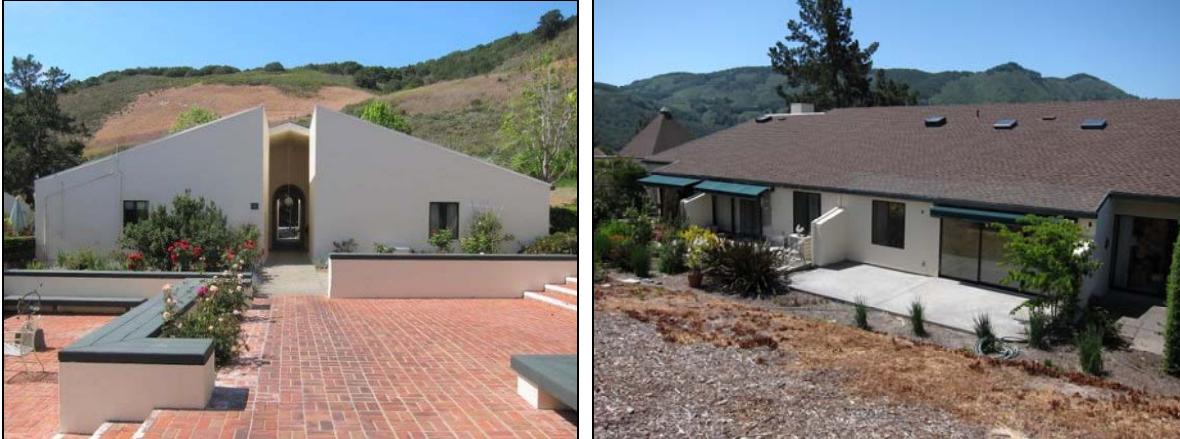
**Figures 4 and 5.** Typical front and side elevations of Building Type B.

1. Extension of patio walls outward. Original roof plane extended to meet new wall.
2. Original roof pitch maintained to meet the newer outer building wall
3. In-kind replacement of black anodized aluminum patio doors and windows.
4. Addition of black anodized aluminum slider window in shed ends matching the existing type, size and design found on other campus buildings.
5. Installation of retractable green window awnings matching other campus buildings.
6. Installation of replacement asphalt shingle roofing to match other campus buildings.

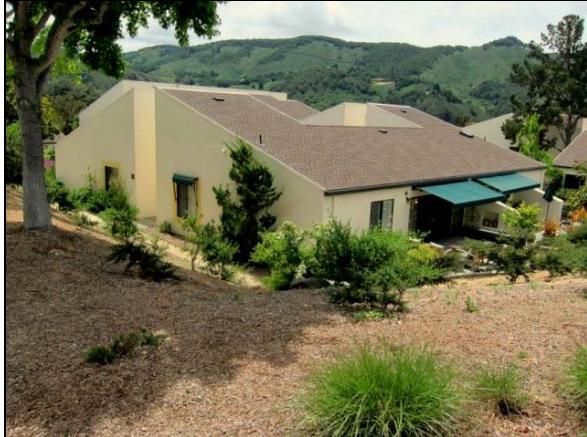
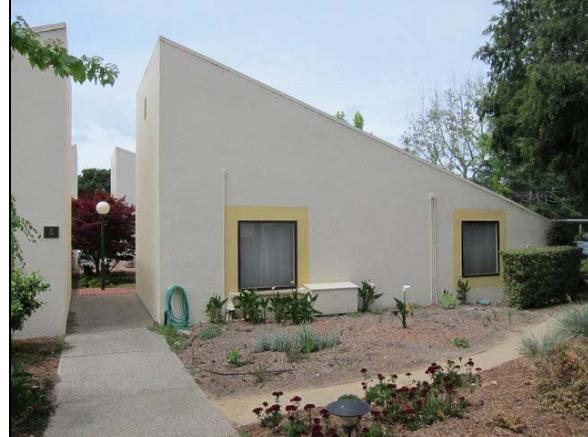
**Figures 6 and 7.** Typical front and side elevations of Building Type C.

1. Extension of patio walls outward. Original roof plane extended to meet new wall.
2. Original roof pitch maintained to meet the newer outer building wall.
3. In-kind replacement of black anodized aluminum patio doors and windows.
4. Addition of in-kind black anodized aluminum slider window in shed end matching the existing window in type, size and design.
5. Installation of retractable green window awnings matching other buildings on the campus.
6. Installation of replacement asphalt shingle roofing to matching other campus buildings.
