Natural Environment Study

*Nacimiento Lake Drive Bridge Replacement Project
Near Town of Bradley, Monterey County, California
(Bridge No. 44C-0009)
Federal Project Number STPLZ 5944(040)*

Revised May 2012

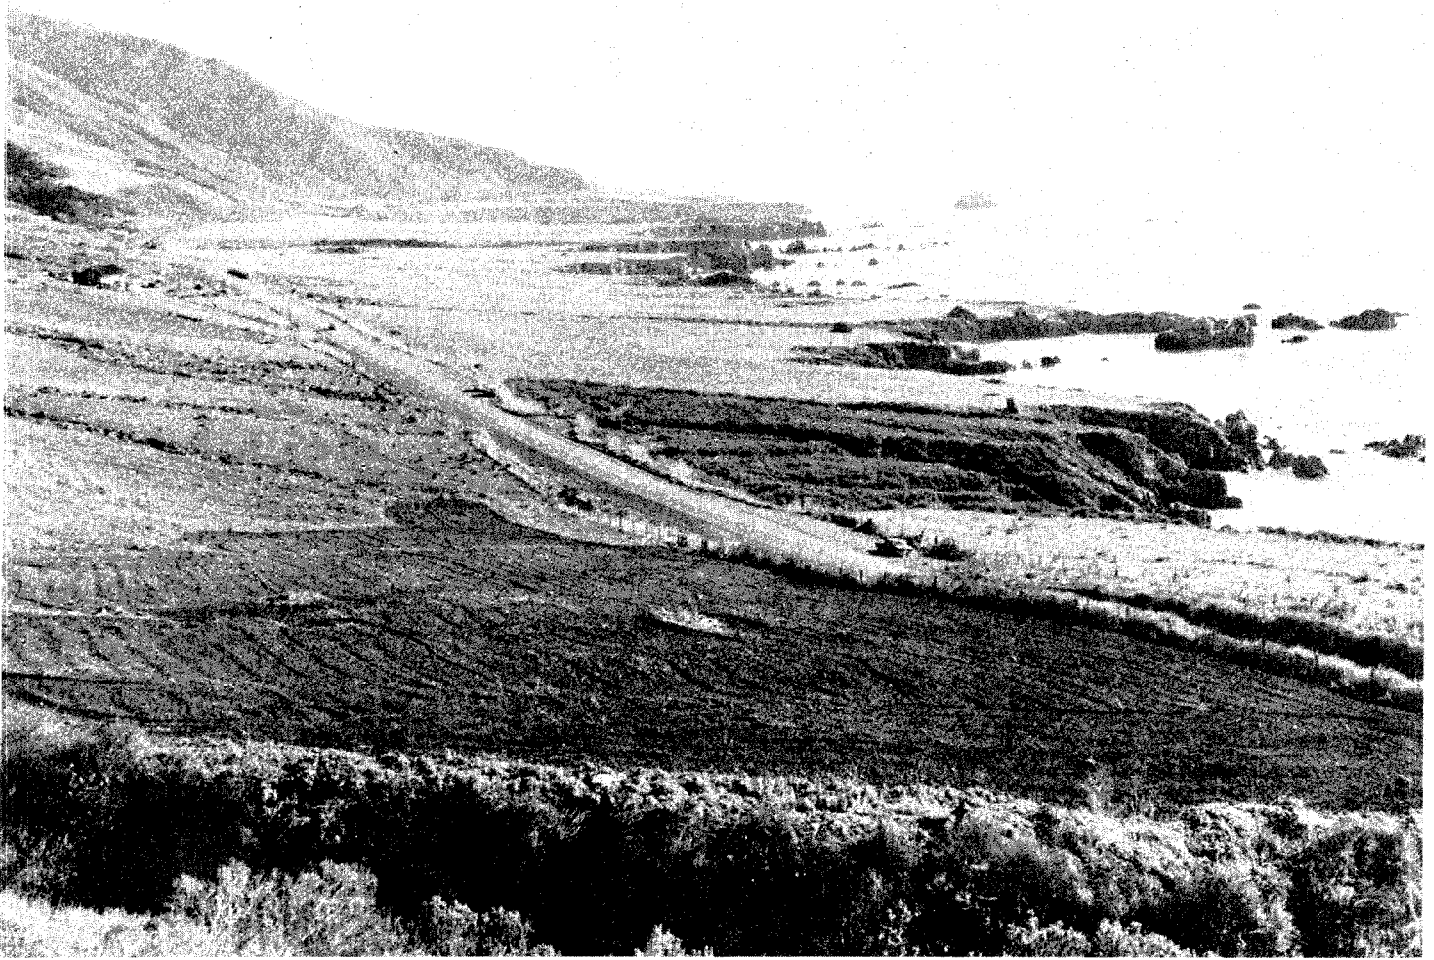
Figure 5.—Wave-cut coastal terraces at Pacific Valley. Fluvents, stony, are in the foreground and along the road. The rest of the terrace area is mainly Lockwood shaly loam, 2 to 9 percent slopes.

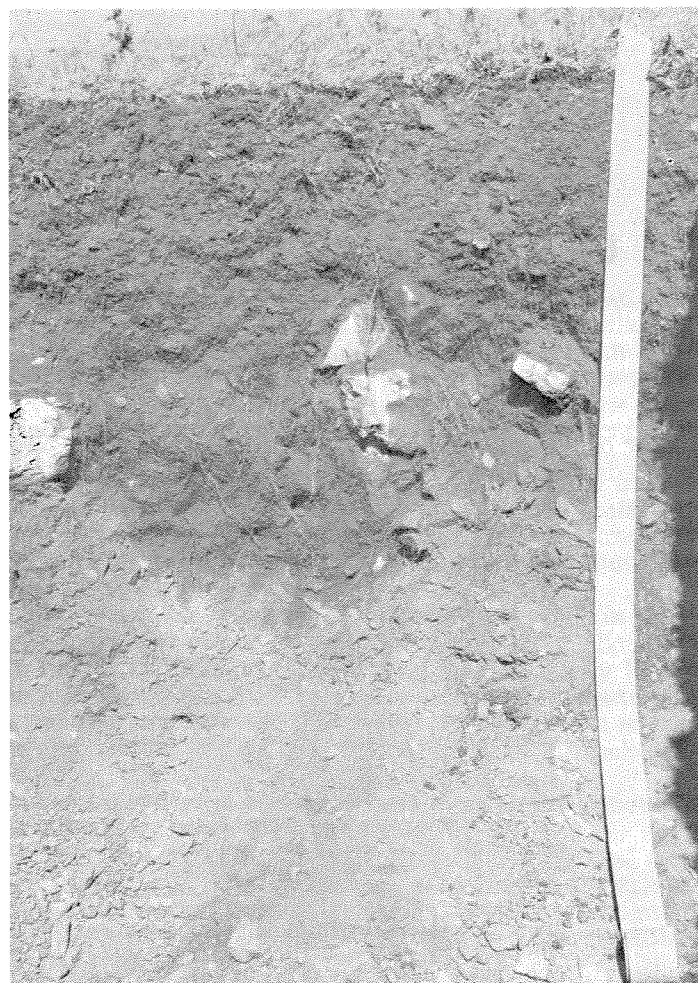
Figure 6.—Profile of Lockwood shaly loam, 2 to 9 percent slopes, at Pacific Valley.

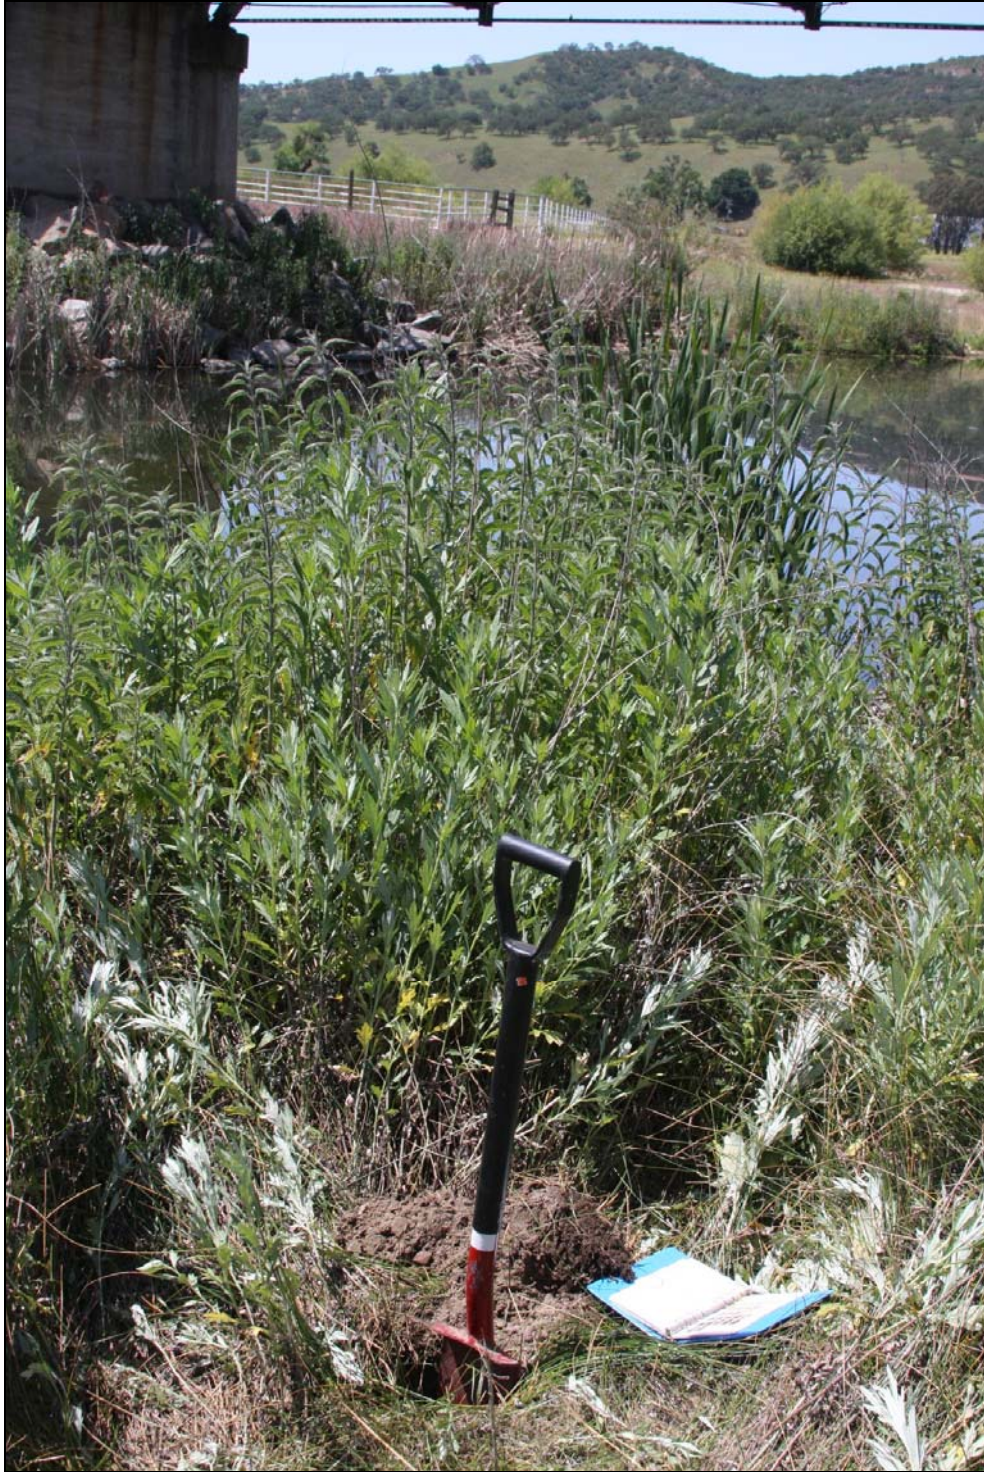
Photograph 1. Southwest view of freshwater wetlands in Sample Point 1A dominated by stinging nettle, Mexican rush, and mugwort growing along the lower north bank of the San Antonio River.

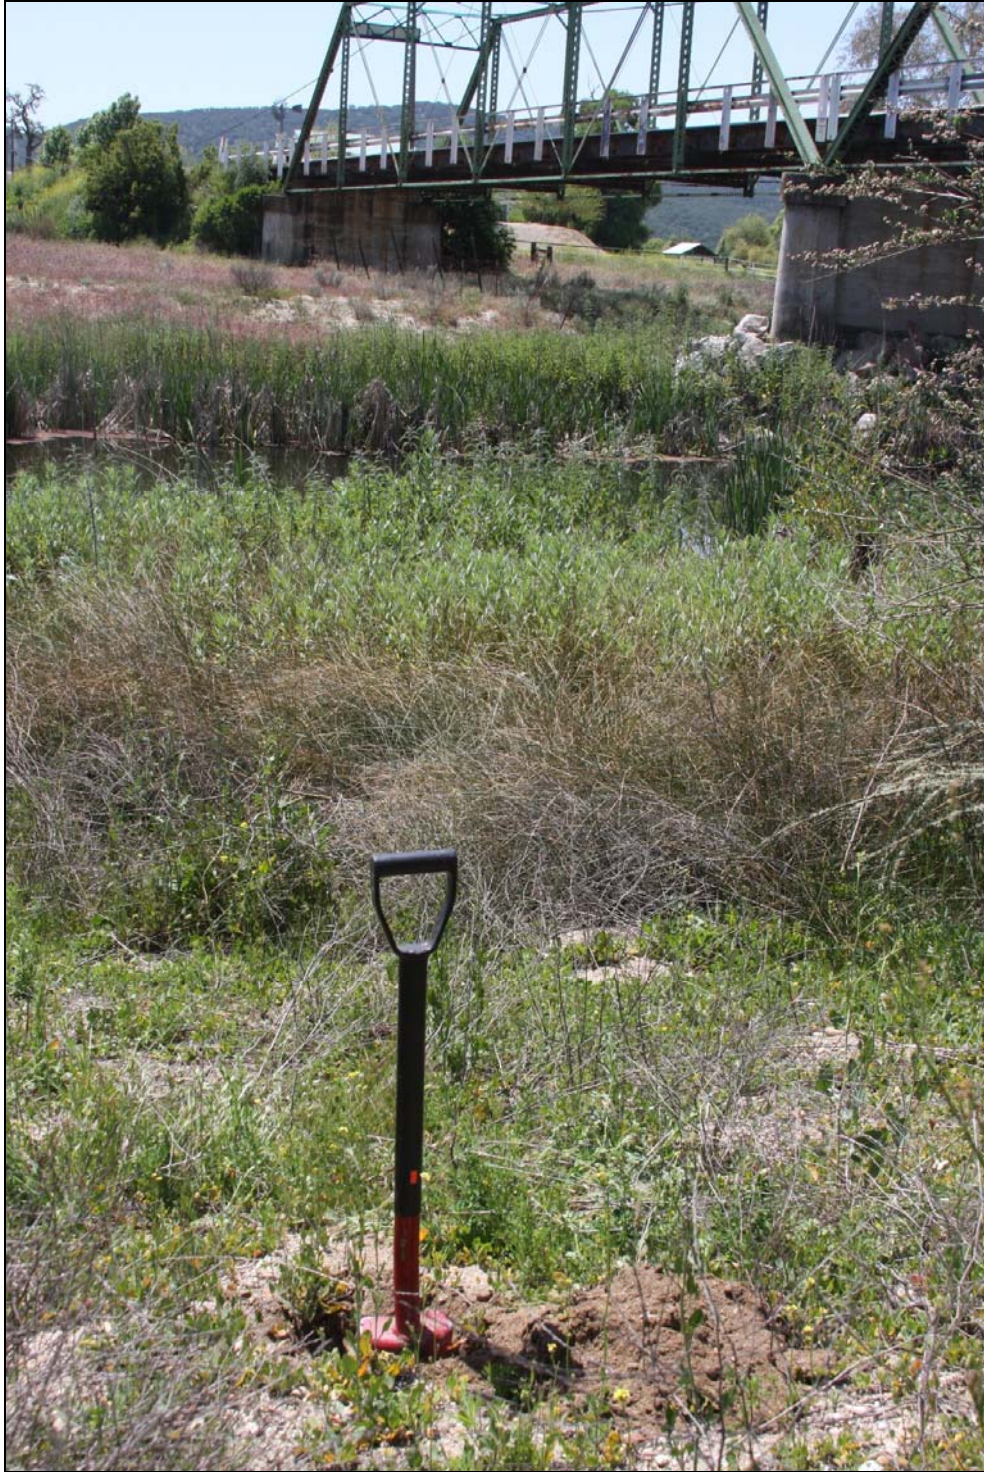
Photograph 2. Southwest view of Sample Point 1B in ruderal upland non-native vegetation along the north mid-bank of the San Antonio River.

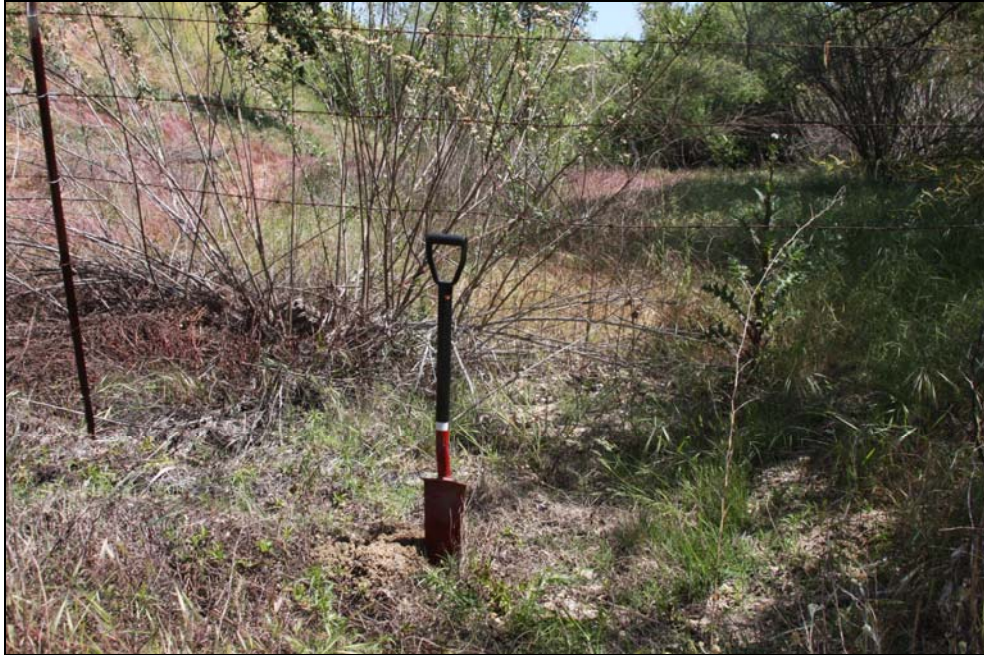
Photograph 3. East view of seasonal wetlands in Sample Point 2A dominated by dotted smartweed. This species was growing within a shallow backwater channel hydrologically connected to the lower north bank of the San Antonio River.

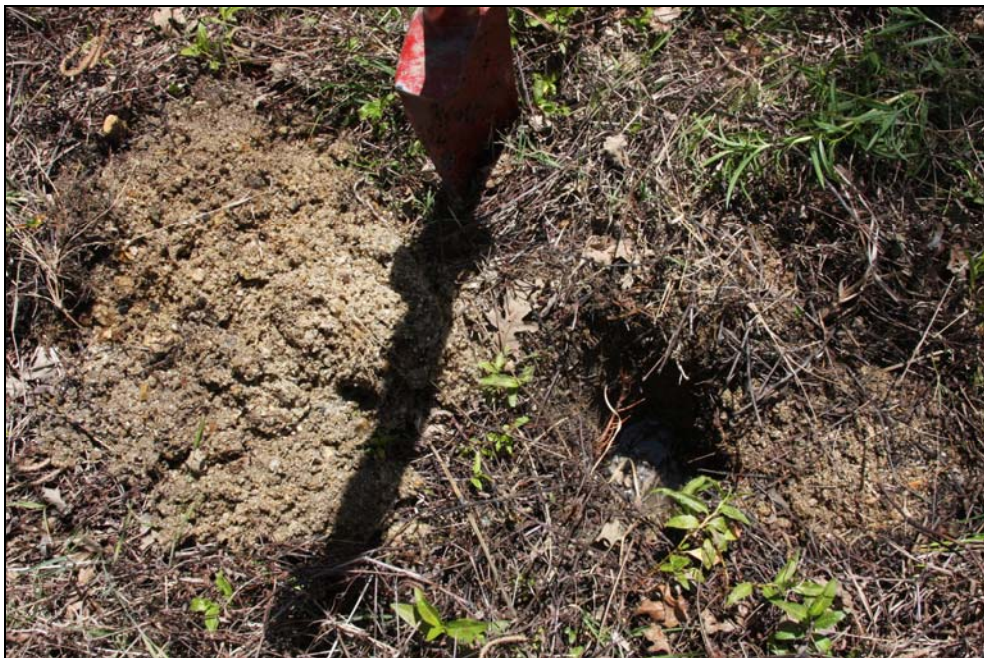
Photograph 4. Approximately two inches of standing water accumulated in the bottom of Sample Point 2A after several minutes following excavation. The hydrology is a result of a high localized groundwater table associated with the adjacent San Antonio River.

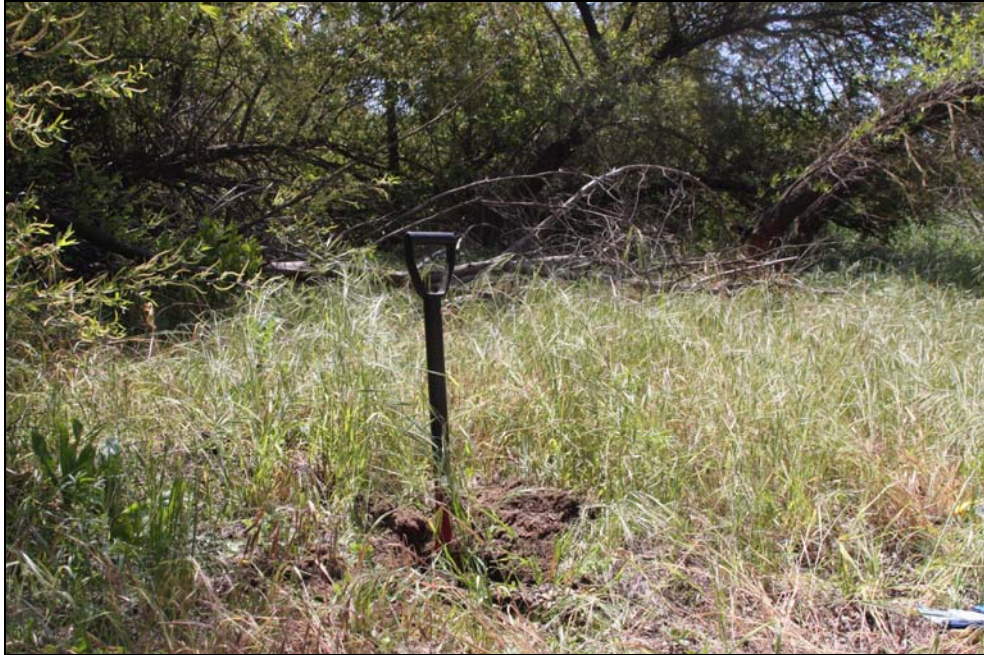
Photograph 5. Sample Point 2B supporting non-native upland plant species adjacent to the active floodplain of the San Antonio River.

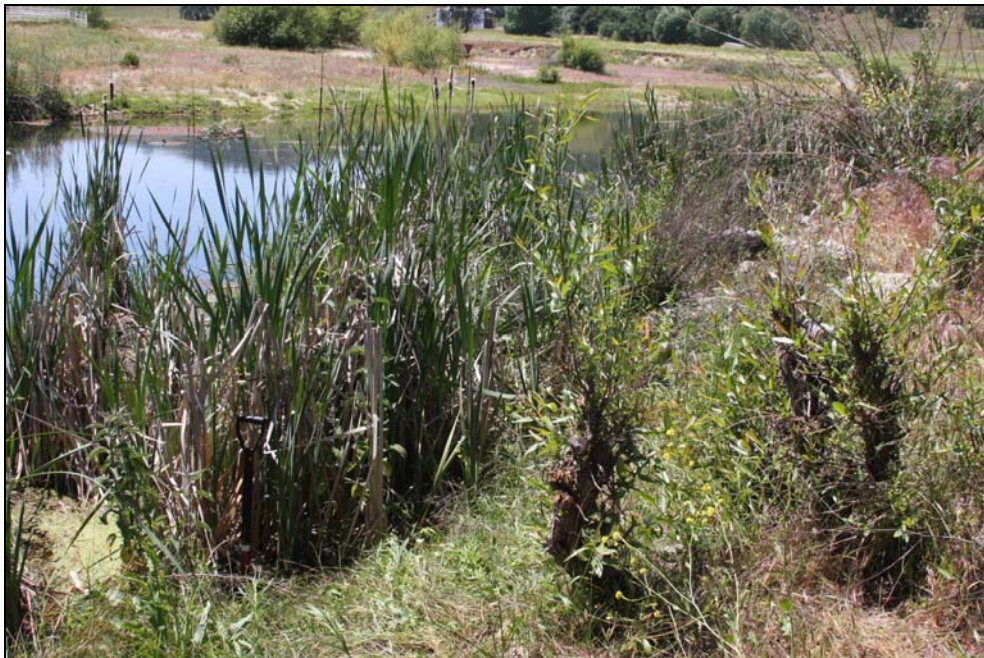
Photograph 6. West view of freshwater emergent wetland in Sample Point 3A dominated by broad-leaved cattail and Mexican rush growing along the lower north bank of the San Antonio River. Note the presence of other waters associated with the San Antonio River channel in the background.

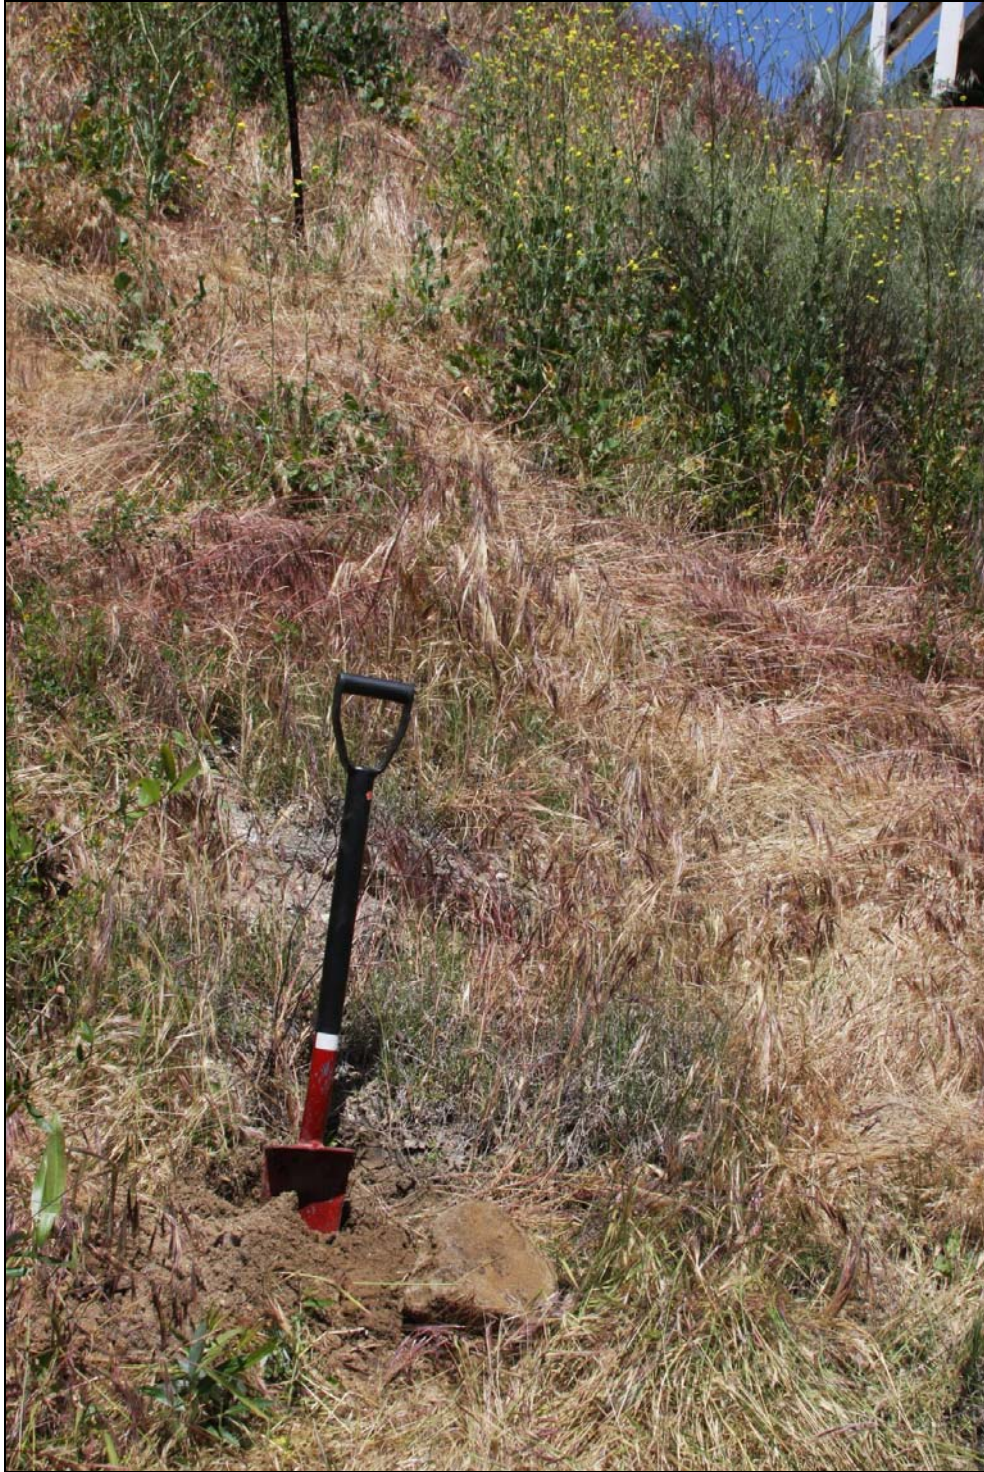
Photograph 7. Sample Point 3B in upland, non-native grasslands along the middle north bank of the San Antonio River.

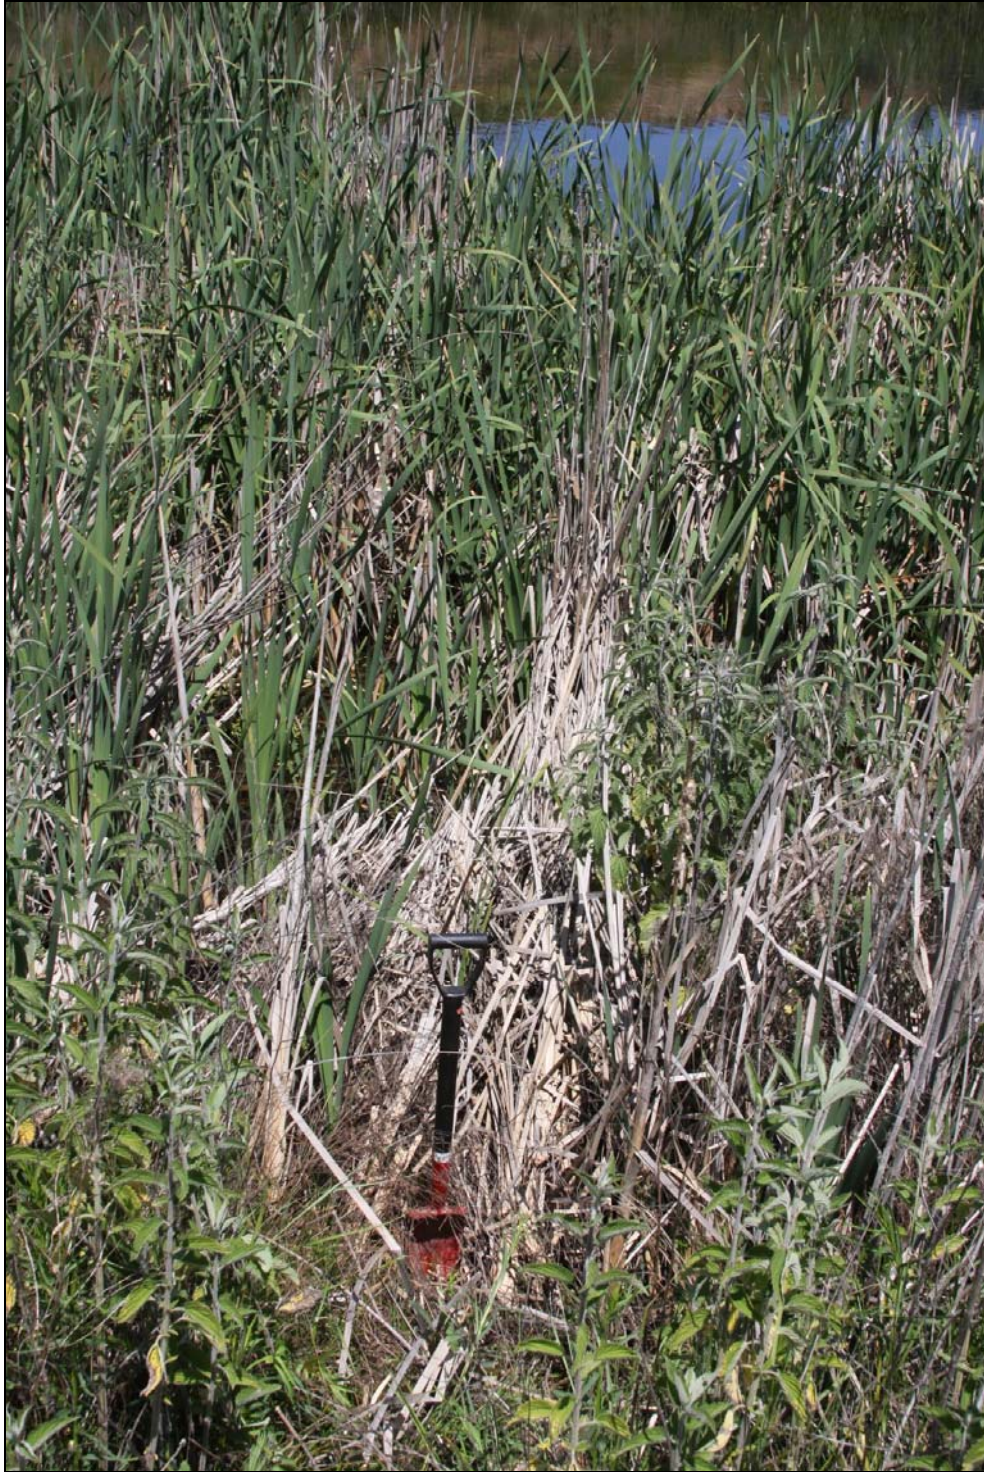
Photograph 8. Freshwater emergent wetlands in Sample Point 4A on the lower south bank of the San Antonio River.

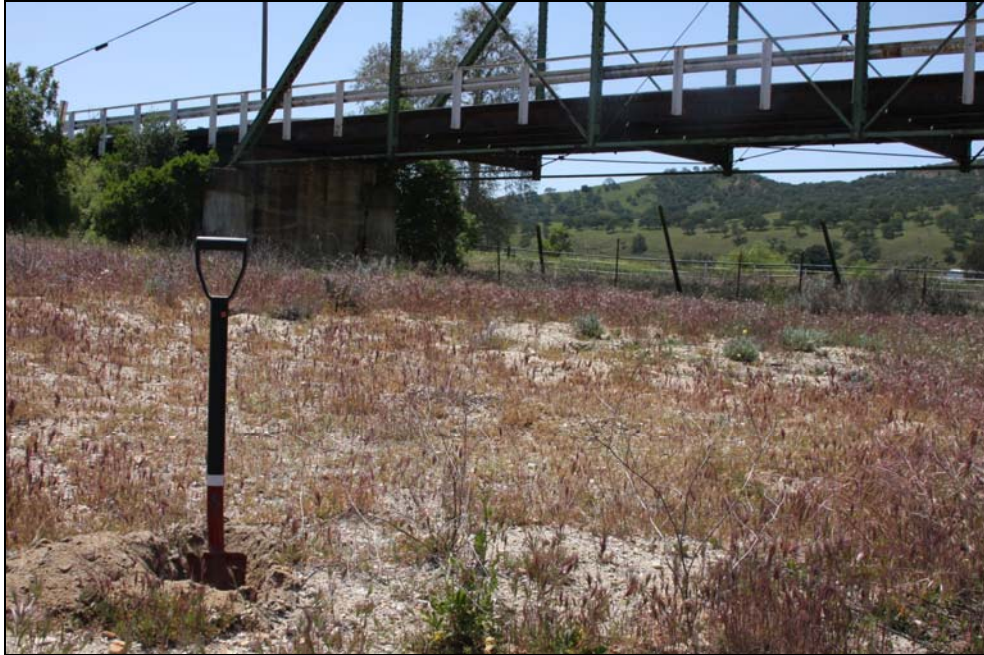
Photograph 9. West view of Sample Point 4B in uplands within the seasonal floodplain of the San Antonio River. Note the presence of other waters associated with the San Antonio River channel in the background.

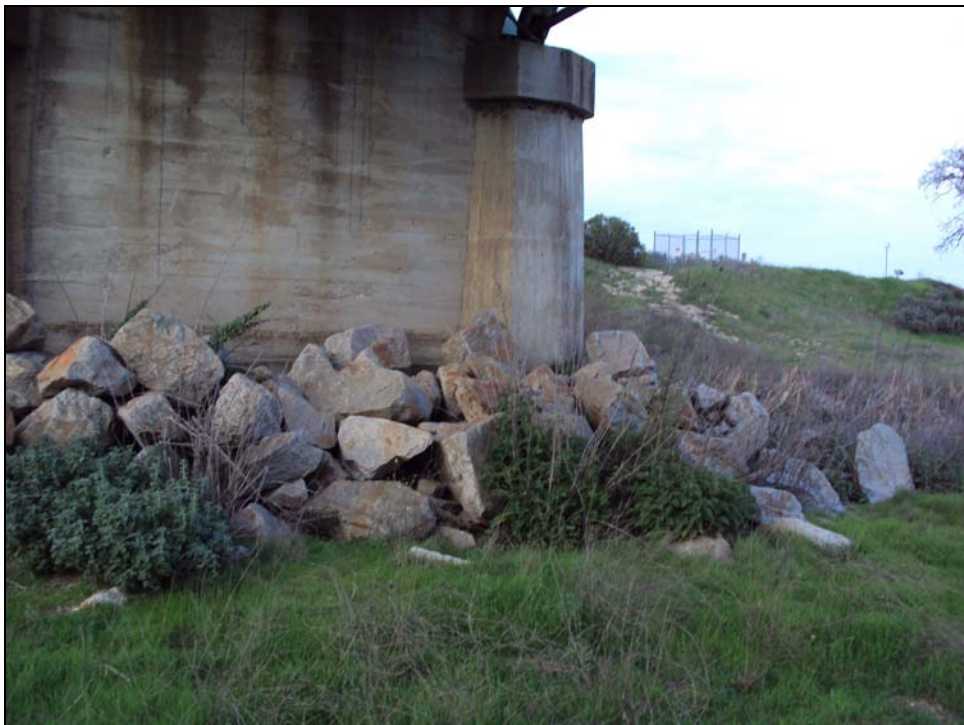
Photo 2. Granite rip-rap around bridge pier.

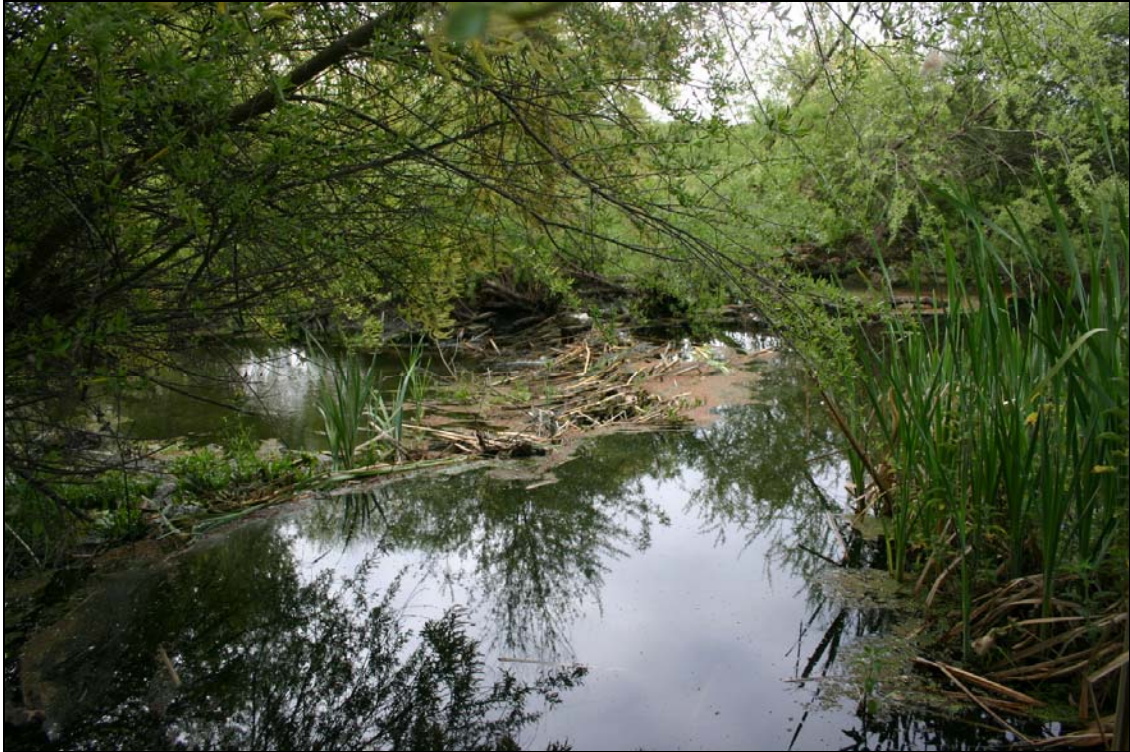
Photo 5. Cattails, overhanging willows, and beaver dam in Willow Riparian habitat in eastern portion of BSA.

A beaver dam was located bridging both channels on the western end of the in-stream island. The beaver dam on the northernmost channel was removed, possibly by high flows associated with the release, at some point between the June and July 2010 surveys. Along the northern riverbank near a sandstone outcropping (Figure 3), strong hydrogen sulfide plumes were observed. Vegetation within the open water habitat was limited but included aquatic species such as duckweeds (*Lemna* sp.).
