PHASE TWO HISTORIC ASSESSMENT

The Porter-Vallejo Mansion

29 Bishop Street

November 20, 2023

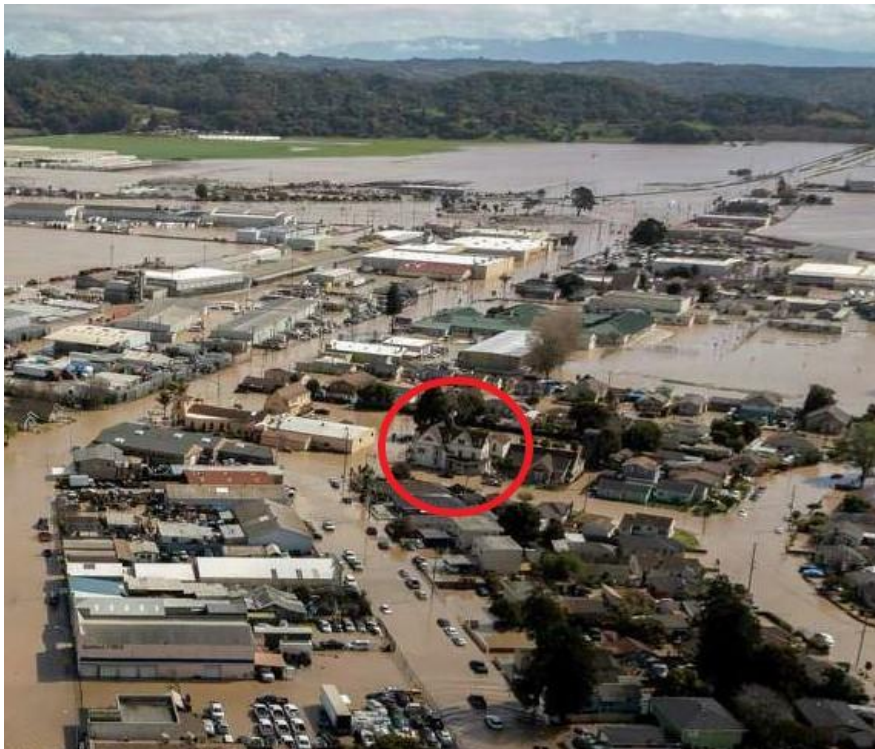
Figure 1: View of Porter-Vallejo Mansion after March 2023 flood.
Courtesy Getty Images.

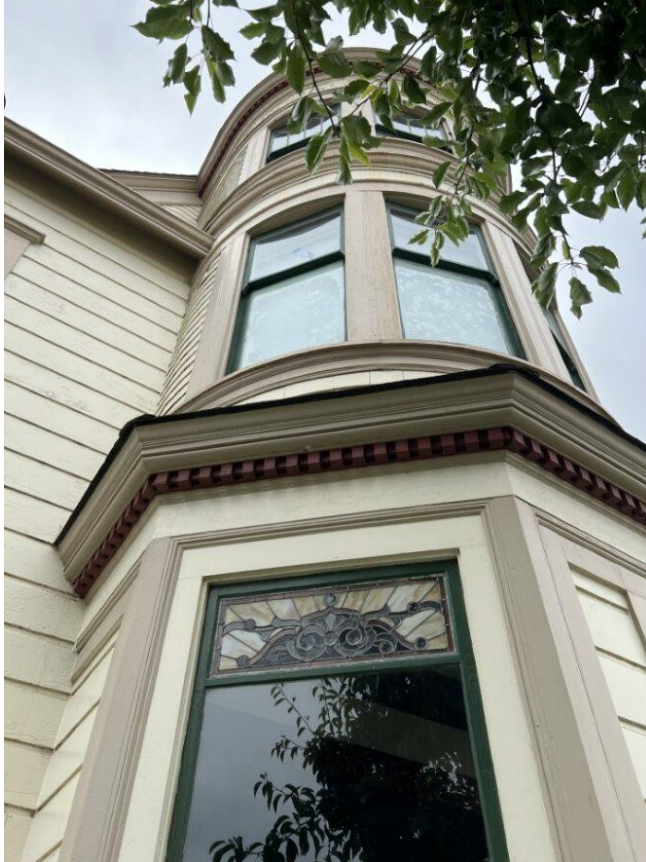
Figure 2: View of tower on the east elevation.

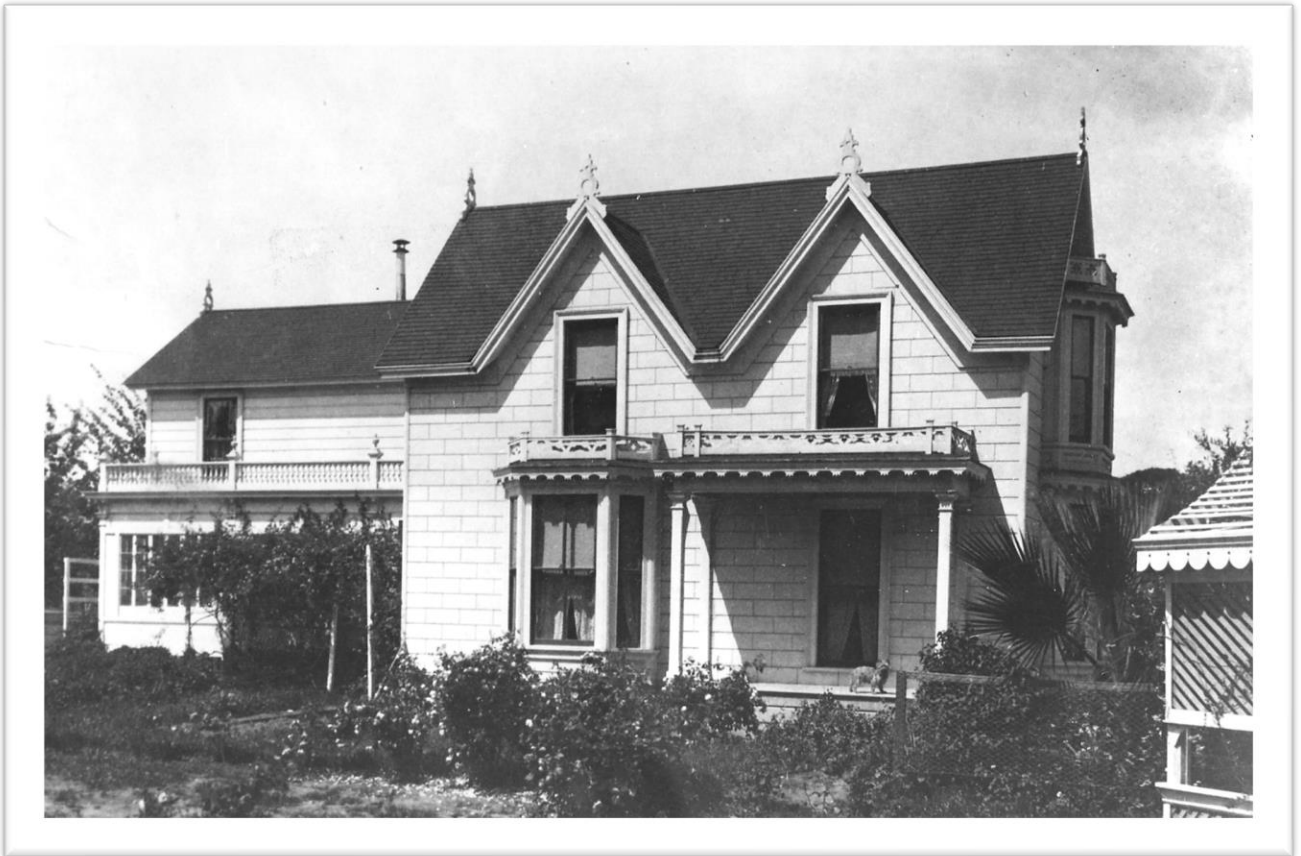
Figure 4: View of east elevation and scored siding c. 1874. Courtesy of the Pajaro Valley Historical Association.

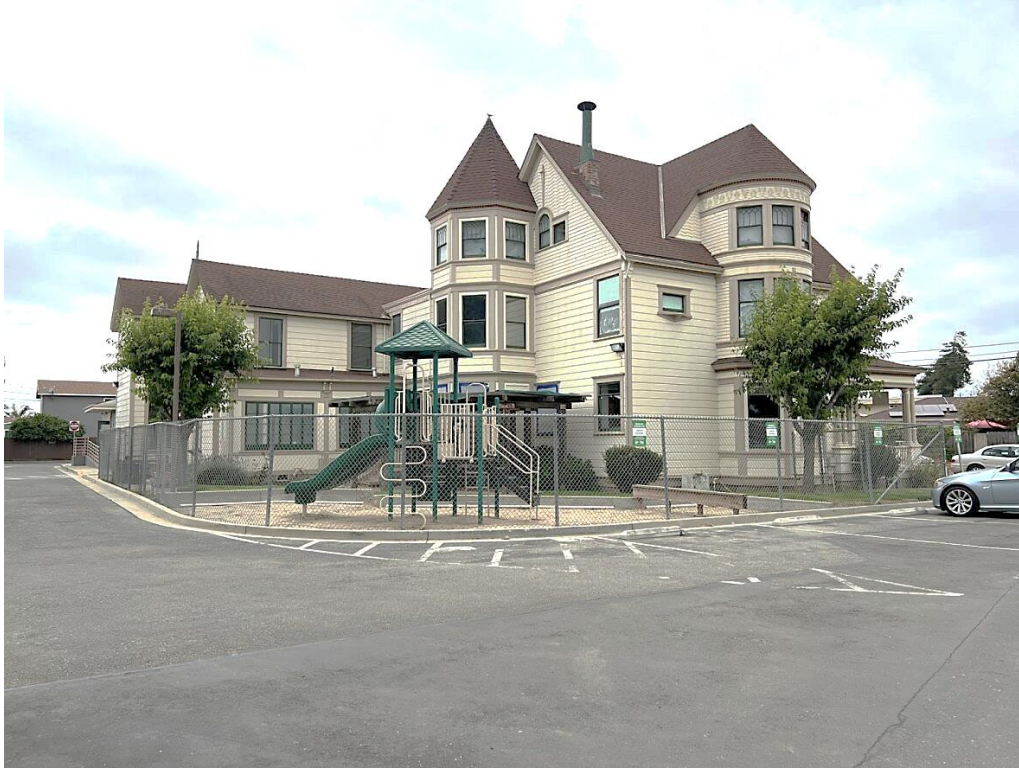
Figure 7: View of the southeast elevation showing many of the Queen Anne details.

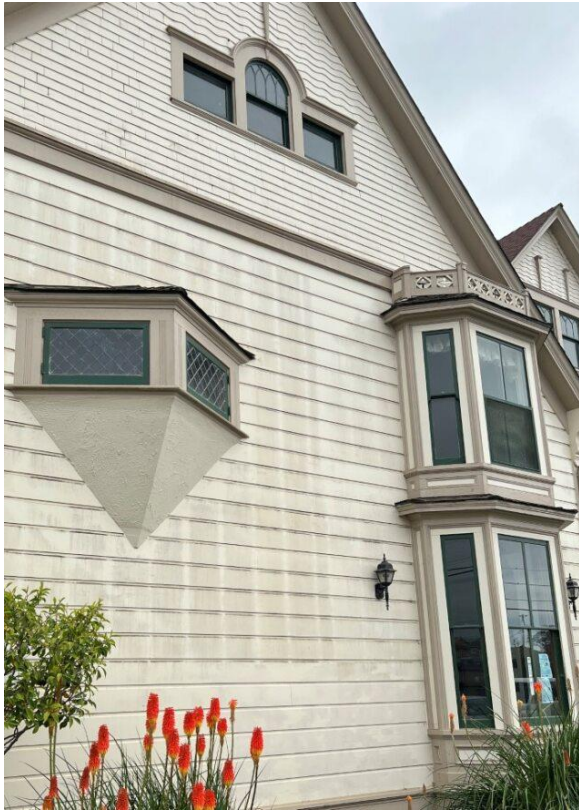
Figure 8: The shiplap siding is mounted directly to the studs, which are visible due to water infiltration.

The project proposes to install flashing around the windows and a vapor barrier underneath the horizontal shiplap siding. The proposed work will not impact the seismic retrofit shear walls and steel frames that were installed in 1995. Therefore, the work will require the removal of the shiplap siding and window trim. These distinctive materials will be catalogued, numbered, and stored in a dry place until they can be cleaned and repainted on all six sides before reinstallation.

Preservation Brief 39 also advises that if a vapor barrier is added to frame walls, then a ventilation channel behind the exterior cladding will help to avoid peeling and blistering paint occurrences. It is recommended that the installation specifications for the vapor barrier clearly state that a ventilation channel will be created behind the siding.

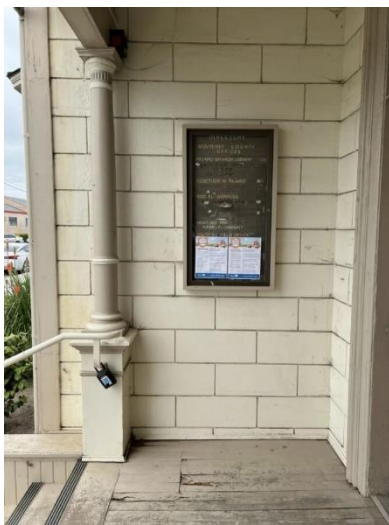
- D. The siding located on the north elevation that dates to 1874 and is scored to imitate masonry is in good condition. This siding will be cleaned and repainted. Due to its location under the front porch, it is not subject to water infiltration so a vapor barrier will not be installed in this location.

Figure 9: Scored siding near the front entrance dates to the 1874 remodel of the mansion.

The shiplap siding on the north, east, and west elevations and a portion of the south elevation will be removed for the installation of the vapor barrier. The scored siding on the front elevation will remain in place. The shiplap siding will be reinstalled after cleaning, repair, and painting. If any sections of the siding are too deteriorated to repair, the sections will be replaced with siding salvaged from the south elevation's 1924 addition.

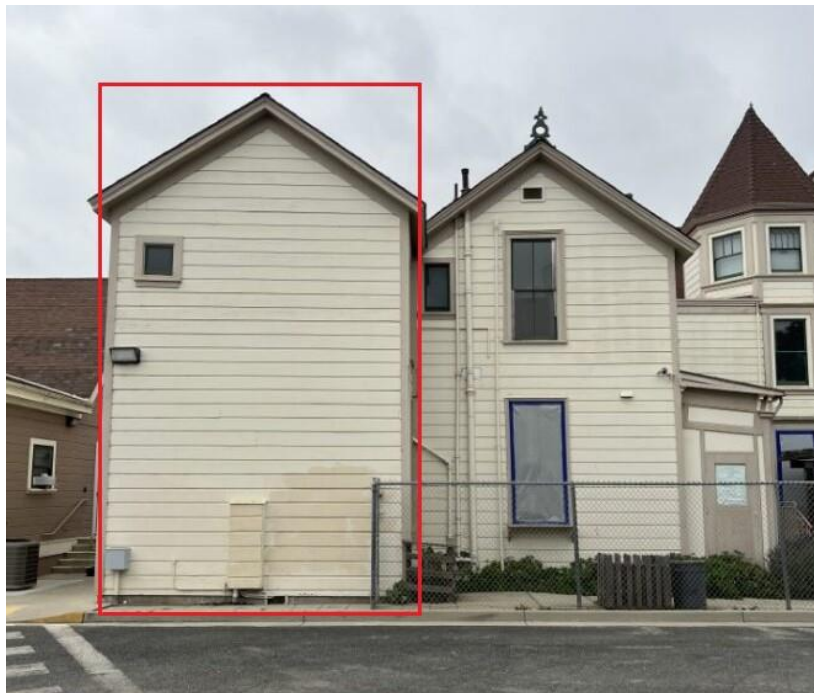
Figure 10: Siding will be removed and replaced within the area delineated in red.

The siding on the south side of the 1924 addition will be totally replaced with a thermally modified wood product. Preservation Brief 16¹⁰ states that it is acceptable to use substitute materials in the treatment of secondary, less distinctive elevations that are less important in defining the historic character of the property. This is the case of the 1924 addition, which was built as a storeroom and does not exhibit the distinctive materials, features and finishes found in the other elevations. It is recommended however to state what type of product will be used based on the inventory of available products found in Preservation Brief 16. Preservation Brief 16 advises however, that "When using a substitute material for replacement it is critical that it match the historic material in all its visual and physical properties to preserve the historic character of the building and minimize the impact on its integrity."
