COMPLIANCE ORDER

NOTICE OF INTENT TO RECORD A NOTICE OF VIOLATION

Violation Location:	1170 Signal Hill Rd., Pebble Beach
APN:	008-261-007-000
Zoning:	LDR/1.5-D(CZ)
Case Number:	13CE00338

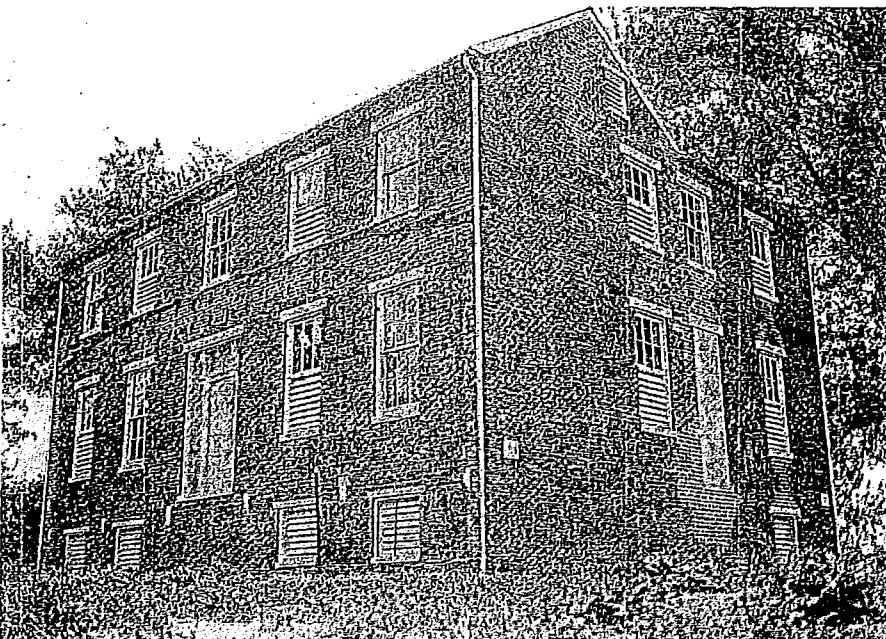
Figure 1. Proper mothballing treatment: This building has been successfully mothballed for 10 years because the roof and walls were repaired and structurally stabilized, ventilation louvers were added, and the property is maintained. Photo: Charles E. Fisher, NPS.

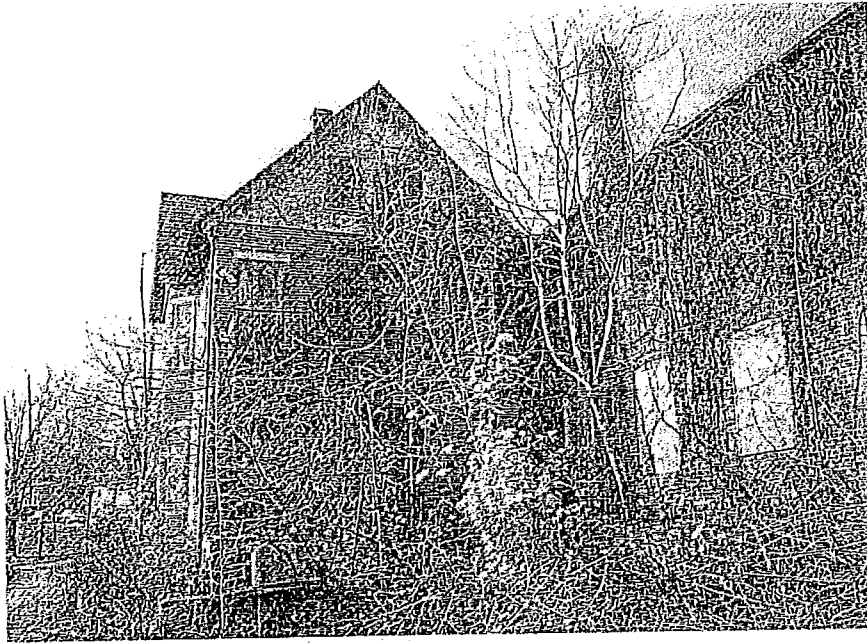
Figure 2. Improper treatment: Boarding up without adequate ventilation, lack of maintenance, and neglect of this property have accelerated deterioration. Photo; NPS file.

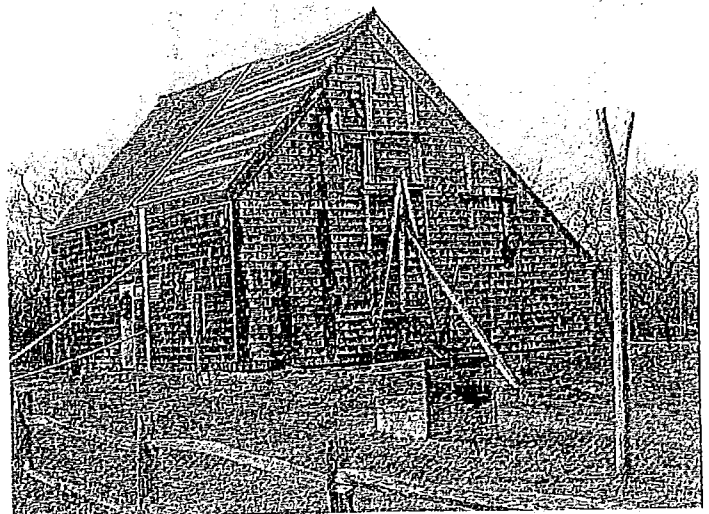
Figure 3. Buildings seriously damaged by storms or deterioration may need to be braced before architectural evaluations can be made. Jethro Coffin House. Photo: John Milner Architects.

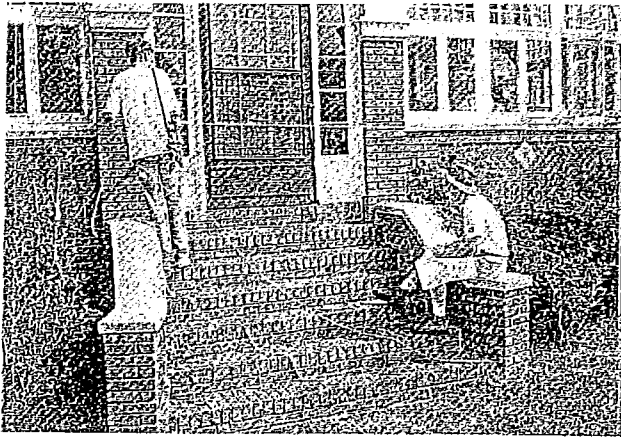
Figure 4. Documenting the building's history, preparing schematic plans, and assessing the condition of the building will provide necessary information on which to set priorities for stabilization and repair prior to securing the building. Photo: Frederick Lindstrom, HABS.

Old photographs can be helpful in identifying early or original features that might be hidden under modern materials. On a walk-through, the architect, historian, or preservation specialist should identify the architecturally significant elements of the building, both inside and out (see fig.4).

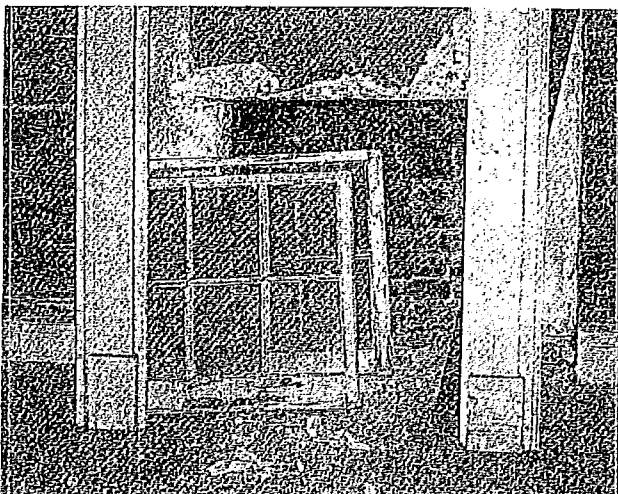
Figure 5. Loose or detached elements should be identified, tagged and stored, preferably on site. Photo: NPS files.

By understanding the history of the resource, significant elements, even though deteriorated, may be spared the trash pile. For that reason alone, any materials removed from the building or site as part of the stabilization effort should be carefully scrutinized and, if appearing historic, should be photographed, tagged with a number, inventoried, and safely stored, preferably in the building, for later retrieval (see fig. 5).

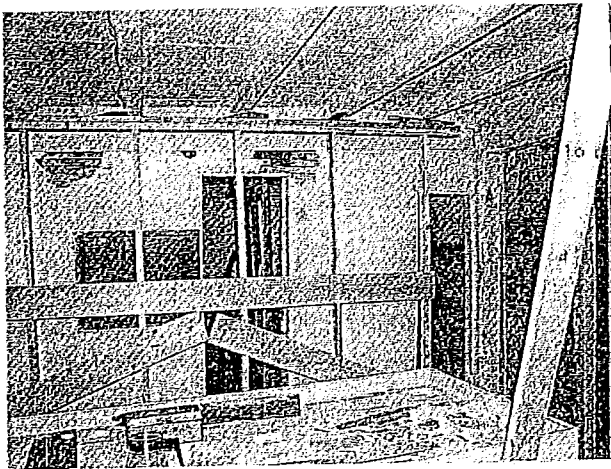
Figure 6. Interior bracing which will last the duration of the mothballing will protect weakened structural members. Jethro Coffin House. Photo: John Milner Architects.

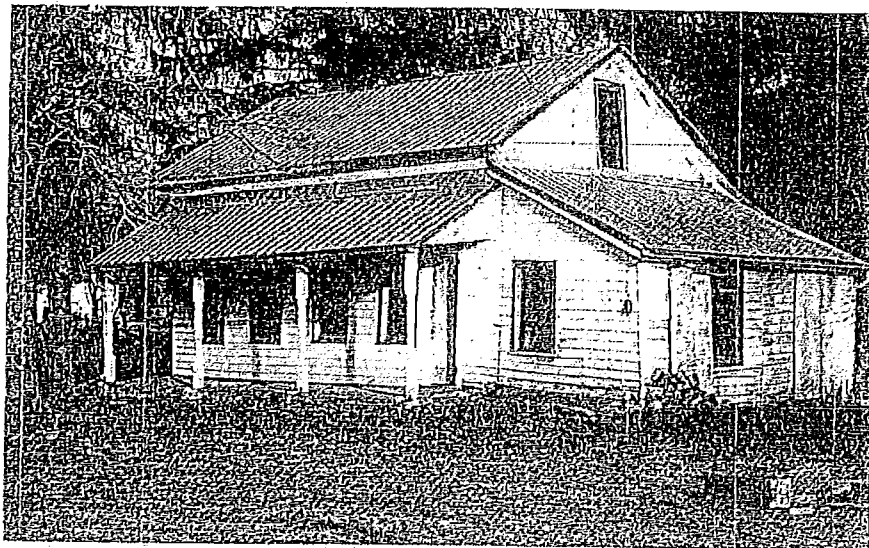
Figure 7. Non-historic materials are appropriate for mothballing projects when they are used to protect historic evidence remaining for future preservation. This lightweight aluminum channel frame and roofing covers the historic wooden shingle roof. Galvanized mesh panels secure the window openings from intrusion by raccoons and other unwanted guests. Photo: Williamsport Preservation Training Center, NPS.

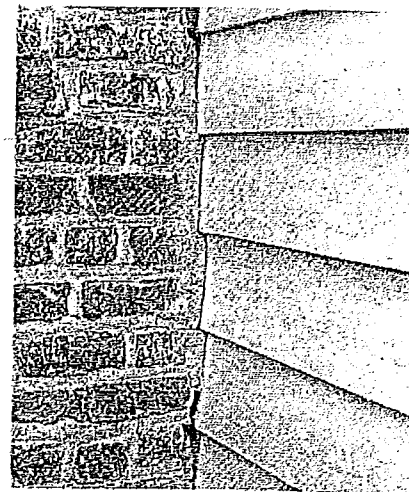
Figure 8. Appropriate mortar mixes should be used when masonry repairs are undertaken. In this case, a soft lime based mortar is used as an infill between the brick and wooden elements. When full repairs are made during the restoration phase, this soft mortar can easily be removed and missing bricks replaced.

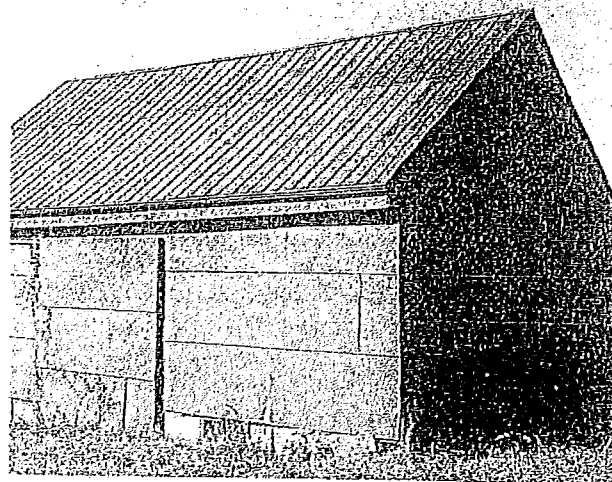
Figure 9. Severely deteriorated wooden siding on a farm building has been covered over with painted plywood panels as a temporary measure to eliminate moisture penetration to the interior. Foundation vents and loose floor boards allow air to circulate inside.

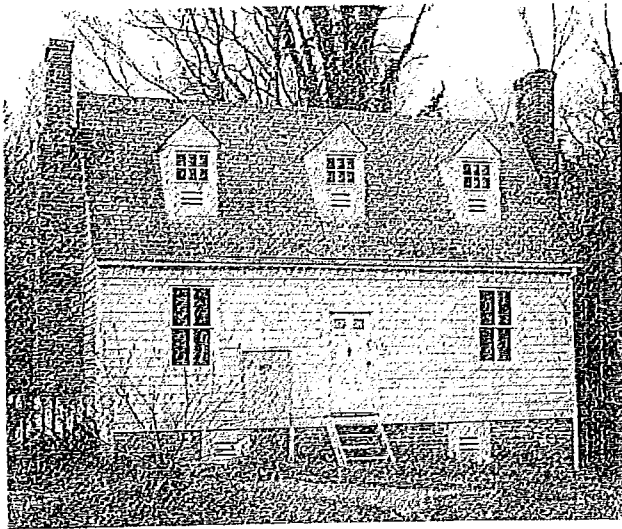
Figure 10. Regrading around the Booker Tenement at Colonial Williamsburg has protected the masonry foundation wall from excessive damp. This building has been successfully mothballed for over 10 years. Note the attic and basement vents, the temporary stairs, and the informative sign interpreting the history of this building.

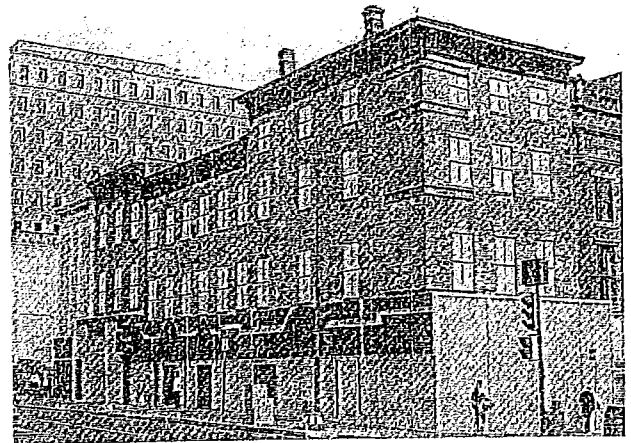
Figure 11: Urban buildings often need additional protection from unwanted entry and graffiti. This commercial building uses painted plywood panels to cover expansive glass storefronts and chain link fencing is applied on top of the panels. The upper windows on the street sides have been covered and painted to resemble 19th century sash. Photo: Thomas Jester, NPS.

Mothballed buildings are usually boarded up, particularly on the first floor and basement, to protect fragile glass windows from breaking and to reinforce entry points (see fig. 11). Infill materials for closing door and window openings include plywood, corrugated panels, metal grates, chain fencing, metal grills, and cinder or cement blocks (see fig. 12). The method of installation should not result in the destruction of the opening and all associated sash, doors, and frames should be protected or stored for future reuse.

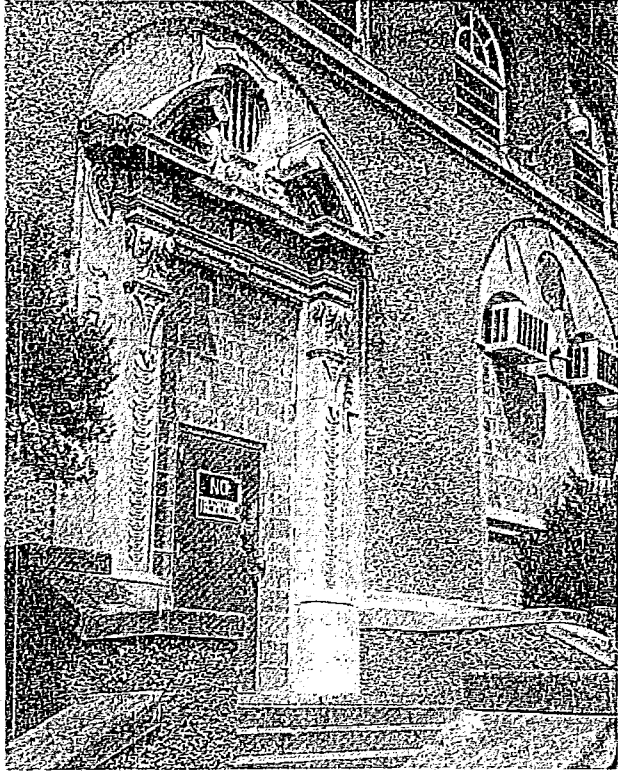
Figure 12. First floor openings have been filled with cinderblocks and doors, window sash and frames have been removed for safe keeping. Note the security light over the windows and the use of a security metal door with heavy duty locks. Photo: H. Ward Jandl, NPS.

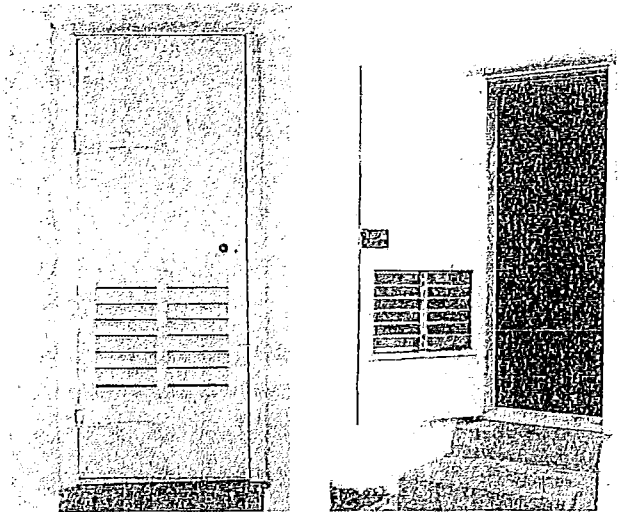
Figure 13. If historic doors would be damaged by adding extra locks, they should be removed and stored and new security doors added. At this lighthouse, the historic door has been replaced with a new door (seen both inside and outside) with an inset vent and new deadbolt locks. The heavy historic hinges have not been damaged. Photo: Williamsport Preservation Training Center, NPS.

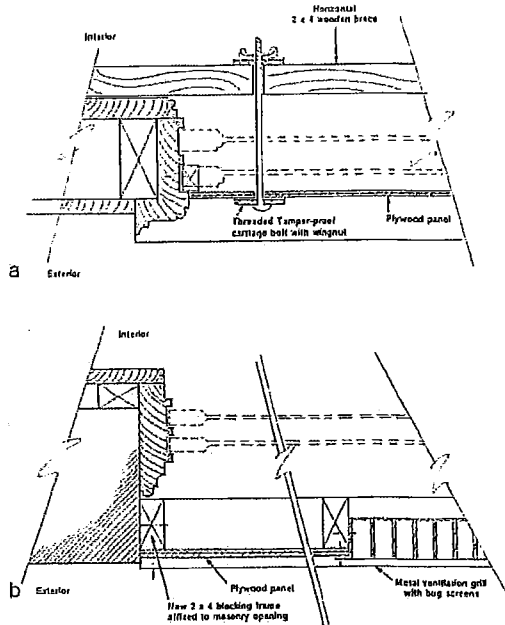
Figure 14. A: Plan detail showing plywood security panel anchored with carriage bolts through to the inside horizontal bracing, or strong backs. B: Plan detail showing section of plywood window panel attached to a new pressure treated wood frame set within the masonry opening. Ventilation should be included whenever possible or necessary.

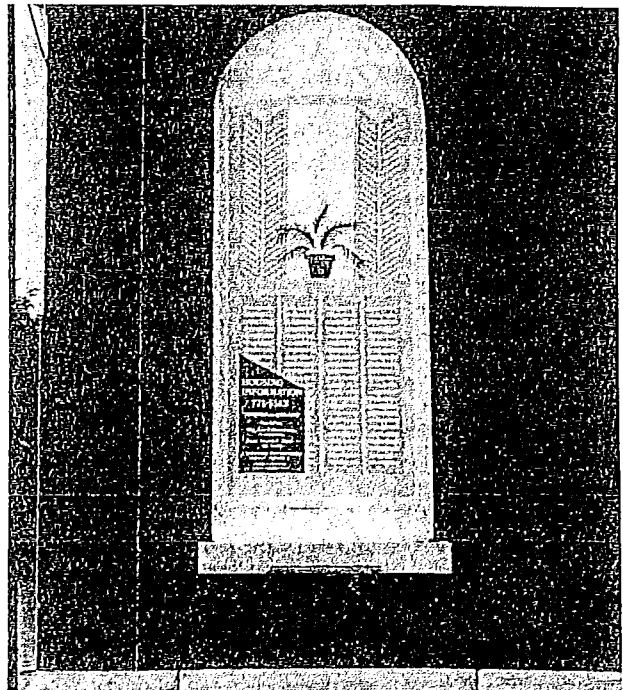
Figure 15. Painting trompe l'oeil scenes on plywood panels is a neighborhood friendly device. In addition, the small sign at the bottom left corner gives information for contacting the organization responsible for the care of the mothballed building. Photo: Lee H. Nelson, FAIA.

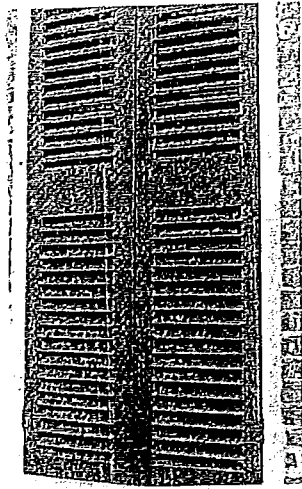
Figure 16. Historic louvered shutters make excellent security closures with passive ventilation.

If the building has shutters, simply close the shutters and secure them from the interior (see fig. 16). If the building had shutters historically, but they are missing, it may be appropriate to install new shutters, even in a modern material, and secure them in the closed position. Louvered shutters will help with interior ventilation if the sash are propped open behind the shutters.

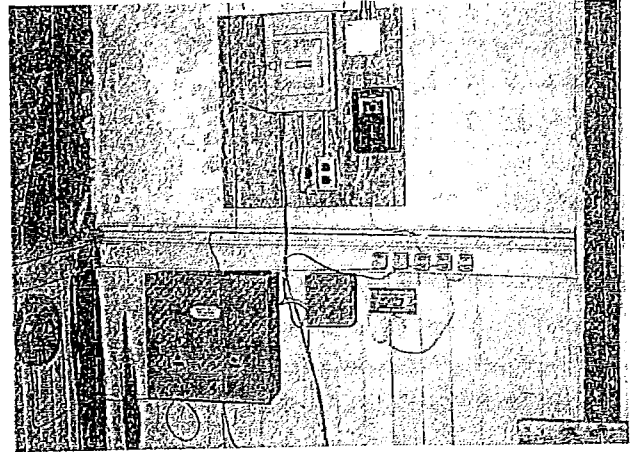
Figure 17. Security systems are very important for mothballed buildings if they are located where fire and security services are available. A temporary electric service with battery back-up has been installed in this building. Intrusion alarms and ionization smoke/fire detectors are wired directly to the nearby security service.

If at all possible, new temporary electric service should be provided to the building (see fig. 17). Generally a telephone

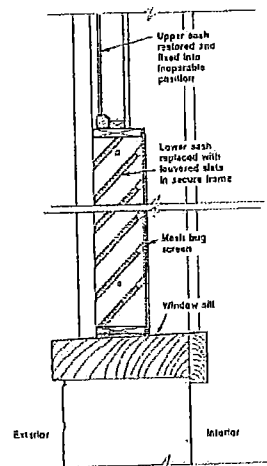
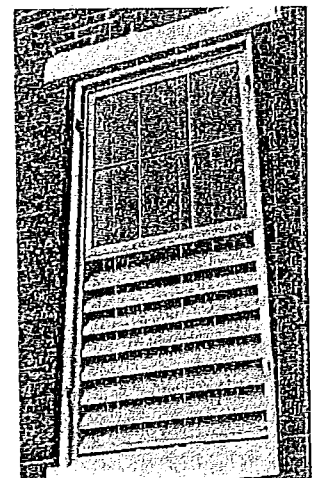
Figure 18. Heavy duty wooden slated louvers were custom fabricated to replace the deteriorated lower sash. The upper sash were rebuilt to retain the historic appearance and to allow light into this vacant historic building. Refer back to Fig. 1 for a view of the building. Photo: Charles E. Fisher, NPS. Drawing by Thomas Vitanza.

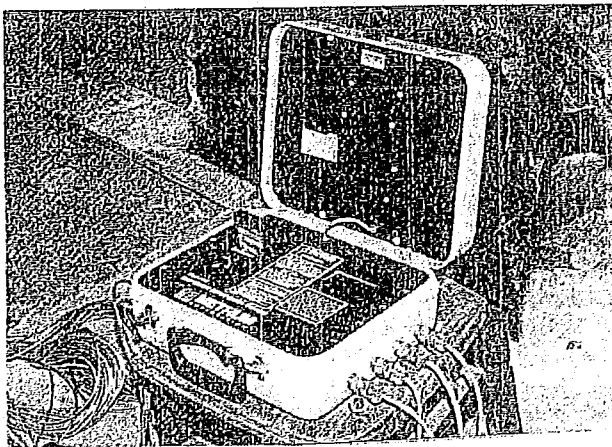
Figure 20. Portable monitors used to record temperature and humidity conditions in historic buildings during mothballing can help identify ventilation needs. This data can be downloaded directly into a laptop computer on site. These monitors are especially helpful over the long term for buildings with significant historic interiors or which are remaining furnished. If interiors are remaining damp or humid, additional ventilation should be added or the source of moisture controlled.

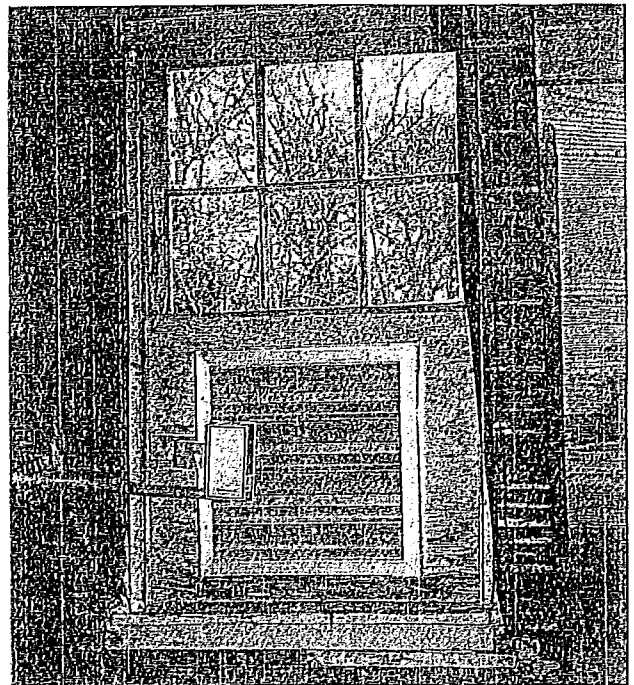
Figure 21. This electric thermostat/humidistat mounted in the attic vent controls a modified ducted air/fan system. The unit uses temporary exposed sheet metal ducts to pull air through the building and exhaust it out of the basement. For over ten years this fan system in combination with 18" x 18" preformed louvers in selective windows has kept the interior dry and with good air exchanges.

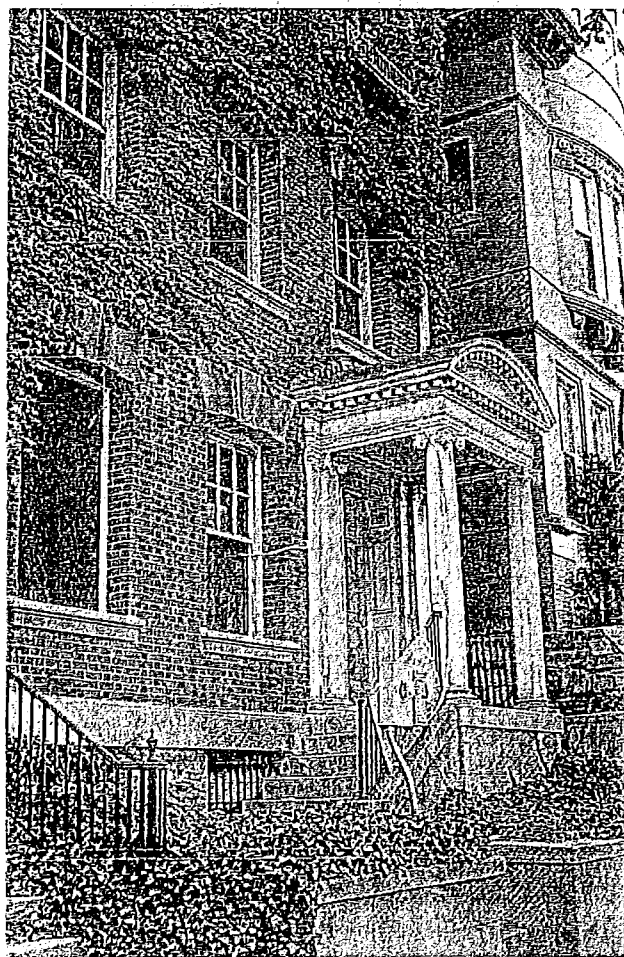
Figure 22. All systems except temporary electric have been shut off at this residence which has been mothballed over 20 years. An electric meter and 100 amp panel box have been set on a plywood panel at the front of the building. It is used for interior lighting and various alarm systems. The building, however, is showing signs of moisture problems with efflorescent stains on the masonry indicating the need for gutter maintenance and additional ventilation for the interior. The vegetation on the walls, although picturesque, traps moisture and is damaging to the masonry. Photo: H. Ward Jandl, NPS.

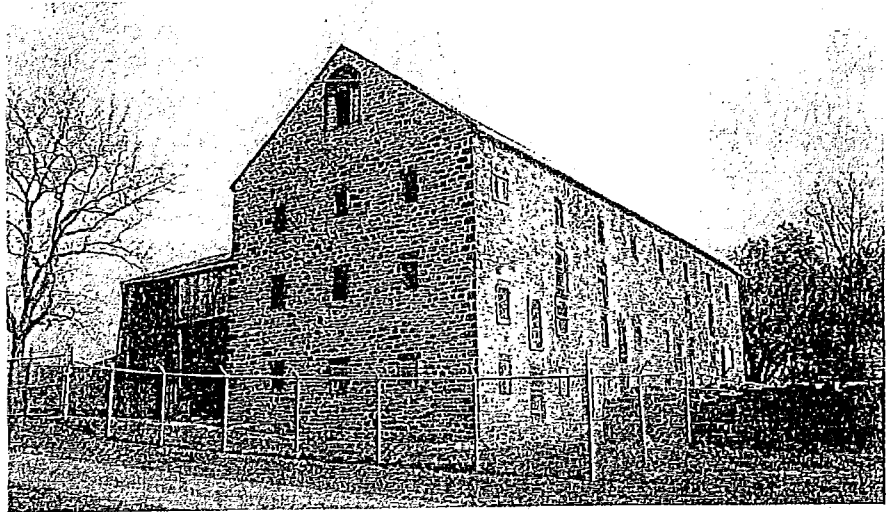
Figure 24. Once mothballed, a property must still be monitored and maintained. The openings in this historic barn has been modified with a combination of wood louvers and metal mesh panels which require little maintenance. The grounds are regularly mowed, even inside the chain link security fence. Photo: Williamsport Preservation Training Center, NPS.

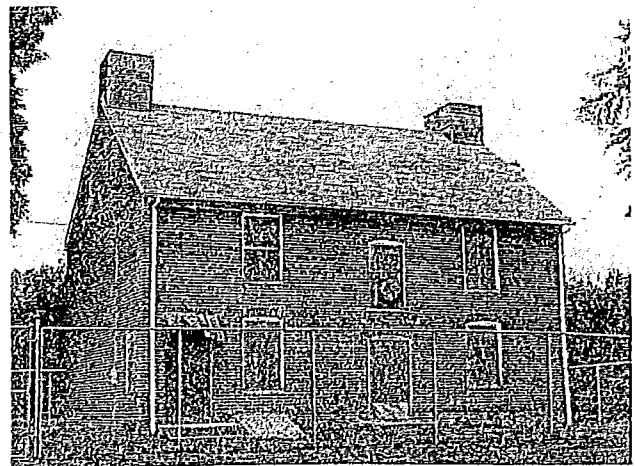
a. A view showing the exterior of the house in its mothballed condition.

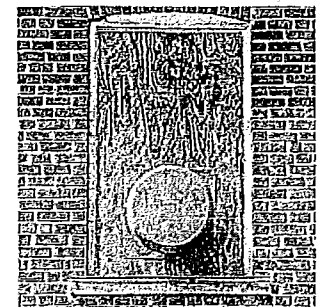
c. The exhaust fan has tamper-proof housing.

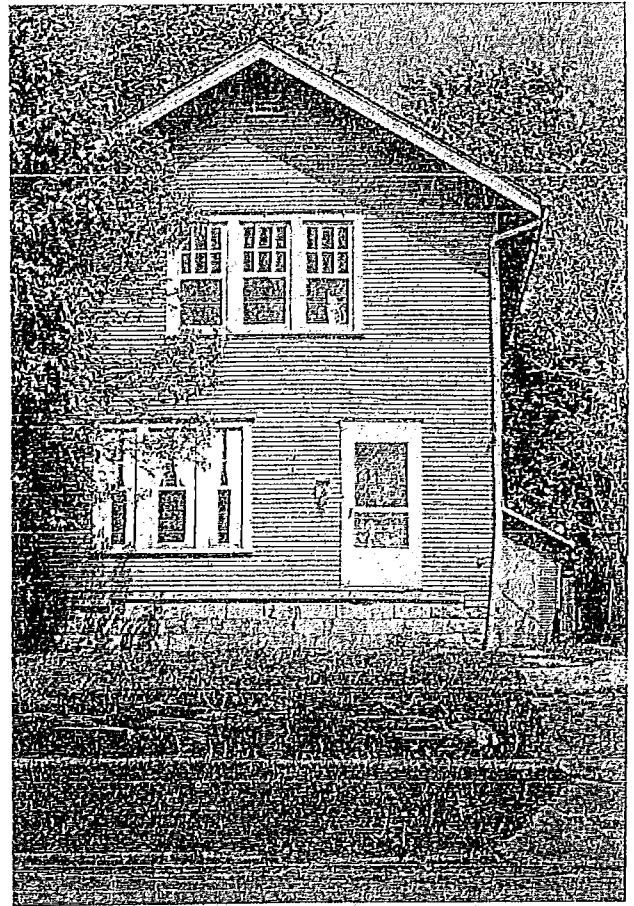
Figure 27. This residential building blends into its neighborhood even though all the windows have been covered over and the front steps are missing. The grounds are maintained and the special attention to decoratively painting the window panels shows that the property is being well cared for until it can be rehabilitated. Photo: Ohio Historical Society.
