Exhibit F

Introduction:

This Focused Phase II Historic Assessment has been prepared as part of an application for repair, and minor alteration to a one-story single family residence, owned by Pam Conant, which is eligible for listing as an historic building. The subject property is located at 14 Coastlands (APN# 420-171-014), in Big Sur (see photos, plans & drawings provided).

14 Coastlands-Big Sur

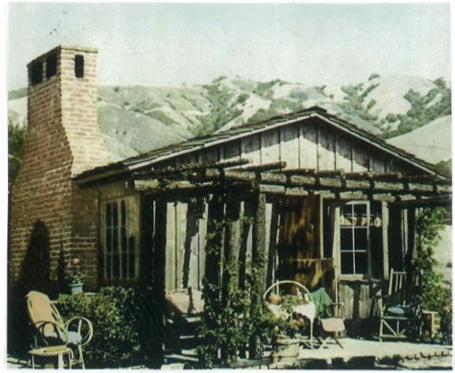
Photo #1. Looking SE at the West facade & North side-elevation, illustrated on the cover of the Jul,1933 issue of Sunset Magazine, note the Barked wood trellis fronting the residence.

This is the primary elevation. As proposed the existing deteriorated front wood trellis would be replaced by a treated barked wood trellis, matching the original feature which is clearly illustrated on the cover of the July 1938 issue of Sunset Magazine (provided., and wood rafter & window repair, as needed.

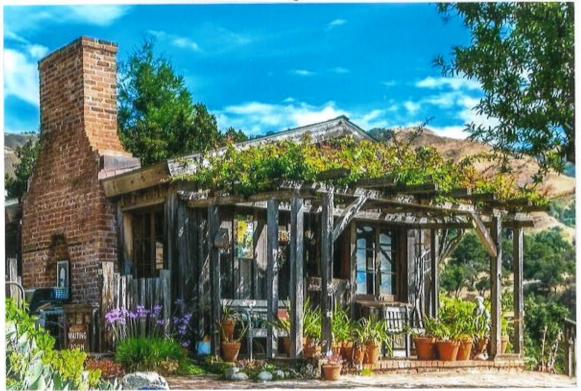
Photo #2. Looking SE at the West facade & North side-elevation, August, 2020, note the undated wood post trellis, wide facia boards & modified Chimney stack, Robert Carver photo.

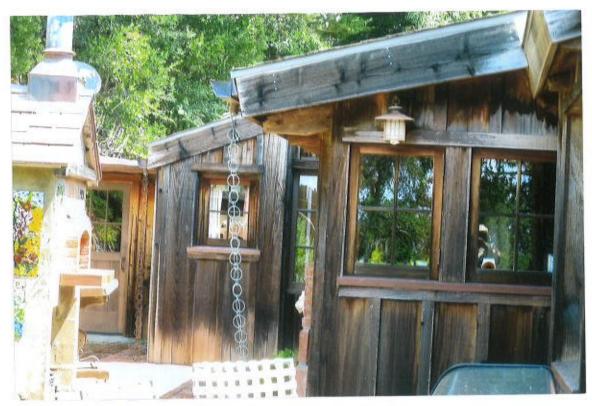
Photo #3. Looking East at the North side additions, entry door to laundry room at left, bathroom window, center & wide facia boards, Kent Seavey, October, 2020.

Remove existing glazed door on the c. 1970s former laundry room, also off the North side-elevation at the rear of the West facing facade, and add a new vertical planked wood door, consistent with the material character of that elevation (see plans & drawings Provided).

Replace existing door adjacent to bathroom with vertically-planked wood door similar to that proposed for laundry room.

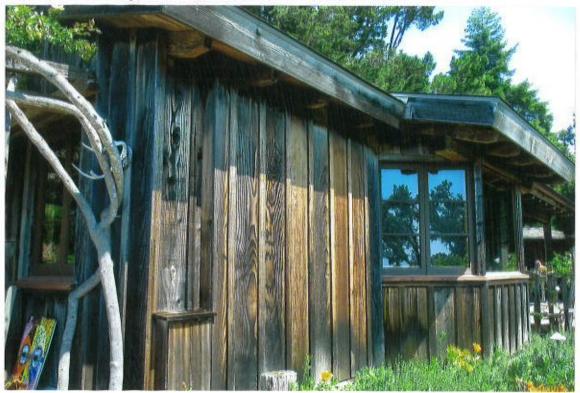
Photo #4. Looking east at the SW cr. of the building envelope proposed for location of repurposed south facing wood window, Kent Seavey, October, 2020.

Add a repurposed wood casement window from owner's bedroom to the West end of this elevation.

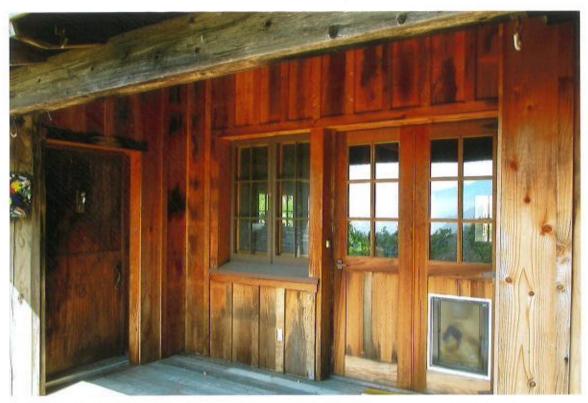
Photo #5. Looking at recessed entry on South elevation proposed for in fill to beam under existing roof overhang. Doors & windows proposed for repurposing on project, Kent Seavey, October 2020.

Create new kitchen space by enclosing existing recessed entry immediately East of the angled bay on this elevation. Add wood door (repurposed) between newly enclosed space & bay window to West. The enclosed bay will remain under the roof overhang, and extend into the former location of an original open passageway between the house & master bedroom spaces, with a new tripartite windows & doors facing South. Employ as much original building material as feasible in this enclosure process.

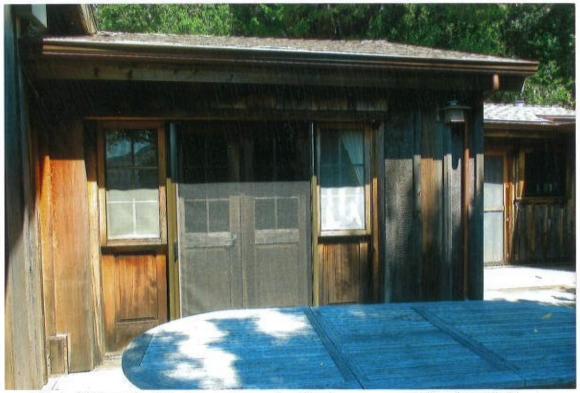
Photo #6. Looking North at bedroom double-doors proposed for single light reglazing & window/door far right for minor reconfiguration, Kent Seavey, October, 2020.

Replace upper multi-paned windows in the two center doors of the banked master bedroom entry to the East of the new enclosed kitchen space with single lights.

Remove the existing door and East window on the master bathroom and replace the existing East window, matching the one on the West of the door, using clear glazing.
