County of Monterey

Meeting Agenda - Final

Thursday, July 11, 2024

Continued from June 13, 2024 - Public hearing to consider restoration of approximately 11,750 square feet of Northern coastal bluff scrub habitat, removal of “Deck 2,” after-the-fact partial conversion of a detached garage into a 336 square foot guesthouse, and after-the-fact construction of outdoor sauna, hot tubs, an outdoor patio, and a deck within 50 feet of a coastal bluff and 100 feet of environmentally sensitive habitat area to partially clear Code Enforcement Violation No. 16CE00201.

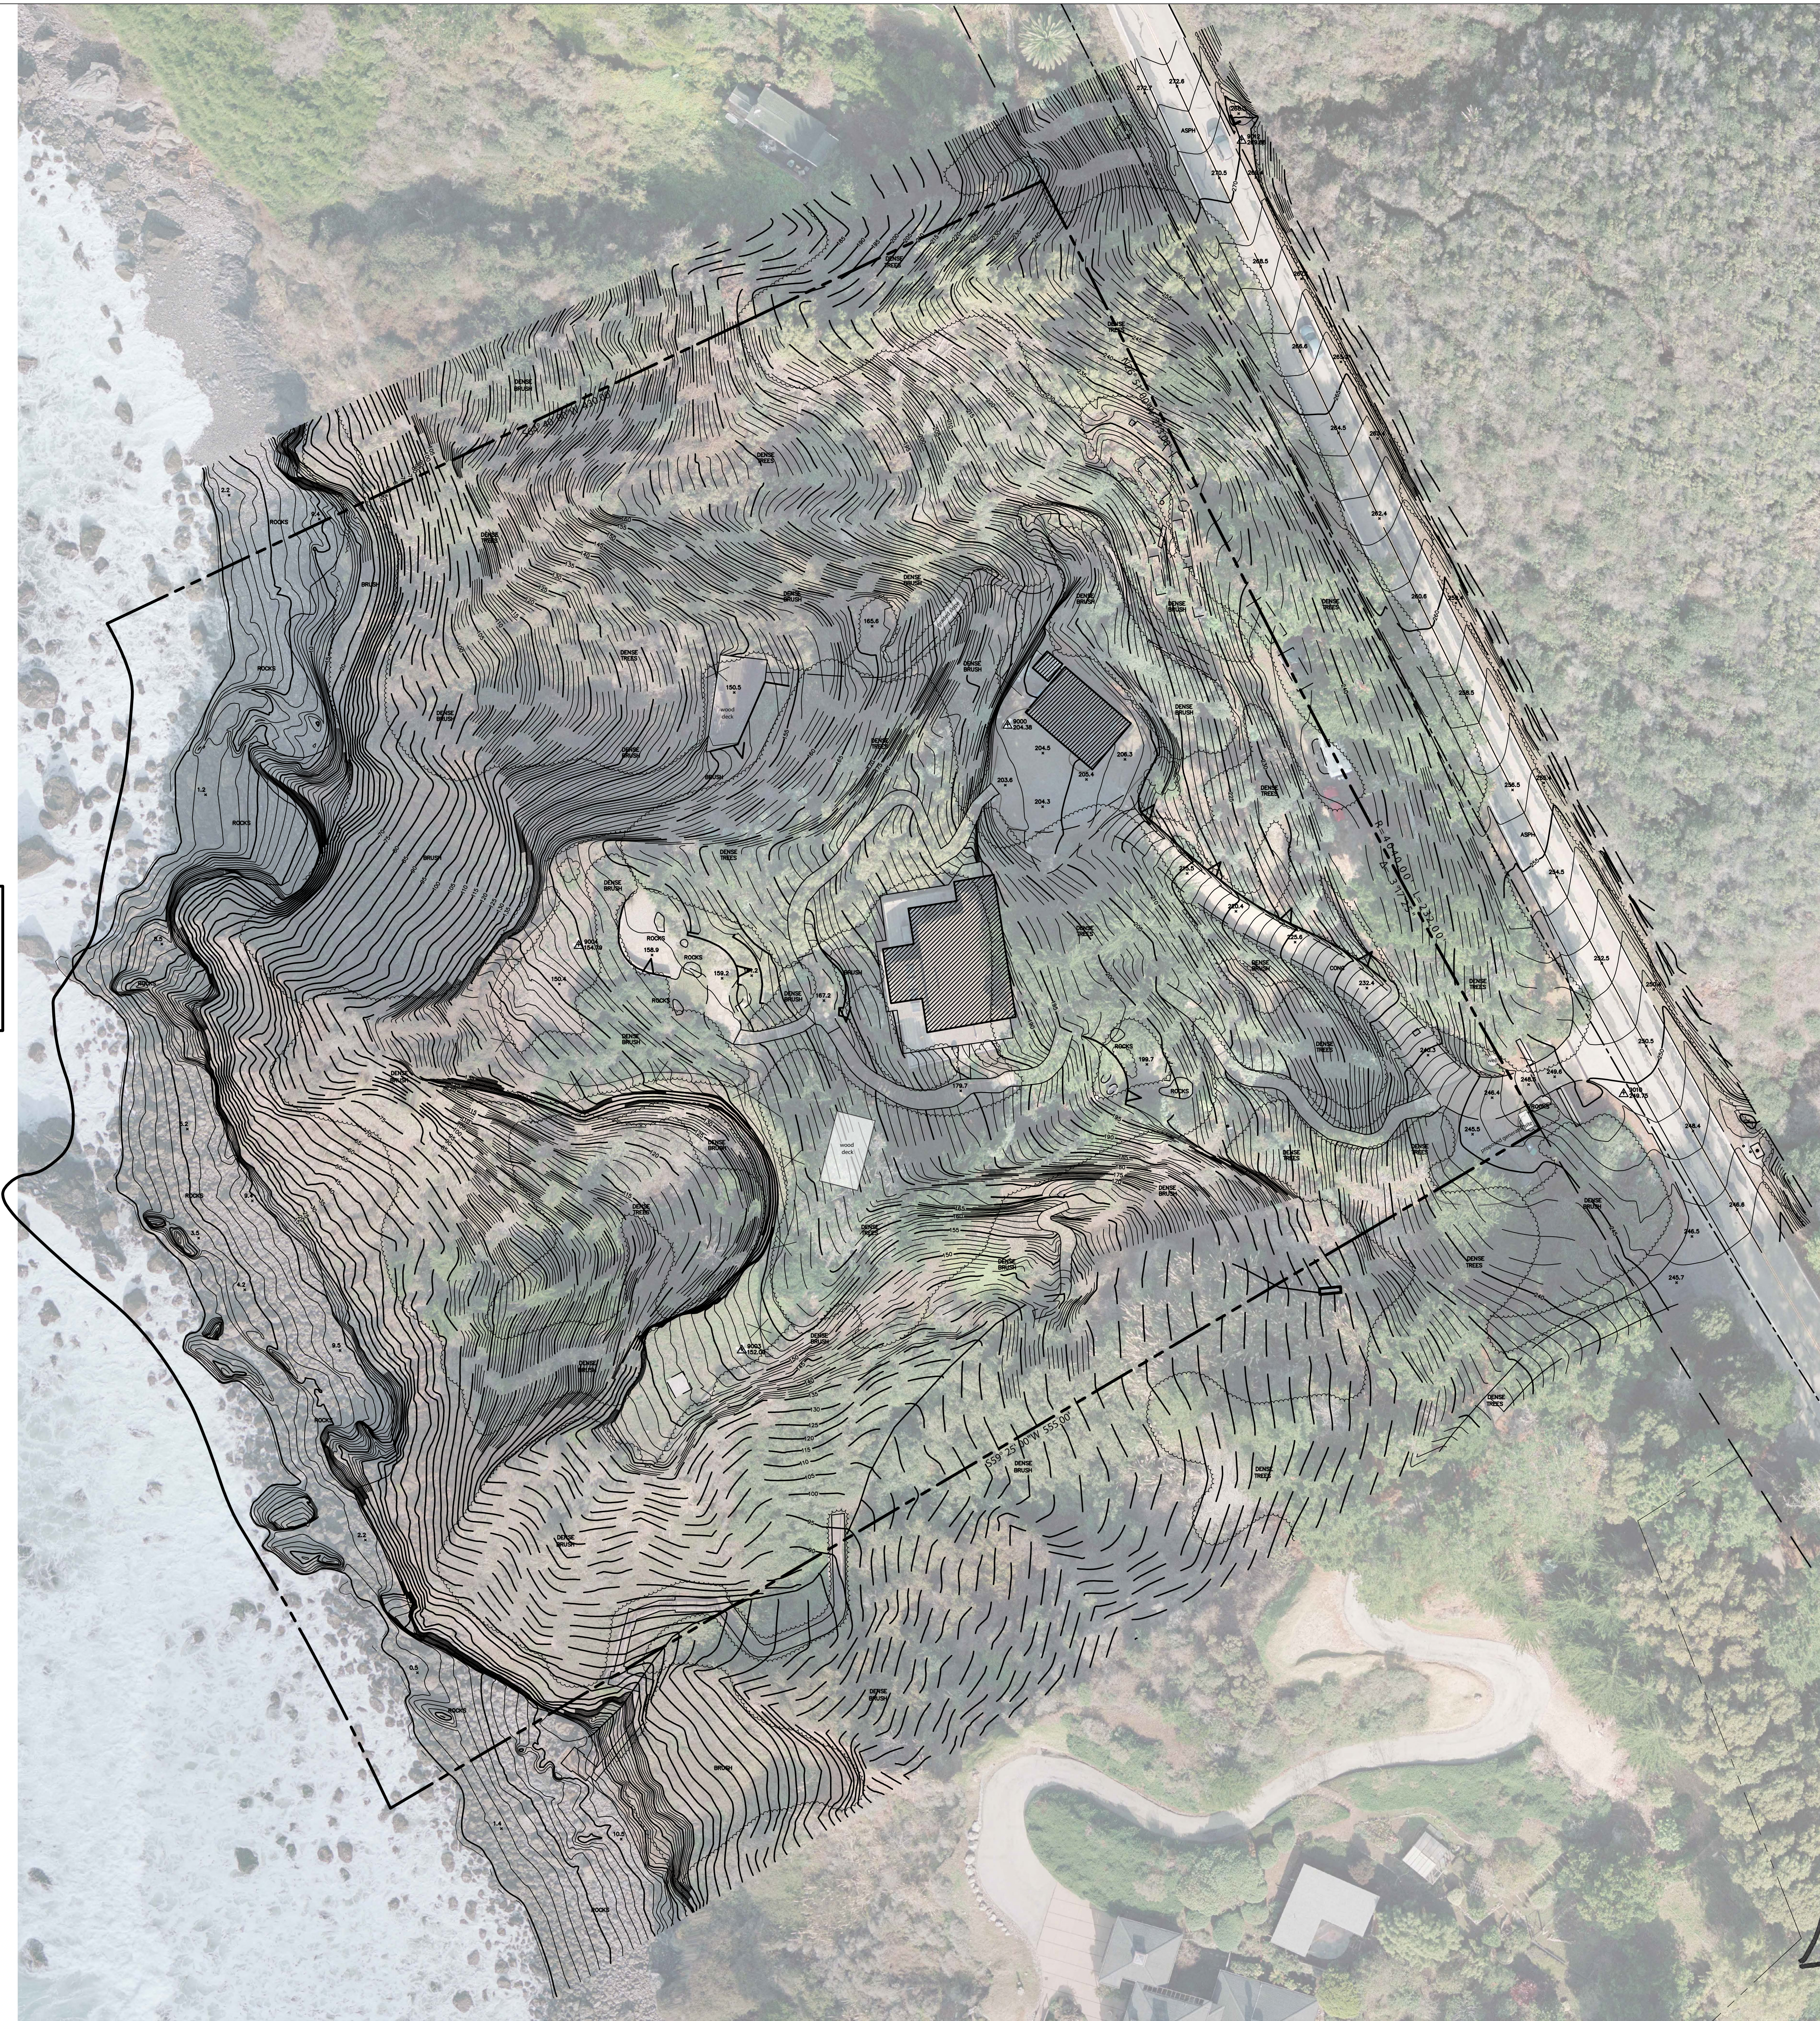
Aerial Topographic Survey

This map portrays the site at the time of the survey and does not show soils or geology information, underground conditions, easements, zoning or regulatory information or any other terms not specifically requested by the property owner. There may be easements or other rights, recorded or unrecorded, affecting the subject property which are not shown hereon.

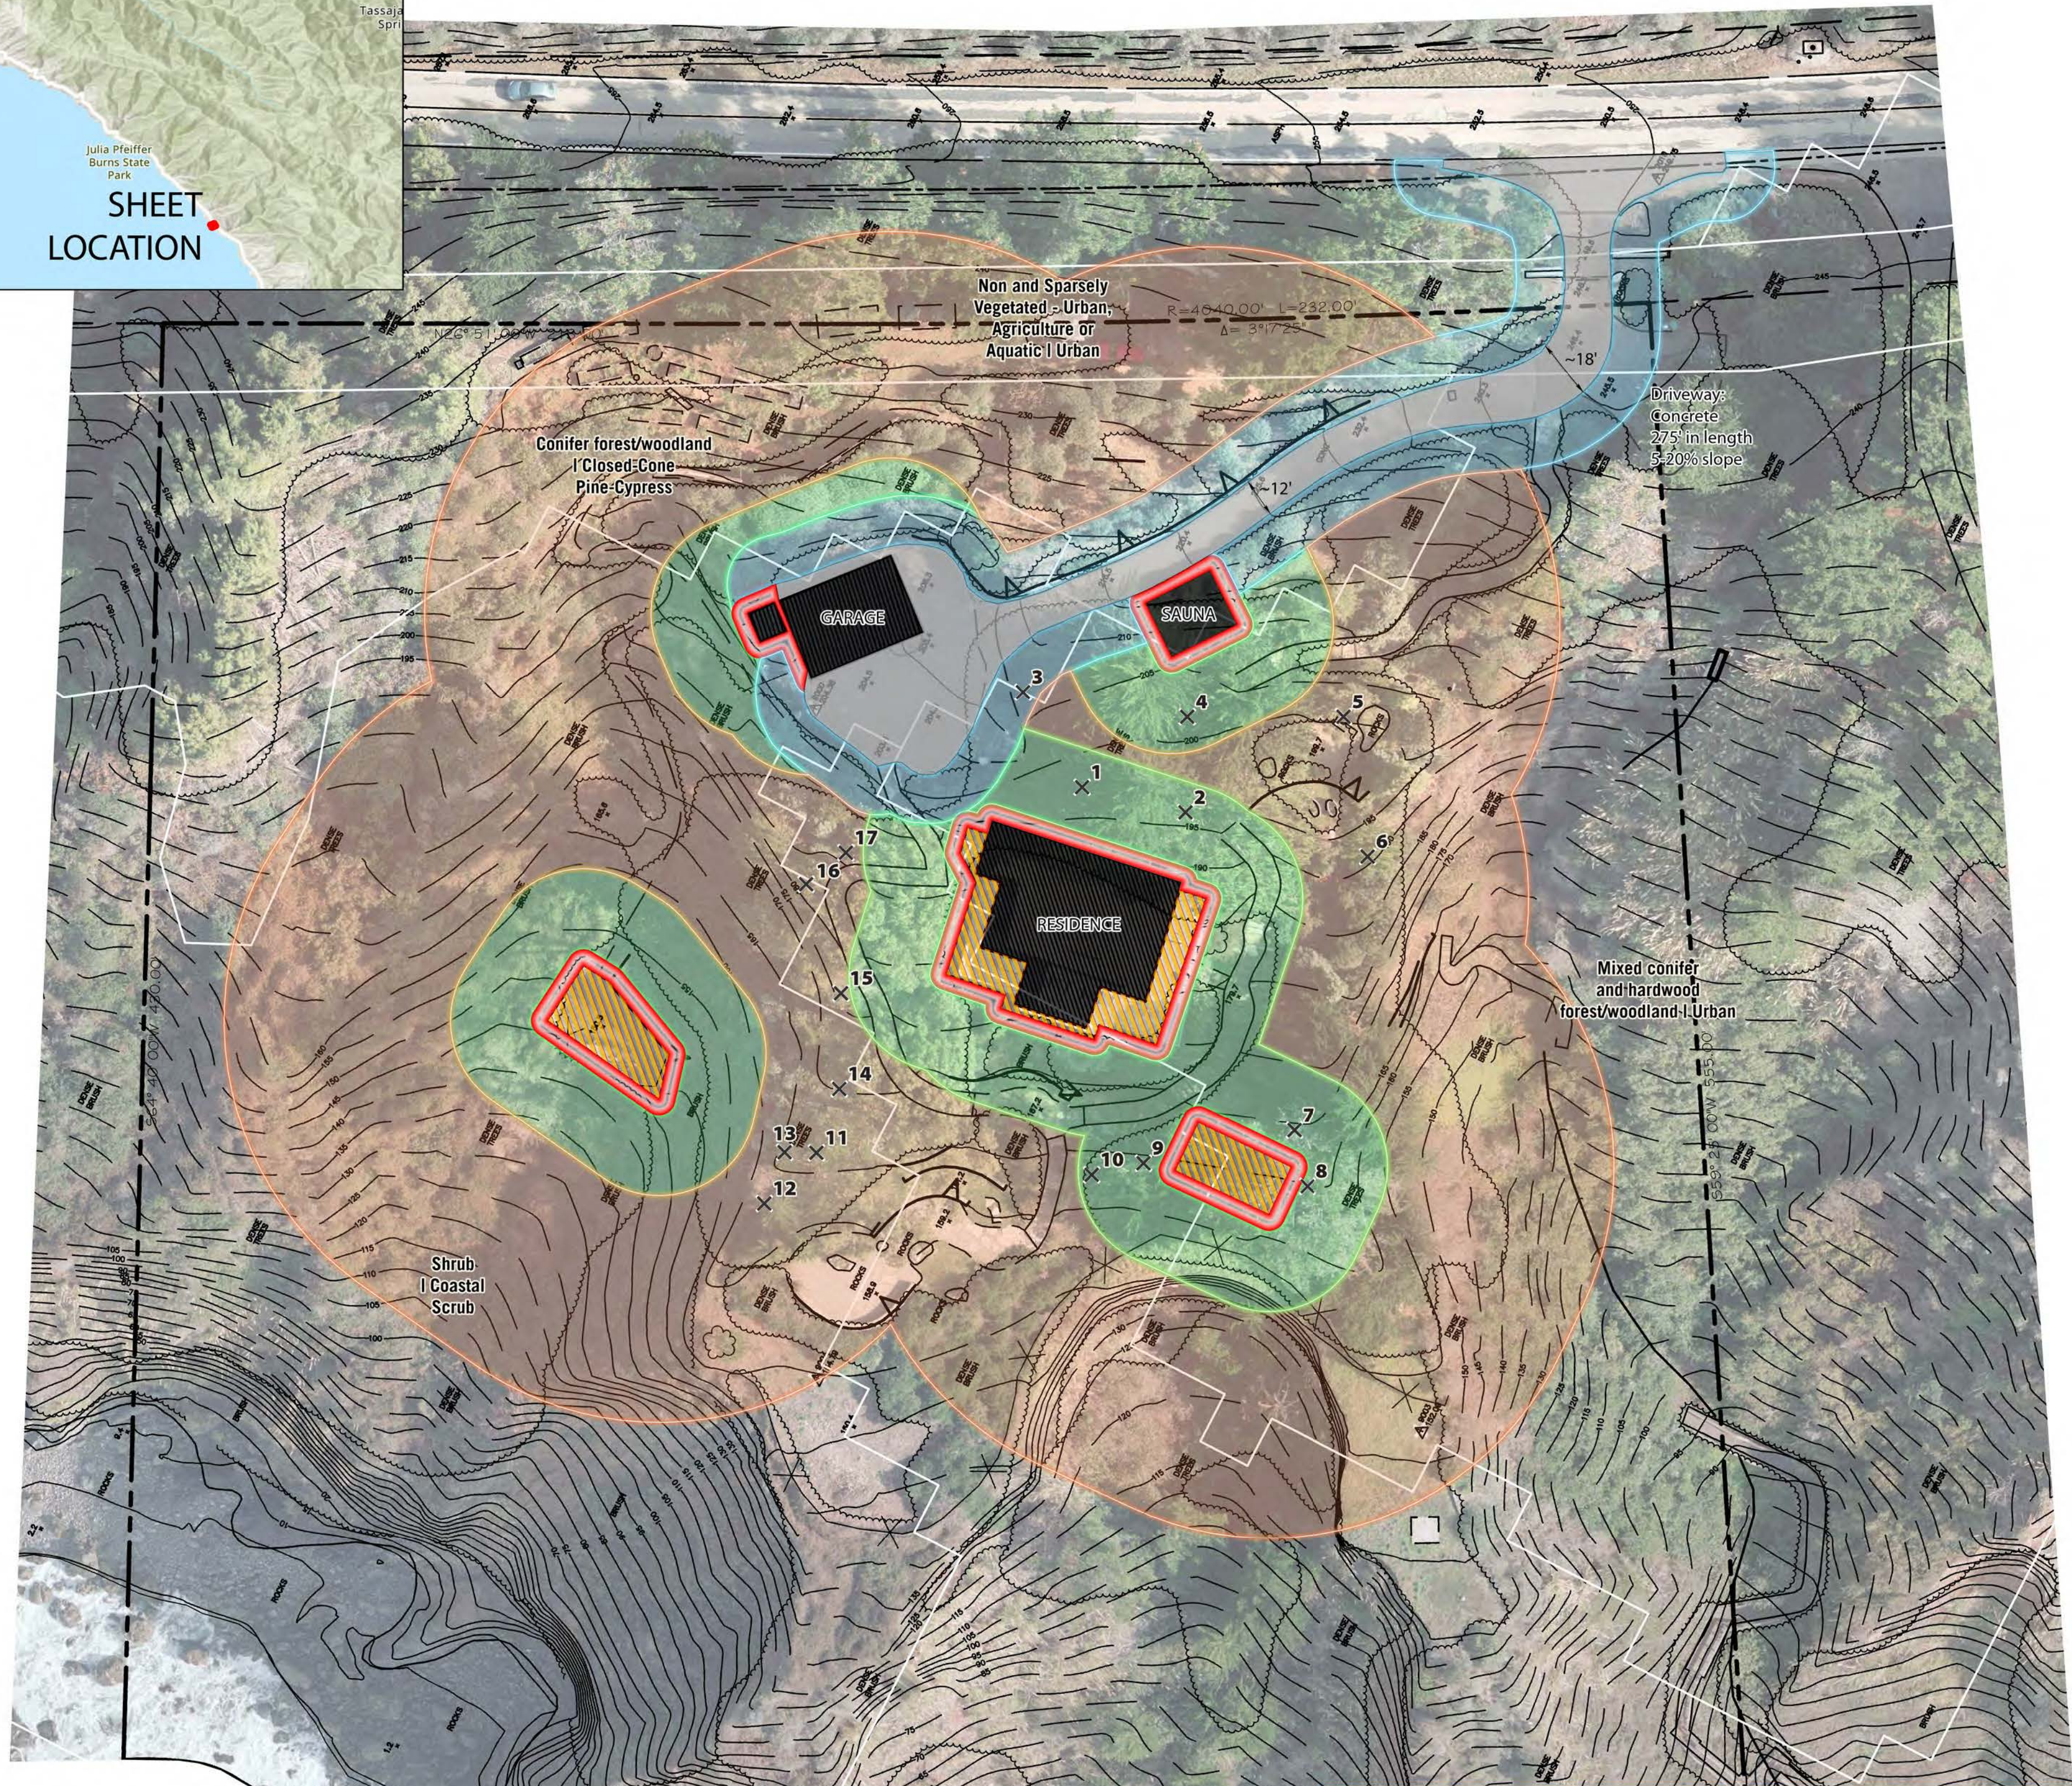
- Legend**
- x Trees
 - Vegetation
- House and Driveway Footprints**
- Home
 - Garage
 - Sauna
 - Deck
 - Driveway
- Zones**
- Non-combustible Zone (0 - 5')
 - Driveway Zone (0 - 15')
 - Green Zone (30')
 - Management Zone (100')

Observations: Dense, dry, woody ladder fuels were observed throughout the Extended Zone. In some areas, such ladder fuels were observed directly below or in contact with low hanging tree canopies in the Extended Zone (pictured). Dense brush and accumulated leaf litter were observed around and above the saunas.

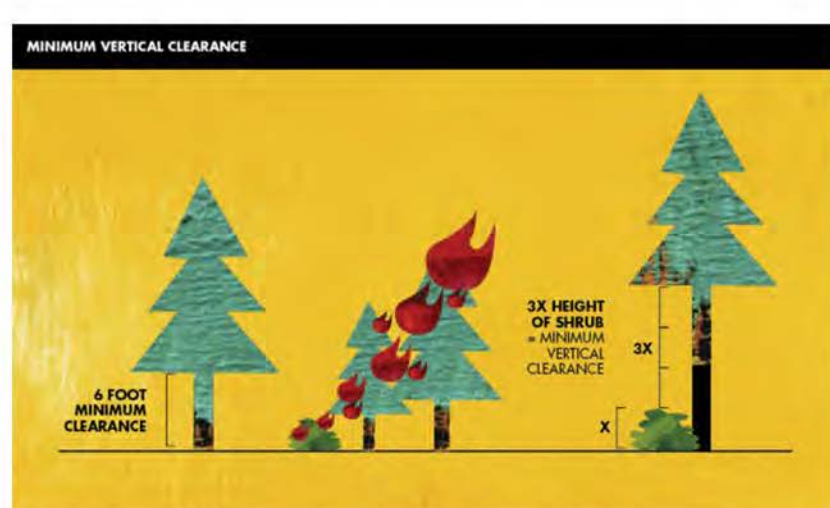
- Maintain space between the lowest tree branches and the ground or shrubs.
- Remove all tree branches at least six feet from the ground.
 - Allow extra vertical space between shrubs and trees. Lack of vertical space can allow a fire to move from the ground to the brush to the treetops like a ladder. This leads to more intense fire closer to your home.
 - Keep at least three times the height of any shrubs between the shrubs and the lowest branches of trees.

Example: A 5-foot shrub is growing near a tree. 15 feet of clearance is needed between the top of the shrub and the lowest tree branch.

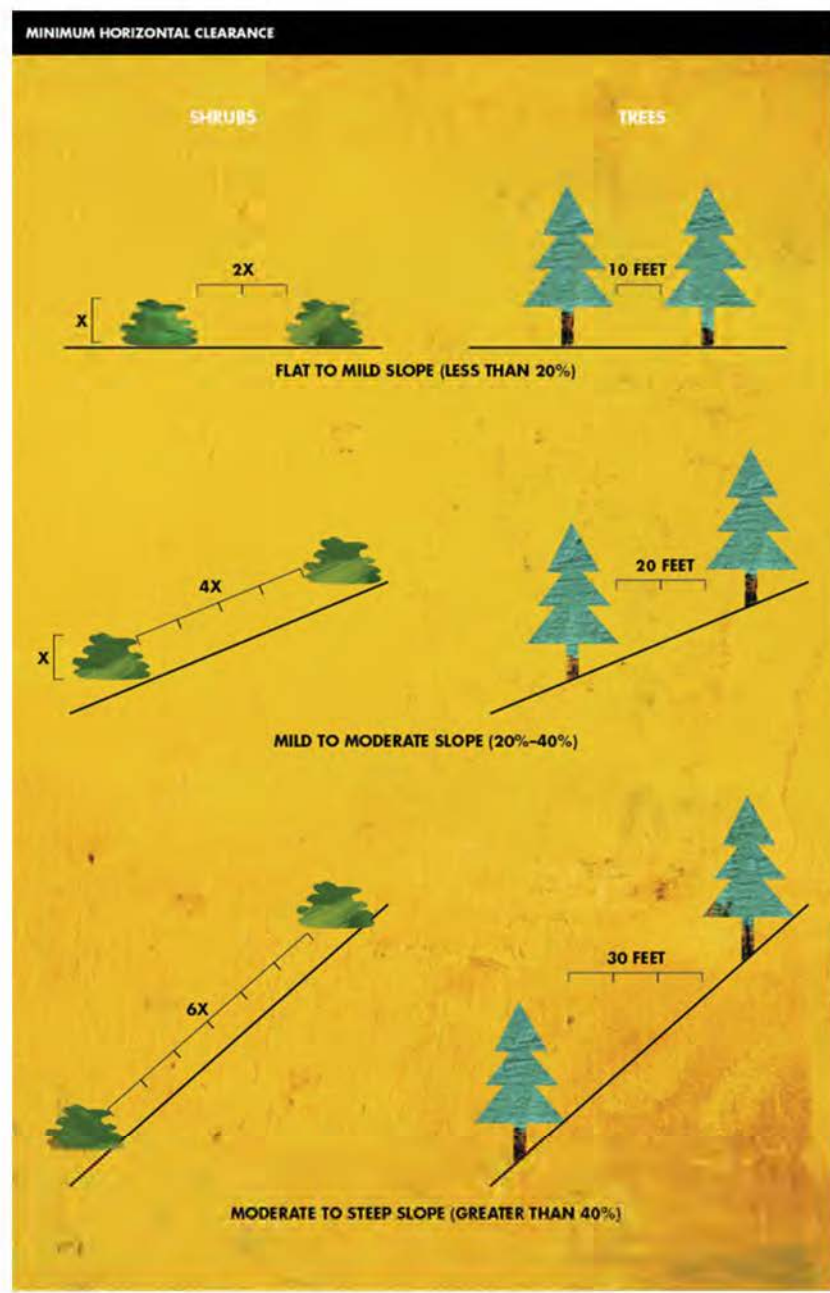
How much space should you leave between trees or shrubs?
 Horizontal space depends on the slope of the land and the height of the shrubs or trees. Leave more space between vegetation on bigger slopes. Refer to the chart below to determine spacing distance.

Space between shrubs:
 Flat or mild slope (less than 20%): Two times the height of the shrub.
 Mild to moderate slope (20-40%): Four times the height of the shrub
 Moderate to steep slope (greater than 40%): Six times the height of the shrub

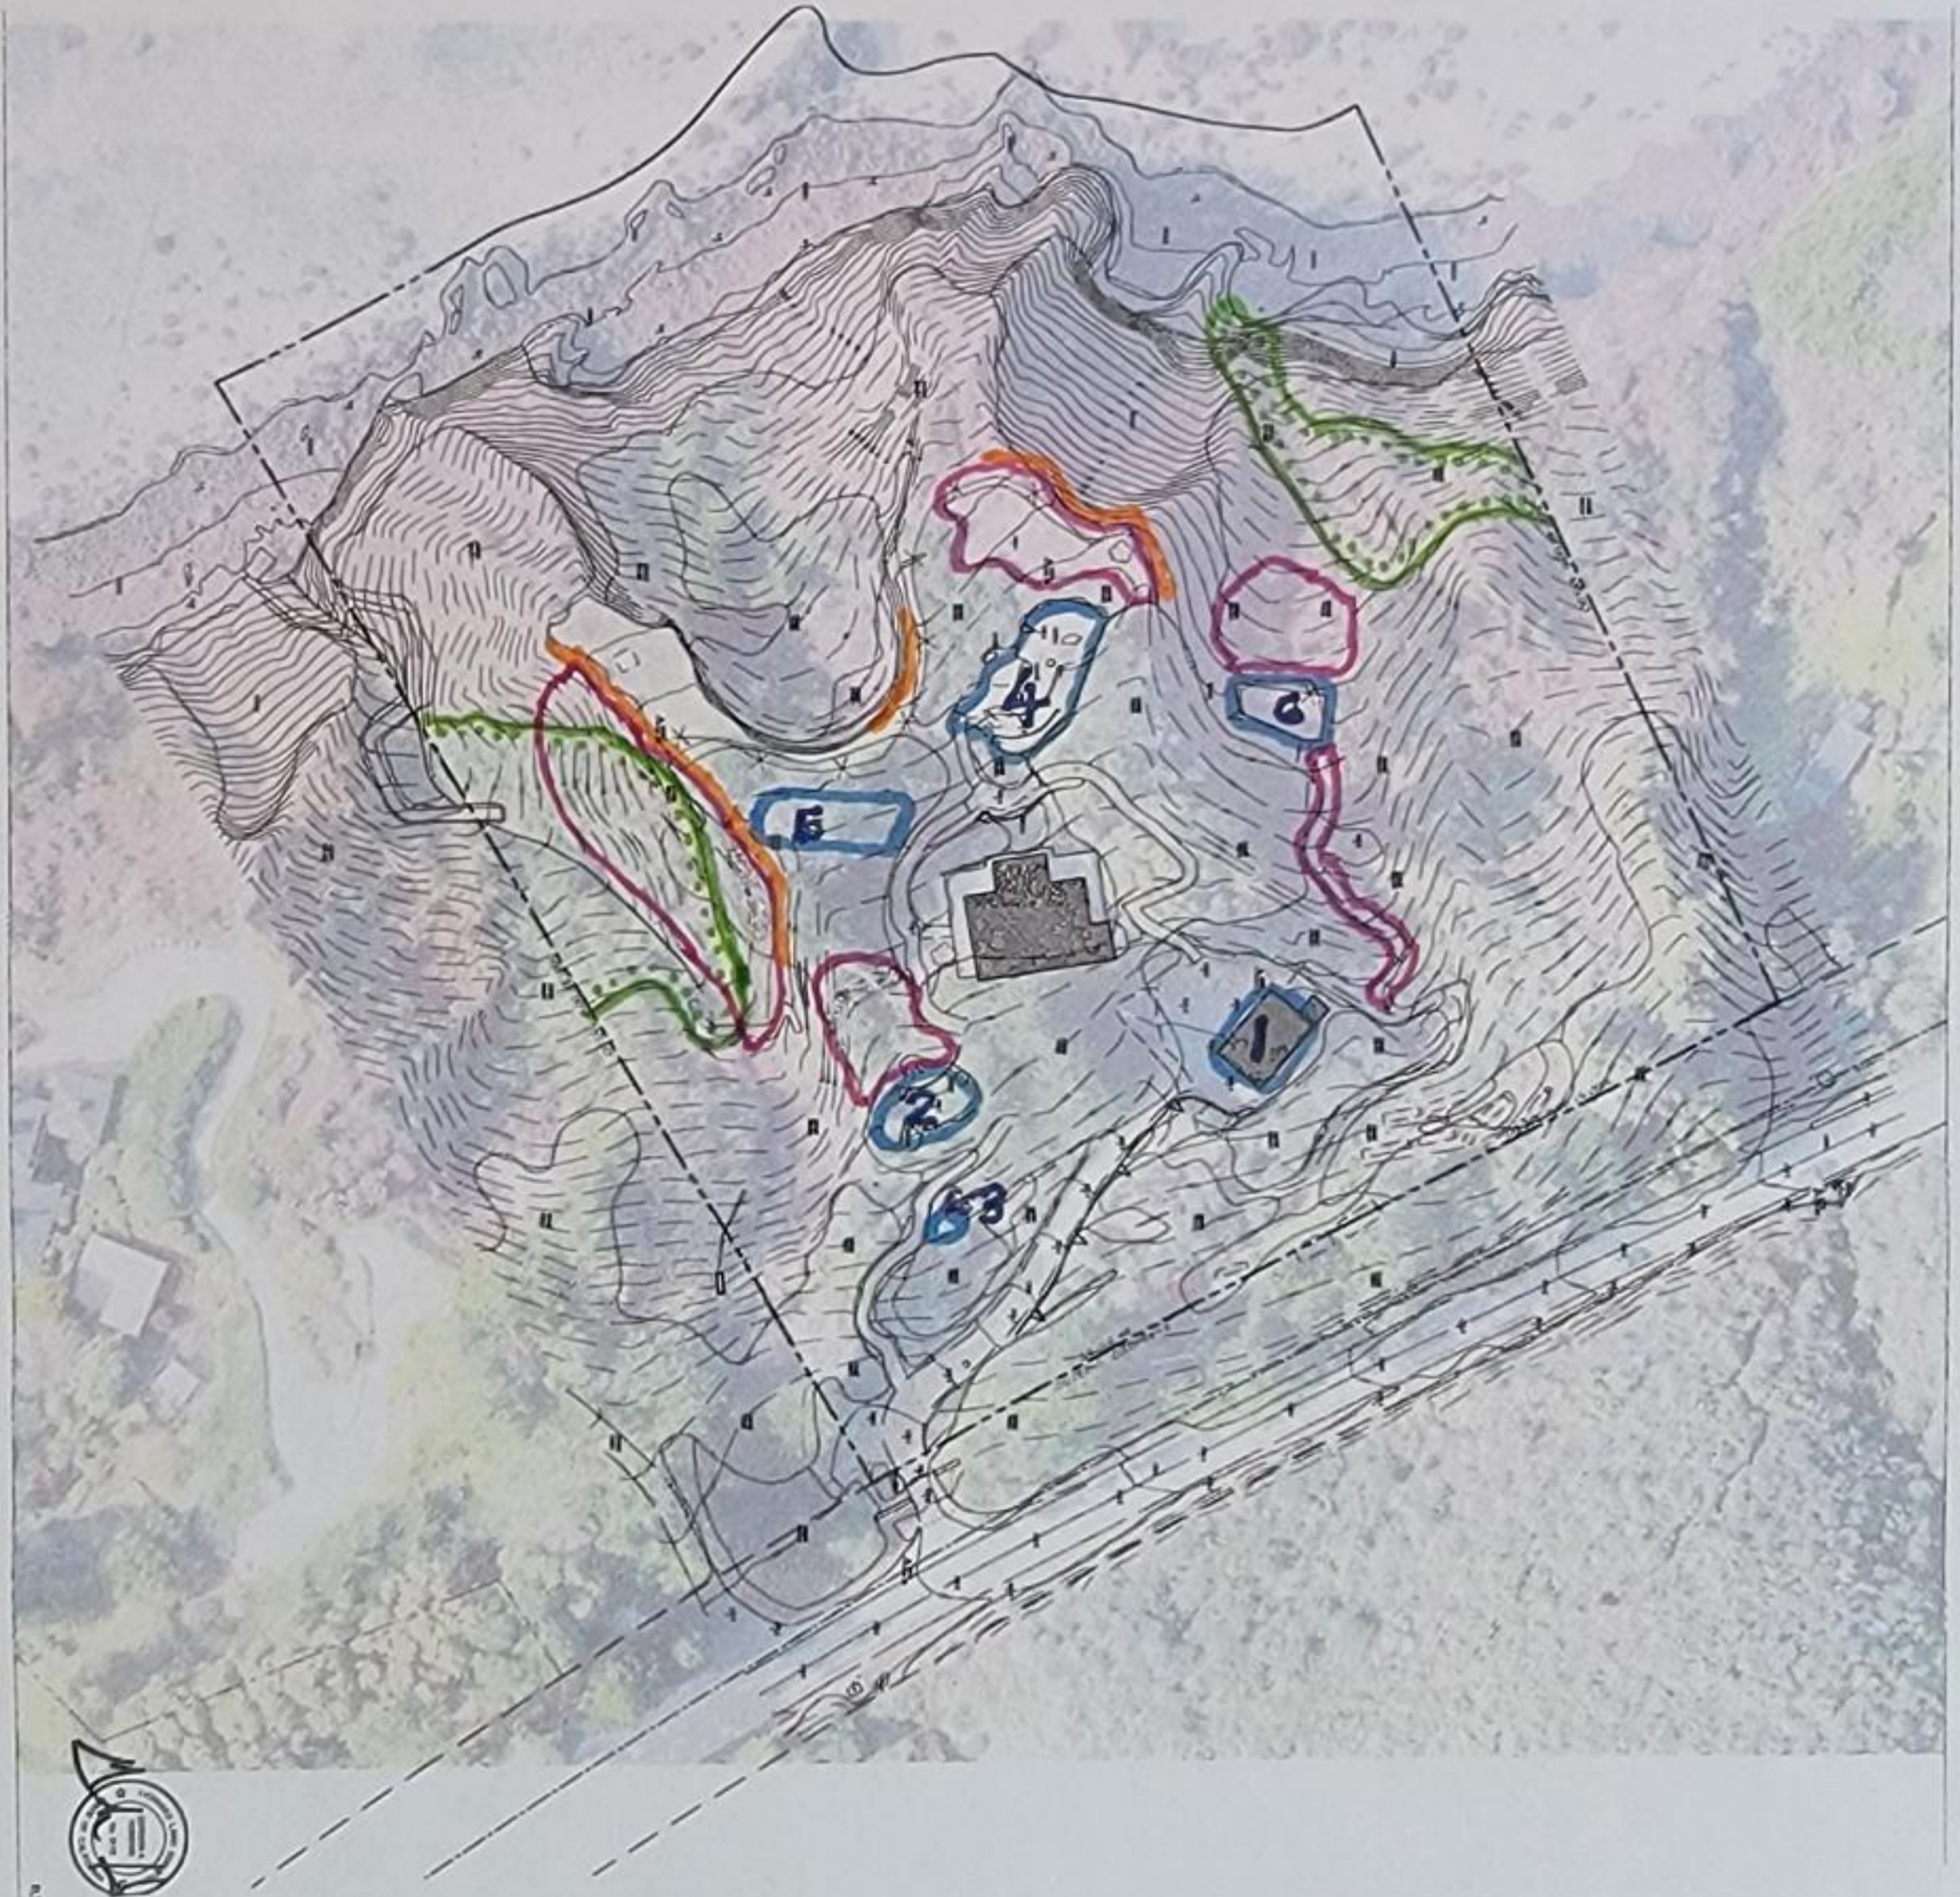
Primary restoration areas are outlined in magenta.

Restoration areas for planting of seacliff buckwheat (*Eriogonum parvifolium*) are shown as orange lines.
