This Phase II Historic Assessment has been prepared on your behalf as part of an application for additions & alterations to a listed historic residence. The subject property is located at 3360 Fifth Ave. (APN #009-162-029), in Carmel, Mo. Co. (see photos, plans & drawings provided).

Historical Background & Description

3360 Fifth Avenue-Carmel

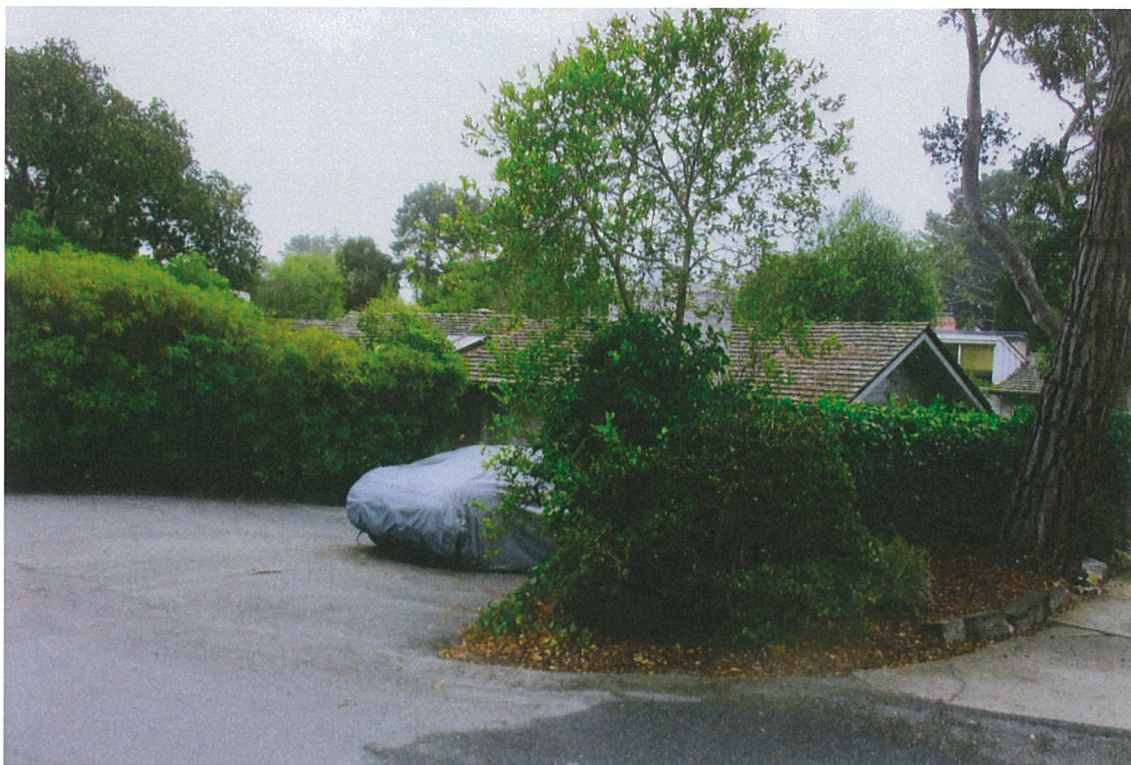
Photo #1. Looking SW at the entry drive to the subject property from Fifth Ave., Kent Seavey, October, 2024.

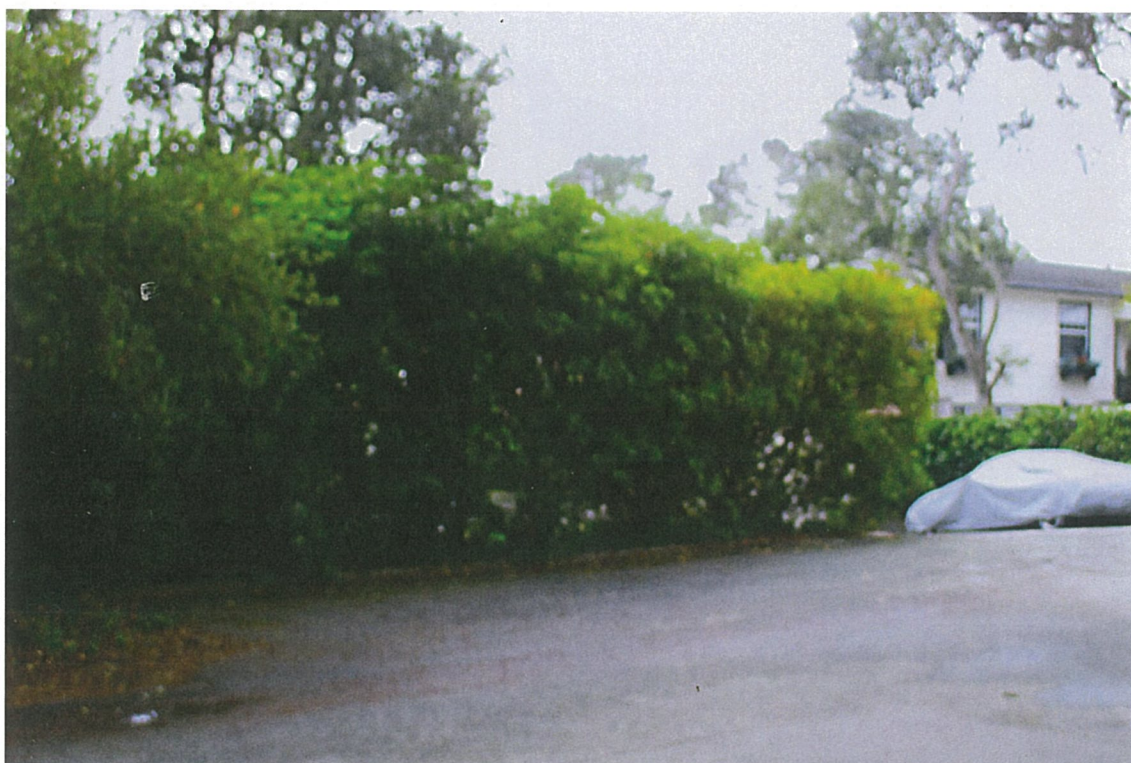
Photo#2. Looking South at the landscape setting of the Subject property, as seen from Fifth Ave., Kent Seavey, October, 2024.

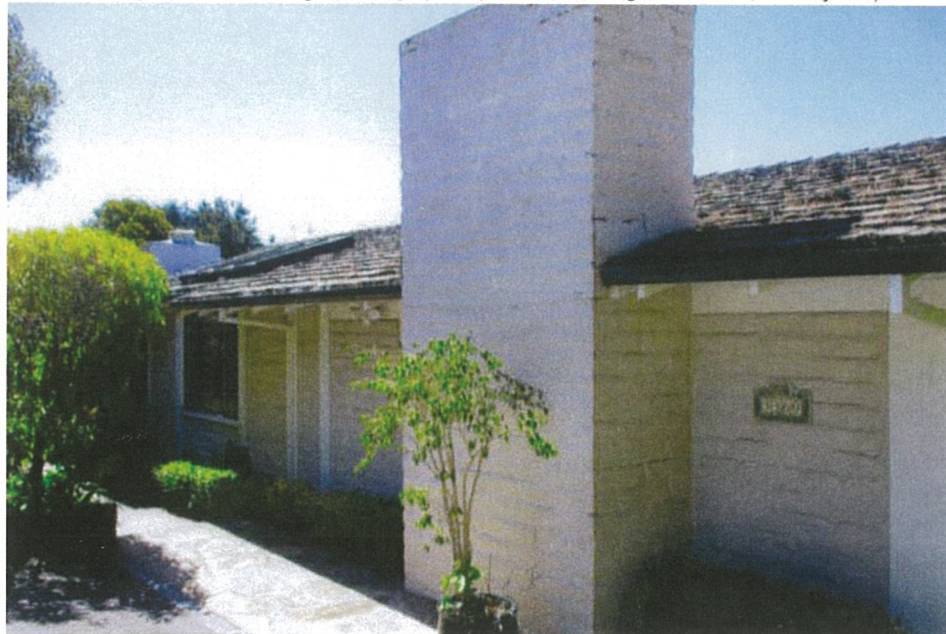
P5a. Photograph or Drawing (Photograph required for buildings, structures, and objects.)

A 1951 one-story Post-Adobe residence, irregular in plan resting on a concrete foundation. The side-gabled & hipped roof system has wide, overhanging eaves with exposed rafter-tails. There are three chimneys present. An eave-wall type just east of the front entrance on the North facing facade, one centered in the ridge line at the East end of the main living room, & one on the South wall of the master bedroom wing. All roof covering is in wood shake. Fenestration includes single, paired and banked multi-paned metal casement type windows. A full-height angled bay, with operable multi-paned metal windows, was added at the South side junction of the living-room wing & dining room c.1997. In c.1955 the original garage, off the West side-elevation was converted to living space. A detached art studio/two-car garage added at the South end of the property, 1953/55.

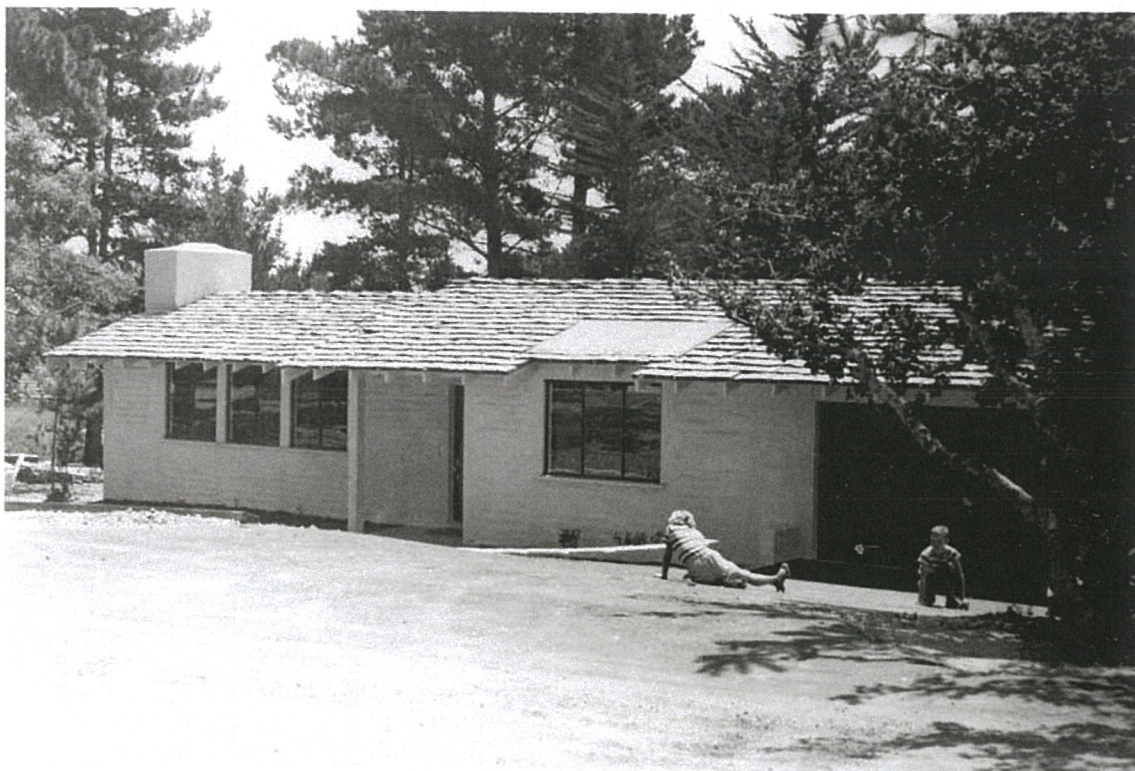
Photo #1, Looking SE at the North facing facade, 1951,
Photo attributed to Donald Teague.

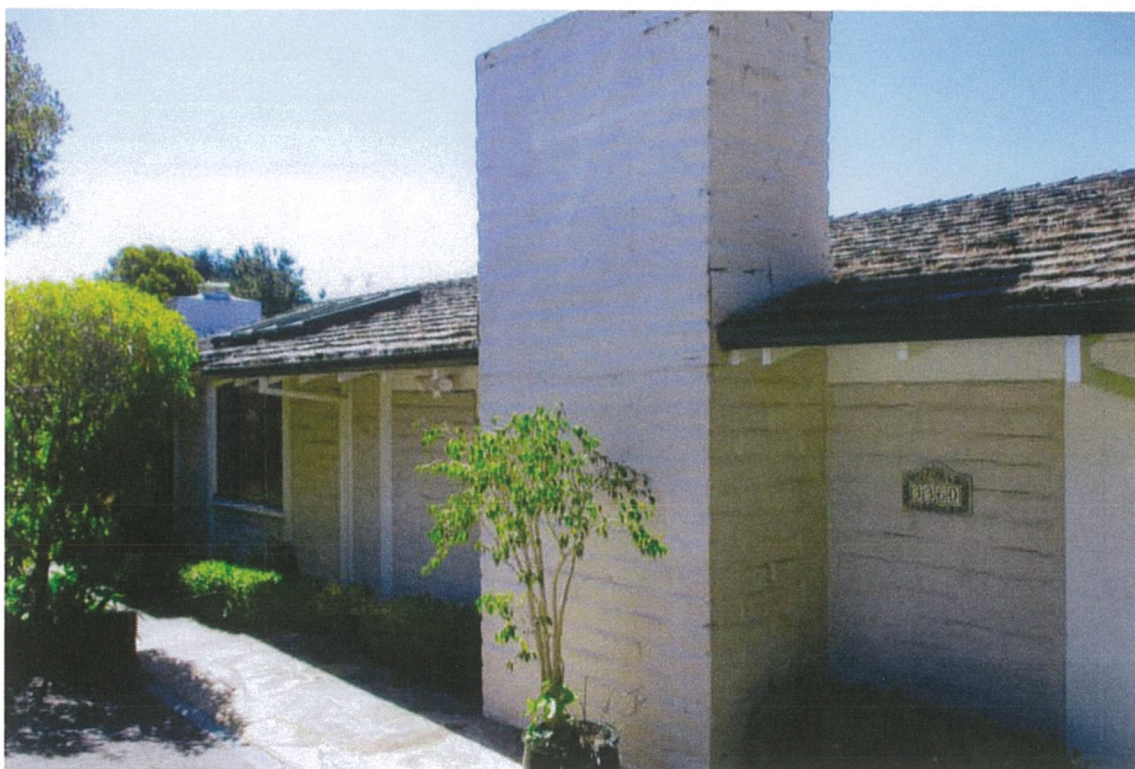
Photo #2, Looking SE at North facing facade, note c.1953 in fill of original
garage for bedroom space, Kent Seavey, December, 2022.

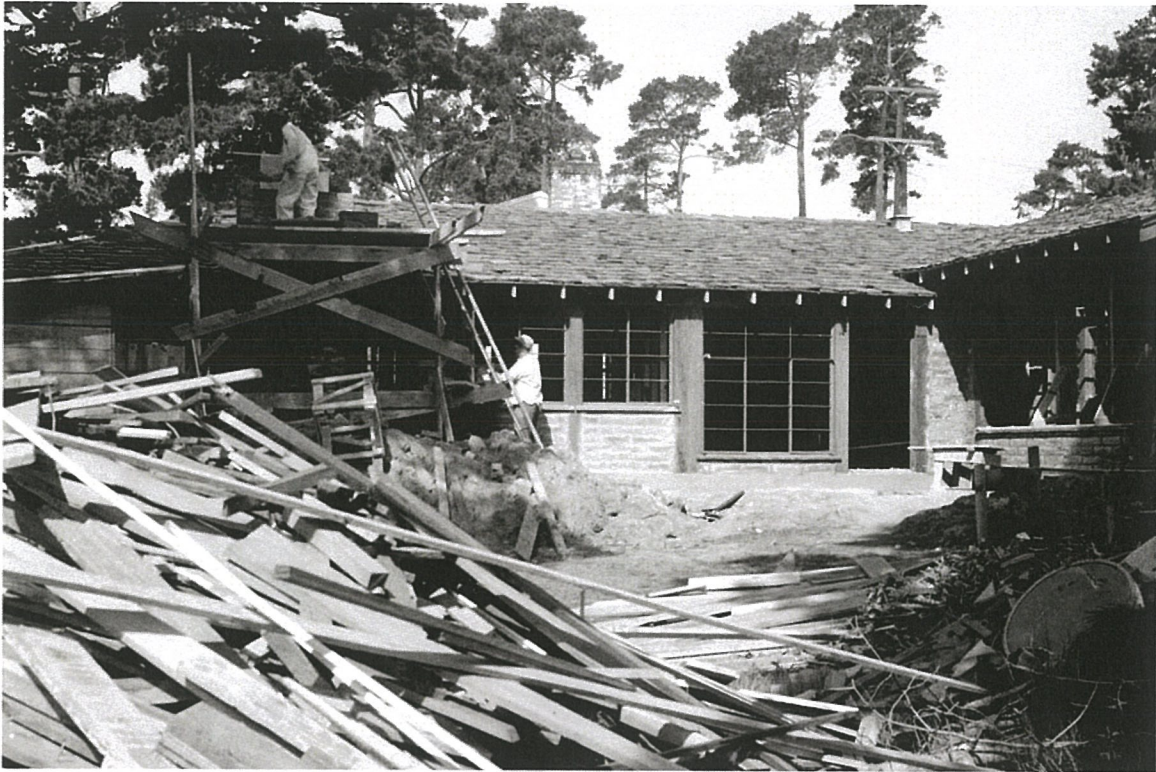
Photo #3. Looking North at the South side-elevation, note original door at right, chimney at left being built, Donald Teague photo, 1951.

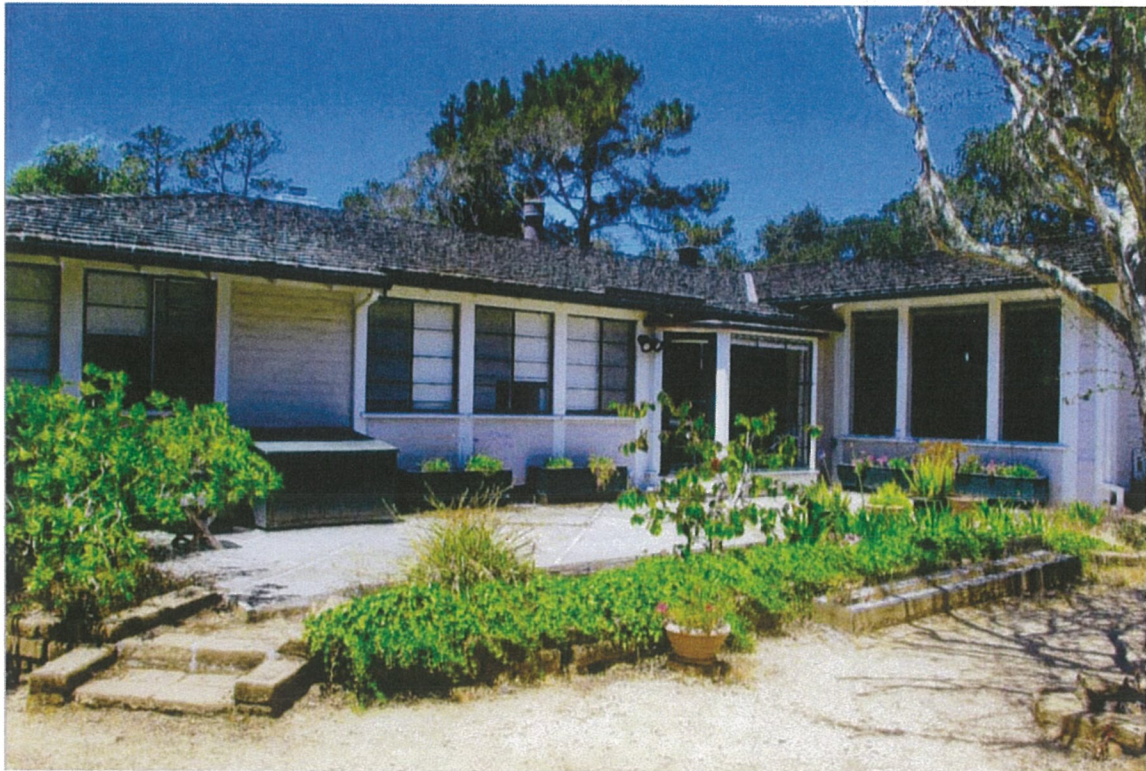
Photo #4. Looking NE at the South side elevation, note angled c. 2007 bay to right & c. 2003 in filled chimney at left, Kent Seavey, Dec., 2022.

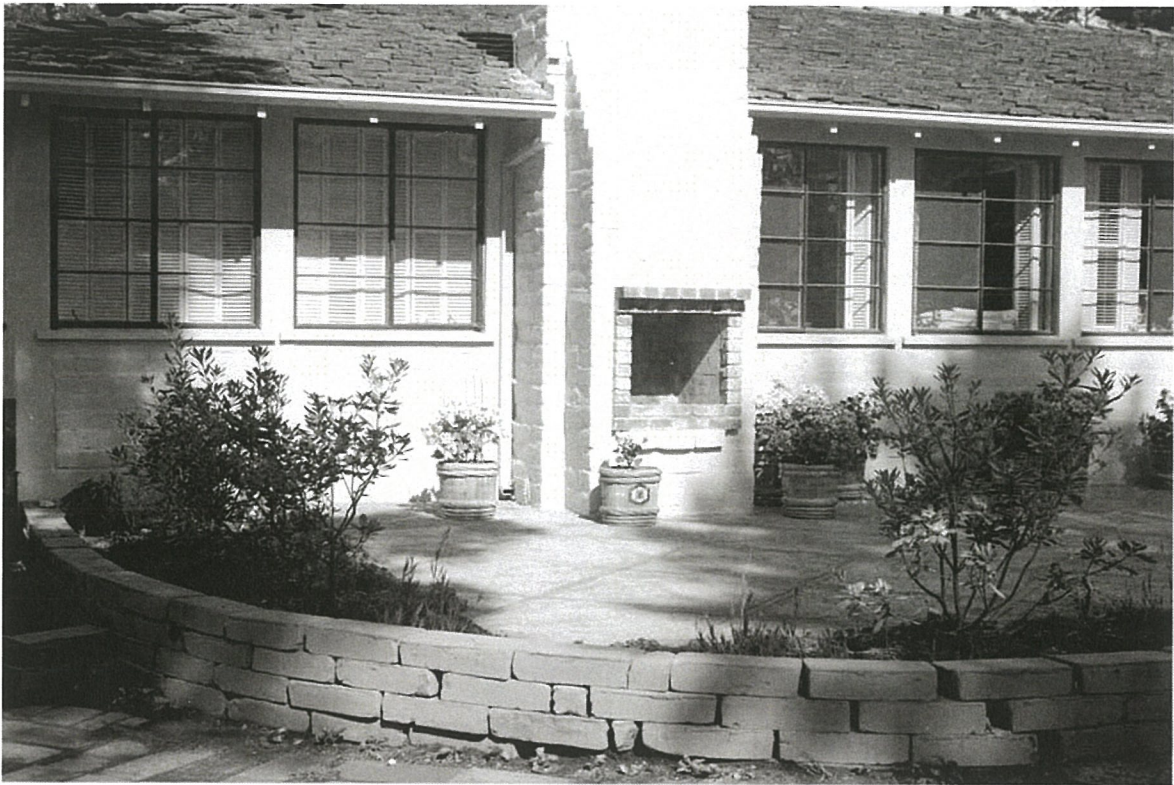
Photo #5. Looking North at original pass through chimney box on South side elevation, Donald Teague photo, 1951.

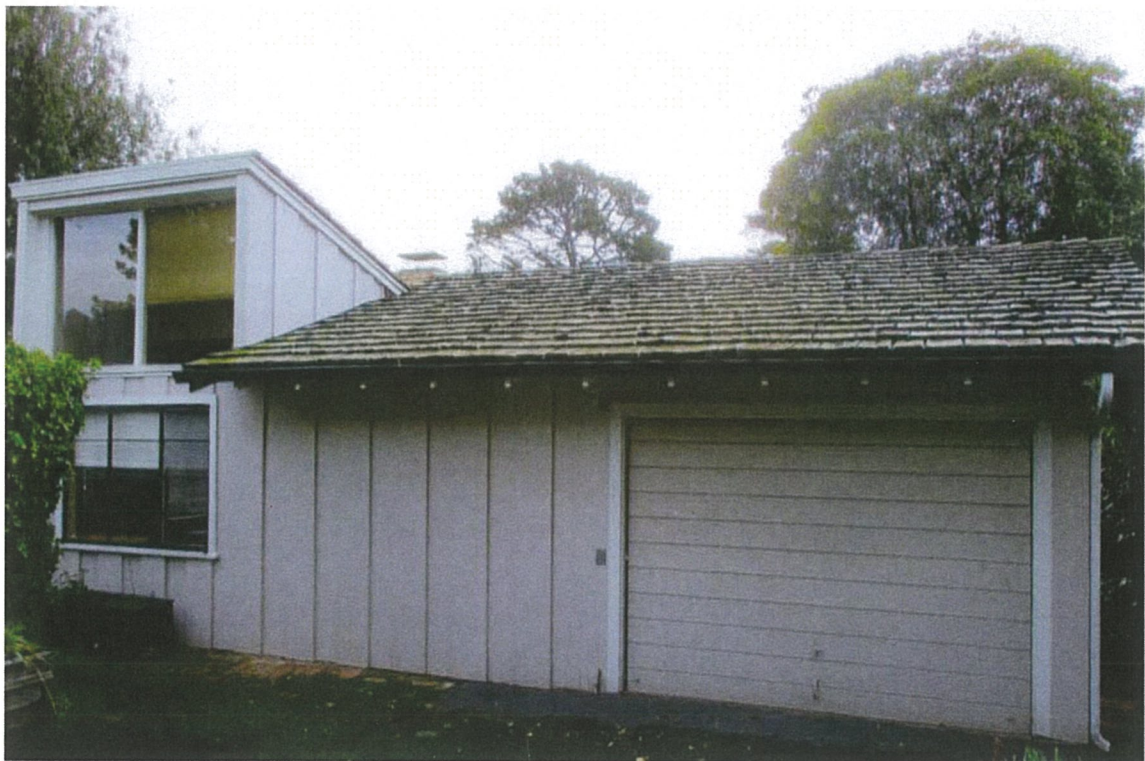
Photo #6. Looking SE at the c.1953 Art studio, left and new garage, right, Kent Seavey, December, 2022.
