**Before the Housing and Community Development Chief of Planning
in and for the County of Monterey, State of California**

ZAMORA-ROCHA ARTURO ADRIAN ET AL (PLN230099)

RESOLUTION NO. 24-009

RESTORATION PERMIT TO PARTIALLY CLEAR CODE ENFORCEMENT VIOLATION (23CE00097) FOR THE RESTORATION OF UNPERMITTED GRADING ON SLOPE GRATER THAN 25%; GRADING OF APPROXIMATELY 140 CUBIC YARDS OF CUT AND 130 CUBIC YARDS OF FILL AND VEGETATION REMOVAL. THE PROPERTY IS LOCATED AT 193 AND 195 STRAWBERRY ROAD, ROYAL OAKS (ASSESSOR'S PARCEL NUMBER 129-261-013-000), NORTH COUNTY LAND USE PLAN, COASTAL ZONE.

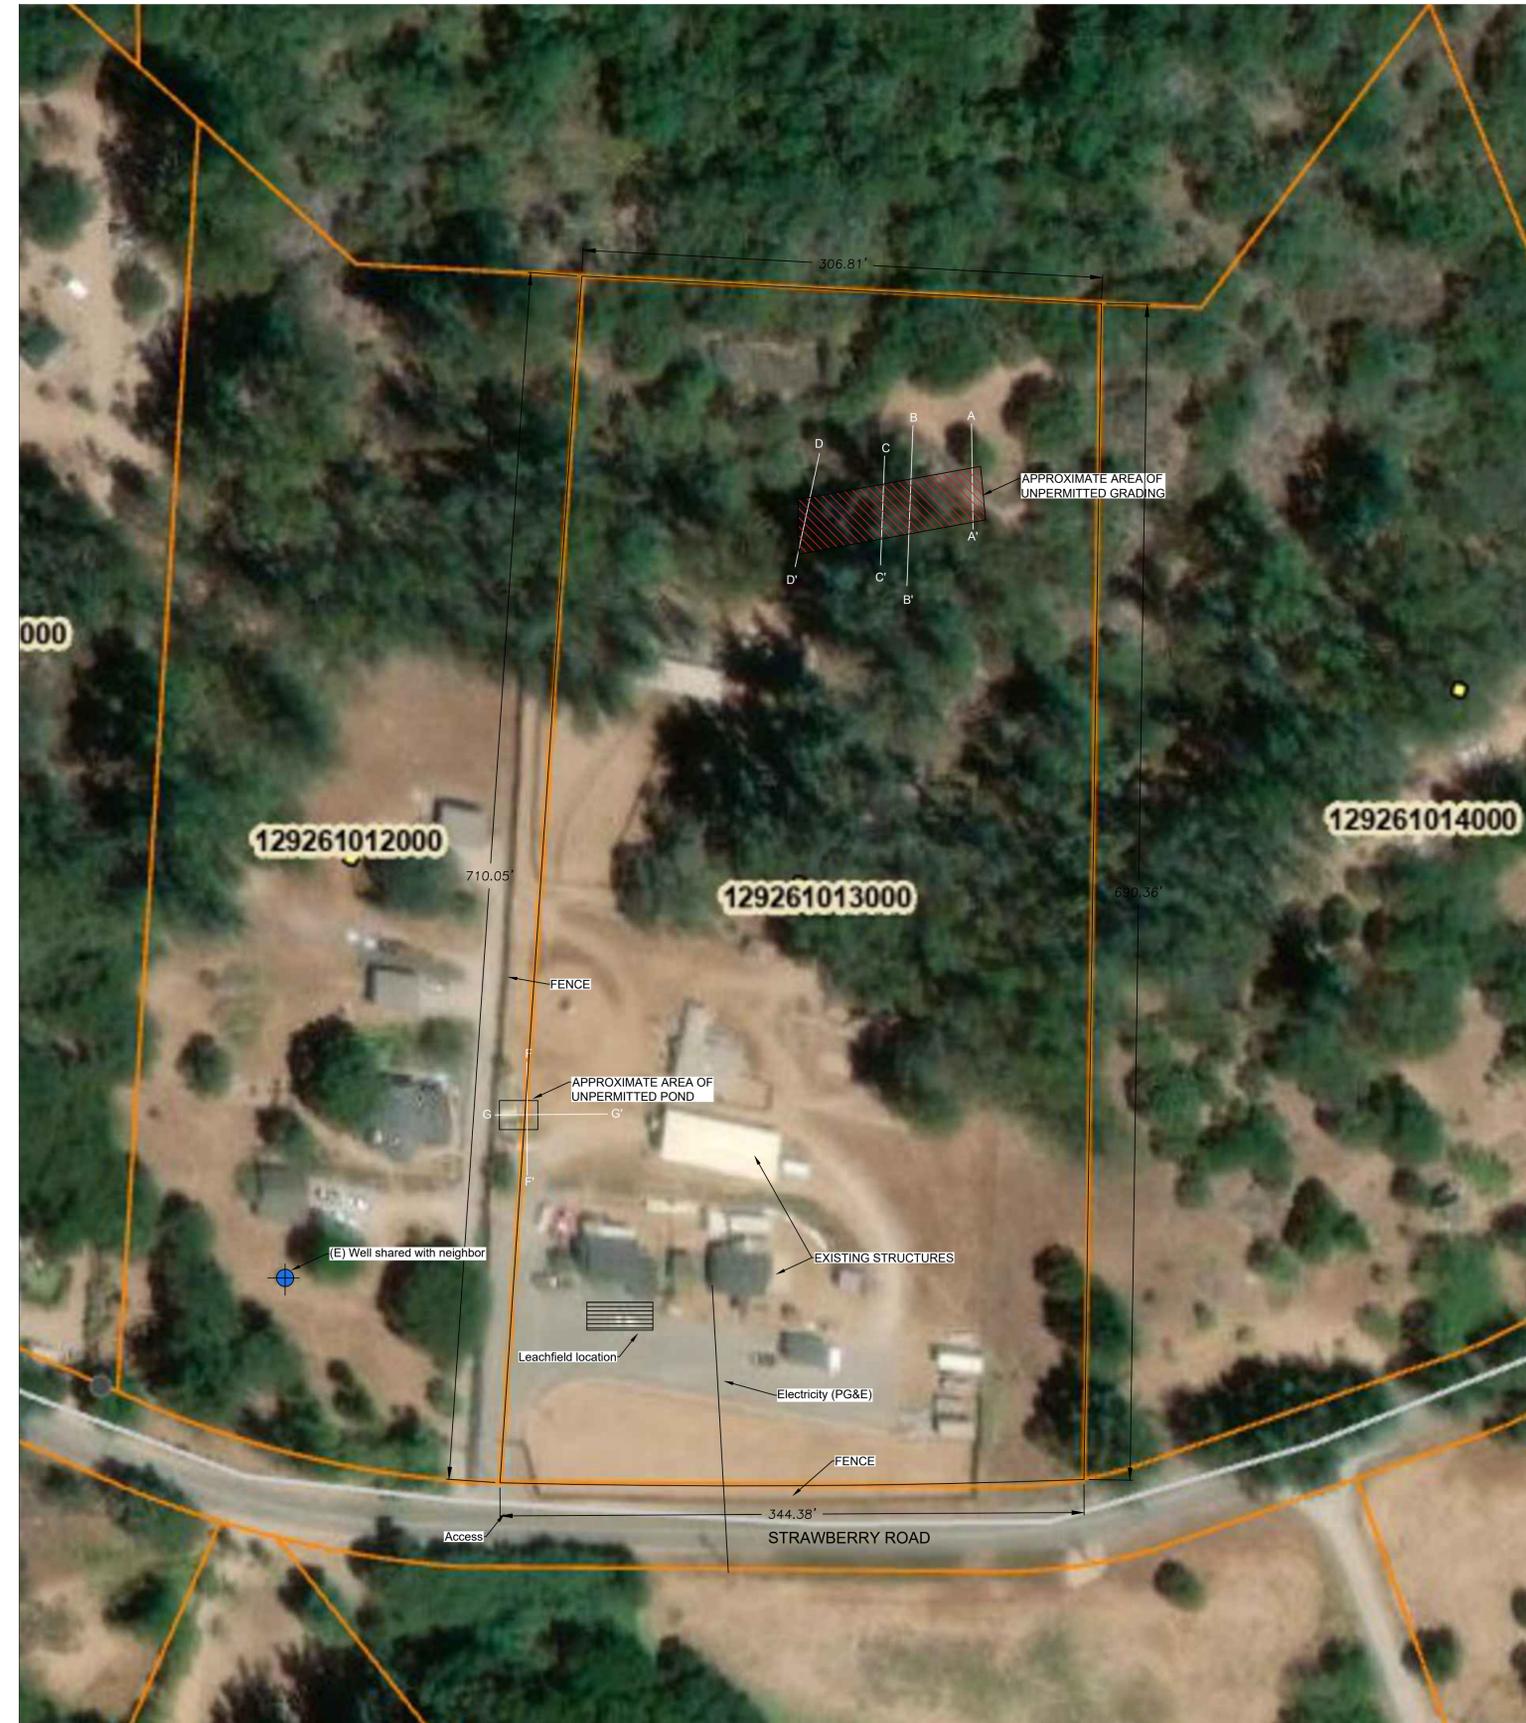
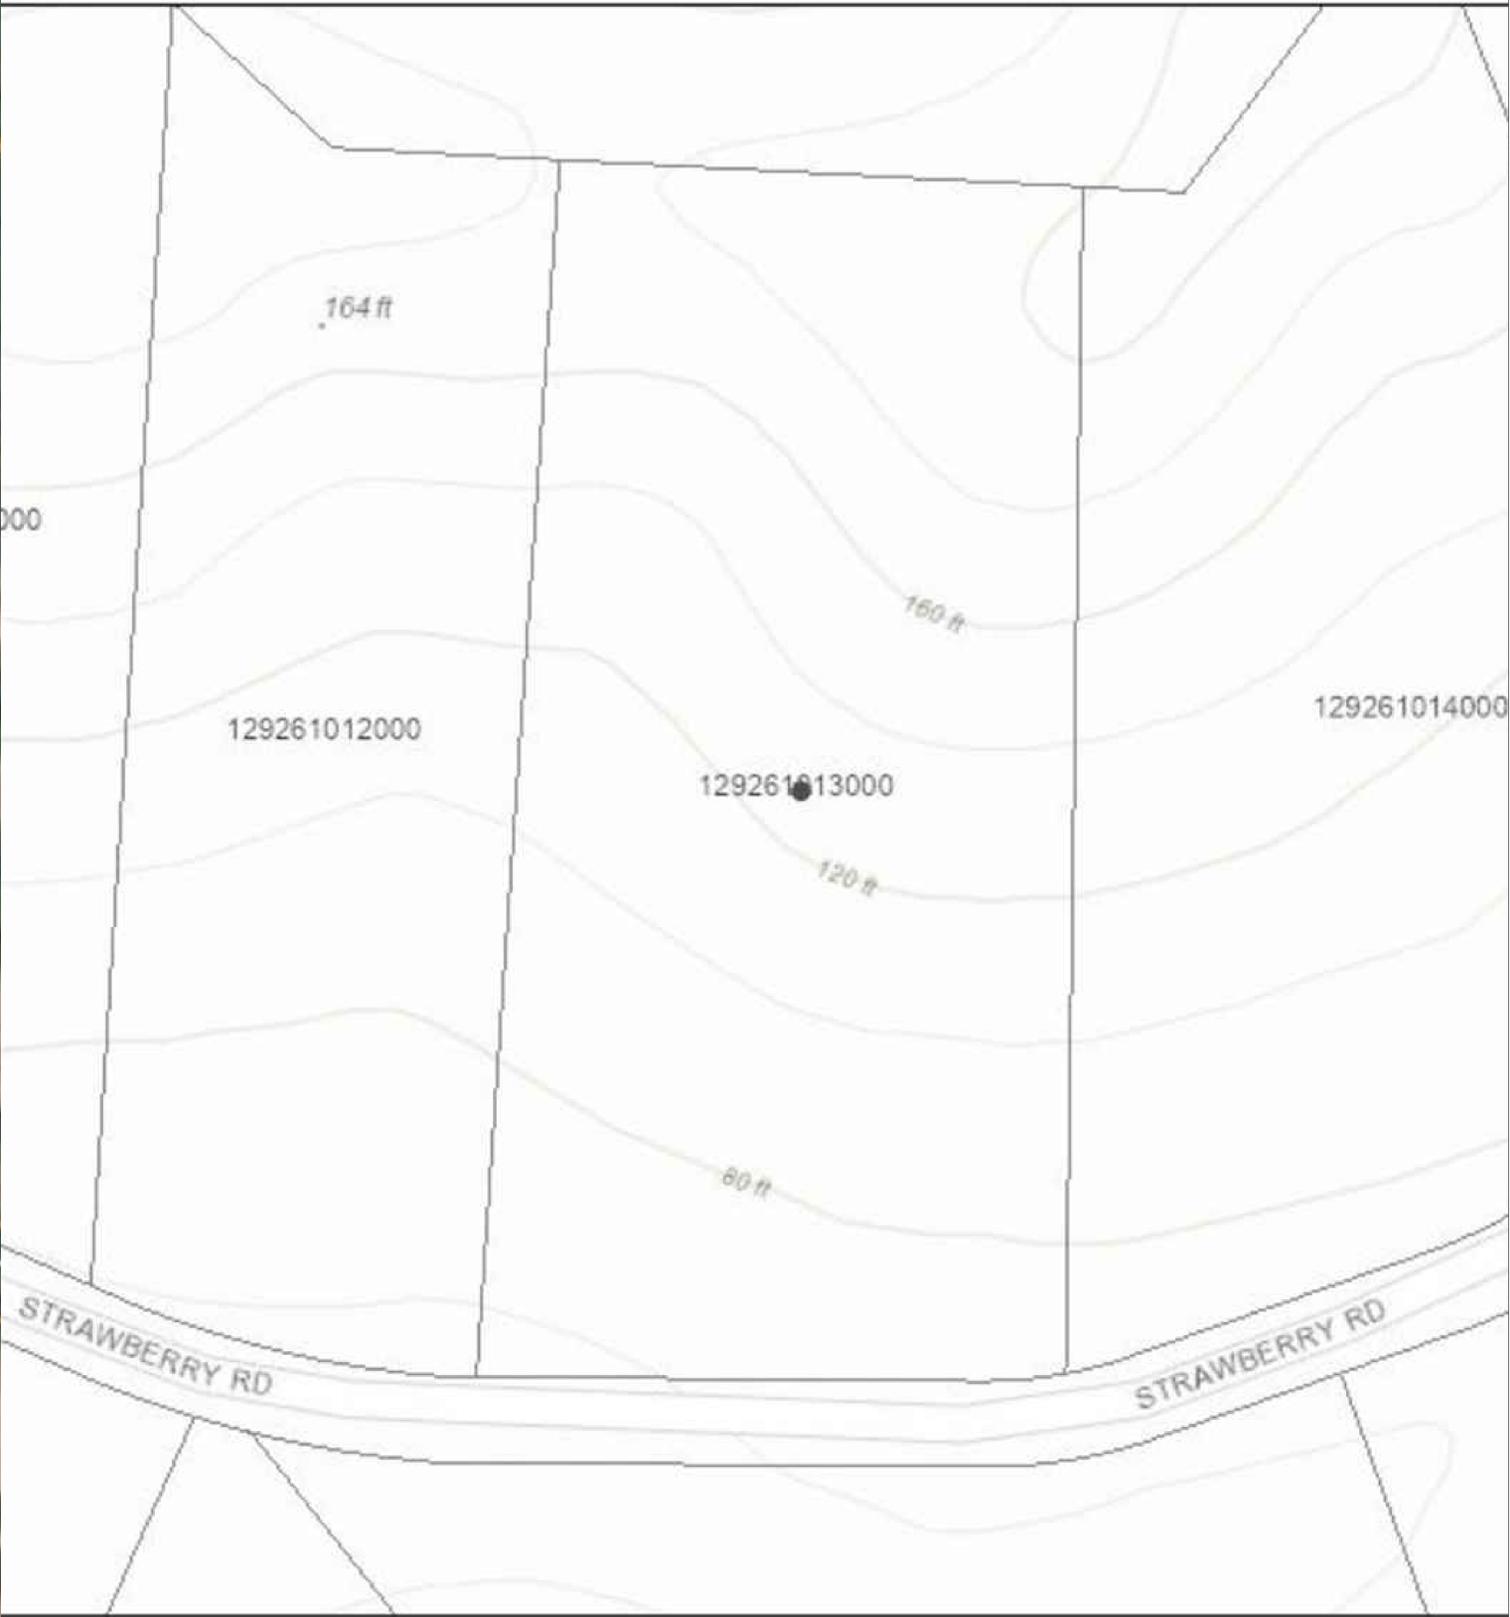
C1

- NOTES:
1. BASE MAP FROM GOOGLE EARTH PRO
 2. CROSS SECTIONS LOCATIONS APPROXIMATE FROM MEASUREMENTS IN THE FIELD USING HANDHELD LASER LEICA DISTO.
 3. TOPOGRAPHIC MAP FROM MONTEREY COUNTY GIS

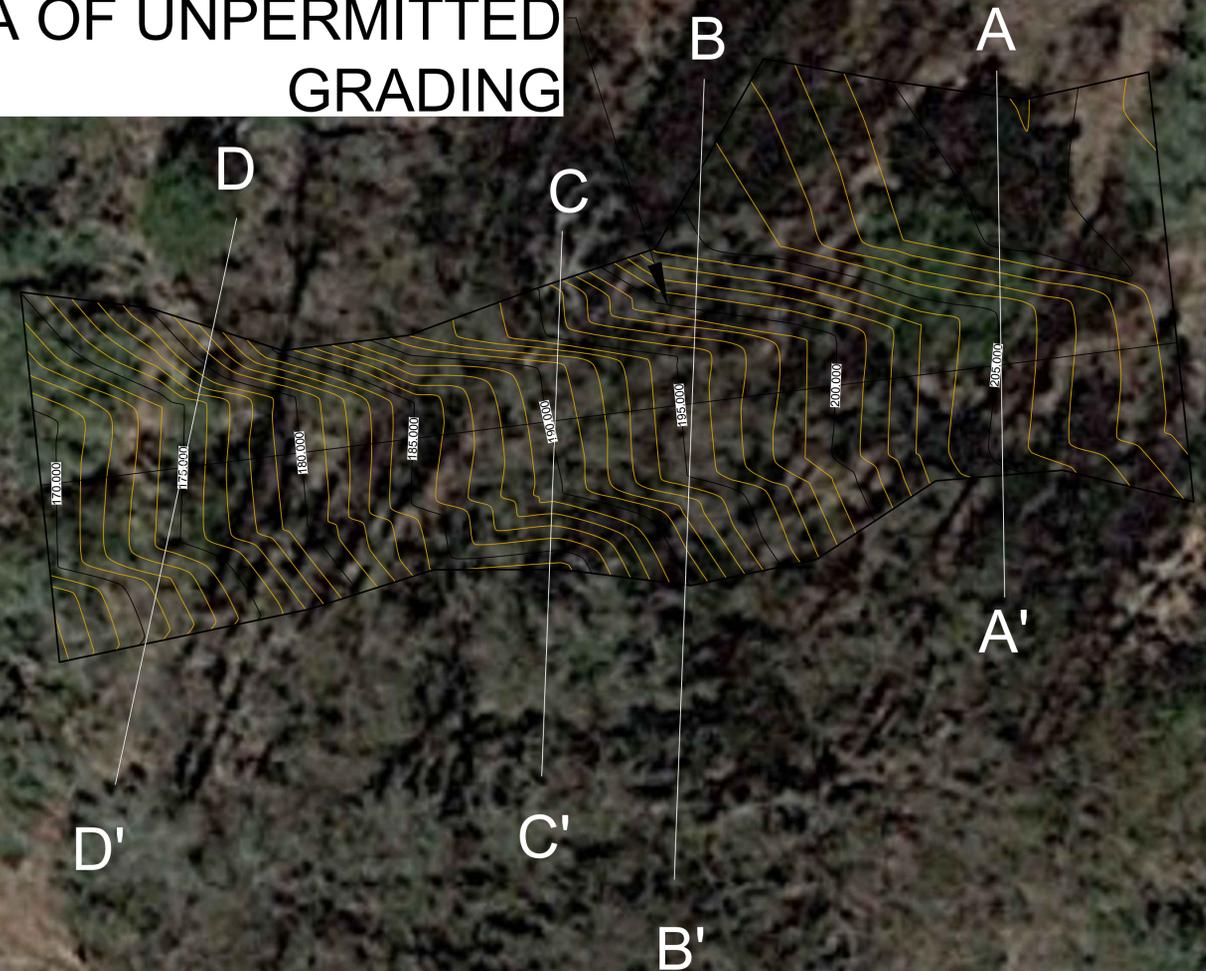
C-2

AREA OF UNPERMITTED GRADING

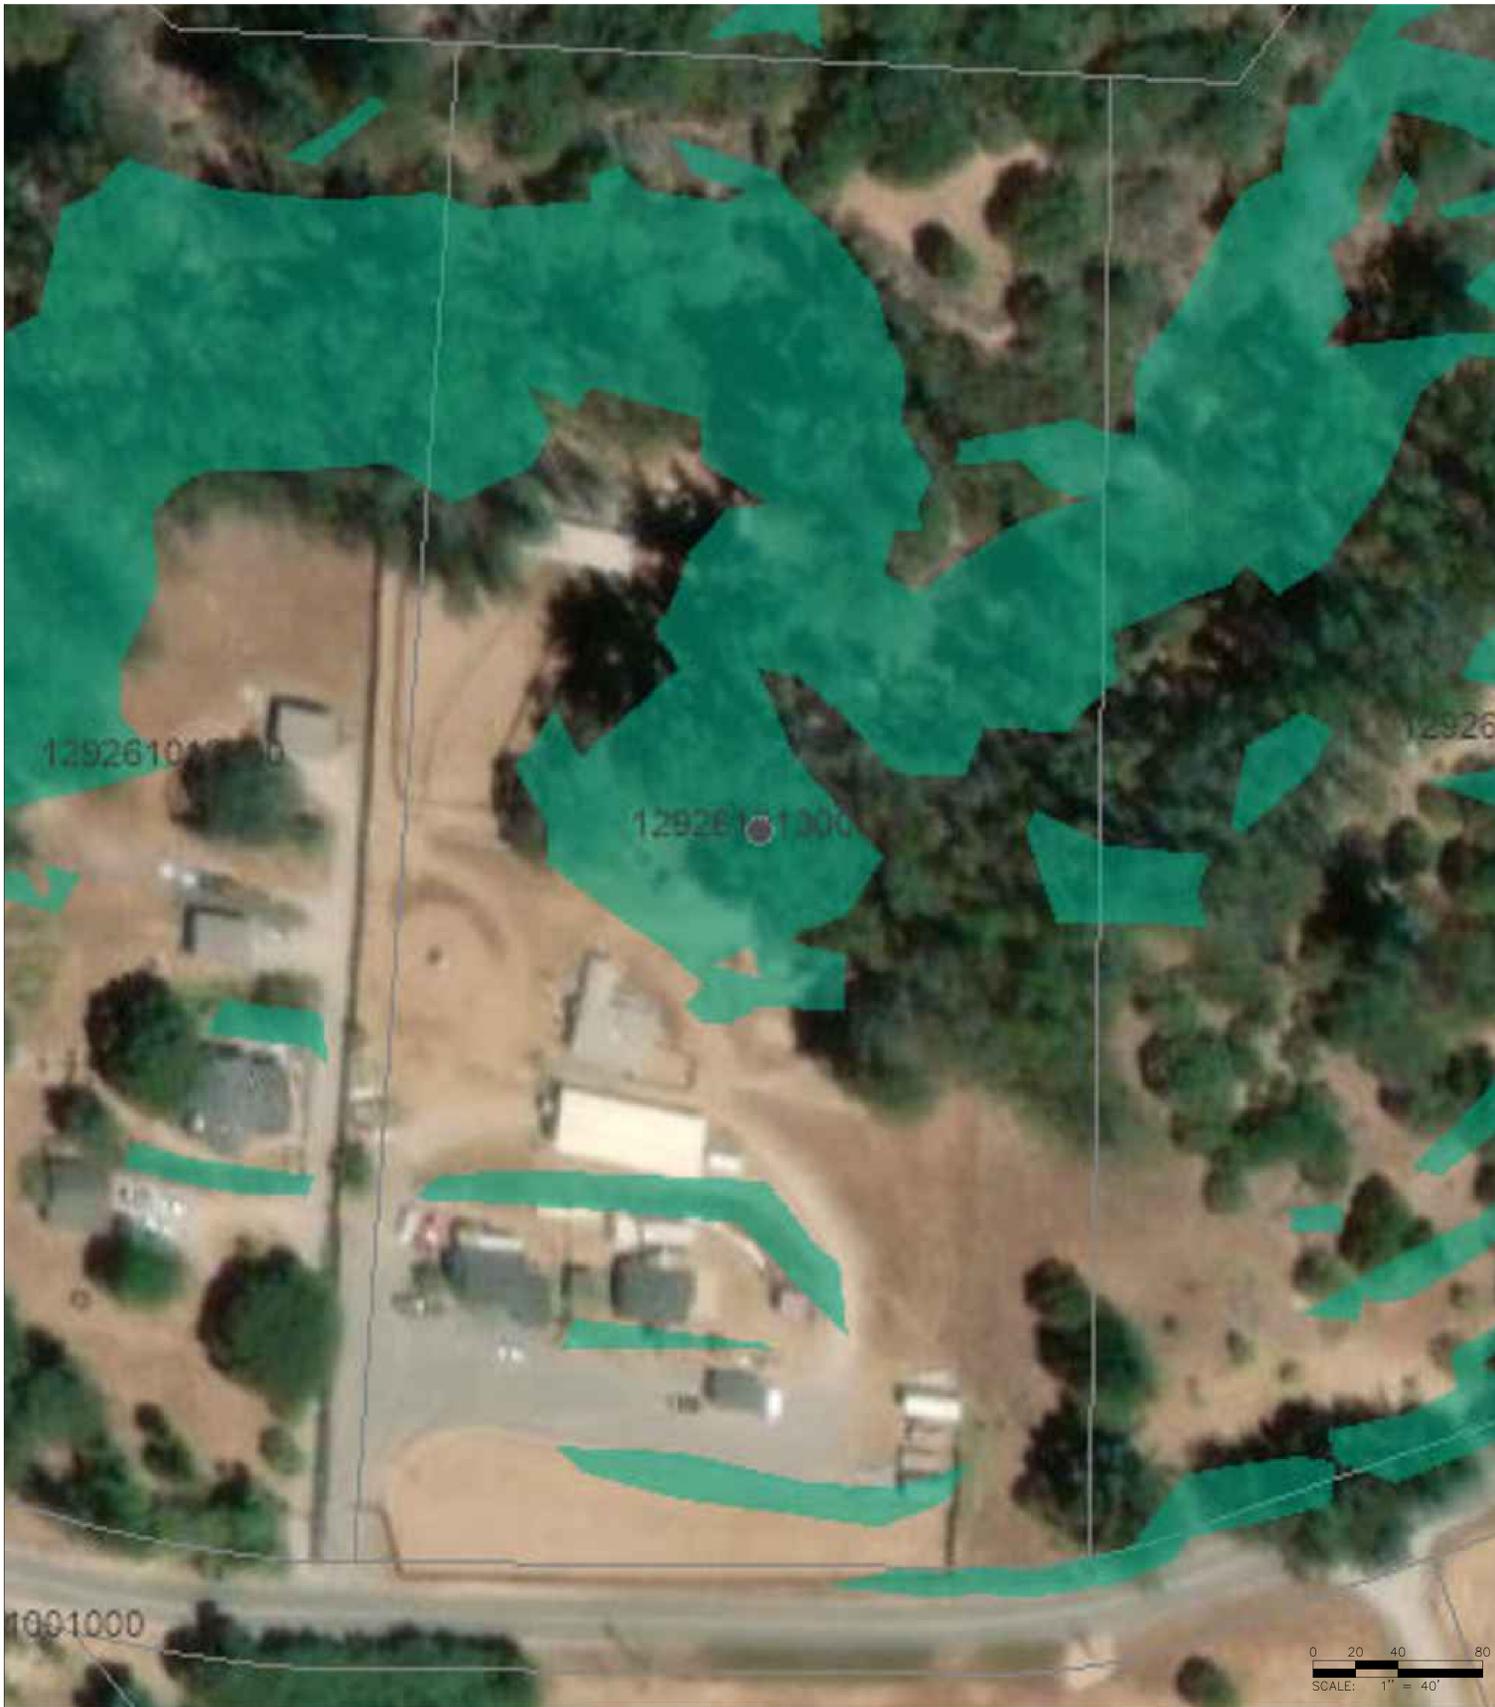
SLOPE / DENSITY CALCULATION
 0-19.9% slope, 1 building per 1 acre.
 20-29.9% slope, 1 building per 2 acres.
 Parcel is 5.26 acres = 2 buildings fro 20-29%
 and 5 for 0-19%, 3.5 blds average

- NOTES:
 1. BASE MAPS FROM GOOGLE EARTH PRO AND MONTEREY COUNTY GIS
 2. CONTOURS GENERATED FROM CROSS SECTIONS SURVEYED, USING CIVIL 3D

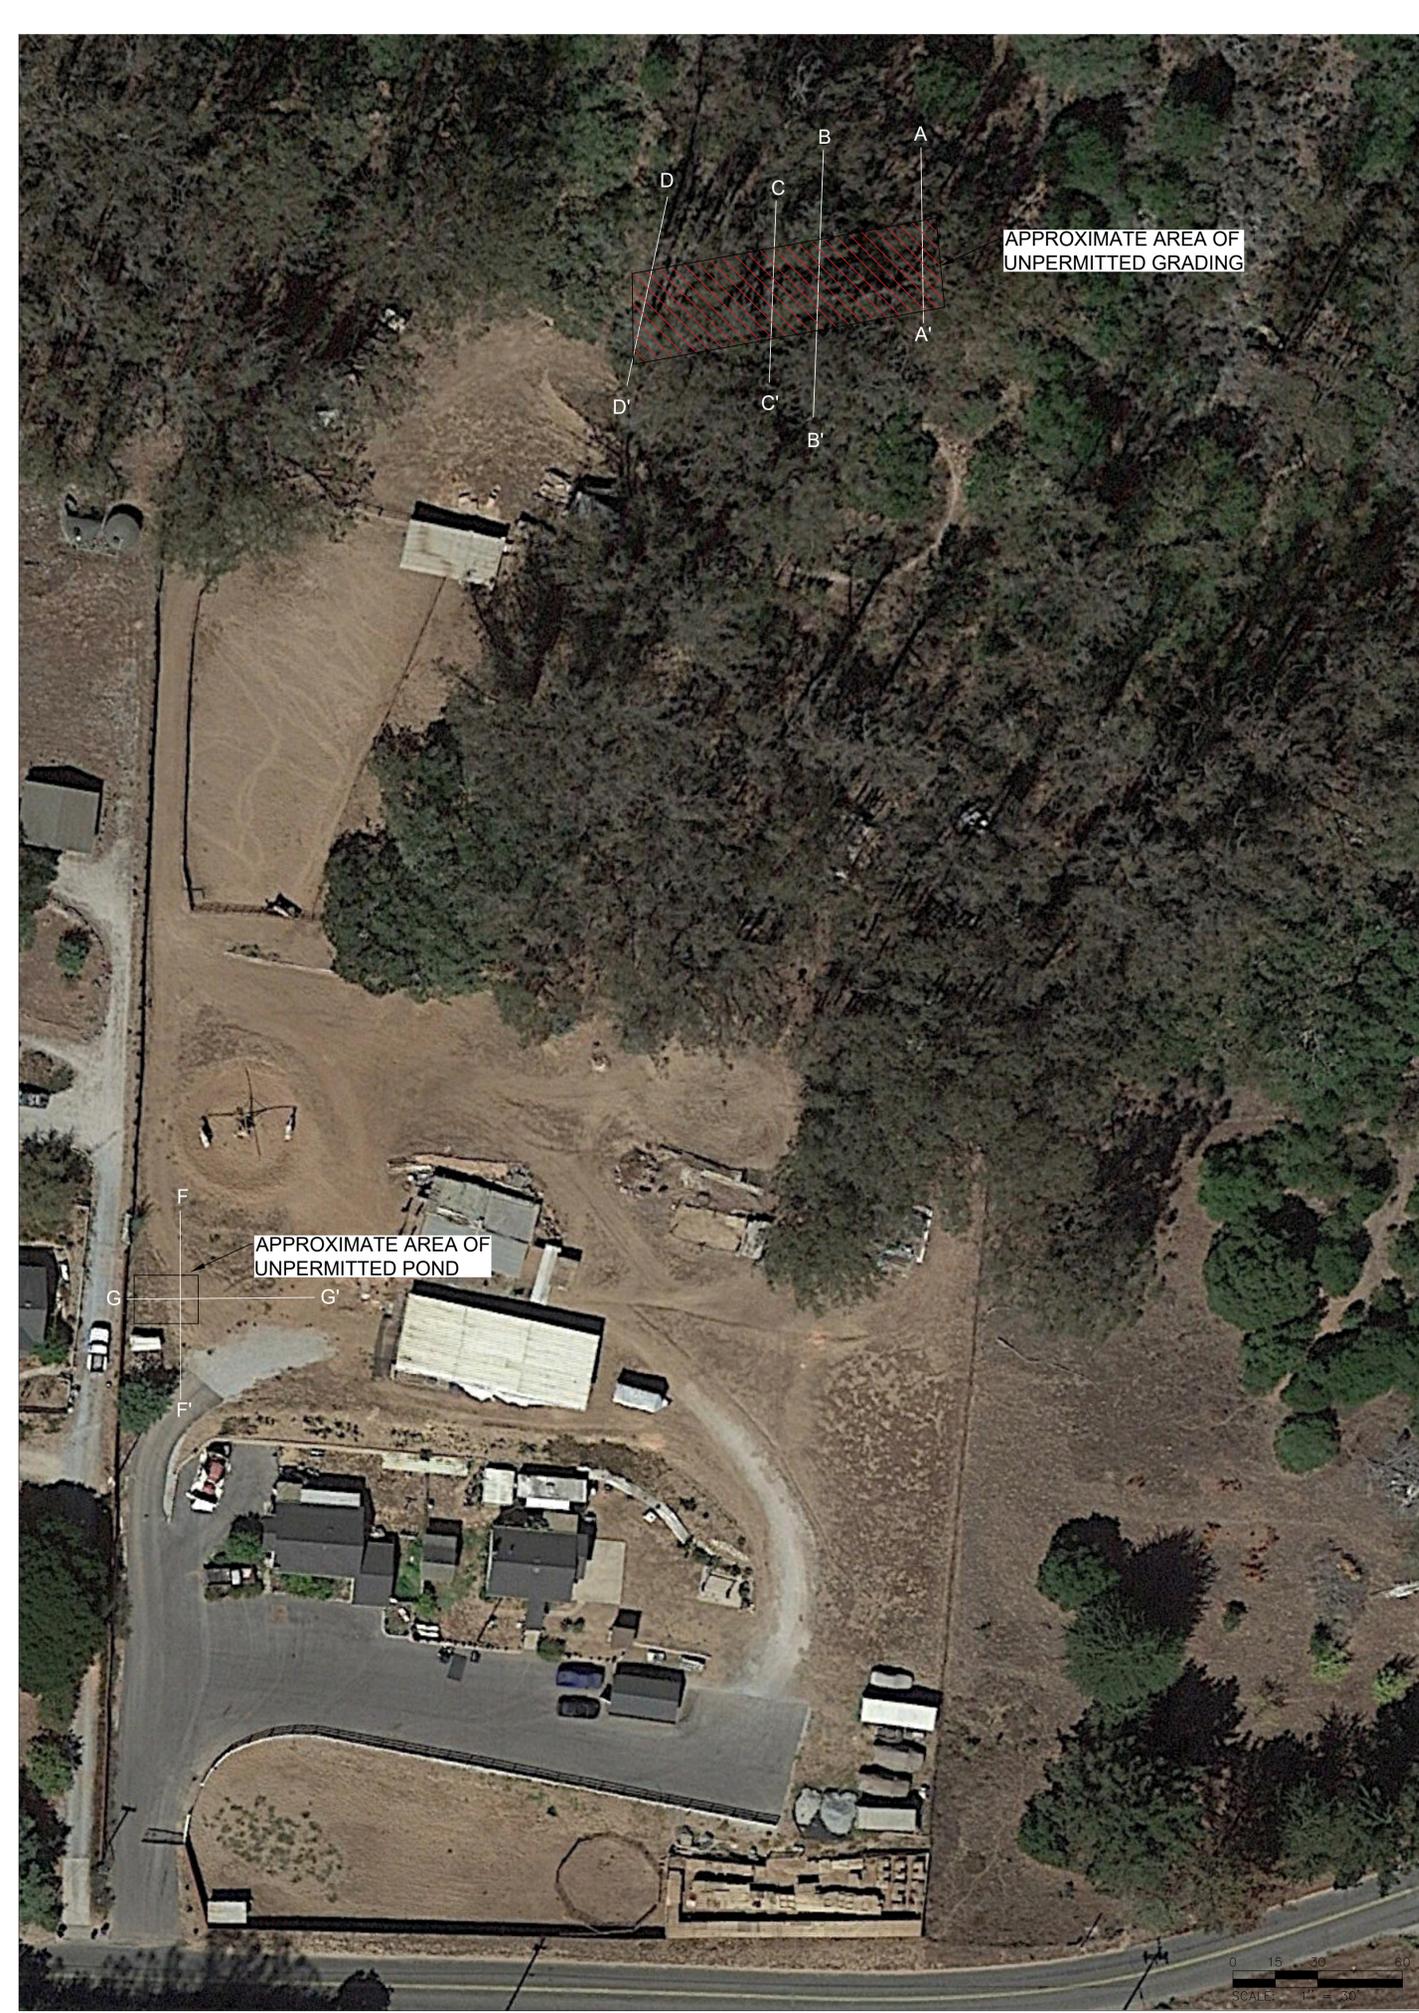
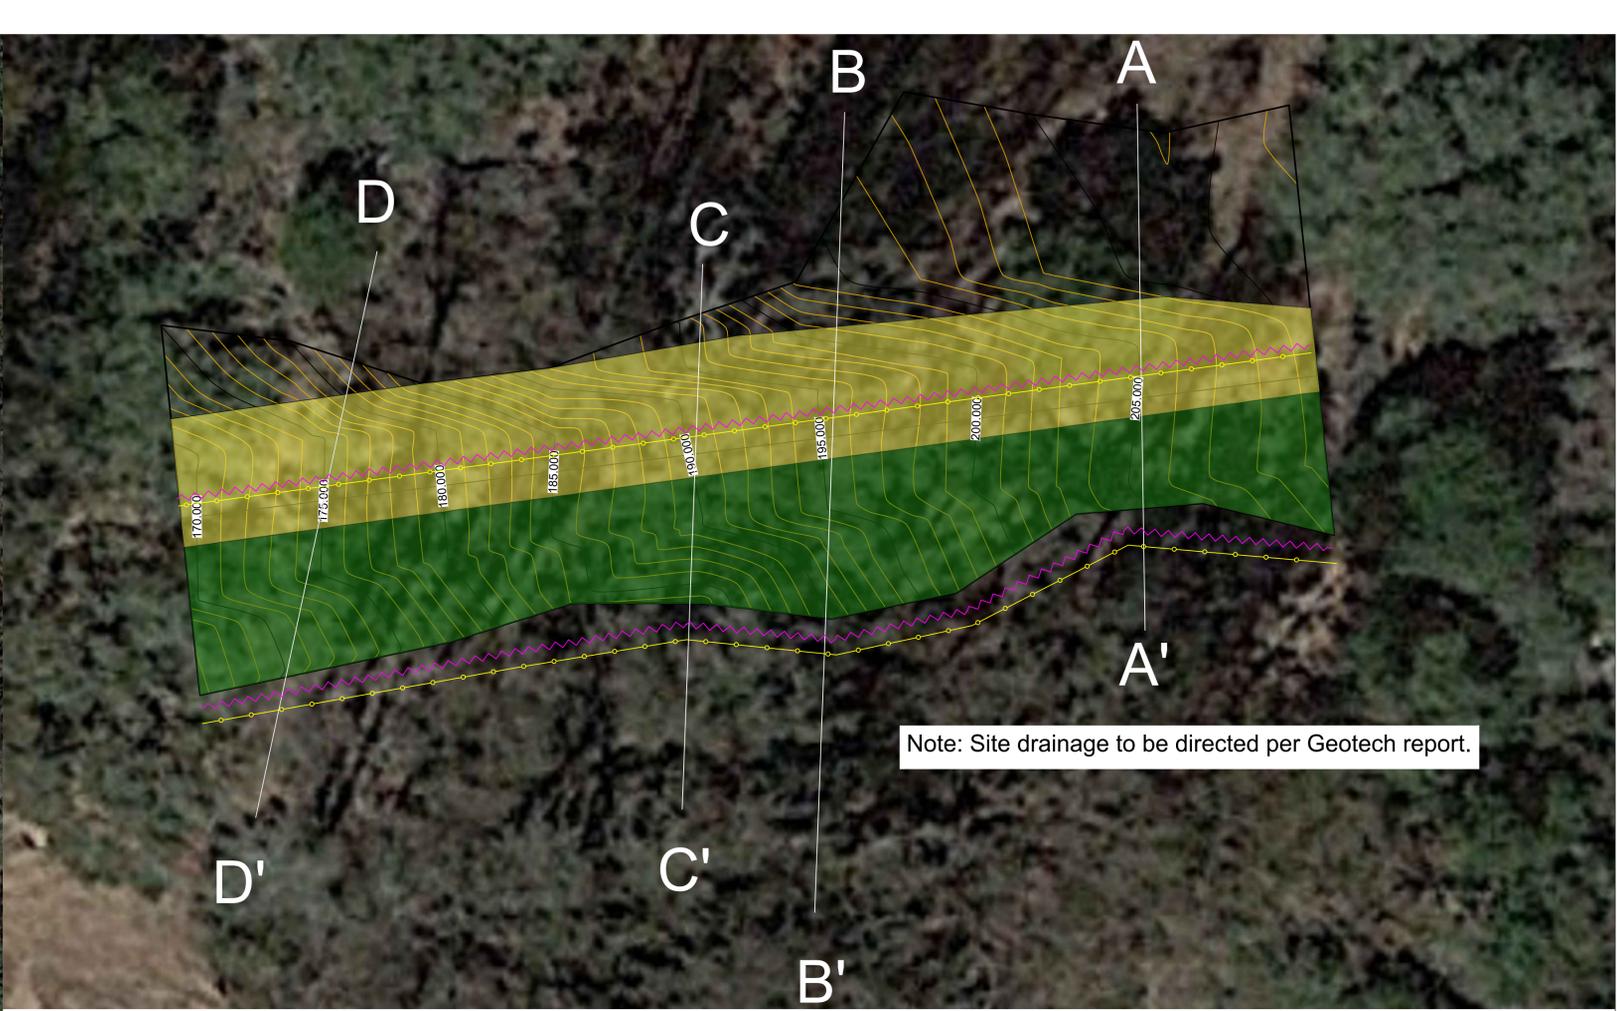
EXISTING CONTOURS AND PROPOSED RESTORATION GRADING

- To be Removed
 - To be backfilled
 - STRAW WADDLE
 - SILT FENCE
- Note: The contours are existing slope conditions.

EXISTING BIOLOGICAL CONDITIONS:
 A BIOLOGICAL CONSULTANT INSPECTED IF ANY LIVING MANZANITA PLANTS WERE REMOVED DURING THE GRADING. HIS CONCLUSIONS WERE THAT NO EVIDENCE OF LIVING MANZANITA SHRUBS WERE REMOVED AND JUST DEAD MANZANITA WOOD WAS REMOVED FOR THE PURPOSE OF FIRE SAFETY. FOR THIS REASON, A REVEGETATION PLAN IS NOT REQUIRED.

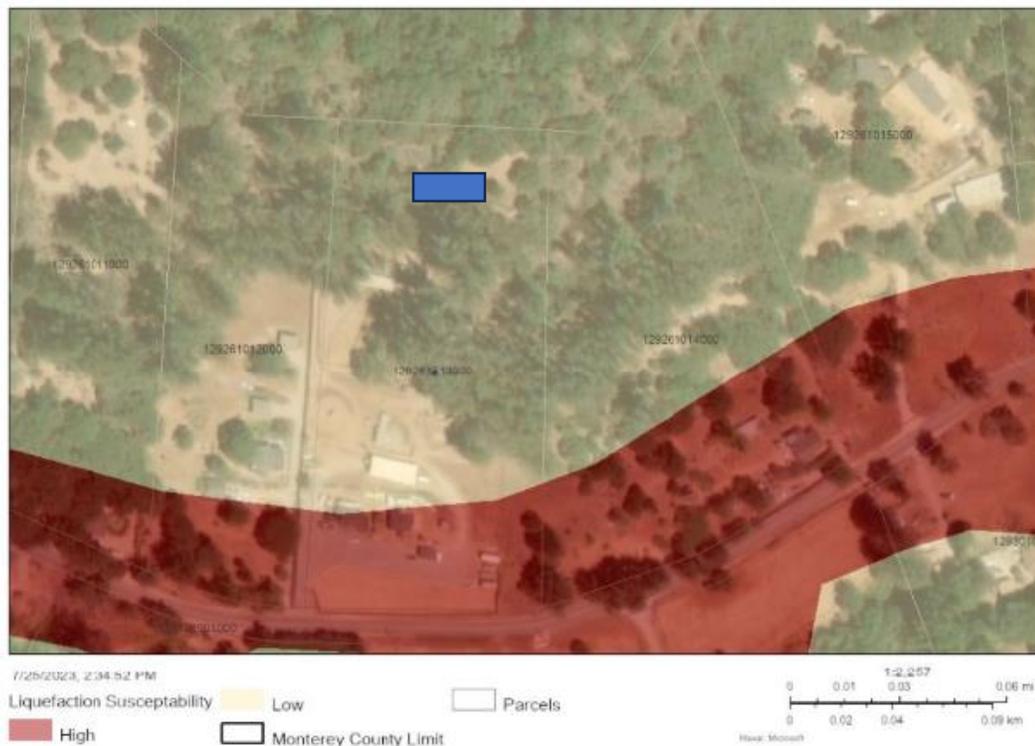
- Liquefaction: The GIS shows that the areas closer to Strawberry Road have a high potential for liquefaction. The proposed corrective grading will take place on the north side of the property, mapped as LOW POTENTIAL for liquefaction. See picture below:

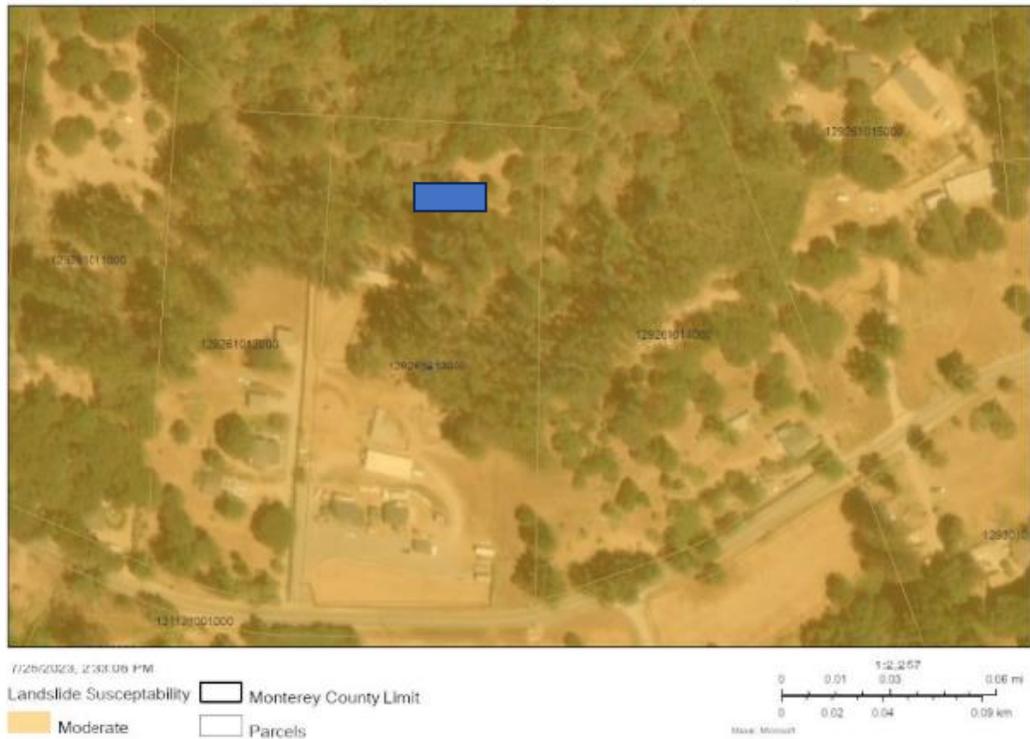
- Landslide susceptibility: The GIS shows the area with a moderate potential for landslides. See picture below:

During our site evaluation, there were no signs of localized land sliding. The proposed grading plan will flatten slopes to a 3:1 gradient that will remain stable.

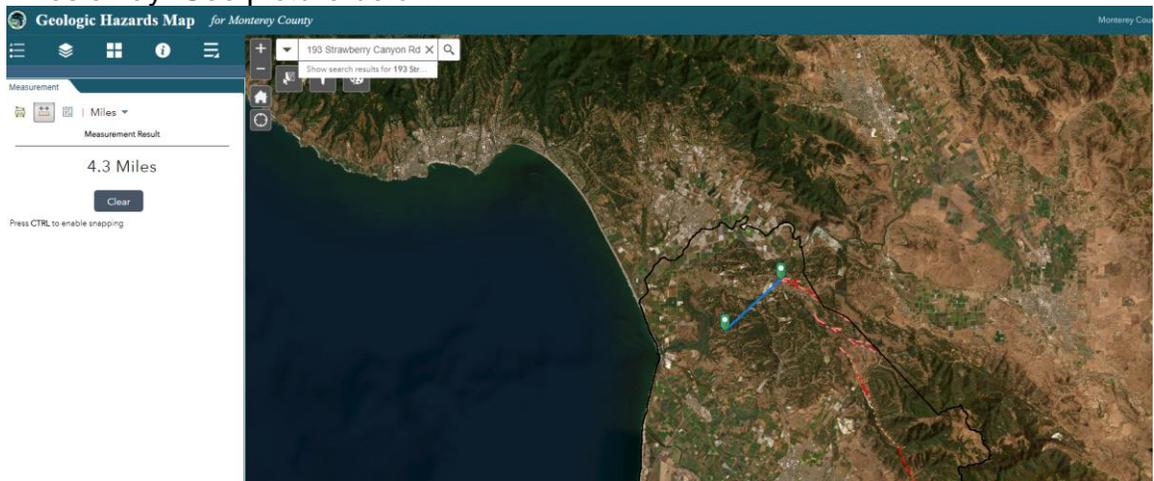
- Faults: Based on the GIS, the closest fault to the site is approximately 4.3 miles away. See picture below:

Geologic Hazards at the site are minimal to null and will not impact the restorative grading area.

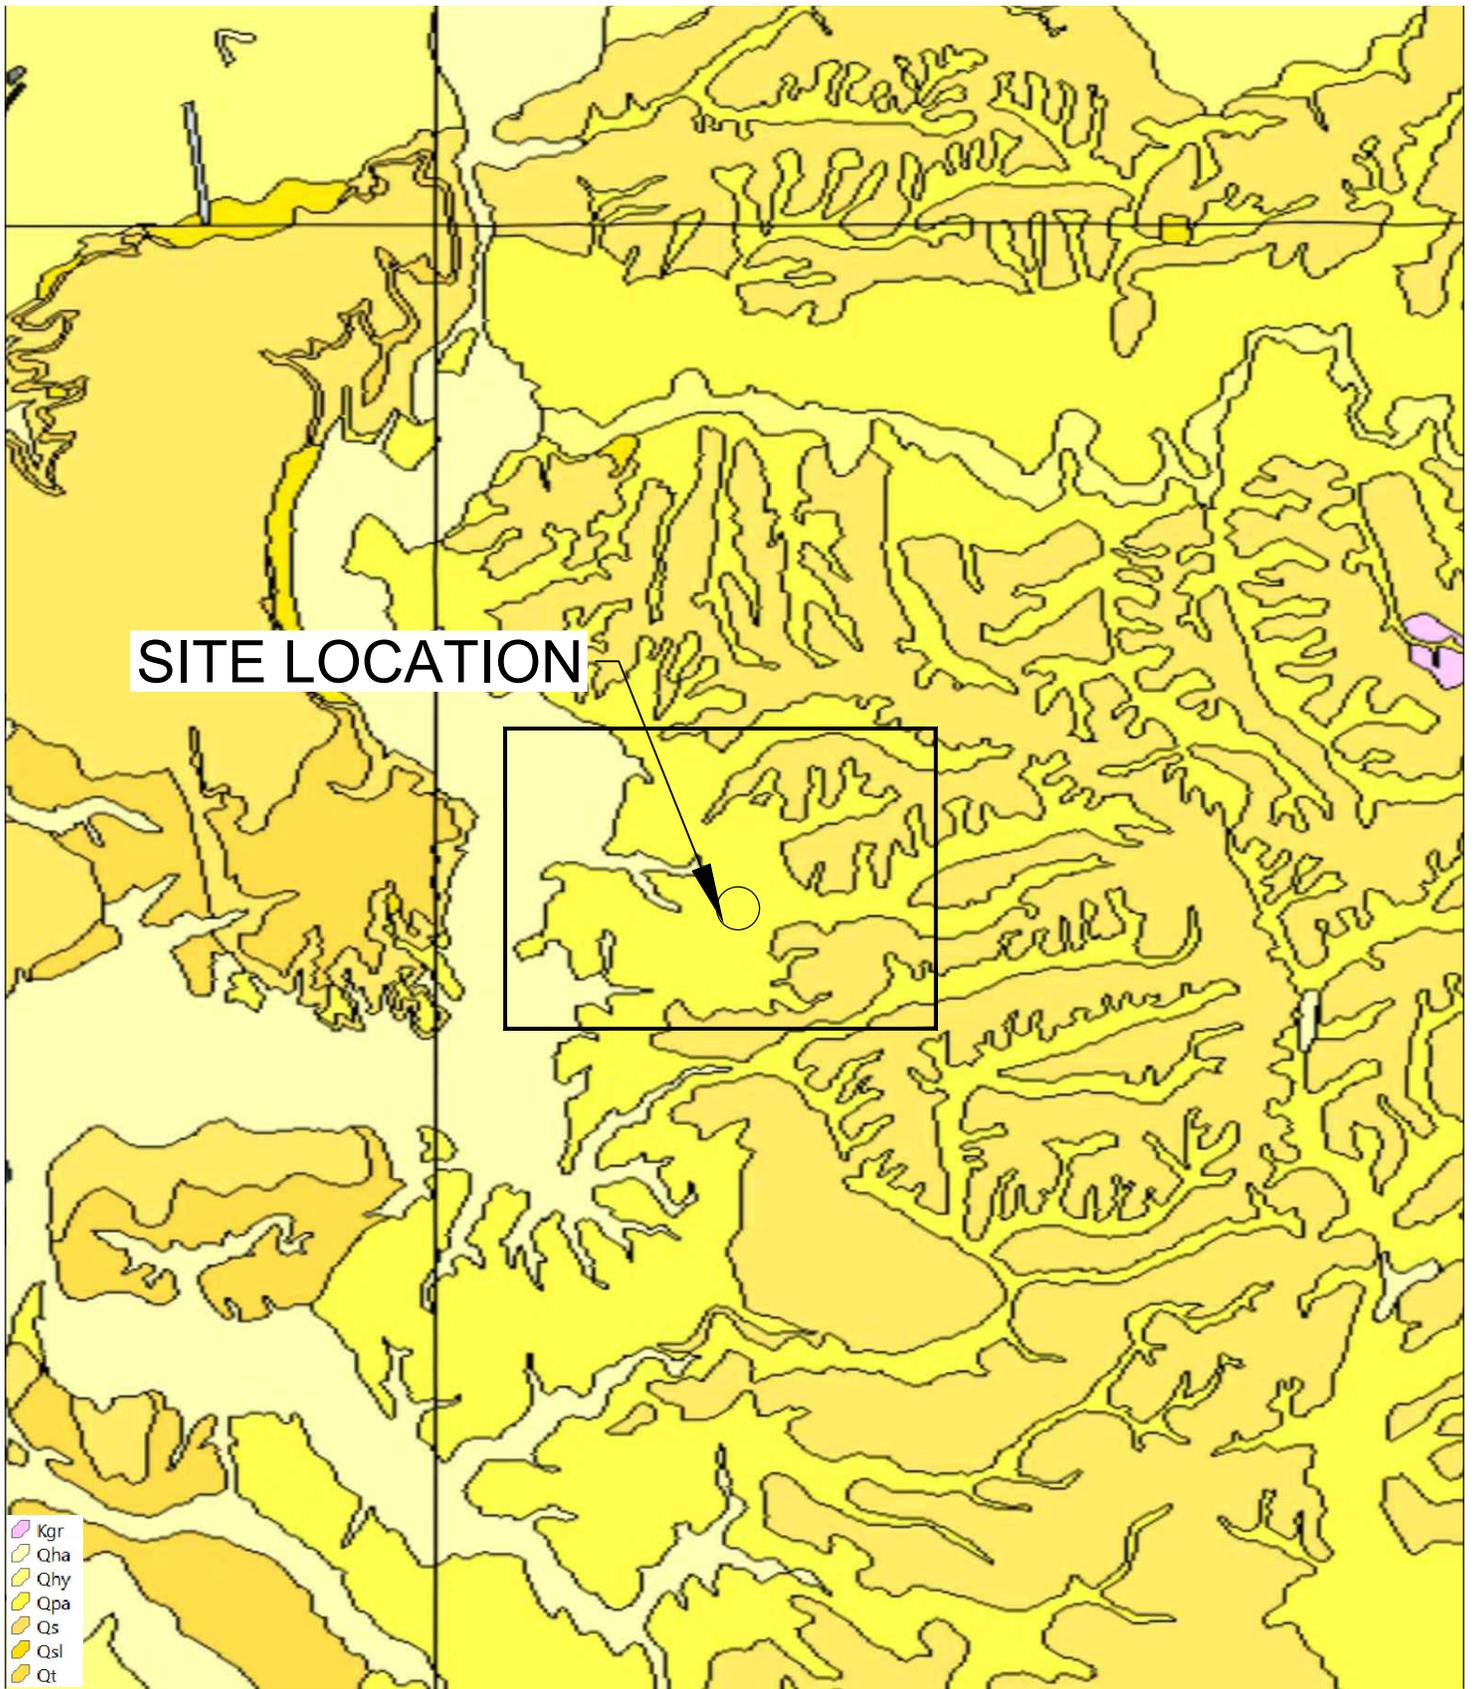
FIGURE NO. 2

As shown on the Geologic Map of Monterey, California the project site is located within Qpa: Alluvium (Pleistocene). A regional geologic map, Figure 2, can be found in the appendix. The soils encountered at the site are consistent with the mapped deposits.

In general, the site consists of orange brown silty sand with clay binder, that increases in moisture with depth. The soils encountered are consistent with the geologic map in appendix A, figure 2.

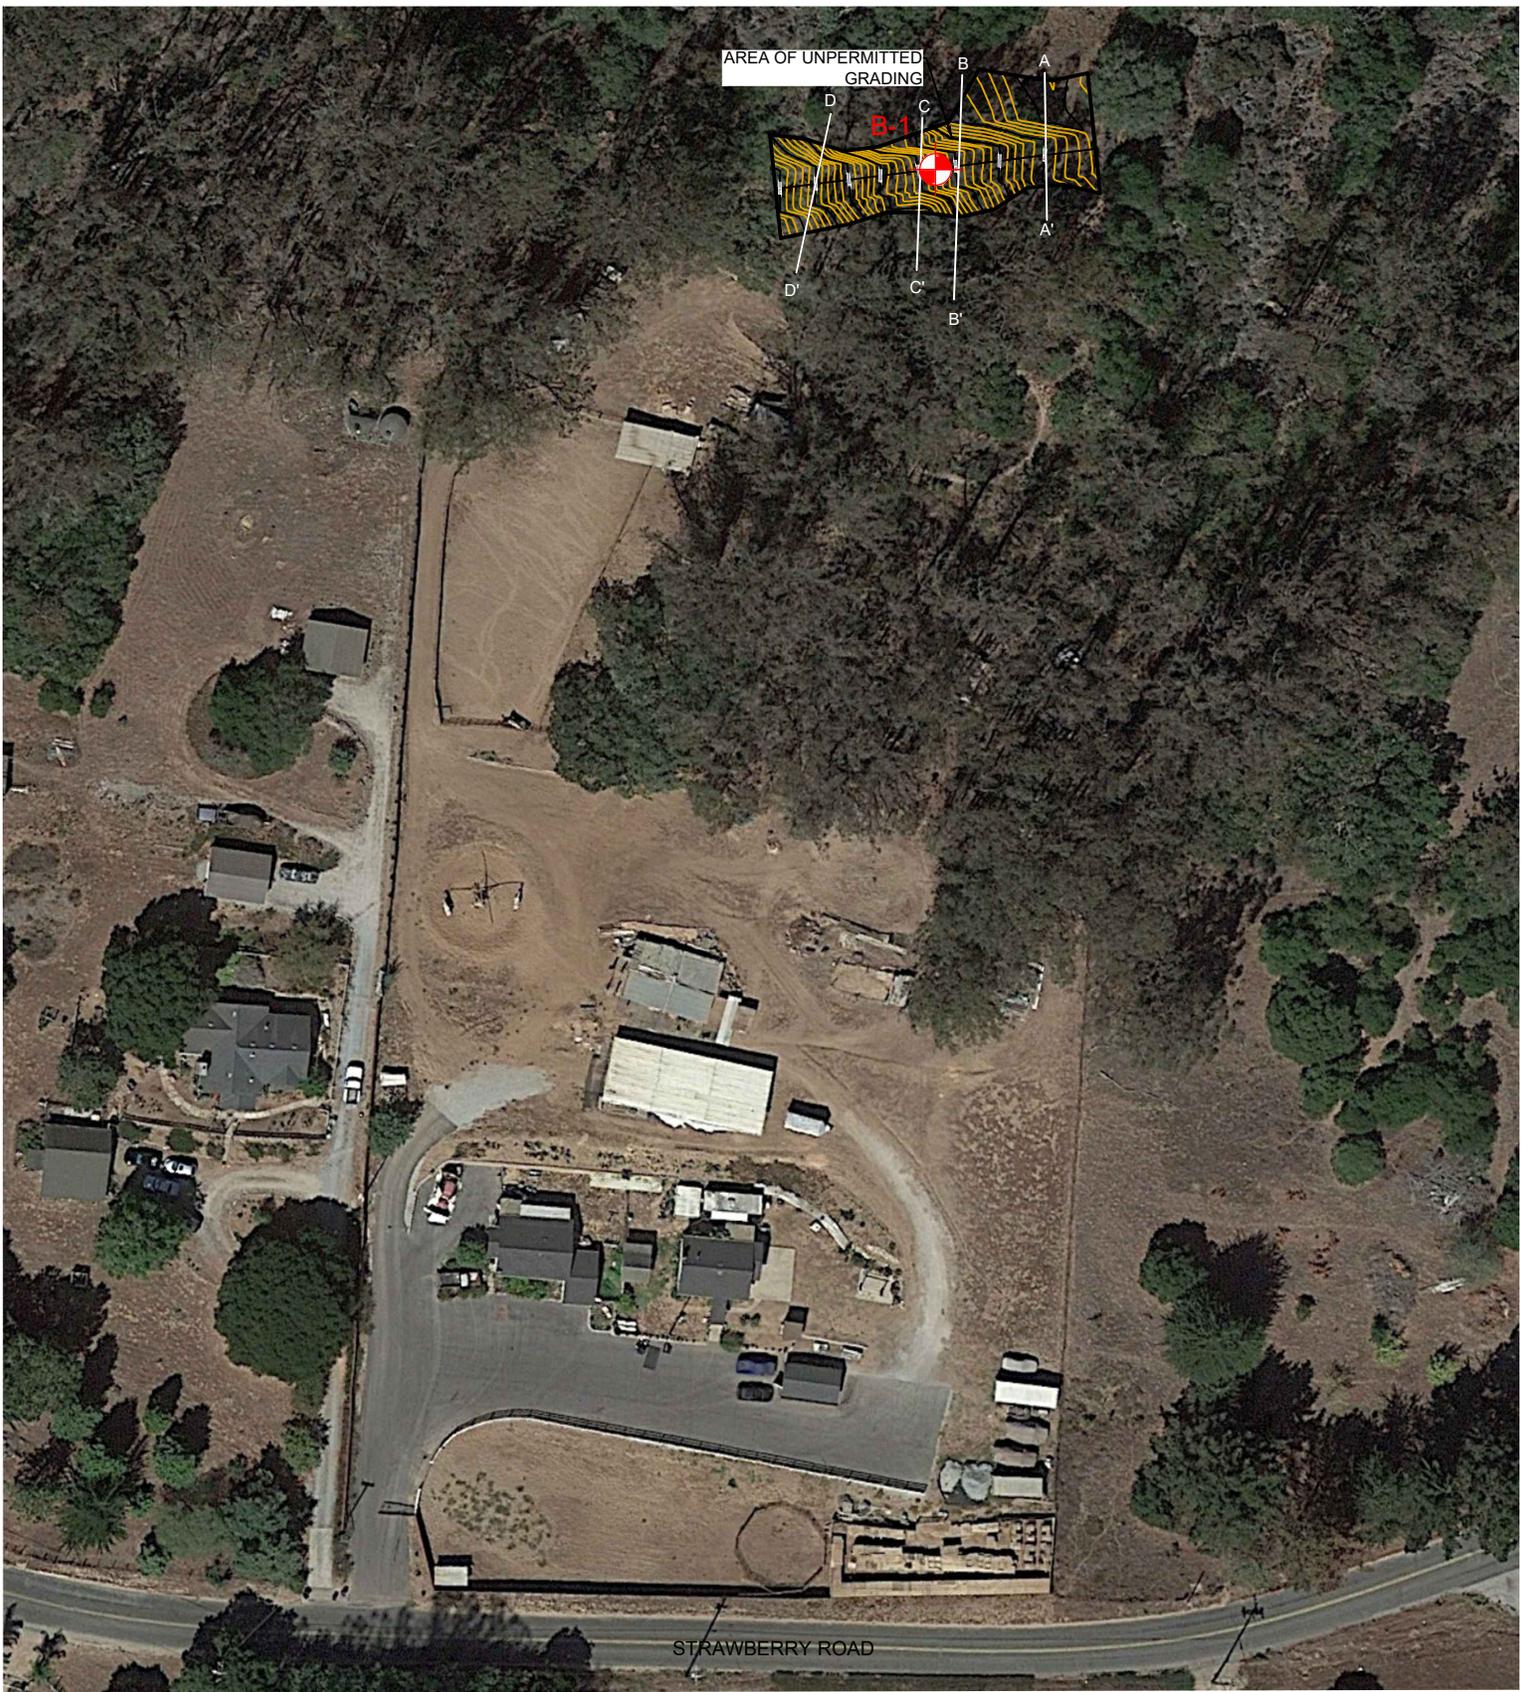
Subsurface conditions were investigated on 7 June 2023. One (1) exploratory boring was drilled in the location of the restorative grading, see Boring Site Plan (see Figure 3, attached).

- NOTES:
1. BASE MAP FROM GOOGLE EARTH PRO
 2. CROSS SECTIONS LOCATIONS APPROXIMATE FROM MEASUREMENTS IN THE FIELD USING HANDHELD LASER LEICA DISTO.
 3. CONTOURS GENERATED FROM CROSS SECTIONS SURVEYED, USING CIVIL 3D

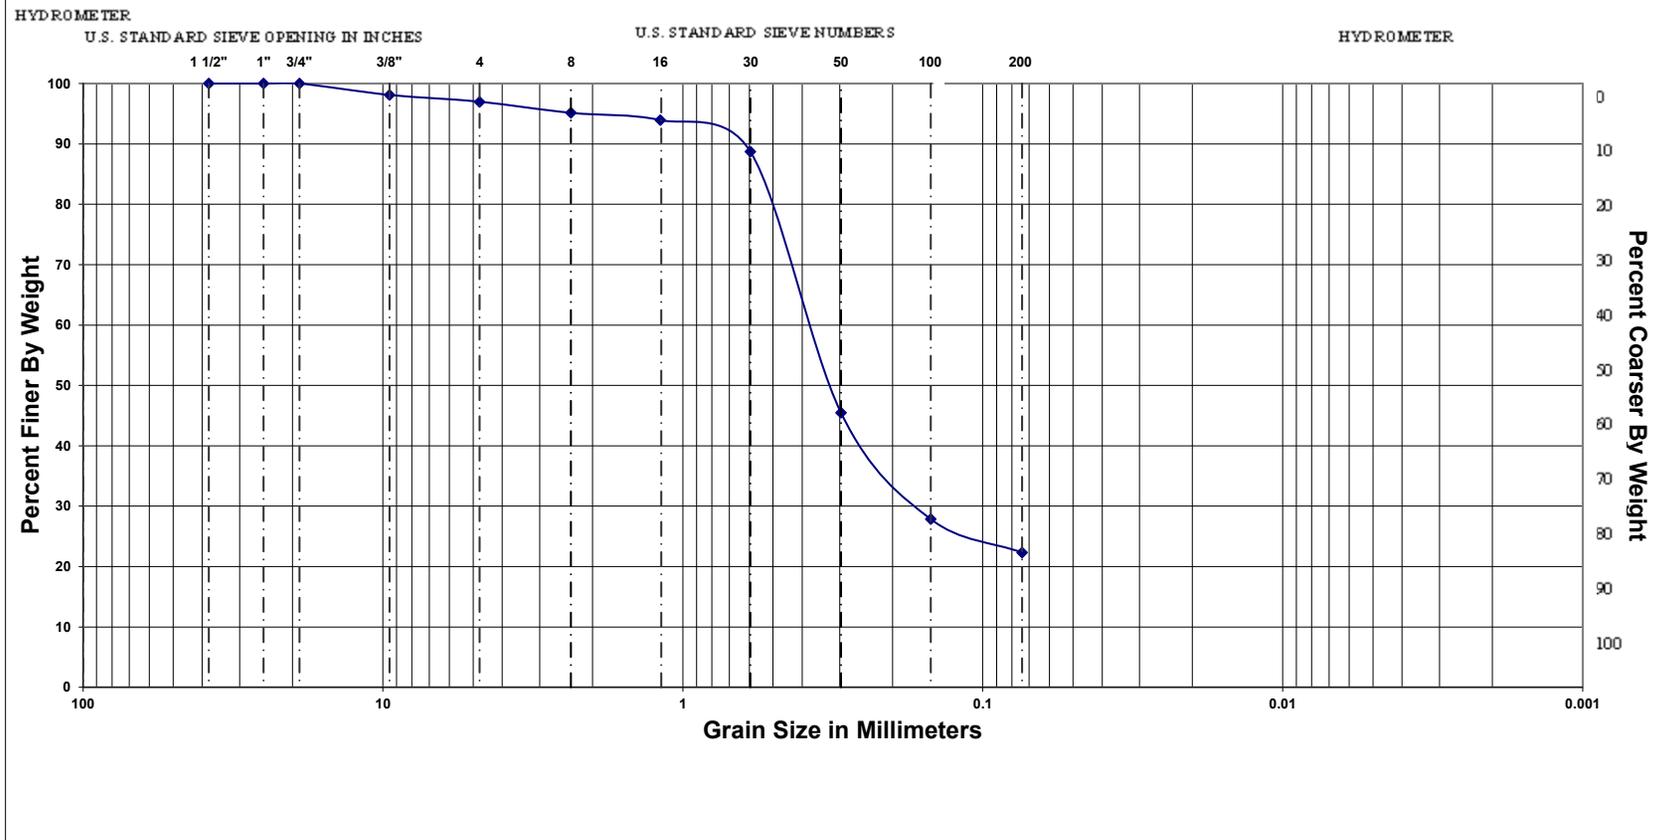
Gravel Content: 3.0%
 Sand Content: 74.6%
 Fines Content: 22.4%
 Cumulative Sum: 100.0%

Sample Description: Orange Brown Silty SAND w/ sandstone & binder
 Group Symbol: SM
