**Before the Housing and Community Development Chief of Planning
in and for the County of Monterey, State of California**

ZAMORA-ROCHA ARTURO ADRIAN ET AL (PLN230099)

RESOLUTION NO. 24-009

RESTORATION PERMIT TO PARTIALLY CLEAR CODE ENFORCEMENT VIOLATION (23CE00097) FOR THE RESTORATION OF UNPERMITTED GRADING ON SLOPE GRATER THAN 25%; GRADING OF APPROXIMATELY 140 CUBIC YARDS OF CUT AND 130 CUBIC YARDS OF FILL AND VEGETATION REMOVAL. THE PROPERTY IS LOCATED AT 193 AND 195 STRAWBERRY ROAD, ROYAL OAKS (ASSESSOR'S PARCEL NUMBER 129-261-013-000), NORTH COUNTY LAND USE PLAN, COASTAL ZONE.

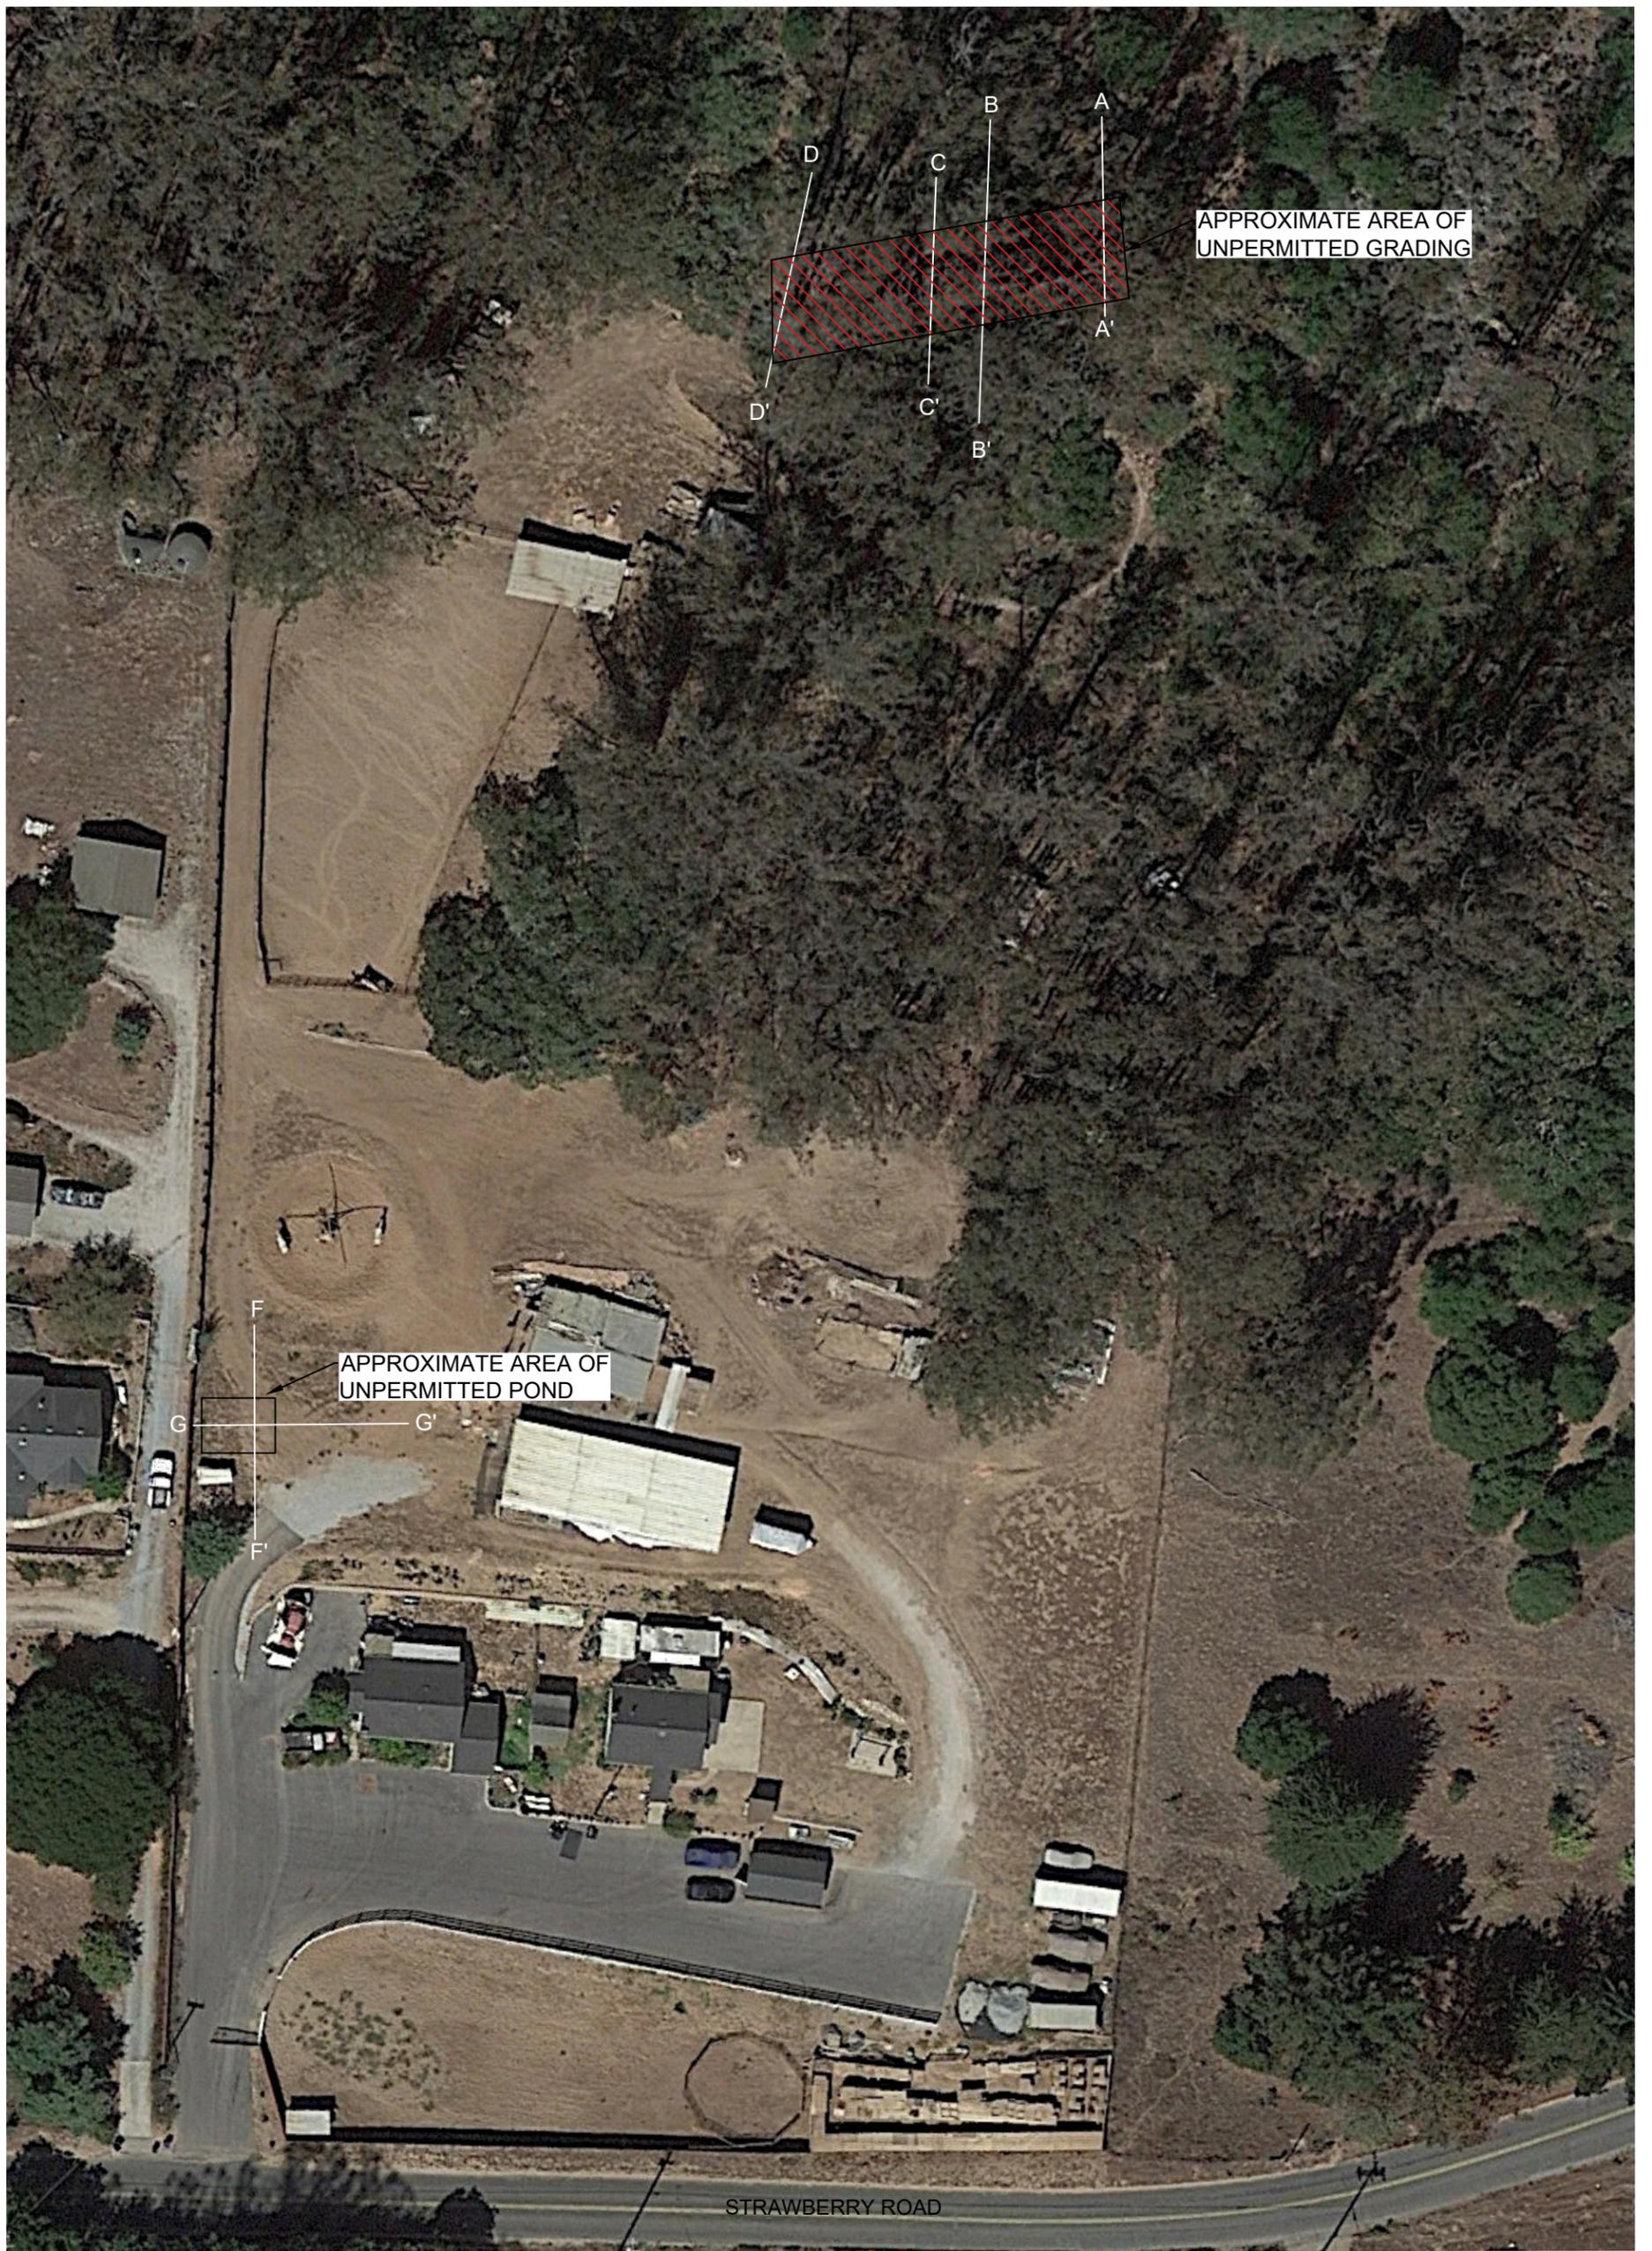
1. BASE MAP FROM GOOGLE EARTH PRO
2. CROSS SECTIONS LOCATIONS APPROXIMATE FROM MEASUREMENTS IN THE FIELD USING HANDHELD LASER LEICA DISTO.

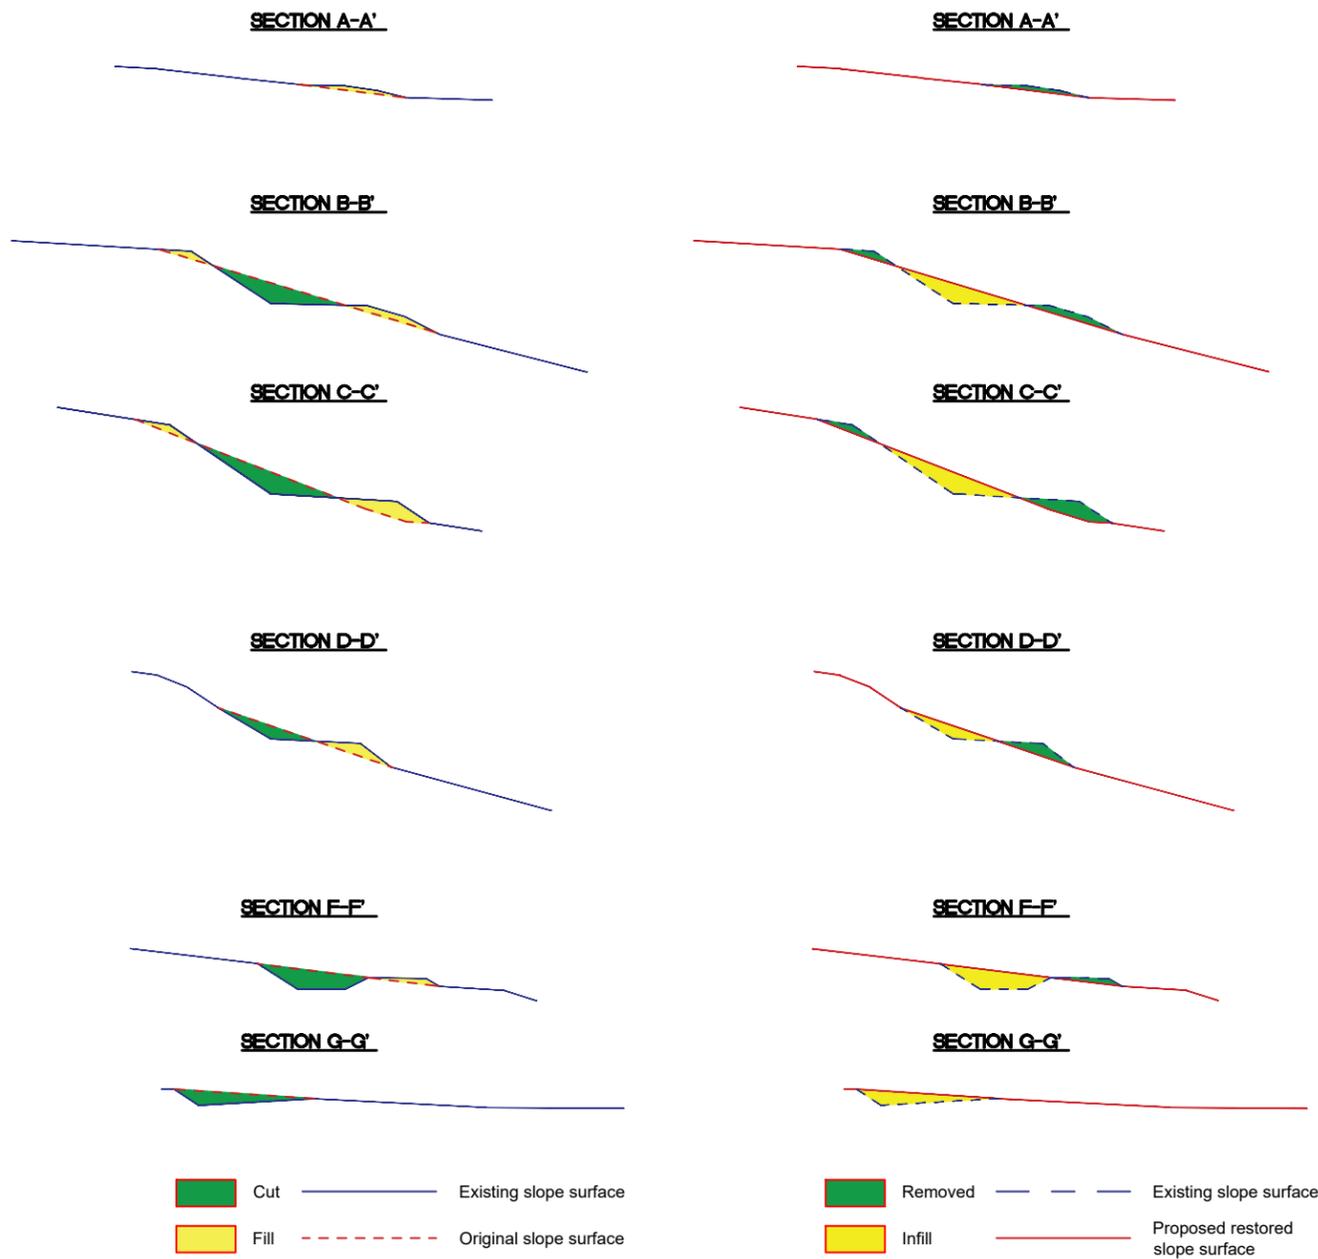
EXISTING CONDITIONS

SECTIONS AFTER RESTORATION

1. Approximate cut volume: 140 approximate fill volume 130 cy.
2. The restoration plan is intended for the period of April 15th to May 15th 2023. Restoration grading should be done between April 16th and May 7th. Erosion control seeding should be done between May 7th and May 15th.
3. Seed and straw mulch should be used on disturbed areas to establish erosion control protection for stabilized 3:1 H:V restored slope surfaces. Seed and straw mulch shall consist of spreading seed (a minimum of 5 lbs/1000 sq. ft.) over disturbed areas and then placing a uniform layer of straw (2-3 bales/1000 sq. ft.) over the seeded slope surface, incorporating it into the soil with a studded roller. The seed shall be annual winter barley and the straw shall be derived from rice, barley or wheat.
4. Hand spray the seeded area twice a week after May 15th if germination of seeds has not occurred.
