SANTA RITA CREEK FLOOD STUDY

July 2025

© 2025 Balance Hydrologics, Inc.
Project Assignment: 224089

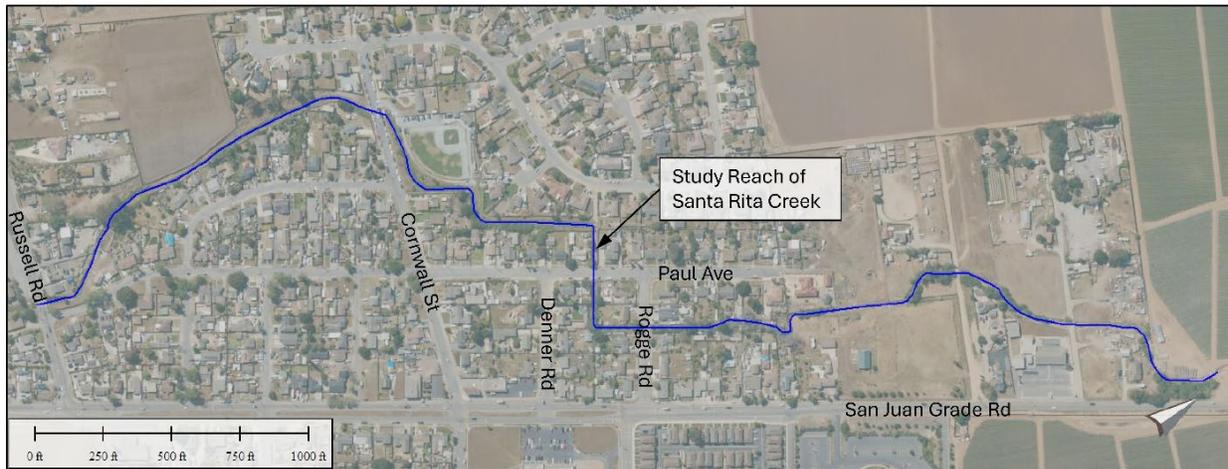
Figure 1-1 Map of study reach. Note that north is pointing to the right.

The defined study reach of Santa Rita Creek extends through the Bolsa Knolls community for a length of approximately 5,600 feet from Russell Road at the downstream end to the limit of residential development at the upstream end. The study reach is shown in **Figure 1-1**.

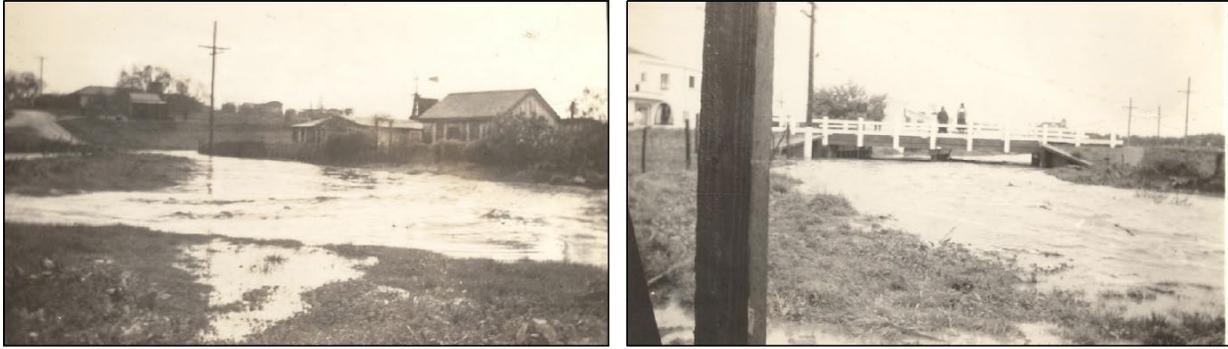
Figure 1-2 Flooding near Highway 101 (now Main Street) circa 1940s

A review of historical flooding was completed using reports from local news outlets. Articles dating as far back as the 1930s describe flooding impacts in the Santa Rita neighborhood of the City of Salinas, downstream of the current study area, indicating that flood issues have long affected Santa Rita Creek, even before later development in Bolsa Knolls. Examples of past flooding are illustrated in **Figure 1-2**, showing both high flood flow rates and overbank flooding in vicinity of what is now North Main Street.

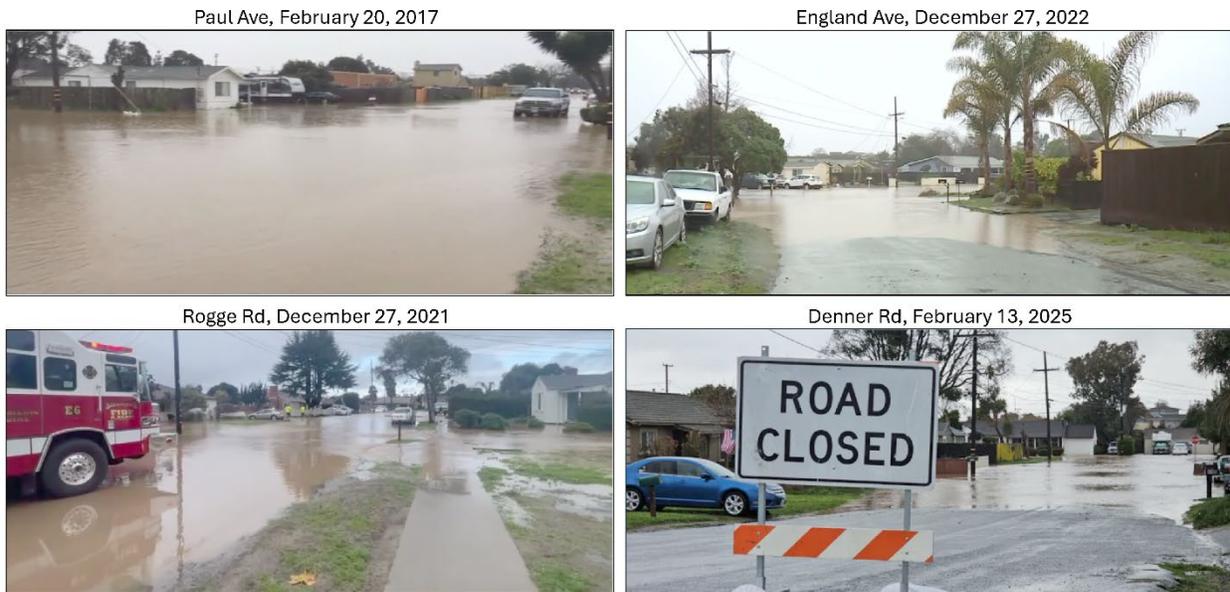
Figure 1-3 Example images of past flooding events. additional photos with dates and locations noted are included as part of **Appendix C**.

More recent flooding within the study area has been documented in the years 2014, 2017, 2021, 2022, 2023, and 2025 (this list is derived from the news reports that were identified and may not include all notable flood events that occurred across this time frame). These events, as reported in the local media, highlight frequent and widespread flooding within Bolsa Knolls. Reports include qualitative descriptions corroborated by photos and videos showing inundated streets, residential yards, and, in several cases, damage to homes. Specific examples are compiled in **Figure 1-3**.

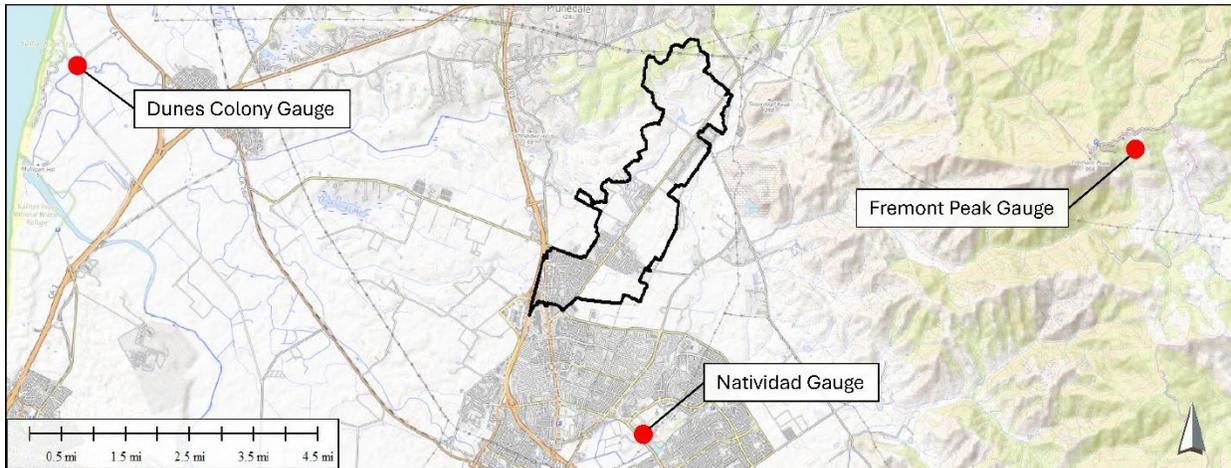
Figure 2-2 Rain gauge locations in relation to the Upper Santa Rita Creek watershed

Rainfall data were obtained from three nearby gauges maintained by the Monterey County Water Resources Agency (MCWRA), as shown in **Figure 2-2**. Among them, the Natividad gauge was deemed most representative of the watershed due to its proximity and similar elevation. Rainfall records were collected from 2007 through 2025 (with the Dunes Colony gauge beginning operation in 2021).

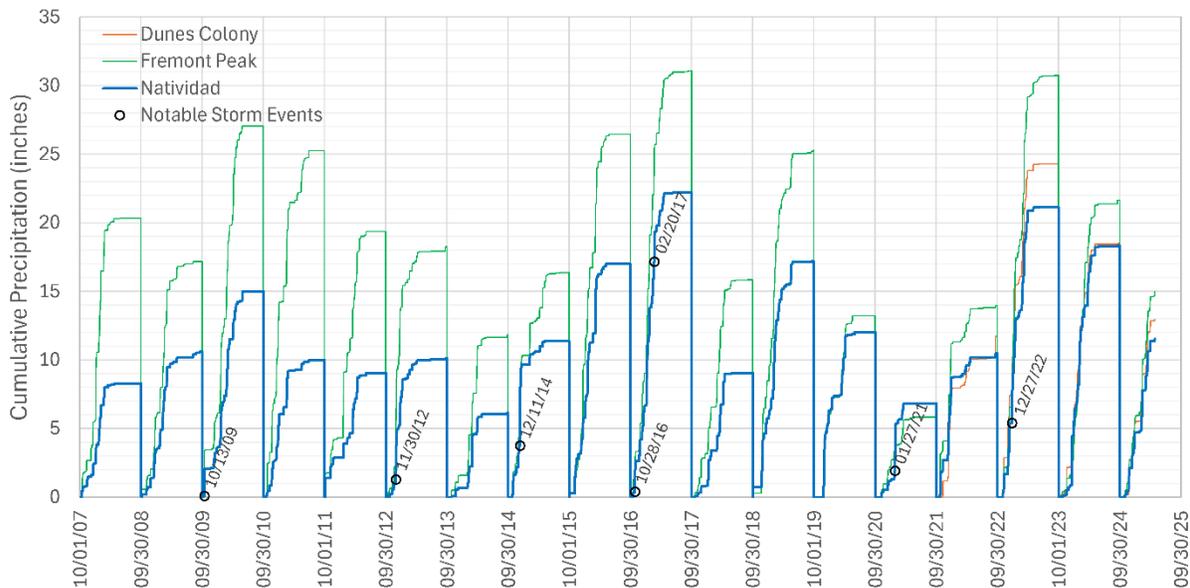
Figure 2-3 Gauged cumulative annual precipitation and significant storm events

Figure 2-3 illustrates the annual cumulative precipitation at each gauge, highlighting year-to-year variability and elevation-driven differences in rainfall depth.

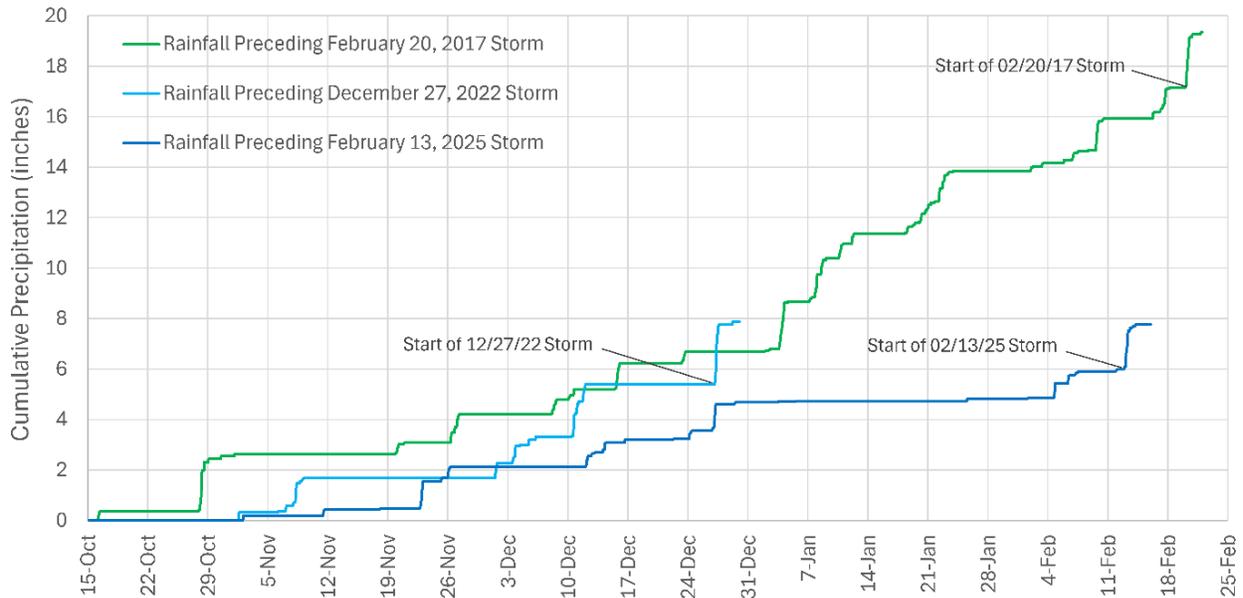
Figure 2-5 Cumulative rainfall preceding calibration storm events

ANTECEDENT MOISTURE CONDITIONS: Antecedent Moisture Conditions (AMC) values were assigned to each storm event and used to adjust Curve Numbers to account for the degree of saturation across the watershed at the initiation of rainfall. AMC values ranged from 1.0 (dry) to 3.0 (wet). 10- and 100-year design storm events were assigned an AMC value of 2.0, assuming moderately saturated watershed conditions. The February 20, 2017; December 27, 2022; and February 13, 2025 calibration storm events were assigned AMCs of 3.0, 1.5, and 2.0 respectively to reflect the preceding rainfall before each event as illustrated in **Figure 2-5**. The Curve Number values assigned for different Antecedent Moisture Conditions are included in **Appendix A**.

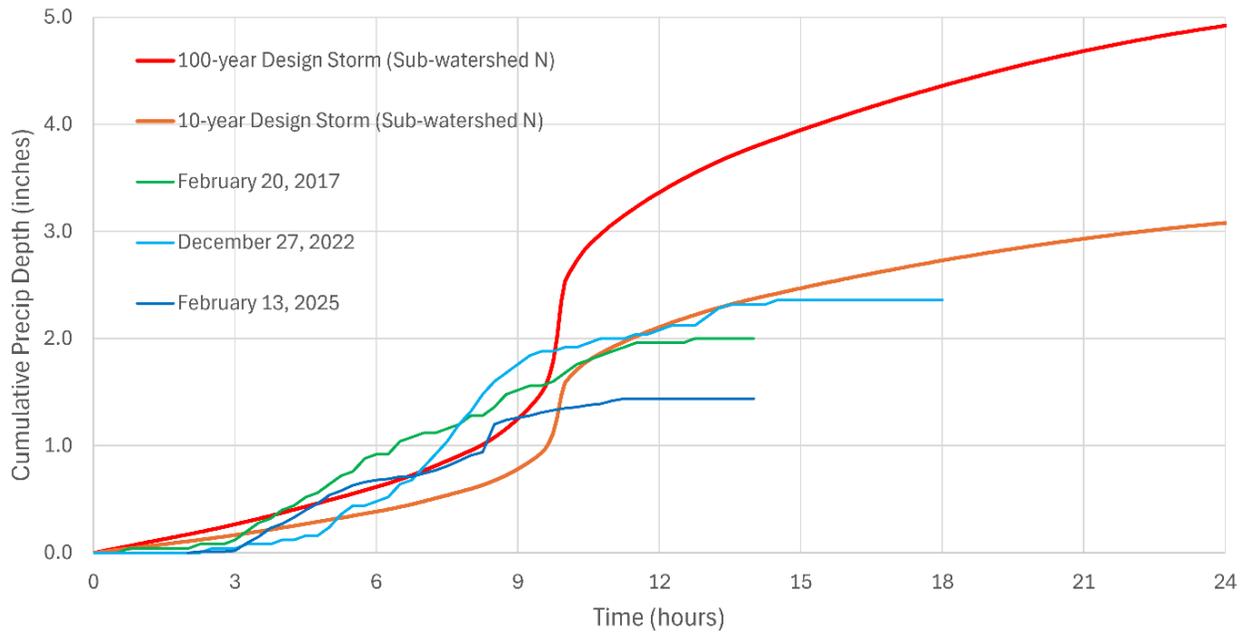
Figure 2-6 Cumulative precipitation across calibration and design storm events

RAINFALL: Calibration event rainfall data were derived from the Natividad gauge, processed into uniform 15-minute intervals, and applied consistently across all sub-watersheds. Design storm depths were based on NOAA Atlas 14 precipitation frequency estimates at each sub-watershed and distributed using an SCS Type I storm pattern. Cumulative precipitation plots for all modeled events are presented in **Figure 2-6**.

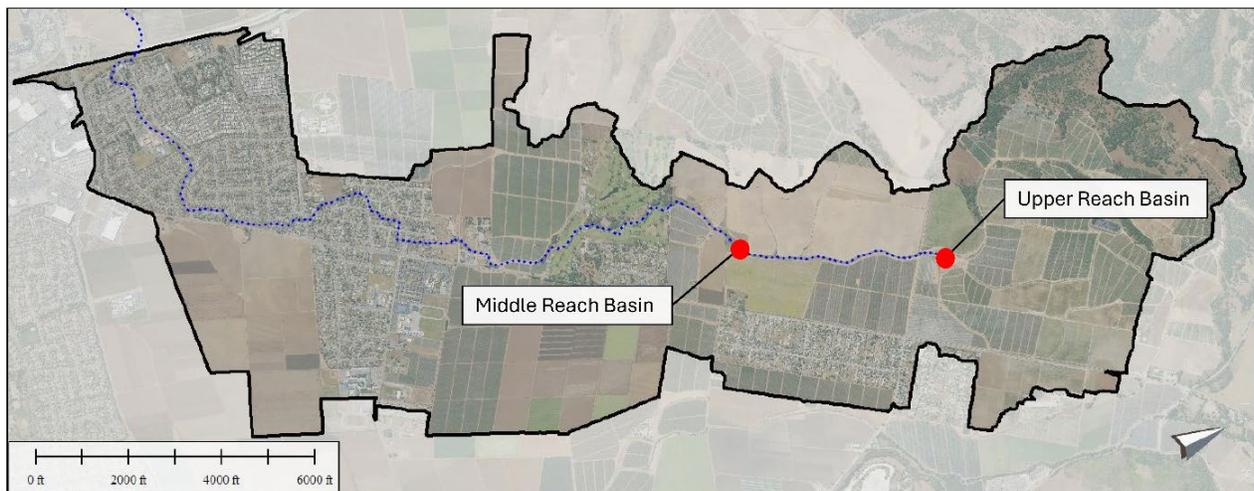
Figure 2-8 Existing basin locations

BASIN ROUTING: Two relatively large detention basins were identified within the upper watershed at the locations shown in Figure 2-8. A review of aerial photographs indicates the embankment defining the middle reach basin was frequently breached and most notably during the February 20, 2017, and December 27, 2022, storm events, and as a result was not considered in the model. However, the larger upper reach basin was included in the model and was parameterized with a storage volume of 37 acre-feet at the basin spillway elevation. The outlet works include twin 36-inch diameter corrugated metal pipes (CMPs) and a 30-foot crest length overflow spillway.

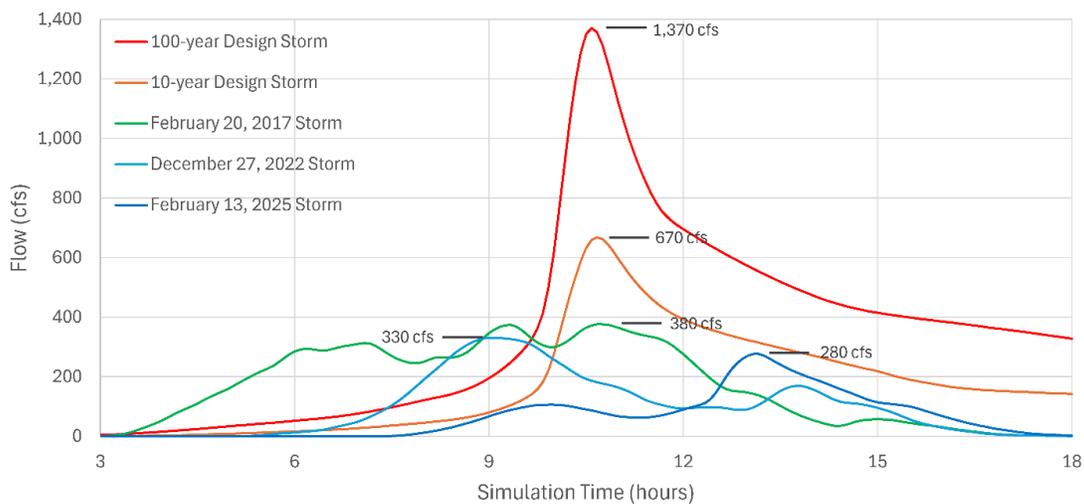
Figure 2-9 Summed hydrographs discharging to the study reach

These results underscore three primary factors that govern peak runoff rates from the watershed: total storm depth, peak storm intensity, and antecedent moisture conditions. For instance, although the December 27, 2022, storm produced both greater rainfall totals and higher peak intensities than the February 20, 2017, event, drier antecedent conditions in 2022, resulted in lower peak flow rates. In contrast, the 10- and 100-year design storms assume conservatively high storm depths, intense rainfall rates, and moderately saturated soil conditions, factors that together are projected to generate significantly higher peak flow rates than those observed during the calibration storm events.

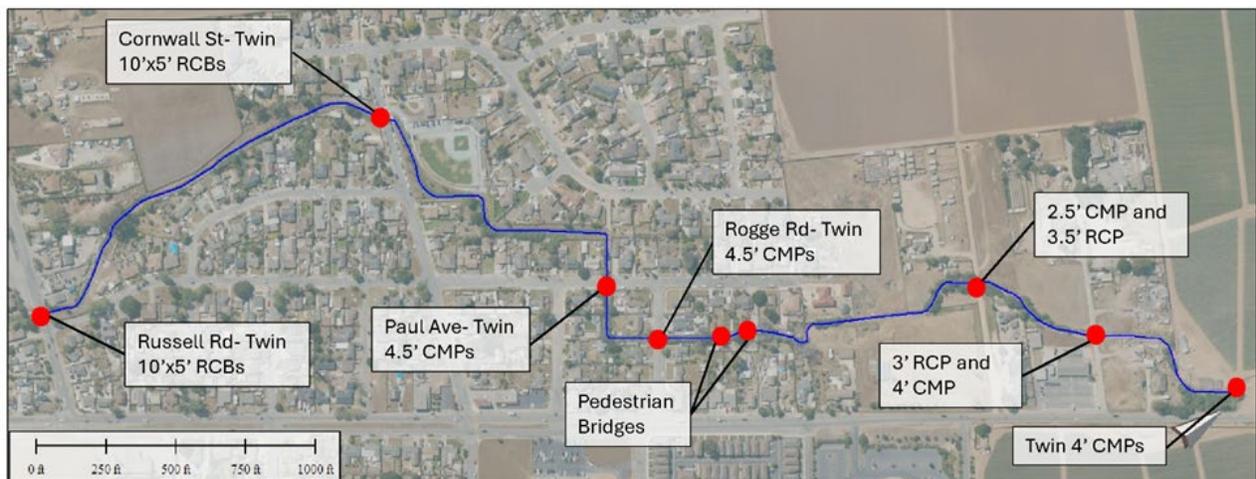
Figure 3-2 Channel crossing locations

Channel crossings were identified at nine locations along the study reach as shown in **Figure 3-2**. These crossings vary greatly in size from the twin 5-foot span by 10-foot box culverts at Cornwall Street to a pair of partially obstructed 2.5 to 3.5-foot diameter pipe culverts located along a private drive near the upstream end of the study reach.

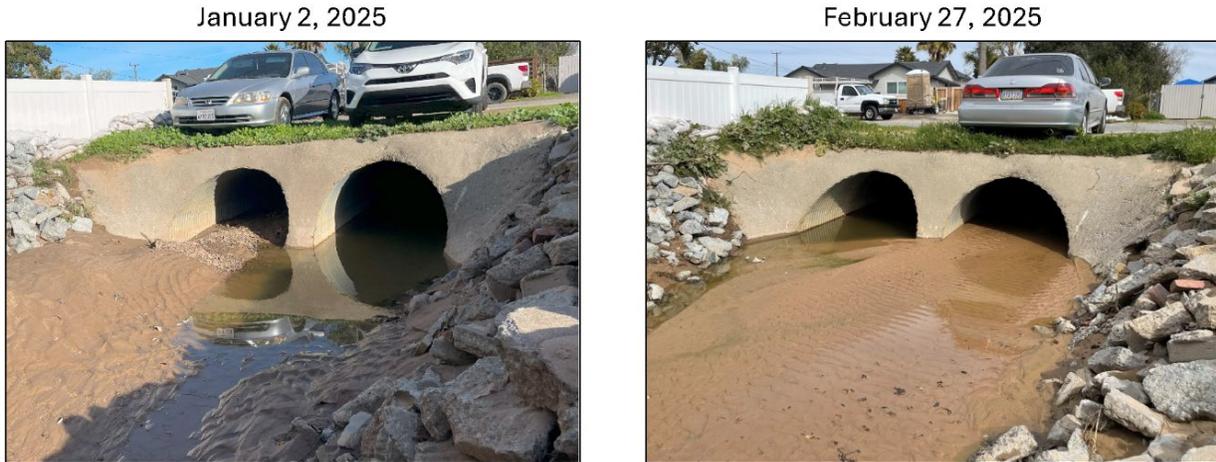
Figure 3-3 Sediment before and after the February 13, 2025, storm event at the downstream face of the culverts at Rogge Road

Sediment accumulation has impacted conveyance in some areas, particularly at culvert inlets. While a comparison between late-1970s survey data (collected for the FEMA Flood Insurance Study) and 2017 USGS LiDAR suggests an average rise of no more than 1 to 2 feet in channel invert elevation, localized sediment buildup at crossings has been more significant, up to 2 to 3 feet in some locations. **Figure 3-3** and **Figure 3-4** illustrate sediment conditions before and after the February 13, 2025, storm event.

presented in **Figure 3-3** and **Figure 3-4**, while additional photographs illustrating turbidity and sediment deposits are included in **Figure 4-8**

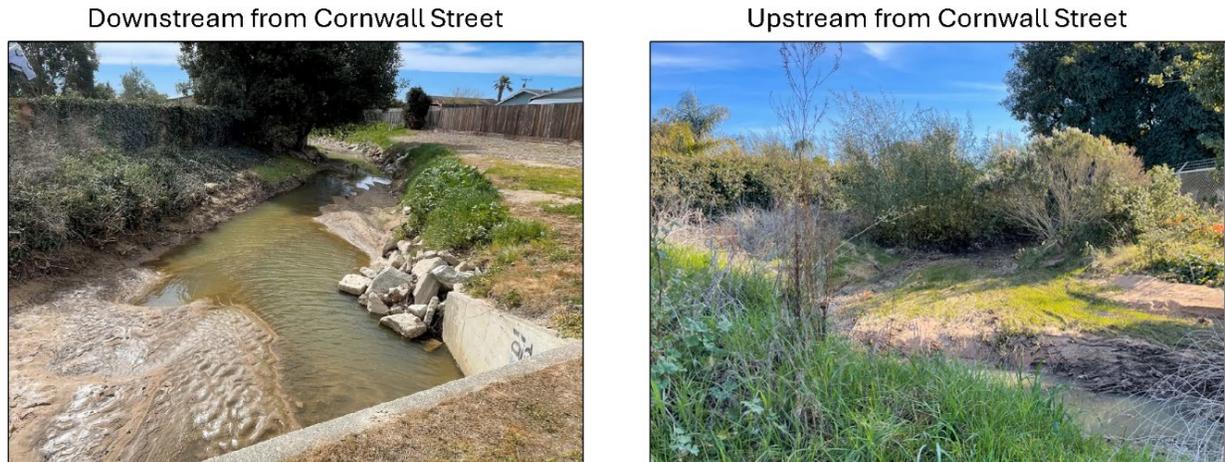
Figure 3-5 Example comparison of the differences in vegetation density across the study reach

Vegetation presents a similar constraint to flow, particularly upstream of Cornwall Street. Aerial imagery review and field reconnaissance indicate denser patches of vegetation along this segment compared to the more open downstream reach. **Figure 3-5** provides a photographic comparison.

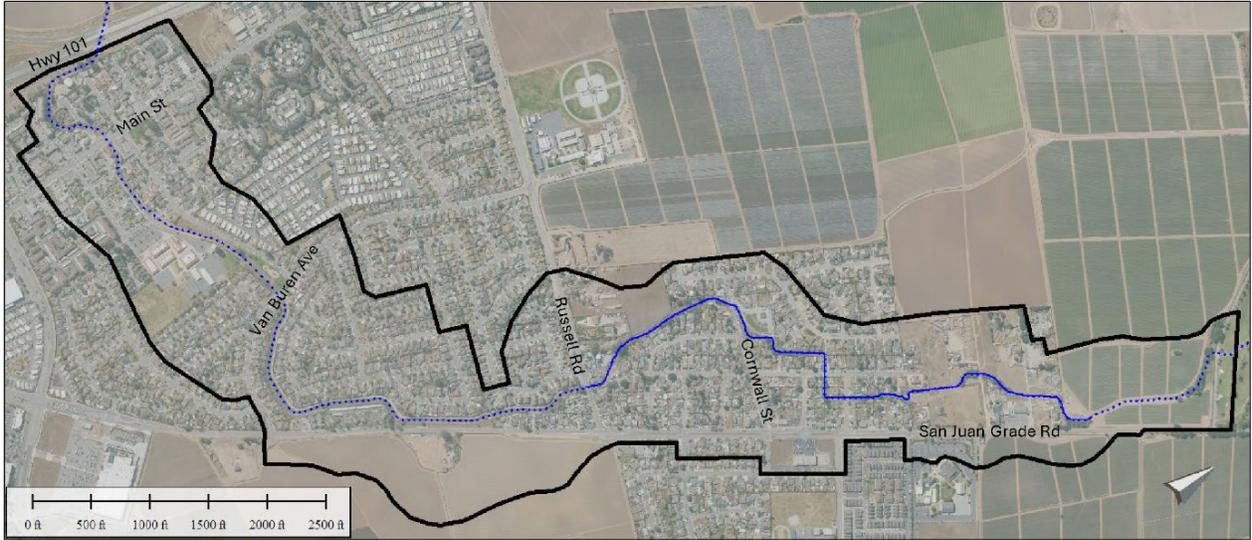
Figure 3-6 Hydraulic model domain

MODEL DOMAIN: The model domain extends downstream to Highway 101 and upstream into the Salinas Golf and Country Club allowing for the assessment of flooding impacts both within and beyond the Bolsa Knolls study area. Additionally, by extending the model further in the upstream direction, a location is provided to evaluate proposed upstream detention alternatives. The full model domain is shown in **Figure 3-6**.

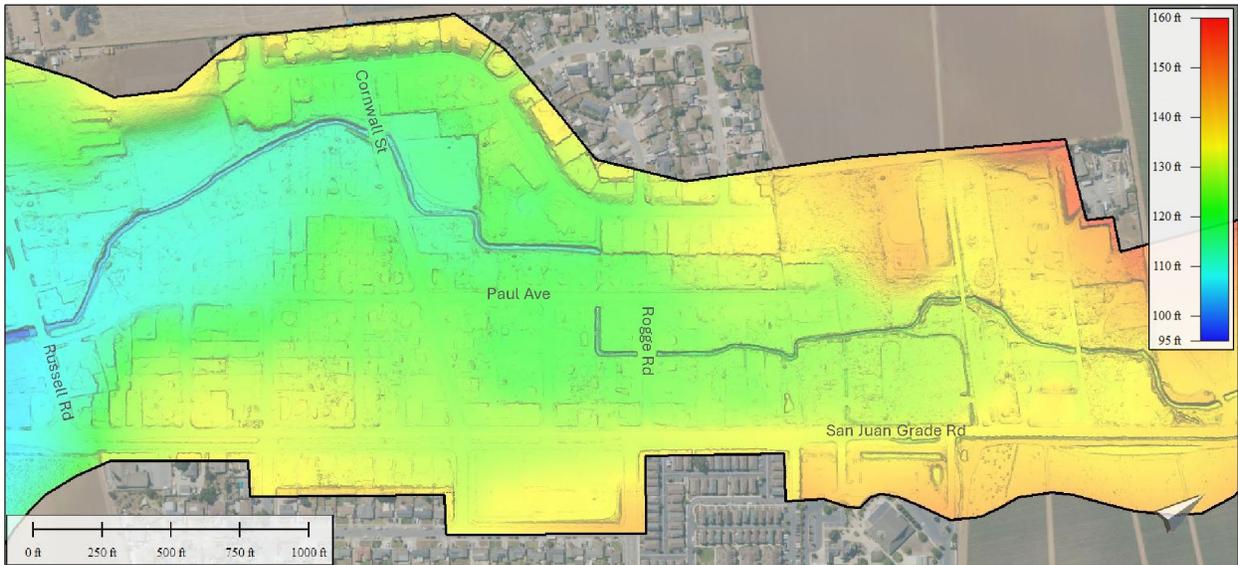
Figure 3-7 Terrain across the study reach

TERRAIN: The terrain, shown across the study reach in **Figure 3-7**, was derived primarily from the 2017 USGS LiDAR data and edited in select locations obscured by vegetation to reflect observations made in the field. Elevations near the crossing locations were also edited to reflect surveyed spot elevation data collected as part of this study.

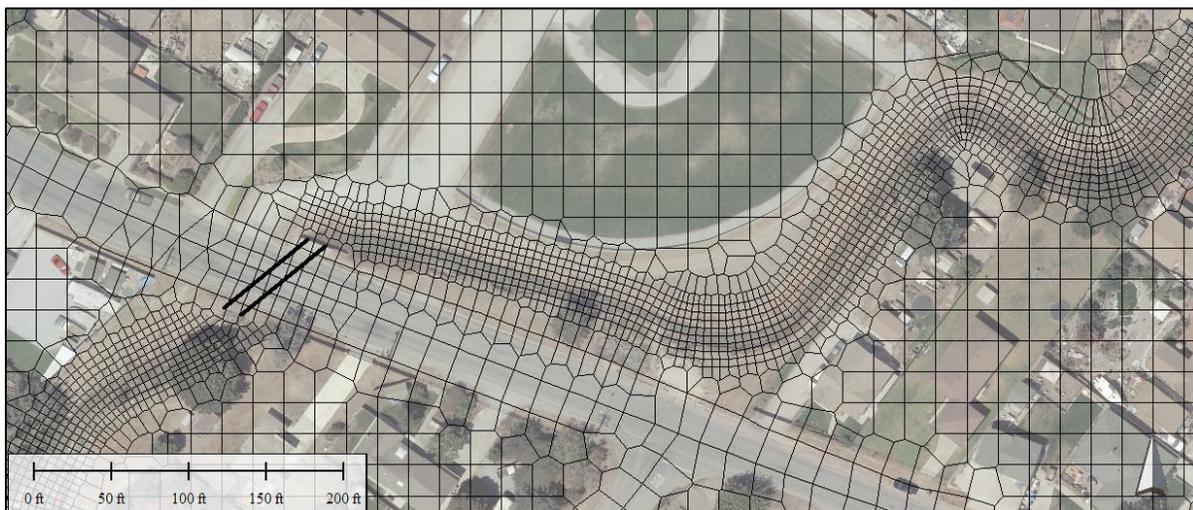
Figure 3-8 Example cell spacing and alignment

CALCULATION CELLS: Model cells along the creek channel were typically defined with dimensions of 5-feet by 5-feet and cells along overbank areas were set to 20-feet by 20-feet, with more than 70,000 cells covering the model domain. Breaklines were used throughout the model to capture high points in the terrain and to align cell faces perpendicular to flow along the channels. An example of the cell spacing and alignments is shown in **Figure 3-8**.

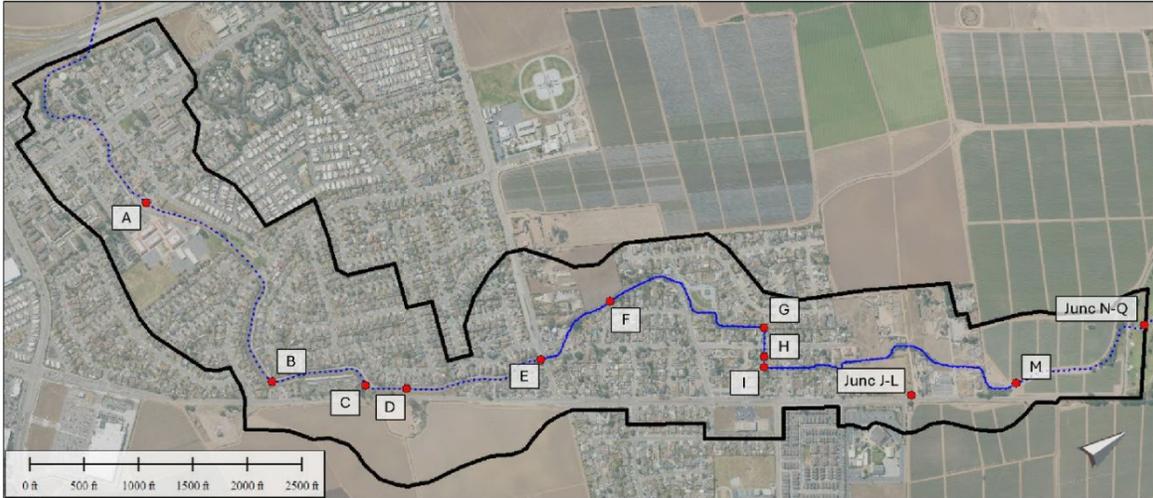
Figure 3-9 Inflow boundary locations. Labels reference sub-watersheds described in hydrologic modeling section.

BOUNDARY CONDITIONS: Flow hydrographs generated by the hydrologic model were loaded at 12 inflow boundary locations shown in **Figure 3-9**. An outflow boundary condition was applied at the downstream end of the model near Highway 101 and defined with a normal depth slope of 0.3 percent.

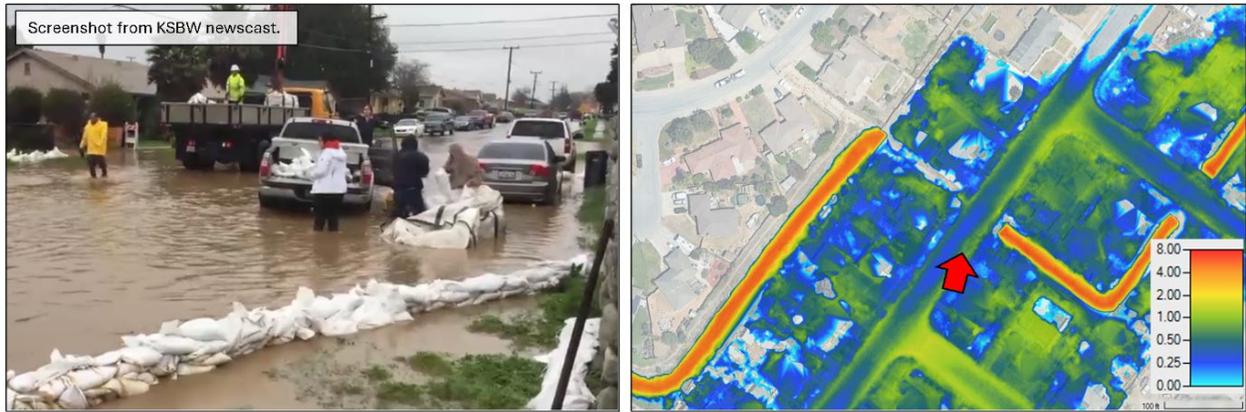
Figure 3-12 Comparison between observed and modeled results at the Paul Avenue Crossing during the February 20, 2017, flood event

Figure 3-12 illustrates conditions for the February 20, 2017, flood event at the Paul Avenue crossing with depth of flood waters at the vehicles as comparison points.

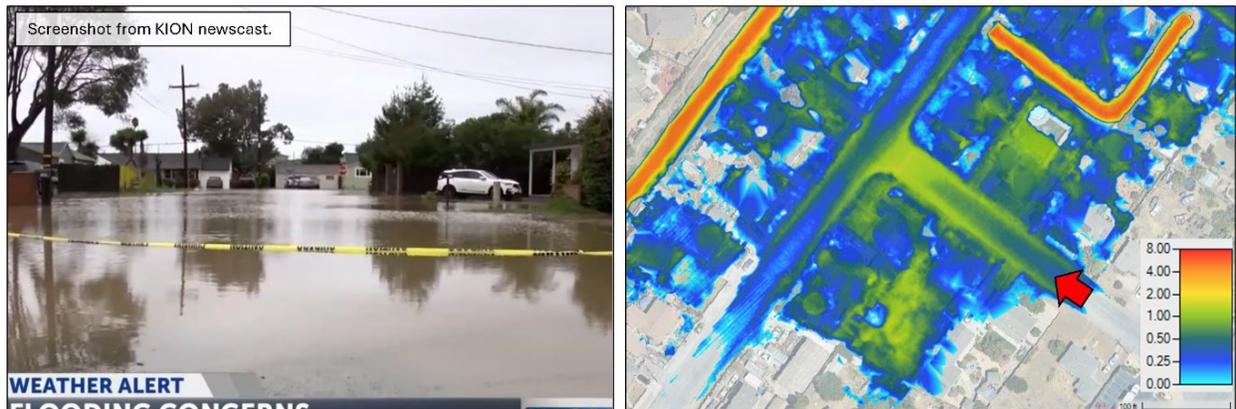
Figure 3-13 Comparison between observed and modeled results at Denner Road during the December 27, 2022, flood event

Figure 3-13 shows the flooding observed in the vicinity of Denner Road during the December 27, 2022, event with lateral extent of the inundation used as a primary metric.

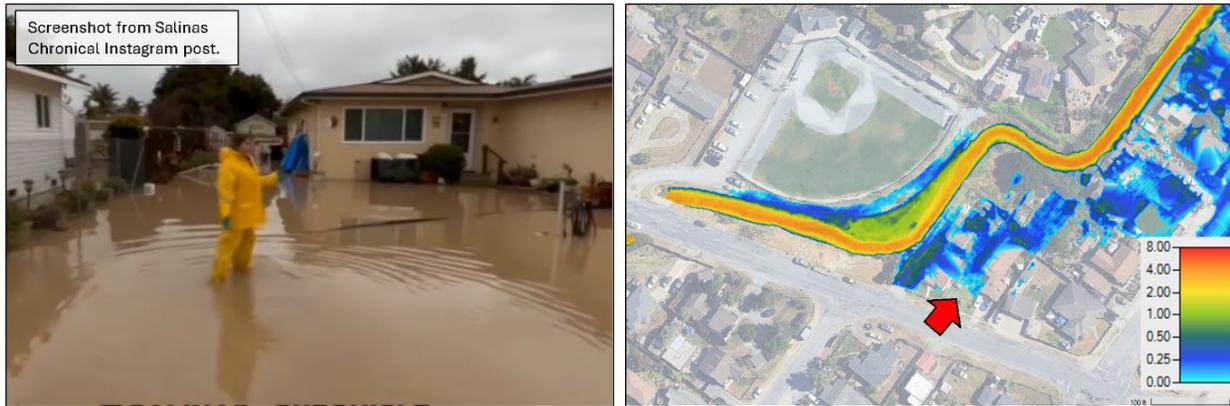
Figure 3-14 Comparison between observed and modeled results at Cornwall Street during the February 13, 2025, flood event

Lastly, **Figure 3-14** shows flooding along Cornwall Street as observed during the February 13, 2025, storm with the encroachment of flooding on the residential structures as important indicators.

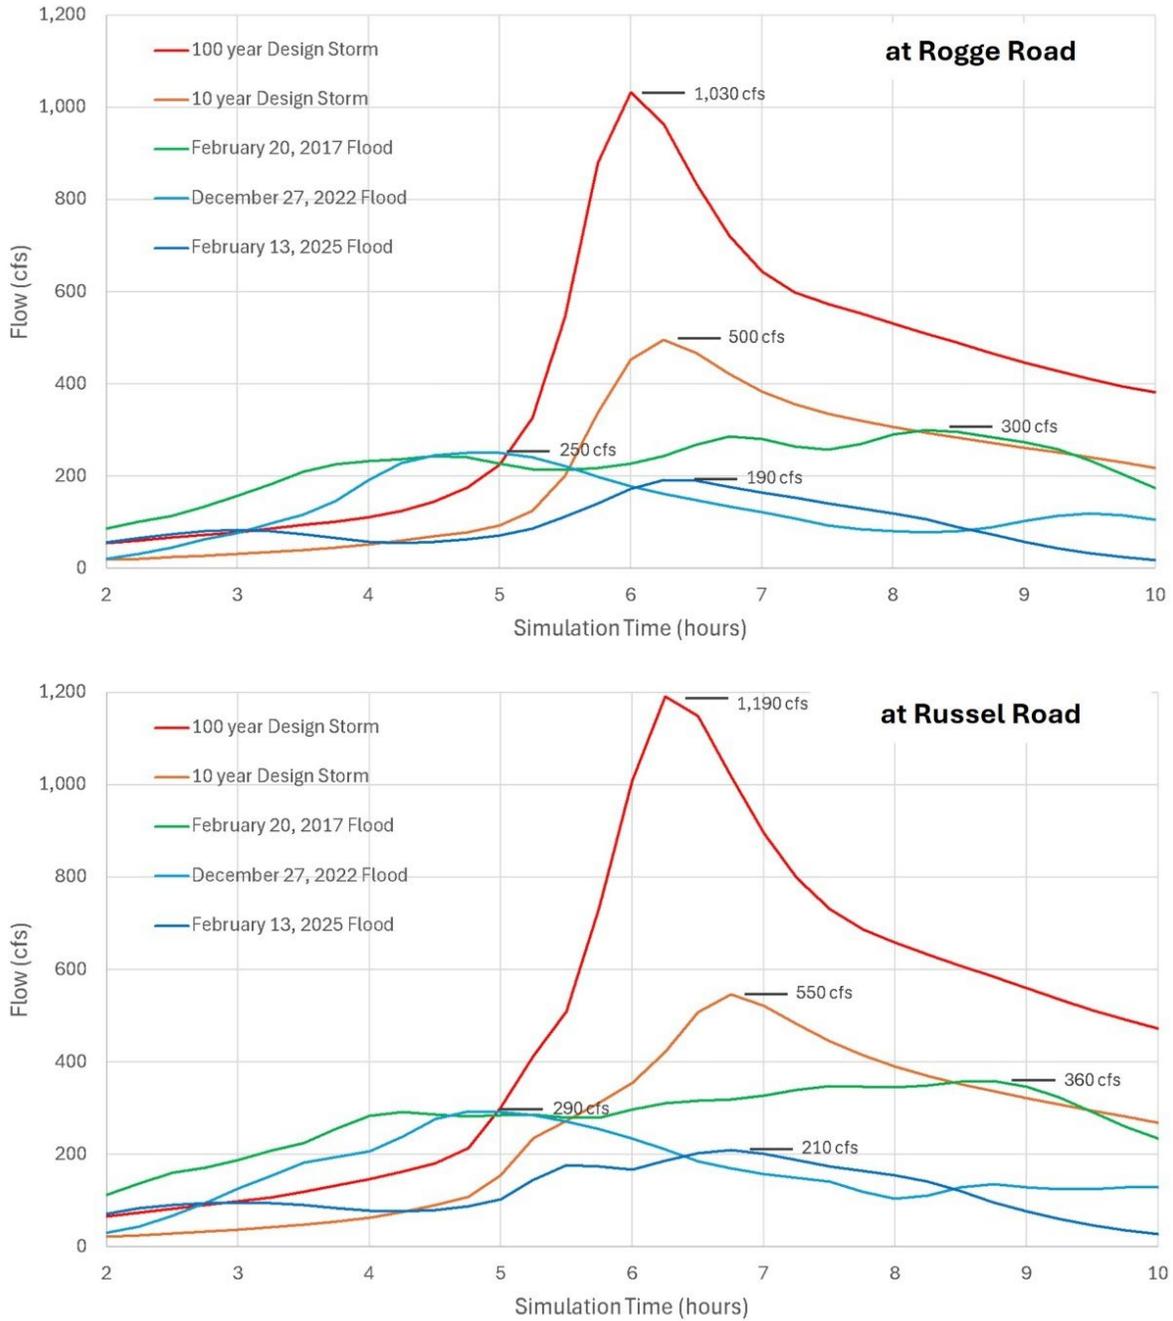
Figure 3-15 Existing conditions routed hydrographs at Rogge Road

Large scale flood depth and water surface elevation plots generated by the existing conditions hydraulic model are included as **Appendix D**. Despite attenuation of peak flow rates in the large existing detention basin upstream of the hydraulic model domain, peak flow rates in the creek clearly exceed the channel capacity at numerous locations for all three of the calibration storms examined. The modeled flood flow hydrographs at the Rogge Road and Russell Road crossings are illustrated in **Figure 3-15** and show that the 10-year design storm is predicted to generate peak flow rates at those locations of 500 and 550 cfs respectively, roughly 200 cfs higher than that of the largest calibration storm (February 20, 2017). Naturally, given the much larger total rainfall, coupled with limited upstream detention capacity, the 100-year design storm results in much higher predicted peak flow rates. At 1,030 and 1,190 cfs respectively, the 100-year flow rate is over twice the magnitude of the 10-year event.

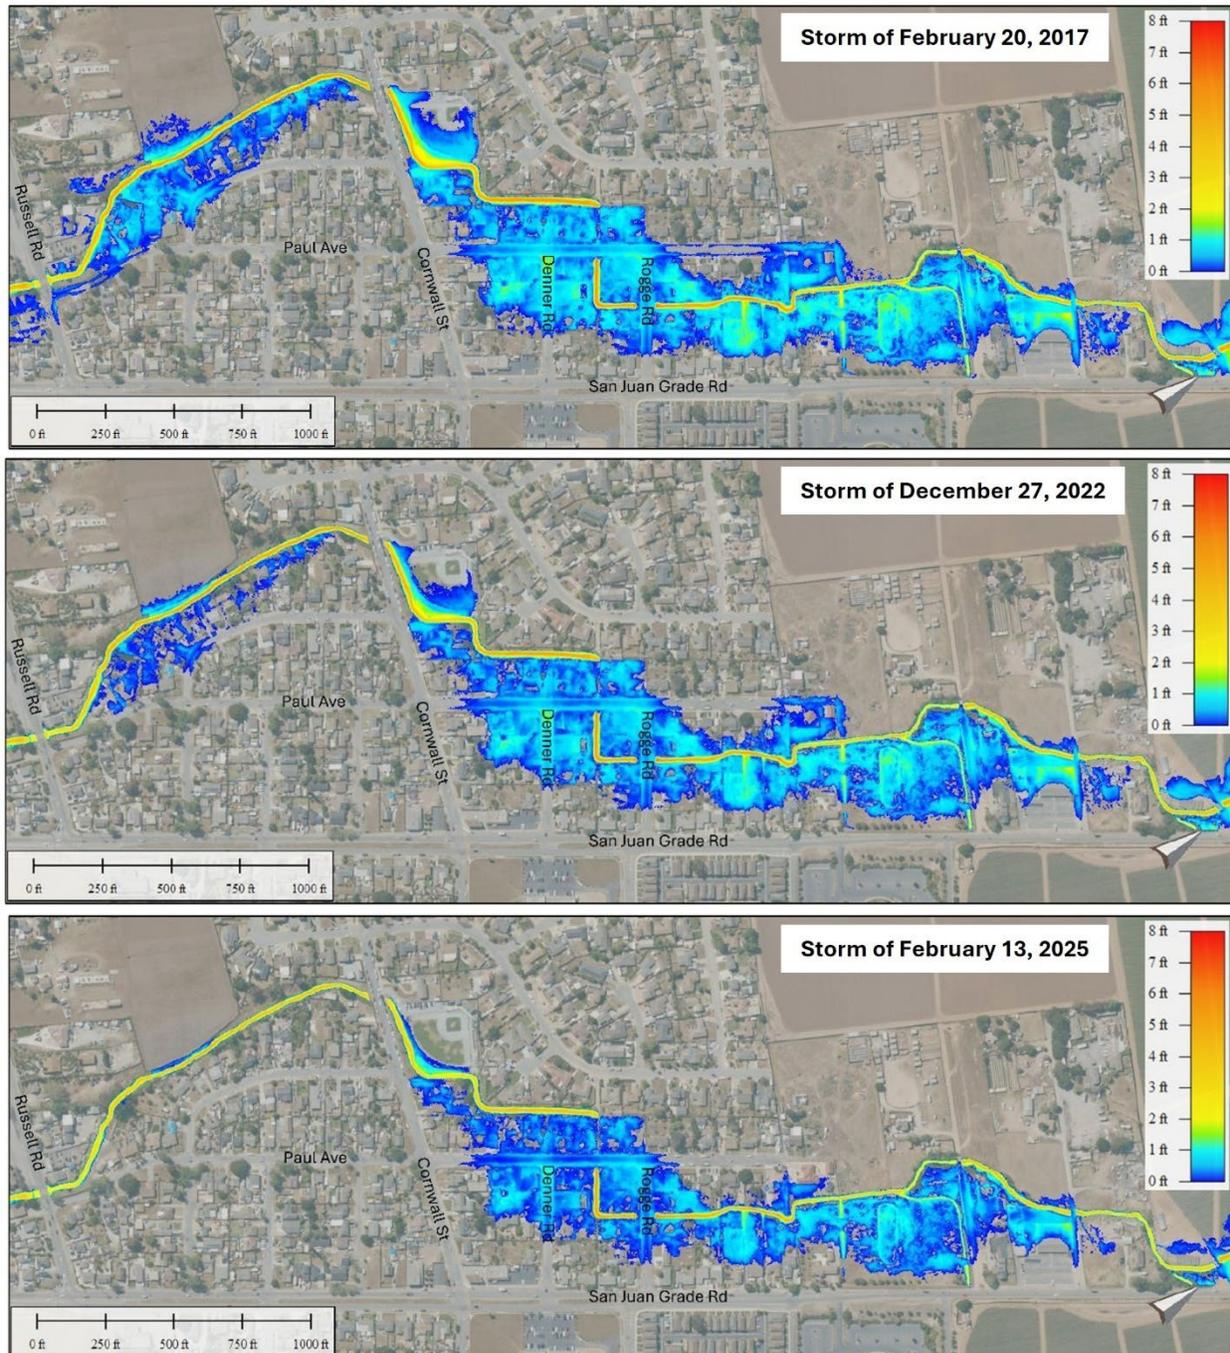
Figure 3-16 Existing conditions flood depths for historical calibration storms

100 cfs. These results are consistent with the Master Drainage Plan Santa Rita Creek Watershed (Monterey County Surveyors, 1972) that estimated a channel capacity along this reach, and all others downstream to Russell Road, of ± 100 cfs. These characteristics of flooding within Bolsa Knolls for the observed calibration storms are illustrated in the model output plots in **Figure 3-16**.

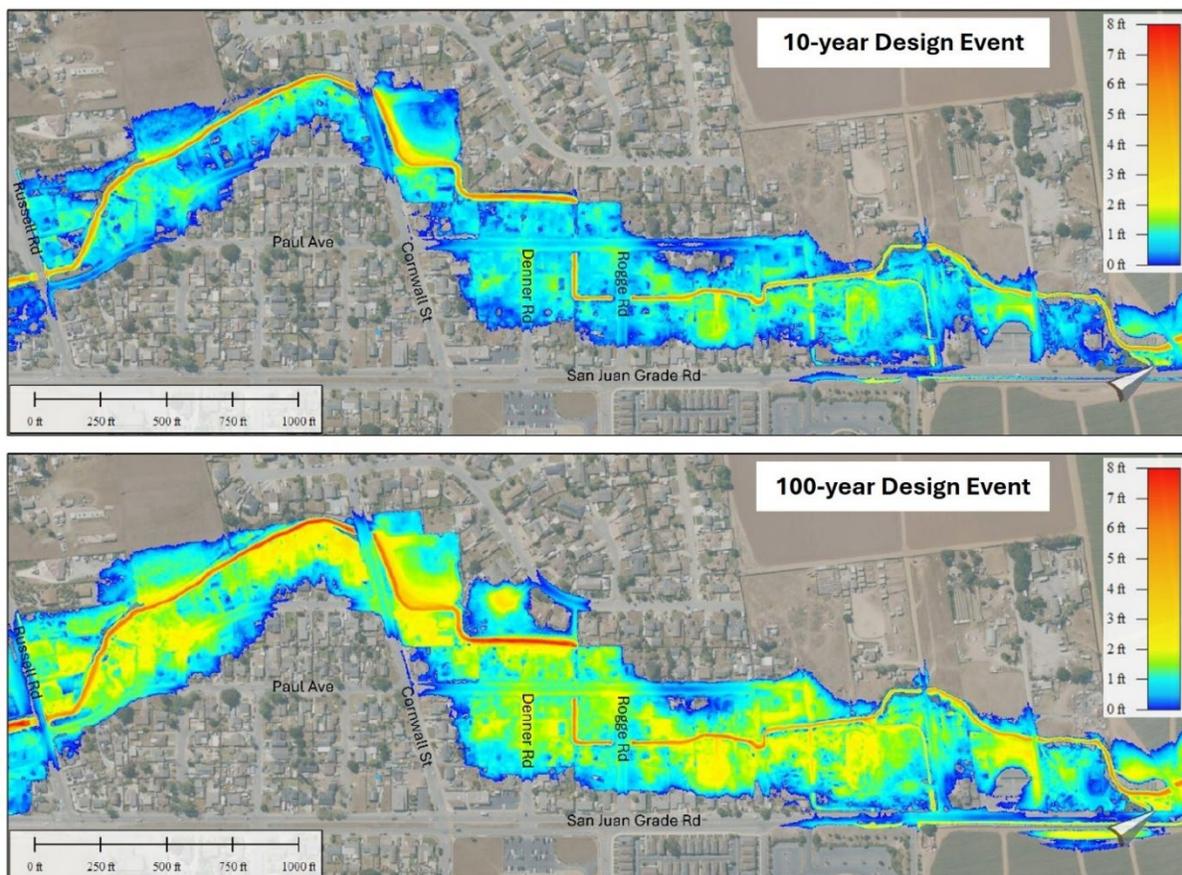
Figure 3-17 10- and 100-year design storm model output for existing conditions

Flooding extents and depths for the 10- and 100-year design floods are naturally markedly larger as shown in **Figure 3-17**.

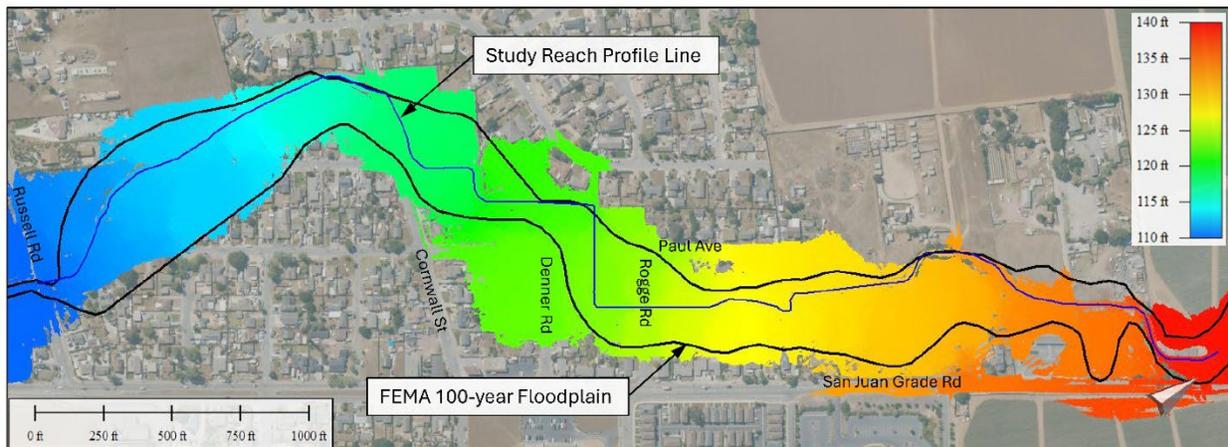
Figure 3-18 Modeled existing 100-year event compared to current FEMA mapping

A comparison between modeled 100-year flood extents and FEMA's mapped floodplain is shown in **Figure 3-18**. While the modeled extents generally indicate greater flood impacts, the FEMA 100-year water surface elevations are locally higher near Rogge Road and Paul Avenue. Upstream of Cornwall Street, the FEMA floodplain aligns more closely with the February 13, 2025, event than with the modeled 100-year scenario. However, in the Denner Road area, flooding observed and modeled from the relatively small February 2025 flood event extends significantly beyond the limits of the FEMA mapping.

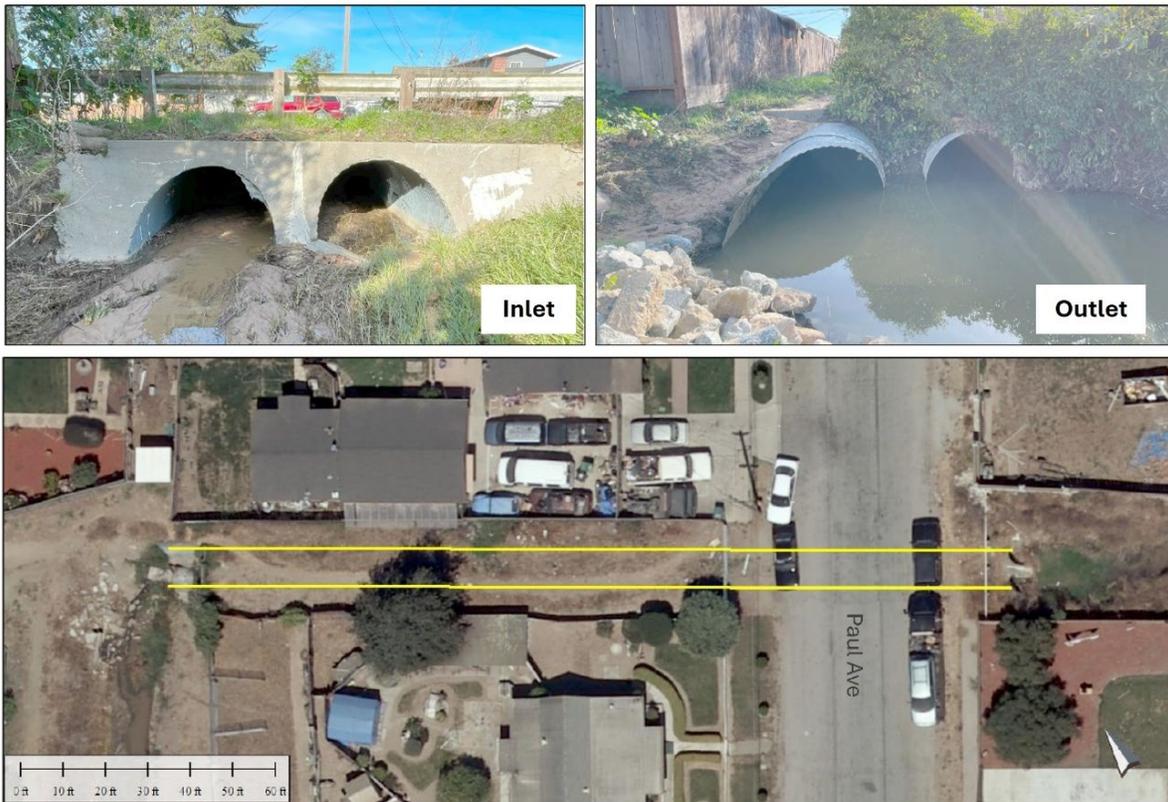
Figure 4-1 Photographs and plan view location of existing culverts at Paul Avenue

San Juan Acres Tract Map dated 1946 indicates that the downstream segment of the culverts lies within a 25-foot-wide drainage easement.

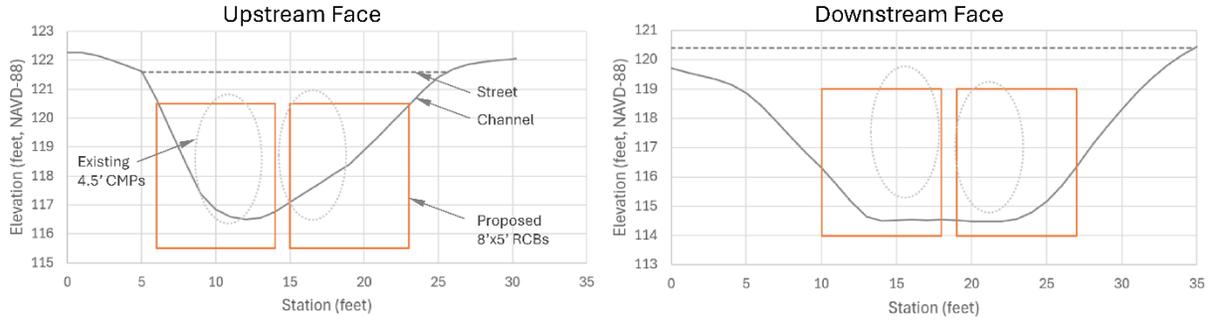
Figure 4-2 Proposed culvert sections at Paul Avenue

A conveyance enhancement project element would replace the existing CMPs with twin by 8-foot-wide by 5-foot-high reinforced concrete box culverts (RCBs). While these are smaller than those at Cornwall Street and Russell Road, they would be sized to fit within the available 25-foot easement. Should subsequent detailed engineering analyses demonstrate that twin 10-foot by 5-foot RCBs can be accommodated within the easement, that larger size would be preferable to further improve capacity. The invert elevations of the new culverts would need to be lowered below existing grade to maintain the necessary cover, as shown in the culvert section views included as **Figure 4-2**.

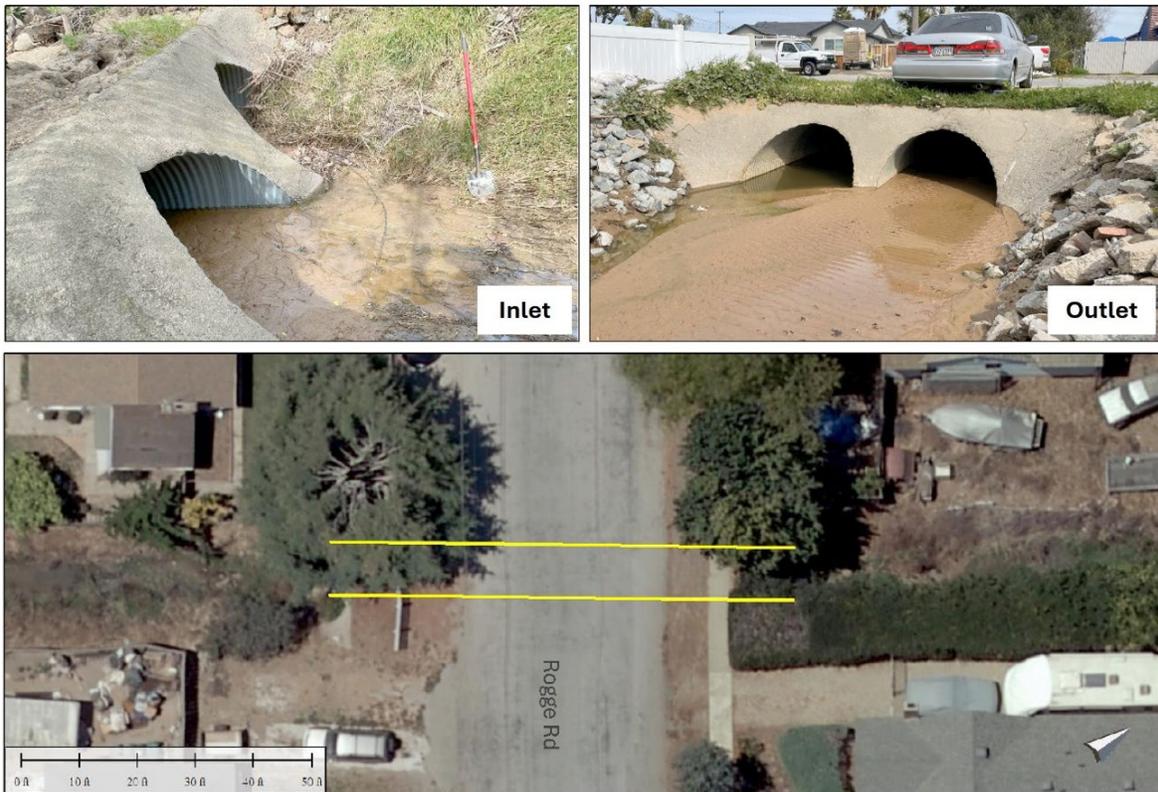
Figure 4-3 Photographs and plan view of existing culverts at Rogge Road

The Rogge Road crossing also comprises twin 4.5-foot CMPs, spanning 76 feet across the right-of-way and potentially extending into 25-foot drainage easements on either side. Photographic documentation and a plan view of the alignment are presented in **Figure 4-3**. As with Paul Avenue, ground cover above the culverts is limited, presenting a vertical constraint for any replacement design.

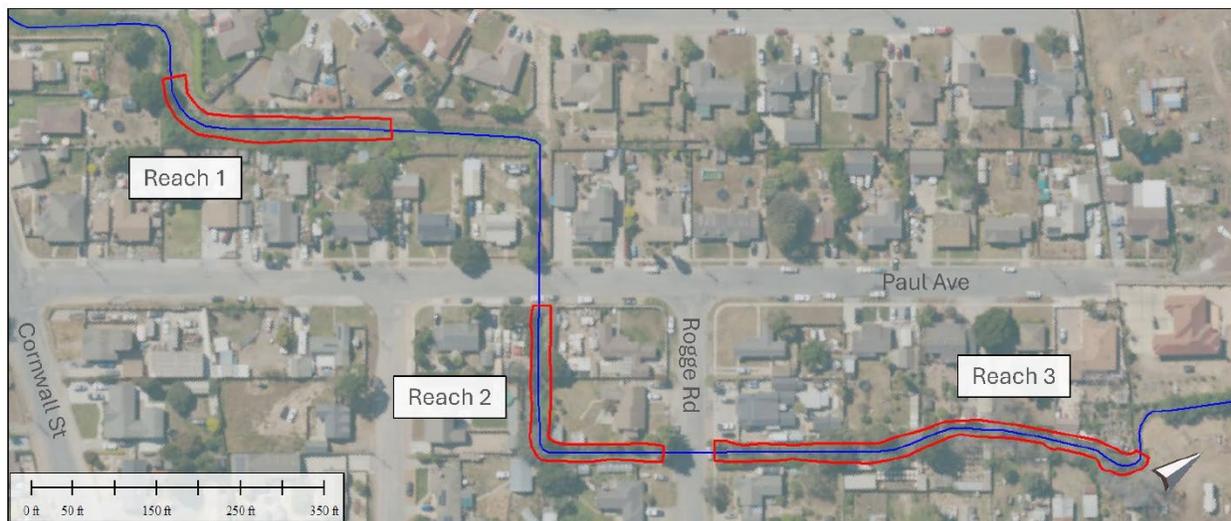
Figure 4-5 Targeted reaches for vegetation management

Field observations and aerial imagery have identified approximately 1,100 feet of channel, distributed across three reaches, with relatively dense vegetation growth (**Figure 4-5**). These areas have been parameterized in the hydraulic model with elevated Manning's 'n' values ranging from 0.055 to 0.06, reflecting increased surface roughness that reduces conveyance capacity and contributes to localized overtopping.
