SANTA RITA CREEK FLOOD STUDY

July 2025

© 2025 Balance Hydrologics, Inc.
Project Assignment: 224089

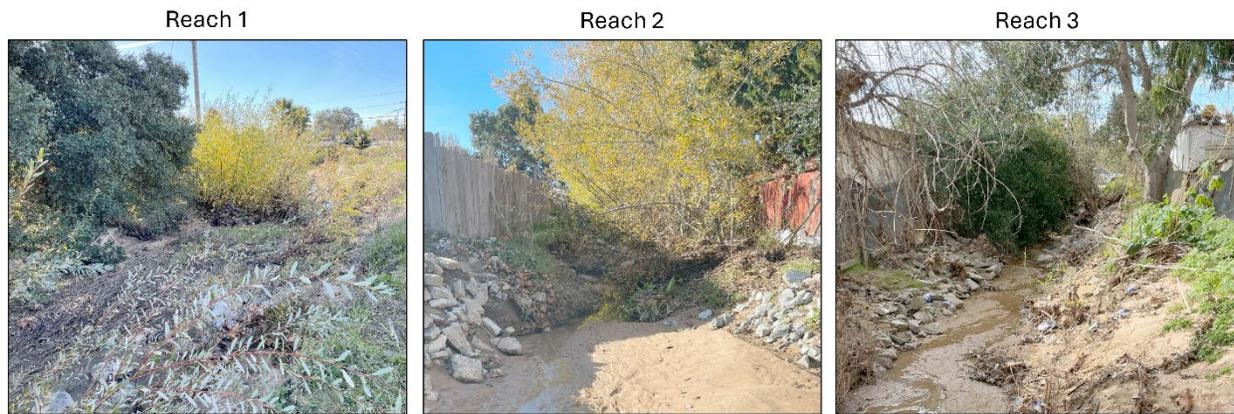
Figure 4-6 Existing vegetation within targeted reaches

The proposed vegetation management strategy would involve selective thinning rather than complete clearing. Vegetation that impedes flow would be removed to improve channel conveyance while maintaining riparian habitat function. Current vegetation conditions are illustrated in **Figure 4-6**, while **Figure 4-7** provides representative

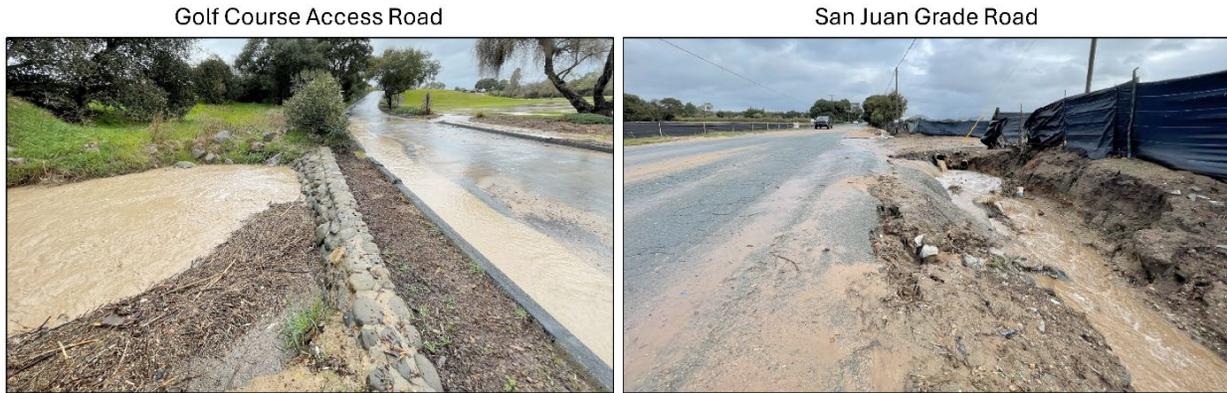
Figure 4-8 High turbidity and sediment deposits observed during the February 13, 2025, storm event

presented in **Figure 3-3** and **Figure 3-4**, while additional photographs illustrating turbidity and sediment deposits are included in **Figure 4-8**

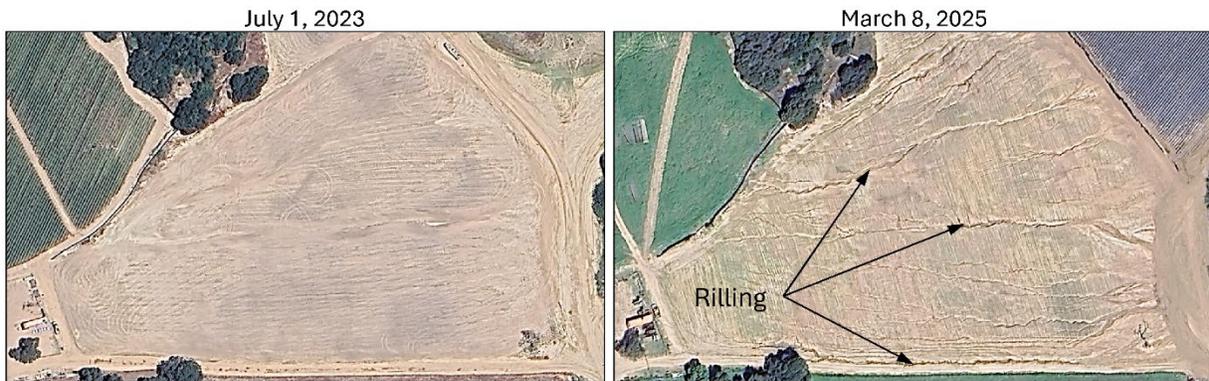
Figure 4-9 Example of a sediment source in the upper watershed

The primary source of sediment is almost certainly agricultural lands upstream in the watershed, particularly fields that are bare or situated on steeper slopes. An example of observed erosion from one such field, likely caused by the February 2025 event, is shown in **Figure 4-9**.

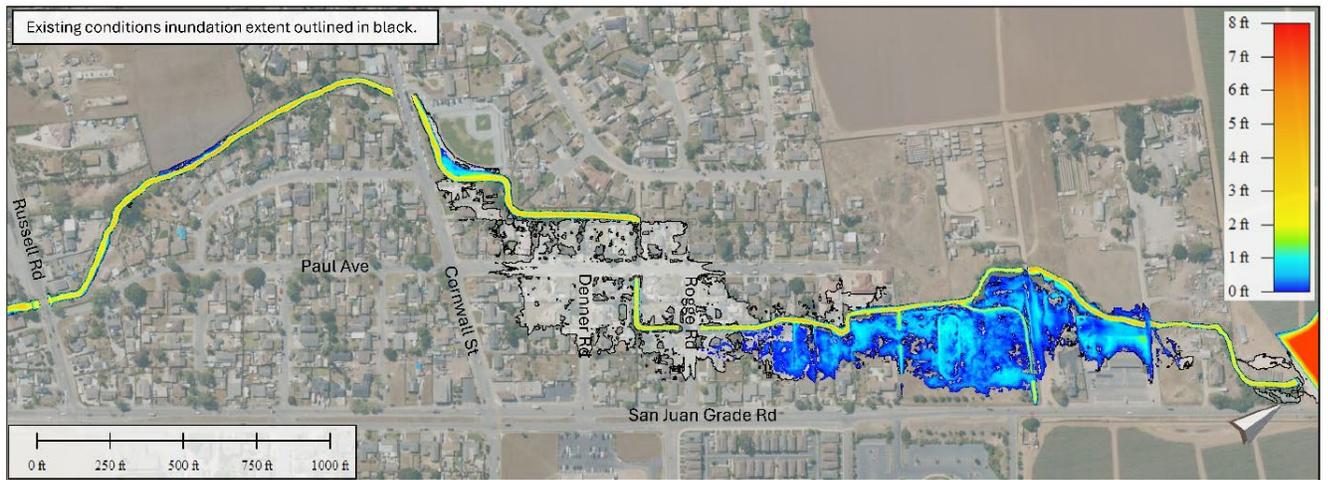
Figure 5-1 Modeled Alternative 1 flood depths compared to existing conditions inundation extents for the February 13, 2025, flood event

Model results indicate that Alternative 1 would eliminate overtopping during storms similar to the February 13, 2025, flood event along the channel reach through the medium-density residential area. Channel overtopping is still predicted in the low-density residential area at the upstream end of the study reach with excess flood flows conveyed across the overbank area toward Rogge Road. These outcomes are illustrated in **Figure 5-1**, which compares modeled flood depths for Alternative 1 with the existing conditions inundation extents for the February 2025 event. Additionally, **Figure 5-2** shows

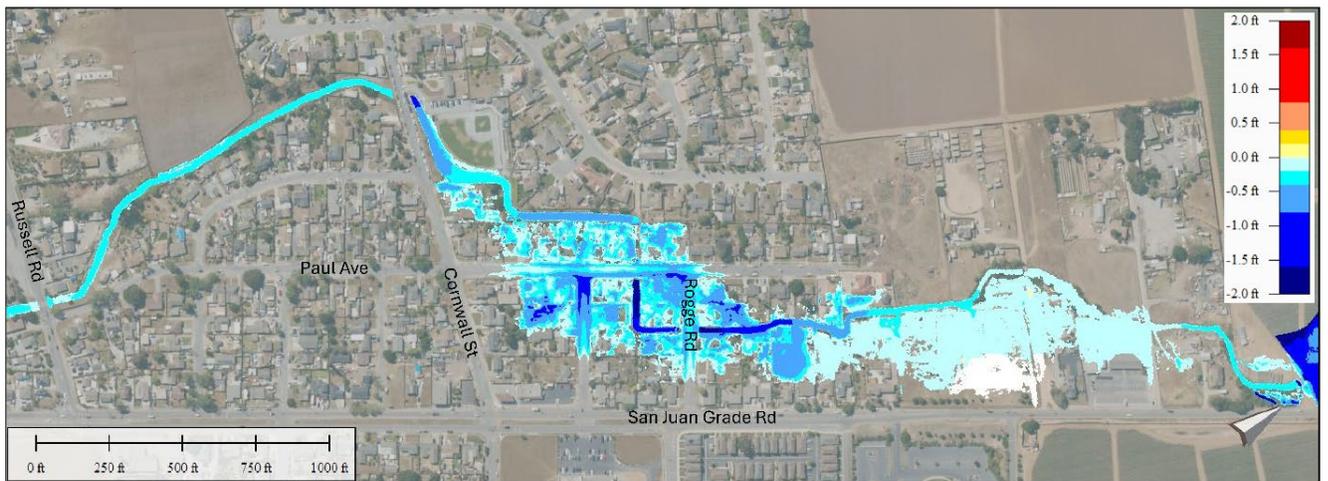
Figure 5-2 Modeled change in peak water surface elevations resulting from Alternative 1 during the February 13, 2025, flood event. Note shades of blue depict lowered water surface elevations and shades of red increased water surface elevations.

the corresponding change in water surface elevations, with reductions of up to 3.1 feet predicted upstream of the Paul Avenue crossing.

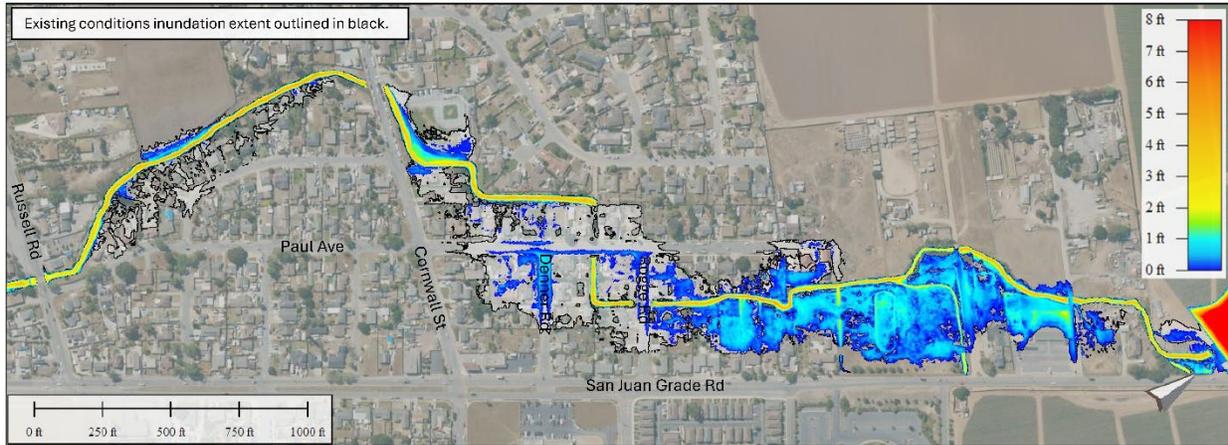
Figure 5-3 Modeled Alternative 1 flood depths compared to existing conditions inundation extents for the December 22, 2022, flood event

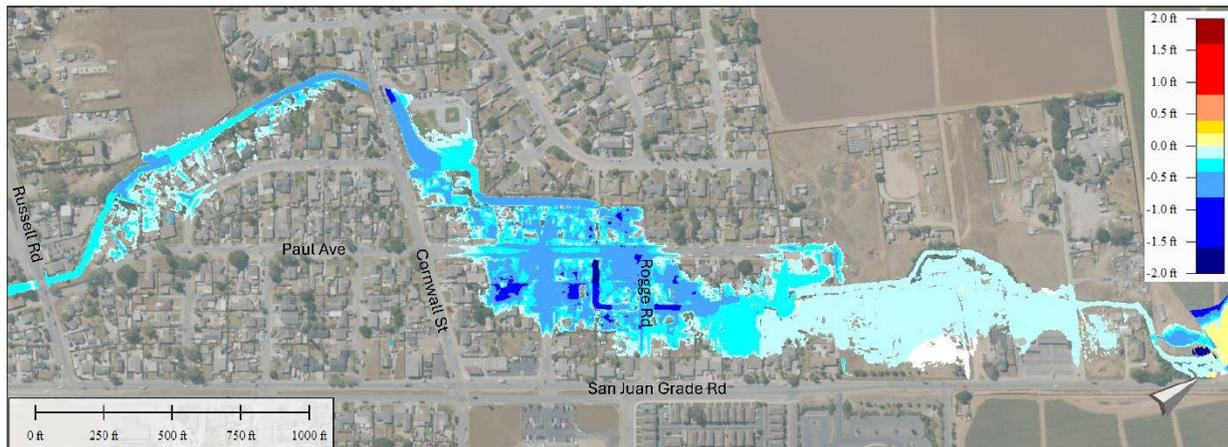
Figure 5-4 Modeled change in peak water surface elevations resulting from Alternative 1 during the December 22, 2022, flood event

lowered throughout the reach as shown on **Figure 5-4.**, with reductions of up to 2.8 feet predicted upstream of the Paul Avenue crossing.

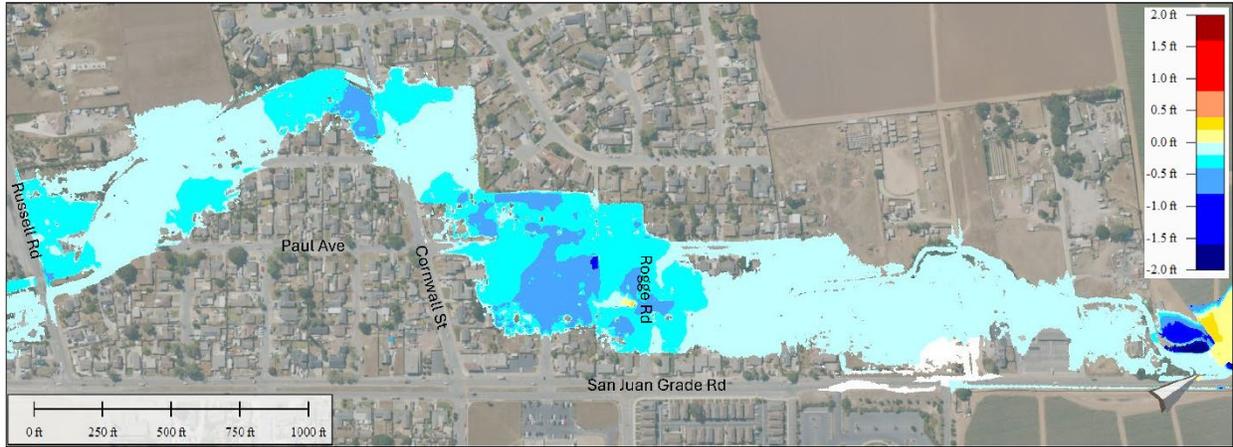
Figure 5-5 Modeled change in peak water surface elevations resulting from Alternative 1 during the 10-year flood event

For larger, less frequent events such as the 10- and 100-year design storms, flood reduction benefits would be more modest. Water surface elevations would be reduced by several tenths of a foot, as illustrated in **Figure 5-5** and **Figure 5-6**. Importantly, no adverse downstream impacts are predicted beyond Russell Road for any of the modeled scenarios (i.e. the modeling predicts no increase in peak flow rate or inundation area down to Highway 101).

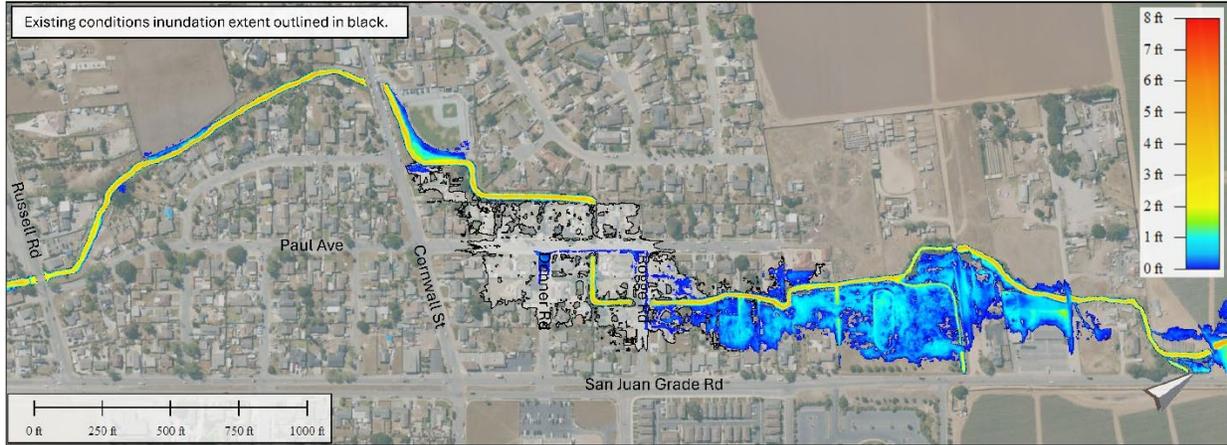
Figure 5-7 Modeled Alternative 2 flood depths compared to existing conditions inundation extents for the February 13, 2025, flood event

Modeling of the removal of sediment management elements as per Alternative 2 results in reduced predicted flood control benefits compared to those predicted with Alternative 1. Nevertheless, modeling of the February 13, 2025, flood event shows that Alternative 2 could still substantially reduce overtopping through the medium-density residential area, with only minor flooding predicted, as illustrated in **Figure 5-7**. Similar reductions in performance relative to Alternative 1 are observed for the December 2022 event as well as the 10- and 100-year design storms.

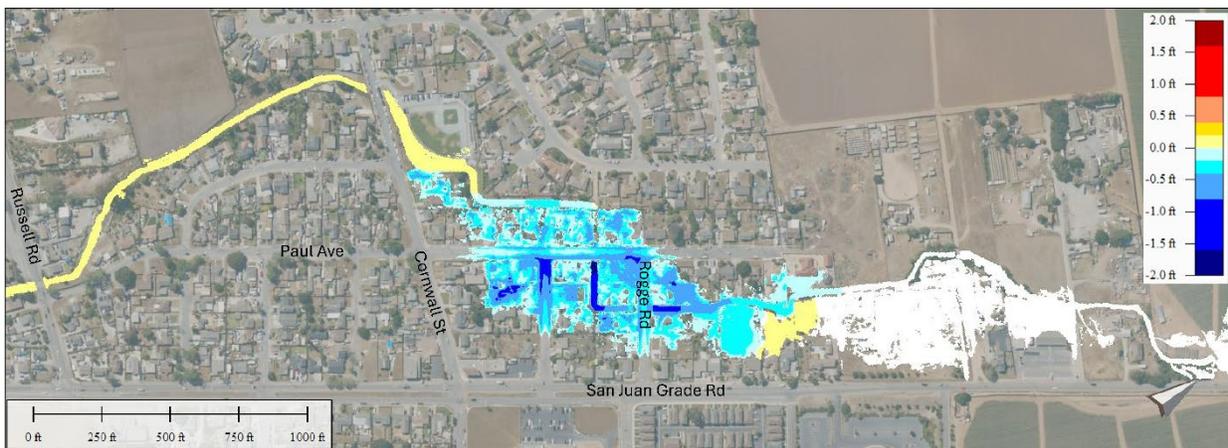
Figure 5-8 Modeled change in peak water surface elevations resulting from Alternative 2 during the February 13, 2025, flood event

Unlike Alternative 1, Alternative 2 is predicted to cause slight increases in water surface elevations, up to 0.09 feet, between Paul Avenue and Highway 101 during the February 2025 flood event. These increases are shown in the change in water surface elevation plot included as **Figure 5-8**. Similar effects are predicted for the December 2022 event. These increases can be attributed to less runoff stored in the reduced floodplain inundation area within the study reach, which would otherwise contribute to peak flow attenuation. While this effect also occurs with Alternative 1, the modeling indicates it would be offset by the attenuation benefits provided by the sediment retention basin in that alternative.

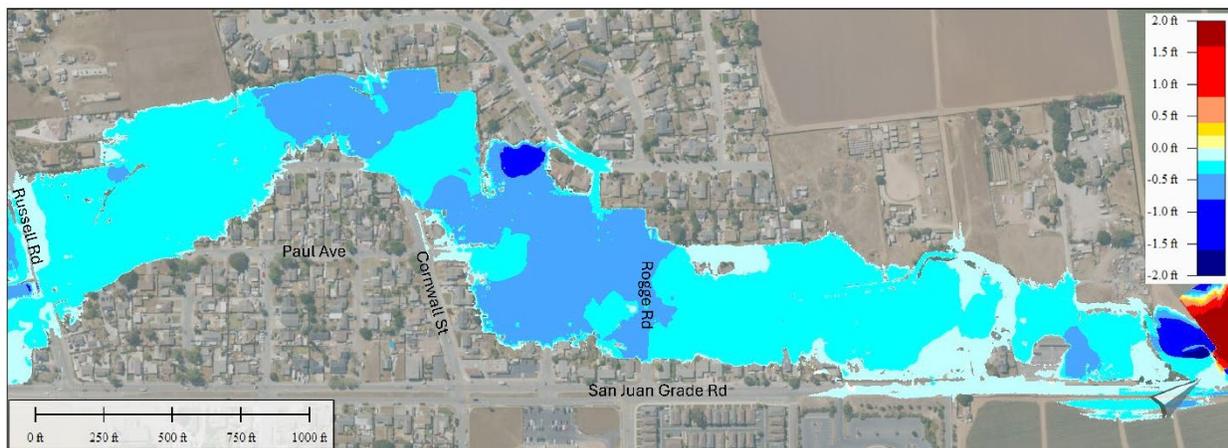
Figure 5-10 Modeled change in peak water surface elevations resulting from Alternative 3 during the 100-year flood event

The 35-acre-foot basin included with Alternative 3 was configured in the modeling to lower peak flow rates at the upstream end of the study reach by 27, 27, 35, and 22 percent for the February 13, 2025; December 27, 2022; and 10- and 100-year design storm events respectively. These reductions result in enhanced flood mitigation benefits throughout the study reach, including for the larger 10- and 100-year events. The associated decreases in water surface elevations are illustrated in **Figure 5-9** and **Figure 5-10**. Importantly, the model predicts no adverse downstream flood impacts beyond the study reach under any of the flood scenarios evaluated.

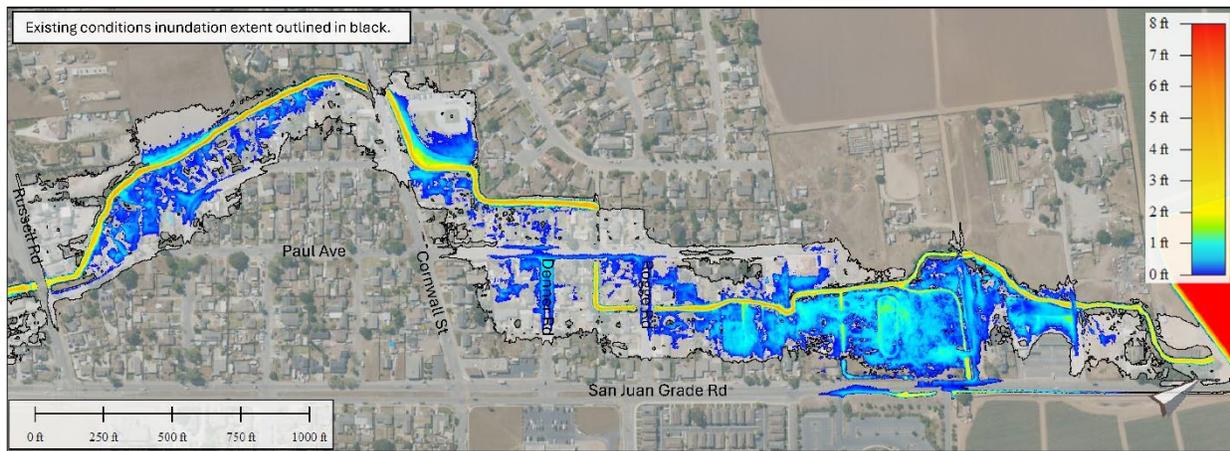
Figure 5-11 Modeled Alternative 4 flood depths compared to existing conditions inundation extents for the 10-year flood event

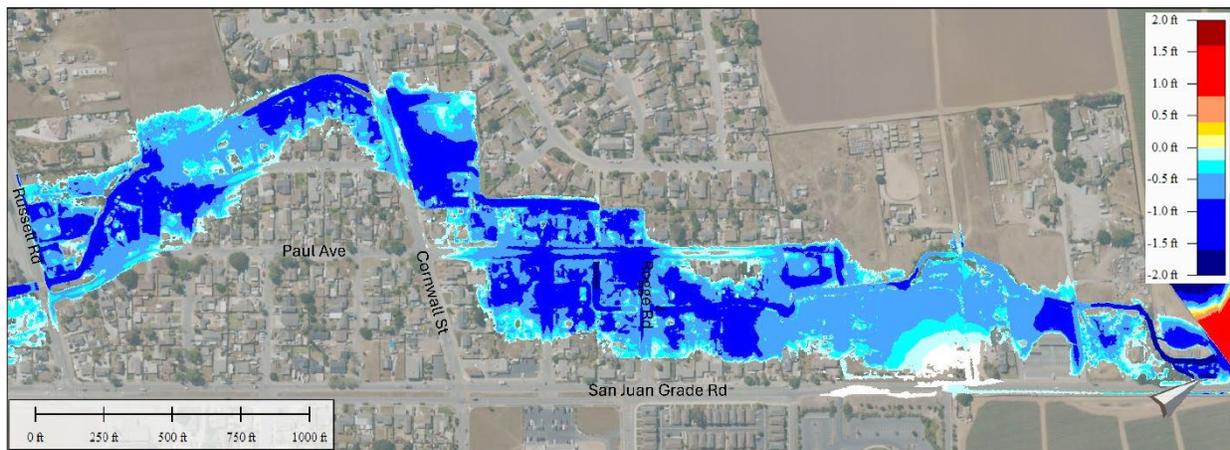
Figure 5-12 Modeled change in peak water surface elevations resulting from Alternative 4 during the 10-year flood event

The 90-acre-foot basin included with Alternative 3 is modeled to lower peak flow rates at the upstream end of the study reach by 44, 66, and 65 percent for the February 13, 2025; December 27, 2022; and 10- and 100-year design storm events respectively. These additional reductions in peak flow rates are predicted to be large enough to eliminate channel overtopping through the medium-density residential portion of the study reach for the February 2025 and December 2022 events and significantly reduce the modeled inundation extents during the 10-year flood event as illustrated by **Figure 5-11**. Change in water surface elevation plots for the 10- and 100-year flood events are included as **Figure 5-12** and **Figure 5-13**.

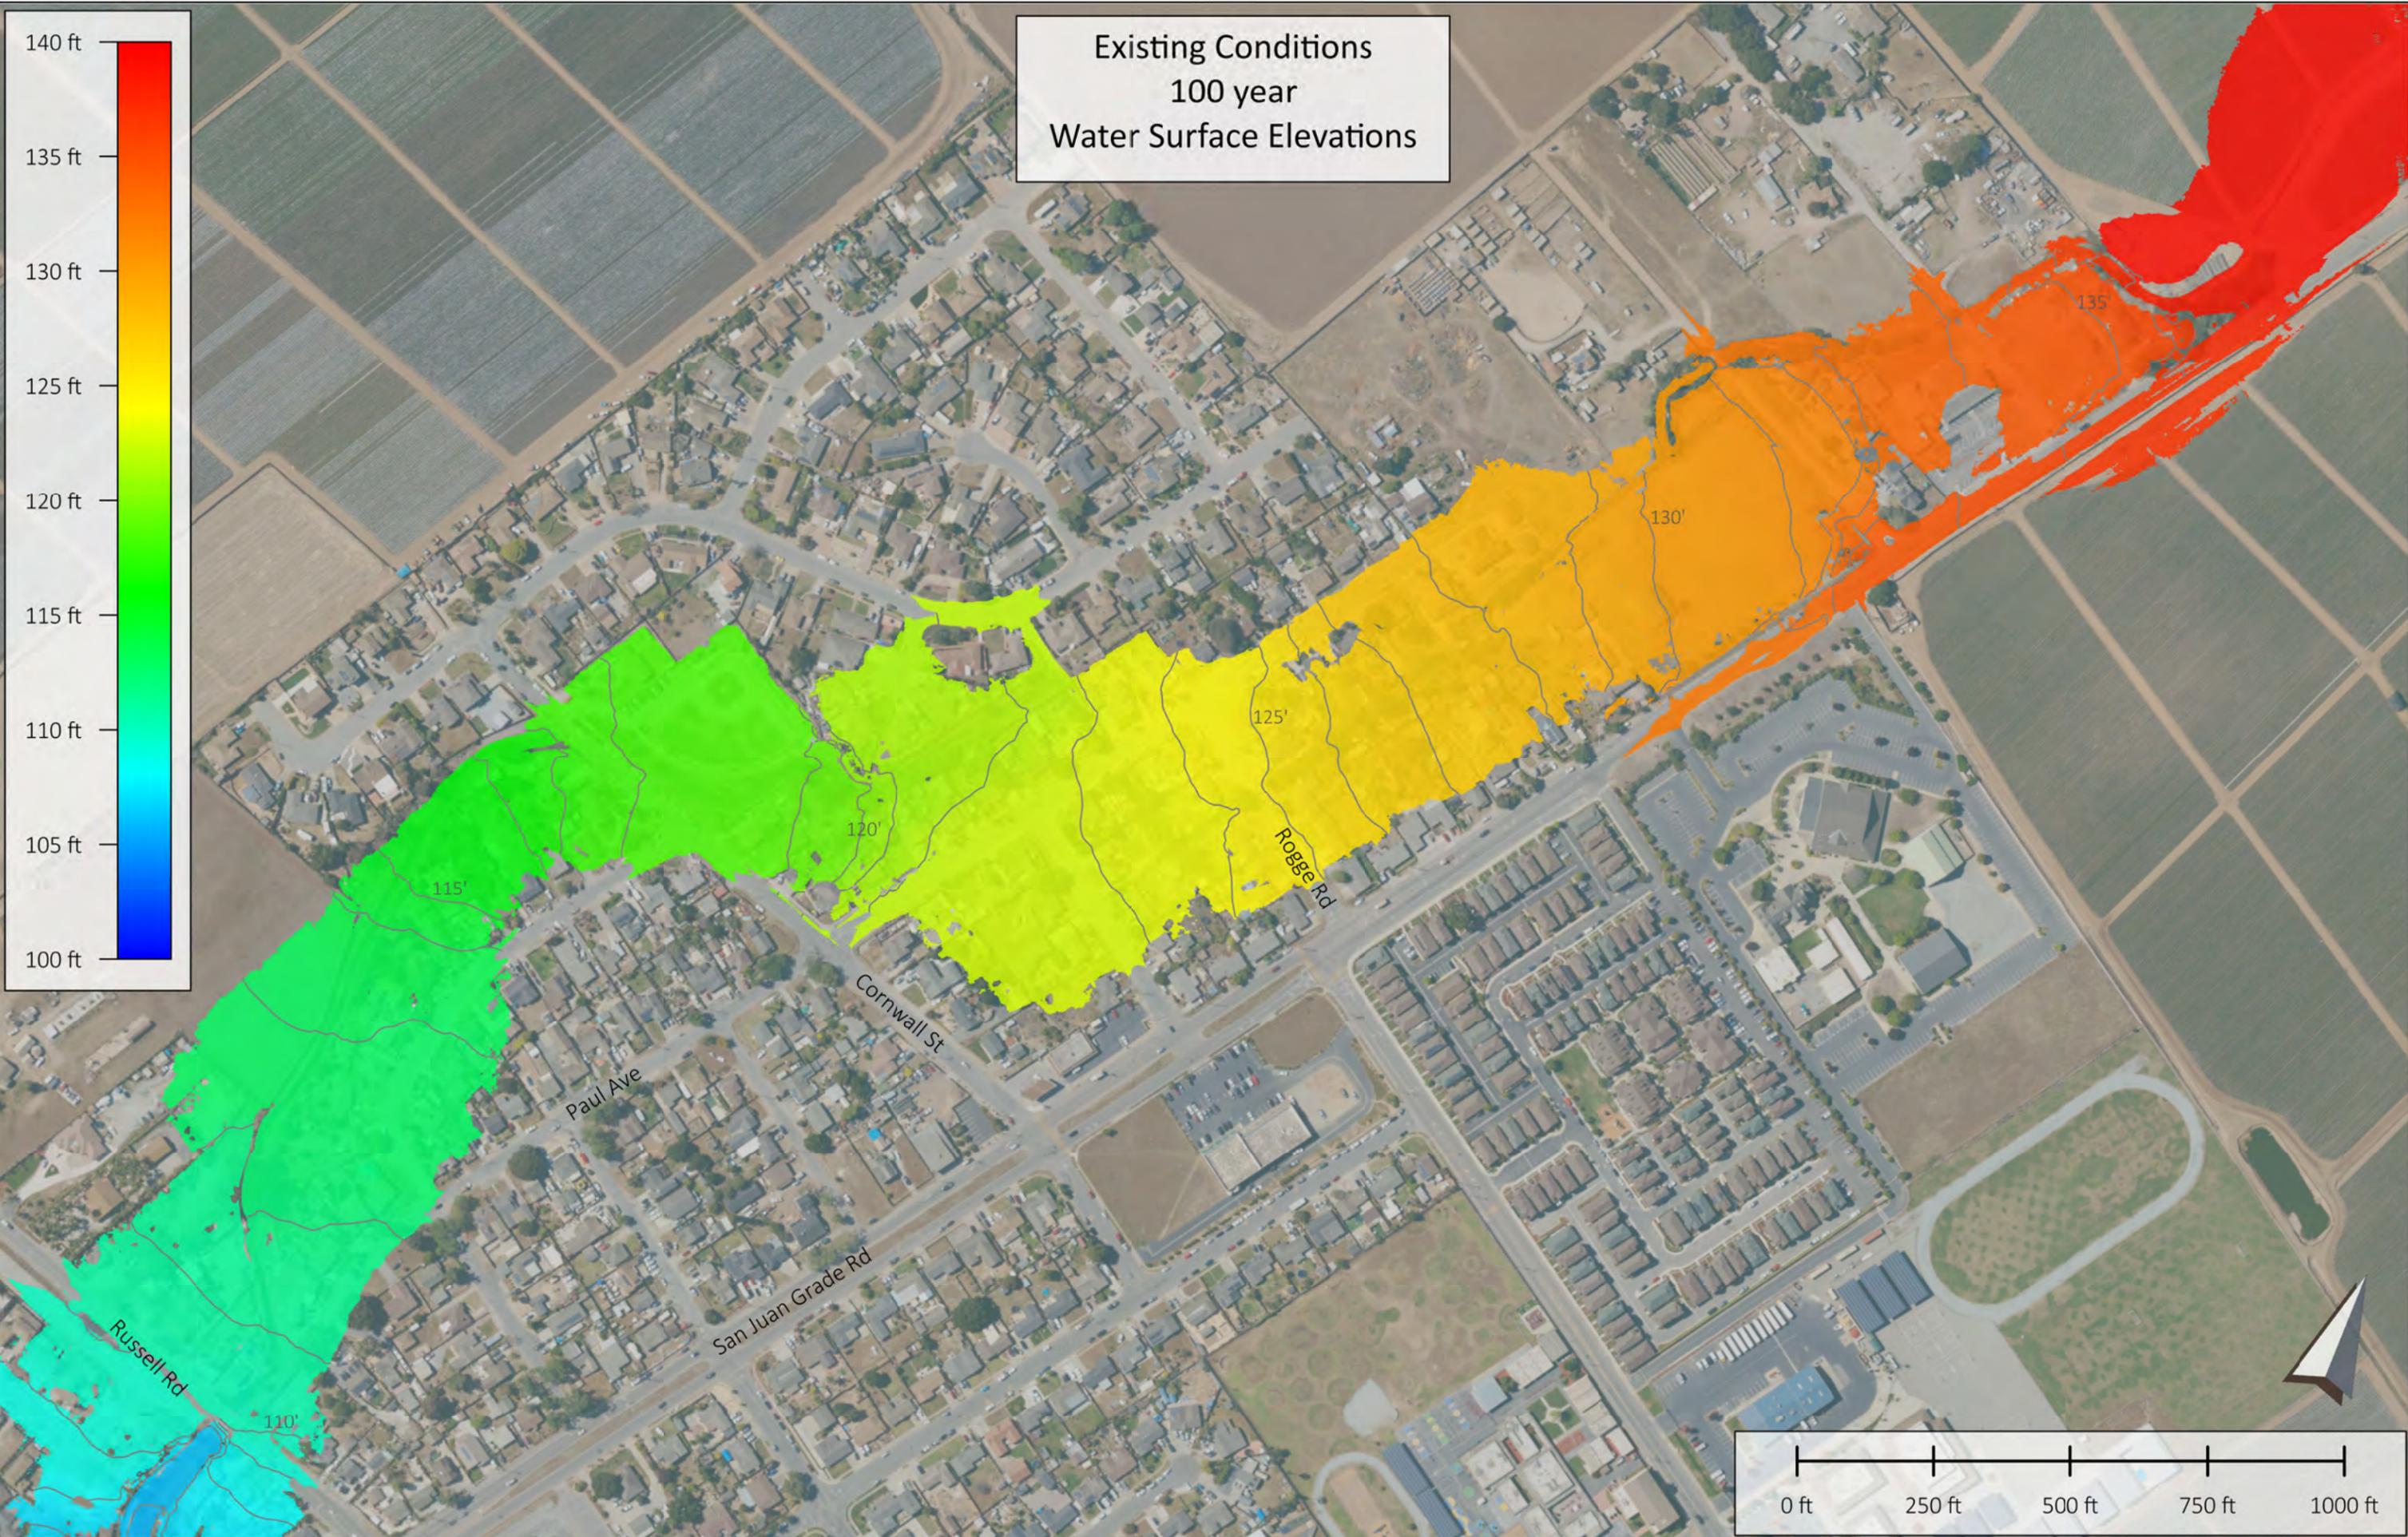
Existing Conditions
100 year
Water Surface Elevations

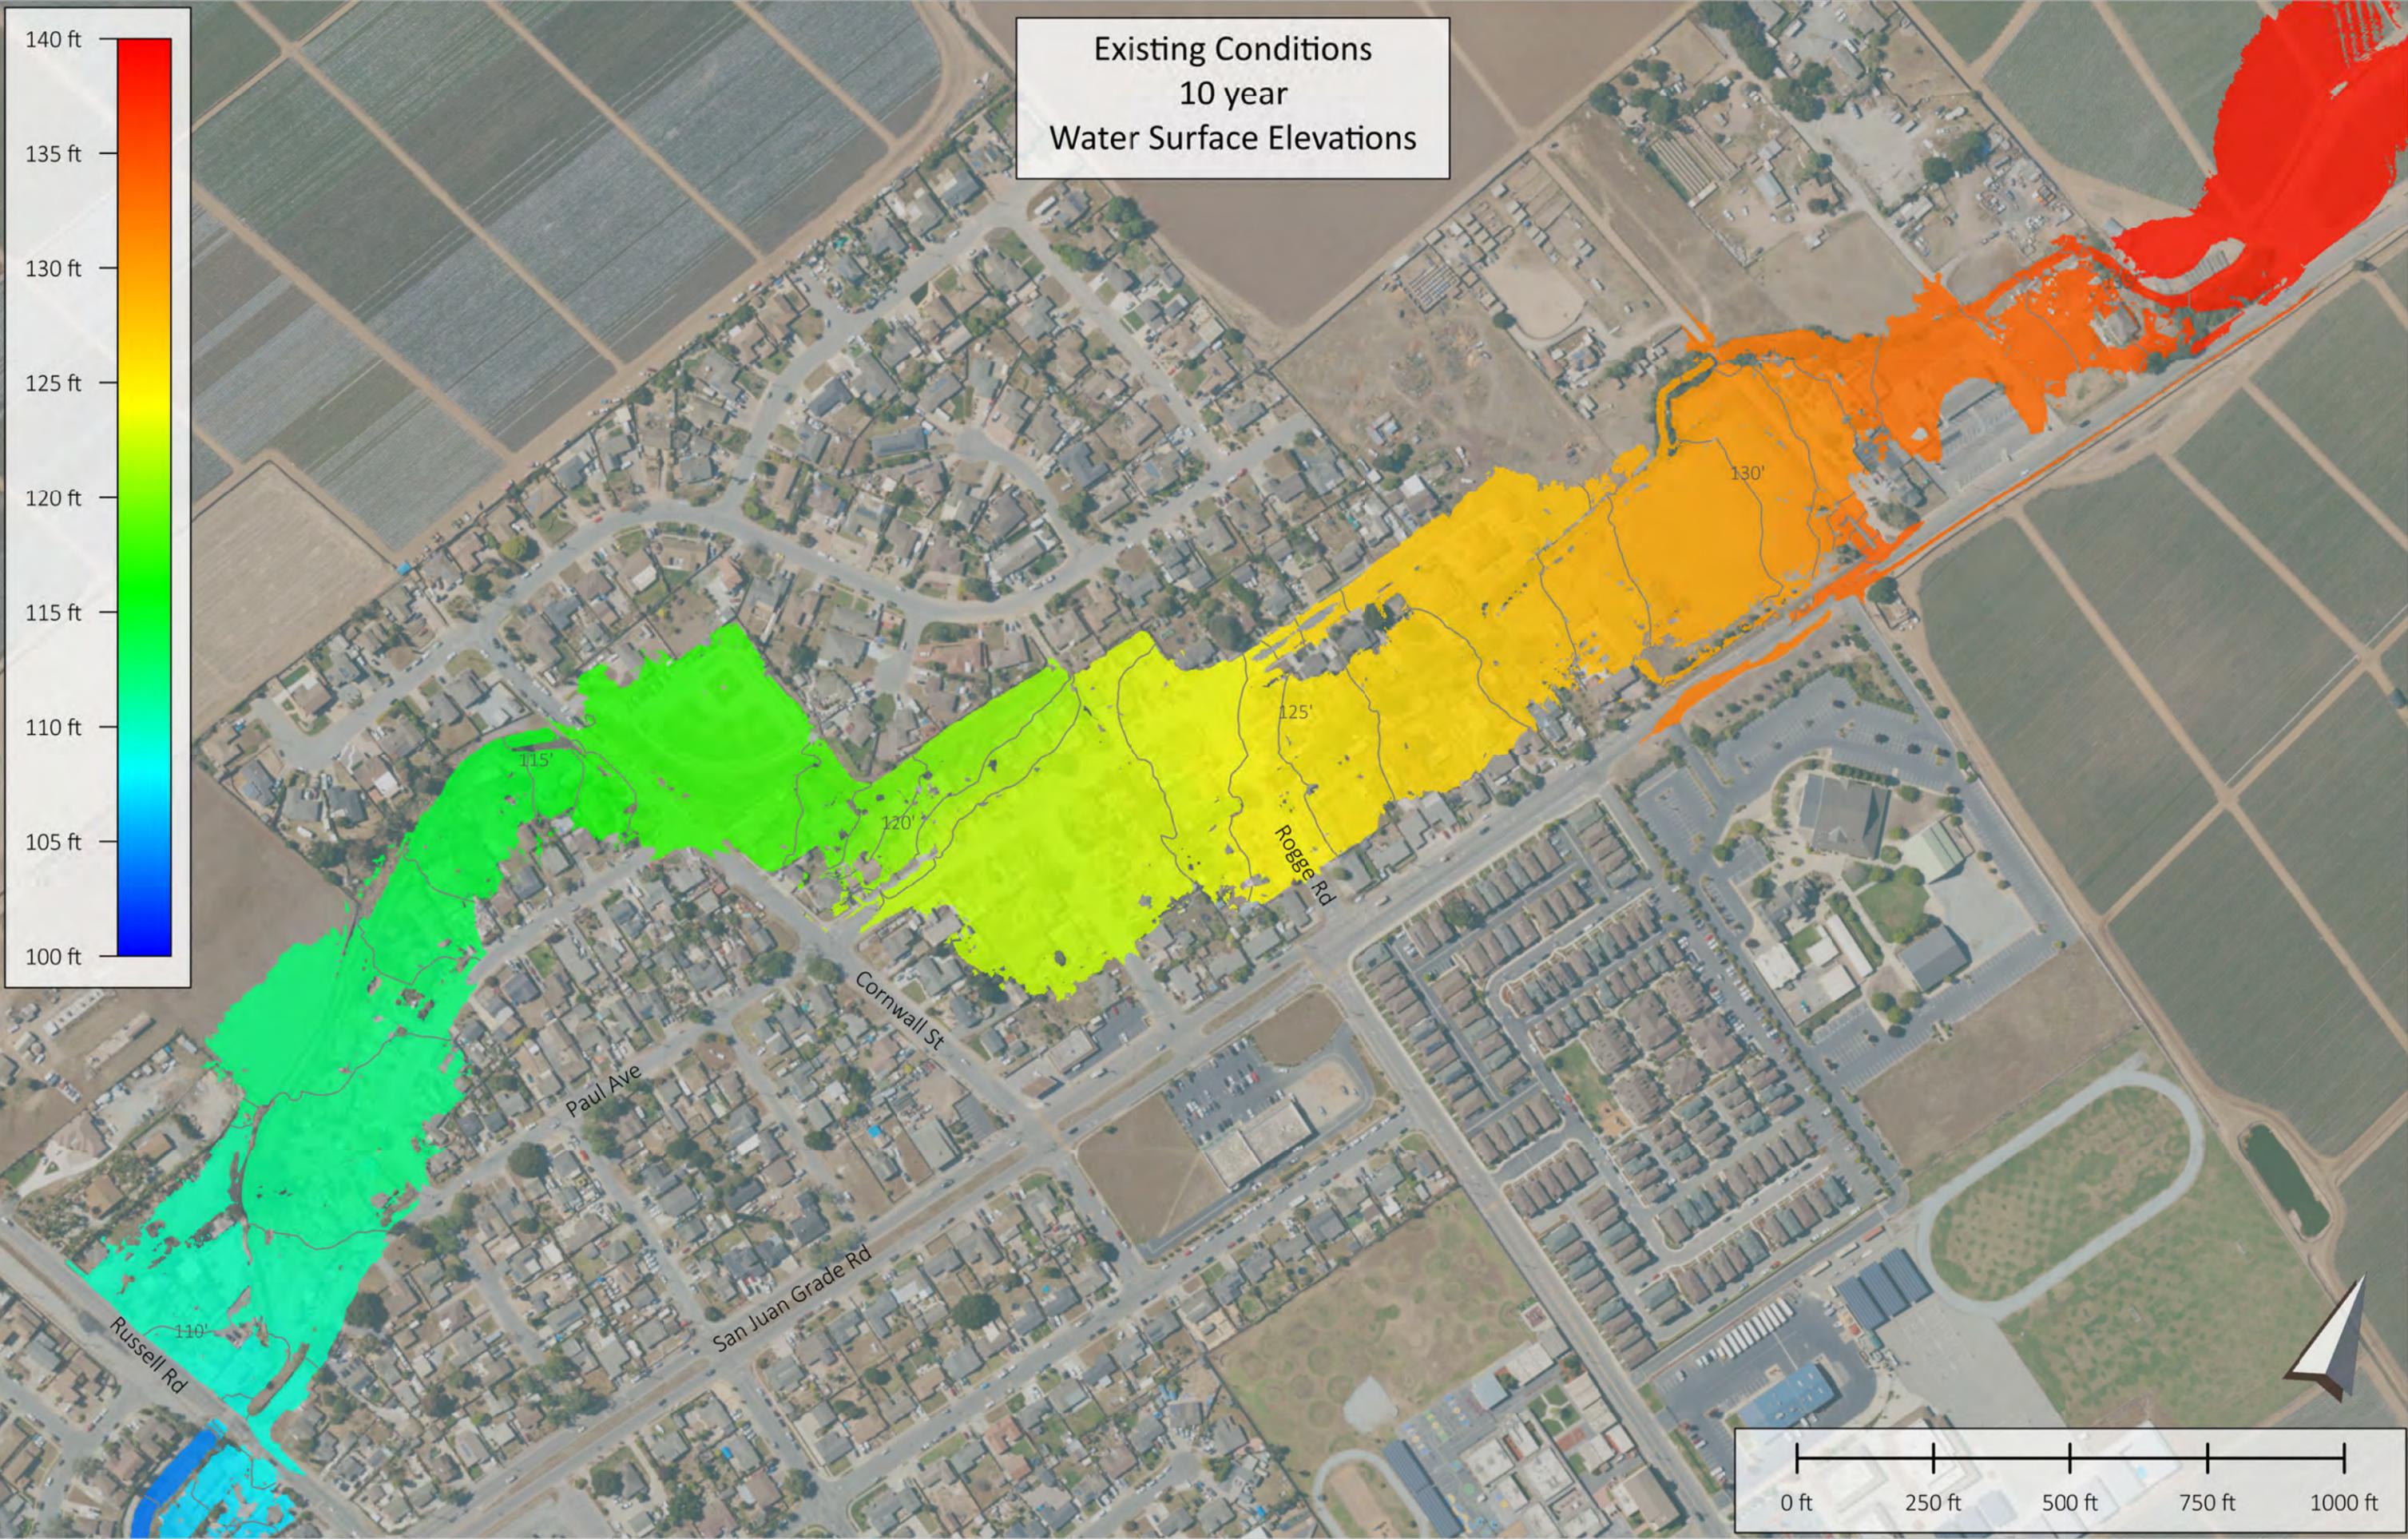
Existing Conditions
10 year
Water Surface Elevations

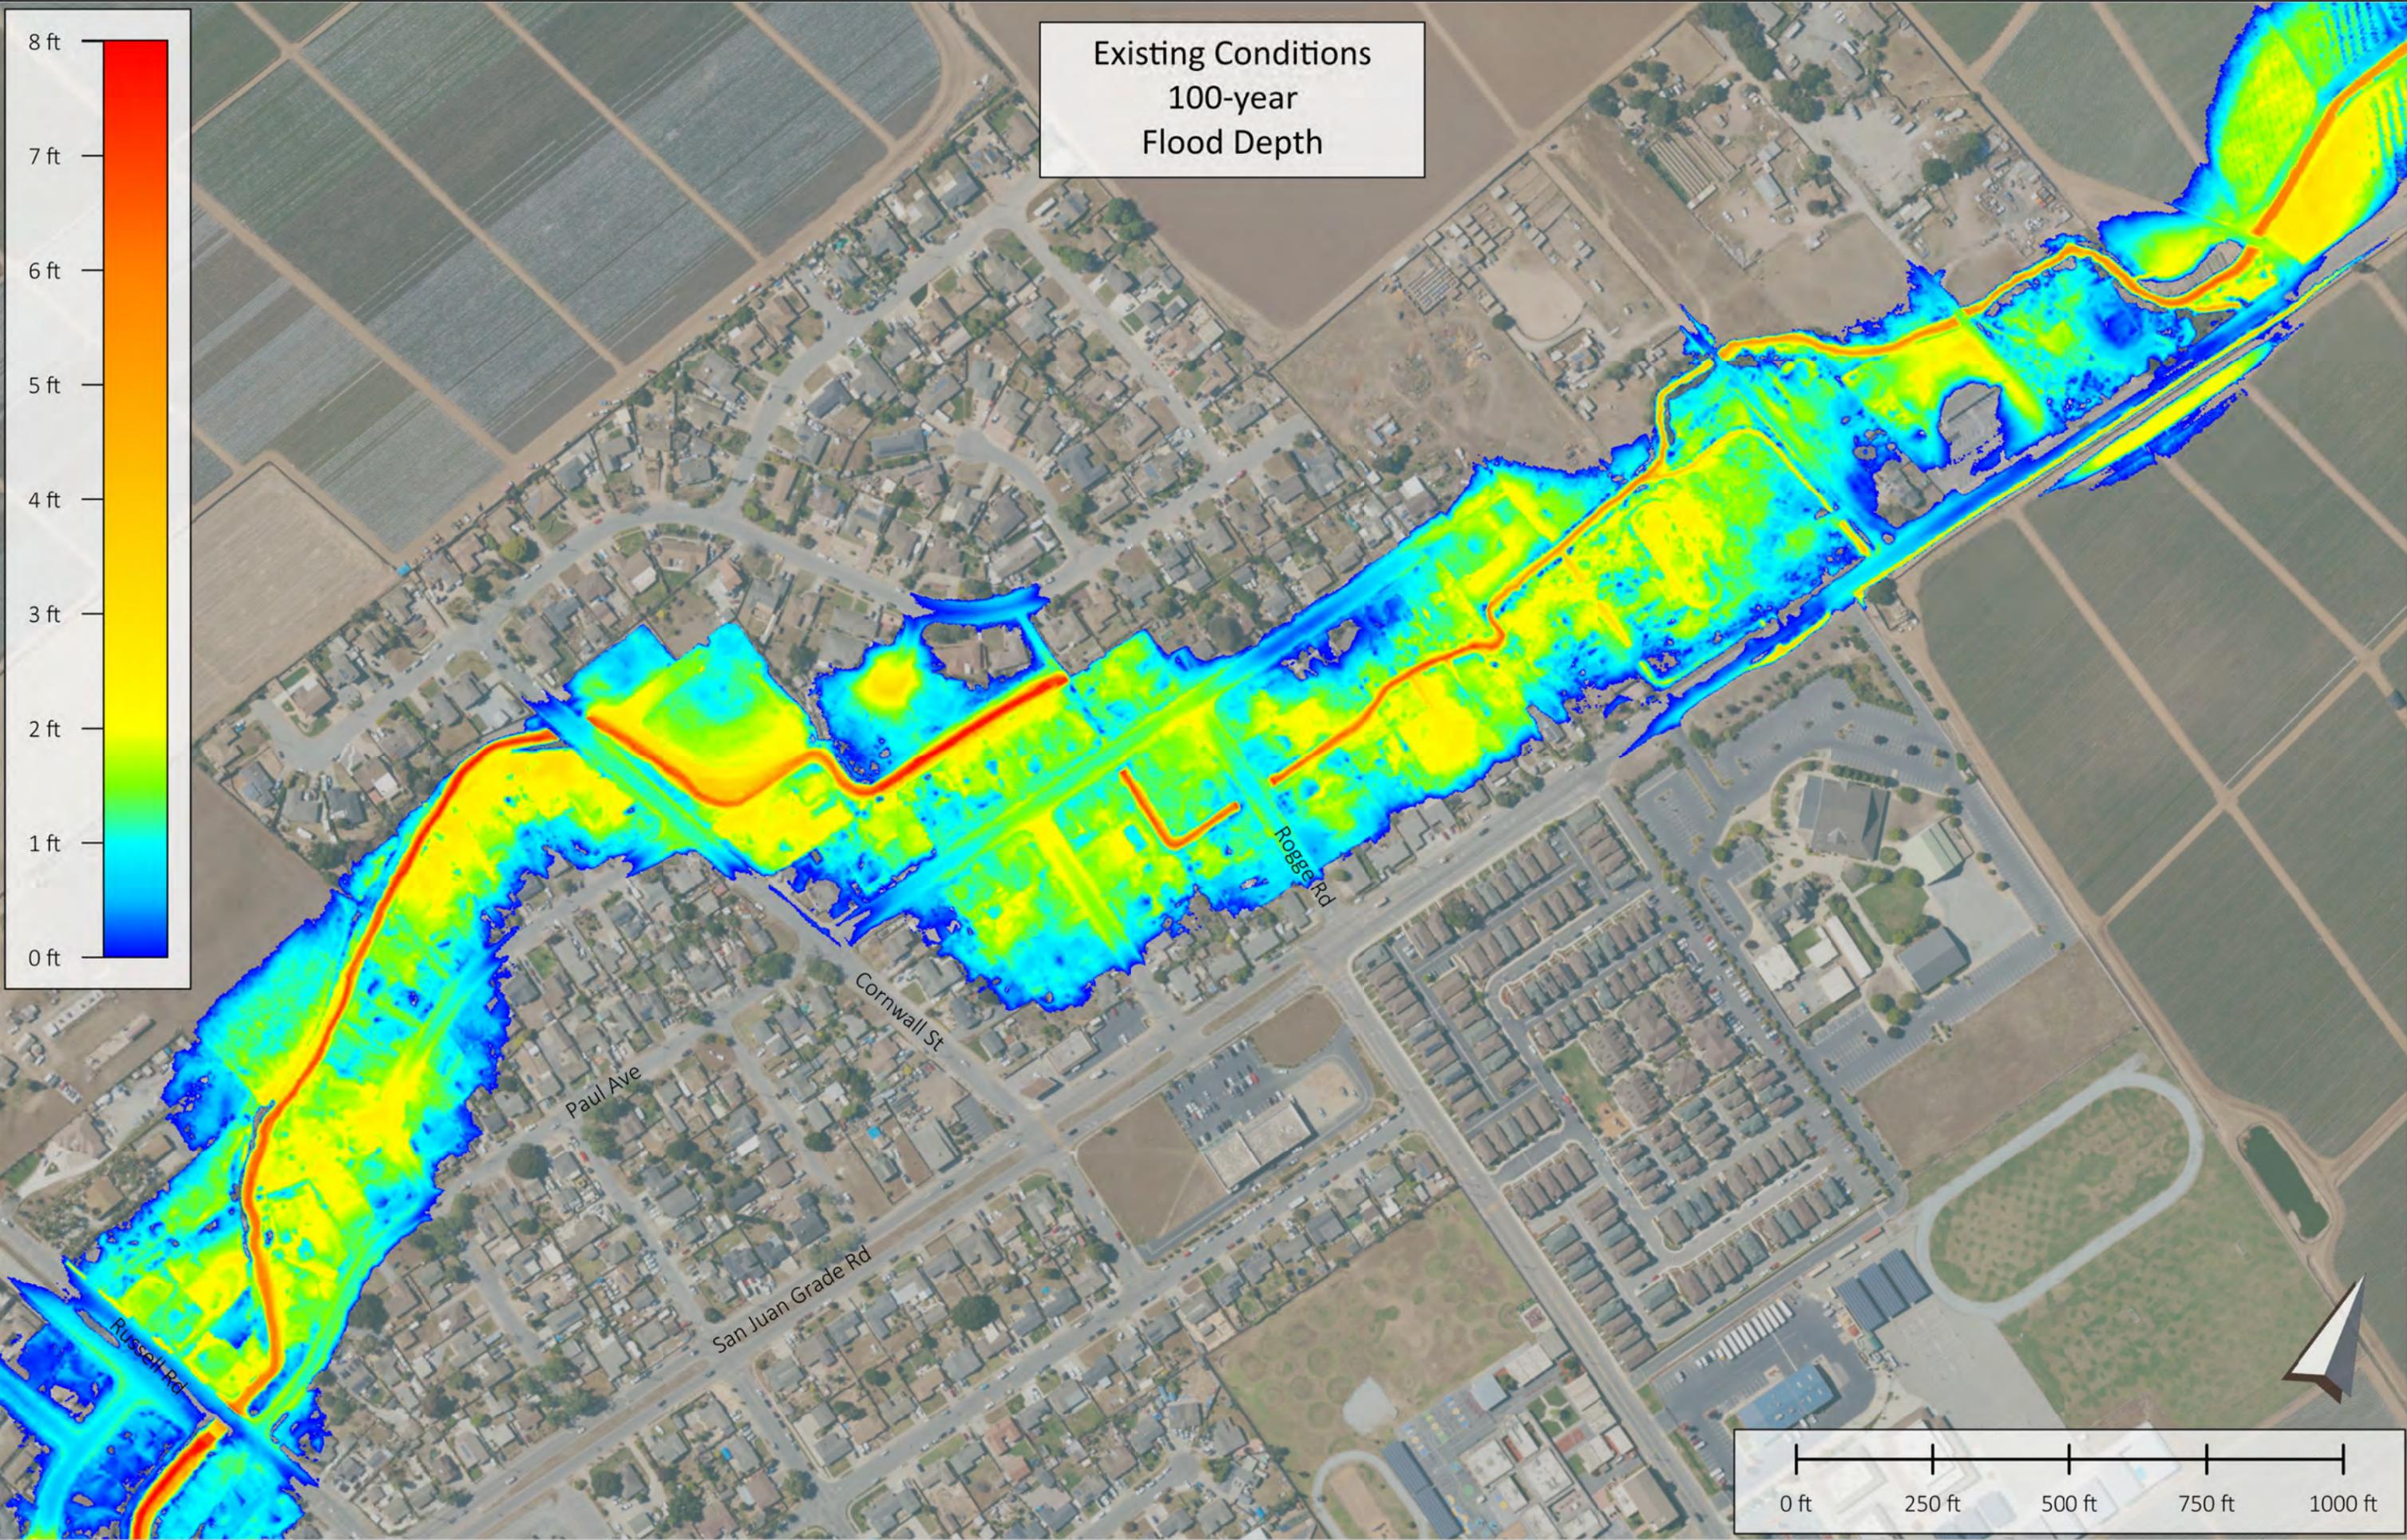
Existing Conditions
100-year
Flood Depth
