SANTA RITA CREEK FLOOD STUDY

July 2025

© 2025 Balance Hydrologics, Inc.
Project Assignment: 224089

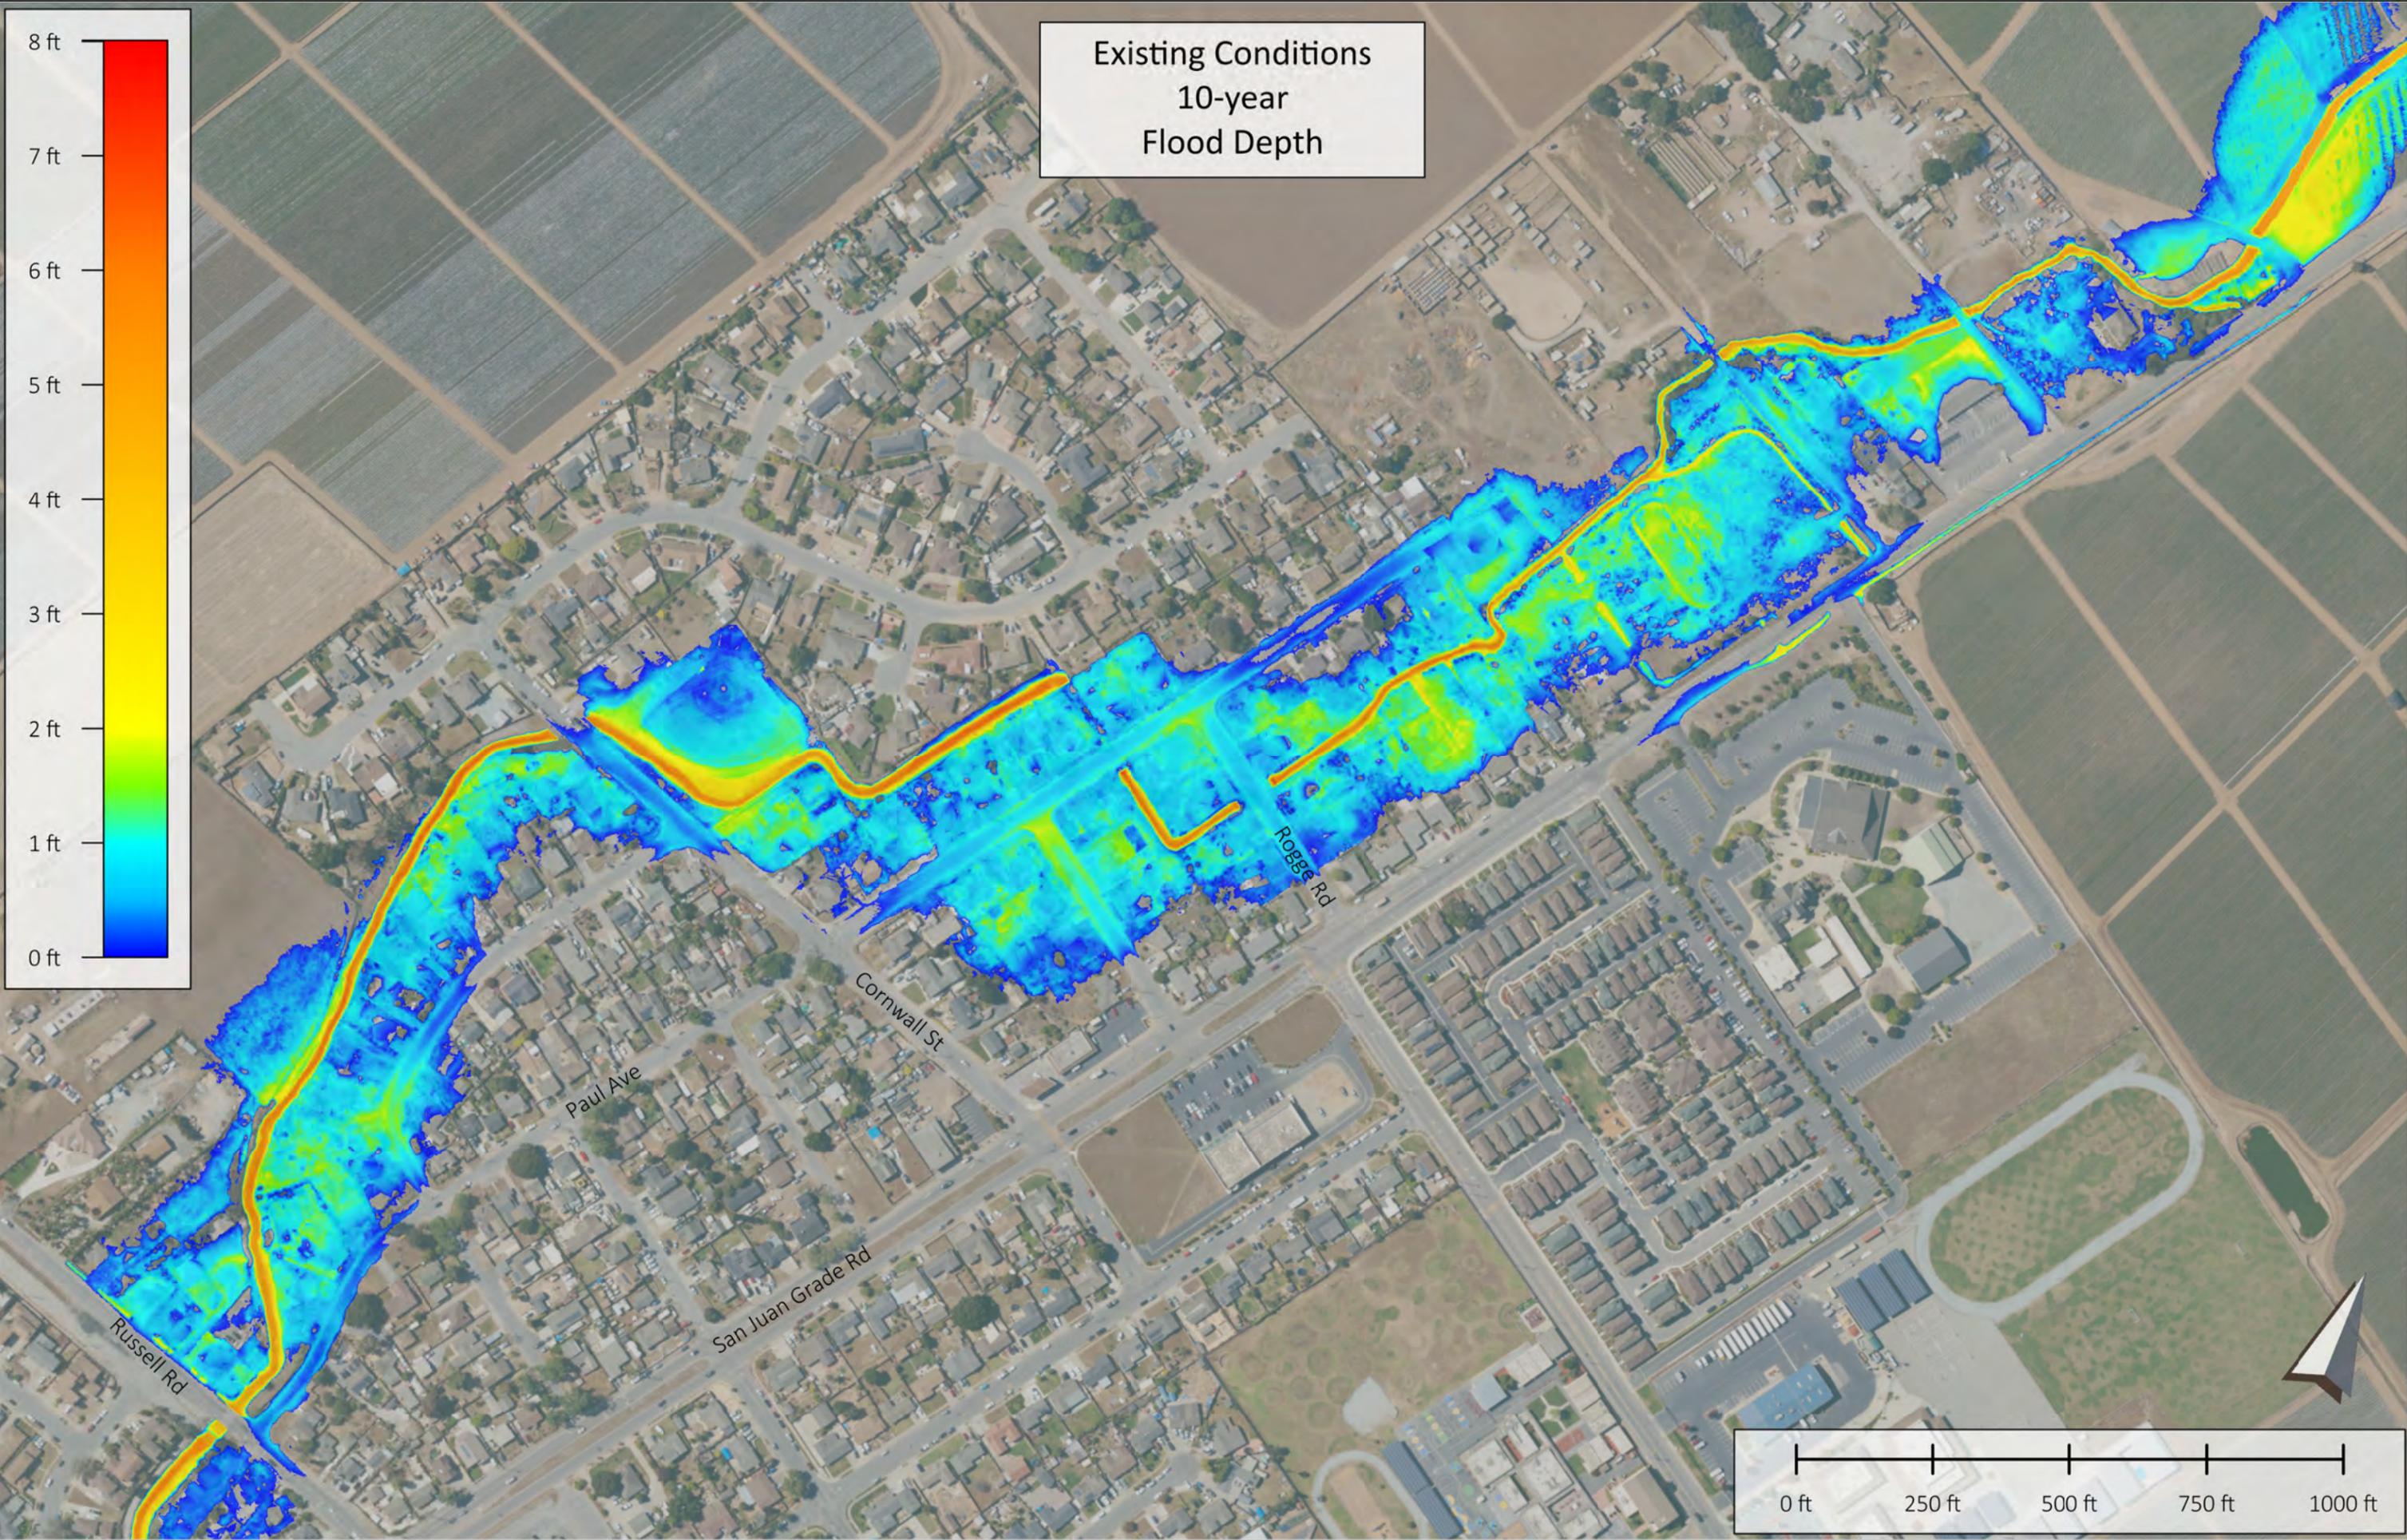
Existing Conditions
10-year
Flood Depth
