**GEOTECHNICAL INVESTIGATION  
EAST/WEST WING RENOVATION  
COURTYARD PROJECT  
240 CHURCH STREET  
SALINAS, CALIFORNIA**

**PROJECT # 20163829.001A**

**FEBRUARY 25, 2016**

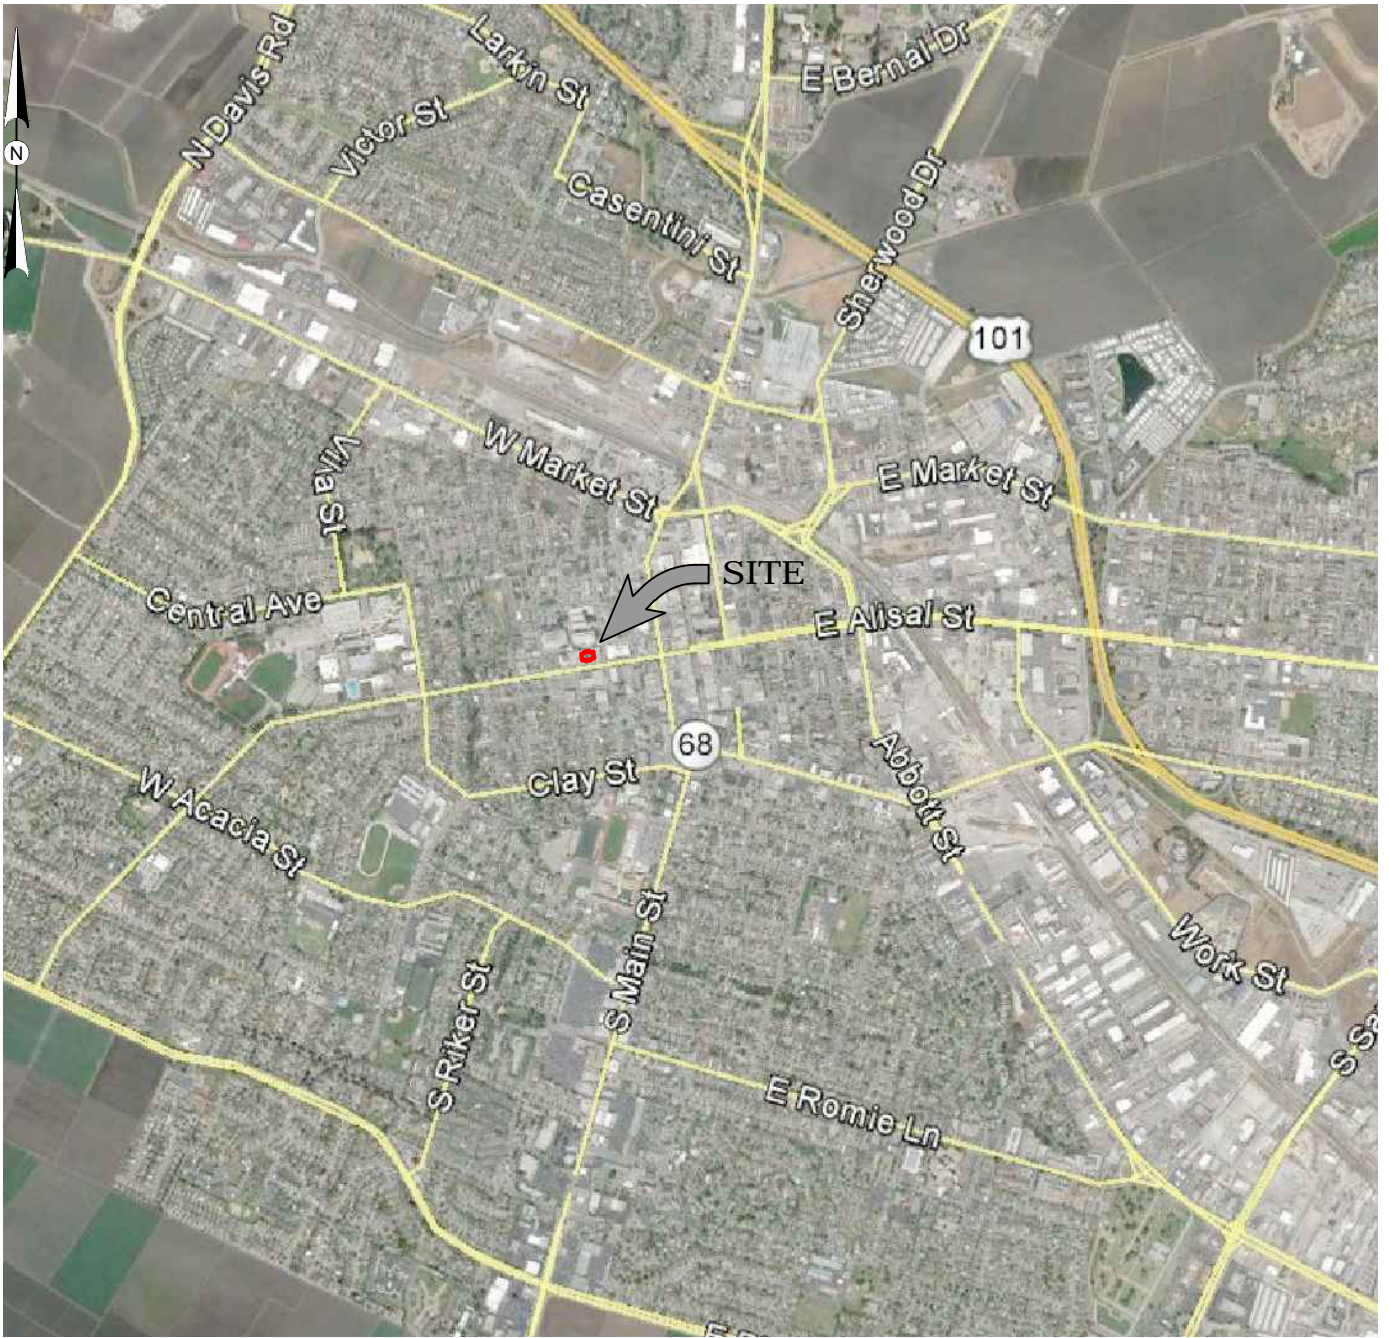
FIGURE  
 1

SITE VICINITY MAP  
 EAST/WEST WING  
 RENOVATION COURTYARD  
 240 CHURCH STREET  
 SALINAS, CALIFORNIA

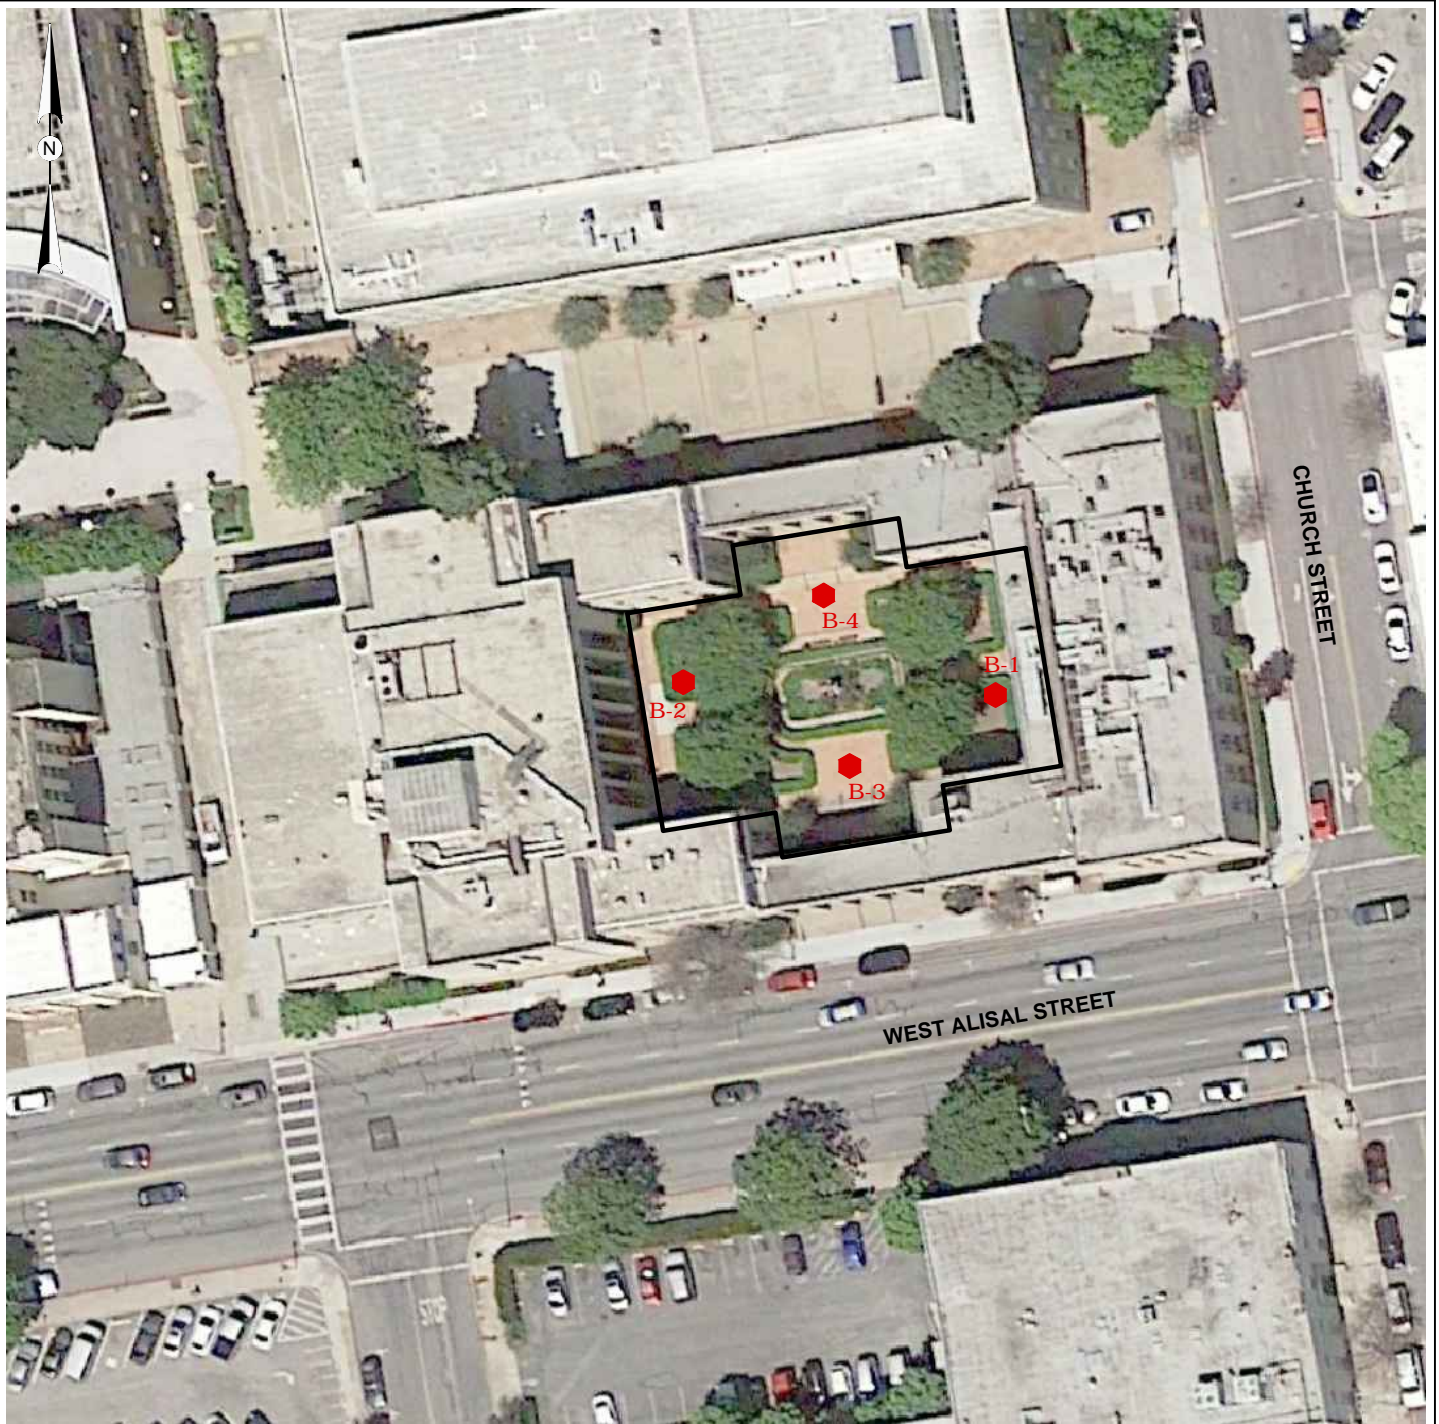
PROJECT NO. 20163829 DRAWN BY: JDS CHECKED BY: RH DATE: 02-22-2016 REVISED:	SITE PLAN	FIGURE
		EAST/WEST WING RENOVATION COURTYARD 240 CHURCH STREET SALINAS, CALIFORNIA	2

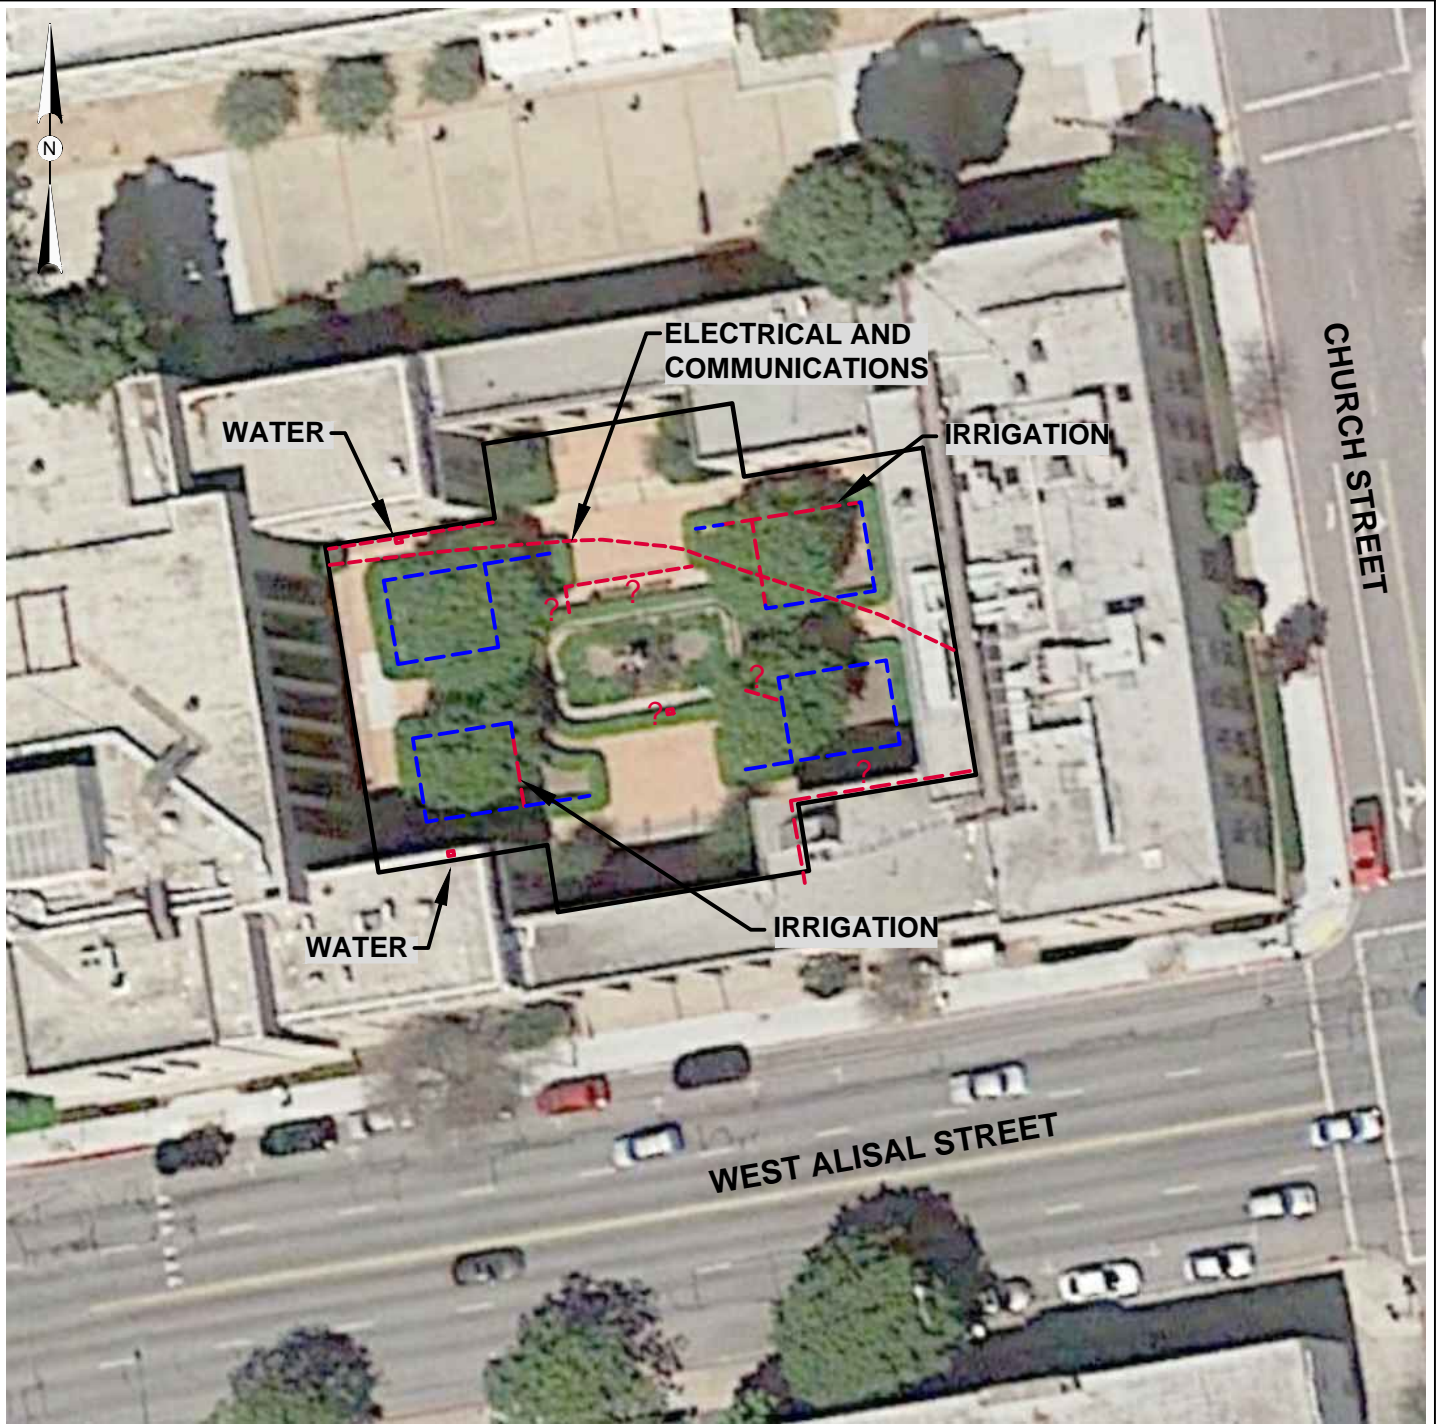
- LEGEND**
- COURTYARD PERIMETER
  - CONJECTURED IRRIGATION LINES
  - DETECTED UTILITY LINES

PROJECT NO. 20163829	<b>UTILITY PLAN</b>  EAST/WEST WING RENOVATION COURTYARD 240 CHURCH STREET SALINAS, CALIFORNIA	FIGURE  <b>3</b>
	DRAWN BY: JDS CHECKED BY: RH DATE: 02-25-2016 REVISED:

Based on our review of our ground penetrating radar survey, there appears to be buried utility ducts throughout the courtyard area. If the ducts are demolished and relocated, the debris should be removed from the site and the excavation backfilled with engineered fill. Utilities to remain active under the courtyard area and/or fill areas should be evaluated by the project civil engineer to determine if they are suitable for the new soil loads, and the construction and structural loads that will be generated by the new courtyard development. If they are not suitable, they should be replaced as determined by the project civil engineer.

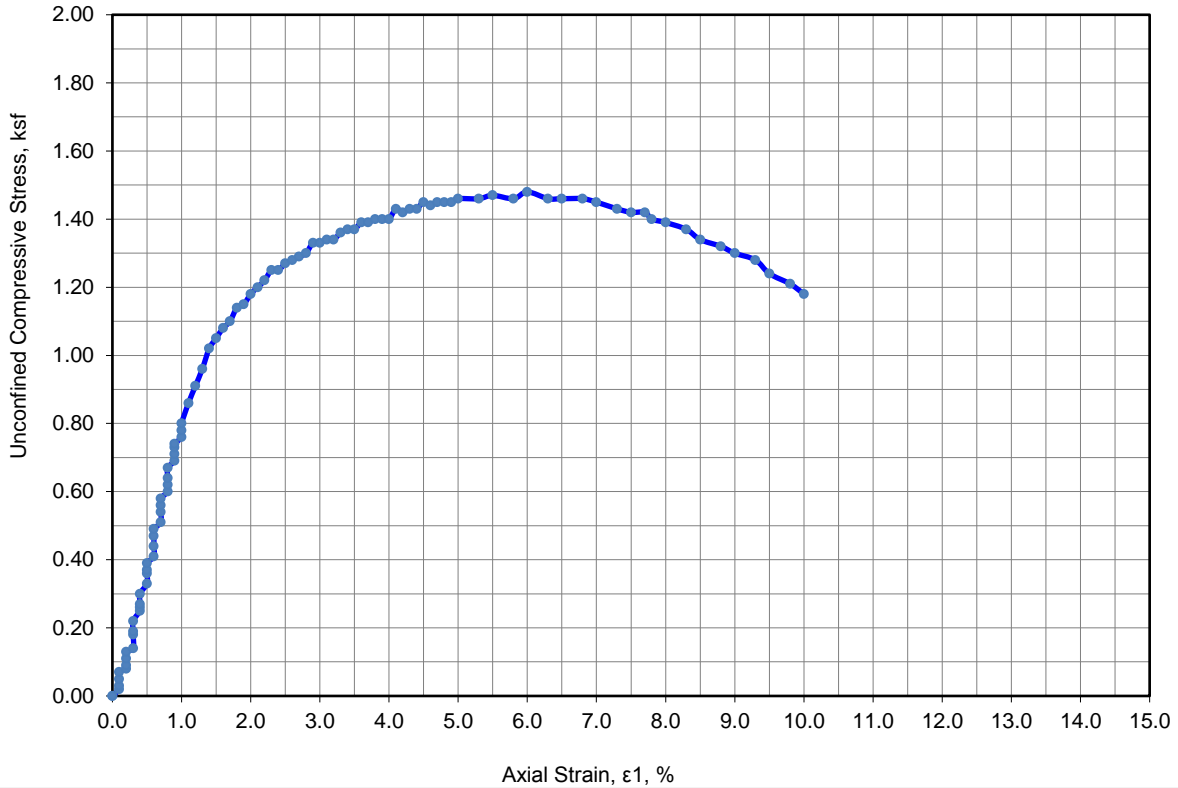
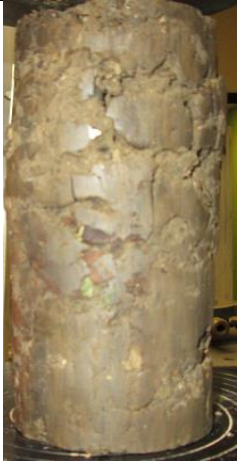
Specimen Failure Picture		Specimen No.		1

Initial	Diameter, in	$D_o$	2.38
		Height, in	$H_o$	5.63
		Height to Diameter Ratio		2.36
		Water Content, %	$\omega_o$	33.0
		Dry Density, lbs/ft <sup>3</sup>	$\gamma_{d_o}$	82.6
		Saturation, %	$S_o$	87.3
		Void Ratio	$e_o$	1.002
	Time to Failure, min.	$t_f$	6.0	
	Unconfined Compressive Strength, ksf	$q_u$	1.48	
	Shear Strength, ksf	$s_u$	0.74	
Strain at Failure, %	$\epsilon_f$	6.0		
Average Rate of Strain to Failure, %/min	$\epsilon$	1.0

Description of Specimen: Olive Fat Clay (CH)

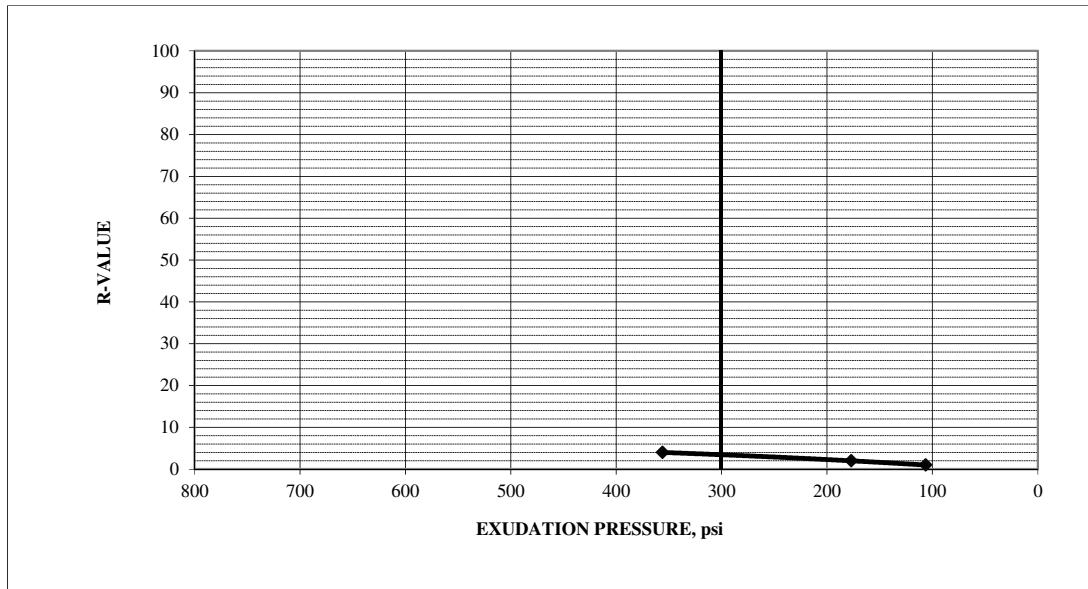
### Resistance R-Value and Expansion Pressure of Compacted Soils (ASTM D2844, CTM 301)

Briquette No.	A	B	C
Moisture at Test, %	33.7	31.6	28.5
Dry Unit Weight at Test, pcf	82.2	84.8	88.8
Expansion Pressure, psf	35	65	108
Exudation Pressure, psi	107	177	356
Resistance Value	1	2	4
<b>R - Value at 300 psi Exudation Pressure:</b>			<b>3</b>

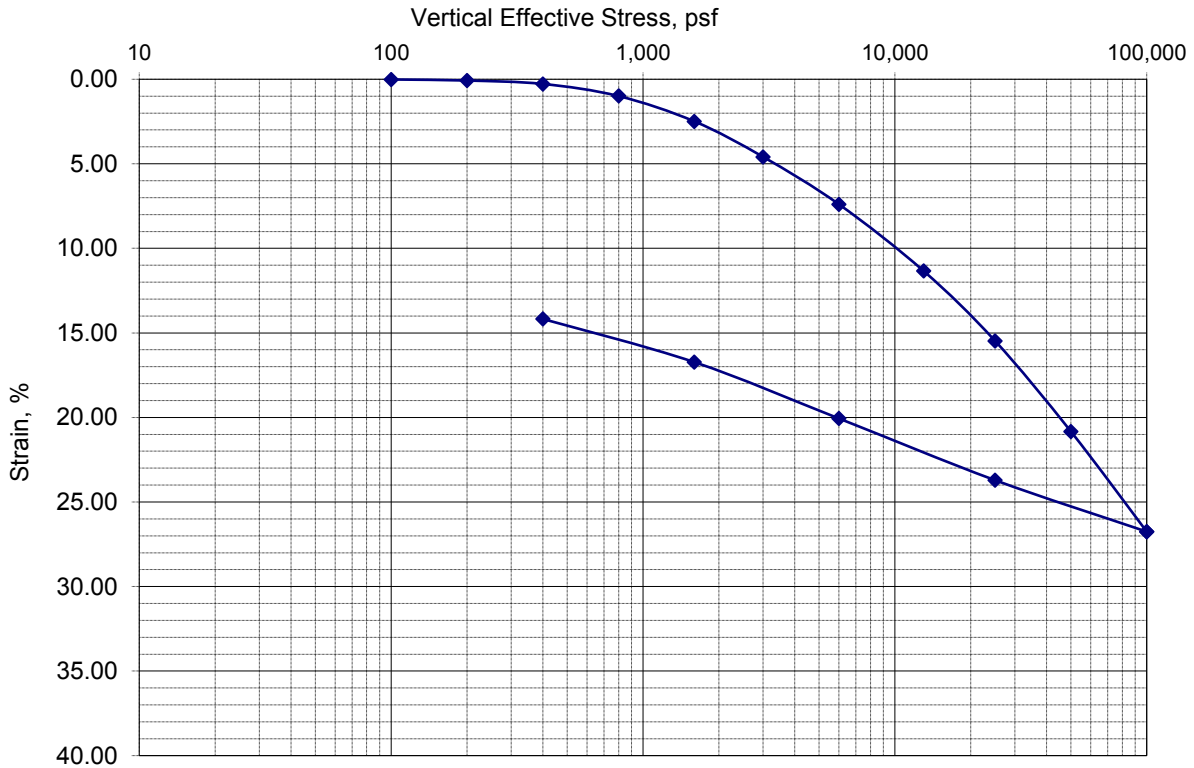
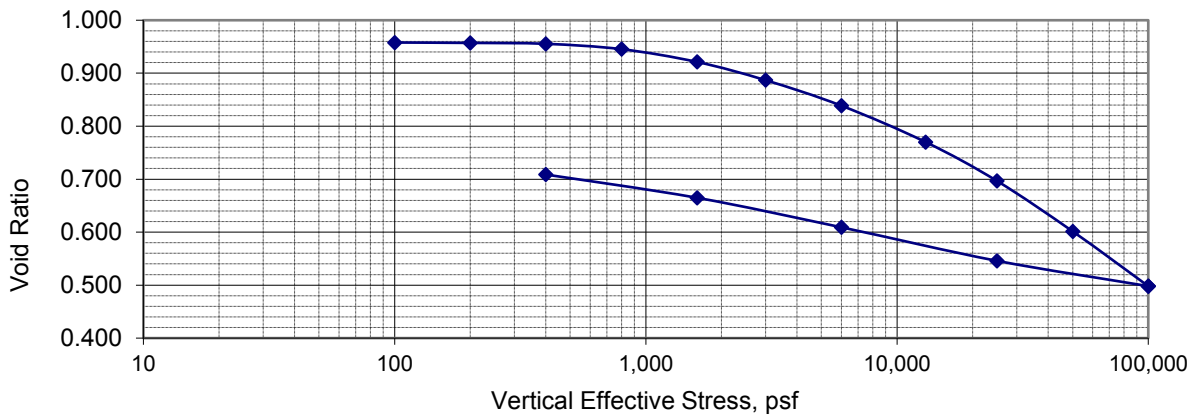
Test Method: ASTM D2435		Sample Type: Intact					
Gs: 2.65	Measured	LL: nm	PI: nm	Amount of Material Finer than the No. 200, %: nm			
	Height, in.	Diameter, in.	Water Content, %	Wet Density, lb/f <sup>3</sup>	Dry Density, lb/f <sup>3</sup>	Saturation, %	Void Ratio
Initial	0.795	1.973	33.9	113.1	84.5	94.0	0.958
Final	0.694	1.973	28.8	125.4	97.3	108.0	0.709
Boring:	B-1	Remarks:					
Sample:	1-2-1						
Depth, ft:	6						
Test Date:	2/10/16

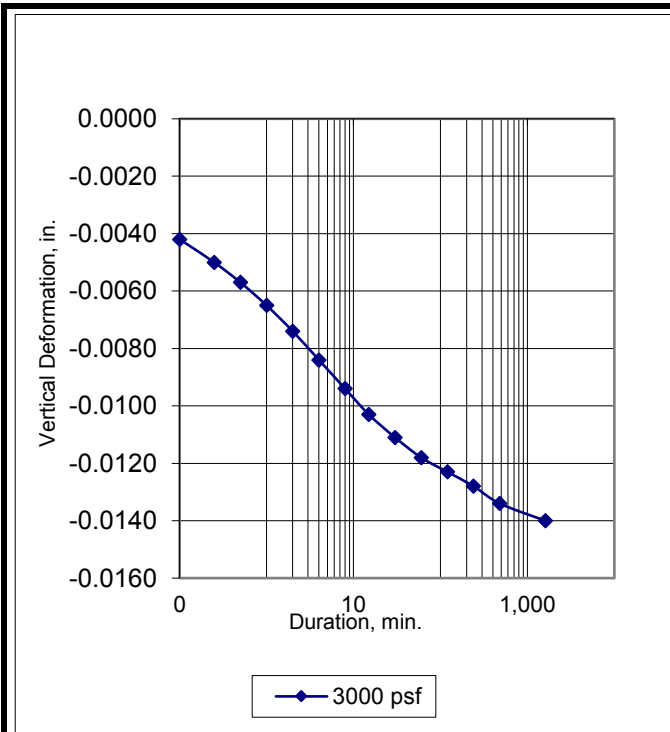
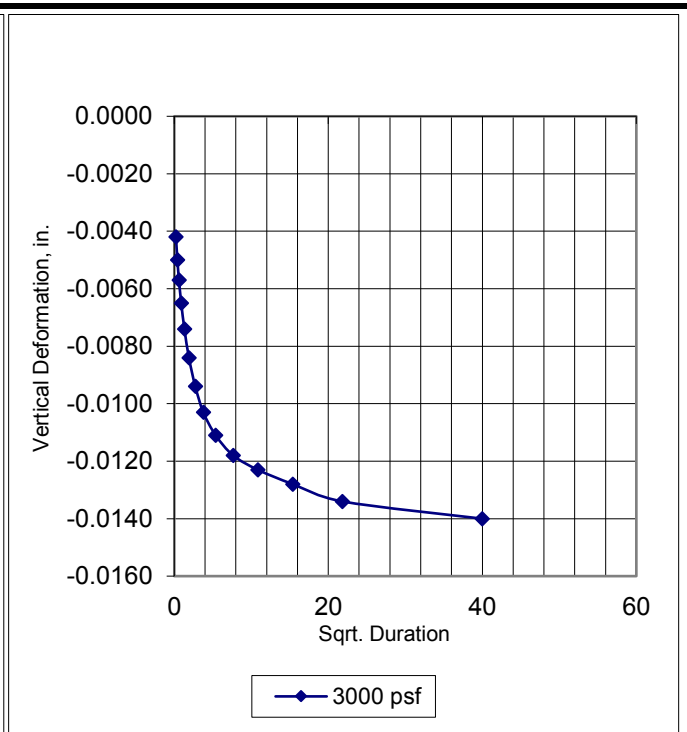
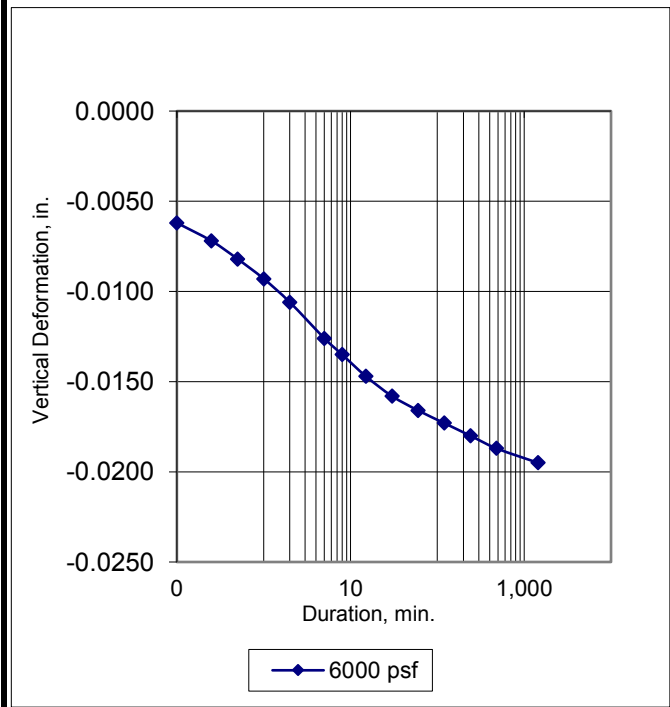
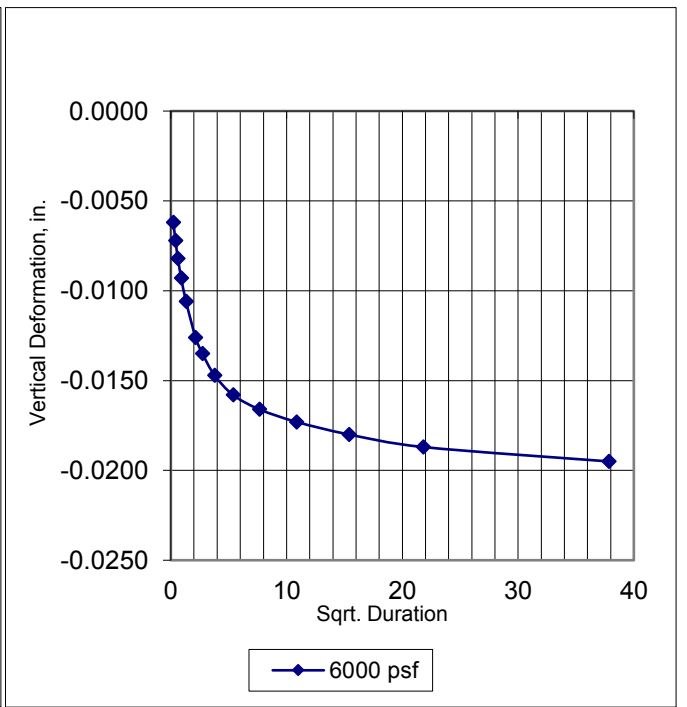
B-5a

Boring:	B-1
Sample:	1-2-1
Depth, ft:	6
Test Date:	2/10/16
