CARMEL VALLEY MANOR MASTER PLAN PHASE TWO HISTORIC ASSESSMENT REPORT

PAST Consultants, LLC
P.O. Box 721
Pacific Grove, CA 93950
September 9, 2025

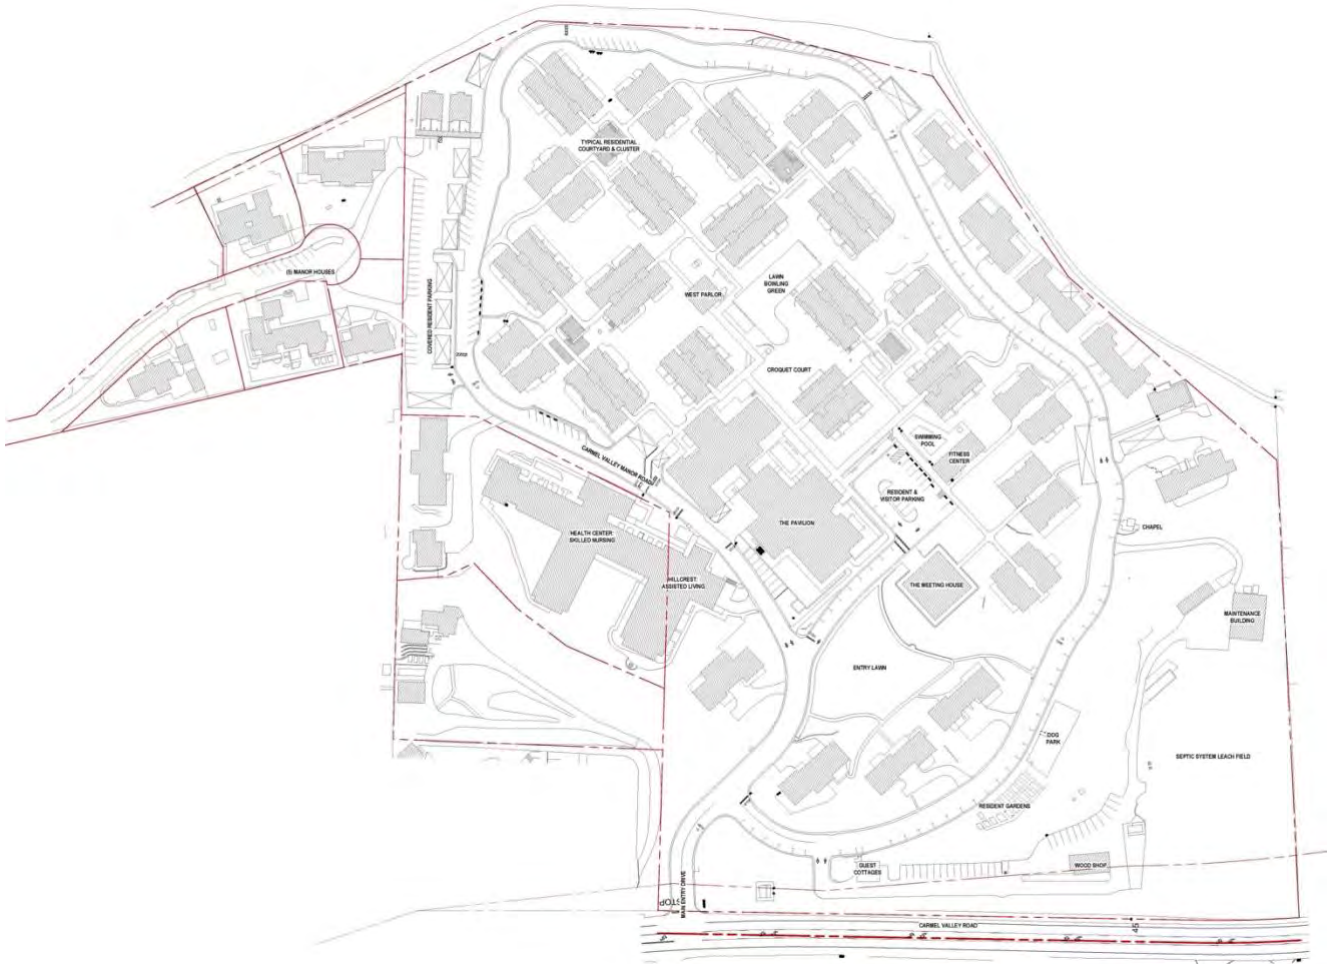
Figure 2. Site Plan showing existing buildings (*Courtesy: Perkins Eastman, 2025*).

The following shows the existing arrangement of buildings at Carmel Valley Manor (**Figure 2**).

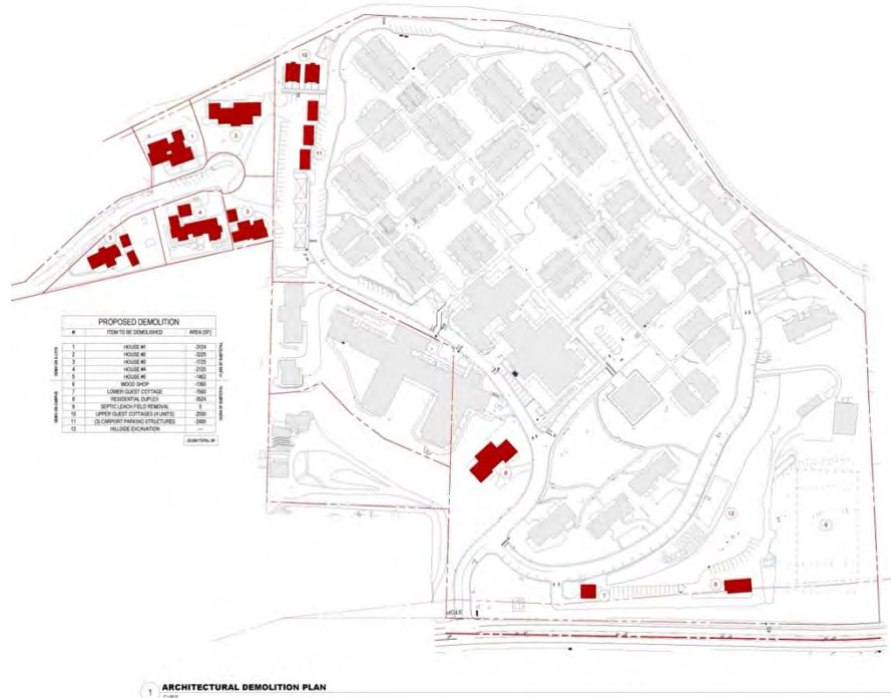
Figure 3. Site Plan showing buildings to be removed in red (Courtesy: Perkins Eastman, 2025).

The proposed project is presented on the design drawings, *Carmel Valley Manor Master Plan*, by Perkins-Eastman, dated January 9, 2025. The demolition plan indicates buildings to be removed (Figure 3).

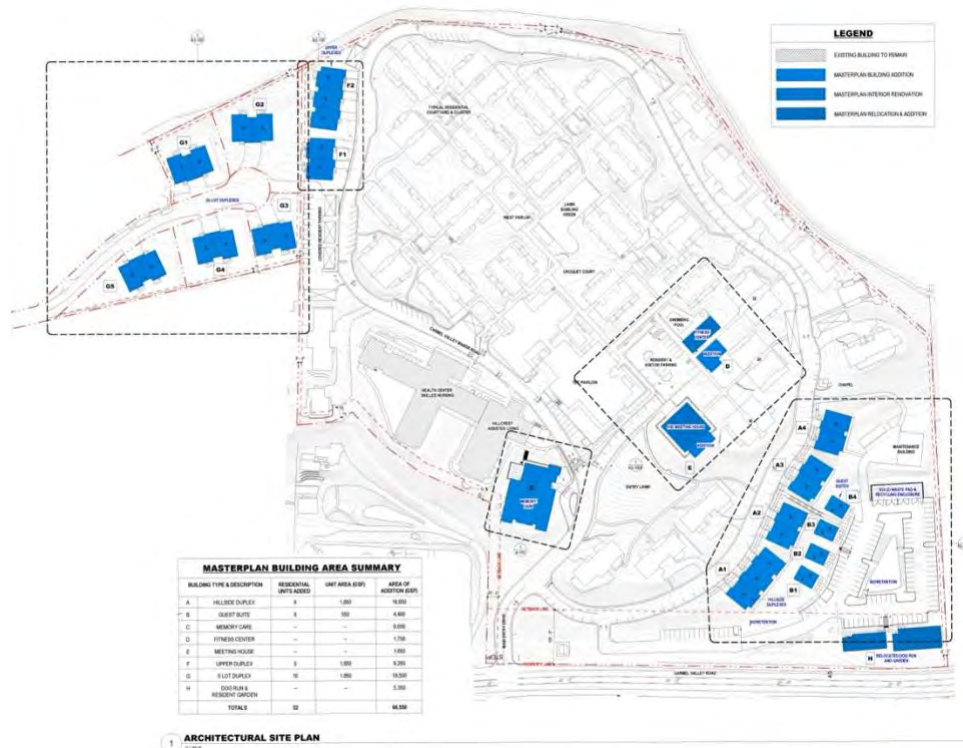
Figure 4. Site Plan showing buildings to be constructed in blue (*Courtesy: Perkins Eastman, 2025*).

The site plan showing new construction appears below (**Figure 4**).

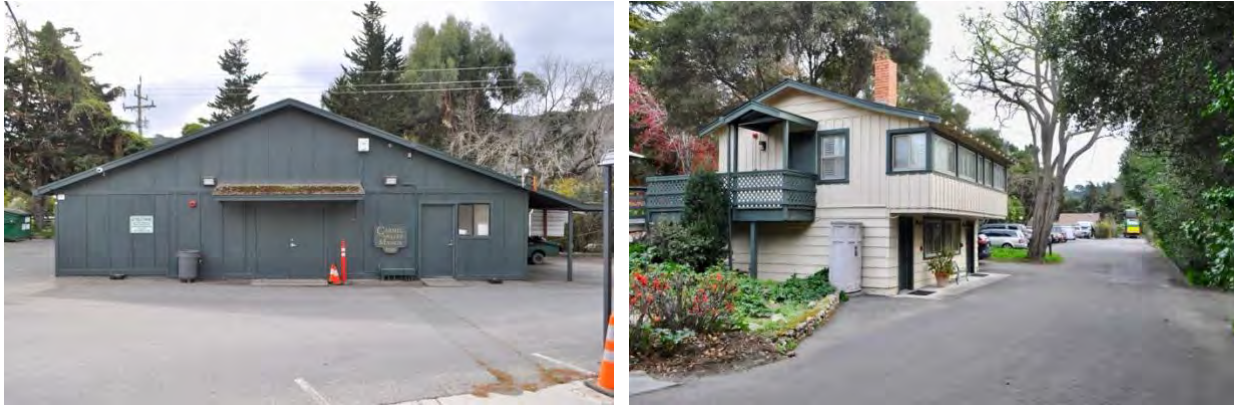
Figures 6 and 7. Left: north elevation of the Wood Shop/Maintenance Shed. Right: south and west elevations of the Lower Guest Cottage.

The Wood Shop/Maintenance Shed and the Lower Guest Cottage will be removed (**Figures 6 & 7**).

Originally the Gate House from the Hollow Hills Period, the building has been highly altered, with the building lifted and a lower story inserted, the construction of a south-elevation addition, a west elevation porch and connection to lower Carmel Valley Manor Drive, replacement of all original windows and replacement of cladding. The building does not have sufficient historic integrity, is not constructed within the SOM-designed Period of Significance and is no longer historic.

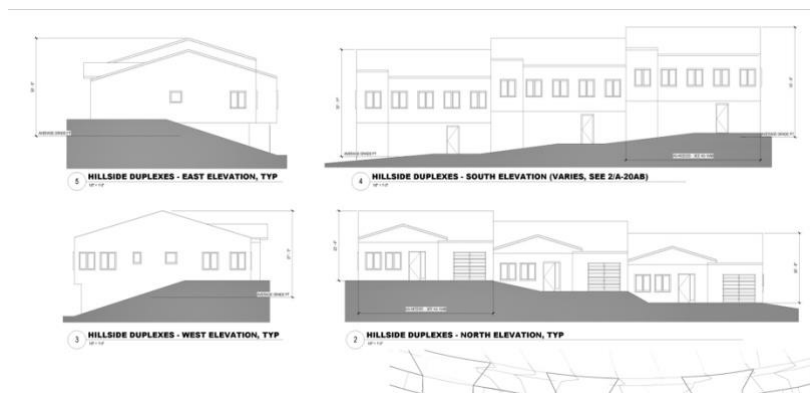
Figure 8. Elevations of proposed hillside duplexes, taken from Sheet A-10A of the Carmel Valley Master Plan design submittal.

The proposed addition of the four residential duplexes appears below (**Figure 8**).

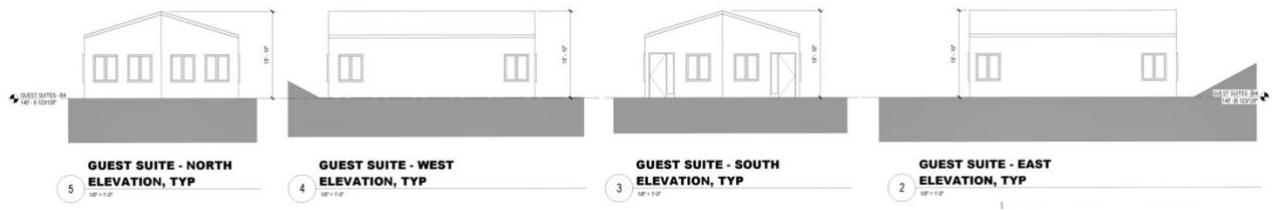
Figure 9. Elevations of proposed guest cottages, taken from Sheet A-10B of the Carmel Valley Master Plan design submittal.

Similarly, the hillside guest cottages (**Figure 9**) utilize the SOM-designed forms of gable rooflines with flush eaves but will be differentiated from the Core Campus designs by a variation of stucco finish.

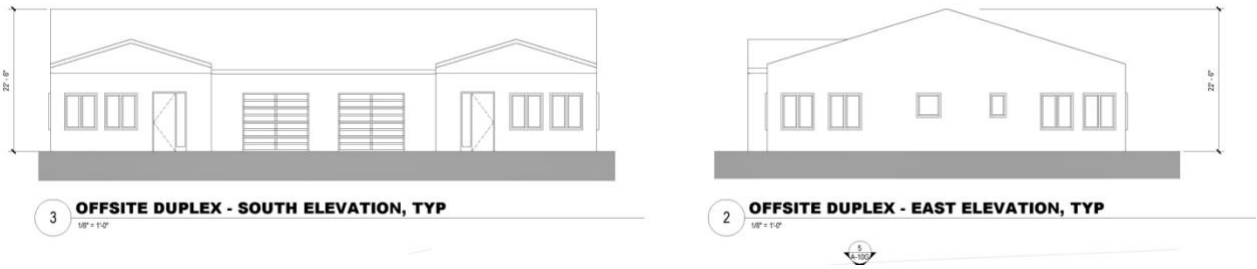
Figure 16. Elevations of the proposed Los Arboles Drive duplexes taken from Sheet A-10G of the Carmel Valley Master Plan design submittal.

The proposed design of the duplexes appears below (**Figure 16**).

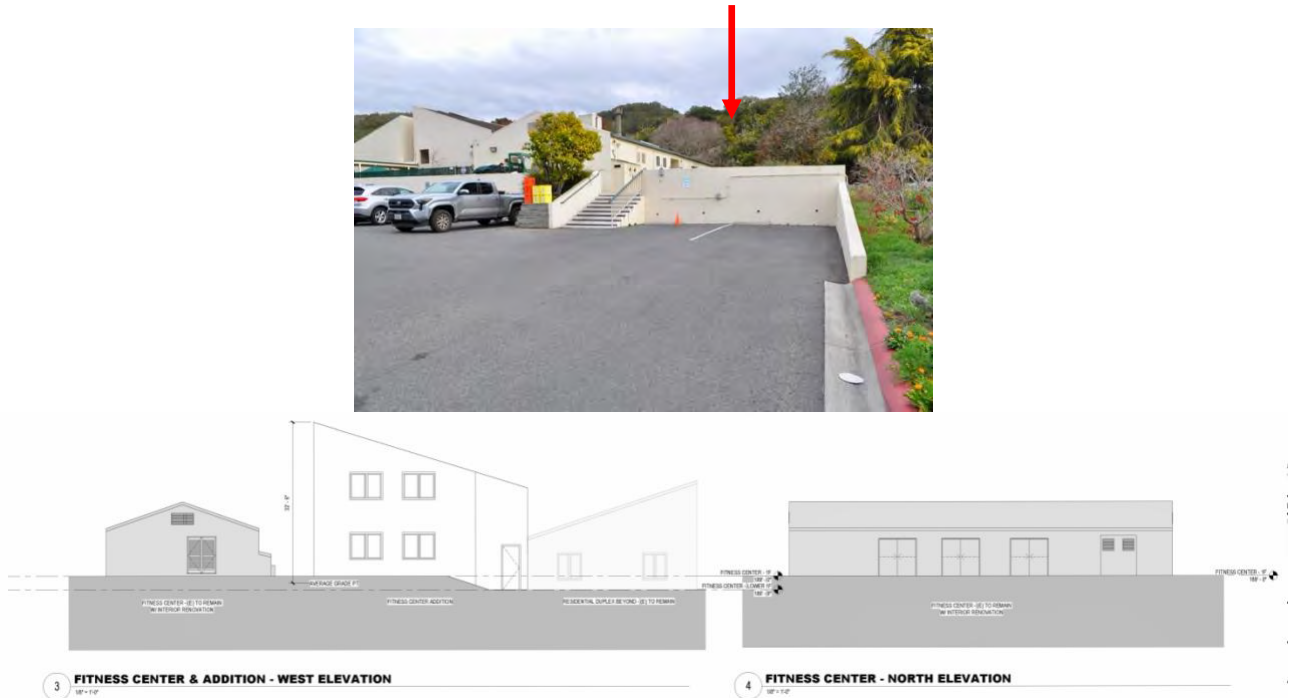
Figures 17 and 18. Two images of the proposed new Fitness Center building.

A two-story addition is proposed adjacent to and south of the existing Fitness Center. This building utilizes similar shed-roofed forms as the SOM-designed historic buildings but will be differentiated from the historic buildings in detailing and stucco finish (**Figures 17 and 18**).

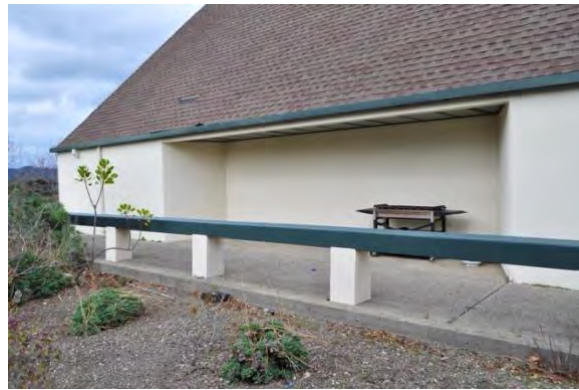
A rear (south elevation) addition is proposed for the Meeting House. The addition is of minimal size, on the least visible elevation of the building and will be differentiated from the historic building by using a flat roof and a different stucco finish, which satisfies *Standard 9* (**Figures 19 and 20**).

Figures 19 and 20. Top image shows the Meeting House’s south elevation and the location of the rear addition. This elevation faces open space and is the least visible elevation of the building. Bottom image shows the elevations of the proposed Meeting House rear addition taken from Sheet A-11E of the Carmel Valley Master Plan design submittal.

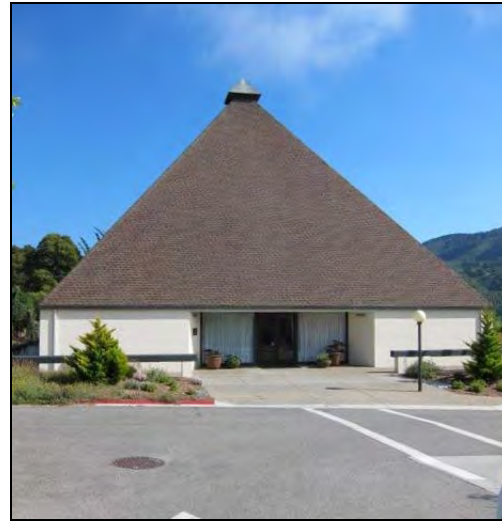
Figure 22. Front (north) elevation of Meeting House.

The most prominent building on the site, the Meeting House is square in plan with a tall pyramidal room. It features symmetrical elevations with a recessed pair of anodized aluminum entry doors on every elevation except the south. Fixed glazing with thick aluminum frames flanks the entry doors. A concrete post and rail surrounds the building. With the exception of roofing material replacement from wood shake to asphalt shingle, the building is largely unaltered.

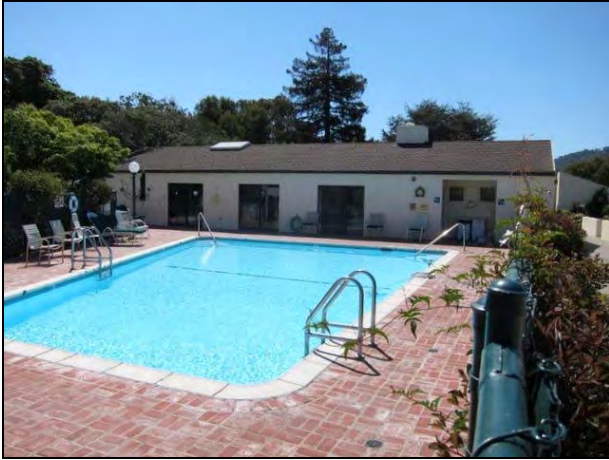
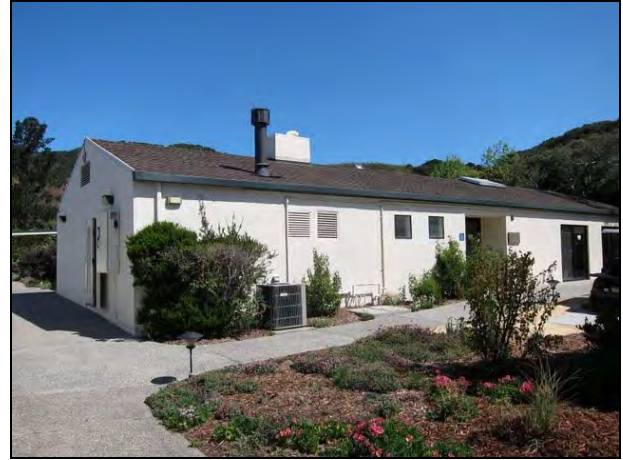
Figure 23. Front (north) elevation of the Fitness Center.

Figure 24. Rear (south) elevation of the Fitness Center.

Originally the Library, the building was highly altered when it was converted into the Fitness Center in 2001. It is a simple gable-roofed structure with an off-center chimney, a central rear entrance and modified openings containing paired sliding glass aluminum doors. Like all buildings on the campus, the Fitness Center has the same replaced asphalt shingle roof and box gutters painted green.

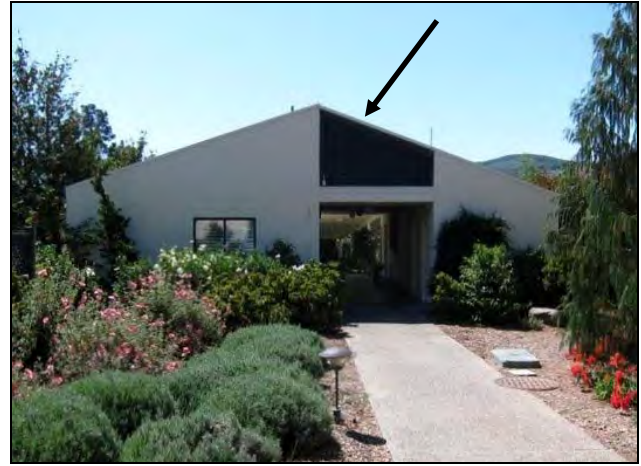
Figure 26. Rear (north) elevation of the West Parlor.
Connection of two shed roofs shown with an arrow.

A subsequent alteration includes the connection of the shed roofs and placement of large louvered vents at each building end, apparently to improve ventilation (**Figure 26**). The vent carries the same roof pitch as the two sheds, making the massing appear as a gable end, rather than individual shed forms. Other alterations common to buildings on campus include the in-kind replacement of aluminum slider windows and patio doors; and replacement of original shake roof with asphalt shingles.

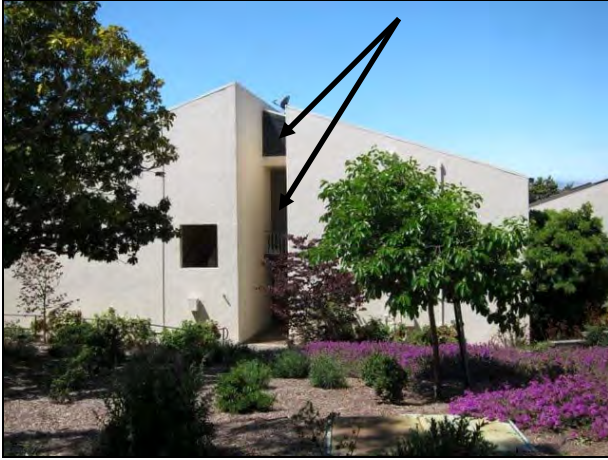
Figure 27. Rear (east) elevation of the Bldg. 17.
Louvered vent and glazing alteration shown with arrows.

A subsequent alteration includes the connection of the two roof forms and placement of large louvered vents at each building end, apparently to improve ventilation. The vent's roof carries the same roof pitch as the two sheds, making the massing appear as a gable end, rather than individual shed forms. The alteration is less prominent on this building type, as the vent is inset from the outer shed walls (**Figure 27**). Glazing is placed below the vents on the second floor to protect upstairs residents from the wind. Other alterations common to buildings on campus include the in-kind replacement of aluminum patio doors; replacement of original shake roof with asphalt shingles; the installation of retractable awnings over the sliding glass doors; and the installation of skylights and a satellite dish to the roof. Individual apartments have been combined on many of the buildings to provide more living space.

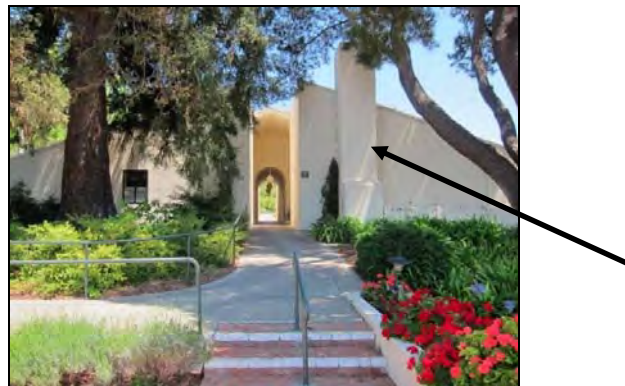
Figure 31. Front (west) elevation of Bldg. 2. Note chimney (arrow) and window in left shed end.

An alteration common to this building type consists of the addition of windows in the shed ends on most of the buildings. Chimneys for furnaces are installed on some of the shed ends. This feature does not appear on the SOM drawings, indicating that this may have been an early design change or is a subsequent alteration (**Figure 31**). Another common alteration is the extension of side façade outer building walls into the patio areas to provide greater living space. This has been done to most units (**Figure 30**). In-kind replacement of aluminum windows and patio doors, awnings, skylights and satellite dishes are also common.

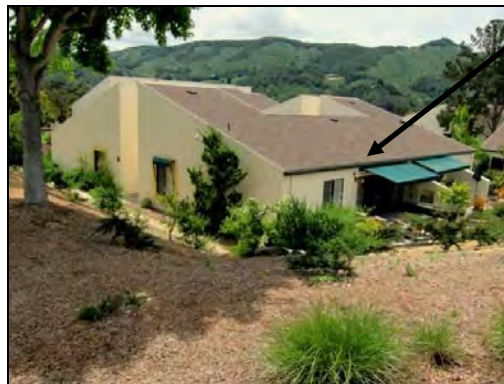
Figure 34. Overall view of Bldg. 18 with full outer wall extension (arrow).

An alteration common to this building type consists of moving the outer wall into the patio area, extension of the roofline, and installation of a window in the shed end. This has been done to most units (**Figure 34**). In-kind replacement of aluminum windows and patio doors, awnings, skylights and satellite dishes are also common alterations.

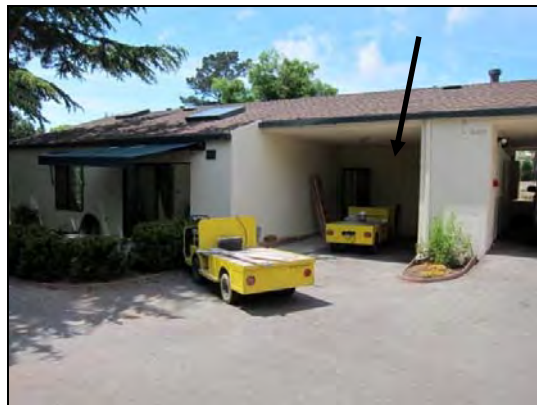
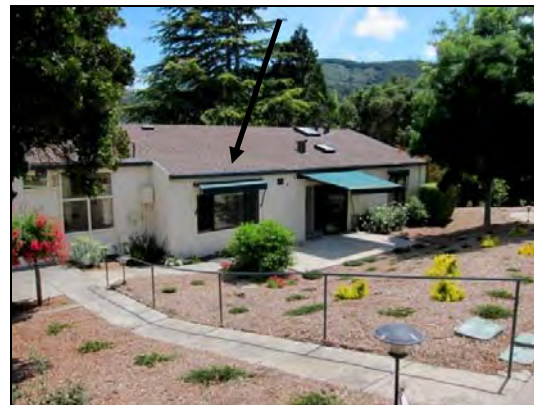
Figure 37. Bldg 29 conversion of garage to study.

Figure 38. Rear of Bldg. 29 showing garage conversion.

A handful of units have undergone removal of the closets in the garage and conversion of the space into an additional room (**Figure 37**). A wide aluminum slider window is installed in the rear façade of units with the garage conversion (**Figure 38**). In-kind replacement of aluminum windows and patio doors, awnings and skylights are also common alterations.

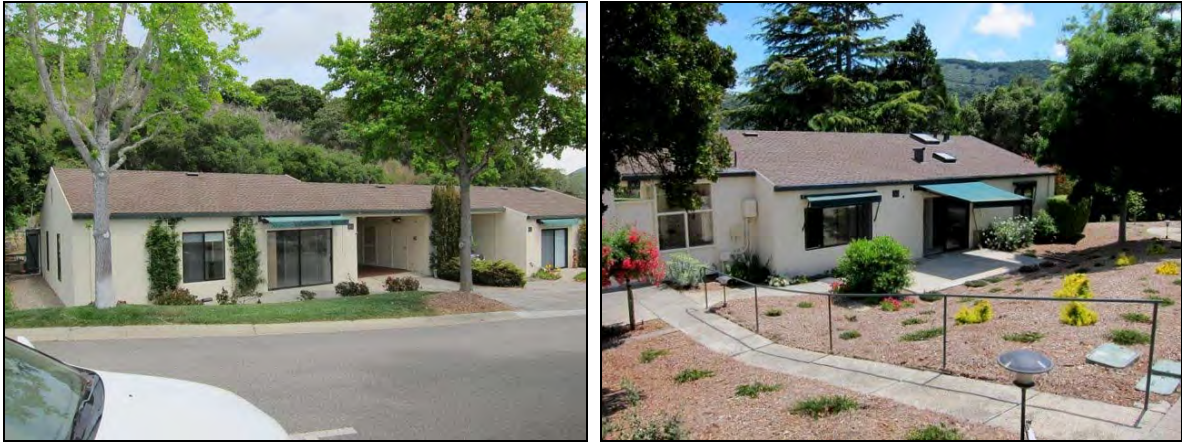
Figures 8 and 9. Typical front and rear elevations of Building Type D. Right image shows window added to rear wall as part of typical carport conversion.
